Visual Site Inspection Report

Project Name H-600 Pipeline Spread G		AFE 124300137	Spread H-600 Pipeline Spread G
Contractor Precision		Report # 40506	
Inspector Patrick Shields		Date/Time 8/1/2022 3:48 PM	
Permit # TBD	Inspection Type VA SWPP	Station Begin	10929+80
State VA	Inspection Area Full	Station End	11023+80
County Giles	Ground Wet	Temperature (°F)	77.00
Municipality N/A	Weather Light Rain	Rain Gauge (in)	0.10
			Rain Accumulation Time (days) 1.00

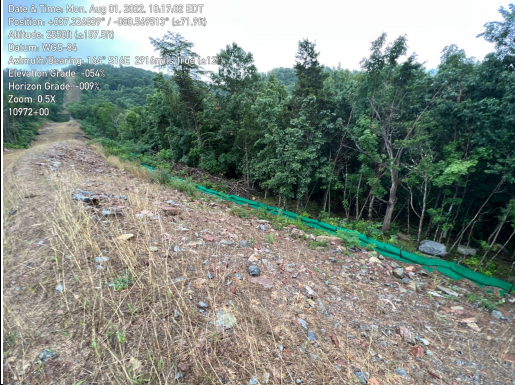
GPS Location	See photo	GPS Location	See photo
Field Station#	10972+00	Field Station#	10968+00
Pic 7 Desc.	CFS triple stack perimeter control in place	Pic 8 Desc.	Waterbars in place

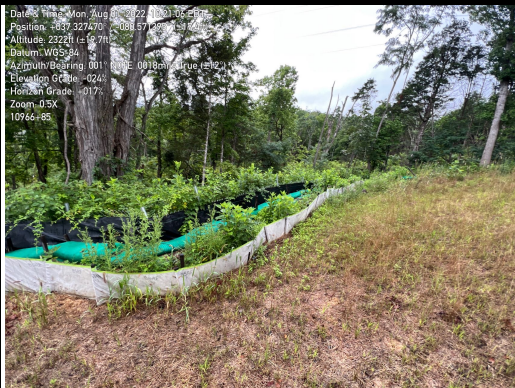
Triple barrier protection around karst feature located at station number 10966+00.
 RCEs in place and maintained at Doe Creek Road crossing, Access Road 244, and Access Road 241.02.
 The ROW is wet and in stable condition. No sensitive resources have been impacted.
 Brickyard rain gauge measured 0.1" of accumulated rainfall.

GPS Location	See photo	GPS Location	See photo
Field Station#	10966+85	Field Station#	10963+25
Pic 9 Desc.	Triple protection ECDs in place at karst feature	Pic 10 Desc.	Cleanwater diversion outlet protection in place

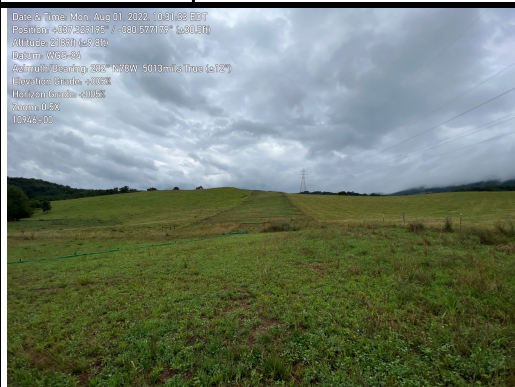
GPS Location	See photo	GPS Location	See photo
Field Station#	10946+00	Field Station#	10930+40
Pic 11 Desc.	Permanent vegetation present	Pic 12 Desc.	RCE in place

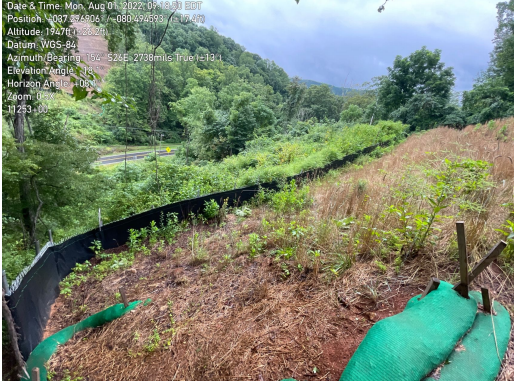
<p><small>Date & Time: Mon, Aug 01, 2022, 09:12:05 EDT Position: +037.3016567, -080.4956765, 11250.00 Altitude: 2089 ft (+1390m) Datum: WGS-84 Azimuth/Bearing: 102.579E 1992mils True (+12) Elevation Angle: -17.3 Horizon Angle: +00.7 Zoom: 1.0X 11250+00</small></p>			
GPS Location	See photo	GPS Location	See photo		
Field Station#	11253+00	Field Station#	11250+00		
Pic 1 Desc.	SSF in place	Pic 2 Desc.	Picture showing condition of row

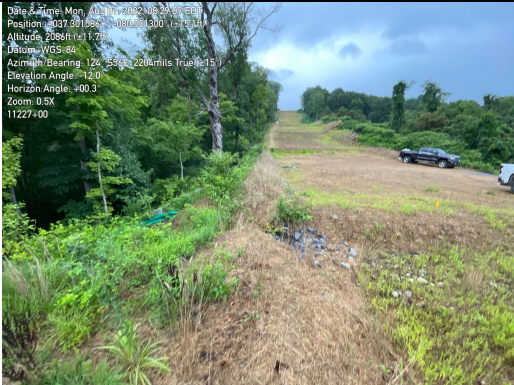
GPS Location	See photo	GPS Location	See photo		
Field Station#	11227+00	Field Station#	11217+00		
Pic 3 Desc.	Inlet in place	Pic 4 Desc.	Subsidence being monitored

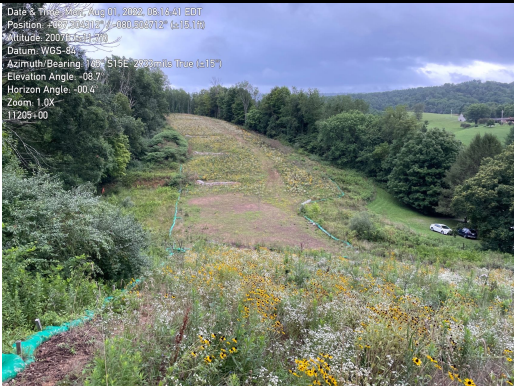
<p><small>Date & Time: Mon, Aug 01, 2022, 08:13:41 EDT Position: +037.3016567, -080.5095917, 11191.00 Altitude: 1924 ft (+580m) Datum: WGS-84 Azimuth/Bearing: 125.558E 2222mils True (+15) Elevation Angle: -12.1 Horizon Angle: -01.2 Zoom: 2.0X 11191+00</small></p>			
GPS Location	See photo	GPS Location	See photo		
Field Station#	11205+00	Field Station#	11191+00		
Pic 5 Desc.	Stabilization being monitored	Pic 6 Desc.	Clean water drainage feature in place

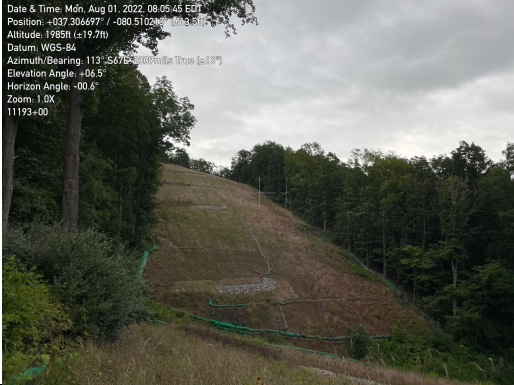
Pic 7 Desc.	Permanent water bars and level spreader in place. Stabilization in place	Pic 8 Desc.	Picture showing condition of row
--------------------	---	--------------------	----------------------------------

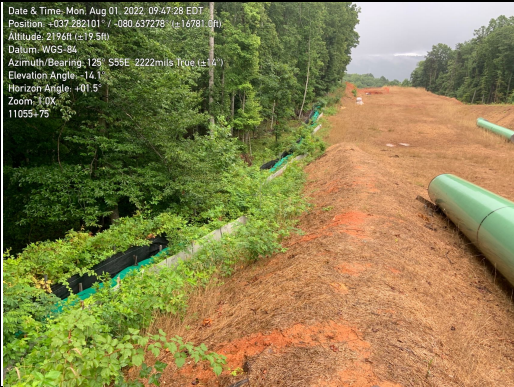
GPS Location	See photo
Field Station#	11055+75
Pic 7 Desc.	Section of Row showing conditions and controls

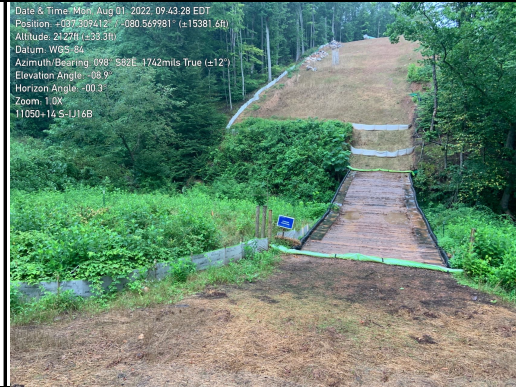
GPS Location	See photo
Field Station#	11050+14
Pic 8 Desc.	Section of Row showing conditions and controls S-IJ16B

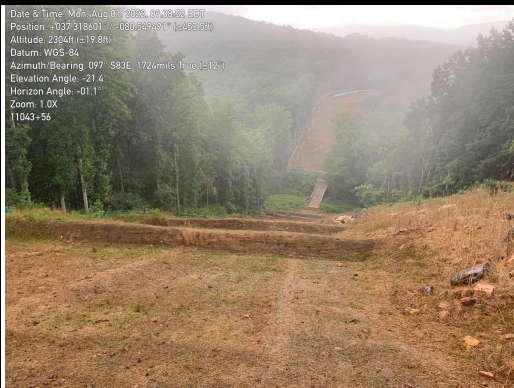
GPS Location	See photo
Field Station#	11043+56
Pic 9 Desc.	Section of Row showing conditions and controls

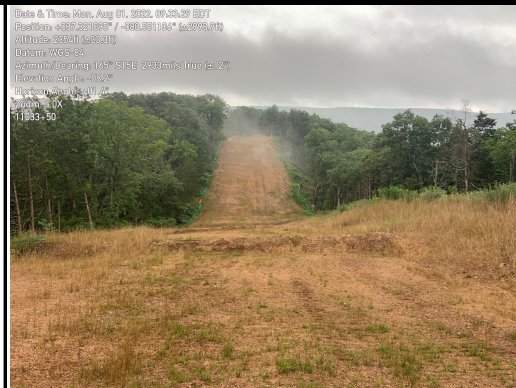
GPS Location	See photo
Field Station#	11033+50
Pic 10 Desc.	Section of Row showing conditions and controls

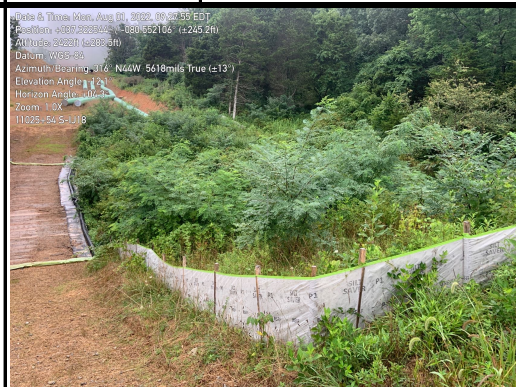
GPS Location	See photo
Field Station#	11025+54
Pic 12 Desc.	Section of Row showing conditions and controls at S-IJ18

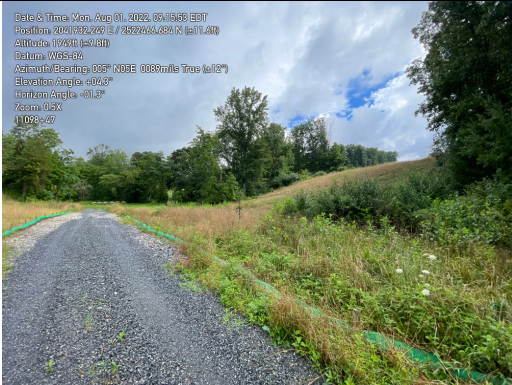
<p>Date & Time: Mon, Aug 01, 2022, 09:21:49 EDT Position: 2092357.206 E / 2922743.651 N (lat/lon) Altitude: 1033ft (lat/lon) Datum: WGS-84 Azimuth/Bearing: 035° N35E 032mils True (lat/lon) Elevation Angle: +09.6° Horizon Angle: +03.0° Zoom: 0.5X 11105+00</p>		
GPS Location 1		GPS Location 2			
Field Station# 11098+47		Field Station# 11105+00			
Pic 1 Desc. Crossing AR 245.02.		Pic 2 Desc. Section of restored RoW showing conditions and controls.

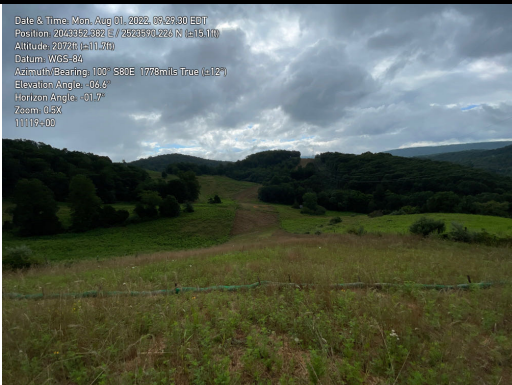
GPS Location 3		GPS Location 4			
Field Station# 11119+00		Field Station# 11131+00			
Pic 3 Desc. Section of restored RoW showing conditions and controls.		Pic 4 Desc. Section of restored RoW showing conditions and controls.

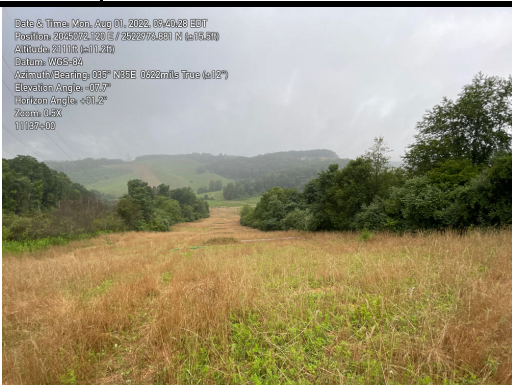
<p>Date & Time: Mon, Aug 01, 2022, 09:46:49 EDT Position: 2096270.822 E / 2922643.922 N (lat/lon) Altitude: 2053ft (lat/lon) Datum: WGS-84 Azimuth/Bearing: 330° N30W 587mils True (lat/lon) Elevation Angle: +11.8° Horizon Angle: +02.4° Zoom: 0.5X 11151+00</p>		
GPS Location 5		GPS Location 6			
Field Station# 11137+00		Field Station# 11151+00			
Pic 5 Desc. Section of restored RoW showing conditions and controls.		Pic 6 Desc. Section of RoW showing conditions and controls.

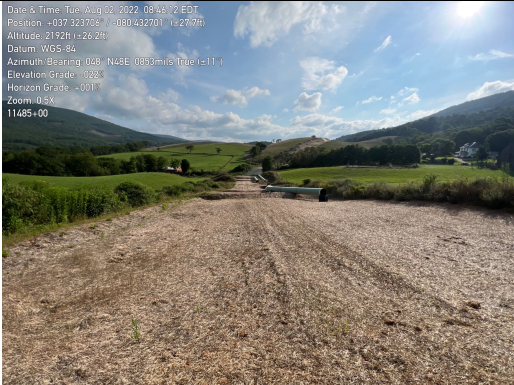
Completed VA SWPPP inspection from ST# 11471+56 (Steele Acres) to ST# 11524+16 (AR-258.02)
 Accompanied by fellow EI Jared Saunders on SWPPP inspection of MP 217.26 to MP 218.26
 Deficiencies found at the following station numbers:
 11471+56 to 11524+16 Overseed and fertilize this section of ROW.
 All issues have been communicated to PPL contractor via punch list
 Active construction site; additional deficiencies may be identified by other EIs.
 Observed since last VA SWPPP inspection environmental crew has completed punch list item# 3158 ST# 11505+90 to 11507+65
 Repair multiple broken stakes and holes in P1 silt fence perimeter control damaged by livestock.
 This section of ROW has undergone temporary stabilization. Topsoil stock piles and cleanwater diversion berms have been stabilized.
 Slope drains with stone inlet protection, Perimeter controls, and waterbars with end treatments are in place.

GPS Location See photo		GPS Location See photo		GPS Location See photo			
Field Station# 11485+00		Field Station# 11472+25		Field Station# 11476+75			
Pic 1 Desc. This section of ROW needs overseeded		Pic 2 Desc. Triple protection ECDs in place at karst feature		Pic 3 Desc. Stone inlet protection in place			
GPS Location See photo		GPS Location See photo		GPS Location See photo			
Field Station# 11476+75		Field Station# 11477+00		Field Station# 11479+00			
Pic 3 Desc. Stone inlet protection in place		Pic 4 Desc. Supersilt fence perimeter control in place		Pic 5 Desc. Cleanwater drainage feature in place

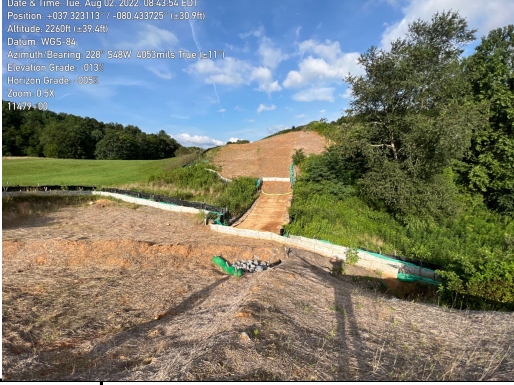
GPS Location See photo		GPS Location See photo		GPS Location See photo			
Field Station# 11479+00		Field Station# 11488+85		Field Station# 11488+85			
Pic 5 Desc. Cleanwater drainage feature in place		Pic 6 Desc. Plunge pool in place

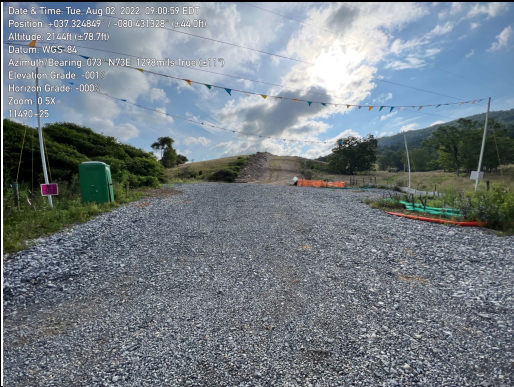
GPS Location	See photo	GPS Location	See photo
Field Station#	11490+25	Field Station#	11494+00
Pic 7 Desc.	RCE in place	Pic 8 Desc.	P1 silt fence perimeter control in place

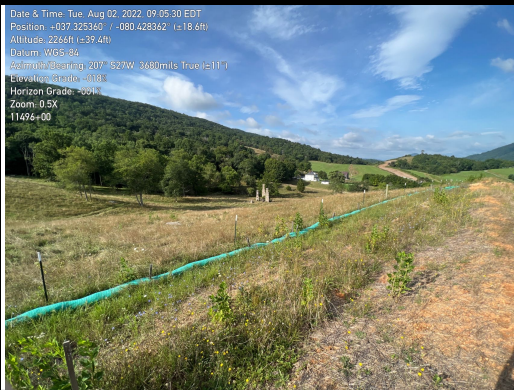
GPS Location	See photo	GPS Location	See photo
Field Station#	11496+00	Field Station#	11503+50
Pic 9 Desc.	CFS perimeter control in place	Pic 10 Desc.	Cleanwater diversion berm in place

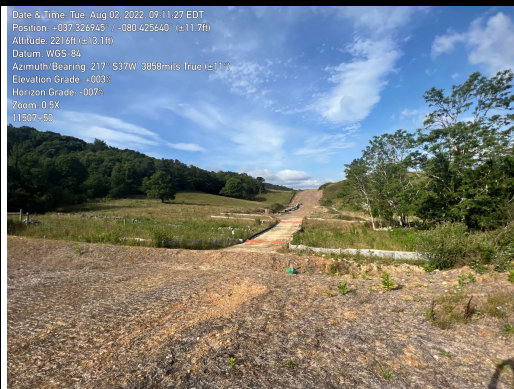
GPS Location	See photo	GPS Location	See photo
Field Station#	11507+50	Field Station#	11512+25
Pic 11 Desc.	Stream buffer in place	Pic 12 Desc.	Cleanwater drainage feature in place

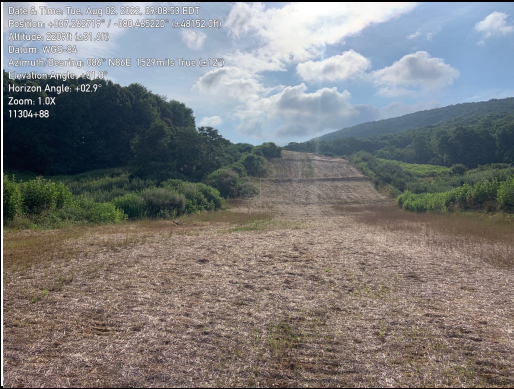
Field Station# 11304+88

Pic 7 Desc. Section of Row showing conditions and controls

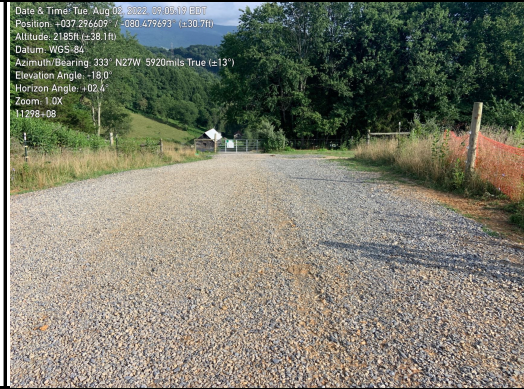
Field Station# 11298+08

Pic 8 Desc. AR253.03

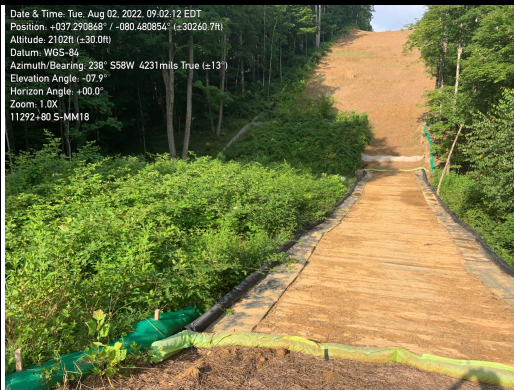
Field Station# 11292+80

Pic 9 Desc. Section of Row showing conditions and controls at S-MM18

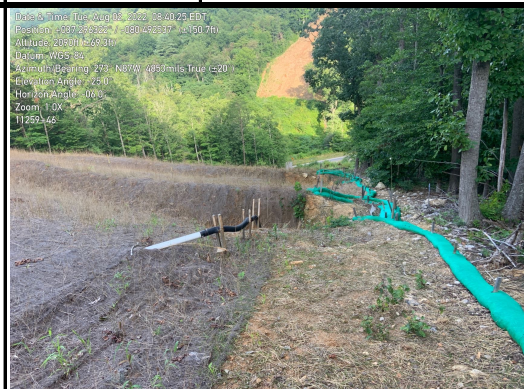
Field Station# 11270+00

Pic 11 Desc. Sump pit, plunge pool and perimeter controls are in acceptable condition

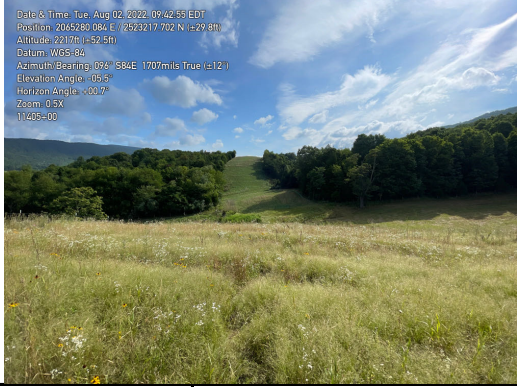
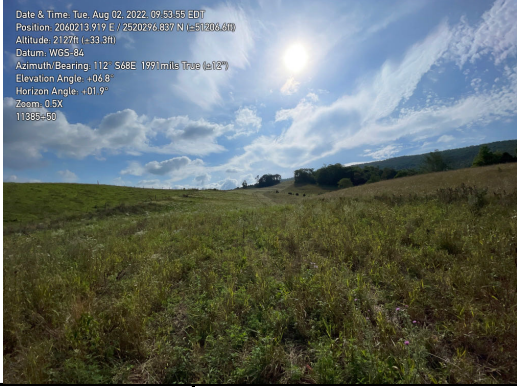
GPS Location	9	GPS Location	10
Field Station#	11405+00	Field Station#	11385+50
Pic 9 Desc.	Section of restored RoW showing conditions and controls.	Pic 10 Desc.	Section of restored RoW showing conditions and controls.

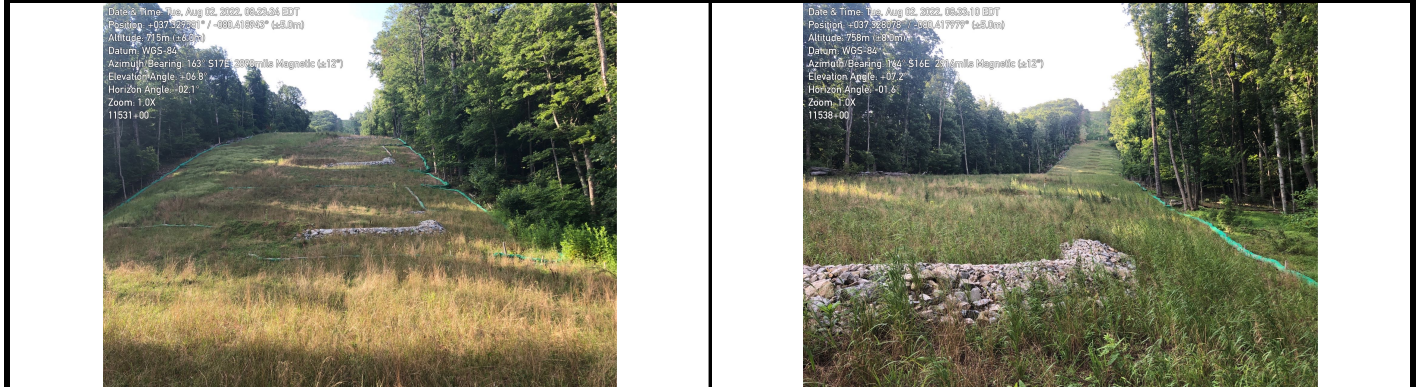
GPS Location	On photo	GPS Location	On photo
Field Station#	11531+00	Field Station#	11538+00
Pic 1 Desc.	ROW stable. ECDs in place.	Pic 2 Desc.	Restored ROW has good vegetation coverage.

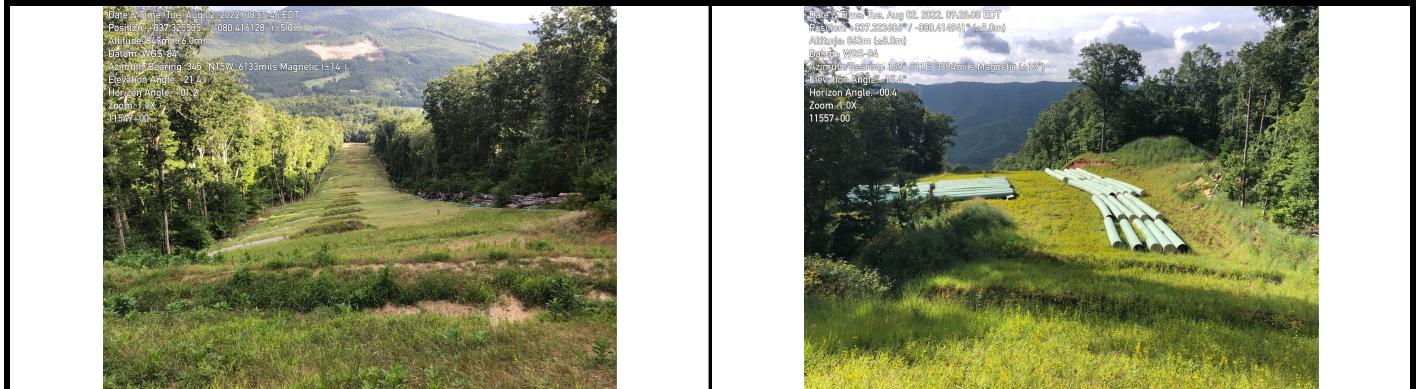
GPS Location	On photo	GPS Location	On photo
Field Station#	11549+00	Field Station#	11557+00
Pic 3 Desc.	ROW stable. Slope breakers functional.	Pic 4 Desc.	ROW stable with no erosion occurring.

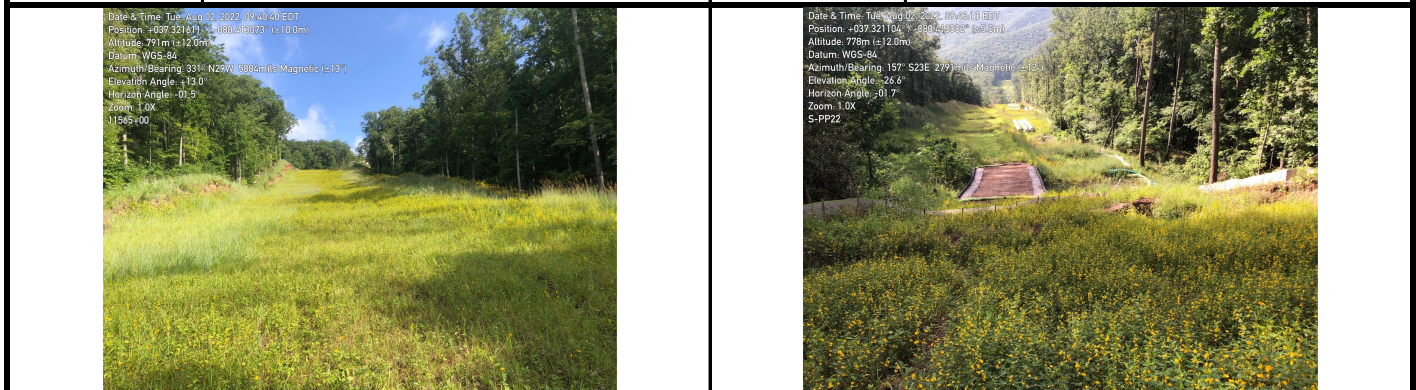
GPS Location	On photo	GPS Location	On photo
Field Station#	11565+00	Field Station#	11568+22
Pic 5 Desc.	Slope breakers controlling runoff properly. Vegetation preventing erosion.	Pic 6 Desc.	ROW stable, well vegetated, at the S-PP22 crossing.

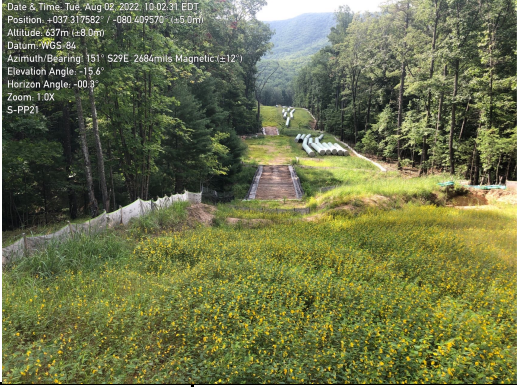
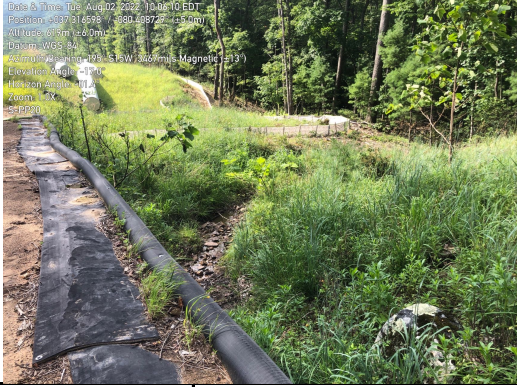
<p><small>Date & Time: Tue Aug 02, 2022 10:08:00 EDT Position: +037.316598 / -080.408722 (+5.0m) Altitude: 637m (+8.0m) Datum: WGS 84 Azimuth/Bearing: 127° S1W 2366mils Magnetic (±13°) Elevation Angle: -11.9° Horizon Angle: -01.1° Zoom: 1.0X S-PP20</small></p>			
GPS Location	On photo	GPS Location	On photo		
Field Station#	11585+48	Field Station#	11588+41		
Pic 7 Desc.	ROW stable upslope of S-PP21 crossing.	Pic 8 Desc.	The S-PP20 crossing remains stable.

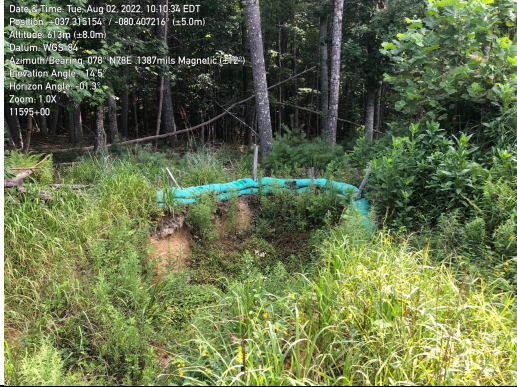
GPS Location	On photo	GPS Location			
Field Station#	11595+00	Field Station#			
Pic 9 Desc.	Slope breakers, sumps and end treatments continue to control stormwater runoff.	Pic 10 Desc.			
Insert image here		Insert image here			
GPS Location		GPS Location			
Field Station#		Field Station#			
Pic 11 Desc.		Pic 12 Desc.

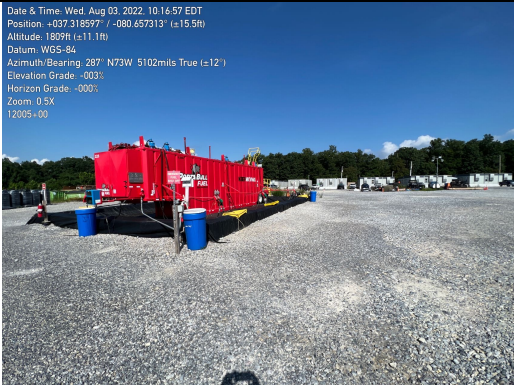
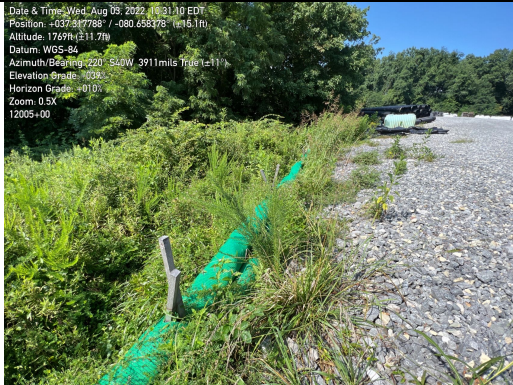
GPS Location		See photo		GPS Location	
Field Station#		12005+00		Field Station#	
Pic 3 Desc.		Fuel island in place		Pic 4 Desc.	
				CFS triple stack perimeter control in place	
<p>Date & Time: Wed Aug 03 2022 10:15:53 EDT Position: -037.318321 / -080.657330 (+15.5ft) Altitude: 1897ft (+11.1ft) Datum: WGS-84 Azimuth/Bearing: 197.S47W 3582mils True (+12.1) Elevation Grade: -0013 Horizon Grade: -0000 Zoom: 0.5X 12005+00</p>

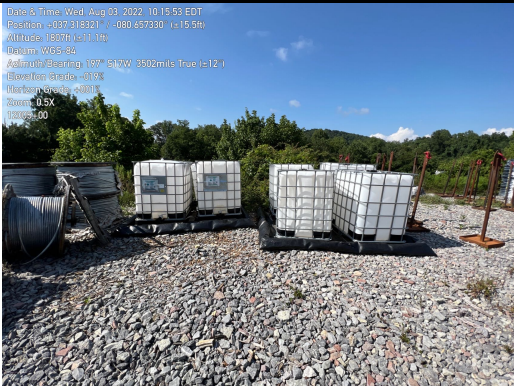
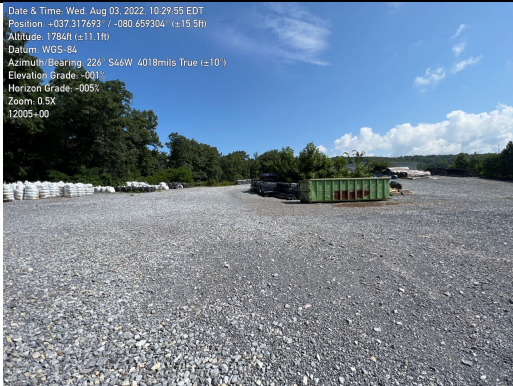
GPS Location		See photo		GPS Location	
Field Station#		12005+00		Field Station#	
Pic 5 Desc.		Secondary containments in place		Pic 6 Desc.	
				Rock surface in acceptable condition

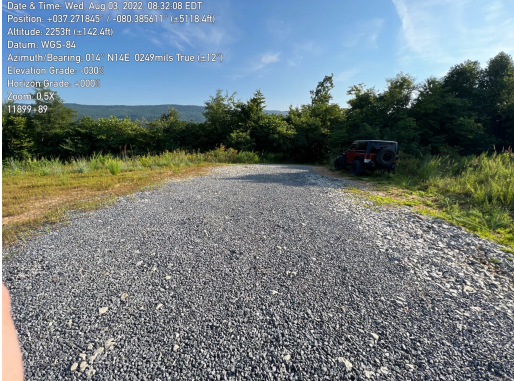
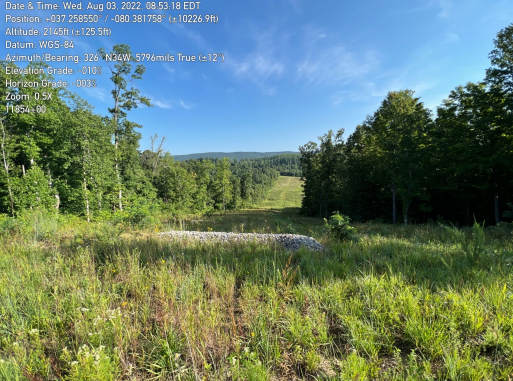
<p>Date & Time: Wed Aug 03 2022 08:53:18 EDT Position: +037.259553, +080.361758 (+10226.9ft) Altitude: 2165ft (+125.5ft) Datum: WGS-84 Azimuth/Bearing: 326. N24W 579mils True (+12.1) Elevation Grade: -010 Horizon Grade: -003 Zoom: 0.5x 11854+00</p>		<p>GPS Location See photo</p> <p>Field Station# 11899+89</p> <p>Pic 1 Desc. RCE in place</p>		<p>GPS Location See photo</p> <p>Field Station# 11854+00</p> <p>Pic 2 Desc. Level spreaders in place</p>

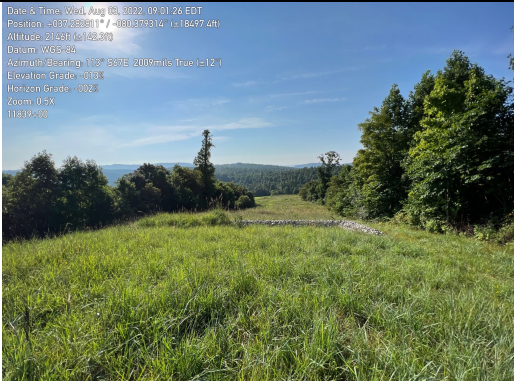
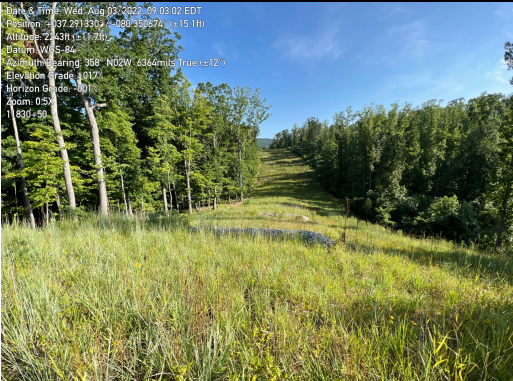
<p>Date & Time: Wed Aug 03 2022 09:03:02 EDT Position: +037.291330, +080.359674 (+15.1ft) Altitude: 2143ft (+11.7ft) Datum: WGS-84 Azimuth/Bearing: 358. N02W 644mils True (+12.1) Elevation Grade: -017 Horizon Grade: -001 Zoom: 0.5x 11830+50</p>		<p>GPS Location See photo</p> <p>Field Station# 11839+00</p> <p>Pic 3 Desc. Waterbar with level spreader in place</p>		<p>GPS Location See photo</p> <p>Field Station# 11830+50</p> <p>Pic 4 Desc. Permanent waterbars in place</p>

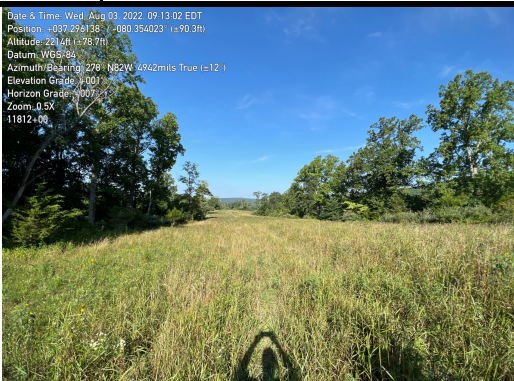
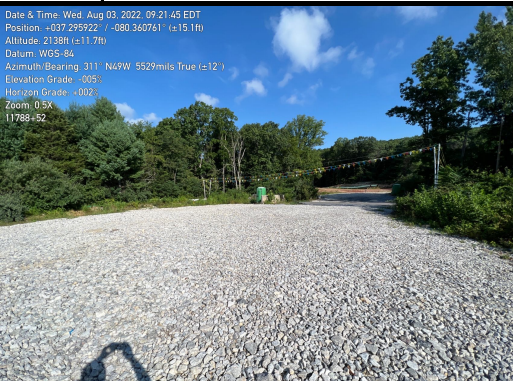
<p>Date & Time: Wed Aug 03 2022 09:21:45 EDT Position: +037.295222, +080.360761 (+15.1ft) Altitude: 2138ft (+11.7ft) Datum: WGS-84 Azimuth/Bearing: 311. N49W 5529mils True (+12.1) Elevation Grade: -005 Horizon Grade: +002 Zoom: 0.5x 11788+52</p>		<p>GPS Location See photo</p> <p>Field Station# 11812+00</p> <p>Pic 5 Desc. Permanent vegetation present</p>		<p>GPS Location See photo</p> <p>Field Station# 11788+52</p> <p>Pic 6 Desc. RCE in place</p>

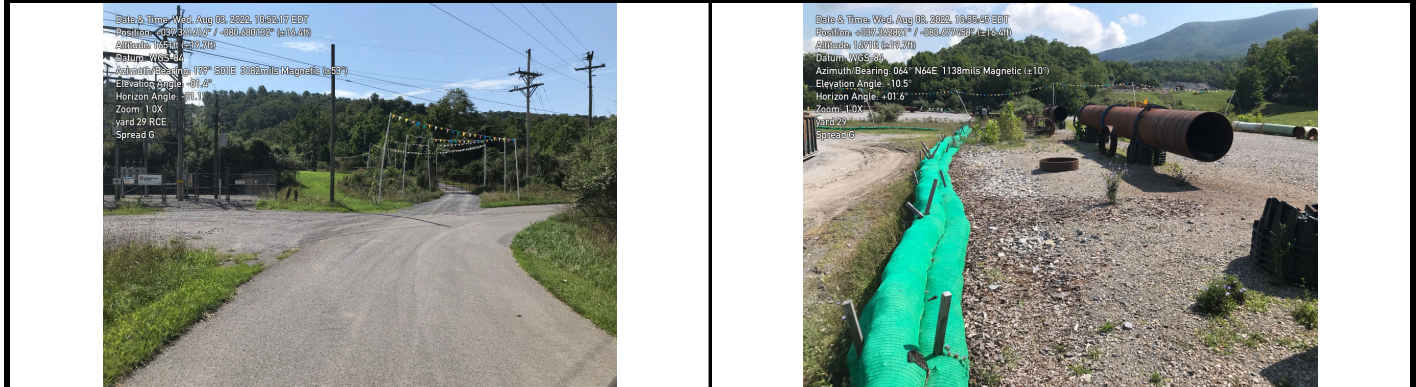
GPS Location	See photo	GPS Location	see photo
Field Station#	12005+00	Field Station#	12005+00
Pic 1 Desc.	RCE	Pic 2 Desc.	Compost sock

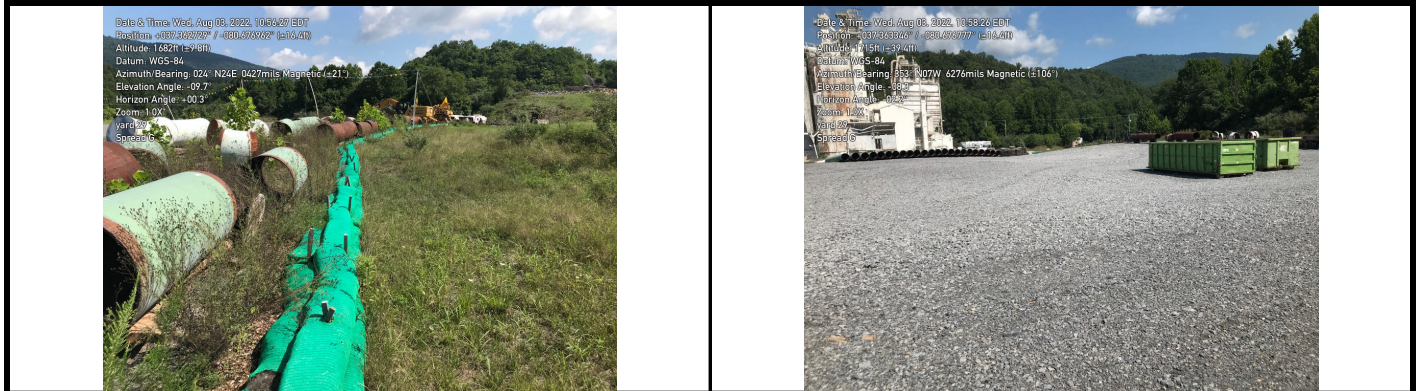
GPS Location	see photo	GPS Location	see photo
Field Station#	12005+00	Field Station#	12005+00
Pic 3 Desc.	Compost sock	Pic 4 Desc.	Waste management

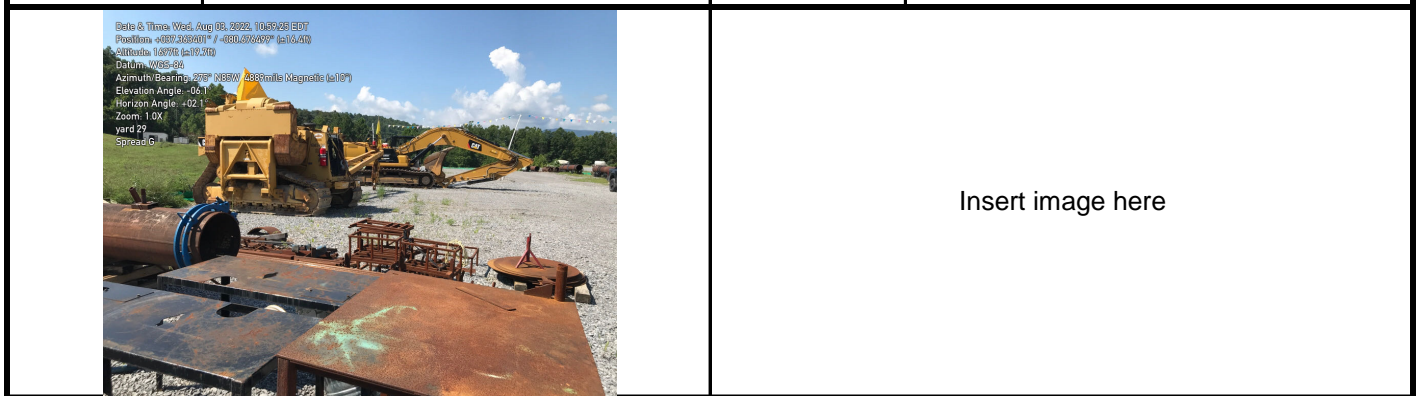
GPS Location	see photo	GPS Location	
Field Station#	12005+00	Field Station#	
Pic 5 Desc.	Stacked equipment	Pic 6 Desc.

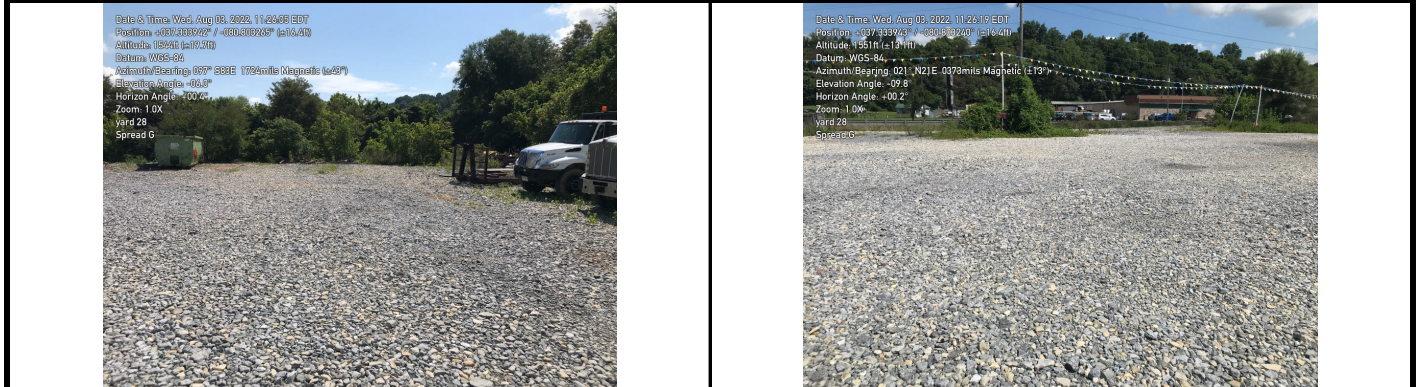
GPS Location	See photo	GPS Location	see photo
Field Station#	12005+00	Field Station#	12005+00
Pic 1 Desc.	Waste management	Pic 2 Desc.	RCE

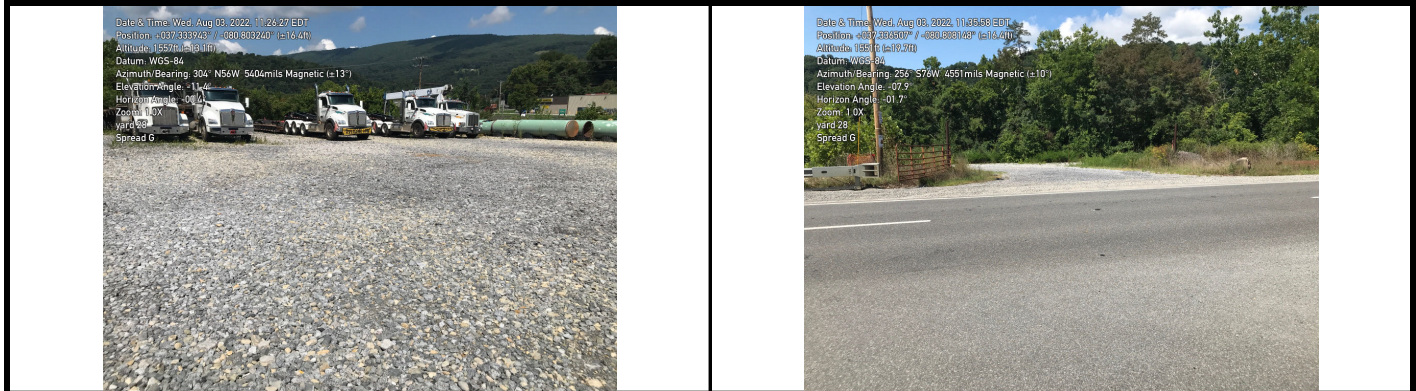
GPS Location	see photo	GPS Location	see photo
Field Station#	12005+00	Field Station#	12005+00
Pic 3 Desc.	Stacked equipment	Pic 4 Desc.	RCE

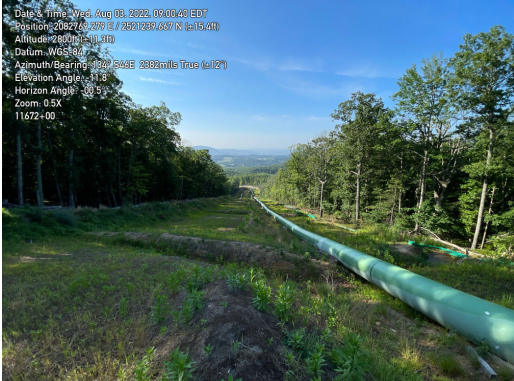
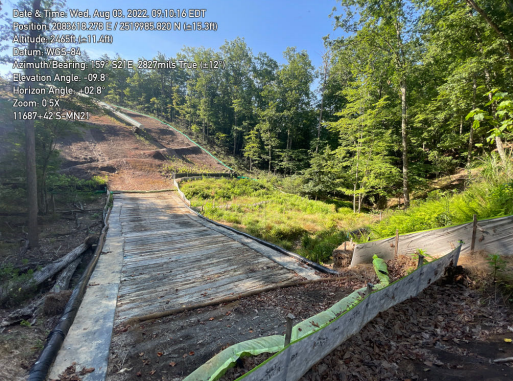
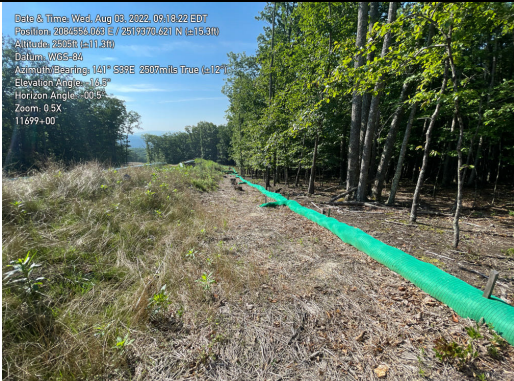
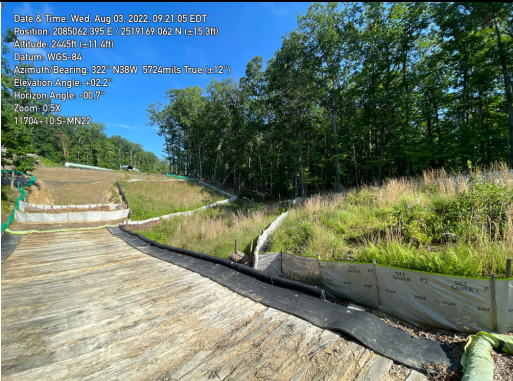
GPS Location 1		GPS Location 2					
Field Station# 11672+00		Field Station# 11687+42					
Pic 1 Desc. Section of RoW showing conditions and controls.		Pic 2 Desc. Overview S-MN21.					
GPS Location 3		GPS Location 4					
Field Station# 11699+00		Field Station# 11604+10					
Pic 3 Desc. Perimeter controls functional.		Pic 4 Desc. Overview S-MN22.

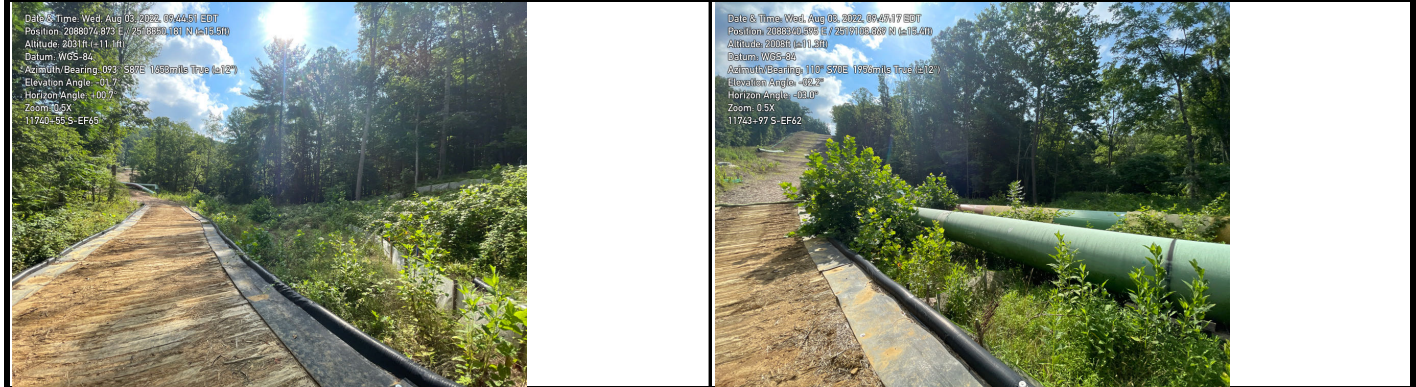
GPS Location	7	GPS Location	8
Field Station#	11740+55	Field Station#	11743+97
Pic 7 Desc.	Overview S-EF65.	Pic 8 Desc.	Overview S-EF62.

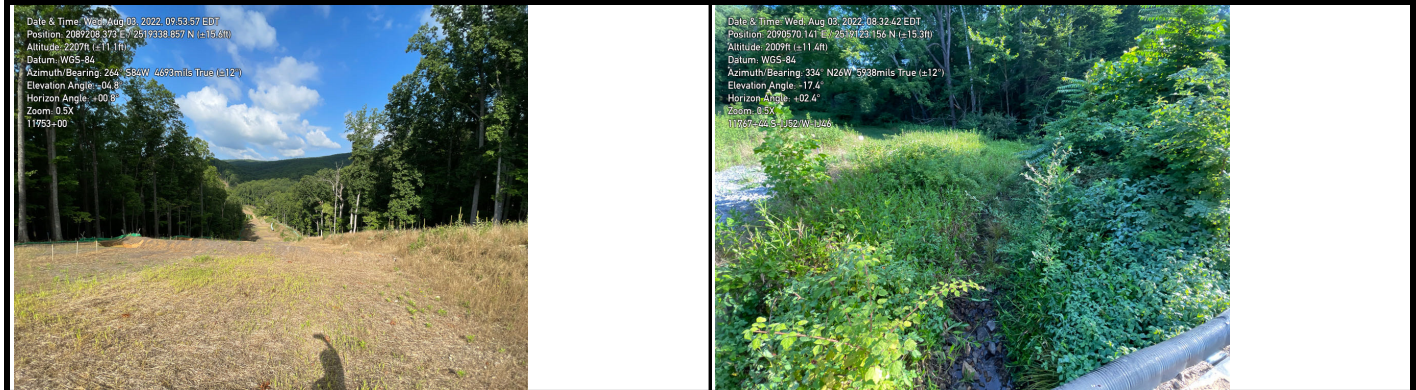
GPS Location	9	GPS Location	10
Field Station#	11753+00	Field Station#	11767+44
Pic 9 Desc.	Section of RoW showing conditions and controls.	Pic 10 Desc.	S-IJ52/W-IJ46.

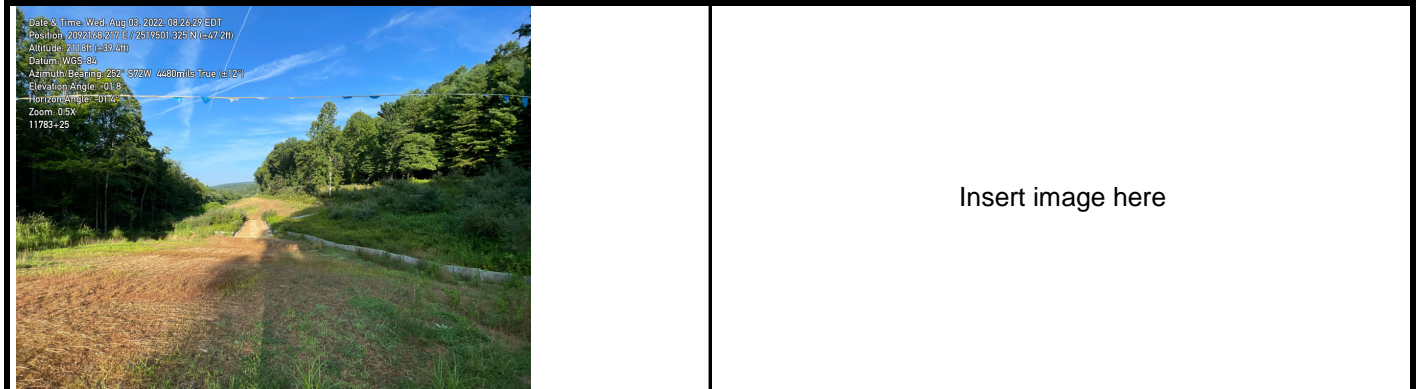
GPS Location	11	GPS Location	
Field Station#	11783+25	Field Station#	
Pic 11 Desc.	Section of RoW showing conditions and controls.	Pic 12 Desc.

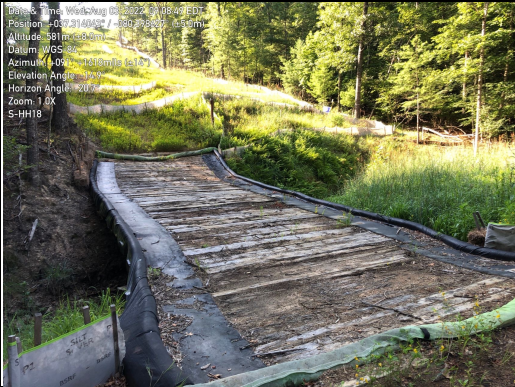
GPS Location	On photo
Field Station#	11626+04
Pic 7 Desc.	The S-HH18 crossing is stable.

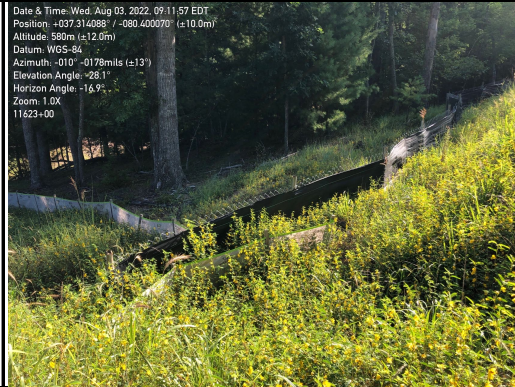
GPS Location	On photo
Field Station#	11623+00
Pic 8 Desc.	ECDs in place. ROW well vegetated, stable.

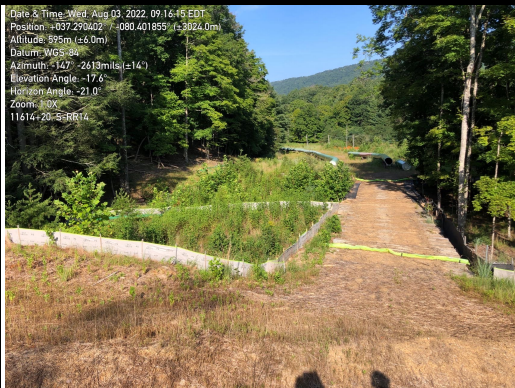
GPS Location	On photo
Field Station#	11614+20
Pic 9 Desc.	The S-RR14 crossing remains stable.

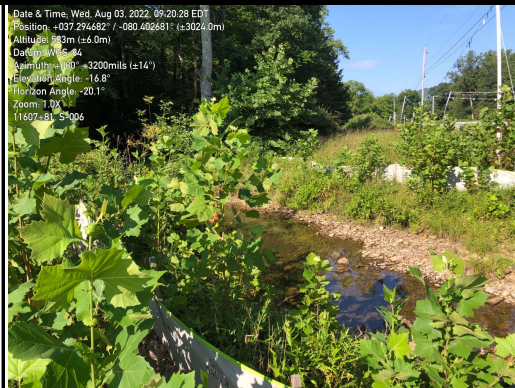
GPS Location	On photo
Field Station#	11607+81
Pic 10 Desc.	The S-006 crossing has no impact.

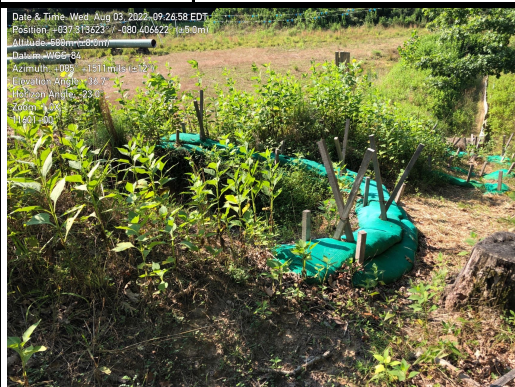
GPS Location	On photo
Field Station#	11601+00
Pic 11 Desc.	End treatments and check dams are effective.

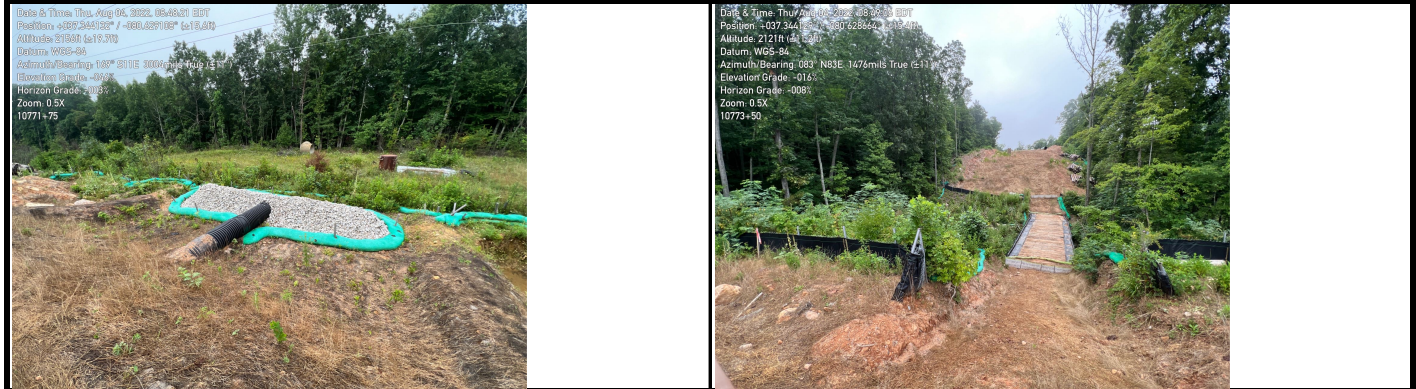
GPS Location	See photo	GPS Location	See photo
Field Station#	10771+75	Field Station#	10773+50
Pic 7 Desc.	Cleanwater outlet protection in place	Pic 8 Desc.	Stream buffer in place

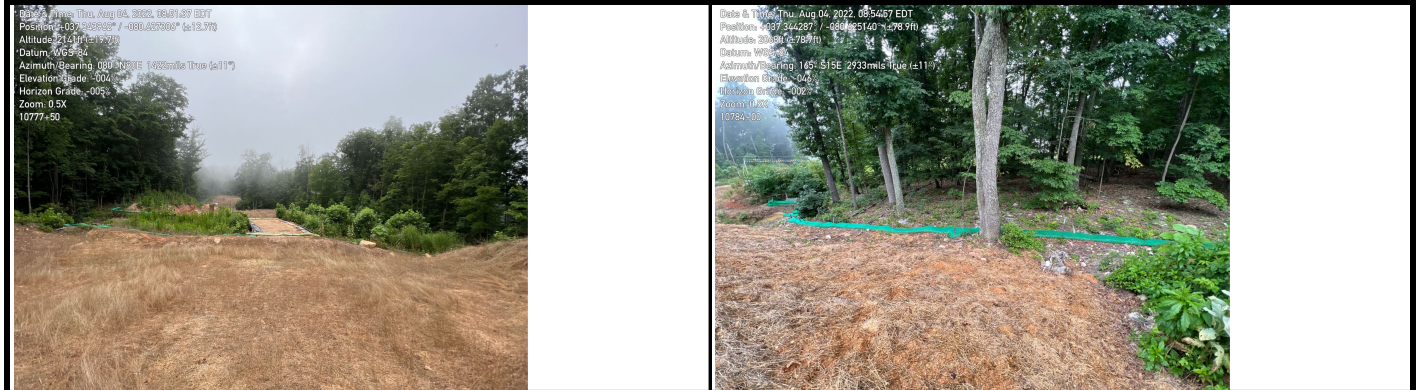
GPS Location	See photo	GPS Location	See photo
Field Station#	10777+50	Field Station#	10784+00
Pic 9 Desc.	Cleanwater drainage feature in place	Pic 10 Desc.	CFS perimeter control in place

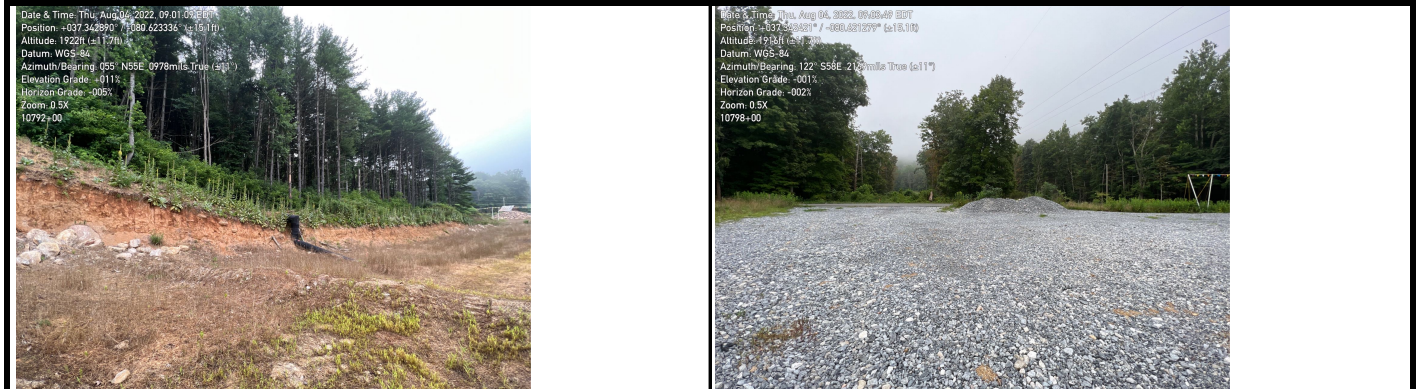
GPS Location	See photo	GPS Location	See photo
Field Station#	10792+00	Field Station#	10798+00
Pic 11 Desc.	Cleanwater diversion berm in place	Pic 12 Desc.	RCE in place

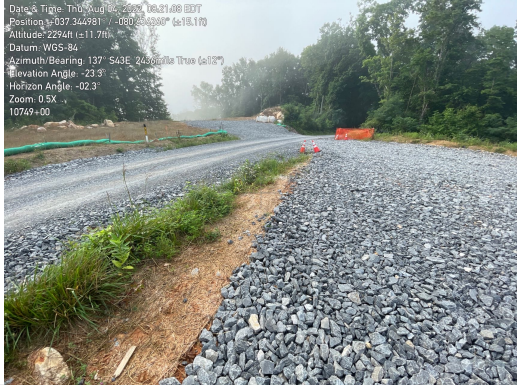
GPS Location	See photo	GPS Location			
Field Station#	10749+00	Field Station#			
Pic 9 Desc.	RCE functional	Pic 10 Desc.			
Insert image here			Insert image here		
GPS Location		GPS Location			
Field Station#		Field Station#			
Pic 11 Desc.		Pic 12 Desc.

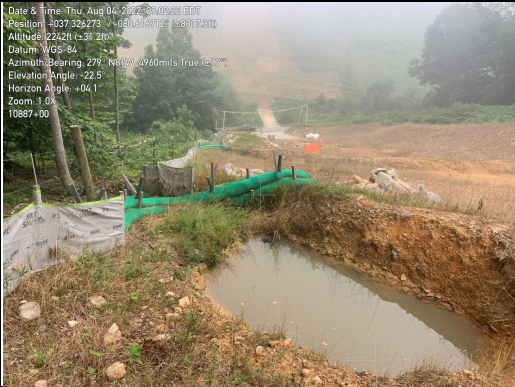
Field Station#	10887+00
-----------------------	----------

Pic 7 Desc.	Section of Row showing conditions and controls
--------------------	--

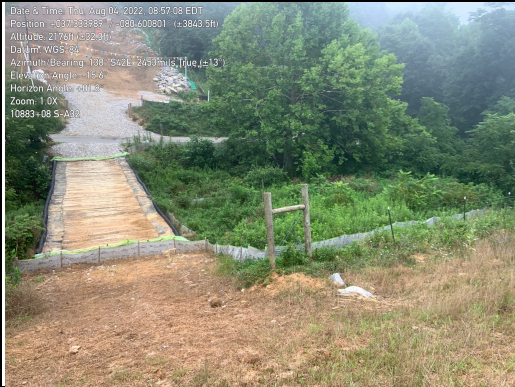
Field Station#	10883+08
-----------------------	----------

Pic 8 Desc.	Section of Row showing conditions and controls at S-A32
--------------------	---

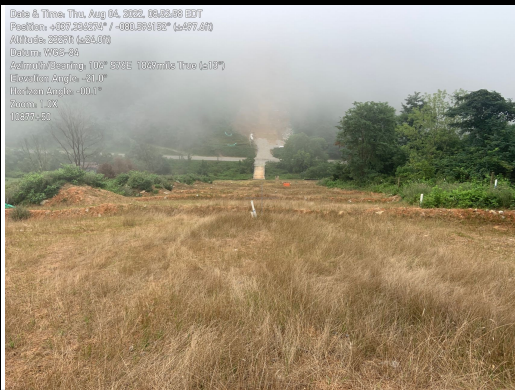
Field Station#	10877+50
-----------------------	----------

Pic 9 Desc.	Section of Row showing conditions and controls
--------------------	--

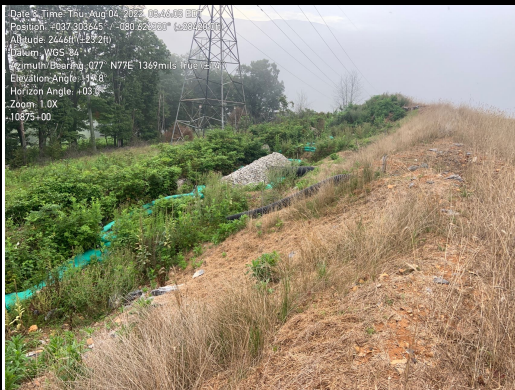
Field Station#	10875+00
-----------------------	----------

Pic 10 Desc.	Clean water diversion pipe and level spreader are in acceptable condition
---------------------	---

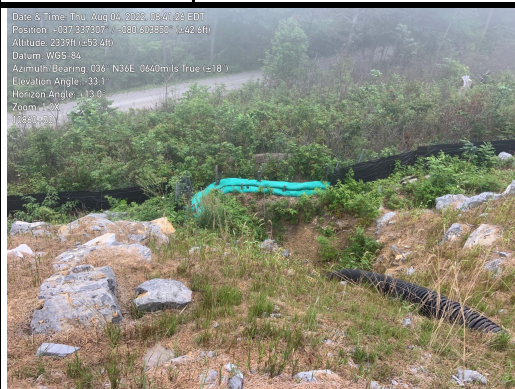
Field Station#	10860+50
-----------------------	----------

Pic 11 Desc.	Sump pit, slope drain pipe and perimeter controls are in place
---------------------	--

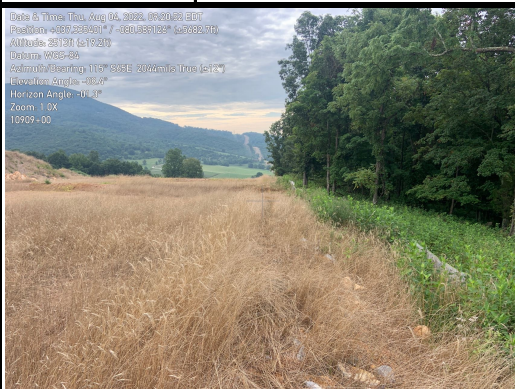
Field Station#	10909+00
-----------------------	----------

Pic 12 Desc.	Section of Row showing conditions and controls
---------------------	--

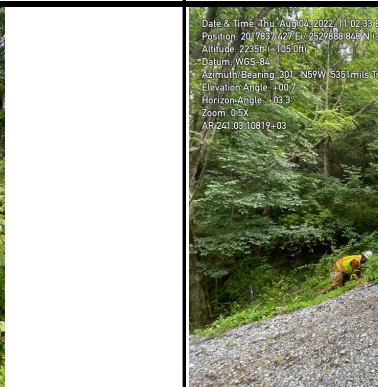
GPS Location	11	GPS Location	12		
Field Station#	10799+00	Field Station#	10819+03		
Pic 11 Desc.	S-Z10/W-Z3.		Pic 12 Desc.	Crews upgrading single 12" CFS to triple 12" CFS along AR 241.03.
