Visual Site Inspection Report

Project Name H-600 Pipeline Spread G		AFE 124300137	Spread H-600 Pipeline Spread G
Contractor Precision		Report # 40506	
Inspector Patrick Shields		Date/Time 8/1/2022 3:48 PM	
Permit # TBD	Inspection Type VA SWPP	Station Begin	10929+80
State VA	Inspection Area Full	Station End	11023+80
County Giles	Ground Wet	Temperature (°F)	77.00
Municipality N/A	Weather Light Rain	Rain Gauge (in)	0.10
			Rain Accumulation Time (days) 1.00

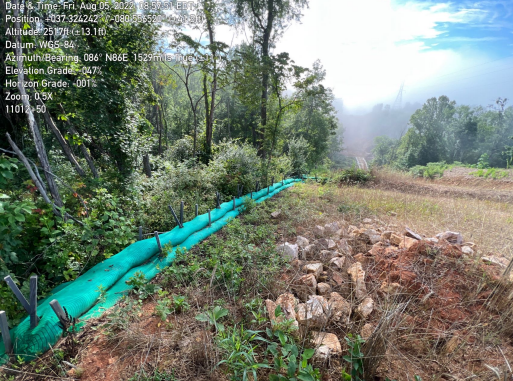
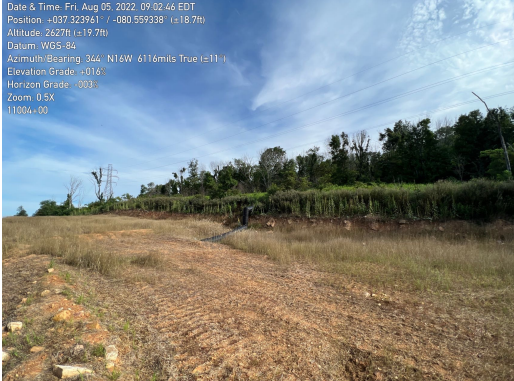
<p><small>Date & Time: Fri, Aug 05, 2022, 08:20:48 EDT Position: -030.3123997 / -080.559338 (118.7m) Altitude: 2127ft (+15.1ft) Datum: WGS-84 Azimuth Bearing: 086° N86E 1529ft True (+11°) Elevation Grade: +047 Horizon Grade: +001 Zoom: 0.5X 11012+00</small></p>	
GPS Location	See photo	GPS Location	See photo		
Field Station#	11016+00	Field Station#	11012+50		
Pic 1 Desc.	Stream buffer in place	Pic 2 Desc.	CFS triple stack perimeter control in place

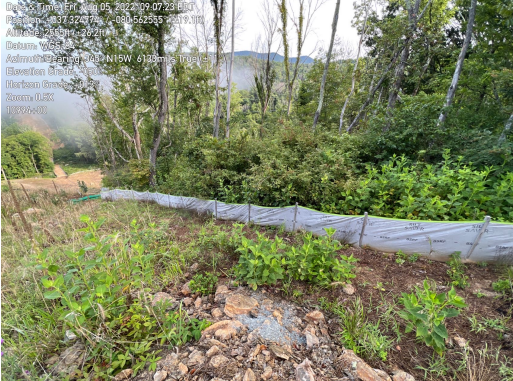
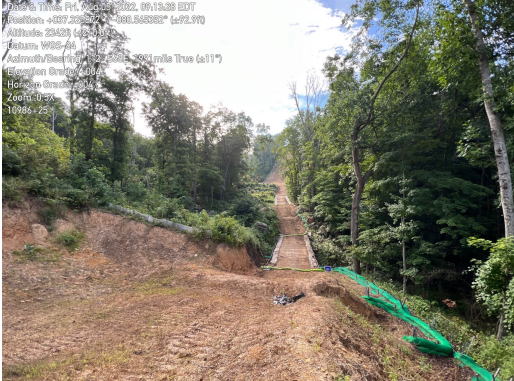
GPS Location	See photo	GPS Location	See photo		
Field Station#	11004+00	Field Station#	10994+00		
Pic 3 Desc.	Cleanwater diversion berm in place	Pic 4 Desc.	P1 silt fence perimeter control in place

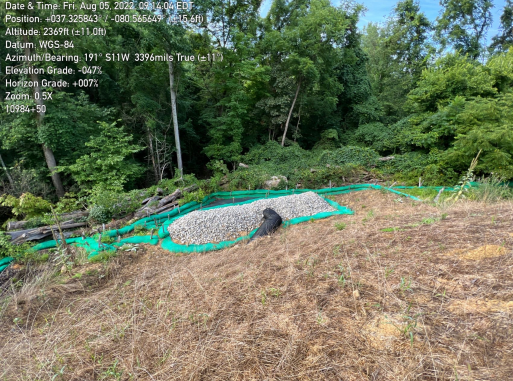
<p><small>Date & Time: Fri, Aug 05, 2022, 09:14:00 EDT Position: -037.323961 / -080.566849 (+16.6ft) Altitude: 2349ft (+11.9ft) Datum: WGS-84 Azimuth Bearing: 191° S11W 339.6mils True (+11°) Elevation Grade: +047 Horizon Grade: +007 Zoom: 0.5X 10984+50</small></p>	
GPS Location	See photo	GPS Location	See photo		
Field Station#	10986+25	Field Station#	10984+50		
Pic 5 Desc.	Stream buffer in place	Pic 6 Desc.	Cleanwater diversion outlet protection in place

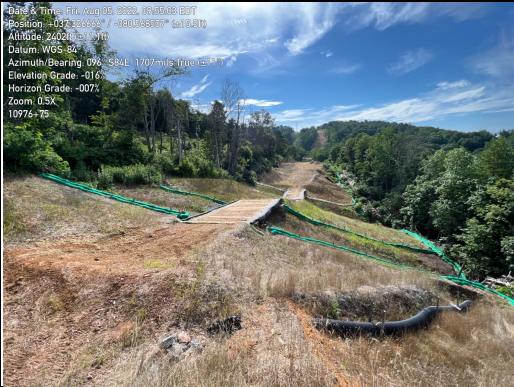
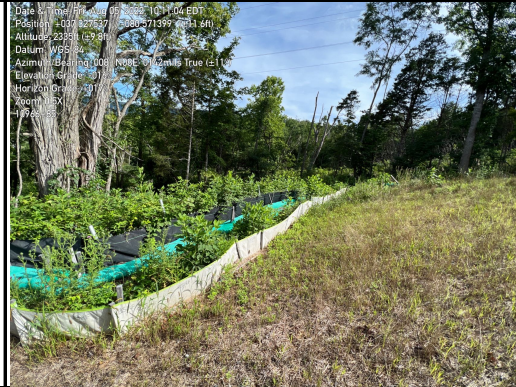
GPS Location	See photo
Field Station#	10976+75
Pic 7 Desc.	Cleanwater drainage feature in place

GPS Location	See photo
Field Station#	10966+85
Pic 8 Desc.	Triple protection ECDs in place at karst feature

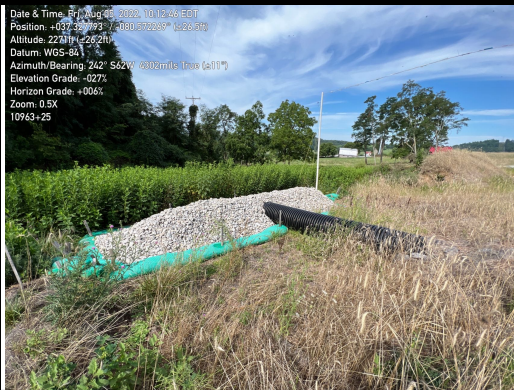
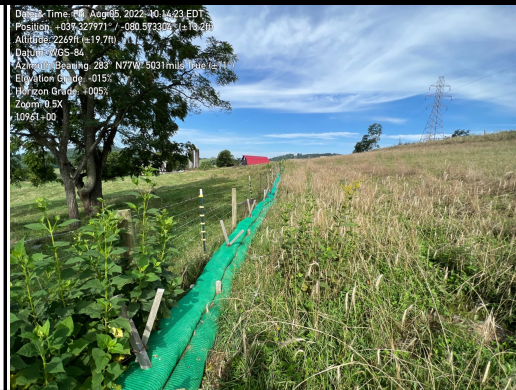
GPS Location	See photo
Field Station#	10963+25
Pic 9 Desc.	Cleanwater outlet protection in place

GPS Location	See photo
Field Station#	10961+00
Pic 10 Desc.	CFS triple stack perimeter control in place

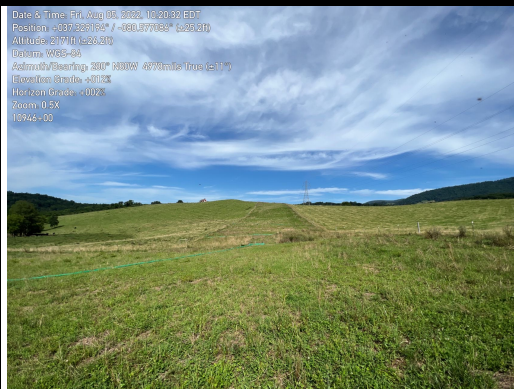
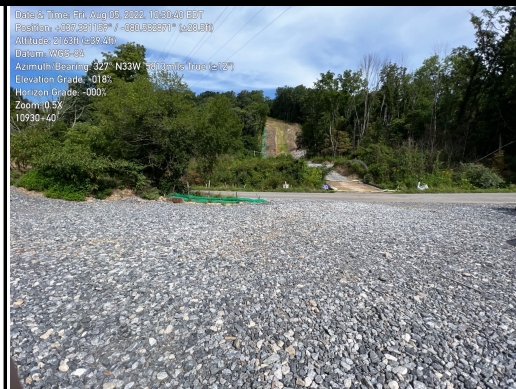
GPS Location	See photo
Field Station#	10946+00
Pic 11 Desc.	Permanent vegetation present

GPS Location	See photo
Field Station#	10930+40
Pic 12 Desc.	RCE in place

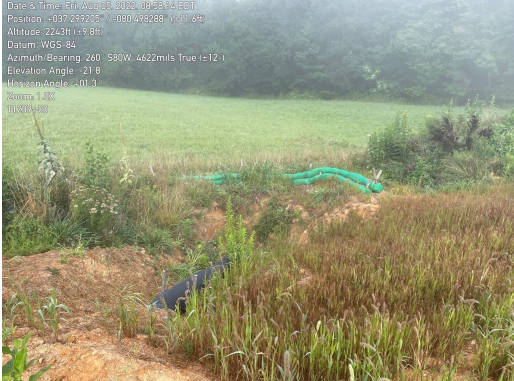
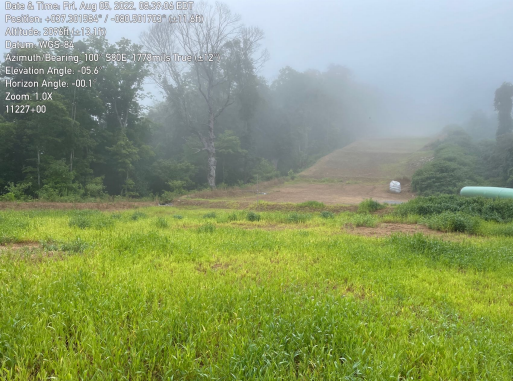
<p data-bbox="889 205 1112 325">Date & Time: Fri Aug 05, 2022, 06:56:06 EDT Position: +037.261587° / -80.001767° (+19.8ft) Altitude: 2022ft (+9.8ft) Datum: WGS-84 Azimuth/Bearing: 100.580E, 1730mils True (+13.2) Elevation Angle: -05.6 Horizon Angle: -00.1 Zoom: 1.0X 11227+00</p>			
GPS Location	See photo	GPS Location	See photo	
Field Station#	11239+00	Field Station#	11227+00	
Pic 1 Desc.	Slope drain pipe and end treatment in place	Pic 2 Desc.	Picture showing condition of row

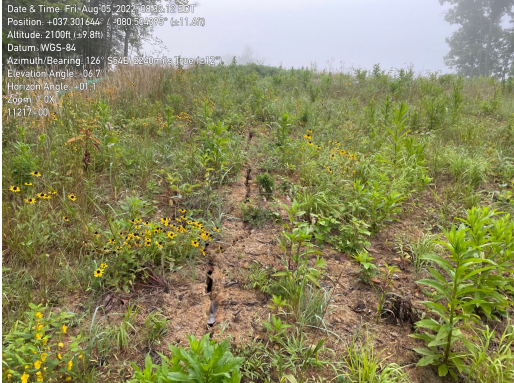
GPS Location	See photo	GPS Location	See photo	
Field Station#	11217+00	Field Station#	11205+00	
Pic 3 Desc.	Subsidence that is being monitored	Pic 4 Desc.	Picture showing condition of row

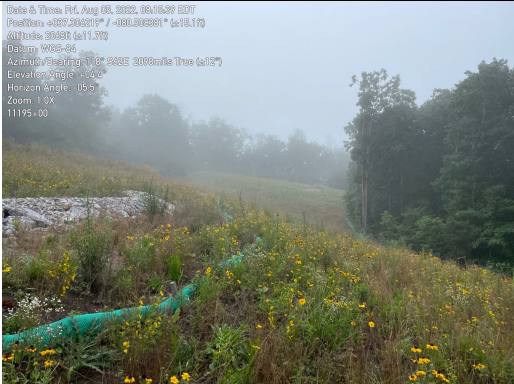
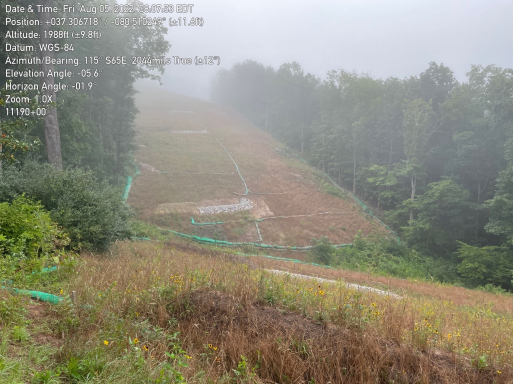
<p data-bbox="889 1362 1112 1482">Date & Time: Fri Aug 05, 2022, 06:17:08 EDT Position: +037.266807° / -80.006881° (+19.8ft) Altitude: 1988ft (+9.8ft) Datum: WGS-84 Azimuth/Bearing: 115.580E, 3098mils True (+13.2) Elevation Angle: -05.6 Horizon Angle: -01.9 Zoom: 1.0X 11190+00</p>			
GPS Location	See photo	GPS Location	See photo	
Field Station#	11195+00	Field Station#	11190+00	
Pic 5 Desc.	Permanent stabilization in place	Pic 6 Desc.	Permanent water bars and level spreader in place

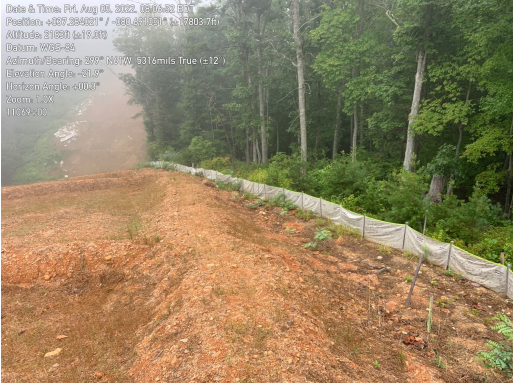
GPS Location	See photo	GPS Location	See photo		
Field Station#	11071+80	Field Station#	11069+00		
Pic 3 Desc.	Section of Row showing conditions and controls	Pic 4 Desc.	P1 silt fence is in acceptable condition		
  <p><small>Date & Time: Fri, Aug 05, 2022, 06:46:27 EDT Position: +405.219497° / +881.856144° (+2859.7m) Altitude: 2173ft (+662.9m) Datum: WGS-84 Azimuth/Bearing: 142° S48E 352/mils True (+13°) Elevation Angle: +22.5° Horizon Angle: +00.3° Zoom: 1.0x 11063+00</small></p>		  <p><small>Date & Time: Fri, Aug 05, 2022, 07:57:04 EDT Position: +407.279465° / +880.574223° (+12011.2ft) Altitude: 2203ft (+671.5m) Datum: WGS-84 Azimuth/Bearing: 159° S21E 282/mils True (+12°) Elevation Angle: +11.7° Horizon Angle: +01.7° Zoom: 1.0x 11054+00</small></p>			
GPS Location	See photo	GPS Location	See photo		
Field Station#	11063+00	Field Station#	11054+00		
Pic 5 Desc.	Section of Row showing conditions and controls	Pic 6 Desc.	Perimeter controls are in acceptable condition

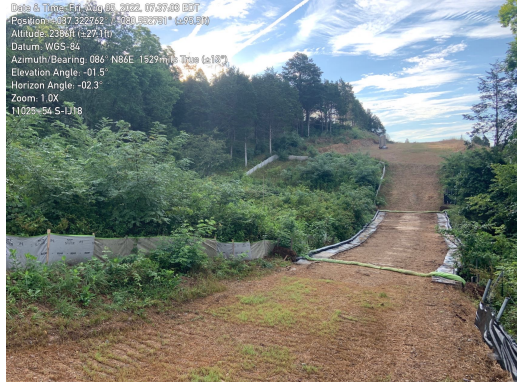
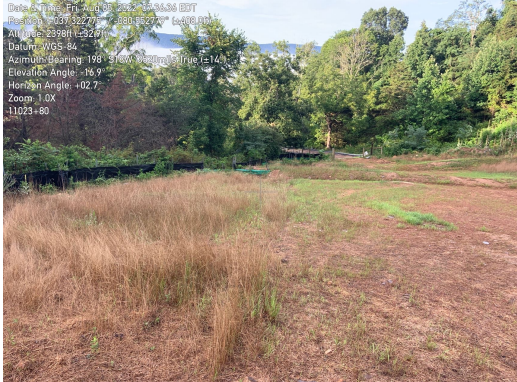
GPS Location	See photo	GPS Location	See photo
Field Station#	11025+54	Field Station#	11023+80
Pic 11 Desc.	Section of Row showing conditions and controls at S-IJ18	Pic 12 Desc.	Section of Row showing conditions and controls

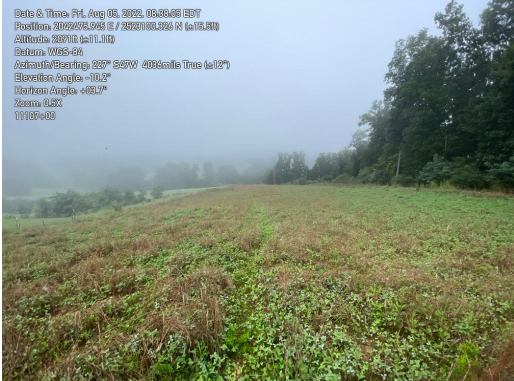
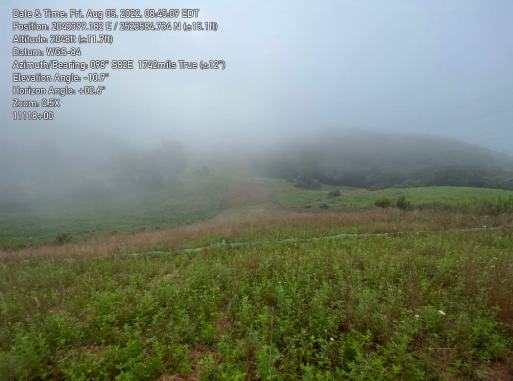
GPS Location 1		GPS Location 2			
Field Station# 11107+00		Field Station# 11118+00			
Pic 1 Desc. Section of restored RoW showing conditions and controls.		Pic 2 Desc. Section of restored RoW showing conditions and controls.			
<p>Date & Time Fri, Aug 05, 2022, 08:46:47 EDT Position 2029262.142 E / 3529204.422 N (±11.11) Altitude 1924ft (±11.11) Bearing W65-64 Azimuth/Bearing 129° S55E 320mils True (±12°) Elevation Angle +11.5° Horizon Angle +02.7° Zoom 0.5X 11129+00</p>

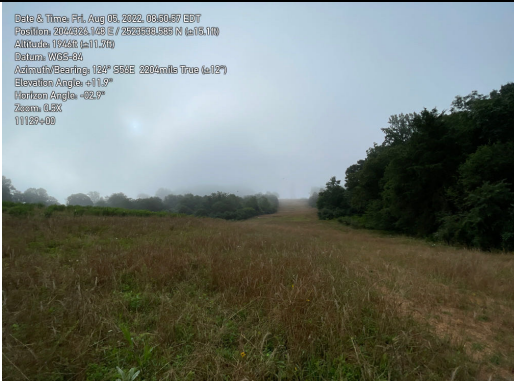
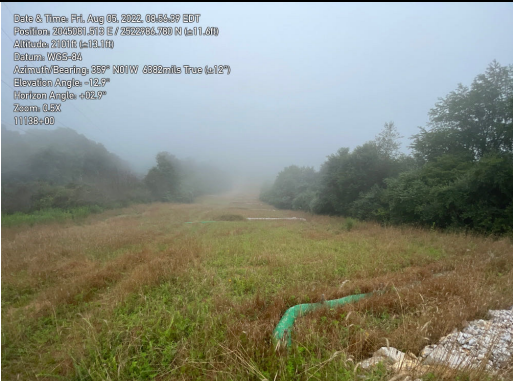
GPS Location 3		GPS Location 4			
Field Station# 11129+00		Field Station# 11138+00			
Pic 3 Desc. Section of restored RoW showing conditions and controls.		Pic 4 Desc. Section of restored RoW showing conditions and controls.			
<p>Date & Time Fri, Aug 05, 2022, 08:47:42 EDT Position 2029242.432 E / 3529204.712 N (±10.71) Altitude 2023ft (±11.11) Bearing W65-64 Azimuth/Bearing 32° S24W 576mils True (±12°) Elevation Angle +09.1° Horizon Angle +03.1° Zoom 0.5X 11151+00</p>

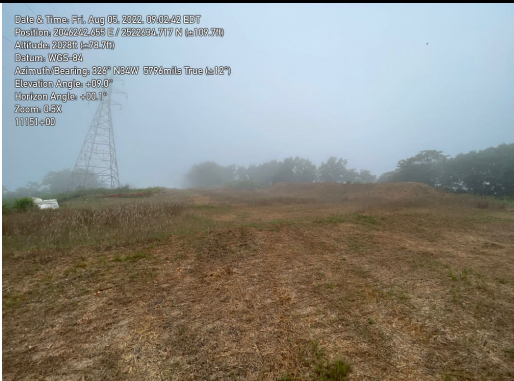
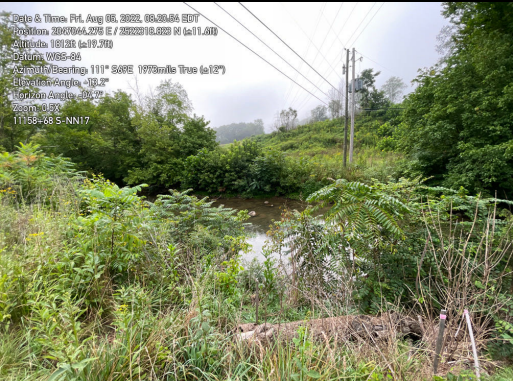
GPS Location 5		GPS Location 6			
Field Station# 11151+00		Field Station# 11158+68			
Pic 5 Desc. Section of RoW showing conditions and controls.		Pic 6 Desc. S-NN17.

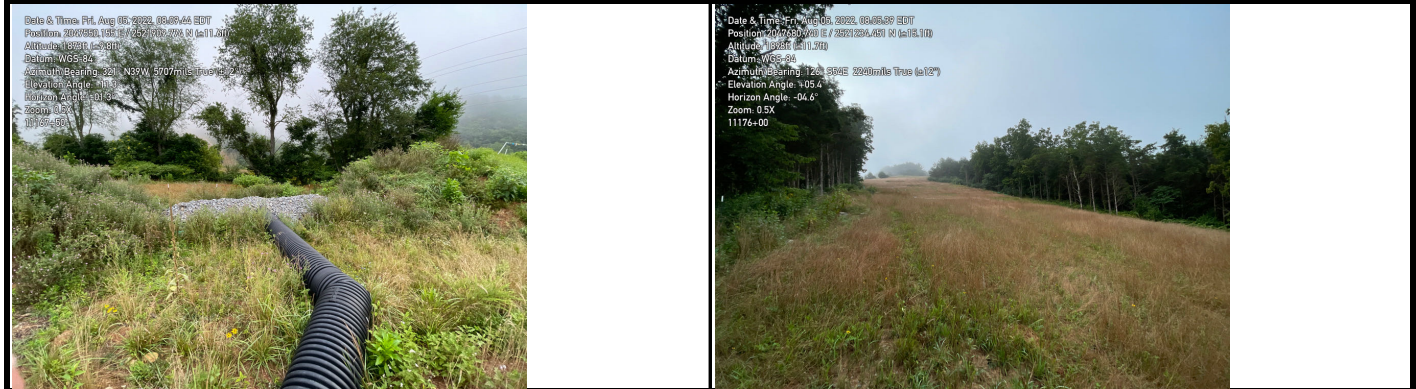
GPS Location 7	GPS Location 8
Field Station# 11167+50	Field Station# 11176+00
Pic 7 Desc. CWDP outlet protection functional.	Pic 8 Desc. Section of restored RoW showing conditions and controls.

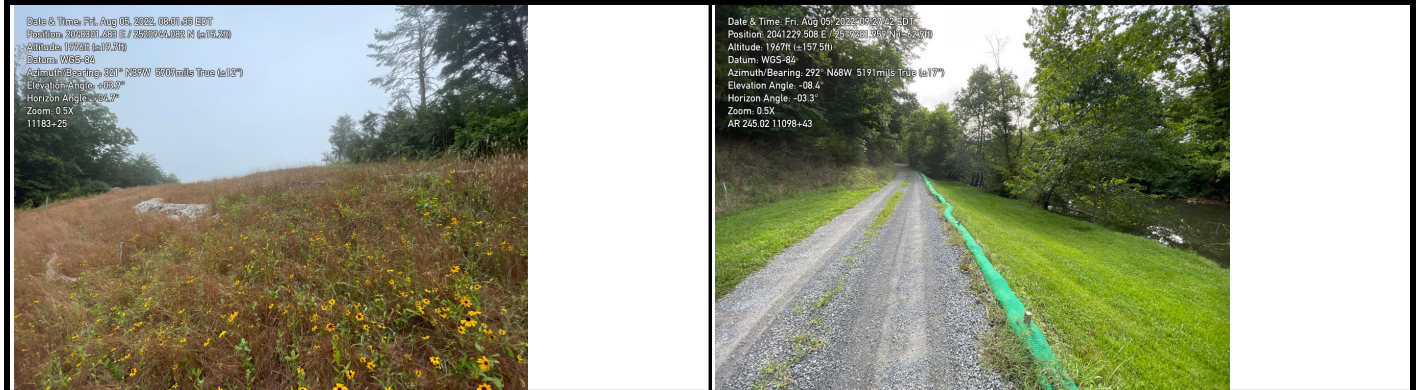
GPS Location 9	GPS Location 10
Field Station# 11183+25	Field Station# 11098+43
Pic 9 Desc. Representative photo of permanent waterbar and level spreaders installed.	Pic 10 Desc. AR 245.02.
