# Visual Site Inspection Report

<b>Project Name</b> H-600 Pipeline Spread G		<b>AFE</b> 124300137	<b>Spread</b> H-600 Pipeline Spread G
<b>Contractor</b> Precision		<b>Report #</b> 40994	
<b>Inspector</b> Eric Hanlon		<b>Date/Time</b> 8/15/2022 6:54 AM	
<b>Permit #</b> TBD	<b>Inspection Type</b> VA SWPP	<b>Station Begin</b> 11899+89	
<b>State</b> VA	<b>Inspection Area</b> Full	<b>Station End</b> 12005+00	
<b>County</b> Giles	<b>Ground</b> Wet	<b>Temperature (°F)</b> 65.00	
<b>Municipality</b> N/A	<b>Weather</b> Heavy Rain	<b>Rain Gauge (in)</b> 0.50	
			<b>Rain Accumulation Time (days)</b> 1.00

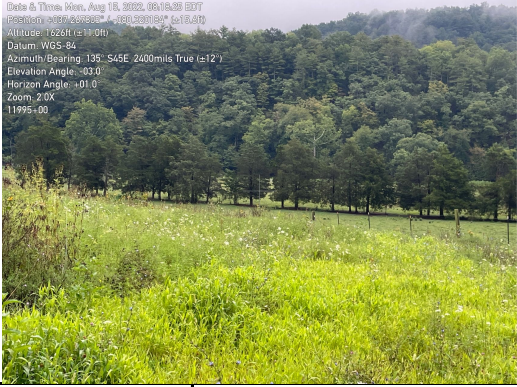
Insert image here	
<b>GPS Location</b>	See photo	<b>GPS Location</b>			
<b>Field Station#</b>	11995+00	<b>Field Station#</b>			
<b>Pic 7 Desc.</b>	Stabilization in place	<b>Pic 8 Desc.</b>			
Insert image here		Insert image here			
<b>GPS Location</b>		<b>GPS Location</b>			
<b>Field Station#</b>		<b>Field Station#</b>			
<b>Pic 9 Desc.</b>		<b>Pic 10 Desc.</b>			
Insert image here		Insert image here			
<b>GPS Location</b>		<b>GPS Location</b>			
<b>Field Station#</b>		<b>Field Station#</b>			
<b>Pic 11 Desc.</b>		<b>Pic 12 Desc.</b>

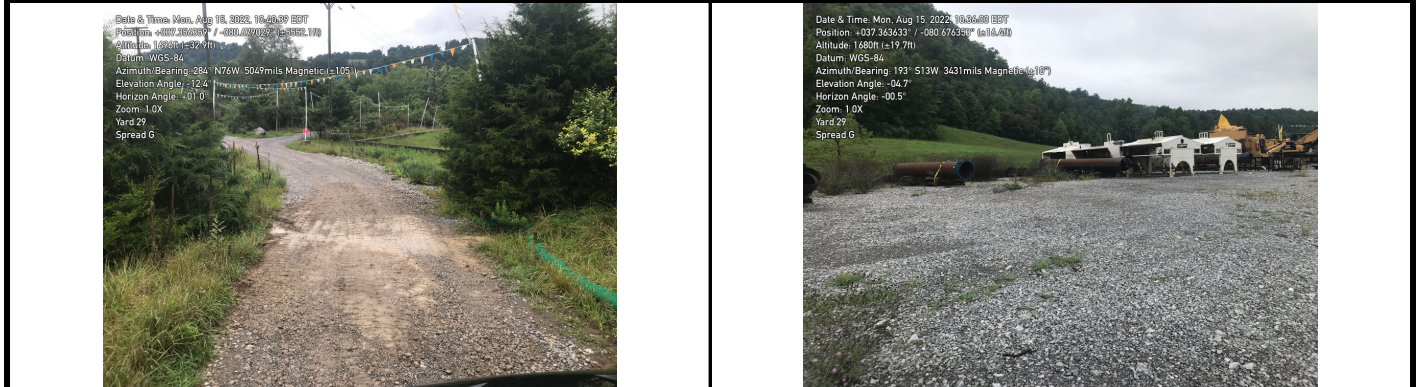
<b>GPS Location</b>	See photo	<b>GPS Location</b>	see photo
<b>Field Station#</b>	12005+00	<b>Field Station#</b>	12005+00
<b>Pic 1 Desc.</b>	Broad base dip	<b>Pic 2 Desc.</b>	Equipment

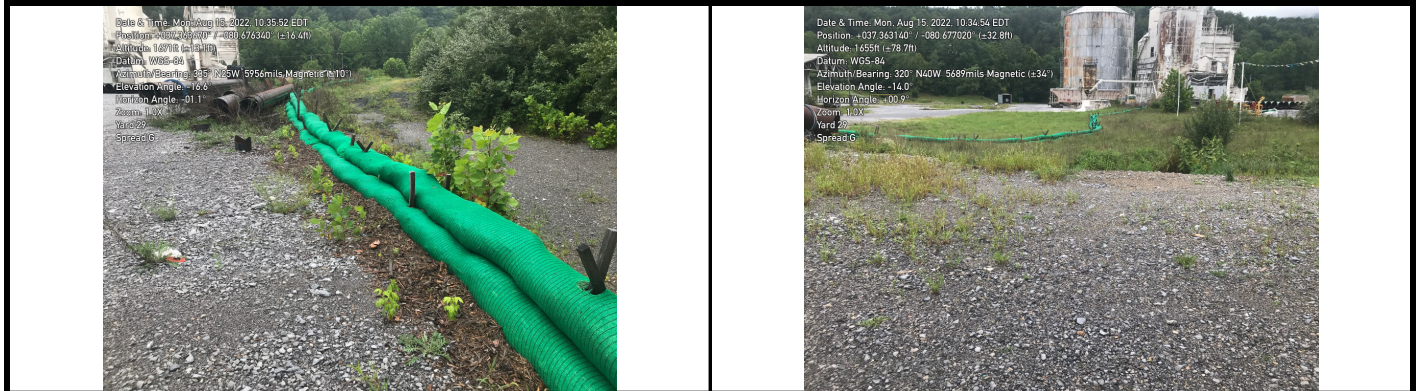
<b>GPS Location</b>	see photo	<b>GPS Location</b>	see photo
<b>Field Station#</b>	12005+00	<b>Field Station#</b>	12005+00
<b>Pic 3 Desc.</b>	Perimeter controls	<b>Pic 4 Desc.</b>	Compost sock

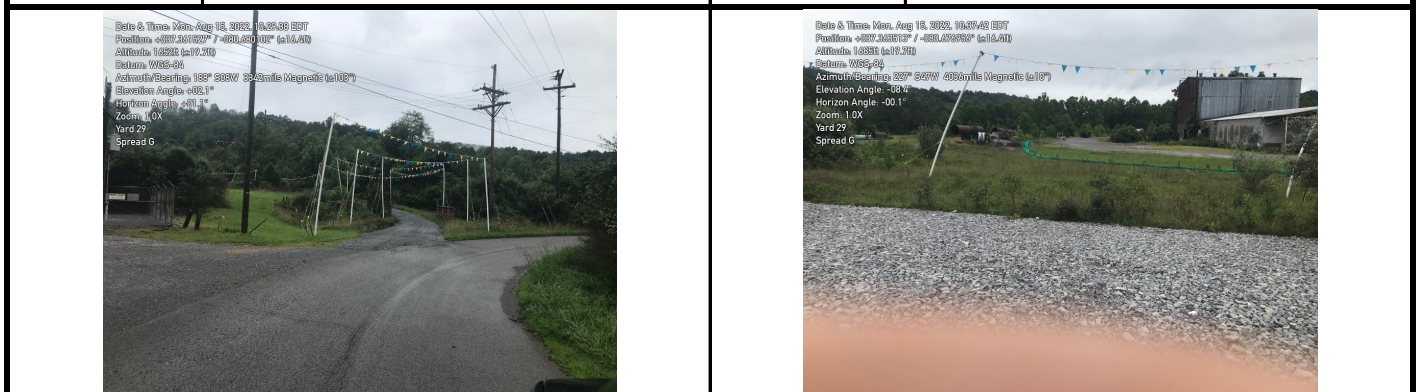
<b>GPS Location</b>	see photo	<b>GPS Location</b>	see photo
<b>Field Station#</b>	12005+00	<b>Field Station#</b>	12005+00
<b>Pic 5 Desc.</b>	RCE	<b>Pic 6 Desc.</b>	Environmental controls

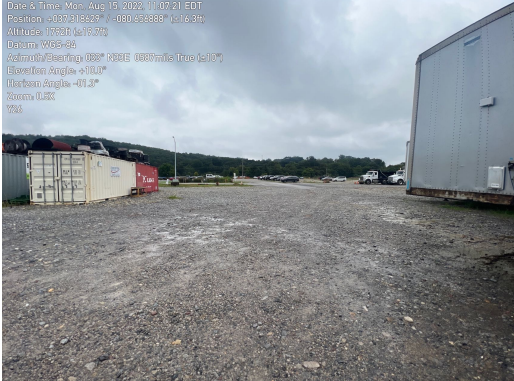
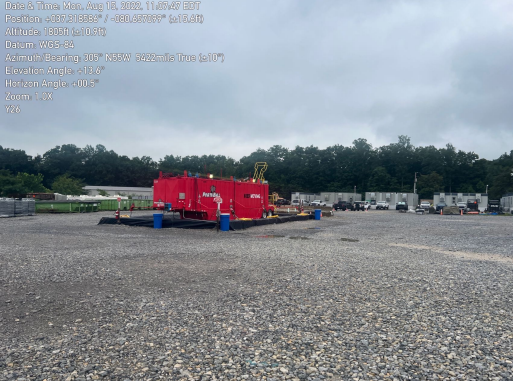
<p>GPS Location See Photo</p>		<p>GPS Location See Photo</p>	
<p>Field Station# 12005+00</p>		<p>Field Station# 12005+00</p>		<p>Pic 1 Desc. RCE</p>		<p>Pic 2 Desc. Fuel containment</p>	
<p>Date &amp; Time Mon, Aug 15, 2022 11:07:46 EDT Position: +38.9131832° / -80.52888° (-13.31) Altitude: 1800' (-11.17) Datum: WGS-84 Azimuth Bearing: 318° NADN 3026mils True (-10°) Elevation Angle: -14.3° Horizon Angle: -01.6° Zoom: 1.0X YZ6</p>

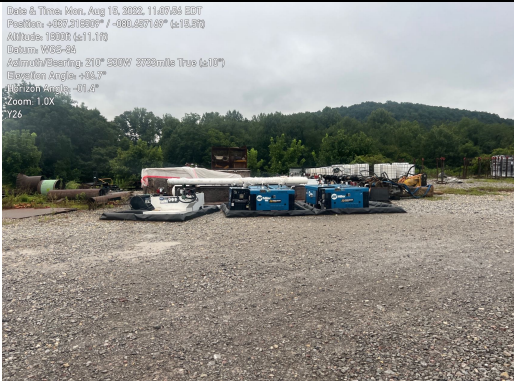
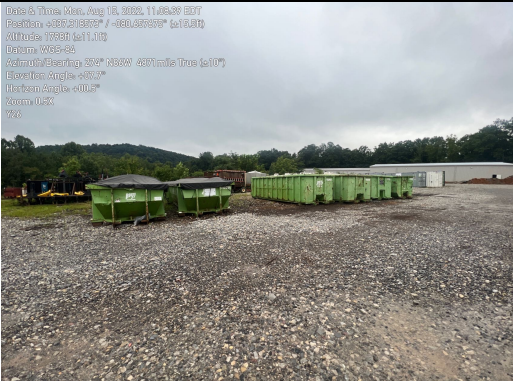
<p>Field Station# 12005+00</p>		<p>Field Station# 12005+00</p>		<p>Pic 3 Desc. Secondary containment</p>		<p>Pic 4 Desc. Trash bins and housekeeping</p>	
<p>Date &amp; Time Mon, Aug 15, 2022 11:11:47 EDT Position: +38.9131832° / -80.52888° (-13.31) Altitude: 1793' (-11.17) Datum: WGS-84 Azimuth Bearing: 363° NADN 1173mils True (-10°) Elevation Angle: -5.7° Horizon Angle: -03.3° Zoom: 1.0X YZ6</p>

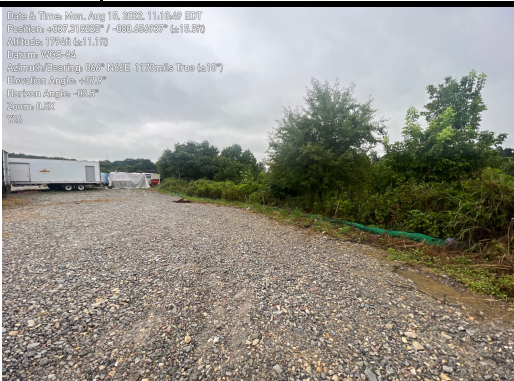
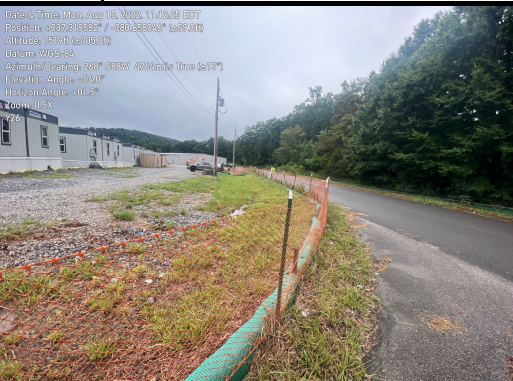
<p>GPS Location See Photo</p>		<p>GPS Location See Photo</p>	
<p>Field Station# 12005+00</p>		<p>Field Station# 12005+00</p>		<p>Pic 5 Desc. CFS perimeter control</p>		<p>Pic 6 Desc. CFS and construction my Giles county</p>

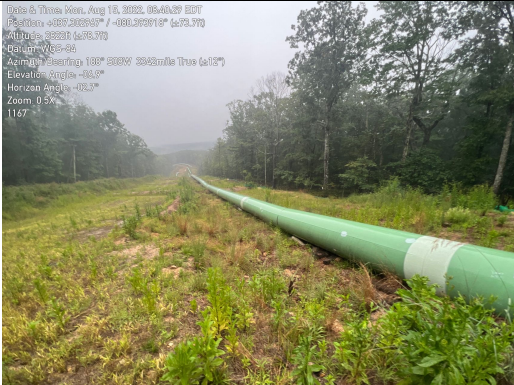
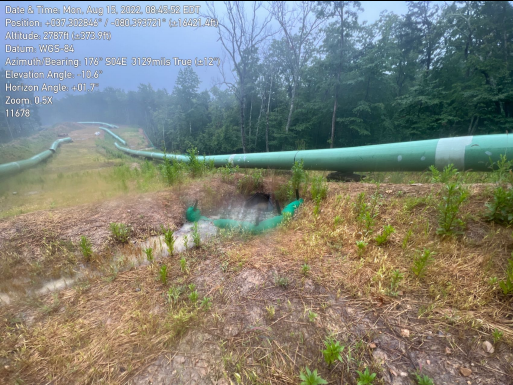
<p>Date &amp; Time: Mon, Aug 15, 2022, 05:45:58 EDT Position: +38.928983° / -98.328114° (-98.370) Altitude: 2320' (708.30) Datum: WGS-84 Azimuth/Bearing: 132° S08W 3922mils True (+13°) Elevation Angle: -13.5° Horizon Angle: -03.3° Zoom: 0.5X 11678</p>		<p><b>GPS Location</b> See Photo</p> <p><b>Field Station#</b> 11671+00</p> <p><b>Pic 1 Desc.</b> Temporary vegetation</p>		<p><b>GPS Location</b> See Photo</p> <p><b>Field Station#</b> 11678+00</p> <p><b>Pic 2 Desc.</b> Slope Drain Inlet</p>

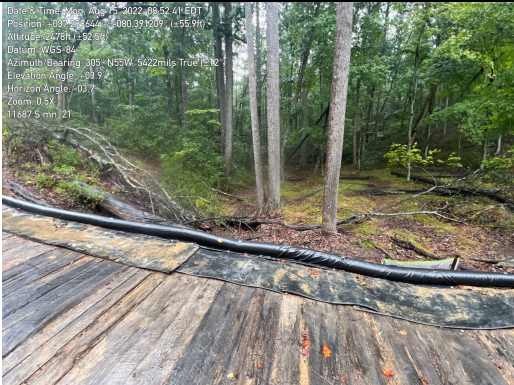
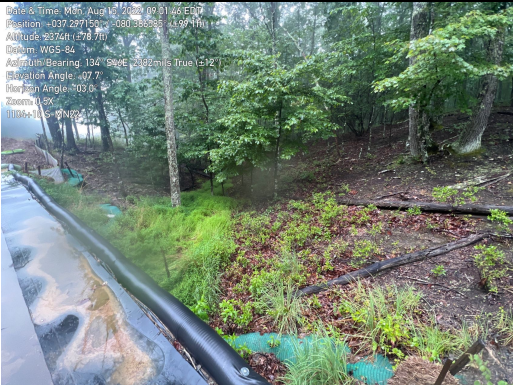
<p>Date &amp; Time: Mon, Aug 15, 2022, 09:51:03 EDT Position: +38.928983° / -98.328114° (-98.370) Altitude: 2320' (708.30) Datum: WGS-84 Azimuth/Bearing: 132° S08W 3922mils True (+13°) Elevation Angle: -13.5° Horizon Angle: -03.3° Zoom: 0.5X 11674 S MN22</p>		<p><b>GPS Location</b> See Photo</p> <p><b>Field Station#</b> 11587+00</p> <p><b>Pic 3 Desc.</b> S-MN21</p>		<p><b>GPS Location</b> See Photo</p> <p><b>Field Station#</b> 11074+10</p> <p><b>Pic 4 Desc.</b> S-MN22</p>

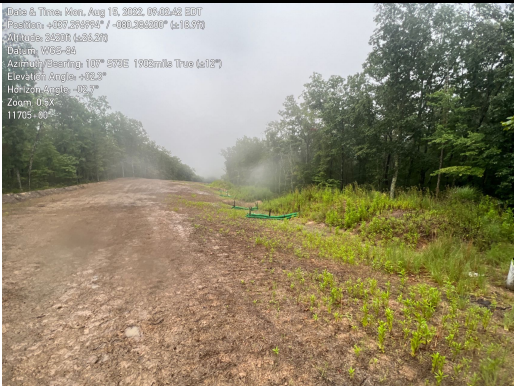
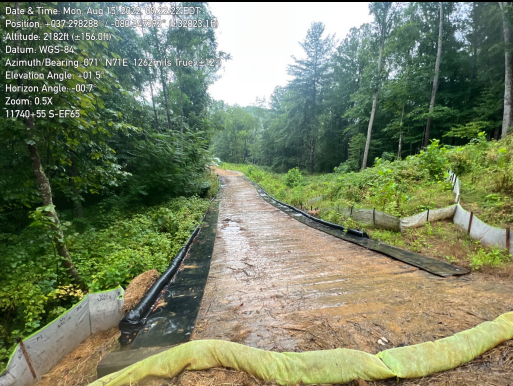
<p>Date &amp; Time: Mon, Aug 15, 2022, 05:43:27 EDT Position: +38.928983° / -98.328114° (-98.370) Altitude: 2320' (708.30) Datum: WGS-84 Azimuth/Bearing: 071° N71E 1242mils True (+2°) Elevation Angle: -01.5° Horizon Angle: -00.7° Zoom: 0.5X 11740-55 S-EF65</p>		<p><b>GPS Location</b> See Photo</p> <p><b>Field Station#</b> 11705+00</p> <p><b>Pic 5 Desc.</b> Section of ROW showing conditions and controls</p>		<p><b>GPS Location</b> See Photo</p> <p><b>Field Station#</b> 11740+55</p> <p><b>Pic 6 Desc.</b> S-EF65</p>

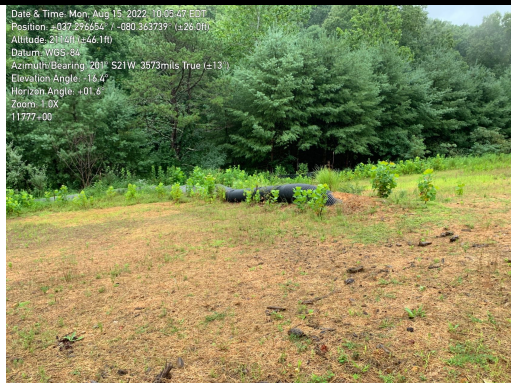
<b>Pic 11 Desc.</b>	Clean water diversion pipe	<b>Pic 12 Desc.</b>	RCE

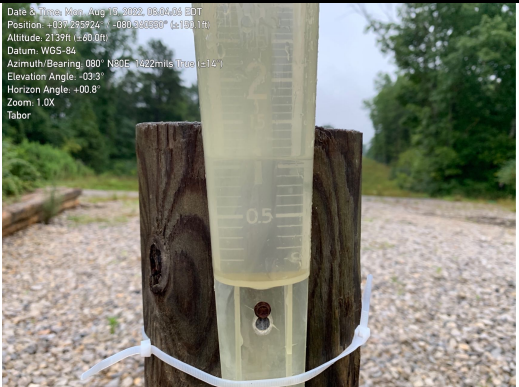
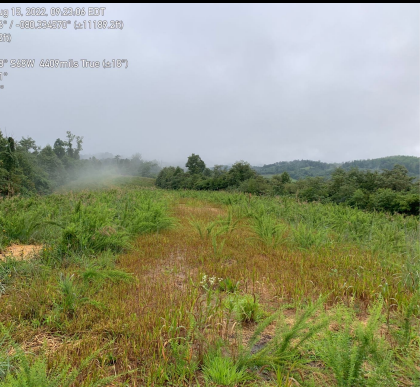
<b>GPS Location</b>	See photo for GPS location.		<b>GPS Location</b>	See photo for GPS location.		
<b>Field Station#</b>	11790+00		<b>Field Station#</b>	11889+00		
<b>Pic 1 Desc.</b>	Rain gauges at Mount Tabor reads 1.1 inches.		<b>Pic 2 Desc.</b>	ROW permanently restored.		
<p>Date &amp; Time: Mon, Aug 15, 2022, 09:35:48 EDT  Position: +037° 28' 58.7" / -80° 34' 22.7" (+15.30)  Altitude: 2179ft (+661.10)  Datum: WGS-84  Azimuth/Bearing: 354° N54W 6329mils True (+18°)  Elevation Angle: -13.2°  Horizon Angle: +00.3°  Zoom: 1.0X  11864+00</p>

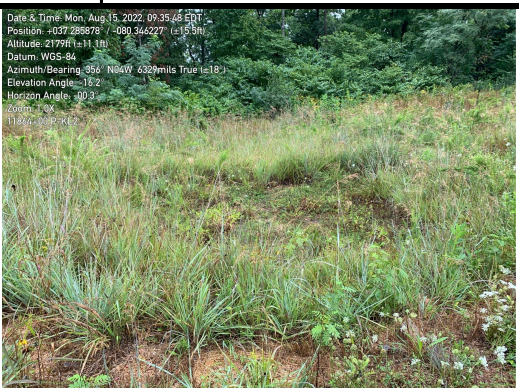
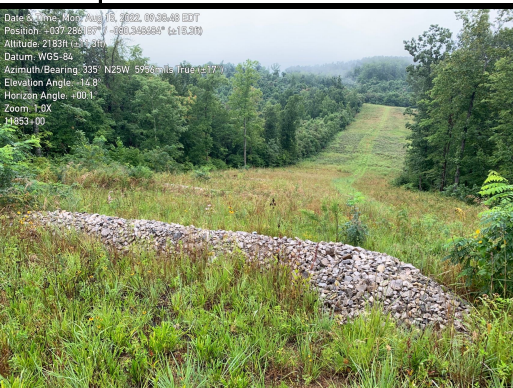
<b>GPS Location</b>	See photo for GPS location.		<b>GPS Location</b>	See photo for GPS location.		
<b>Field Station#</b>	11864+00		<b>Field Station#</b>	11853+00		
<b>Pic 3 Desc.</b>	Sensitive resource P-KL2.		<b>Pic 4 Desc.</b>	Permanent waterbars with level spreaders in place.		
<p>Date &amp; Time: Mon, Aug 15, 2022, 10:01:58 EDT  Position: +39° 29' 19.7" / -80° 34' 59.9" (+18.30)  Altitude: 2230ft (+677.00)  Datum: WGS-84  Azimuth/Bearing: 341° N39W 6045mils True (+18°)  Elevation Angle: -04.5°  Horizon Angle: -01.1°  Zoom: 1.0X  11819+00</p>

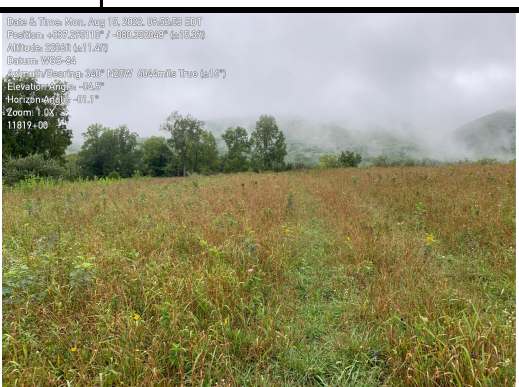
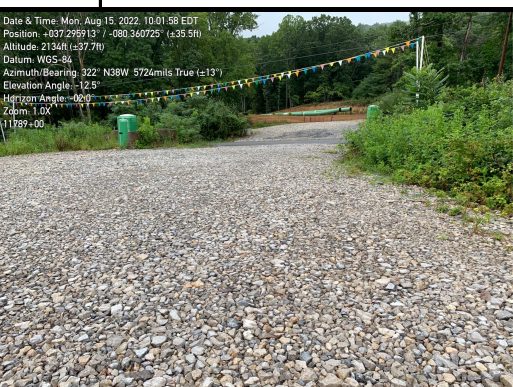
<b>Field Station#</b>	11819+00		<b>Field Station#</b>	11789+00		
<b>Pic 5 Desc.</b>	ROW permanently restored.		<b>Pic 6 Desc.</b>	RCE in place at Mount Tabor Road crossing.

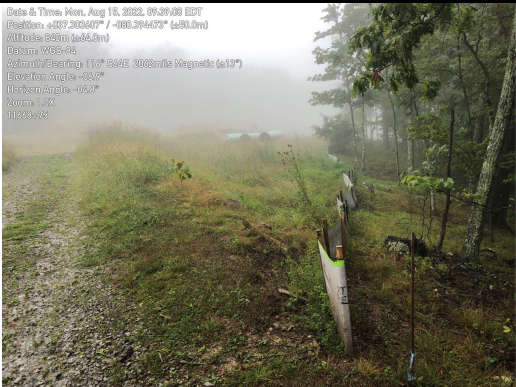
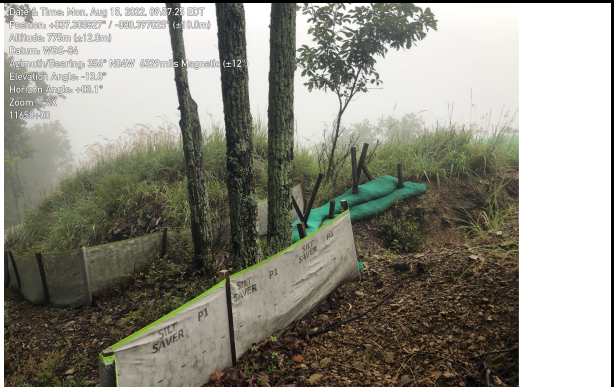
<b>GPS Location</b>	On photo	<b>GPS Location</b>	On photo		
<b>Field Station#</b>	11668+75	<b>Field Station#</b>	11658+00		
<b>Pic 1 Desc.</b>	Top of Brush Mountain is stable.		<b>Pic 2 Desc.</b>	ROW stable with ECDs in place.	
<p>Date &amp; Time: Mon, Aug 15, 2022, 10:10:57 EDT  Position: +037.306212° / -080.397335° (+110.0m)  Altitude: 707m (+24.0m)  Datum: WGS-84  Azimuth/Bearing: 355° 00'00" 3811mils Magnetic (+12°)  Elevation Angle: -24.3°  Horizon Angle: +01.5°  Zoom: 1.0X  11647+00</p>

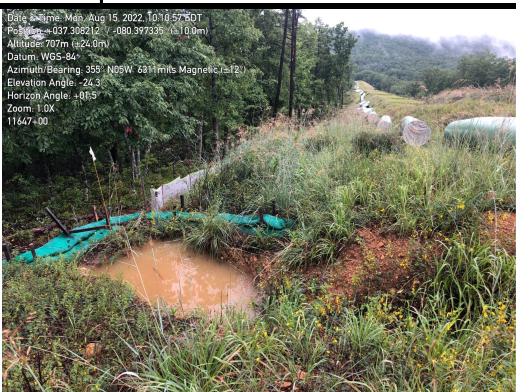
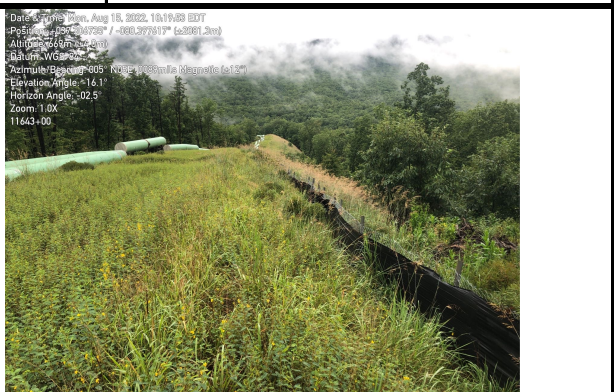
<b>GPS Location</b>	On photo	<b>GPS Location</b>	On photo		
<b>Field Station#</b>	11647+00	<b>Field Station#</b>	11643+00		
<b>Pic 3 Desc.</b>	ROW stable with ECDs in place.		<b>Pic 4 Desc.</b>	No erosion of any type.	
<p>Date &amp; Time: Mon, Aug 15, 2022, 10:35:53 EDT  Position: +037.313922° / -080.392521° (+5.0m)  Altitude: 580m (+4.0m)  Datum: WGS-84  Azimuth/Bearing: 283° 00'00" 3031mils Magnetic (+12°)  Elevation Angle: -14.3°  Horizon Angle: -02.5°  Zoom: 1.0X  11626+04, S-HH18</p>

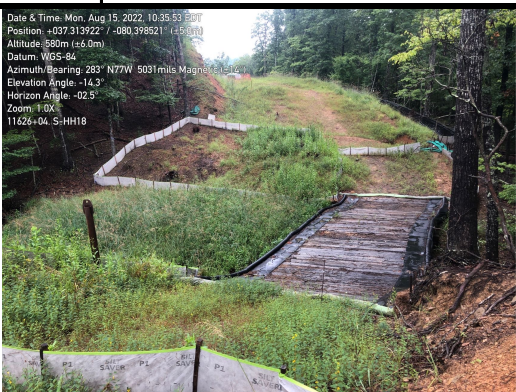
<b>GPS Location</b>	On photo	<b>GPS Location</b>	On photo		
<b>Field Station#</b>	11626+04	<b>Field Station#</b>	11625+00		
<b>Pic 5 Desc.</b>	No impact at the S-HH18 crossing.		<b>Pic 6 Desc.</b>	ECDs in place and functional.

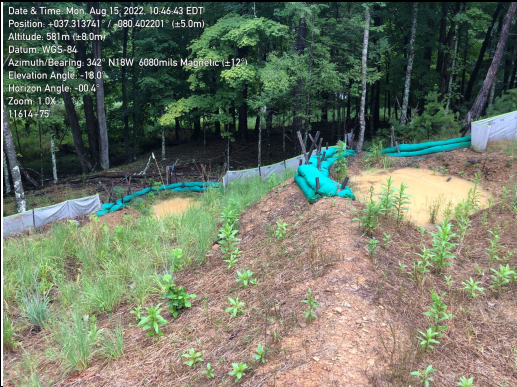
<b>GPS Location</b>	On photo
<b>Field Station#</b>	11614+75
<b>Pic 7 Desc.</b>	Slope breakers, sumps and end treatments are functioning.

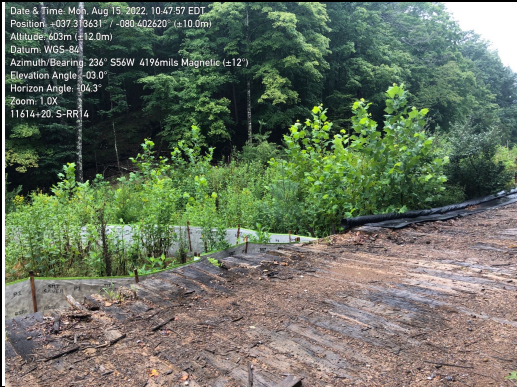
<b>GPS Location</b>	On photo
<b>Field Station#</b>	11614+20
<b>Pic 8 Desc.</b>	No impact occurring at the S-RR14 crossing.

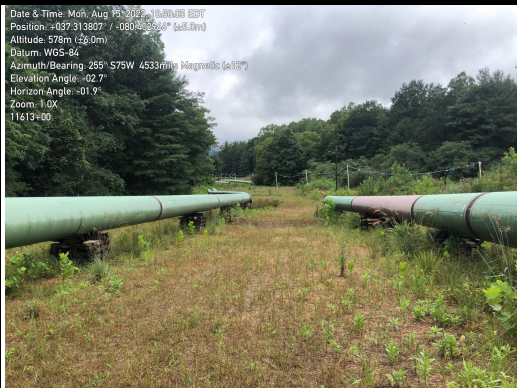
<b>GPS Location</b>	On photo
<b>Field Station#</b>	11613+00
<b>Pic 9 Desc.</b>	ROW stable on private property.

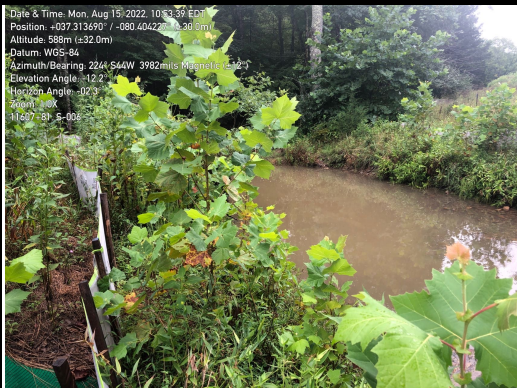
<b>GPS Location</b>	On photo
<b>Field Station#</b>	11607+81
<b>Pic 10 Desc.</b>	The S-006 crossing is stable with no impact to stream.

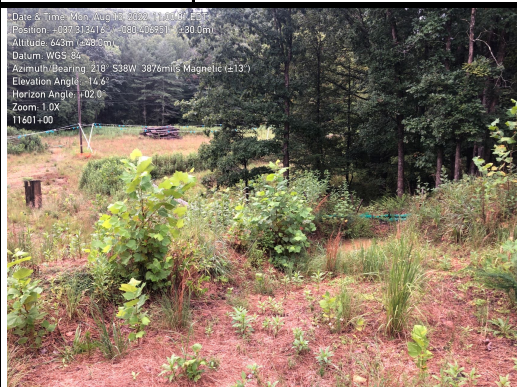
<b>GPS Location</b>	On photo
<b>Field Station#</b>	11601+00
<b>Pic 11 Desc.</b>	ROW stable with ECDs in place.

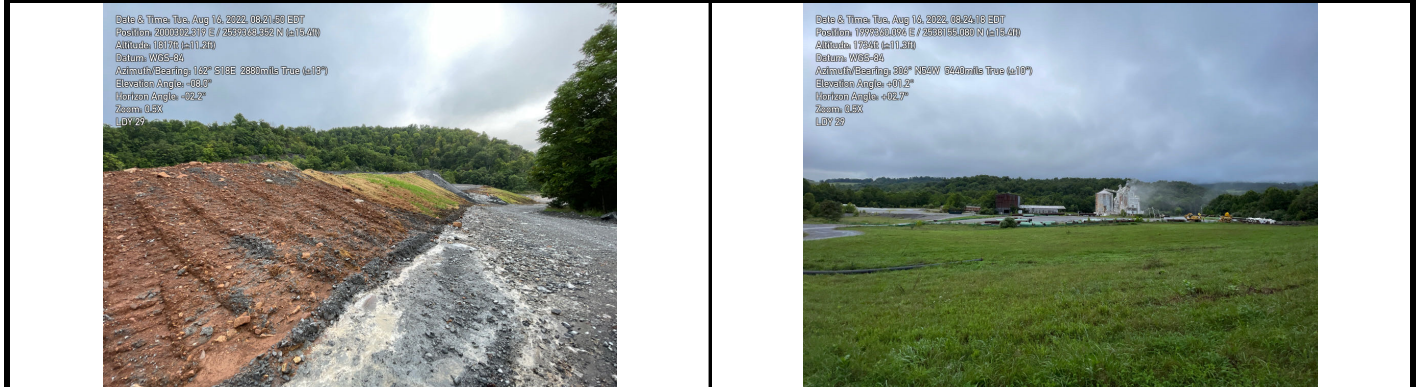
See photos for GPS coordinates.  
 Met with environmental staff.  
 Performed SWPPP inspection of LDY 29.  
 All perimeter controls, ECDs and BMPs functional at time of inspection.  
 Vegetation or stabilization sufficient.  
 No impact to sensitive resources observed.  
 No visual leaks from staged equipment.  
 Observed recent ground disturbance, by others, impacting access road.

<b>GPS Location</b>	1	<b>GPS Location</b>	2
<b>Field Station#</b>	12005+00	<b>Field Station#</b>	12005+00
<b>Pic 1 Desc.</b>	Impact to access road by others.	<b>Pic 2 Desc.</b>	Overview of LDY 29.

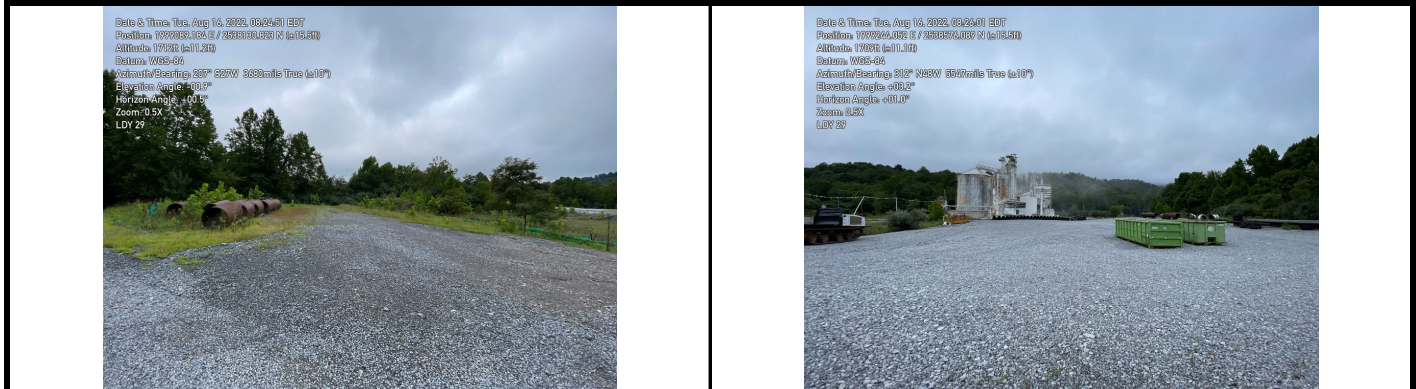
<b>GPS Location</b>	3	<b>GPS Location</b>	4
<b>Field Station#</b>	12005+00	<b>Field Station#</b>	12005+00
<b>Pic 3 Desc.</b>	Upper auxiliary to LDY 29.	<b>Pic 4 Desc.</b>	Overview main part of LDY 29.

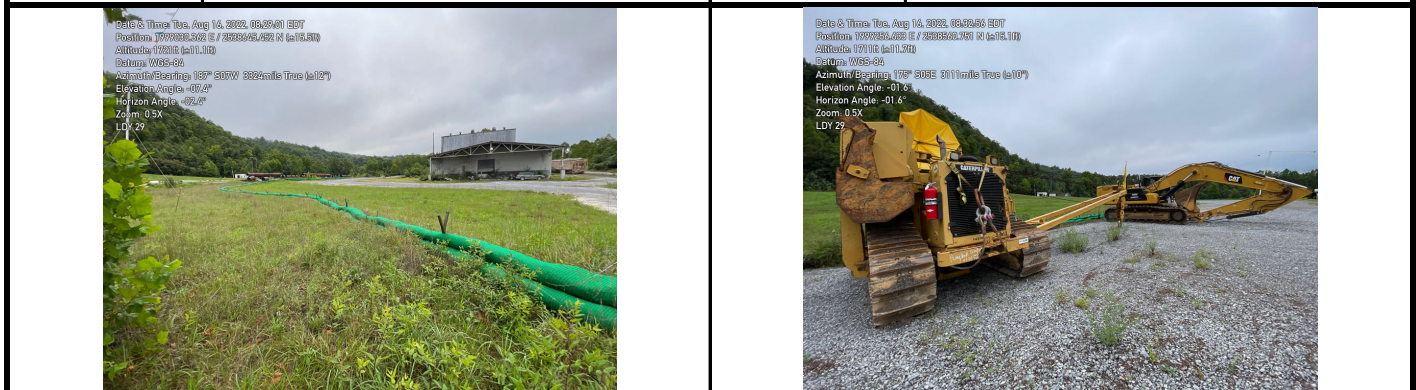
<b>GPS Location</b>	5	<b>GPS Location</b>	6
<b>Field Station#</b>	12005+00	<b>Field Station#</b>	12005+00
<b>Pic 5 Desc.</b>	Perimeter controls functional.	<b>Pic 6 Desc.</b>	Staged equipment.

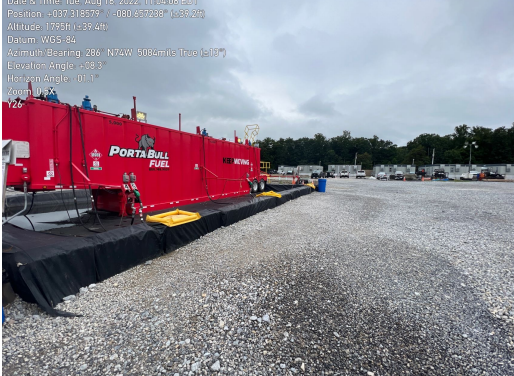
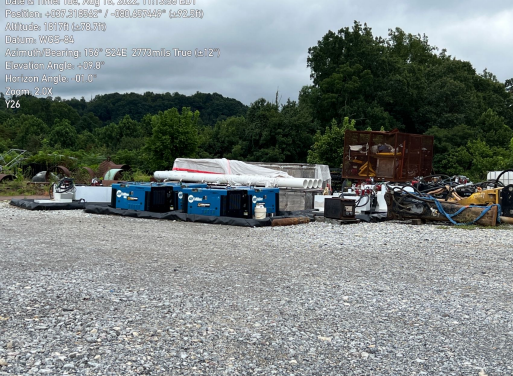
<p><small>Date &amp; Time: Tue, Aug 16, 2022, 11:18:05 EDT Position: +037.318362° / +080.572447° (-63.21) Altitude: 1757ft (-33.0ft) Datum: WGS-84 Azimuth Bearing: 136° S64E 273mils True (+2°) Elevation Angle: +38.0° Horizon Angle: -01.0° Zoom: 2.0X Y26</small></p>			
<b>GPS Location</b>	See Photo	<b>GPS Location</b>	See Photo		
<b>Field Station#</b>	12005+00	<b>Field Station#</b>	12005+00		
<b>Pic 1 Desc.</b>	Fuel containment	<b>Pic 2 Desc.</b>	Secondary containment

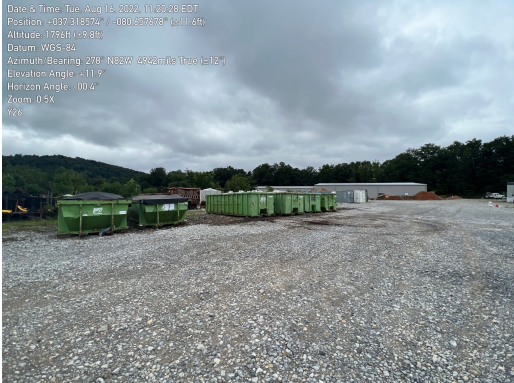
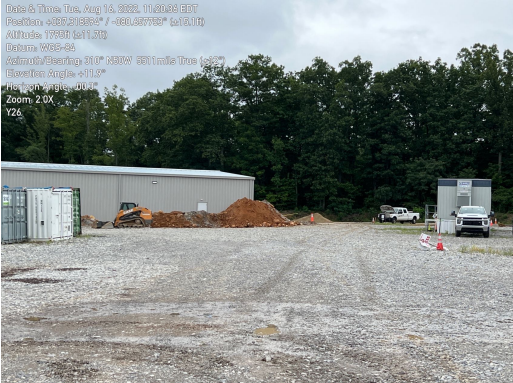
<b>GPS Location</b>	See Photo	<b>GPS Location</b>	See Photo		
<b>Field Station#</b>	12005+00	<b>Field Station#</b>	12005+00		
<b>Pic 3 Desc.</b>	Trash bins and house keeping	<b>Pic 4 Desc.</b>	Giles county construction

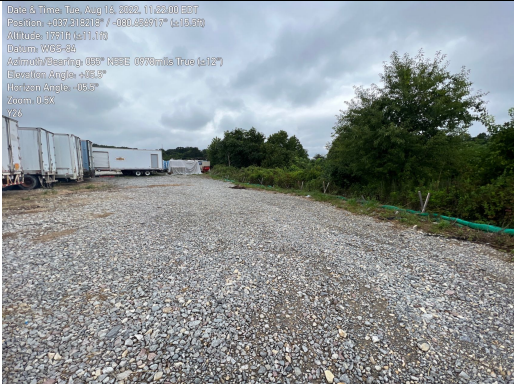
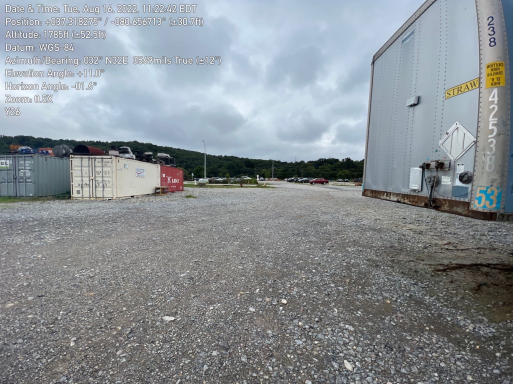
<p><small>Date &amp; Time: Tue, Aug 16, 2022, 11:22:42 EDT Position: +037.318367° / +080.568117° (-63.11) Altitude: 1753ft (-32.2ft) Datum: WGS-84 Azimuth Bearing: 032° N32E 053mils True (+2°) Elevation Angle: +11.0° Horizon Angle: -01.2° Zoom: 0.5X Y26</small></p>			
<b>GPS Location</b>	See Photo	<b>GPS Location</b>	See Photo		
<b>Field Station#</b>	12005+00	<b>Field Station#</b>	12005+00		
<b>Pic 5 Desc.</b>	Cfs controls	<b>Pic 6 Desc.</b>	RCE

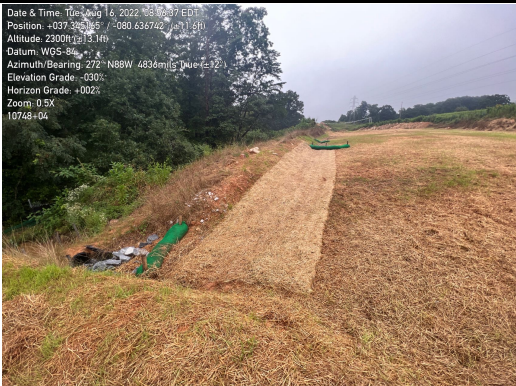
<p style="text-align: center;">Insert image here</p>			
<b>GPS Location</b>	See photo	<b>GPS Location</b>			
<b>Field Station#</b>	10748+04	<b>Field Station#</b>			
<b>Pic 15 Desc.</b>	View of ECB to a row drain path to a sump pit. No issues at this time .	<b>Pic 16 Desc.</b>			
<p style="text-align: center;">Insert image here</p>		<p style="text-align: center;">Insert image here</p>			
<b>GPS Location</b>		<b>GPS Location</b>			
<b>Field Station#</b>		<b>Field Station#</b>			
<b>Pic 17 Desc.</b>		<b>Pic 18 Desc.</b>

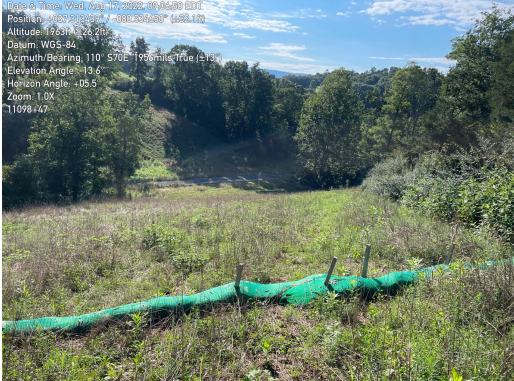
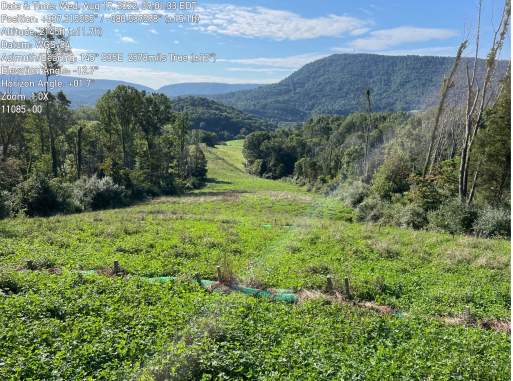
<b>GPS Location</b>	See photo		<b>GPS Location</b>	See photo	
<b>Field Station#</b>	11098+47		<b>Field Station#</b>	11085+00	
<b>Pic 1 Desc.</b>	Picture showing condition of row		<b>Pic 2 Desc.</b>	CFS water bars	
<p>Date &amp; Time: Wed Aug 17, 2022, 08:56 EDT  Position: -037.315360 / -080.541198 (-25.0ft)  Altitude: 2195ft (+13.1ft)  Datum: WGS-84  Azimuth/Bearing: 089.889E 1582mils True (+13.1)  Elevation Angle: -09.0  Horizon Angle: -03.0  Zoom: 1.0X  11073+00</p>

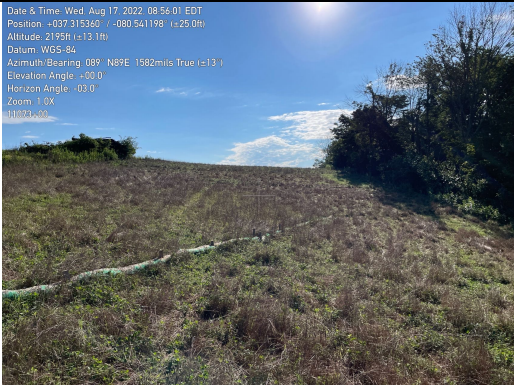
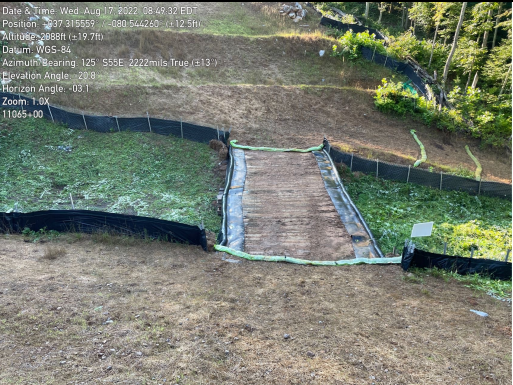
<b>GPS Location</b>	See photo		<b>GPS Location</b>	See photo	
<b>Field Station#</b>	11073+00		<b>Field Station#</b>	11065+00	
<b>Pic 3 Desc.</b>	Permanent stabilization in place		<b>Pic 4 Desc.</b>	Equipment bridge functional	
<p>Date &amp; Time: Wed Aug 17, 2022, 08:40 EDT  Position: -037.315779 / -080.542114 (-12.9ft)  Altitude: 2185ft (+17.7ft)  Datum: WGS-84  Azimuth/Bearing: 023.587E 1653mils True (+13.1)  Elevation Angle: -19.7  Horizon Angle: +03.3  Zoom: 1.0X  11056+00</p>

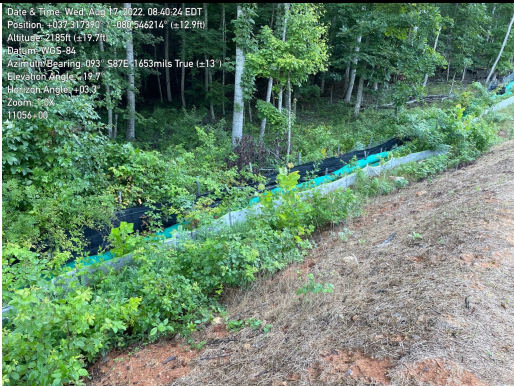
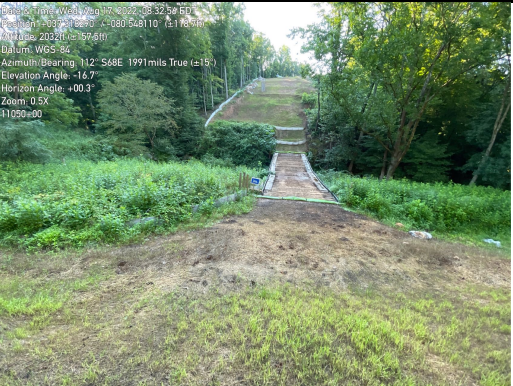
<b>GPS Location</b>	See photo		<b>GPS Location</b>	See photo	
<b>Field Station#</b>	11056+00		<b>Field Station#</b>	11050+00	
<b>Pic 5 Desc.</b>	Perimeter controls in place		<b>Pic 6 Desc.</b>	Resource buffers in place

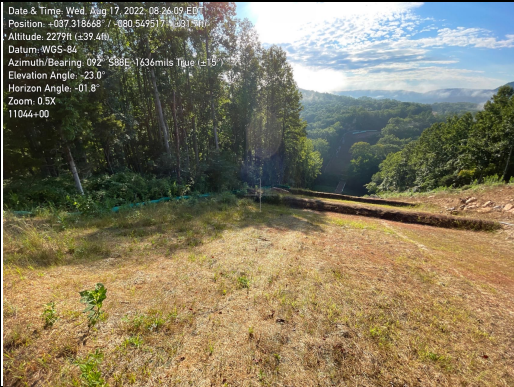
Date & Time: Wed, Aug 17, 2022, 08:26:09 EDT  
 Position: -037.318668 / -80.549517 (-37.318668, -80.549517)  
 Altitude: 2279ft (±39.4ft)  
 Datum: WGS-84  
 Azimuth/Bearing: 092.588E 183.36mils True (±15.7)  
 Elevation Angle: -22.0  
 Horizon Angle: -01.8  
 Zoom: 0.5X  
 11044+00

<b>GPS Location</b>	See photo	<b>GPS Location</b>	See photo
<b>Field Station#</b>	11044+00	<b>Field Station#</b>	11026+00
<b>Pic 7 Desc.</b>	Water bars and ET in place	<b>Pic 8 Desc.</b>	Wattles in place

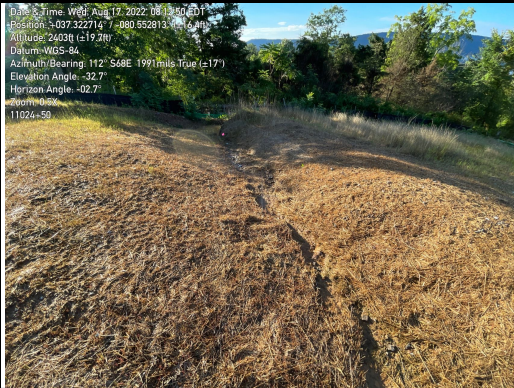
Date & Time: Wed, Aug 17, 2022, 08:13:50 EDT  
 Position: -037.322714 / -80.552813 (-37.322714, -80.552813)  
 Altitude: 2402ft (±17.2ft)  
 Datum: WGS-84  
 Azimuth/Bearing: 112.568E 199.1mils True (±17)  
 Elevation Angle: -32.7  
 Horizon Angle: -02.7  
 Zoom: 0.5X  
 11024+50

<b>GPS Location</b>	See photo	<b>GPS Location</b>	See photo
<b>Field Station#</b>	11024+50	<b>Field Station#</b>	11023+80
<b>Pic 9 Desc.</b>	Rilling in throat of water bar	<b>Pic 10 Desc.</b>	Broad base dips functional

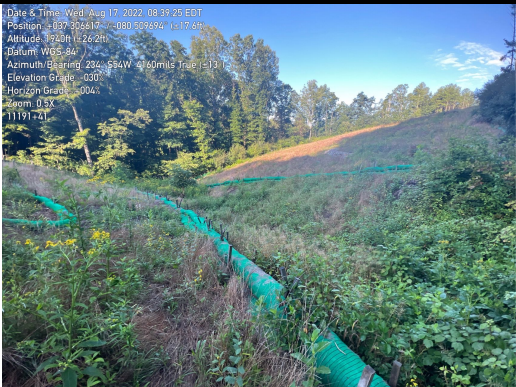
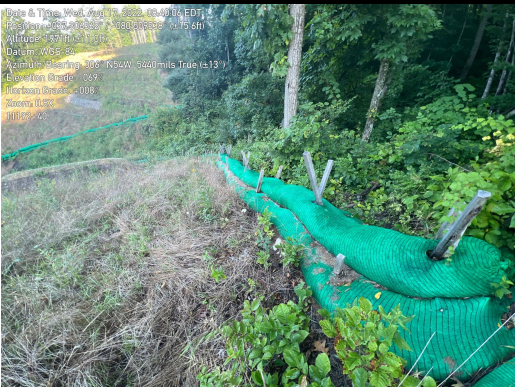
<b>GPS Location</b>	See photo	<b>GPS Location</b>	See photo		
<b>Field Station#</b>	11191+41	<b>Field Station#</b>	11192+40		
<b>Pic 3 Desc.</b>	Heavily vegetated row through the drainage feature area. CFS functional as a water bar.	<b>Pic 4 Desc.</b>	Perimeter CFS controls in final restoration area.

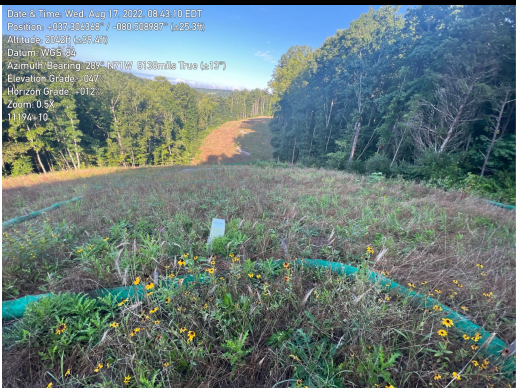
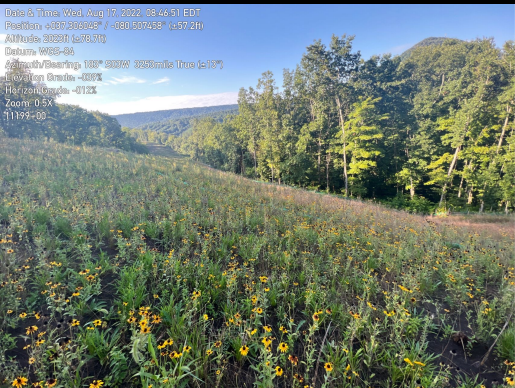
<b>GPS Location</b>	See photo	<b>GPS Location</b>	See photo		
<b>Field Station#</b>	11194+10	<b>Field Station#</b>	11199+00		
<b>Pic 5 Desc.</b>	Area of slight subsidence in final restoration area. Depression not visible in photo.	<b>Pic 6 Desc.</b>	Steep side slope heavy vegetation in final restoration area.

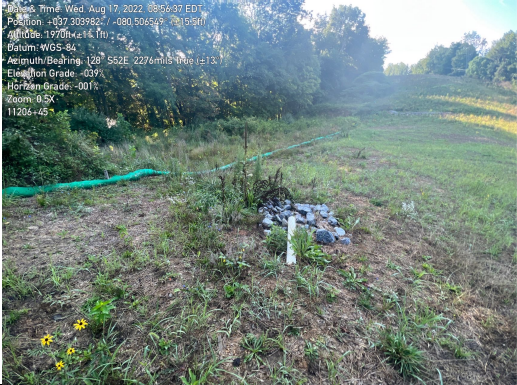
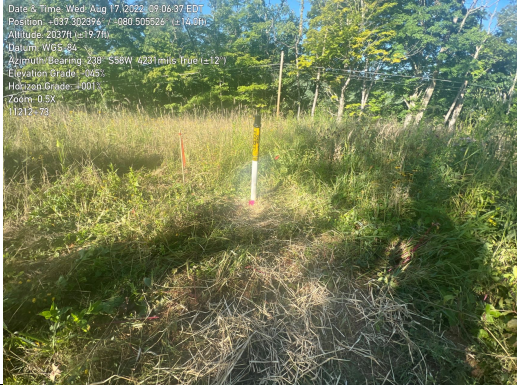
<b>GPS Location</b>	See photo	<b>GPS Location</b>	See photo
<b>Field Station#</b>	11206+45	<b>Field Station#</b>	11212+73
<b>Pic 7 Desc.</b>	Daylight drain within the final restoration area.	<b>Pic 8 Desc.</b>	Area of depression at the test lead site location. This area is in the final restoration area.

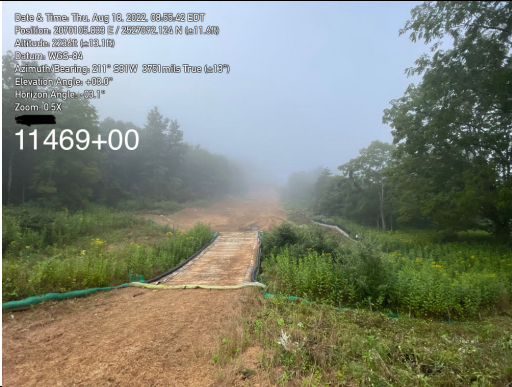
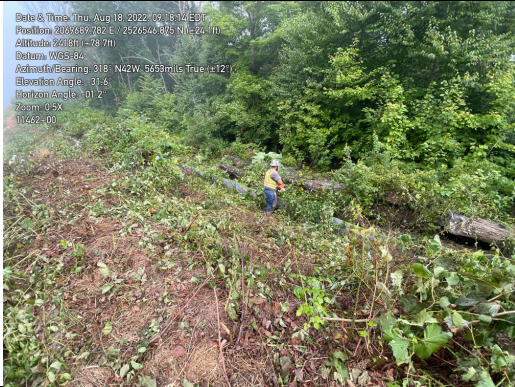
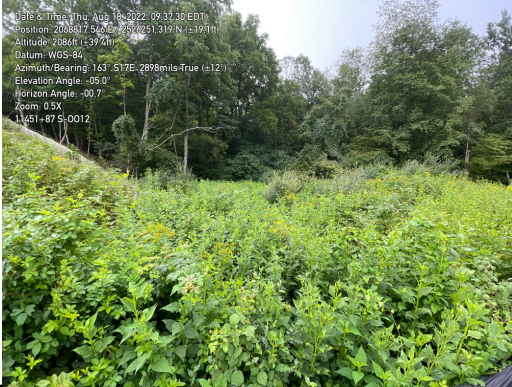
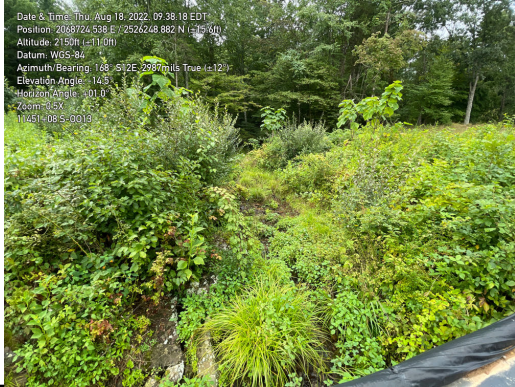
GPS Location 1		GPS Location 2		GPS Location 3			
Field Station# 11469+00		Field Station# 11462+00		Field Station# 11451+87			
Pic 1 Desc. Section of RoW showing conditions and controls.		Pic 2 Desc. Crews performing vegetative maintenance.		Pic 3 Desc. S-0012.			
GPS Location 5		GPS Location 6		GPS Location 5			
Field Station# 11448+93		Field Station# 11438+75		Field Station# 11448+93			
Pic 5 Desc. S-0014/W-CD12.		Pic 6 Desc. Section of restored RoW showing conditions and controls.		Pic 5 Desc. S-0014/W-CD12.

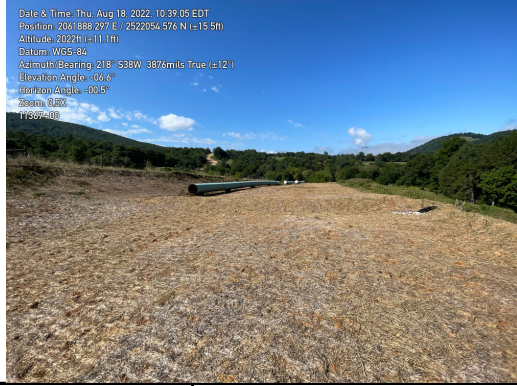
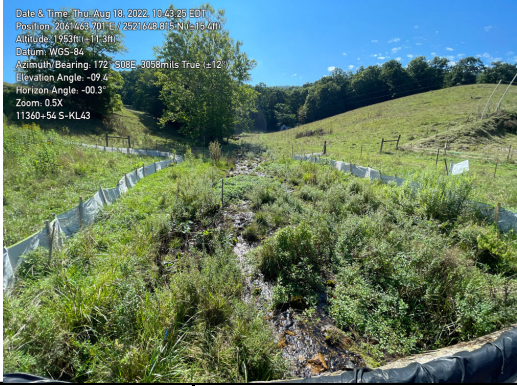
<b>GPS Location</b> 11		<b>GPS Location</b> 12			
<b>Field Station#</b> 11367+00		<b>Field Station#</b> 11360+54			
<b>Pic 11 Desc.</b> Section of RoW showing conditions and controls.		<b>Pic 12 Desc.</b> S-KL43.

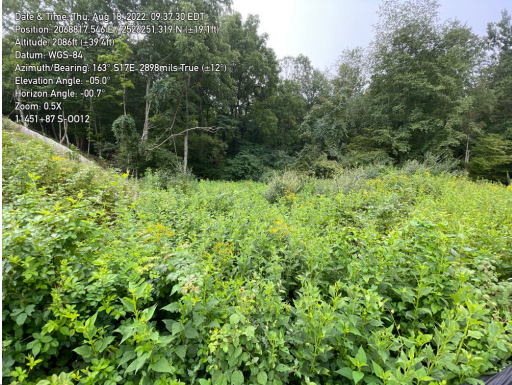
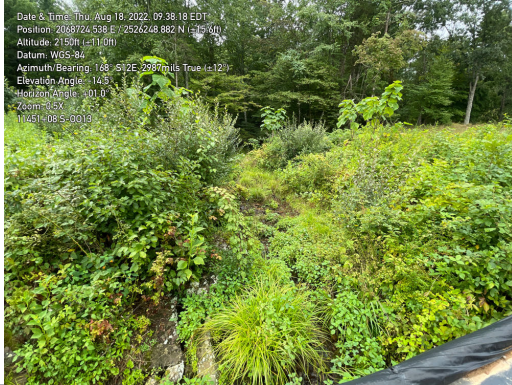
<b>GPS Location</b> 3		<b>GPS Location</b> 4			
<b>Field Station#</b> 11451+87		<b>Field Station#</b> 11451+08			
<b>Pic 3 Desc.</b> S-0012.		<b>Pic 4 Desc.</b> S-0013

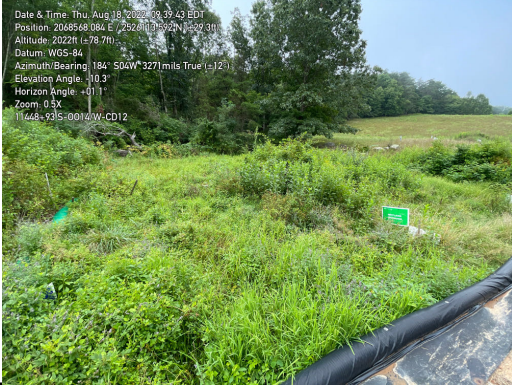
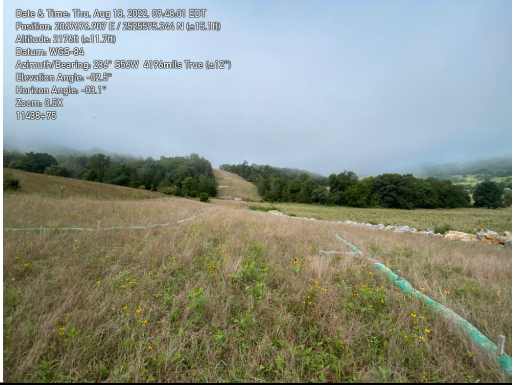
<b>GPS Location</b> 5		<b>GPS Location</b> 6			
<b>Field Station#</b> 11448+93		<b>Field Station#</b> 11438+75			
<b>Pic 5 Desc.</b> S-0014/W-CD12.		<b>Pic 6 Desc.</b> Section of restored RoW showing conditions and controls.

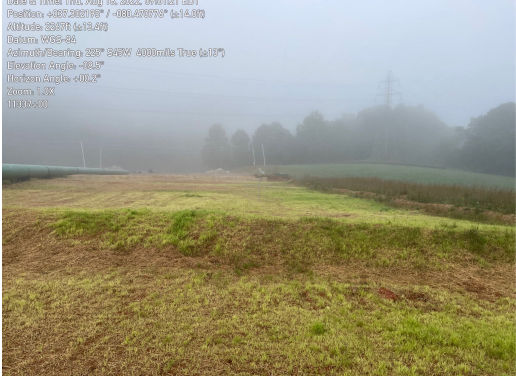
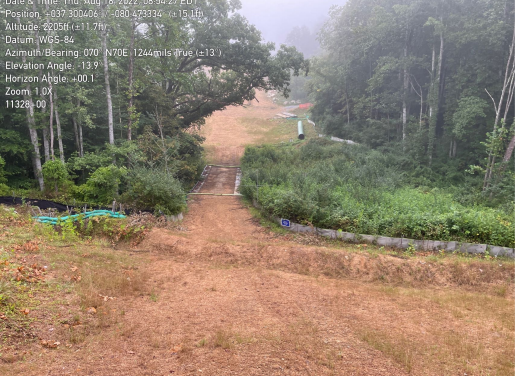
<p>Date &amp; Time: Thu, Aug 18, 2022, 06:50:27 EDT Position: +38.202187° / -080.49797° (-14.27) Altitude: 2237 ft (-13.27) Datum: WGS-84 Azimuth/Bearing: 070° N20E 1244mils True (-13°) Elevation Angle: -13.9° Horizon Angle: +00.1° Zoom: 1.0X 11285.00</p>			
<b>GPS Location</b>	See photo	<b>GPS Location</b>	See photo	
<b>Field Station#</b>	11337+00	<b>Field Station#</b>	11328+00	
<b>Pic 1 Desc.</b>	Temporary stabilization in place	<b>Pic 2 Desc.</b>	Resource buffers in place

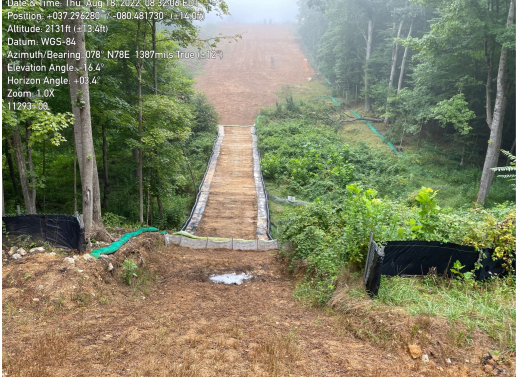
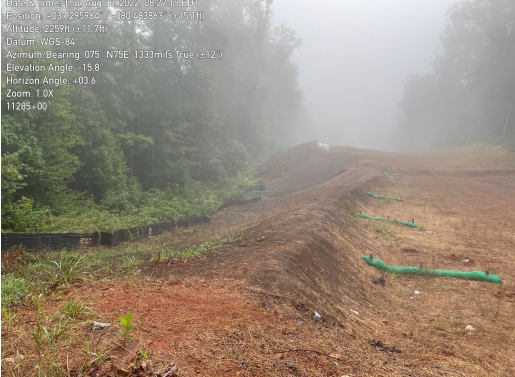
<b>GPS Location</b>	See photo	<b>GPS Location</b>	See photo	
<b>Field Station#</b>	11293+00	<b>Field Station#</b>	11285+00	
<b>Pic 3 Desc.</b>	Equipment bridge functional	<b>Pic 4 Desc.</b>	Picture showing condition of row

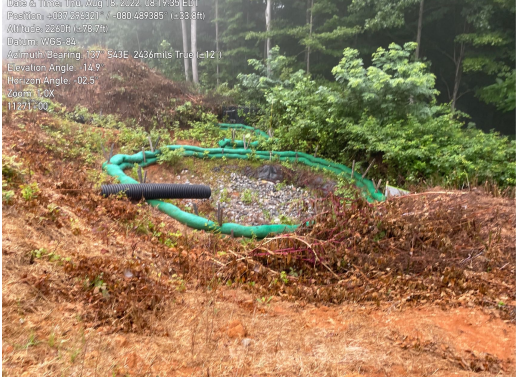
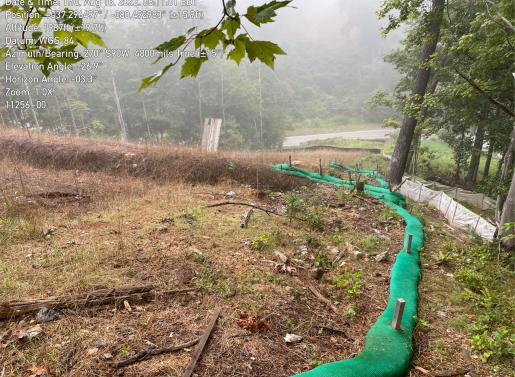
<p>Date &amp; Time: Thu, Aug 18, 2022, 08:11:10 EDT Position: +38.202187° / -080.49797° (-14.27) Altitude: 2237 ft (-13.27) Datum: WGS-84 Azimuth/Bearing: 270° S43W 480mils True (-13°) Elevation Angle: -2.9° Horizon Angle: +03.3° Zoom: 1.0X 11255.00</p>			
<b>GPS Location</b>	See photo	<b>GPS Location</b>	See photo	
<b>Field Station#</b>	11271+00	<b>Field Station#</b>	11256+00	
<b>Pic 5 Desc.</b>	Plunge pool in place	<b>Pic 6 Desc.</b>	Water bars and ET in place

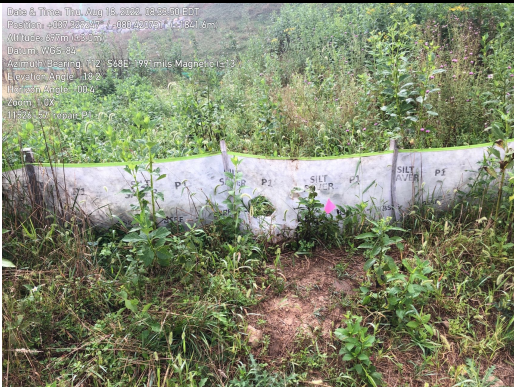
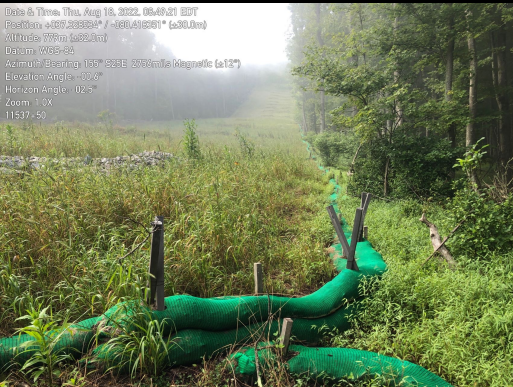
<p><small>Date &amp; Time: Thu, Aug 18, 2022, 09:49:21 EDT Position: +037.325530 / -080.416373 (+30.0m) Altitude: 79.9m (+22.0m) Datum: WGS-84 Azimuth/Bearing: 155° 534E 254mils Magnetic (+13°) Elevation Angle: -0.2° Horizon Angle: -0.2° Zoom: 1.0X 11537+50</small></p>			
<b>GPS Location</b>	On photo	<b>GPS Location</b>	On photo		
<b>Field Station#</b>	11526+57	<b>Field Station#</b>	11537+50		
<b>Pic 1 Desc.</b>	COMMUNICATION; livestock damage to P1 silt fence. Contractor will be notified via punch list.	<b>Pic 2 Desc.</b>	Good vegetation. ECDs in place. No erosion taking place.

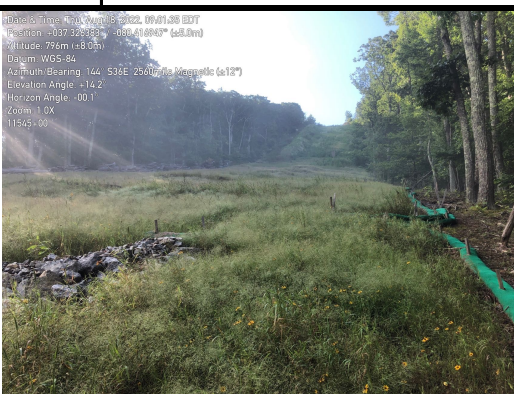
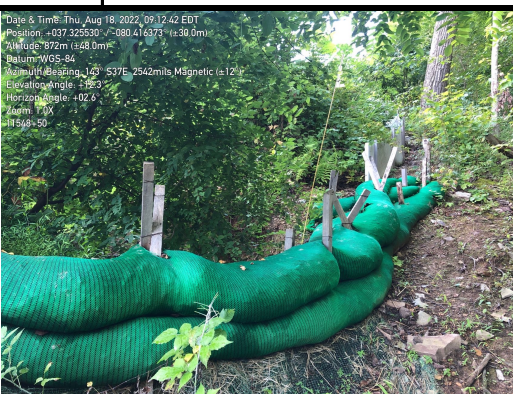
<p><small>Date &amp; Time: Thu, Aug 18, 2022, 09:12:42 EDT Position: +037.325530 / -080.416373 (+30.0m) Altitude: 82.9m (+24.0m) Datum: WGS-84 Azimuth/Bearing: 109.537E 254mils Magnetic (+12°) Elevation Angle: -15.3° Horizon Angle: -02.5° Zoom: 1.0X 11548+50</small></p>			
<b>GPS Location</b>	On photo	<b>GPS Location</b>	On photo		
<b>Field Station#</b>	11545+00	<b>Field Station#</b>	11548+50		
<b>Pic 3 Desc.</b>	ROW stable with ECDs in place. No movement of sediment.	<b>Pic 4 Desc.</b>	ROW stable. Vegetation and erosion control blanket holding surface soils. ECDs in place.

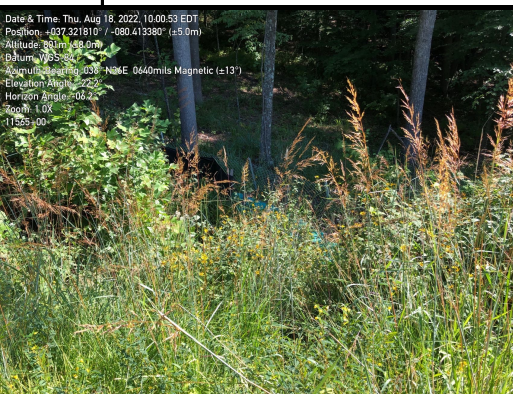
<p><small>Date &amp; Time: Thu, Aug 18, 2022, 10:00:33 EDT Position: +037.324099 / -080.413181 (+30.0m) Altitude: 82.9m (+24.0m) Datum: WGS-84 Azimuth/Bearing: 160.520E 284mils Magnetic (+12°) Elevation Angle: -28.4° Horizon Angle: -00.1° Zoom: 1.0X 11554+00</small></p>

<b>GPS Location</b>	On photo	<b>GPS Location</b>	On photo		
<b>Field Station#</b>	11554+00	<b>Field Station#</b>	11555+00		
<b>Pic 5 Desc.</b>	Good vegetation on steep slope. No erosion. ECDs in place.	<b>Pic 6 Desc.</b>	Heavy vegetation. No erosion taking place. ECDs in place.

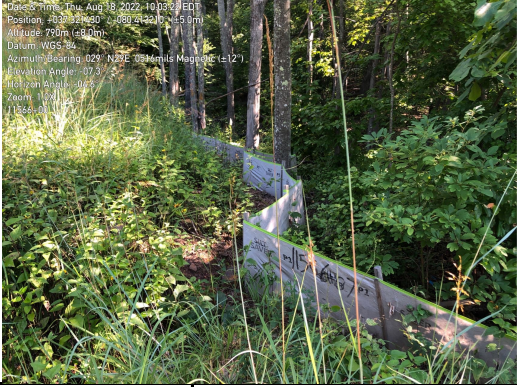
<p><small>Date &amp; Time: Thu, Aug 18, 2022, 10:13:31 EDT Position: +433.41630 / -839.41310 (±5.0m) Altitude: 780m (±8.0m) Datum: WGS-84 Azimuth/Bearing: 029° N47E 834mils Magnetic (±12°) Elevation Angle: +5.2° Horizon Angle: +0.7° Zoom: 1.0X 11566+00</small></p>

<p><small>Date &amp; Time: Thu, Aug 18, 2022, 10:10:42 EDT Position: +433.41630 / -839.41310 (±5.0m) Altitude: 779m (±8.0m) Datum: WGS-84 Azimuth/Bearing: 221° S51W 319mils Magnetic (±12°) Elevation Angle: +25.7° Horizon Angle: +05.0° Zoom: 1.0X 11567+83 S-PP22</small></p>	
<b>GPS Location</b>	On photo	<b>GPS Location</b>	On photo
<b>Field Station#</b>	11566+00	<b>Field Station#</b>	11568+22
<b>Pic 7 Desc.</b>	ROW stable. ECDs in place.	<b>Pic 8 Desc.</b>	The S-PP22 crossing is stable.
