# Visual Site Inspection Report

<b>Project Name</b> H-600 Pipeline Spread G		<b>AFE</b> 124300137	<b>Spread</b> H-600 Pipeline Spread G
<b>Contractor</b> Precision		<b>Report #</b> 40994	
<b>Inspector</b> Eric Hanlon		<b>Date/Time</b> 8/15/2022 6:54 AM	
<b>Permit #</b> TBD	<b>Inspection Type</b> VA SWPP	<b>Station Begin</b> 11899+89	
<b>State</b> VA	<b>Inspection Area</b> Full	<b>Station End</b> 12005+00	
<b>County</b> Giles	<b>Ground</b> Wet	<b>Temperature (°F)</b> 65.00	
<b>Municipality</b> N/A	<b>Weather</b> Heavy Rain	<b>Rain Gauge (in)</b> 0.50	
			<b>Rain Accumulation Time (days)</b> 1.00

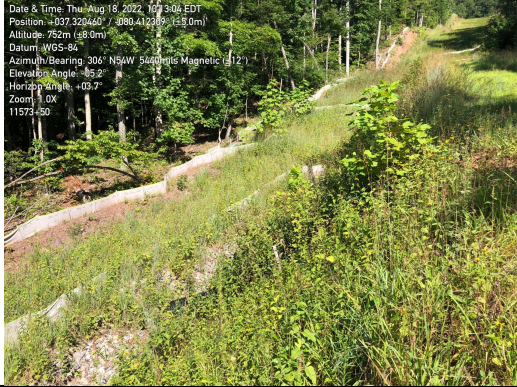
<p><small>Date &amp; Time: Thu, Aug 18, 2022, 10:33:04 EDT Position: +437.22460 / -880.41210 (±5.0m) Altitude: 753m (±8.0m) Datum: WGS-84 Azimuth/Bearing: 306° N54W 542mils Magnetic (±12°) Elevation Angle: +5.2° Horizon Angle: +03.7° Zoom: 1.0X 11573+50</small></p>

<b>GPS Location</b>	On photo	<b>GPS Location</b>	On photo
<b>Field Station#</b>	11573+50	<b>Field Station#</b>	11585+48
<b>Pic 9 Desc.</b>	ROW stable. Good vegetation coverage with ECDs in place.	<b>Pic 10 Desc.</b>	The S-PP21 crossing is stable with no impact.

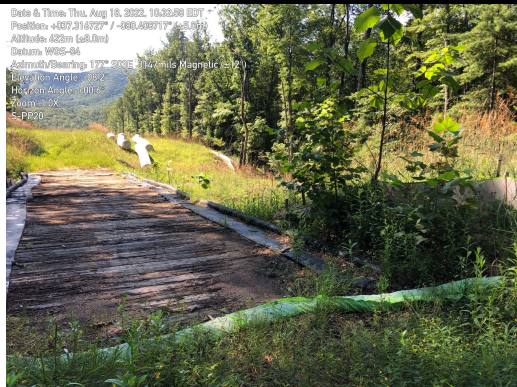
<p><small>Date &amp; Time: Thu, Aug 18, 2022, 10:35:58 EDT Position: +437.21672 / -880.40971 (±5.0m) Altitude: 623m (±8.0m) Datum: WGS-84 Azimuth/Bearing: 177° S70E 514mils Magnetic (±12°) Elevation Angle: +02.2° Horizon Angle: +00.4° Zoom: 1.0X S-PP20</small></p>

<b>Pic 11 Desc.</b>	The S-PP20 crossing is stable.	<b>Pic 12 Desc.</b>	ROW stable with ECDs in place.

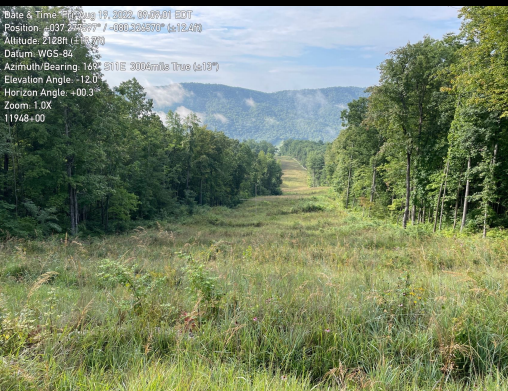
<b>GPS Location</b>	See photo	<b>GPS Location</b>	See photo		
<b>Field Station#</b>	11948+00	<b>Field Station#</b>	11944+00		
<b>Pic 3 Desc.</b>	Water bars in place	<b>Pic 4 Desc.</b>	Permanent stabilization in place

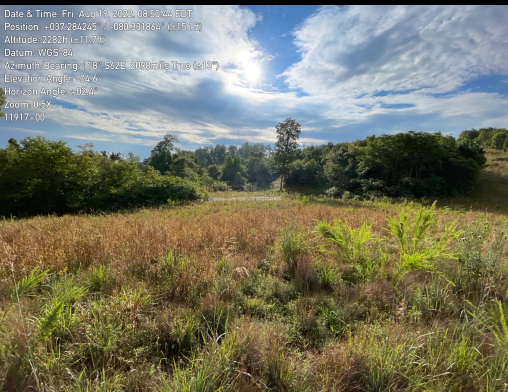
<b>GPS Location</b>	See photo	<b>GPS Location</b>	See photo		
<b>Field Station#</b>	11917+00	<b>Field Station#</b>	11907+00		
<b>Pic 5 Desc.</b>	Perimeter controls in place	<b>Pic 6 Desc.</b>	Permanent water bars and level spreader in place

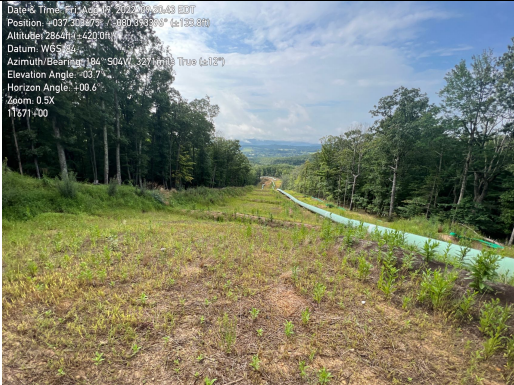
<p>Date &amp; Time: Fri, Aug 19, 2022 7:48:03 EDT  Position: +037.2232297, -080.3452411  Altitude: 2268ft (691m)  Datum: WGS-84  Azimuth/Bearing: 184.532E 2631mils True (+12°)  Elevation Angle: -03.7°  Horizon Angle: -100.6°  Zoom: 0.5X  11671+00</p>

<p>Date &amp; Time: Fri, Aug 19, 2022 7:53:18 EDT  Position: +037.2232297, -080.3452411  Altitude: 2268ft (691m)  Datum: WGS-84  Azimuth/Bearing: 148.532E 2631mils True (+12°)  Elevation Angle: -04.5°  Horizon Angle: -00.2°  Zoom: 0.5X  11687+02</p>		GPS Location See Photo		GPS Location See Photo	
Field Station# 11671+00		Field Station# 11687+42		Pic 1 Desc. Waterbars		Pic 2 Desc. Equipment bridge

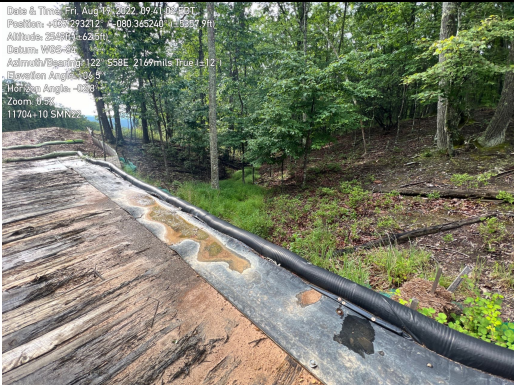
<p>Date &amp; Time: Fri, Aug 19, 2022 7:47:10 EDT  Position: +037.223212, -080.3452411  Altitude: 2269ft (691m)  Datum: WGS-84  Azimuth/Bearing: 112.532E 2169mils True (+12°)  Elevation Angle: -04.5°  Horizon Angle: -083.1°  Zoom: 0.5X  11704+10 SMN22</p>

Field Station# 11704+10		Field Station# 11724+00		Pic 3 Desc. S-MN22		Pic 4 Desc. Perimeter controls

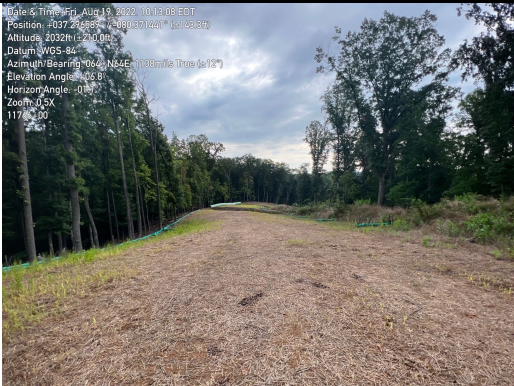
<p>Date &amp; Time: Fri, Aug 19, 2022 10:18:08 EDT  Position: +037.2232297, -080.3452411  Altitude: 2032ft (620m)  Datum: WGS-84  Azimuth/Bearing: 044.532E 1038mils True (+12°)  Elevation Angle: -05.9°  Horizon Angle: -01.9°  Zoom: 0.5X  11766+00</p>

<p>Date &amp; Time: Fri, Aug 19, 2022 10:19:55 EDT  Position: +037.2232297, -080.3452411  Altitude: 2040ft (621m)  Datum: WGS-84  Azimuth/Bearing: 007E 0458mils True (+12°)  Elevation Angle: -01.9°  Horizon Angle: -011.4°  Zoom: 0.5X  11766+80</p>		GPS Location See Photo		GPS Location See Photo	
Field Station# 11766+00		Field Station# 11766+80		Pic 5 Desc. Section of row showing conditions and controls		Pic 6 Desc. RCE

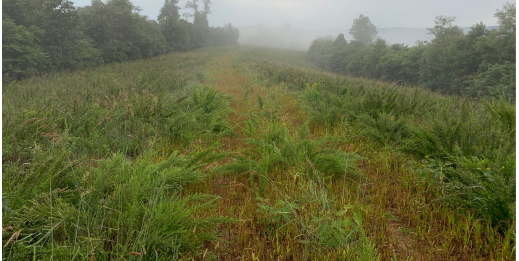
<b>GPS Location</b>	See photo for GPS location.		<b>GPS Location</b>	See photo for GPS location.	
<b>Field Station#</b>	11885+00		<b>Field Station#</b>	11864+00	
<b>Pic 1 Desc.</b>	ROW permanently restored.		<b>Pic 2 Desc.</b>	Sensitive resource P-KL2.

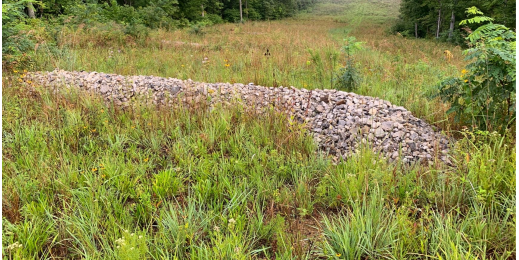
<b>GPS Location</b>	See photo for GPS location.		<b>GPS Location</b>	See photo for GPS location.	
<b>Field Station#</b>	11855+00		<b>Field Station#</b>	11830+00	
<b>Pic 3 Desc.</b>	ROW permanently restored. waterbars with level spreaders in place.		<b>Pic 4 Desc.</b>	ROW permanently restored. waterbars with level spreaders in place.

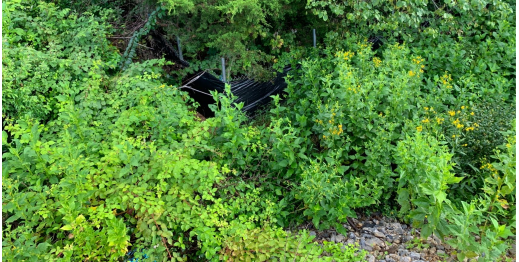
<b>GPS Location</b>	See photo for GPS location.		<b>GPS Location</b>	See photo for GPS location.	
<b>Field Station#</b>	11789+00		<b>Field Station#</b>	11788+75	
<b>Pic 5 Desc.</b>	Super silt fence in place along LOD.		<b>Pic 6 Desc.</b>	RCE in place at Mount Tabor Road.

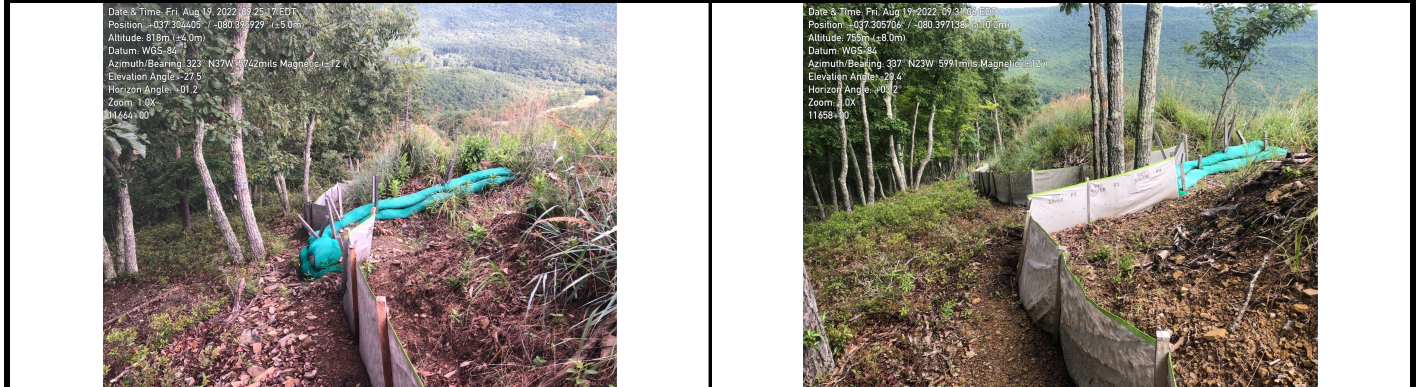
<b>GPS Location</b>	On photo	<b>GPS Location</b>	On photo
<b>Field Station#</b>	11664+00	<b>Field Station#</b>	11658+00
<b>Pic 1 Desc.</b>	ROW stable with ECDs in place.	<b>Pic 2 Desc.</b>	No sediment movement. Runoff being properly controlled.

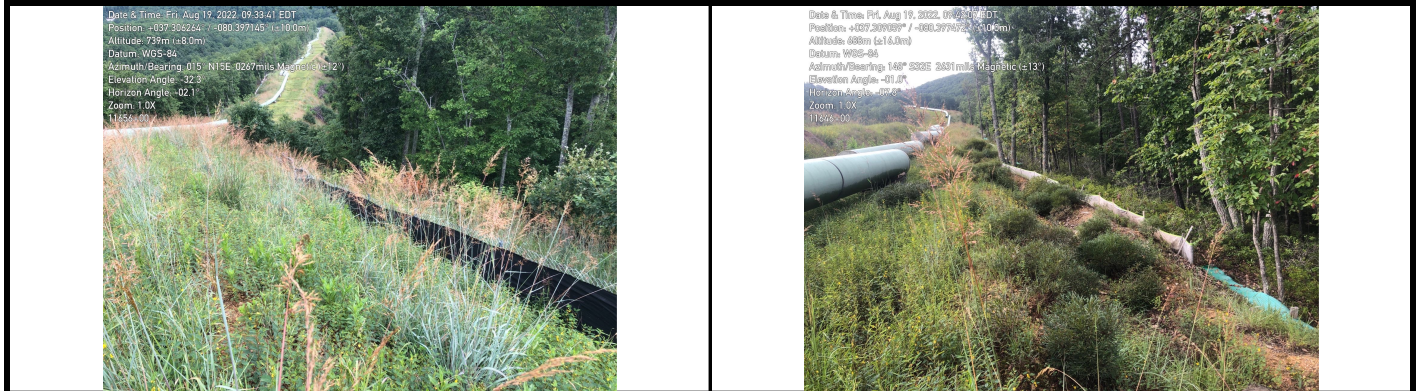
<b>GPS Location</b>	On photo	<b>GPS Location</b>	On photo
<b>Field Station#</b>	11656+00	<b>Field Station#</b>	11646+00
<b>Pic 3 Desc.</b>	ROW stable. No movement of soils taking place.	<b>Pic 4 Desc.</b>	ROW stable. ECDs in place.

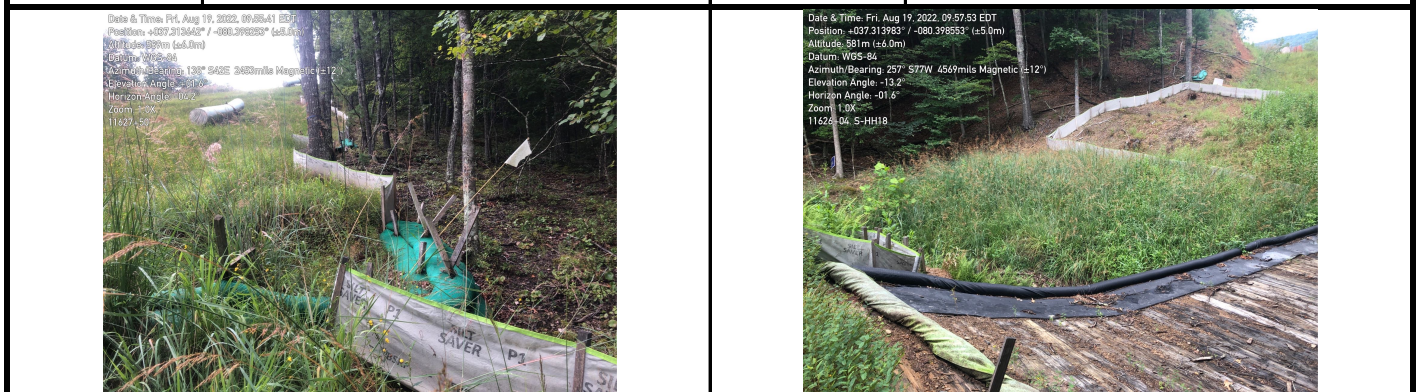
<b>GPS Location</b>	On photo	<b>GPS Location</b>	On photo
<b>Field Station#</b>	11627+50	<b>Field Station#</b>	11626+04
<b>Pic 5 Desc.</b>	No erosion occurring. ECDs in place.	<b>Pic 6 Desc.</b>	The S-HH18 crossing is stable.

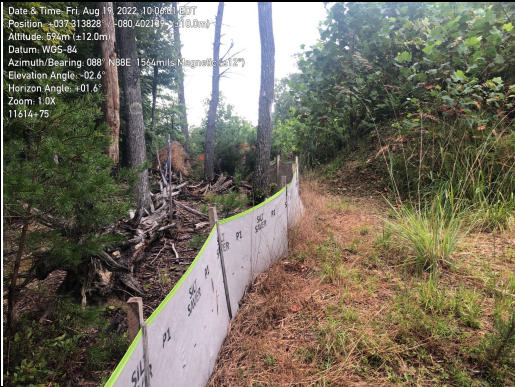
<b>GPS Location</b>	On photo
<b>Field Station#</b>	11614+75
<b>Pic 7 Desc.</b>	Perimeter ECDs are functional.

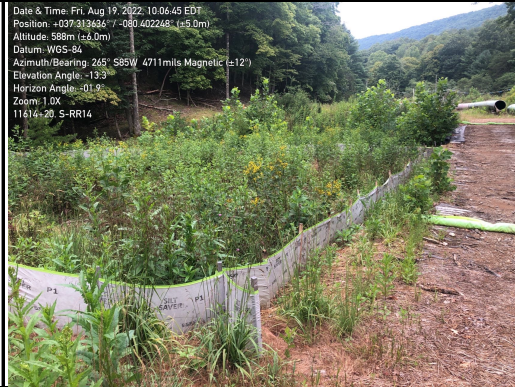
<b>GPS Location</b>	On photo
<b>Field Station#</b>	11614+20
<b>Pic 8 Desc.</b>	The S-RR14 crossing is stable.

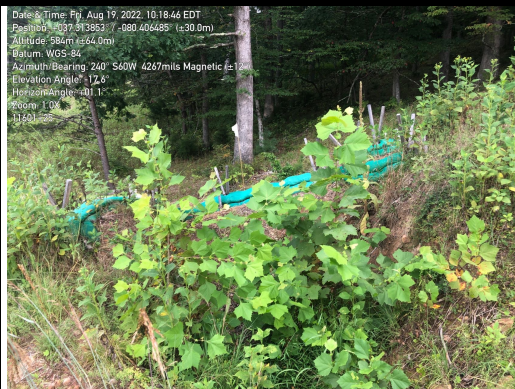
<b>GPS Location</b>	On photo
<b>Field Station#</b>	11601+50
<b>Pic 11 Desc.</b>	ROW stable. No issues caused by runoff.
