Visual Site Inspection Report

Project Name H-600 Pipeline Spread G		AFE 124300137	Spread H-600 Pipeline Spread G
Contractor Precision		Report # 40724	
Inspector Joe Sweeden		Date/Time 8/8/2022 6:53 AM	
Permit # TBD	Inspection Type VA SWPP	Station Begin 11254+99	
State VA	Inspection Area Partial	Station End 11353+67	
County Giles	Ground Wet	Temperature (°F) 80.00	
Municipality N/A	Weather Cloudy	Rain Gauge (in) 0.40	
			Rain Accumulation Time (days) 1.00

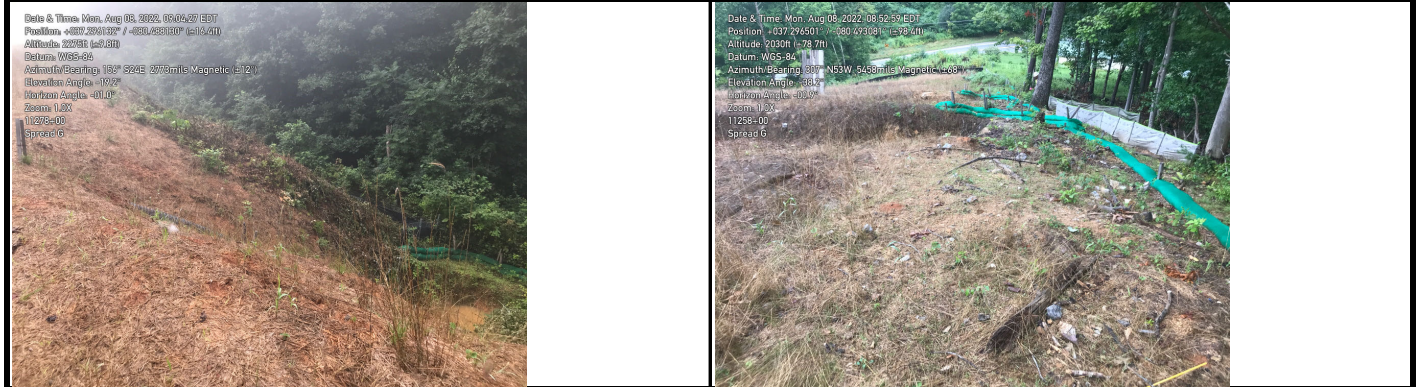
GPS Location	See photo	GPS Location	see photo
Field Station#	11278+00	Field Station#	11258+00
Pic 7 Desc.	Cut vegetation	Pic 8 Desc.	Sumps/water bars/end treatments

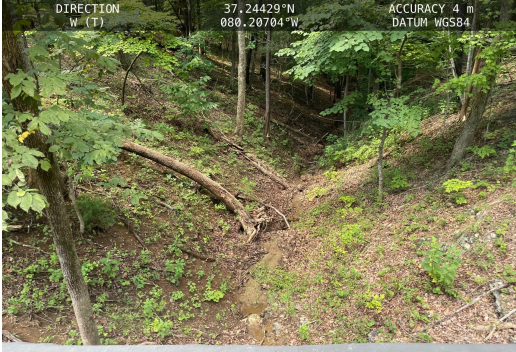
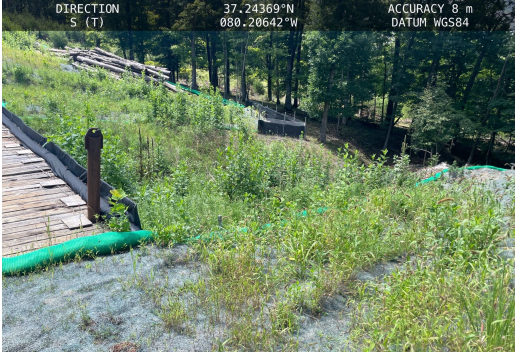
<p>DIRECTION S (T) 37.24369°N 080.20642°W ACCURACY 8 m DATUM WGS84</p> <p>12382+00 Drainage feature 8/8/22, 12:10:02 PM</p>			
GPS Location	See photo		GPS Location	See photo	
Field Station#	12380+04		Field Station#	12382+00	
Pic 13 Desc.	Downstream of crossing at Stream S-NN19		Pic 14 Desc.	Drainage feature is functional

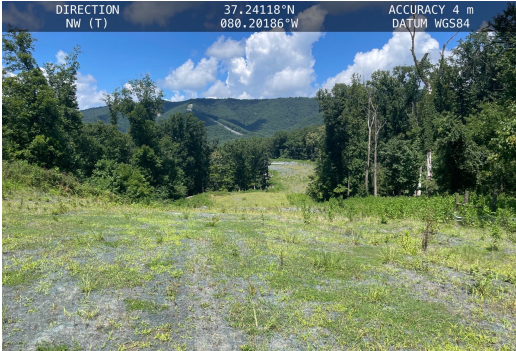
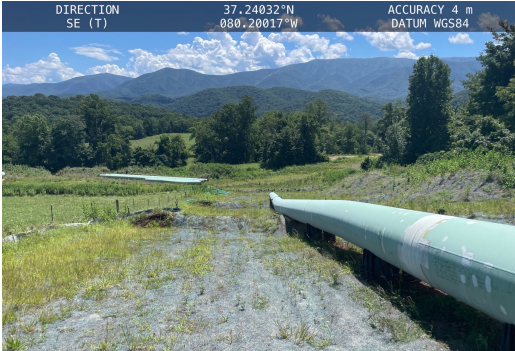
<p>DIRECTION SE (T) 37.24032°N 080.20017°W ACCURACY 4 m DATUM WGS84</p> <p>12407+00 ROW 8/8/22, 12:22:17 PM</p>			
GPS Location	See photo		GPS Location	See photo	
Field Station#	12398+00		Field Station#	12407+00	
Pic 15 Desc.	Current ROW conditions. ROW is stable and ECDs are functional.		Pic 16 Desc.	Current ROW conditions. ROW is stable and ECDs are functional.

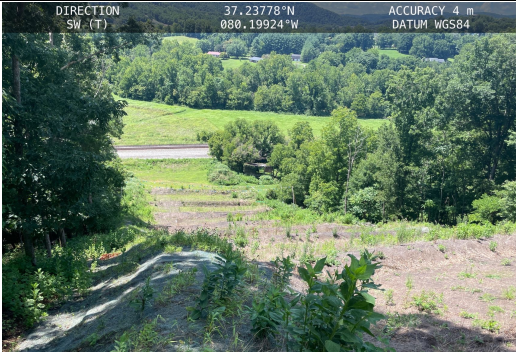
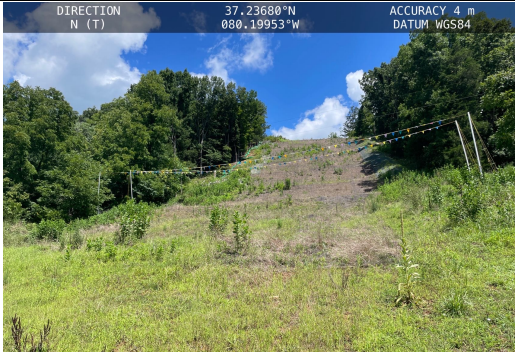
<p>DIRECTION N (T) 37.23680°N 080.19953°W ACCURACY 4 m DATUM WGS84</p> <p>12420+00 ROW 8/8/22, 12:29:46 PM</p>			
GPS Location	See photo		GPS Location	See photo	
Field Station#	12417+00		Field Station#	12420+00	
Pic 17 Desc.	Current ROW conditions. ROW is stable and ECDs are functional.		Pic 18 Desc.	Current ROW conditions. ROW is stable and ECDs are functional.

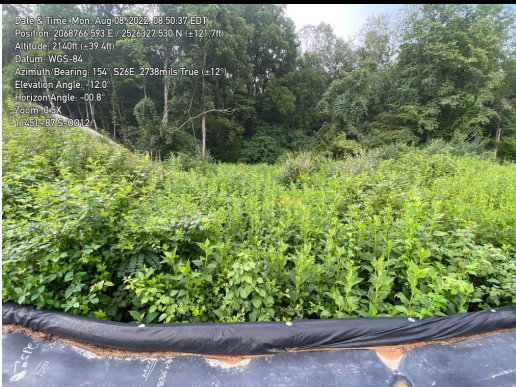
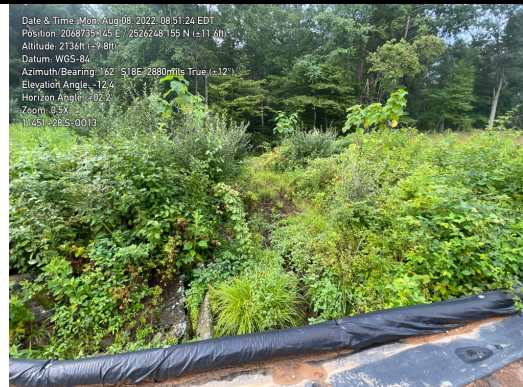
GPS Location	3		GPS Location	4	
Field Station#	11452+87		Field Station#	11451+28	
Pic 3 Desc.	S-0012.		Pic 4 Desc.	S-0013.

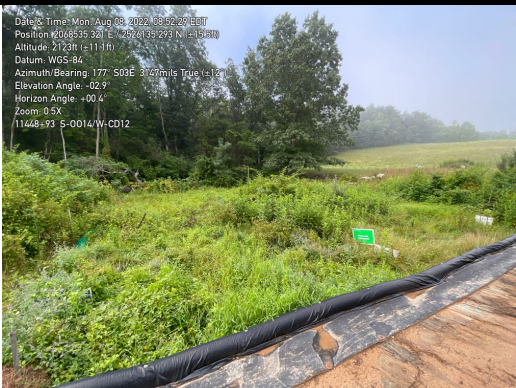
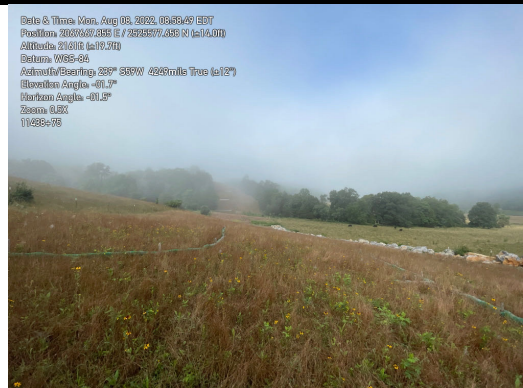
GPS Location	5		GPS Location	6	
Field Station#	11448+93		Field Station#	11438+75	
Pic 5 Desc.	S-0014/W-CD12.		Pic 6 Desc.	Section of restored RoW showing conditions and controls.

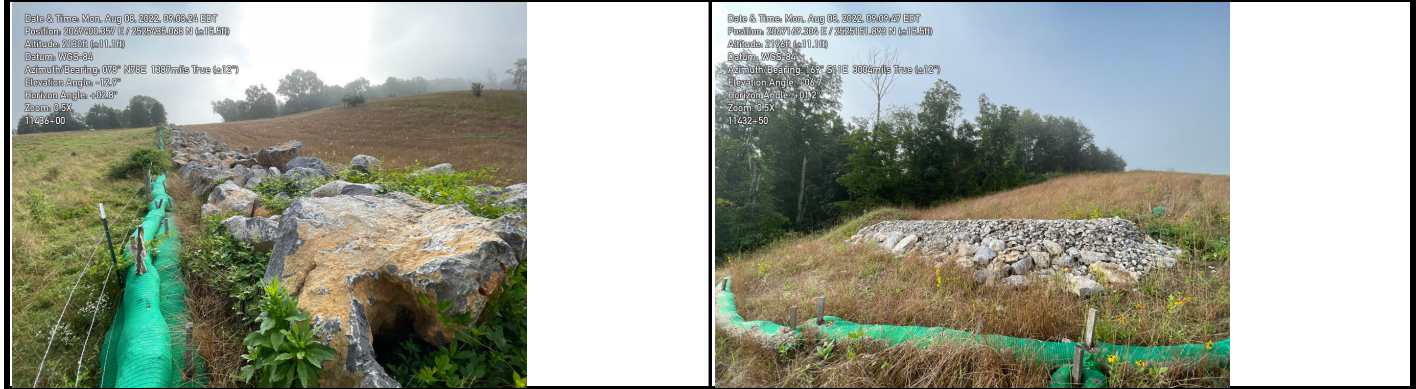
GPS Location	7	GPS Location	8
Field Station#	11436+00	Field Station#	11432+50
Pic 7 Desc.	Perimeter controls functional.	Pic 8 Desc.	Representative photo of permanent waterbar and level spreaders installed.

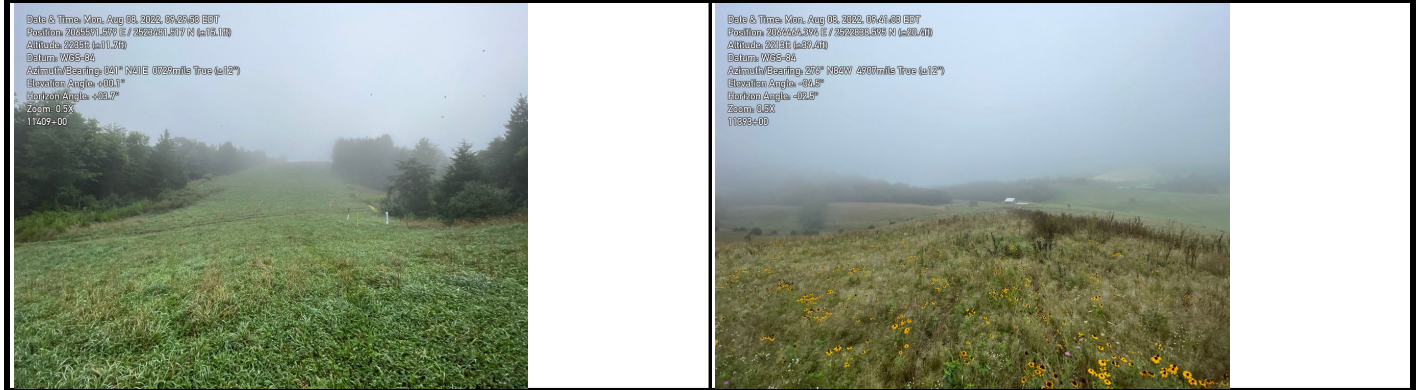
GPS Location	9	GPS Location	10
Field Station#	11409+00	Field Station#	11393+00
Pic 9 Desc.	Section of restored RoW showing conditions and controls.	Pic 10 Desc.	Section of restored RoW showing conditions and controls.

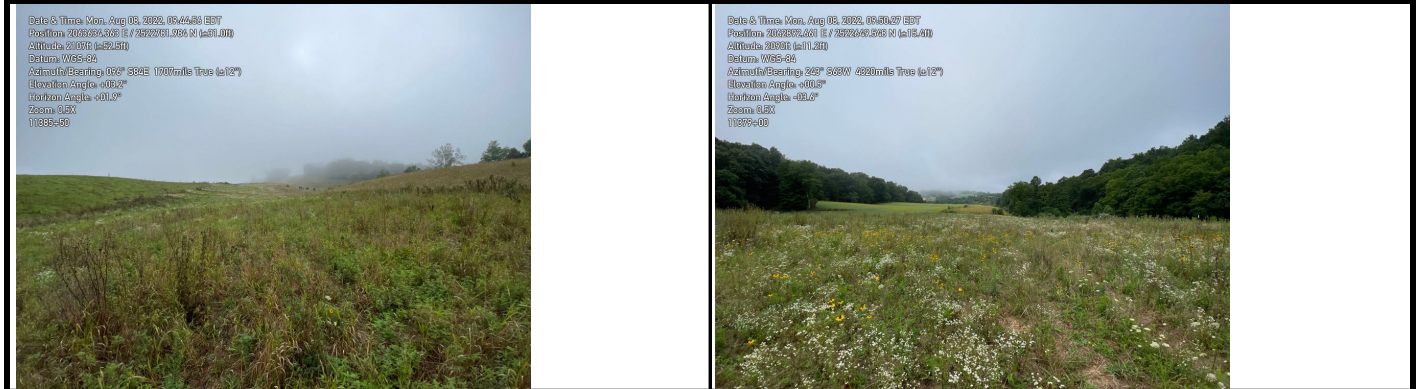
GPS Location	11	GPS Location	12
Field Station#	11385+50	Field Station#	11379+00
Pic 11 Desc.	Section of restored RoW showing conditions and controls.	Pic 12 Desc.	Section of restored RoW showing conditions and controls.

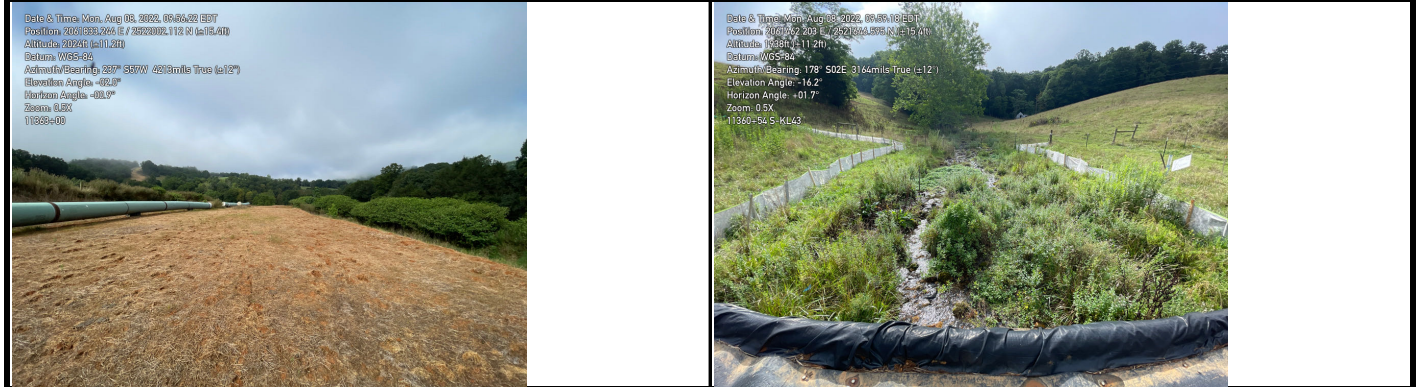
GPS Location 13	GPS Location 14
Field Station# 11363+00	Field Station# 11360+54
Pic 13 Desc. Section of RoW showing conditions and controls.	Pic 14 Desc. S-KL43.

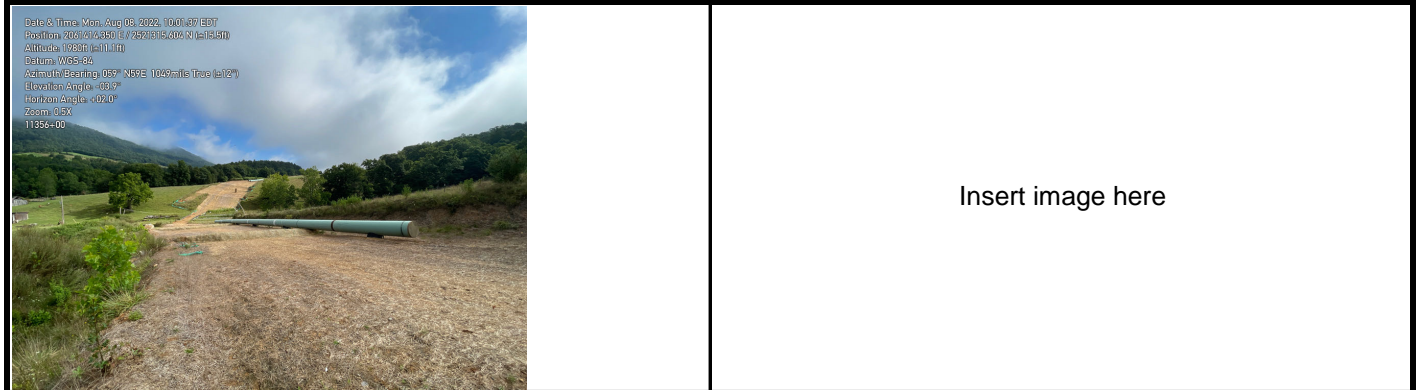
GPS Location 15	GPS Location
Field Station# 11356+00	Field Station#
Pic 15 Desc. Section of RoW showing conditions and controls.	Pic 16 Desc.

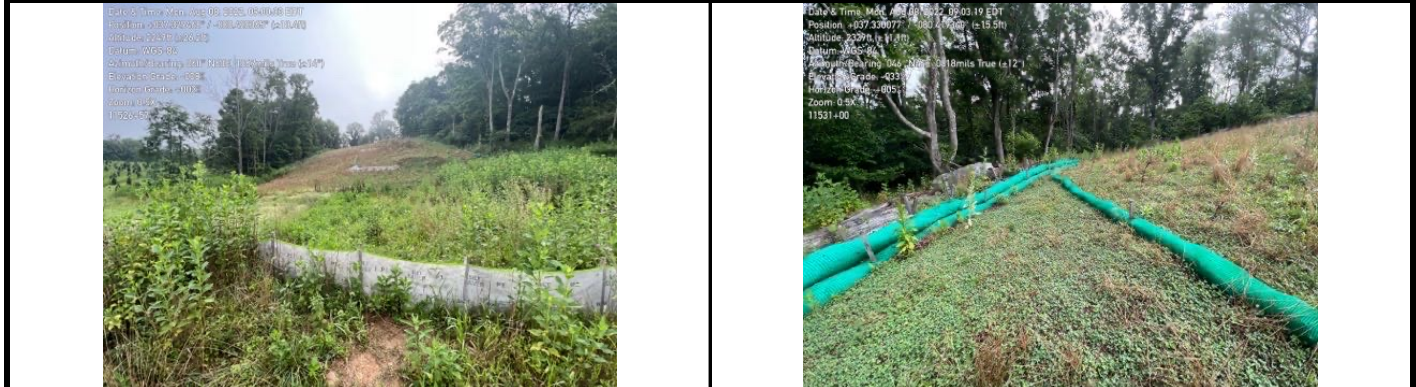
GPS Location	On photo	GPS Location	On photo
Field Station#	11526+57	Field Station#	11531+00
Pic 1 Desc.	ROW stable and ECDs in place. No erosion occurring.	Pic 2 Desc.	ROW stable with no erosion.

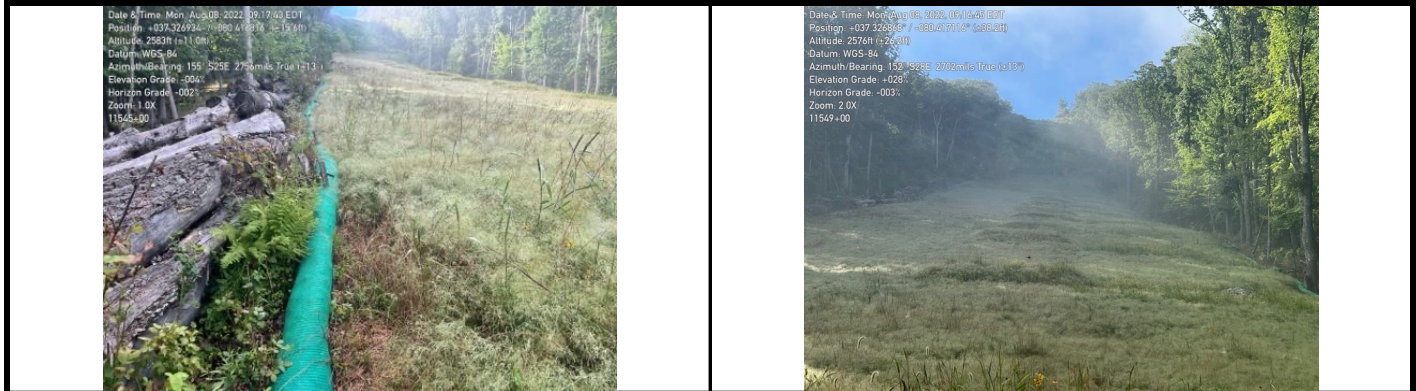
GPS Location	On photo	GPS Location	On photo
Field Station#	11545+00	Field Station#	11549+00
Pic 3 Desc.	ROW is stable. No erosion.	Pic 4 Desc.	ROW well vegetated with ECDs in place.

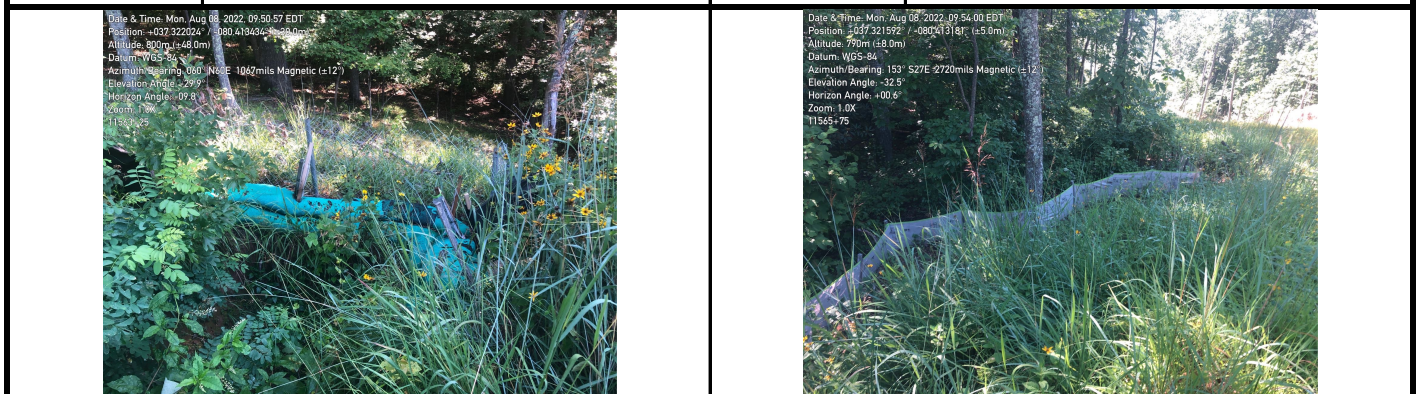
GPS Location	On photo	GPS Location	On photo
Field Station#	11563+25	Field Station#	11565+75
Pic 5 Desc.	No erosion occurring at sumps.	Pic 6 Desc.	Well vegetated ROW and ECDs in place.

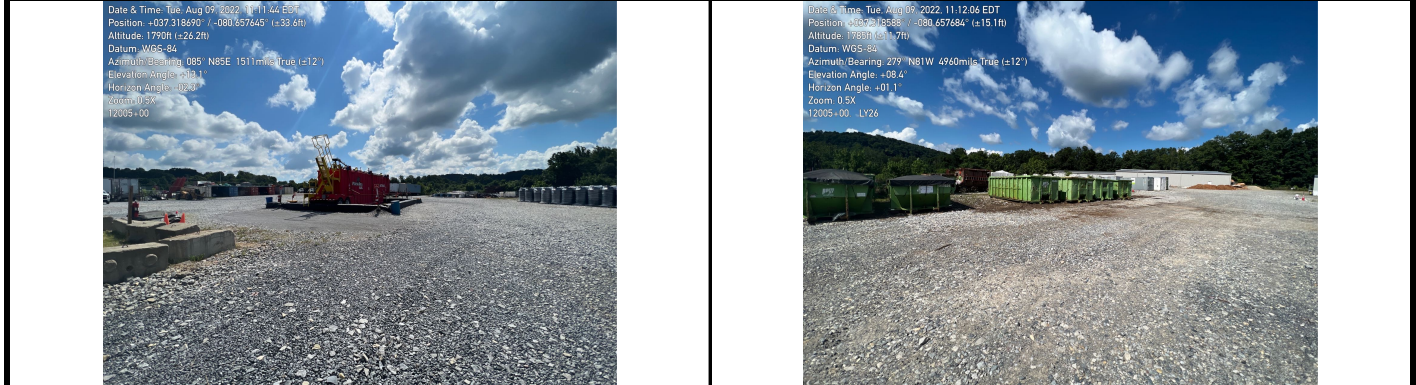
GPS Location	See Photo	GPS Location	See Photo
Field Station#	12005+00	Field Station#	12005+00
Pic 1 Desc.	Fuel cell and secondary containment	Pic 2 Desc.	Trash containers and housekeeping

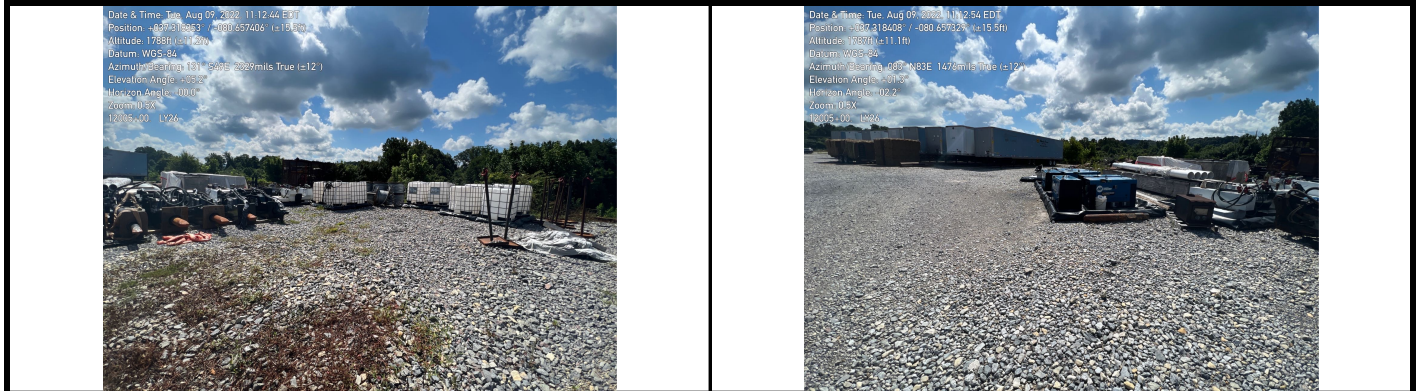
GPS Location	See Photo	GPS Location	See Photo
Field Station#	12005+00	Field Station#	12005+00
Pic 3 Desc.	Secondary Containment	Pic 4 Desc.	Secondary Containment

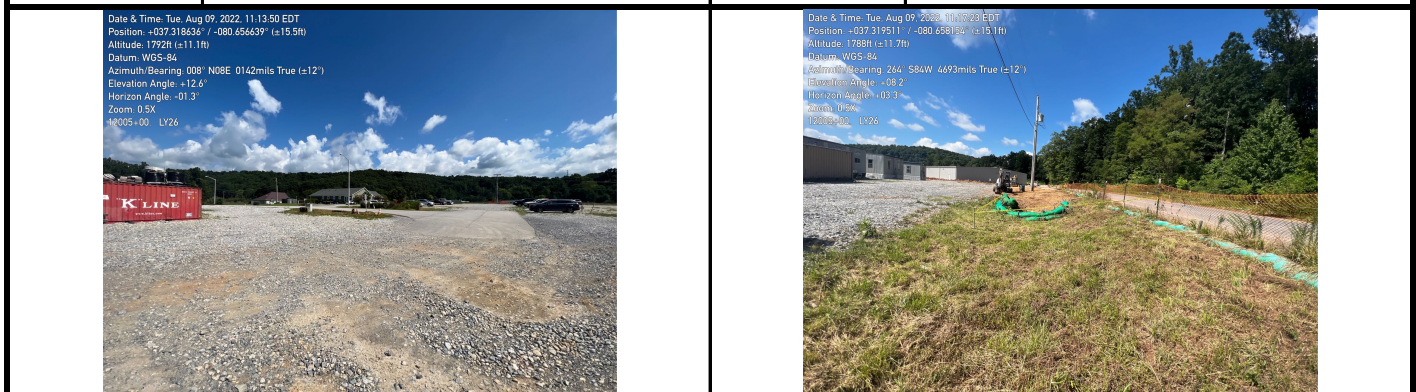
GPS Location	See Photo	GPS Location	See Photo
Field Station#	12005+00	Field Station#	12005+00
Pic 5 Desc.	RCE	Pic 6 Desc.	Perimeter controls

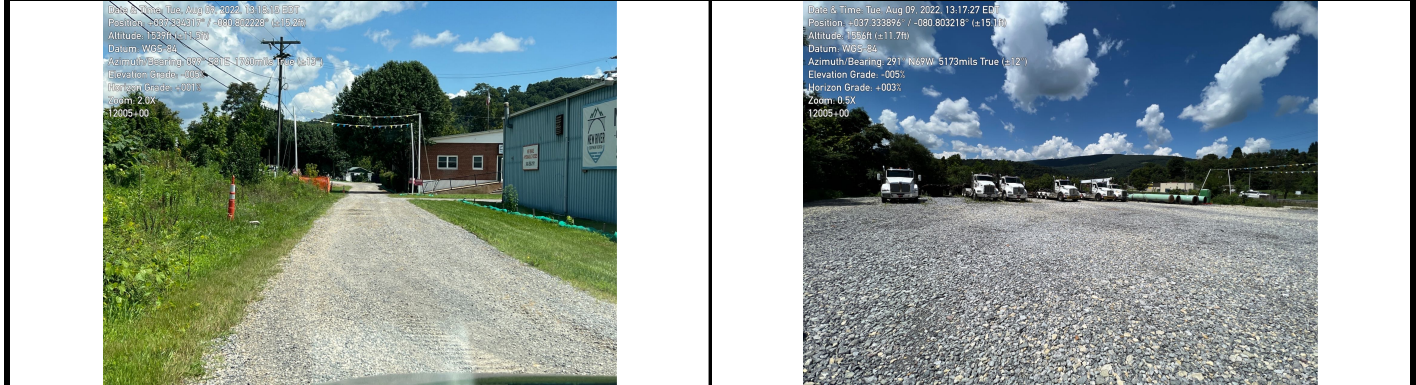
Pic 1 Desc.	RCE to LY028. No Issues at this time.	Pic 2 Desc.	RCE and Truck storage area.
--------------------	---------------------------------------	--------------------	-----------------------------

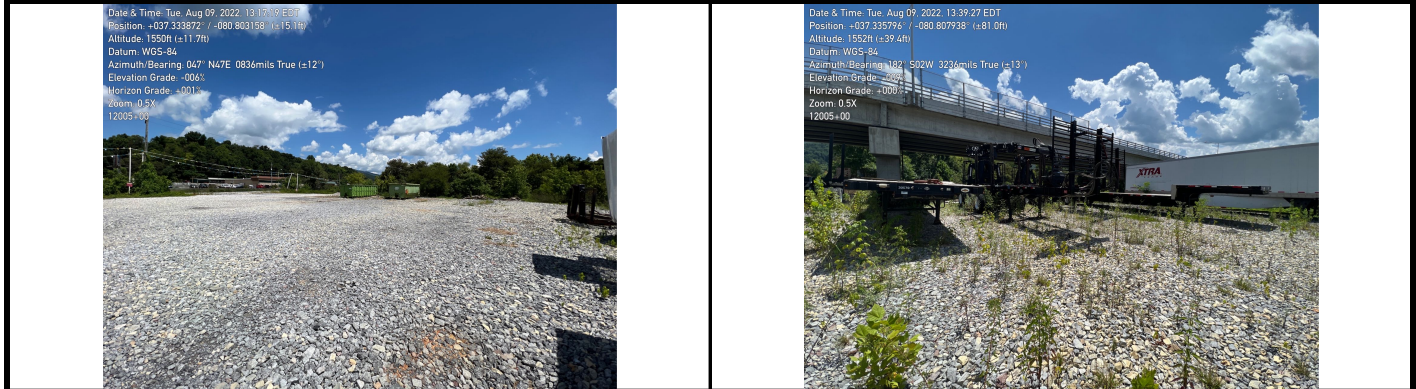
Pic 3 Desc.	RCE and trash receptacle area. No Issues at this time.	Pic 4 Desc.	Logging trailers and float trailer storage area.
--------------------	--	--------------------	--

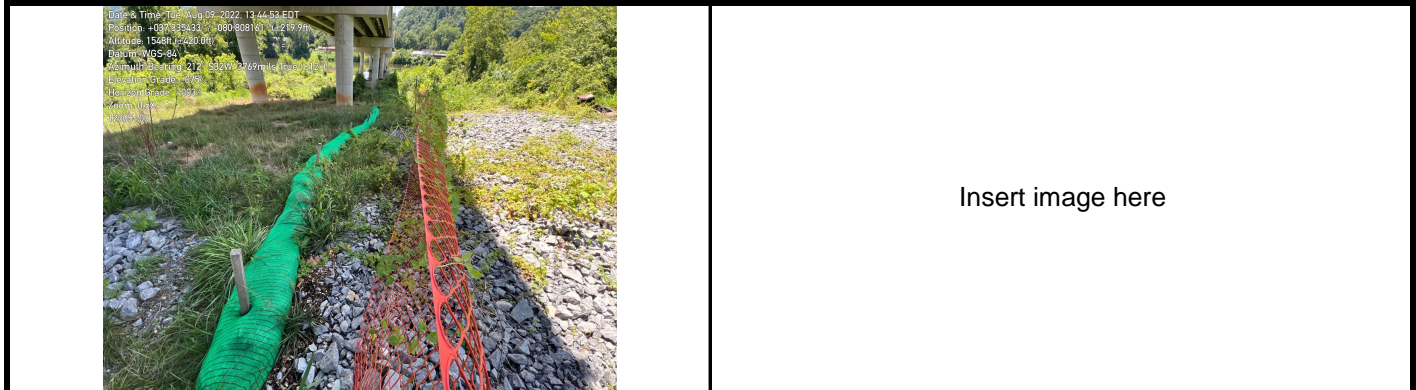
Pic 5 Desc.	Perimeter CFS controls found functional.	Pic 6 Desc.	
--------------------	--	--------------------	--

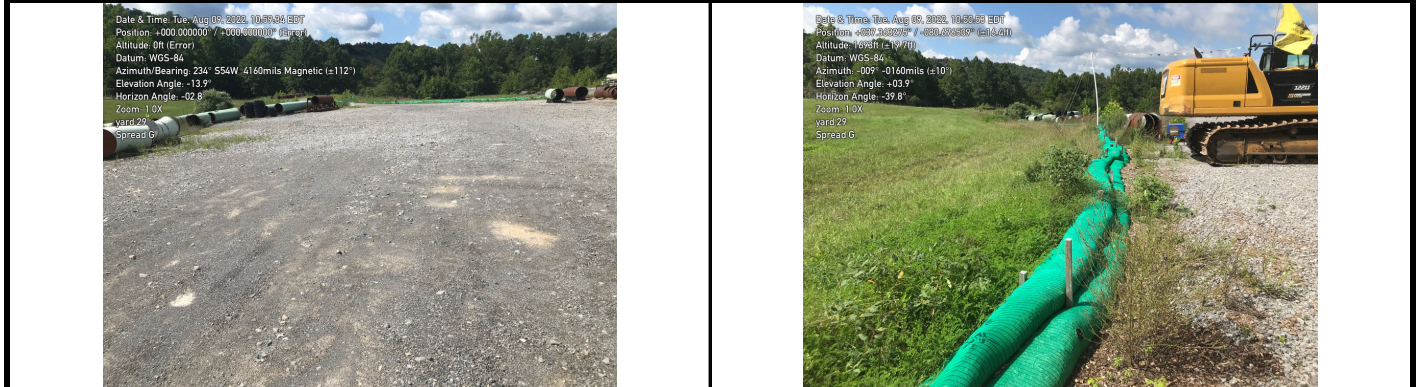
GPS Location	See photo	GPS Location	see photo
Field Station#	12005+00	Field Station#	12005+00
Pic 1 Desc.	Yard 29	Pic 2 Desc.	Vegetation

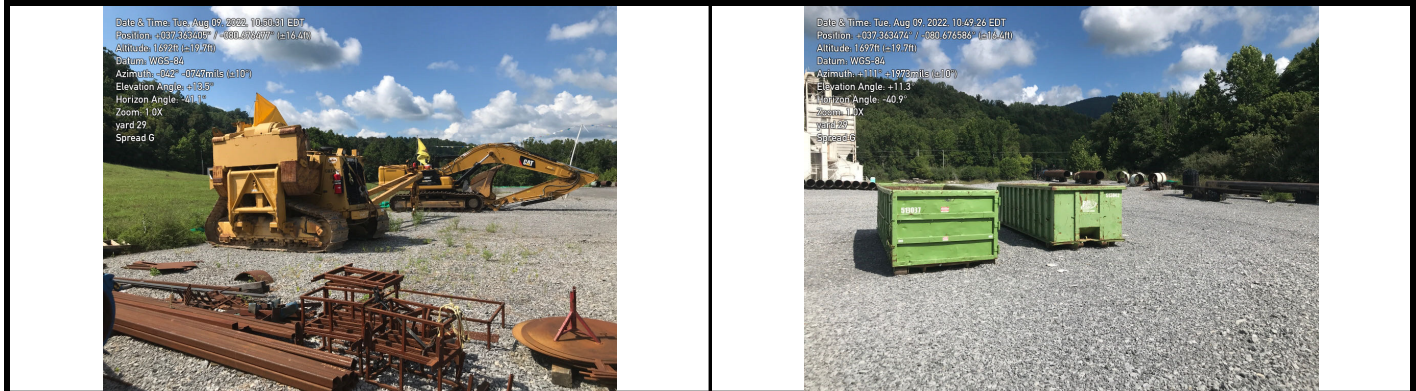
GPS Location	see photo	GPS Location	see photo
Field Station#	12005+00	Field Station#	12005+00
Pic 3 Desc.	Equipment	Pic 4 Desc.	Waste management

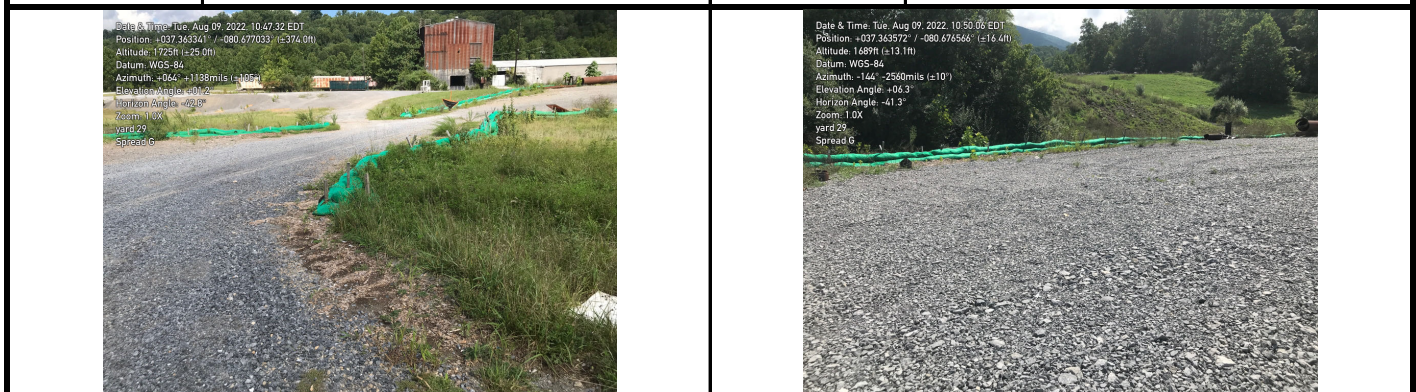
GPS Location	see photo	GPS Location	see photo
Field Station#	12005+00	Field Station#	12005+00
Pic 5 Desc.	Compost sock	Pic 6 Desc.	Compost sock

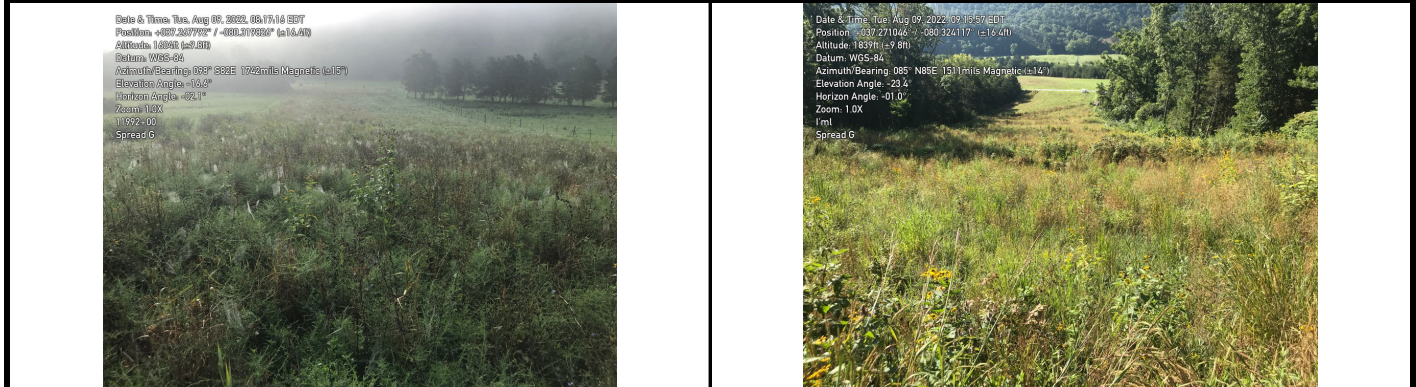
Pic 1 Desc.	Restored ROW	Pic 2 Desc.	Water bars
--------------------	--------------	--------------------	------------

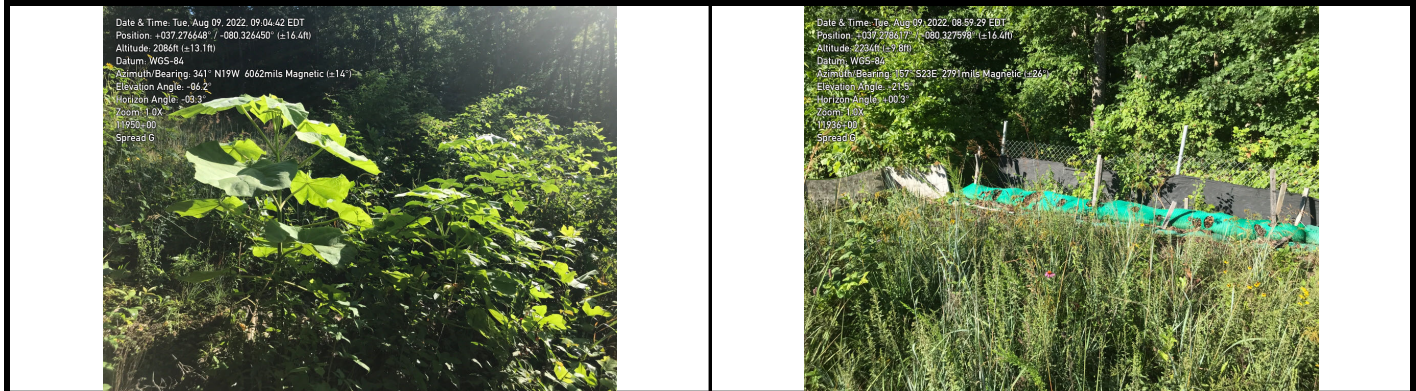
Pic 3 Desc.	Tall trees and brush	Pic 4 Desc.	Compost sock/super silt
--------------------	----------------------	--------------------	-------------------------

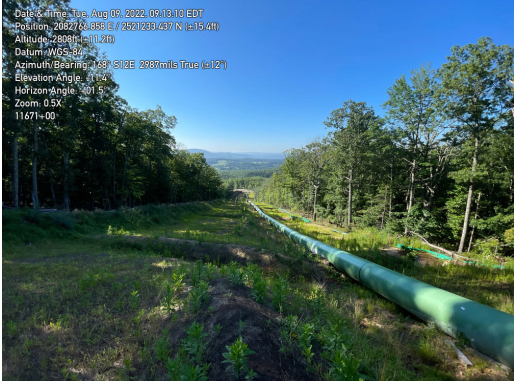
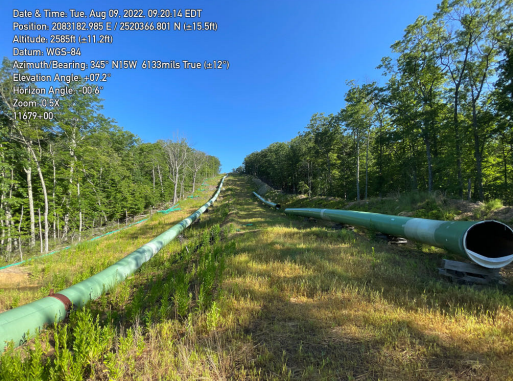
GPS Location 1		GPS Location 2			
Field Station# 11671+00		Field Station# 11679+00			
Pic 1 Desc. Section of RoW showing conditions and controls.		Pic 2 Desc. Section of RoW showing conditions and controls.

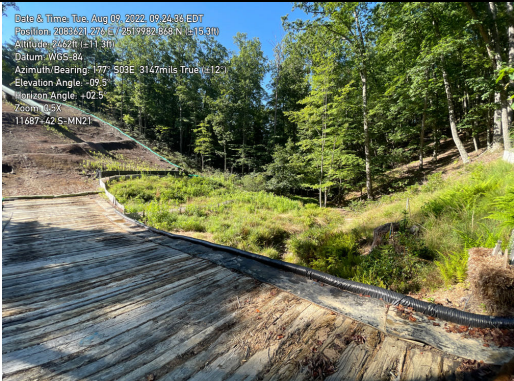
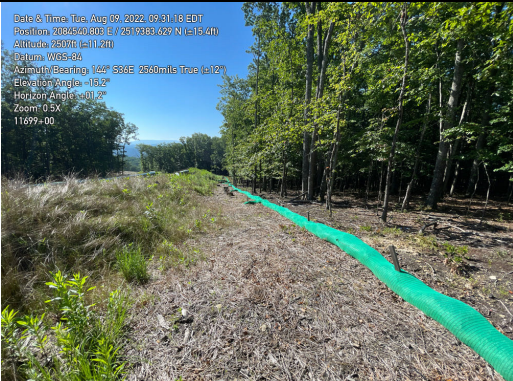
GPS Location 3		GPS Location 4			
Field Station# 11687+42		Field Station# 11699+00			
Pic 3 Desc. Overview S-MN21.		Pic 4 Desc. Perimeter controls functional.

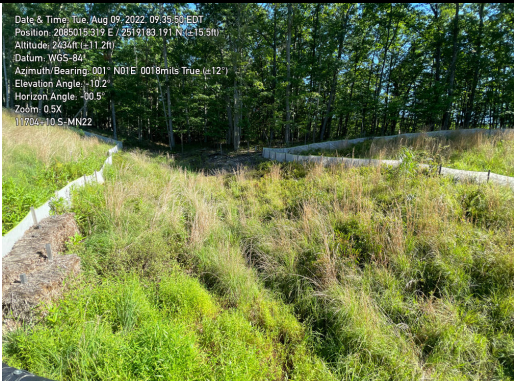
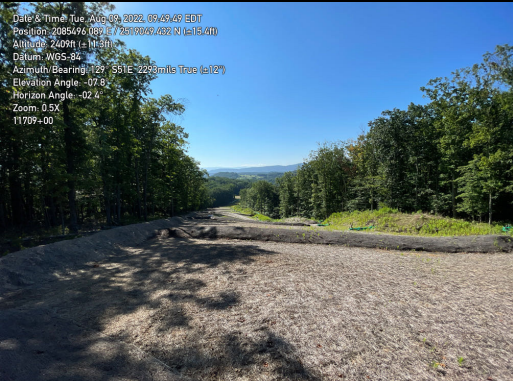
GPS Location 5		GPS Location 6			
Field Station# 11704+10		Field Station# 11709+00			
Pic 5 Desc. S-MN22.		Pic 6 Desc. Section of RoW showing conditions and controls.

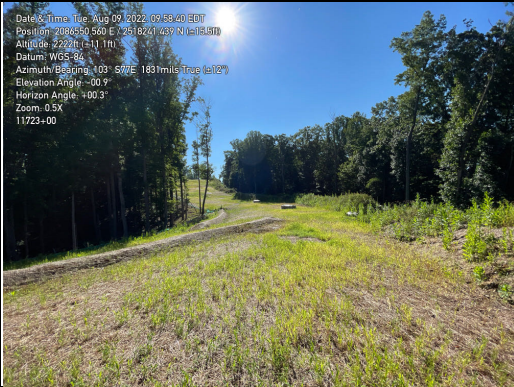
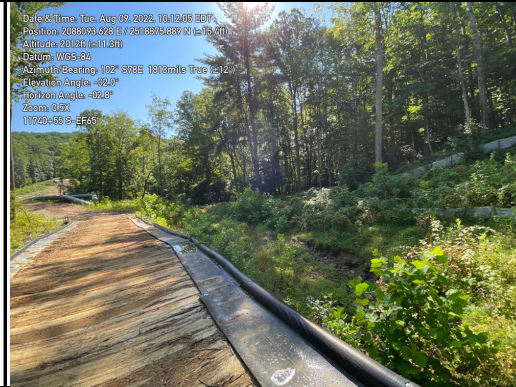
GPS Location	7	GPS Location	8
Field Station#	11723+00	Field Station#	11740+55
Pic 7 Desc.	Section of RoW showing conditions and controls.	Pic 8 Desc.	Overview of S-EF65.

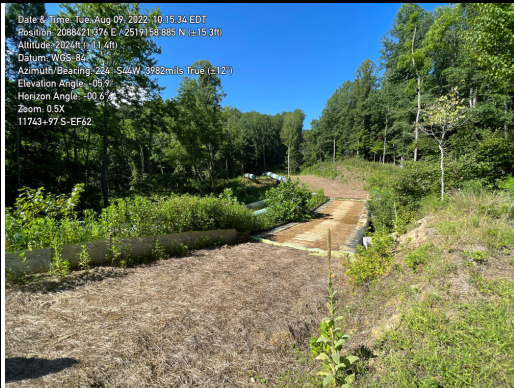
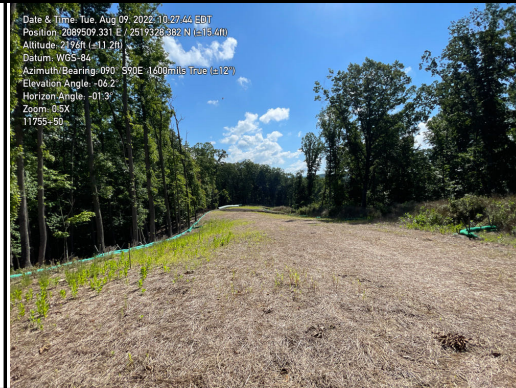
GPS Location	9	GPS Location	10
Field Station#	11743+97	Field Station#	11755+50
Pic 9 Desc.	Overview of S-EF62.	Pic 10 Desc.	Section of RoW showing conditions and controls.

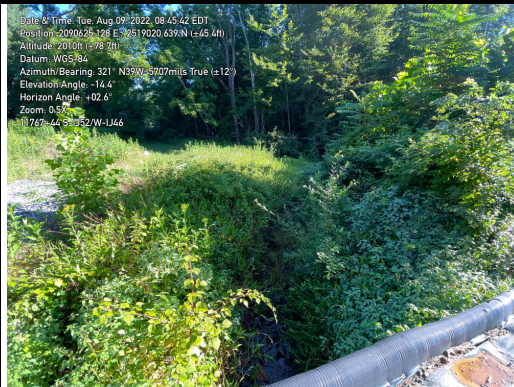
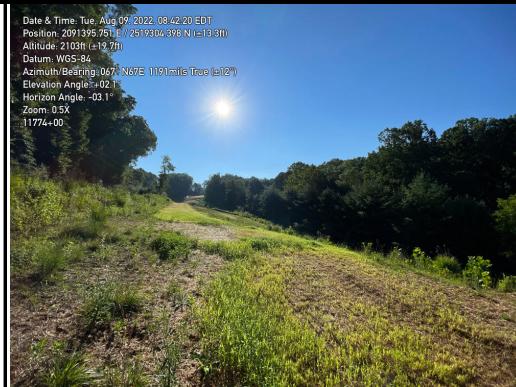
GPS Location	11	GPS Location	12
Field Station#	11767+44	Field Station#	11774+00
Pic 11 Desc.	S-IJ52/W-IJ46.	Pic 12 Desc.	Section of RoW showing conditions and controls.

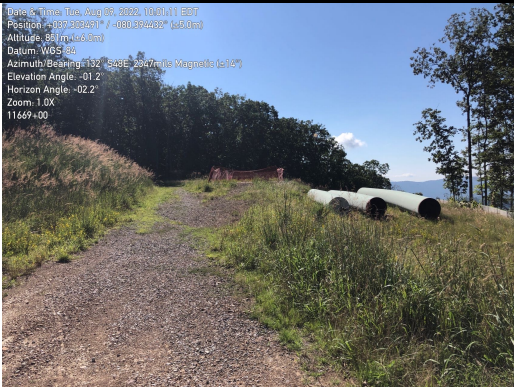
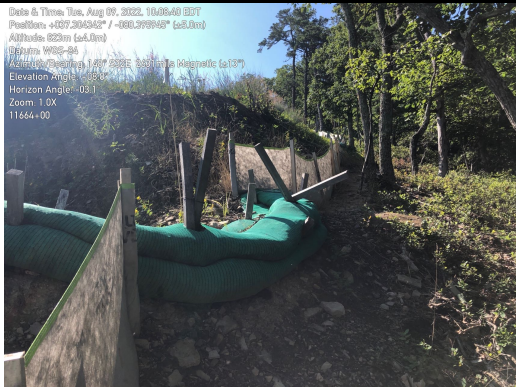
<p><small>Date & Time: Tue, Aug 09, 2022, 10:05:40 EDT Position: +037.394267° / +80.394629° (±5.0m) Altitude: 823m (±6.0m) Datum: WGS 84 Azimuth/Bearing: 137.558E 3347mils Magnetic (±10°) Elevation Angle: -00.8 Horizon Angle: -03.1 Zoom: 1.0x 11664+00</small></p>	
GPS Location	On photo		GPS Location	On photo	
Field Station#	11669+00		Field Station#	11664+00	
Pic 1 Desc.	Top of Brush Mountain is stable.		Pic 2 Desc.	ECDs along perimeter in acceptable condition.

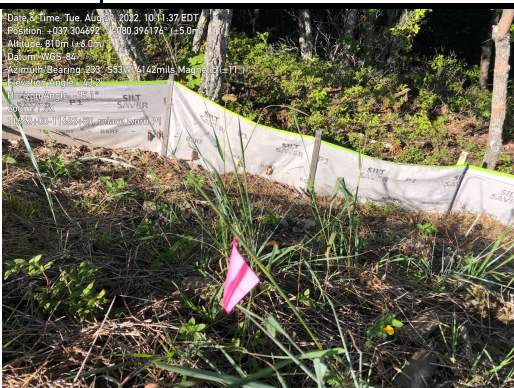
GPS Location	On photo		GPS Location	On photo	
Field Station#	11662+00		Field Station#	11660+00	
Pic 3 Desc.	COMMUNICATION; p1 silt fence in need of replacement from 11662+00 - 11662+50. The wooden stakes are broken or rotten.		Pic 4 Desc.	ROW stable. No issues from runoff. ECDs in place.

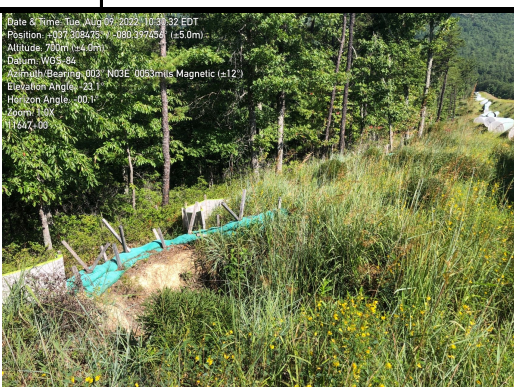
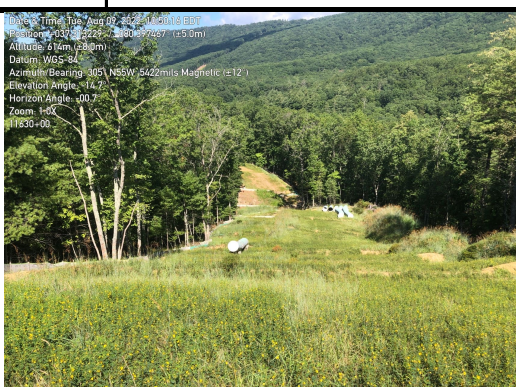
Pic 5 Desc.	Vegetation coverage very good. ECDs in place.		Pic 6 Desc.	ROW stable. Slope breakers functional. ECDs are in place.

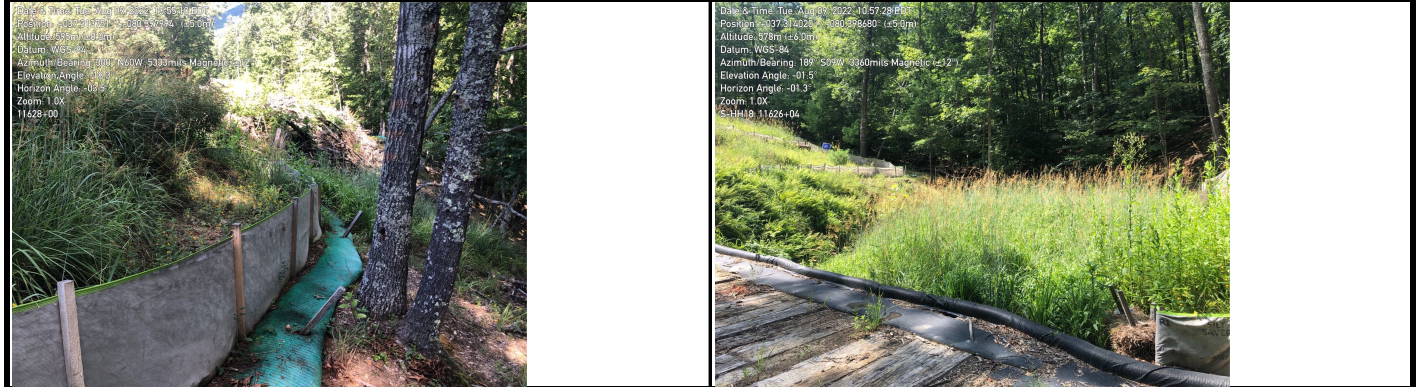
GPS Location	On photo	GPS Location	On photo
Field Station#	11628+00	Field Station#	11626+04
Pic 7 Desc.	ECDs functional.	Pic 8 Desc.	The S-HH18 crossing is currently stable. No impact occurring.

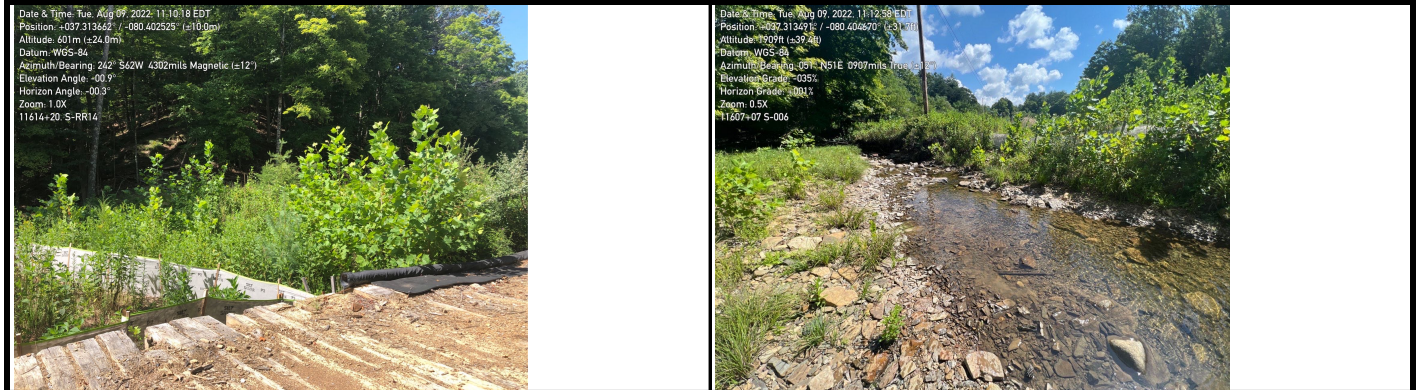
GPS Location	On photo	GPS Location	On photo
Field Station#	11614+20	Field Station#	11607+81
Pic 9 Desc.	The S-RR14 crossing is stable. No impact occurring.	Pic 10 Desc.	The S-006 crossing remains stable with no impact.

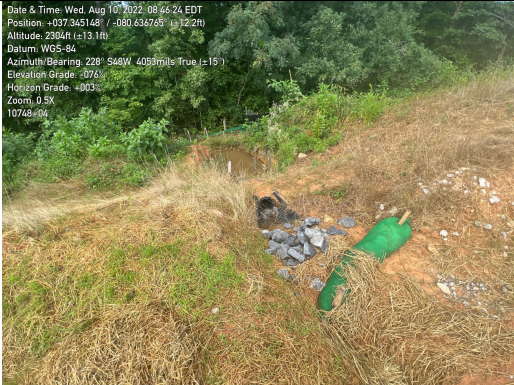
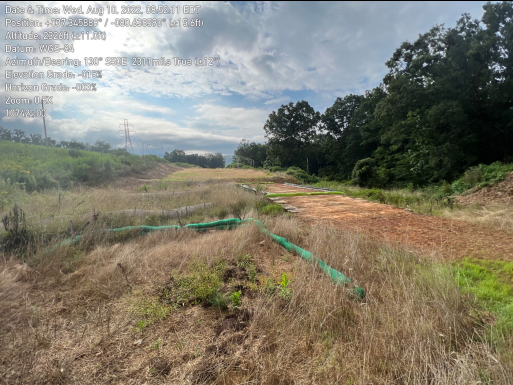
<p>Date & Time: Wed, Aug 10, 2022, 08:46:11 EDT Position: +037.345145° / -080.535765° (-12,21) Altitude: 2390ft (-13.1ft) Datum: WGS-84 Azimuth/Bearing: 130° 53W 300mils True (-13°) Elevation Grade: -076° Horizon Grade: +003° Zoom: 0.5X 10748+04</p>		<p>GPS Location See photo</p> <p>Field Station# 10748+04</p> <p>Pic 1 Desc. Stone inlet protection conditions.</p>		<p>GPS Location See photo</p> <p>Field Station# 10742+00</p> <p>Pic 2 Desc. Drainage feature and adequate vegetation conditions.</p>

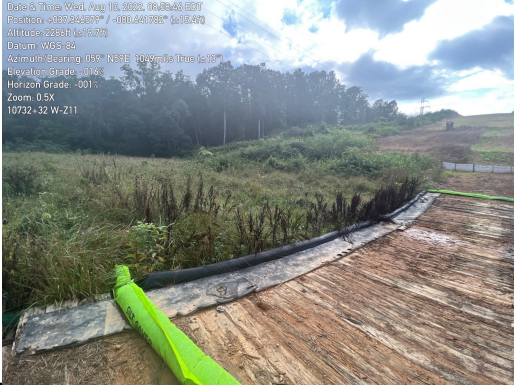
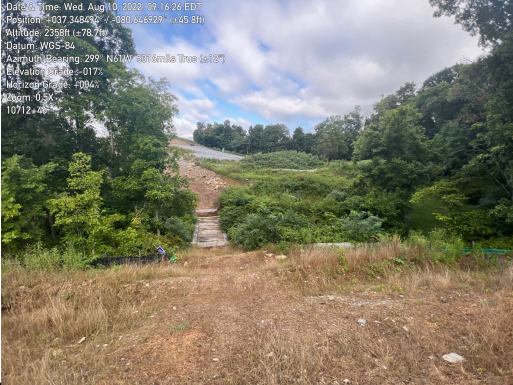
<p>Date & Time: Wed, Aug 10, 2022, 09:16:25 EDT Position: +037.345452° / -080.545929° (-12,21) Altitude: 2358ft (-7.8ft) Datum: WGS-84 Azimuth/Bearing: 239° N31W 800mils True (-15°) Elevation Grade: -017° Horizon Grade: +004° Zoom: 0.5X 10712+02</p>		<p>GPS Location See photo</p> <p>Field Station# 10732+32</p> <p>Pic 3 Desc. W-Z11 wetland. Equipment bridge found functional</p>		<p>GPS Location See photo</p> <p>Field Station# 10712+46</p> <p>Pic 4 Desc. S-G33 and vegetated buffer zones.</p>

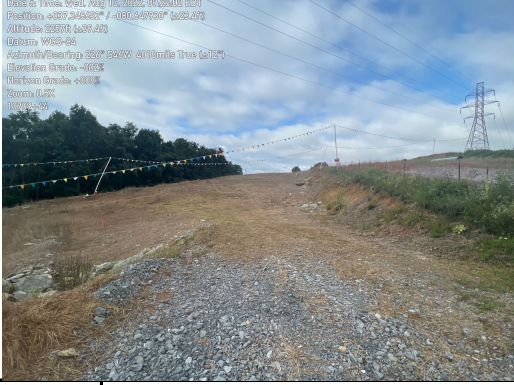
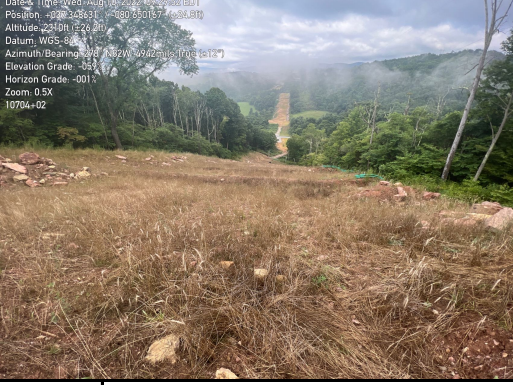
<p>Date & Time: Wed, Aug 10, 2022, 09:29:02 EDT Position: +037.345382° / -080.541707° (-12,21) Altitude: 2370ft (-9.9ft) Datum: WGS-84 Azimuth/Bearing: 330° 53W 401mils True (-15°) Elevation Grade: -002° Horizon Grade: +002° Zoom: 0.5X 10704+02</p>		<p>GPS Location See photo</p> <p>Field Station# 10709+44</p> <p>Pic 5 Desc. Temporary stabilization of row</p>		<p>GPS Location See photo</p> <p>Field Station# 10704+02</p> <p>Pic 6 Desc. Steep slope stabilization and temporary vegetation growth.</p>

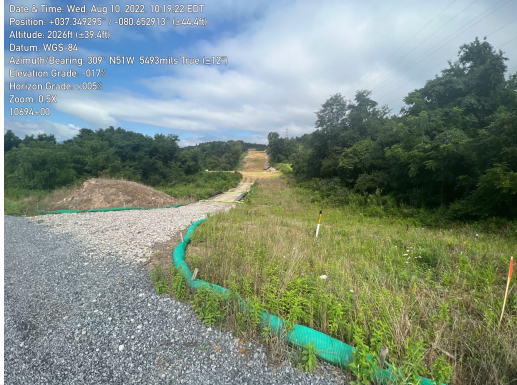
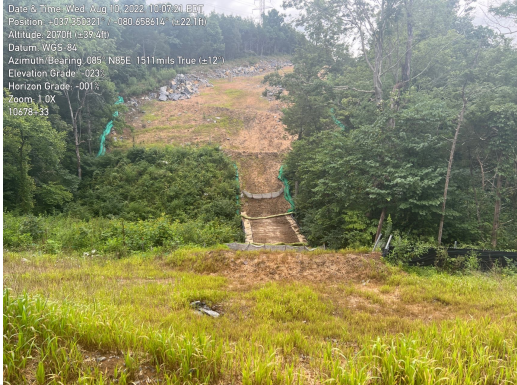
GPS Location	See photo	GPS Location	See photo		
Field Station#	10694+00	Field Station#	10678+33		
Pic 9 Desc.	AR at Buffalo anklets access and vegetated drainage features.		Pic 10 Desc.	S-G30 Stream resource conditions. Temporary stabilization of row also in view.

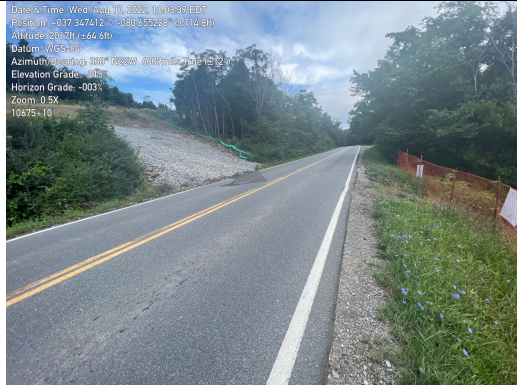
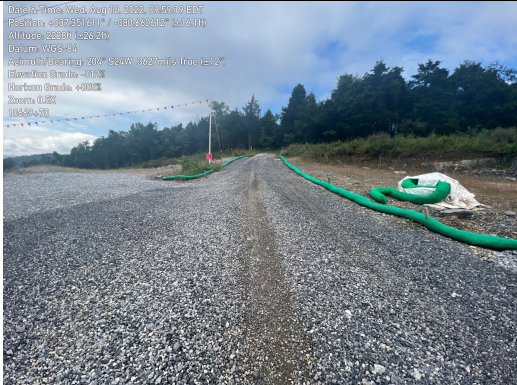
Pic 11 Desc.	Big Stoney Rd conditions at row crossing.		Pic 12 Desc.	AR (GI 240) conditions.

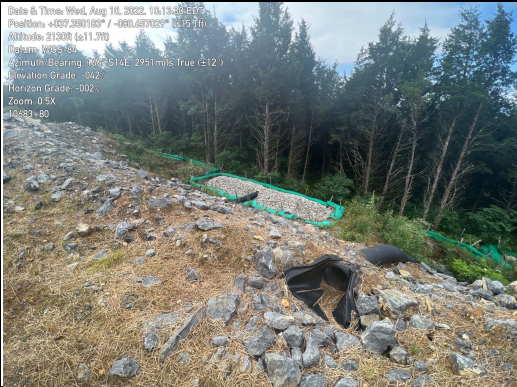
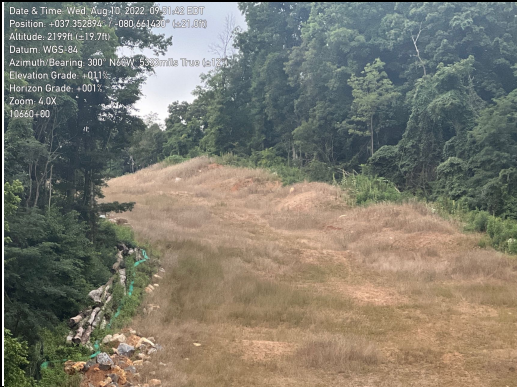
Pic 13 Desc.	Stone inlet protection and TLS conditions. No issues at this time.	Pic 14 Desc.	Temporary stabilization of row.
---------------------	--	---------------------	---------------------------------

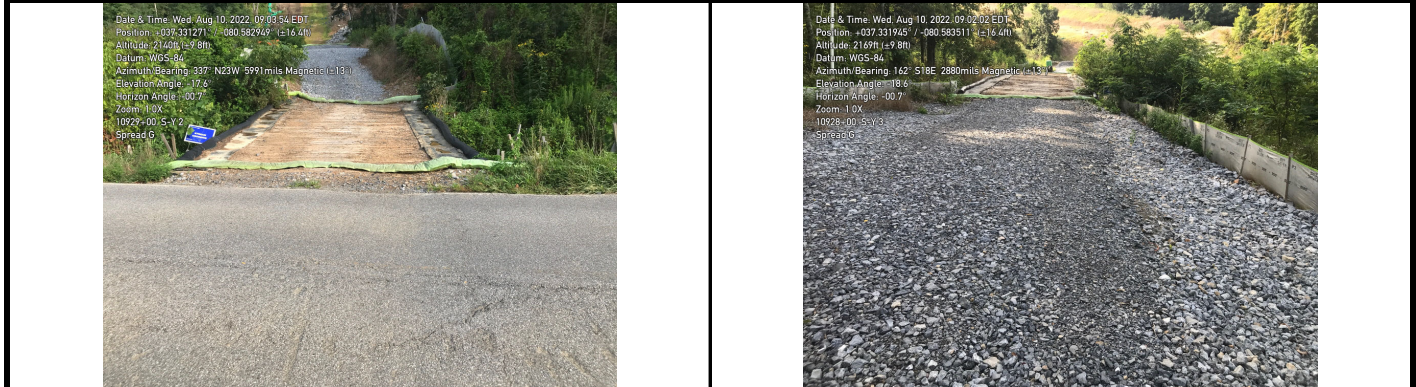
GPS Location	See photo	GPS Location	see photo
Field Station#	10929+00	Field Station#	10928+00
Pic 1 Desc.	Doe creek RCE, S-Y 2	Pic 2 Desc.	S-Y 3
