Visual Site Inspection Report

Project Name H-600 Pipeline Spread G		AFE 124300137	Spread H-600 Pipeline Spread G
Contractor Precision		Report # 40724	
Inspector Joe Sweeden		Date/Time 8/8/2022 6:53 AM	
Permit # TBD	Inspection Type VA SWPP	Station Begin 11254+99	
State VA	Inspection Area Partial	Station End 11353+67	
County Giles	Ground Wet	Temperature (°F) 80.00	
Municipality N/A	Weather Cloudy	Rain Gauge (in) 0.40	
			Rain Accumulation Time (days) 1.00

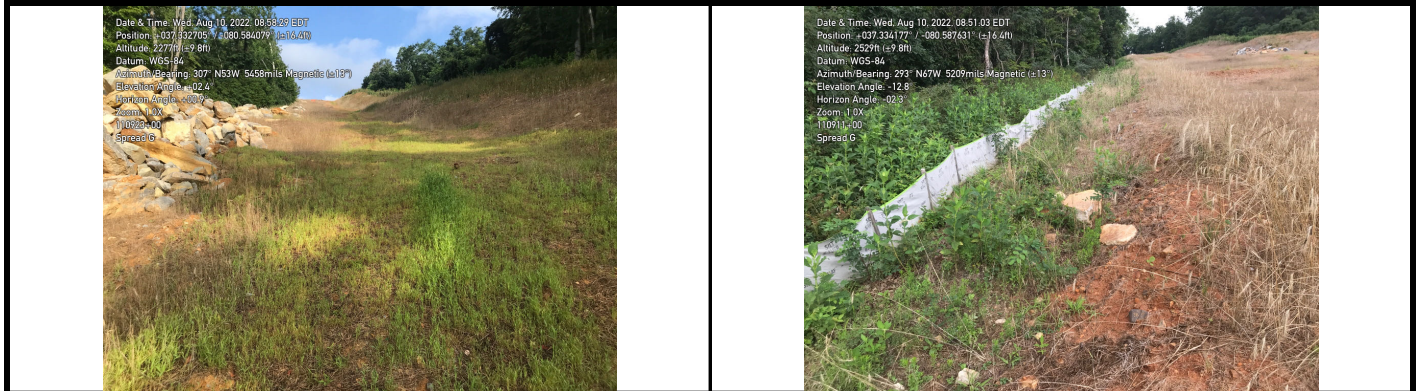
GPS Location	see photo	GPS Location	see photo
Field Station#	10923+00	Field Station#	10911+00
Pic 3 Desc.	Stabilized ROW	Pic 4 Desc.	P1, water bars

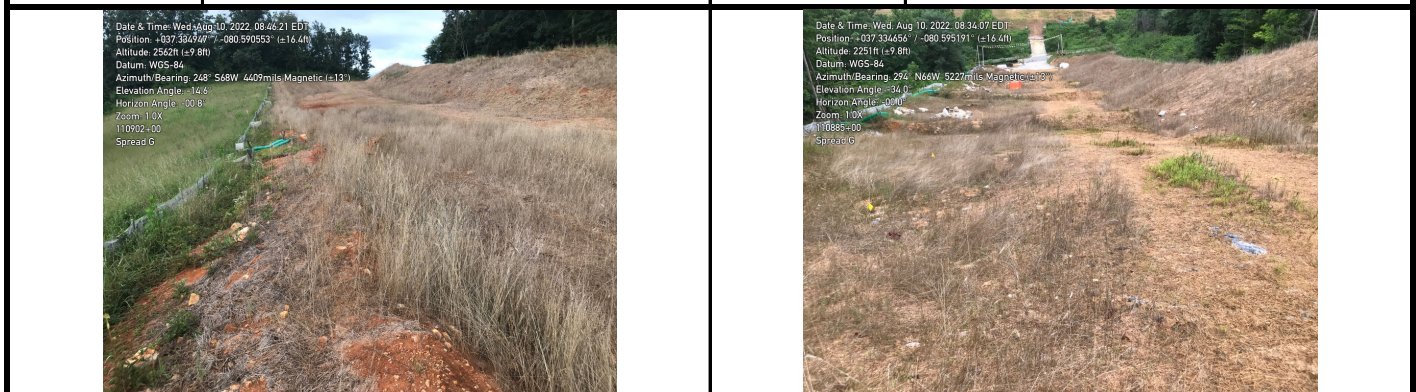
GPS Location	see photo	GPS Location	see photo
Field Station#	11902+00	Field Station#	11885+00
Pic 5 Desc.	P 1, perimeter controls, water bars	Pic 6 Desc.	Water bars, sumps

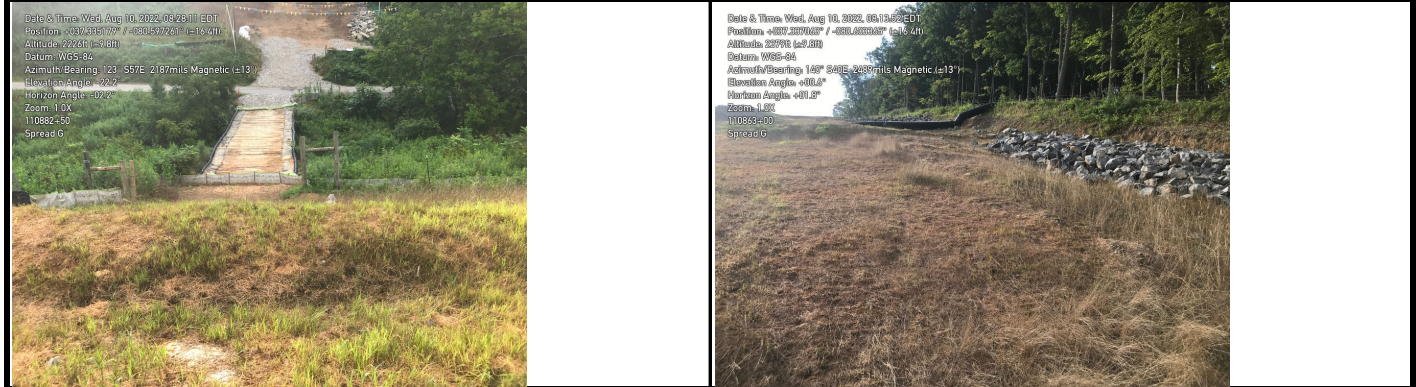
GPS Location	See photo	GPS Location	see photo
Field Station#	110882+50	Field Station#	10863+00
Pic 7 Desc.	Kow Camp, S-A 32	Pic 8 Desc.	Clean water diversion pipe

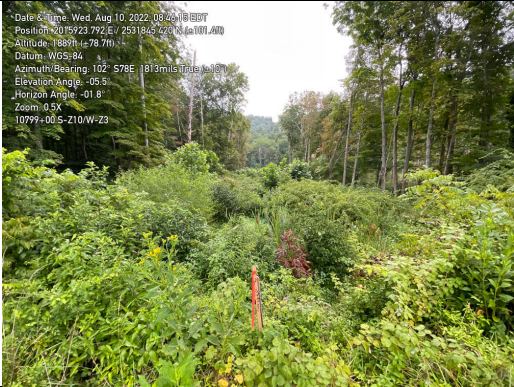
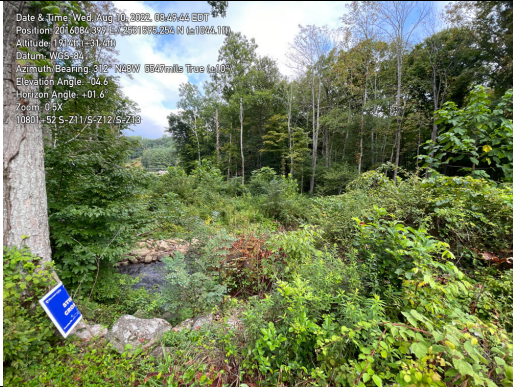
GPS Location 1		GPS Location 2		GPS Location 3			
Field Station# 10799+00		Field Station# 10801+52		Field Station# 10859+25			
Pic 1 Desc. S-Z10/W-Z3.		Pic 2 Desc. S-Z11/S-Z12/S-Z13.		Pic 3 Desc. Section of RoW showing conditions and controls.

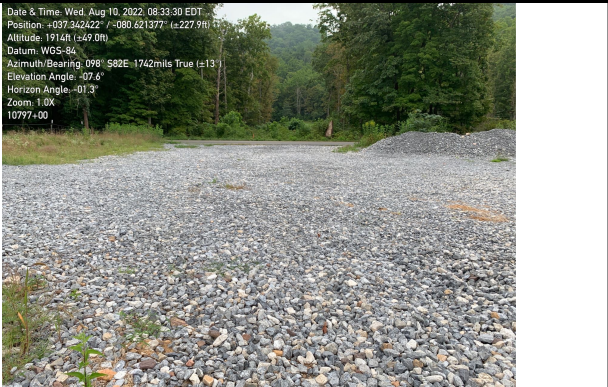
GPS Location	See photo for GPS location.		GPS Location	See photo for GPS location.	
Field Station#	10797+00		Field Station#	10791+00	
Pic 1 Desc.	RCE in place at Cascade Road crossing.		Pic 2 Desc.	Clean water diversion berm and clean water diversion pipe inlet in place.	
<p>Date & Time: Wed, Aug 10, 2022, 08:26:31 EDT Position: -037.344193 / -080.626354 (-15.7m) Altitude: 2107ft (-648.0m) Datum: WGS-84 Azimuth/Bearing: 049 N49E-0871mils True (+14) Elevation Angle: -08.2° Horizon Angle: -00.5° Zoom: 1.0x 10780+00</p>

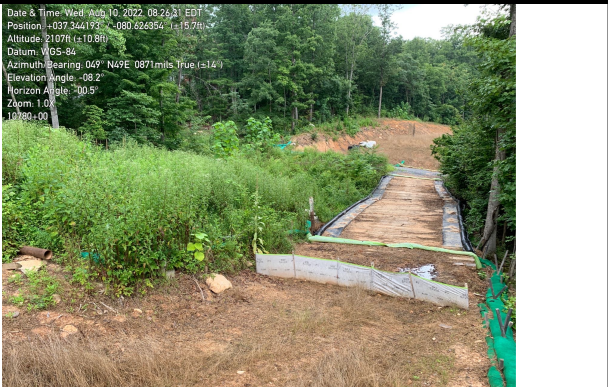
GPS Location	See photo for GPS location.		GPS Location	See photo for GPS location.	
Field Station#	10780+00		Field Station#	10762+00	
Pic 3 Desc.	Sensitive resource buffer in place S-Z7.		Pic 4 Desc.	Rock inlet in place at slope drain pipe inlet.	
<p>Date & Time: Wed, Aug 10, 2022, 08:15:57 EDT Position: -037.344743 / -080.633797 (-15.6m) Altitude: 2055ft (-626.0m) Datum: WGS-84 Azimuth/Bearing: 025 N65E-1173mils True (+17) Elevation Angle: -11.6° Horizon Angle: -02.2° Zoom: 1.0x 10758+00 S-G35</p>

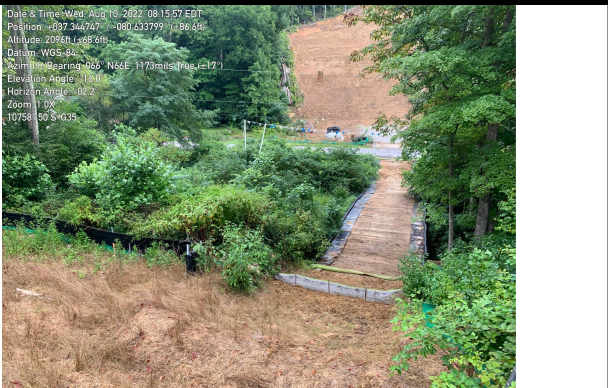
GPS Location	See photo for GPS location.		GPS Location	See photo for GPS location.	
Field Station#	10758+00		Field Station#	10753+00	
Pic 5 Desc.	Sensitive resource buffer in place at stream S-G35.		Pic 6 Desc.	Waterbars in place over steep slope.

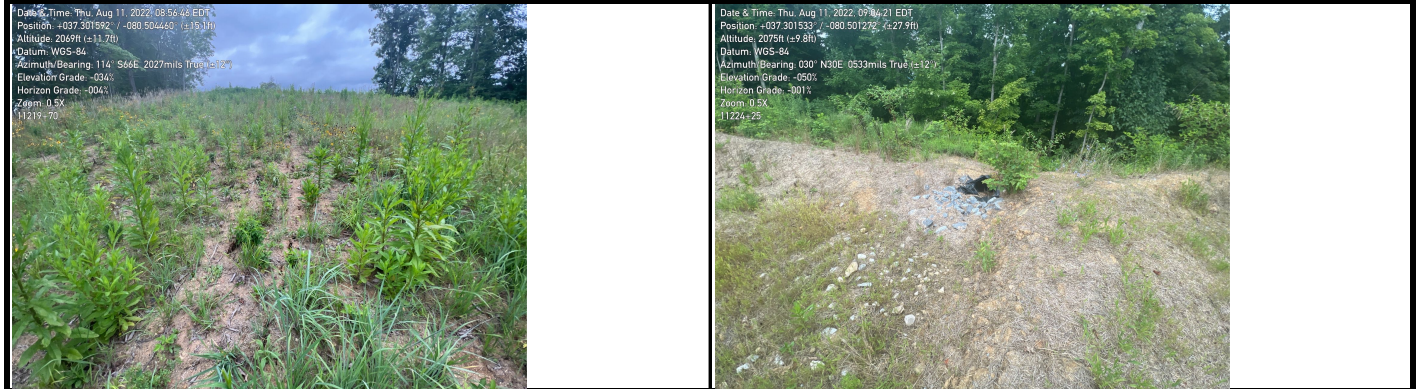
GPS Location	See photo	GPS Location	See photo
Field Station#	11219+70	Field Station#	11224+25
Pic 7 Desc.	Another sparse area in the final restoration.	Pic 8 Desc.	Stone inlet protection. Temporary stabilized area.

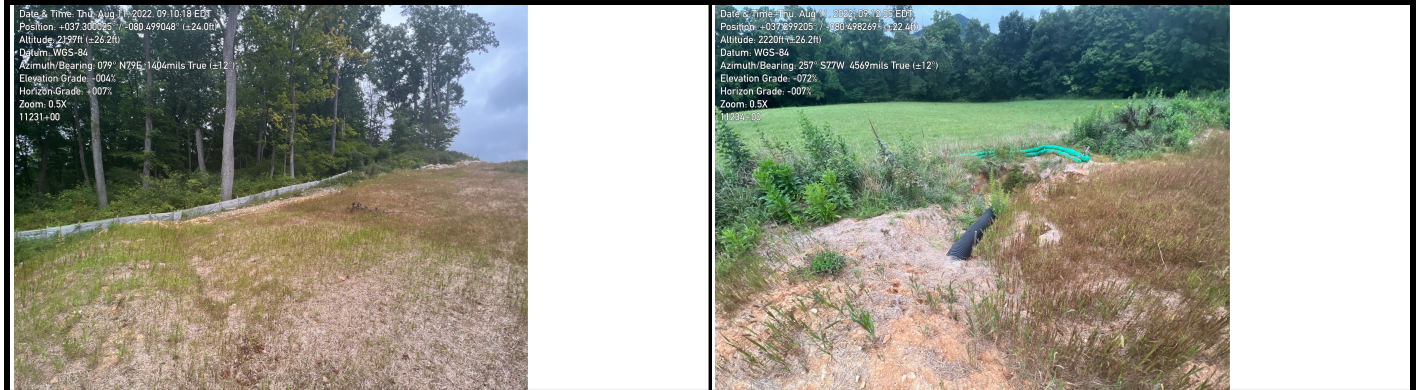
GPS Location	See photo	GPS Location	See photo
Field Station#	11231+00	Field Station#	11234+00
Pic 9 Desc.	Perimeter P1 silt fencing conditions. No Issues at this time.	Pic 10 Desc.	Slope drain pipe conditions along with the sump pit and water bar end treatment. No Issues at this time.

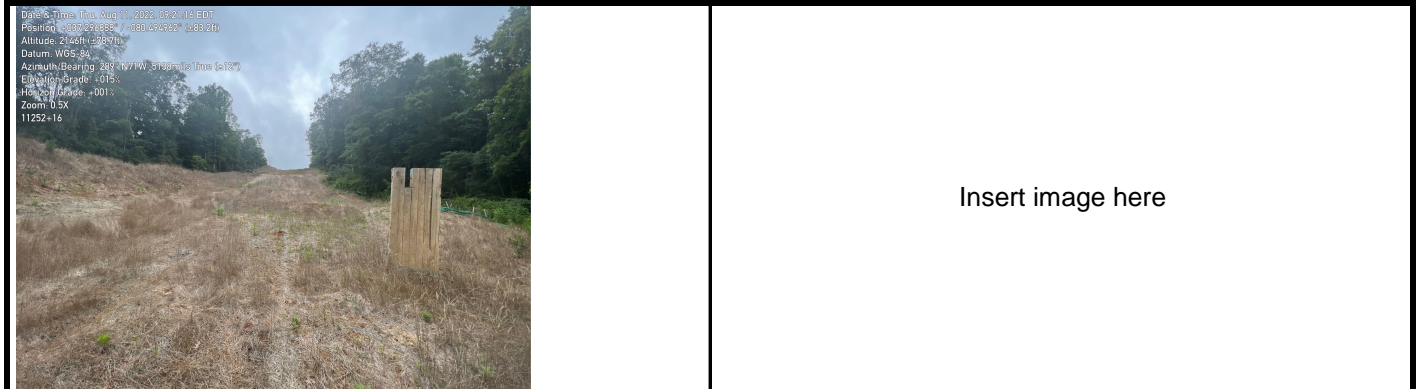
GPS Location	See photo	GPS Location	
Field Station#	11252+16	Field Station#	
Pic 11 Desc.	Steep slope and died off vegetation conditions. No erosion issues at this time.	Pic 12 Desc.

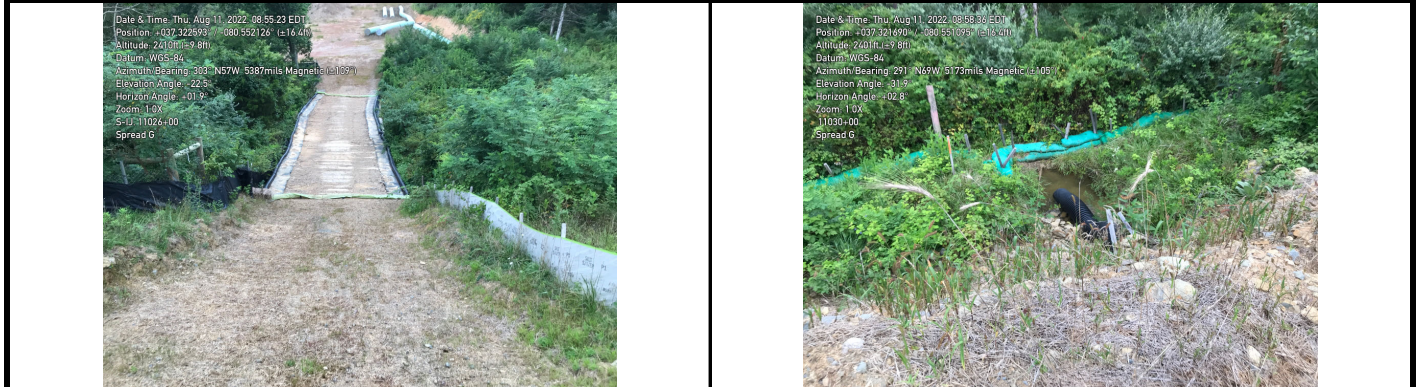
GPS Location	See photo	GPS Location	see photo
Field Station#	11026+00	Field Station#	11030+00
Pic 1 Desc.	S-IJ 18	Pic 2 Desc.	Slope drain/end treatments/sumps

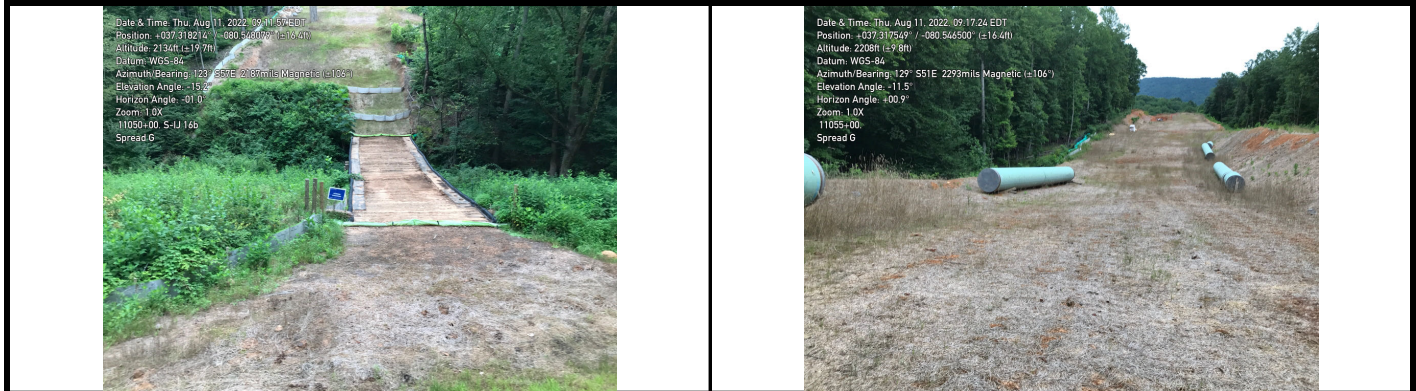
GPS Location	see photo	GPS Location	see photo
Field Station#	11050+00	Field Station#	11055+00
Pic 3 Desc.	S-IJ 16B	Pic 4 Desc.	Stabilized ROW

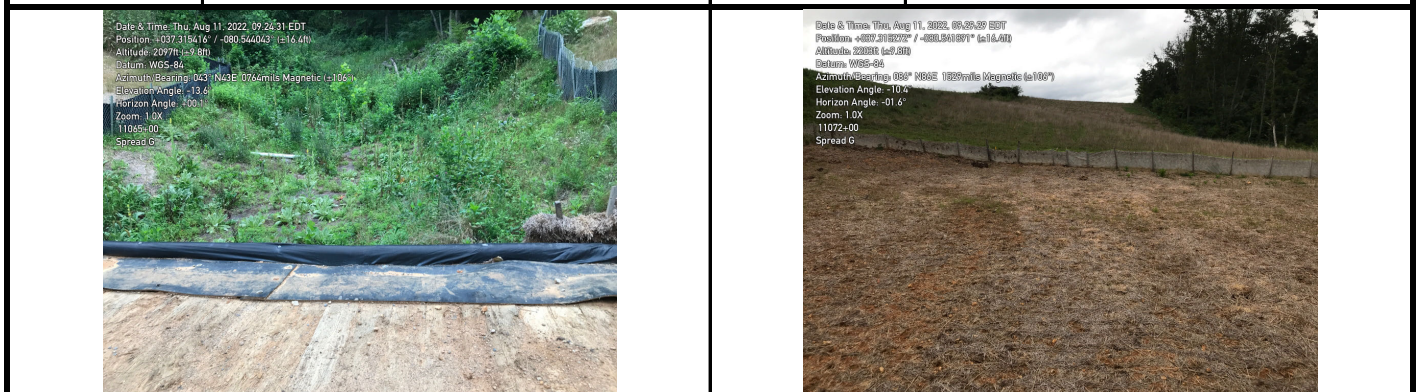
GPS Location	see photo	GPS Location	see photo
Field Station#	11065+00	Field Station#	11072+00
Pic 5 Desc.	Drainage feature @ 245.01	Pic 6 Desc.	Stabilized/restored ROW

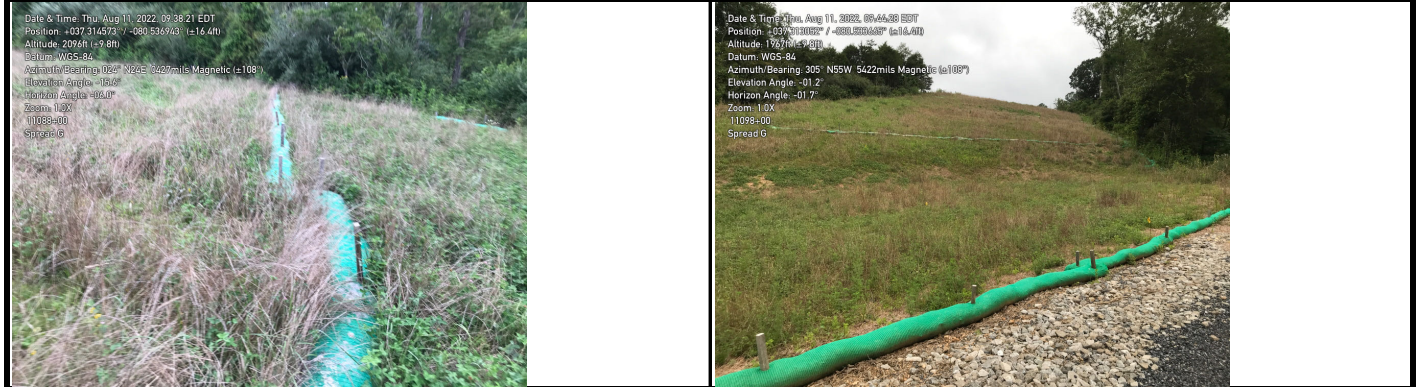
GPS Location	See photo	GPS Location	see photo
Field Station#	11088+00	Field Station#	11098+00
Pic 7 Desc.	Water bars (other), permanent vegetation	Pic 8 Desc.	245.02

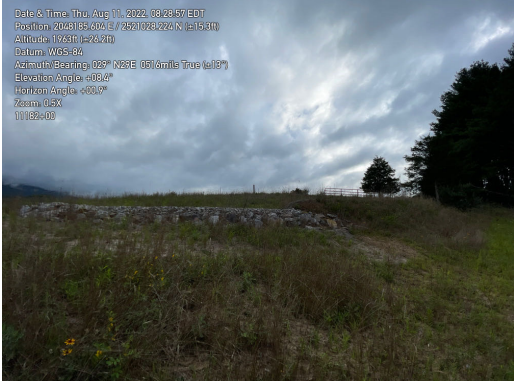
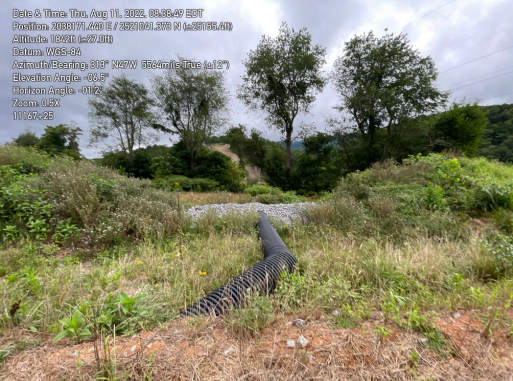
GPS Location 1		GPS Location 2					
Field Station# 11182+00		Field Station# 11167+25					
Pic 1 Desc. Representative photo of permanent waterbar and level spreaders installed.		Pic 2 Desc. CWDP outlet protection functional.

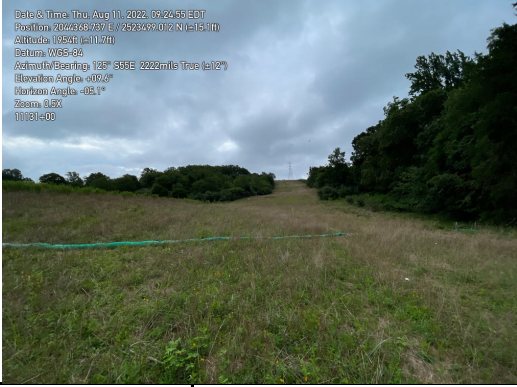
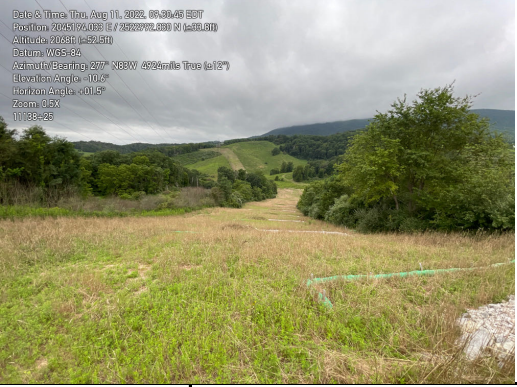
GPS Location 7		GPS Location 8			
Field Station# 11131+00		Field Station# 11138+25			
Pic 7 Desc. Section of restored RoW showing conditions and controls.		Pic 8 Desc. Section of restored RoW showing conditions and controls.

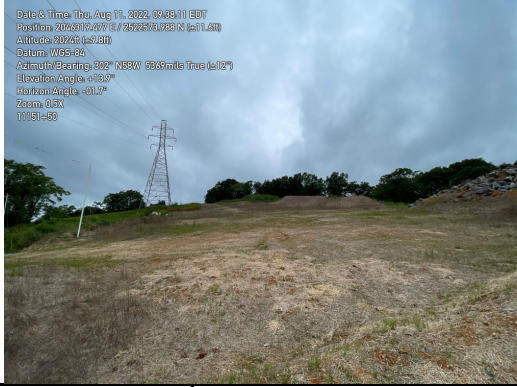
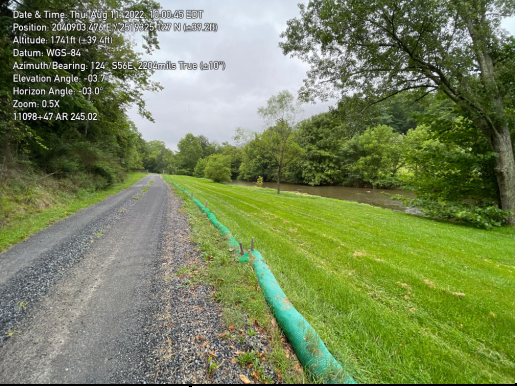
GPS Location 9		GPS Location 10			
Field Station# 11151+50		Field Station# 11098+47			
Pic 9 Desc. Section of RoW showing conditions and controls.		Pic 10 Desc. AR 245.02 conditions and controls.			
Insert image here			Insert image here		
GPS Location		GPS Location			
Field Station#		Field Station#			
Pic 11 Desc.		Pic 12 Desc.

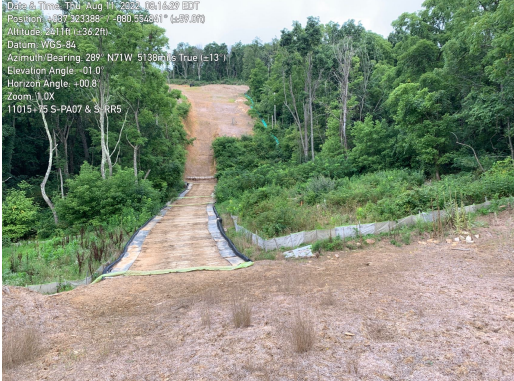
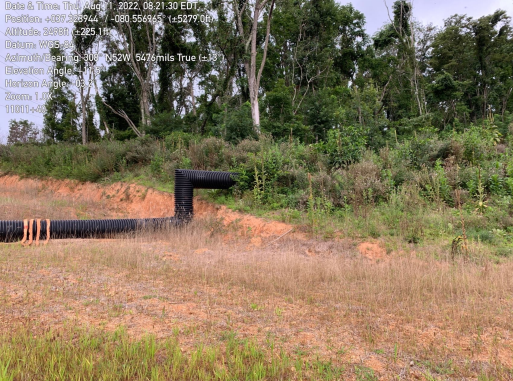
<p><small>Date & Time: Thu, Aug 11, 2022, 08:21:30 EDT Position: +037.3232447, -080.5263663 (+59.870) Altitude: 2658ft (+80.95m) Datum: WGS-84 Azimuth Bearing: 330° N30W 5078mils True (+13.1°) Elevation Angle: -01.0° Horizon Angle: +00.8° Zoom: 1.0X 11011+40</small></p>			
GPS Location	See photo for GPS location.		GPS Location	See photo for GPS location.	
Field Station#	11015+75		Field Station#	11011+40	
Pic 1 Desc.	Sensitive resource buffer in place at streams S-PA07 and S-RR5.		Pic 2 Desc.	Clean water diversion pipe inlet and clean water diversion berm in place.

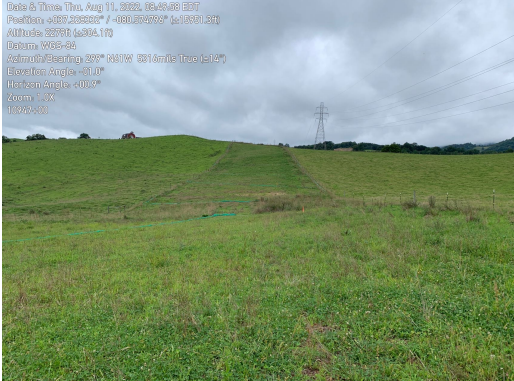
<p><small>Date & Time: Thu, Aug 11, 2022, 08:29:38 EDT Position: +037.3243207, -080.5593857 (+17.55ft) Altitude: 2658ft (+80.95m) Datum: WGS-84 Azimuth Bearing: 316° N66W 5382mils True (+13.1°) Elevation Angle: -31.4° Horizon Angle: +09.6° Zoom: 1.0X 10995+00</small></p>			
GPS Location	See photo for GPS location.		GPS Location	See photo for GPS location.	
Field Station#	11004+00		Field Station#	10995+00	
Pic 3 Desc.	Clean water diversion pipe and level spreader in place.		Pic 4 Desc.	Priority one silt fence in place along LOD.

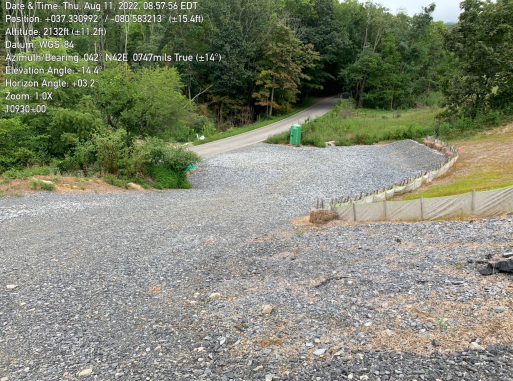
GPS Location	See photo for GPS location.		GPS Location	See photo for GPS location.	
Field Station#	10947+00		Field Station#	10930+00	
Pic 5 Desc.	ROW permanently restored.		Pic 6 Desc.	RCE in place at Doe Creek Road.

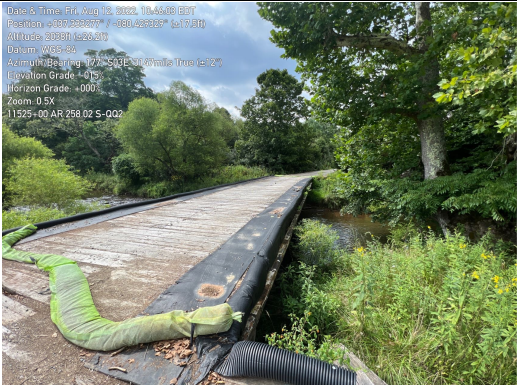
<p><small>Date & Time: Fri, Aug 12, 2022, 11:42:08 EDT Position: +037.329377° / -080.423355° (-11525+00 AR 258.02 S-QQ2) Altitude: 2338ft (+13.2ft) Datum: WGS-84 Azimuth/Bearing: 177° S41E 3116mils True (+27°) Elevation Grade: +0% Horizon Grade: +00% Zoom: 0.5X 11525+00 AR 258.02 S-QQ2</small></p>		Insert image here	
GPS Location	See photo	GPS Location	
Field Station#	11525+00	Field Station#	
Pic 17 Desc.	AR 258.02 - S-QQ2 equipment bridge crossing condition. No Issues at this time.	Pic 18 Desc.

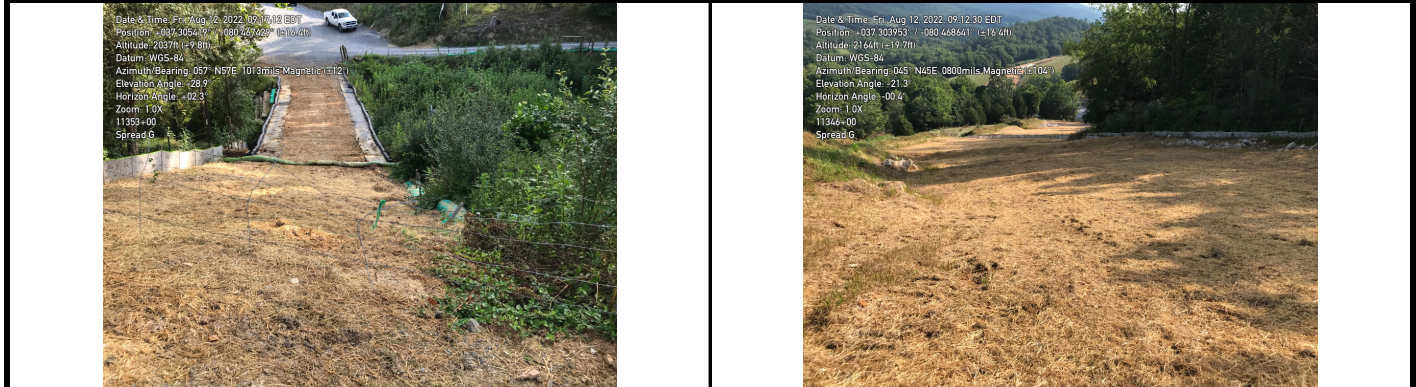
GPS Location	See photo	GPS Location	see photo
Field Station#	11353+00	Field Station#	11346+00
Pic 1 Desc.	S-NN 11	Pic 2 Desc.	Stabilized ROW

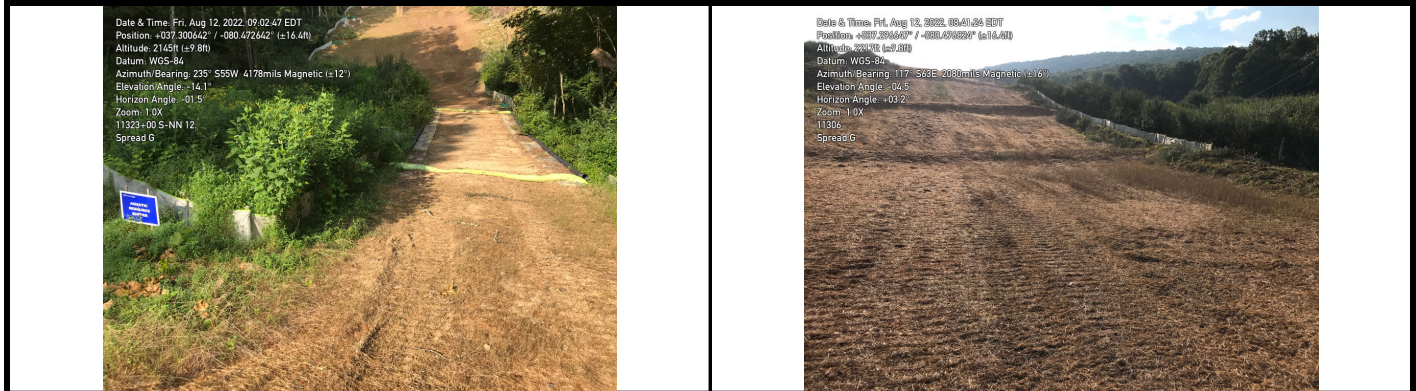
GPS Location	see photo	GPS Location	see photo
Field Station#	11323+00	Field Station#	11306+00
Pic 3 Desc.	S-NN12	Pic 4 Desc.	Stabilized ROW

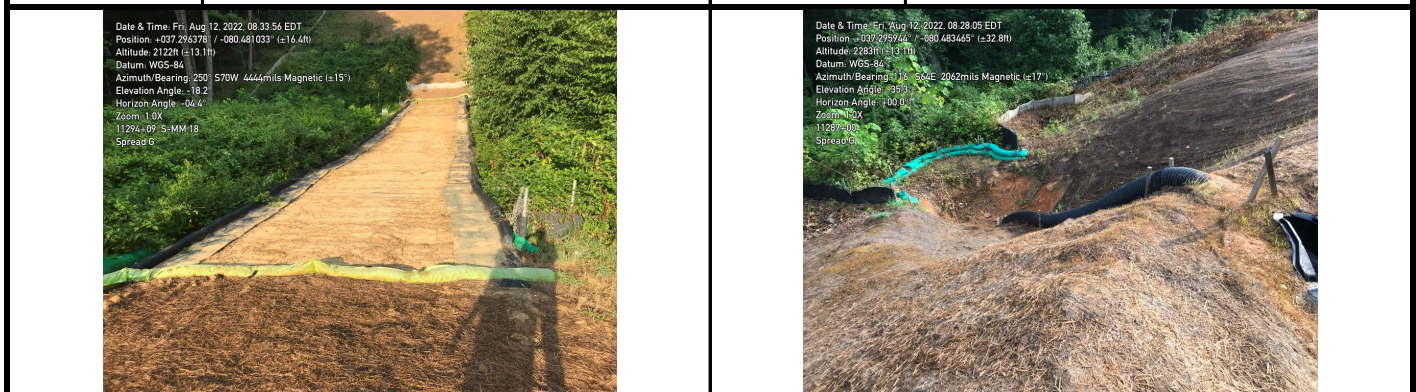
GPS Location	see photo	GPS Location	See photo
Field Station#	11294+09	Field Station#	11287+00
Pic 5 Desc.	S-MM 18	Pic 6 Desc.	Slope drain/sump

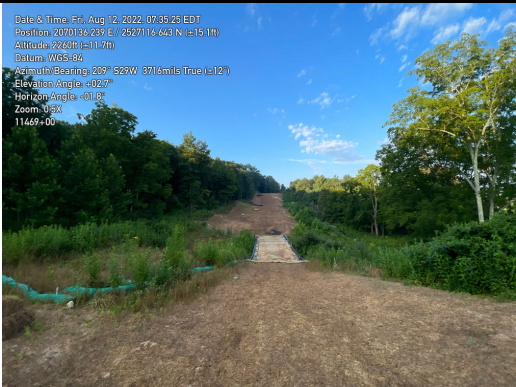
GPS Location	1		GPS Location	2	
Field Station#	11469+00		Field Station#	11451+87	
Pic 1 Desc.	Section of RoW showing conditions and controls.		Pic 2 Desc.	S-0012.

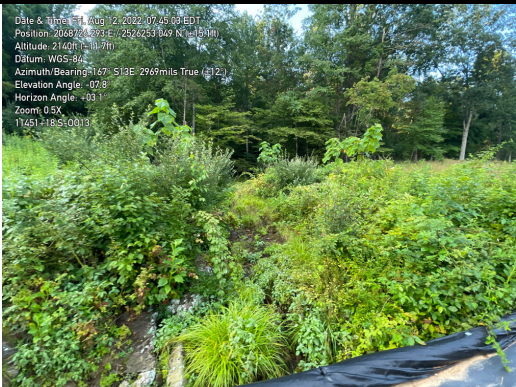
GPS Location	3		GPS Location	4	
Field Station#	11451+18		Field Station#	11448+93	
Pic 3 Desc.	S-0013.		Pic 4 Desc.	S-0014/W-CD12.

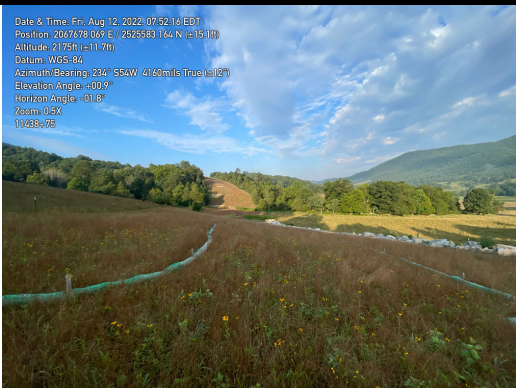
GPS Location	5		GPS Location	6	
Field Station#	11438+75		Field Station#	11430+00	
Pic 5 Desc.	Section of restored RoW showing conditions and controls.		Pic 6 Desc.	Representative photo of permanent waterbar and level spreaders installed.

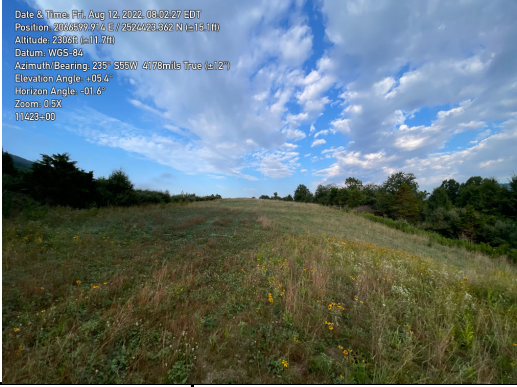
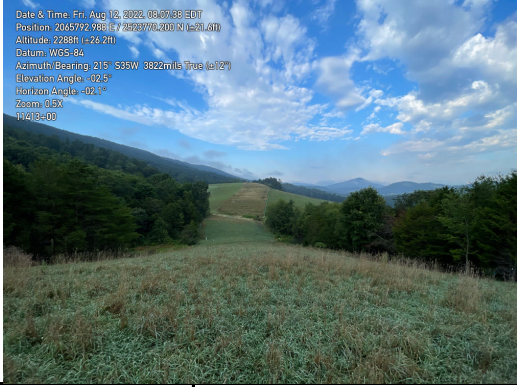
<p><small>Date & Time: Fri, Aug 12, 2022, 08:07:38 EDT Position: 2065792.988 E / 7872770.200 N (e15.1M) Altitude: 2280ft (e11.2M) Datum: WGS-84 Azimuth (Bearing): 215° 53W (3822mils True (e12°)) Elevation Angle: -02.5° Horizon Angle: -02.1° Zoom: 0.5X 11413+00</small></p>	
GPS Location	7	GPS Location	8
Field Station#	11423+00	Field Station#	11413+00
Pic 7 Desc.	Section of restored RoW showing conditions and controls.	Pic 8 Desc.	Section of restored RoW showing conditions and controls.

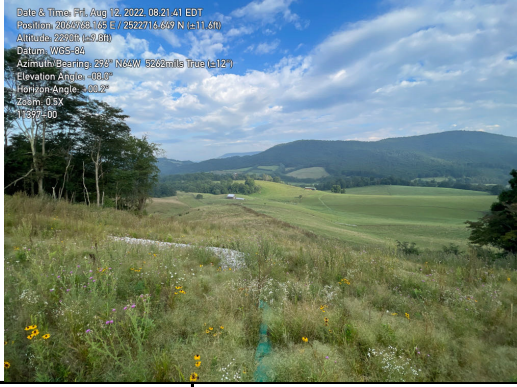
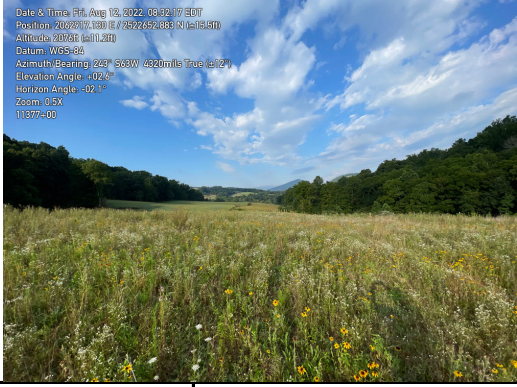
GPS Location	9	GPS Location	10
Field Station#	11397+00	Field Station#	11377+00
Pic 9 Desc.	Section of restored RoW showing conditions and controls.	Pic 10 Desc.	Section of restored RoW showing conditions and controls.

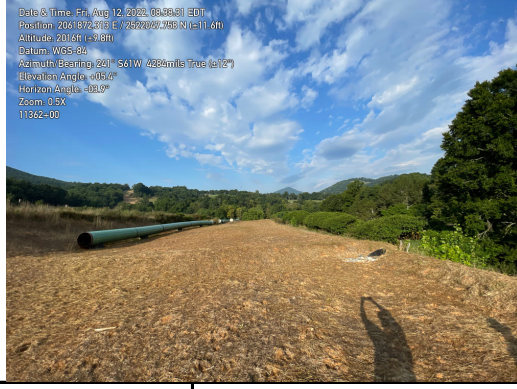
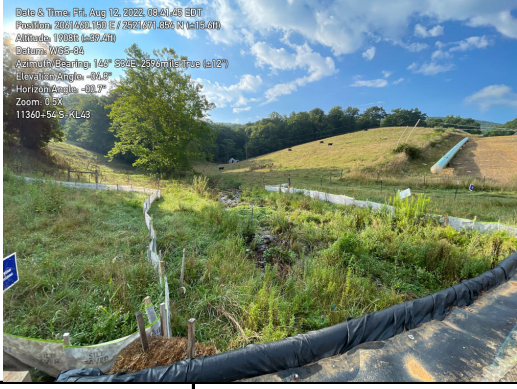
<p><small>Date & Time: Fri, Aug 12, 2022, 08:41:45 EDT Position: 2061462.130 E / 7872771.634 N (e15.1M) Altitude: 1988ft (e60.4M) Datum: WGS-84 Azimuth (Bearing): 145° S=2E (2530mils True (e12°)) Elevation Angle: -06.5° Horizon Angle: -01.1° Zoom: 0.5X 11360+54.5_KL43</small></p>	
GPS Location	11	GPS Location	12
Field Station#	11362+00	Field Station#	11360+54
Pic 11 Desc.	Section of RoW showing conditions and controls.	Pic 12 Desc.	S-KL43.

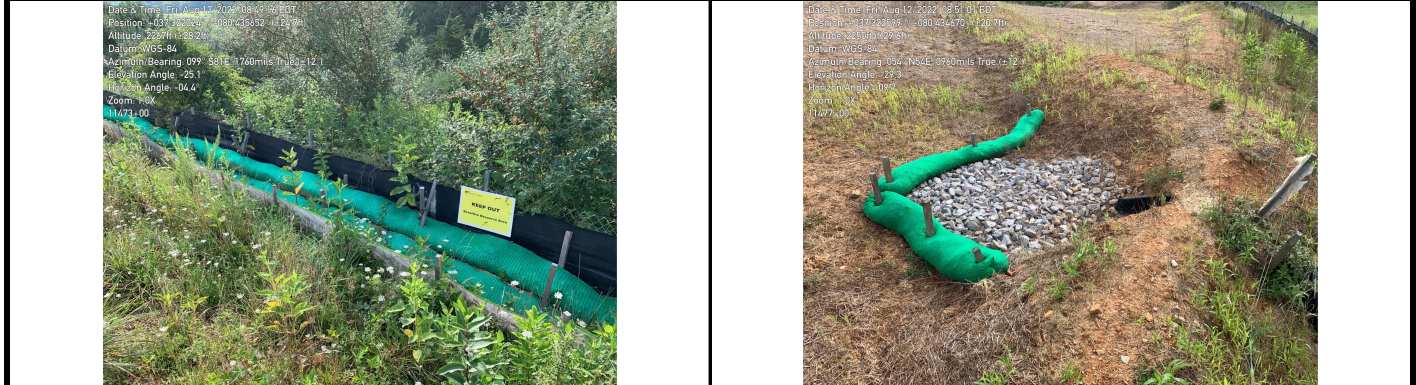
GPS Location	See photo for GPS location.	GPS Location	See photo for GPS location.
Field Station#	11473+00	Field Station#	11477+00
Pic 1 Desc.	Triple barrier ECDs in place at off ROW karst feature.	Pic 2 Desc.	Rock inlet protection at slope drain inlet.

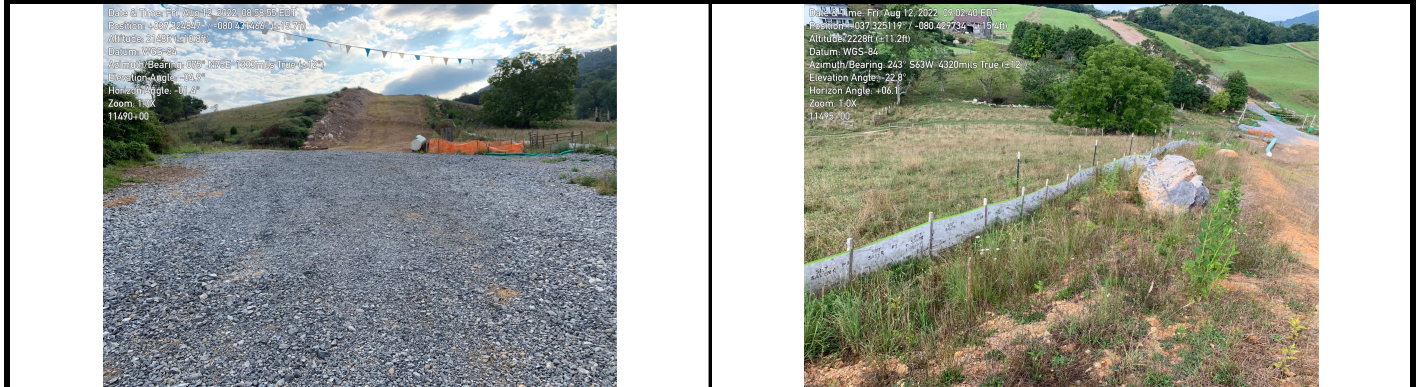
GPS Location	See photo for GPS location.	GPS Location	See photo for GPS location.
Field Station#	11490+00	Field Station#	11495+00
Pic 3 Desc.	RCE in place at Stevers Gap Road.	Pic 4 Desc.	Priority one silt fence in place along LOD.

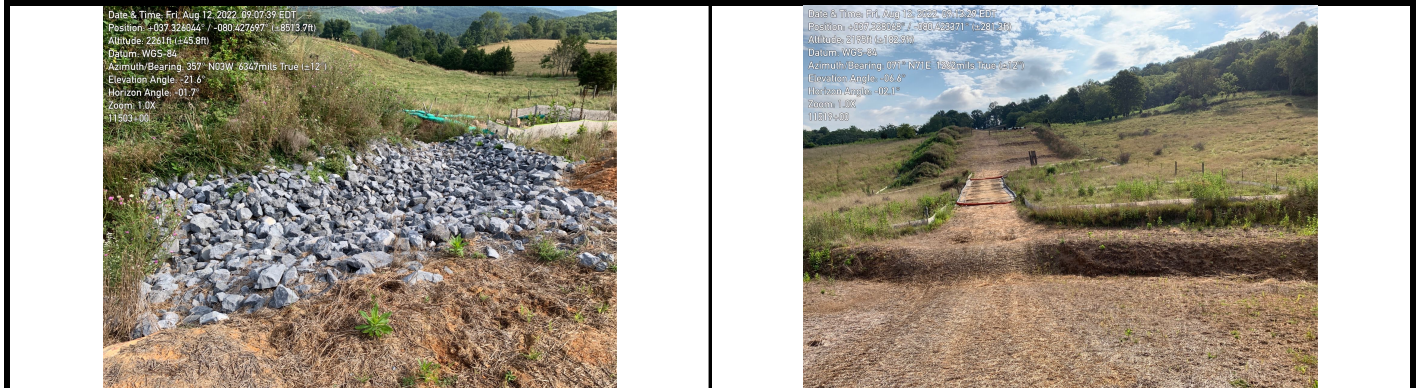
GPS Location	See photo for GPS location.	GPS Location	See photo for GPS location.
Field Station#	11503+00	Field Station#	11519+00
Pic 5 Desc.	Rock lined channel in place.	Pic 6 Desc.	Sensitive resource buffer in place at stream S-PP4.
