# Visual Site Inspection Report

<b>Project Name</b> H-600 Pipeline Spread H		<b>AFE</b> 124300138	<b>Spread</b> H-600 Pipeline Spread H
<b>Contractor</b> Precision		<b>Report #</b> 40516	
<b>Inspector</b> Jonathan Altizer		<b>Date/Time</b> 8/1/2022 3:21 PM	
<b>Permit #</b> TBD	<b>Inspection Type</b> VA SWPP	<b>Station Begin</b>	12600+00
<b>State</b> VA	<b>Inspection Area</b> Partial	<b>Station End</b>	12725+00
<b>County</b> Roanoke	<b>Ground</b> Wet	<b>Temperature (°F)</b>	80.00
<b>Municipality</b> N/A	<b>Weather</b> Cloudy	<b>Rain Gauge (in)</b>	0.30
			<b>Rain Accumulation Time (days)</b> 1.00

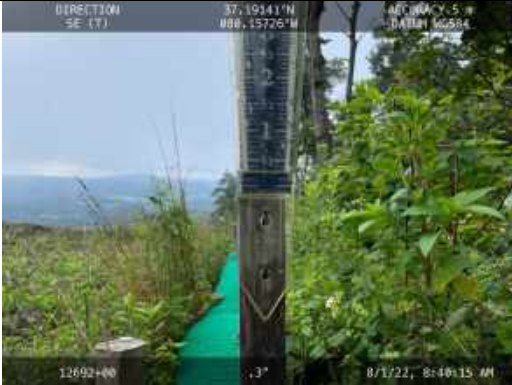
<b>GPS Location</b>	See photo		<b>GPS Location</b>	See photo	
<b>Field Station#</b>	12692+00		<b>Field Station#</b>	12692+00	
<b>Pic 1 Desc.</b>	Rain Gauge shows .3" of rain		<b>Pic 2 Desc.</b>	Current ROW conditions. ROW is stable and ECDs are functional.

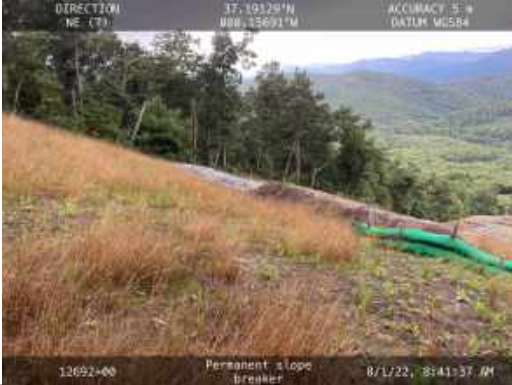
<b>GPS Location</b>	See photo		<b>GPS Location</b>	See photo	
<b>Field Station#</b>	12692+00		<b>Field Station#</b>	12629+00	
<b>Pic 3 Desc.</b>	Permanent Slope Breaker is functional		<b>Pic 4 Desc.</b>	Current ROW conditions. ROW is stable and ECDs are functional.

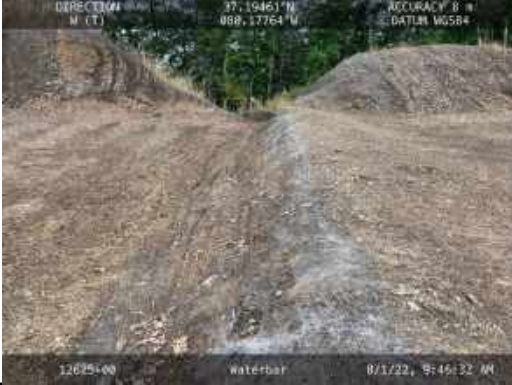
<b>GPS Location</b>	See photo		<b>GPS Location</b>	See photo	
<b>Field Station#</b>	12625+00		<b>Field Station#</b>	12615+00	
<b>Pic 5 Desc.</b>	Waterbar is functional		<b>Pic 6 Desc.</b>	Sump and End Treatment are functional

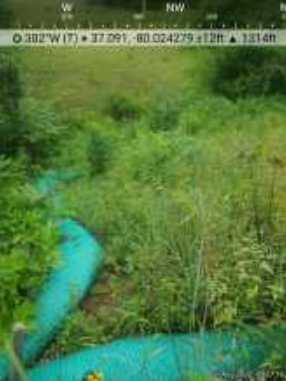
GPS Location 0		GPS Location 0			
Field Station# 13426+00		Field Station# 13428+00			
Pic 1 Desc. GAS S-IJ4 Buffer zone and ECDs		Pic 2 Desc. Waterbar and level spreader

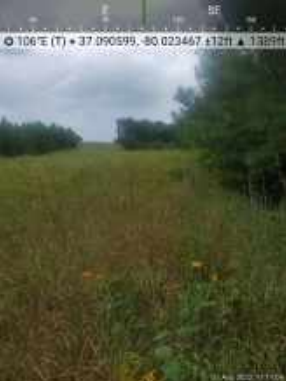
GPS Location 0		GPS Location 0			
Field Station# 13430+00		Field Station# 13433+00			
Pic 3 Desc. Sideslope vegetation		Pic 4 Desc. Perimeter CFS and vegetation

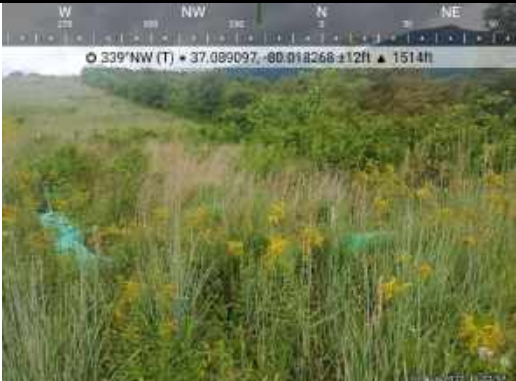
GPS Location 0		GPS Location 0			
Field Station# 13445+00		Field Station# 13437+00			
Pic 5 Desc. S-IJ8 Buffer zone and vegetation		Pic 6 Desc. Perimeter CFS

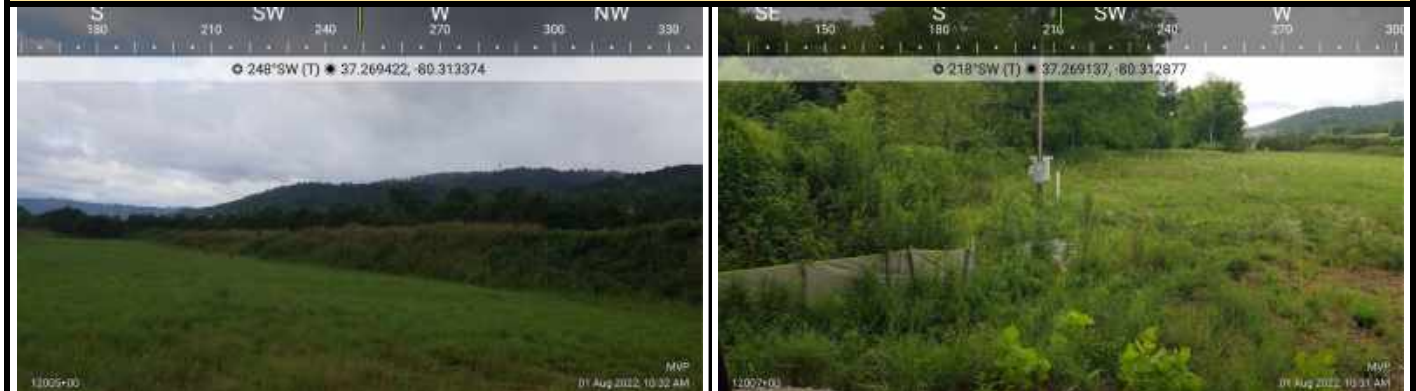
<b>Field Station#</b>	12005+00	<b>Field Station#</b>	12007+00
-----------------------	----------	-----------------------	----------

<b>Pic 1 Desc.</b>	Photo shows current stabilized ROW conditions along with stabilized topsoil pile on the perimeter of the ROW.	<b>Pic 2 Desc.</b>	Photo shows stabilized ROW conditions along with P1 silt fence installed around a segregated topsoil pile.
--------------------	---	--------------------	--

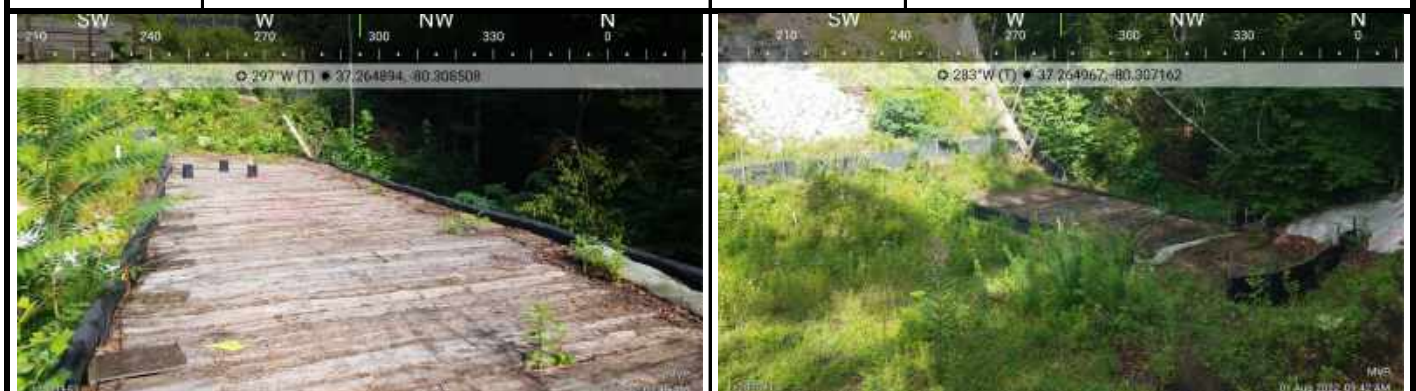
<b>Field Station#</b>	12031+51	<b>Field Station#</b>	12035+11
-----------------------	----------	-----------------------	----------

<b>Pic 5 Desc.</b>	Photo shows equipment bridge condition that spans over the stream channel of Stream S-G39 looking towards the coming in side.	<b>Pic 6 Desc.</b>	Photo shows overview of Stream S-G40, it's buffer zone and the equipment bridge that spans the stream channel.
--------------------	---	--------------------	--

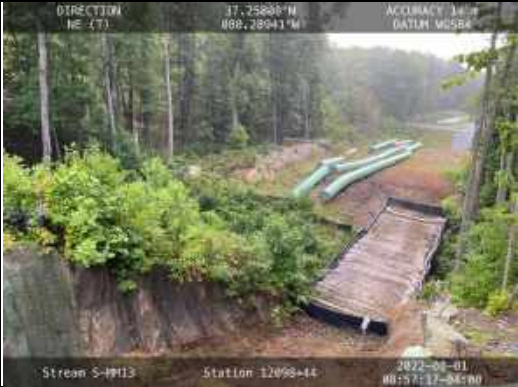
<p>Stream S-MM13 Station 12098+44 2022-08-01 09:57:17-04:00</p>		  <p>Stream S-MM11 Station 12101+57 2022-08-01 09:01:26-04:00</p>			
<b>GPS Location</b>	Please see photo for details.		<b>GPS Location</b>	Please see photo for details.	
<b>Field Station#</b>	12098+44		<b>Field Station#</b>	12101+57	
<b>Pic 13 Desc.</b>	Photo shows overview of Stream S-MM13 and its buffer zone from the coming in side while standing on cut bank.		<b>Pic 14 Desc.</b>	Photo shows upstream view of Stream S-MM11 from the equipment bridge spanning the stream channel.

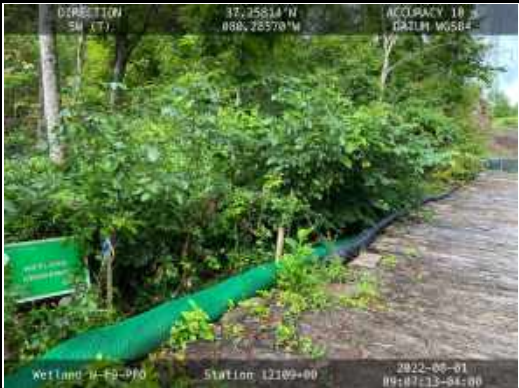
<b>Pic 15 Desc.</b>	Photo shows overview of Stream S-MM11, it's buffer zone and environmental crew walking back from resolving punch list item.		<b>Pic 16 Desc.</b>	Photo shows Wetland W-F9-PFO that is next to Stream S-F15.

\* One punch list item was found and resolved during todays VA DEQ SWPPP inspection. Repair holes in perimeter CFS from station 12093+00 to station 12094+00.

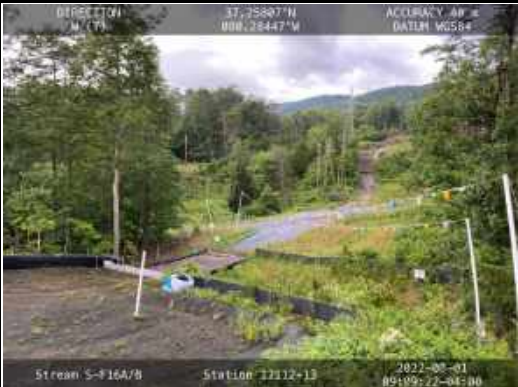
<p>Stream S-F16A/B Station 12112+13 2022-08-01 09:19:22-04:00</p>

<p>Station 12118+00 2022-08-01 09:17:27-04:00</p>			
<b>GPS Location</b>	Please see photo for details.		<b>GPS Location</b>	Please see photo for details.	
<b>Field Station#</b>	12112+13		<b>Field Station#</b>	12118+00	
<b>Pic 17 Desc.</b>	Photo shows overview of Stream S-F16A/B and its buffer zone while standing on the clean water diversion on the going away side.		<b>Pic 18 Desc.</b>	Phot shows current stabilized ROW conditions with both the permanent restoration area as well as temporary stabilization area.

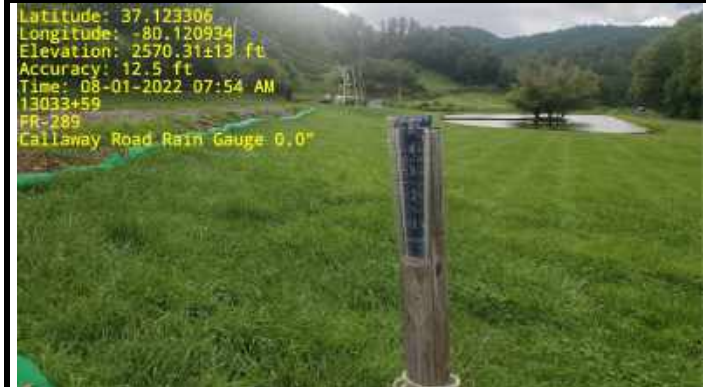
**Pic 1 Desc.** 0.0" total precipitation.

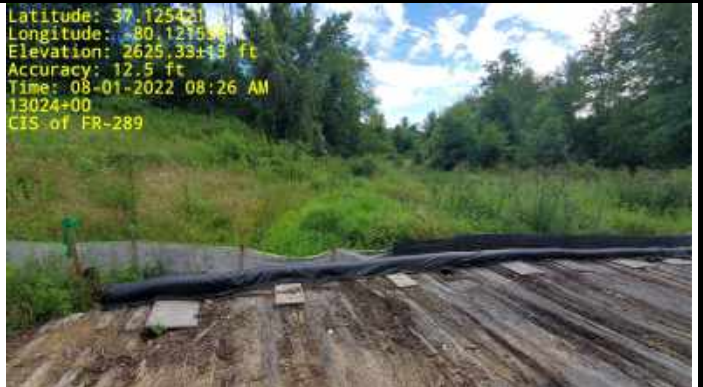
**Pic 2 Desc.** Upstream side of stream S-G24 from the CIS.

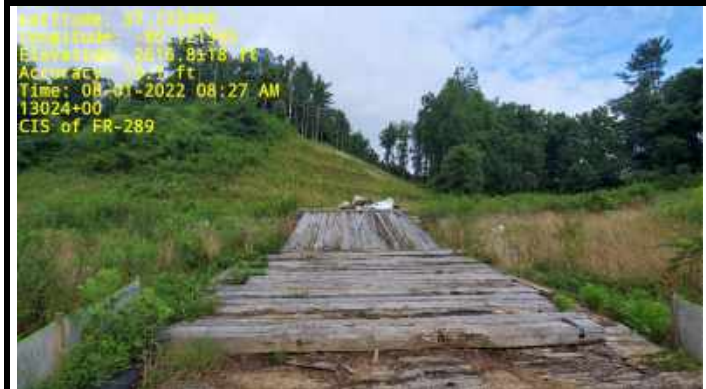
**Pic 3 Desc.** Current ROW conditions.

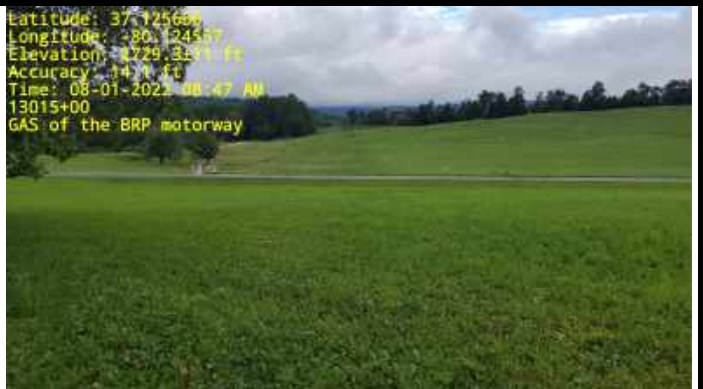
**Pic 4 Desc.** Current ROW conditions.

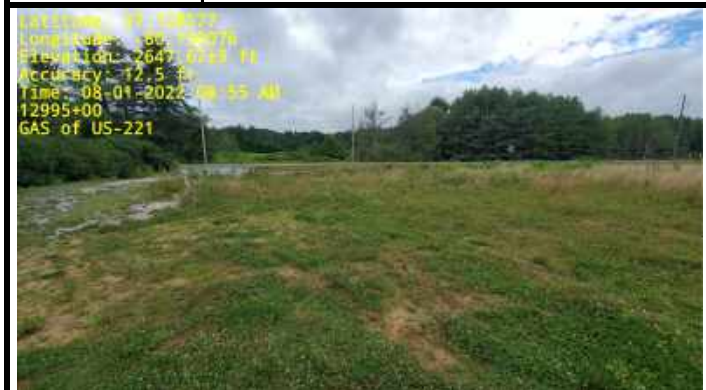
**Pic 5 Desc.** Current ROW conditions.

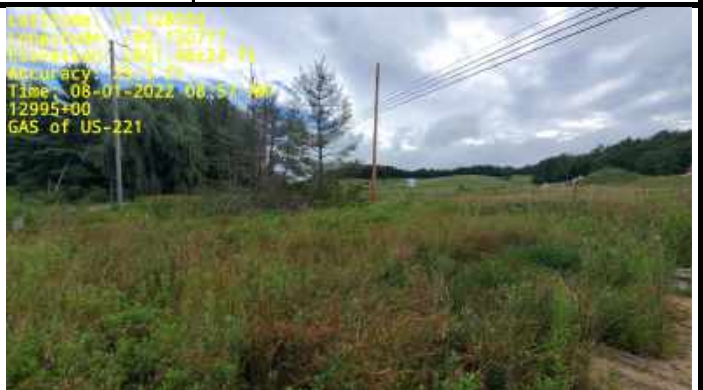
**Pic 6 Desc.** Current ROW conditions.

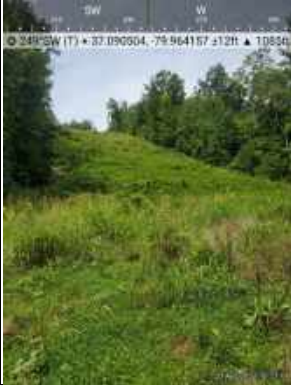
GPS Location	0	GPS Location	0		
Field Station#	13633+00	Field Station#	13642+00		
Pic 13 Desc.	Hillside vegetation	Pic 14 Desc.	CIS S-E28 Vegetation and silt fence

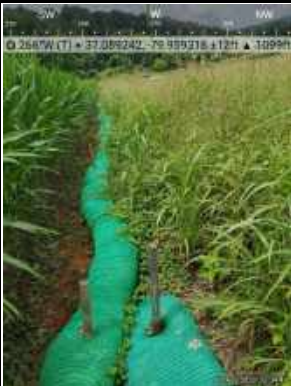
GPS Location	0	GPS Location	0		
Field Station#	13650+00	Field Station#	13660+00		
Pic 15 Desc.	Perimeter CFS	Pic 16 Desc.	GAS S-GH3 ECDs		
<p style="text-align: center;">Insert image here</p>			<p style="text-align: center;">Insert image here</p>		
GPS Location		GPS Location			
Field Station#		Field Station#			
Pic 17 Desc.		Pic 18 Desc.

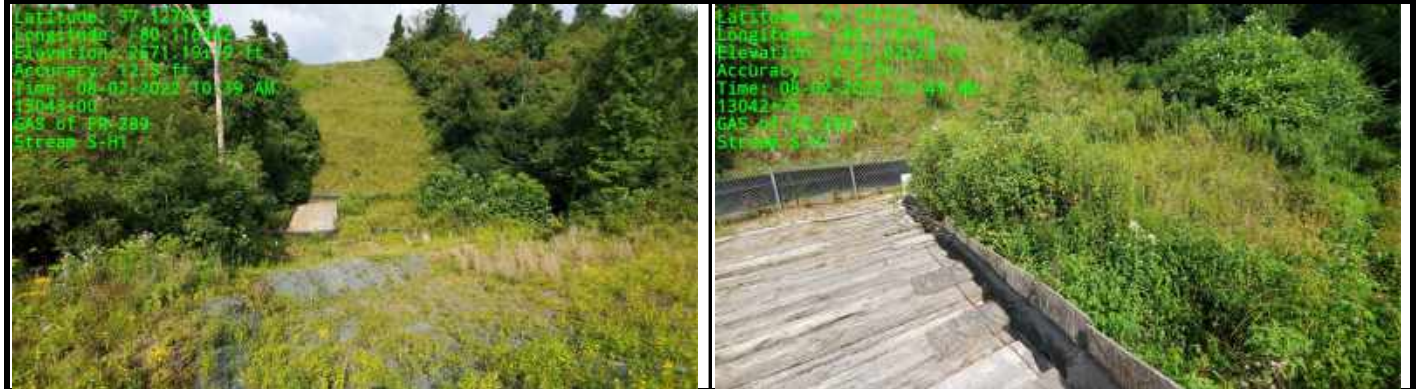
<b>GPS Location</b>	See pic.	<b>GPS Location</b>	See pic.
<b>Field Station#</b>	13043+00	<b>Field Station#</b>	13042+75
<b>Pic 7 Desc.</b>	Stream crossing S-H1 from the GAS.	<b>Pic 8 Desc.</b>	Upstream side of stream S-H1.

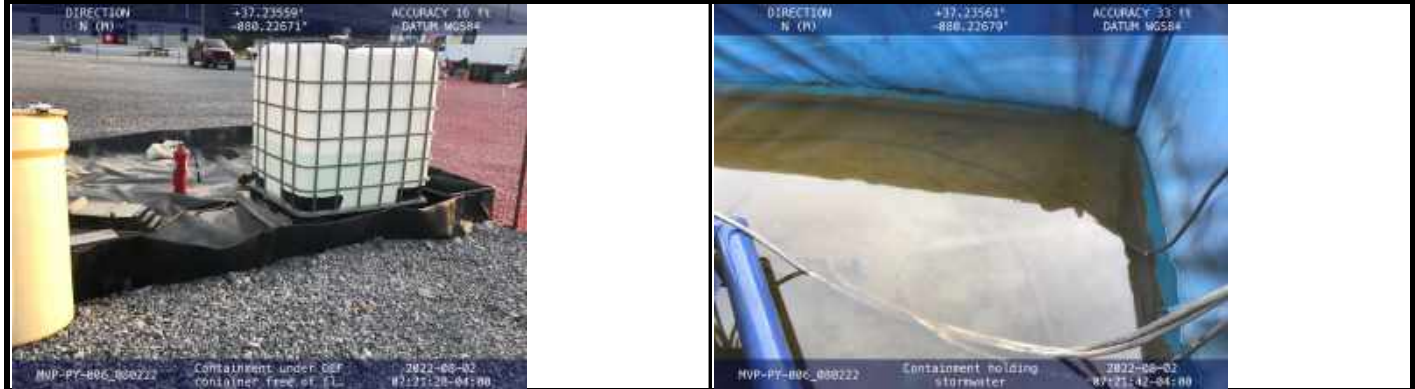
<b>GPS Location</b>	MVP-PY-006 See photo for gps data	<b>GPS Location</b>	MVP-PY-006 See photo for gps data
<b>Field Station#</b>	+0	<b>Field Station#</b>	+0
<b>Pic 13 Desc.</b>	Secondary containment under DEF container free of fluids. Looking N.	<b>Pic 14 Desc.</b>	Blue Bulk Fuel tanks secondary containment holding stormwater. Looking N.

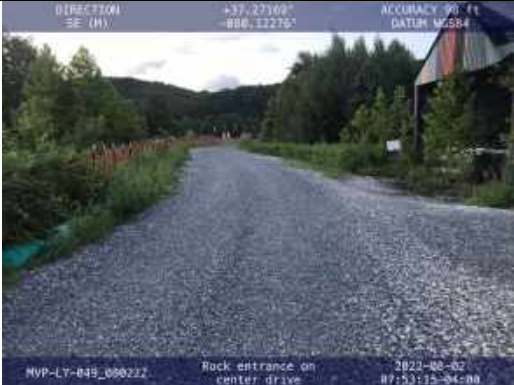
<b>GPS Location</b>	MVP-LY-049 See photo for gps data	<b>GPS Location</b>	MVP-LY-049 See photo for gps data		
<b>Field Station#</b>	+0	<b>Field Station#</b>	+0		
<b>Pic 1 Desc.</b>	Rock entrance on center drive. Smaller stone applied over larger stone. No sediment or debris on stone. Looking SE.	<b>Pic 2 Desc.</b>	Rock entrance on north drive. No sediment or debris on stone. Looking SW.

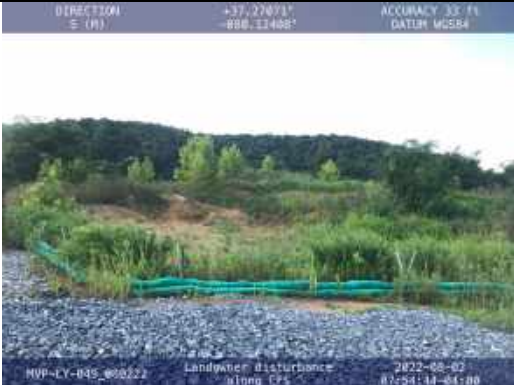
<b>GPS Location</b>	MVP-LY-049 See photo for gps data	<b>GPS Location</b>	MVP-LY-049 See photo for gps data		
<b>Field Station#</b>	+0	<b>Field Station#</b>	+0		
<b>Pic 3 Desc.</b>	Landowner soil disturbance along triple stack compost filter. No new damage to installed ECD's. Looking S.	<b>Pic 4 Desc.</b>	Landowner soil disturbance along feature W-CV21A. Area no stabilized. Looking NW.

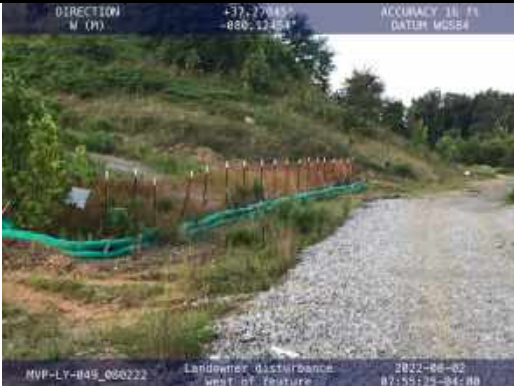
<b>Field Station#</b>	+0	<b>Field Station#</b>	+0		
<b>Pic 5 Desc.</b>	Landowner soil disturbance west of feature W-CV21B. Areas not stabilized. Looking W.	<b>Pic 6 Desc.</b>	Landowner soil disturbance and debris piled along triple stack compost filter sock and east of feature W-CV21B. Looking SW.

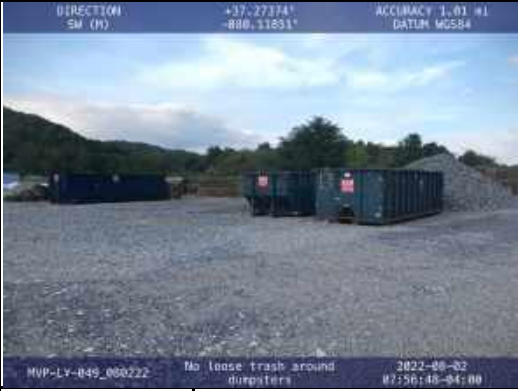
<b>GPS Location</b>	MVP-LY-049 See photo for gps data	<b>GPS Location</b>	MVP-LY-049 See photo for gps data		
<b>Field Station#</b>	+0	<b>Field Station#</b>	+0		
<b>Pic 7 Desc.</b>	No loose trash around dumpsters or in the yard. Looking SW.	<b>Pic 8 Desc.</b>	Temporary trash transfer pit holding debris. Looking W.

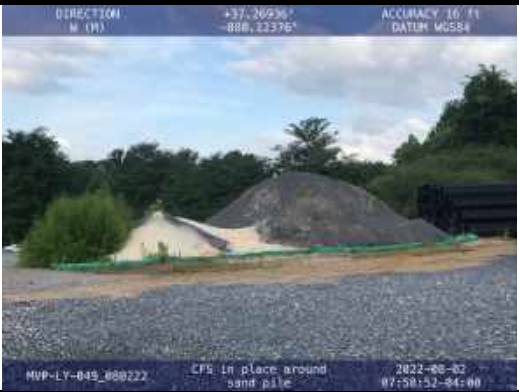
<b>GPS Location</b>	MVP-LY-049 See photo for gps data	<b>GPS Location</b>	MVP-LY-049 See photo for gps data		
<b>Field Station#</b>	+0	<b>Field Station#</b>	+0		
<b>Pic 9 Desc.</b>	No fluids or deposits around hazardous waste dumpsters. Looking E.	<b>Pic 10 Desc.</b>	Compost filter sock in place and functioning around sand pile. Looking W.

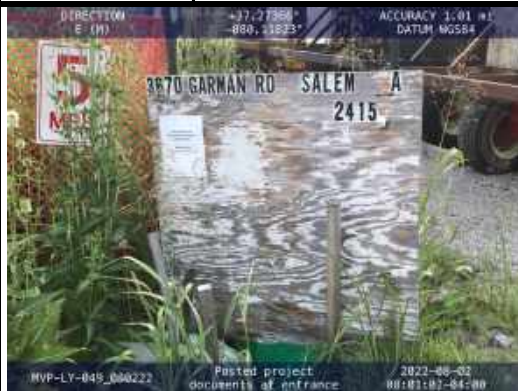
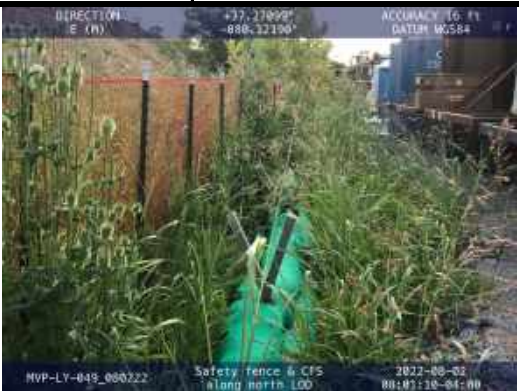
<b>GPS Location</b>	MVP-LY-049 See photo for gps data	<b>GPS Location</b>	MVP-LY-049 See photo for gps data		
<b>Field Station#</b>	+0	<b>Field Station#</b>	+0

<b>Pic 11 Desc.</b>	Posted project document at main entrance. Looking E.	<b>Pic 12 Desc.</b>	Safety fence and triple stack compost filter sock along north LOD overgrown with vegetation. Looking E.

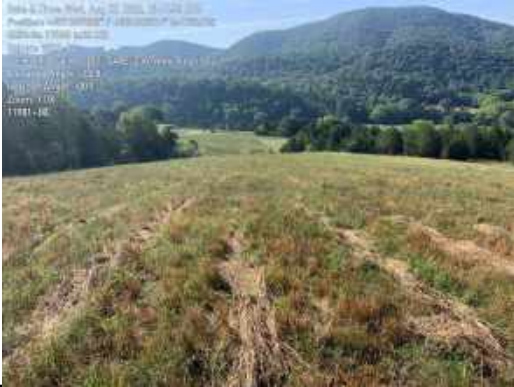
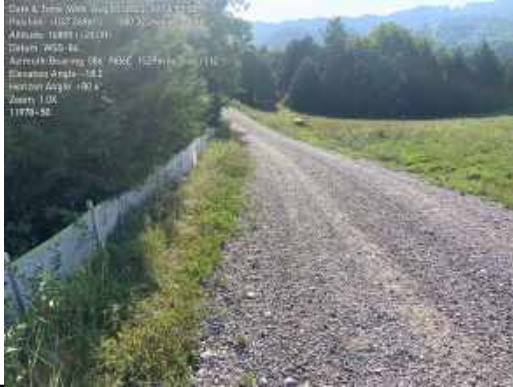
<b>GPS Location</b>	See photo		<b>GPS Location</b>	See photo	
<b>Field Station#</b>	11981+00		<b>Field Station#</b>	11978+50	
<b>Pic 3 Desc.</b>	Section of Row where perimeter controls have been removed		<b>Pic 4 Desc.</b>	Perimeter controls are in place along AR266

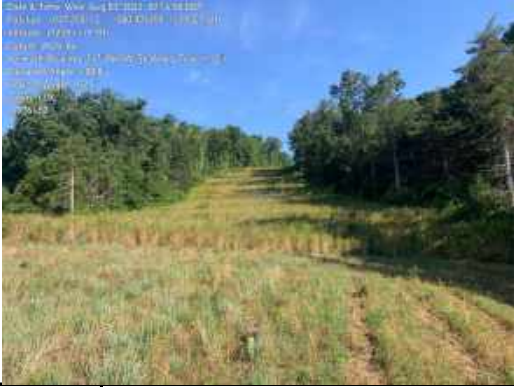
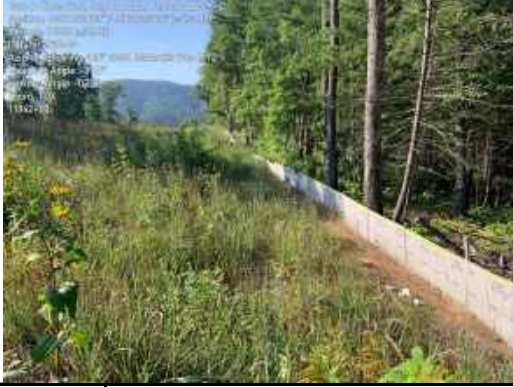
<b>GPS Location</b>	See photo		<b>GPS Location</b>	See photo	
<b>Field Station#</b>	11976+50		<b>Field Station#</b>	11962+00	
<b>Pic 5 Desc.</b>	Section of Row showing conditions and controls		<b>Pic 6 Desc.</b>	P1 silt fence is in acceptable condition

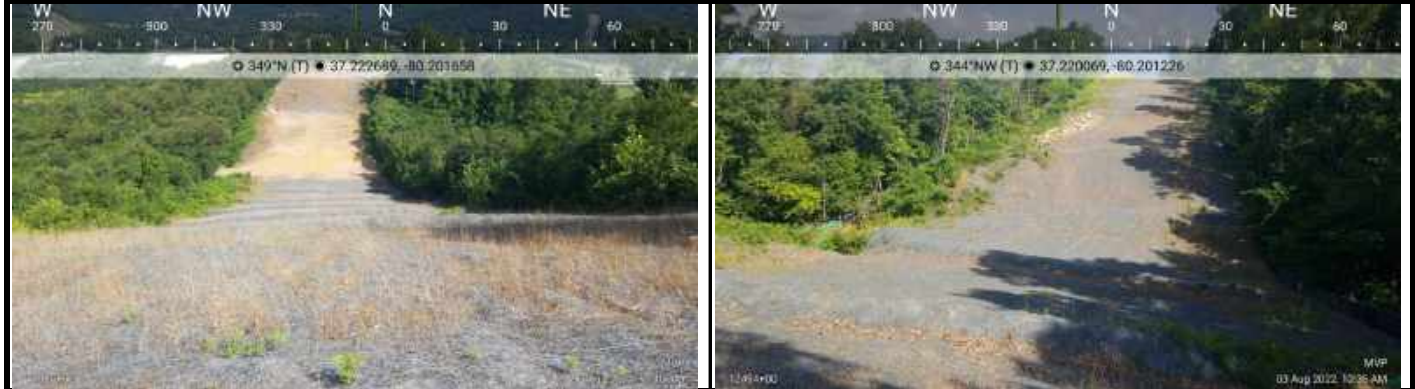
<b>GPS Location</b>	See Above	<b>GPS Location</b>	See Above
<b>Field Station#</b>	12486+00	<b>Field Station#</b>	12494+00
<b>Pic 7 Desc.</b>	ROW Overview (temporary stabilization). ECDs are functional and ROW is stable.	<b>Pic 8 Desc.</b>	ROW Overview (temporary stabilization). ECDs are functional and ROW is stable.

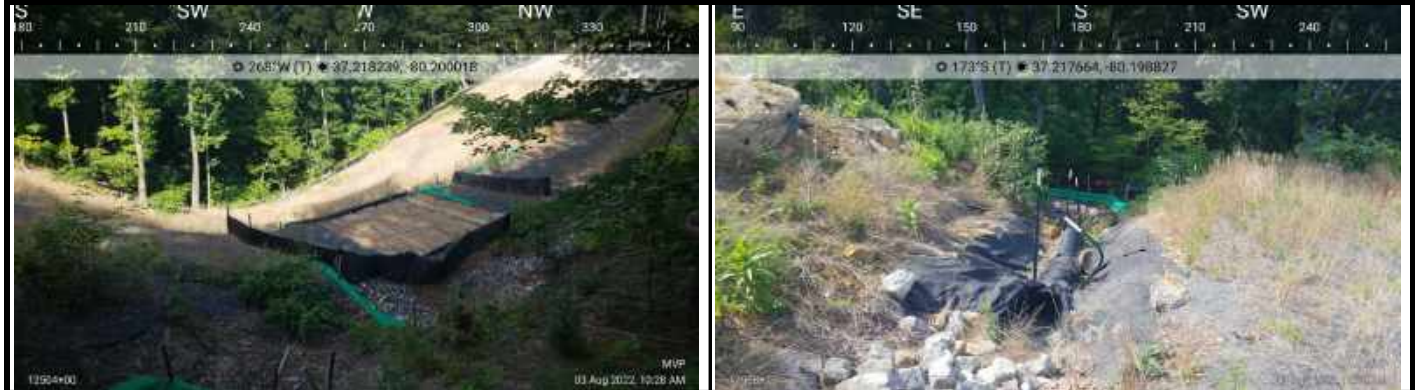
<b>GPS Location</b>	See Above	<b>GPS Location</b>	See Above
<b>Field Station#</b>	12504+00	<b>Field Station#</b>	12508+75
<b>Pic 9 Desc.</b>	ROW Overview (temporary stabilization). ECDs are functional and ROW is stable.v	<b>Pic 10 Desc.</b>	ROW Overview (temporary stabilization). ECDs are functional and ROW is stable.

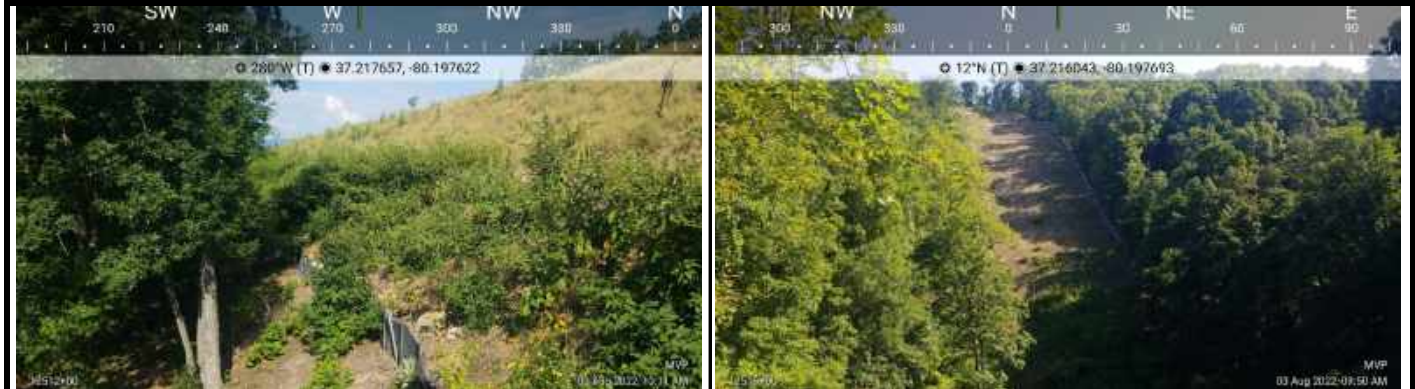
<b>GPS Location</b>	See Above	<b>GPS Location</b>	See Above
<b>Field Station#</b>	12512+00	<b>Field Station#</b>	12516+00
<b>Pic 11 Desc.</b>	ROW Overview (temporary stabilization). ECDs are functional and ROW is stable.	<b>Pic 12 Desc.</b>	ROW Overview (temporary stabilization). ECDs are functional and ROW is stable.

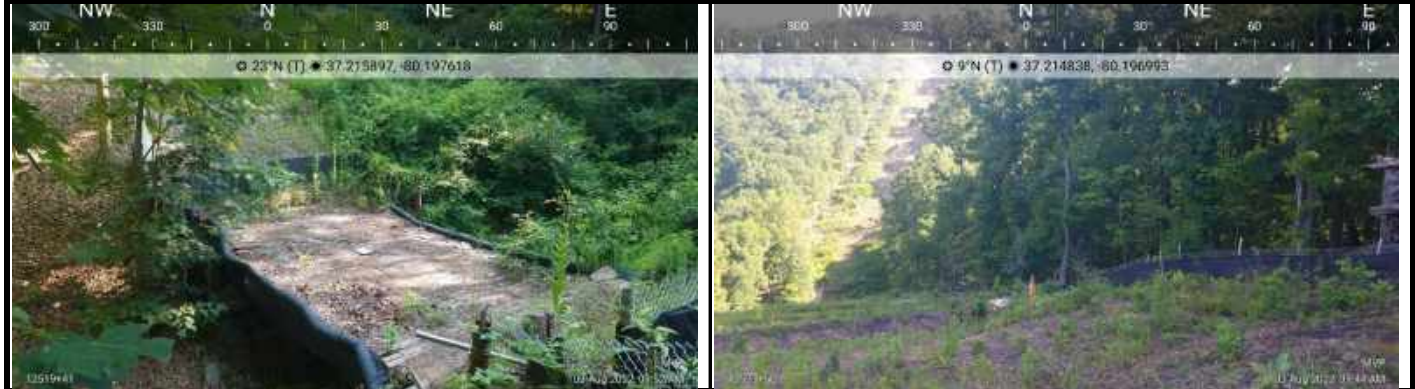
<b>GPS Location</b>	See Above	<b>GPS Location</b>	See Above
<b>Field Station#</b>	12519+41	<b>Field Station#</b>	12523+50
<b>Pic 13 Desc.</b>	Overview of Waterbody S-EF19. ECDs are functional and ROW is stable.	<b>Pic 14 Desc.</b>	ROW Overview (temporary stabilization). ECDs are functional and ROW is stable.

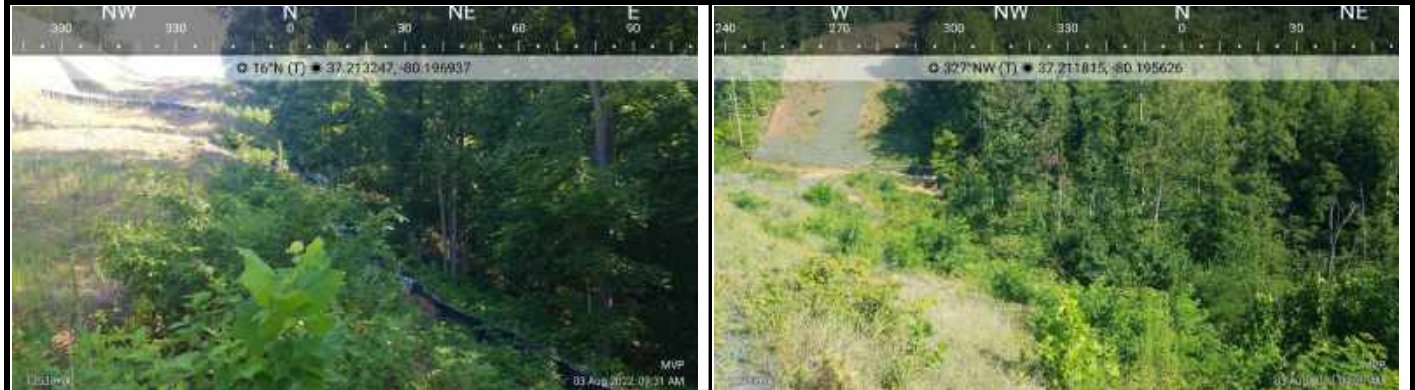
<b>GPS Location</b>	See Above	<b>GPS Location</b>	See Above
<b>Field Station#</b>	12530+00	<b>Field Station#</b>	12535+00
<b>Pic 15 Desc.</b>	ROW Overview (temporary stabilization). ECDs are functional and ROW is stable.	<b>Pic 16 Desc.</b>	ROW Overview (temporary stabilization). ECDs are functional and ROW is stable.

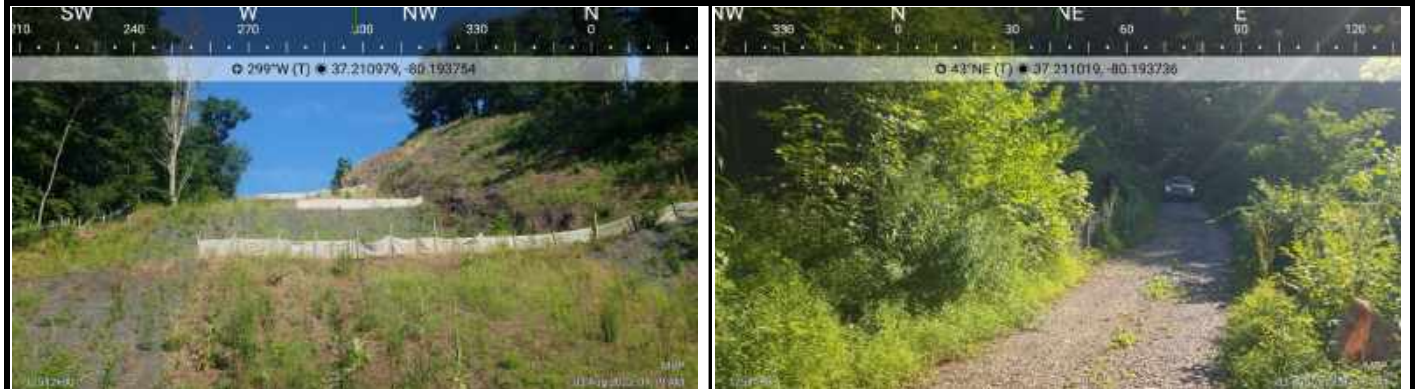
<b>GPS Location</b>	See Above	<b>GPS Location</b>	See Above
<b>Field Station#</b>	12542+00	<b>Field Station#</b>	12544+06
<b>Pic 17 Desc.</b>	ROW Overview (temporary stabilization). ECDs are functional and ROW is stable.	<b>Pic 18 Desc.</b>	ECDs are functional and Access road MN-278.01 (Yellow Finch Lane) area is stable.

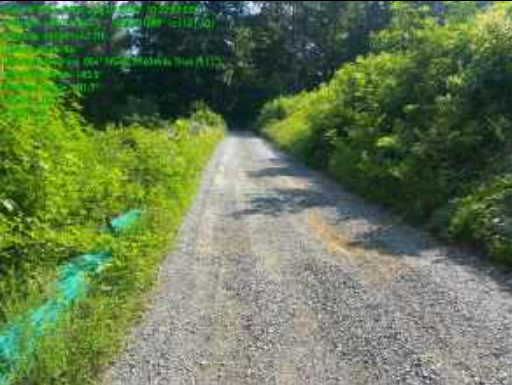
<b>GPS Location</b>	See photo for coordinates.		<b>GPS Location</b>	See photo for coordinates.	
<b>Field Station#</b>	13316+21		<b>Field Station#</b>	13317+02	
<b>Pic 1 Desc.</b>	Wades Gap road crossing in acceptable condition.		<b>Pic 2 Desc.</b>	No environmental issues noted along private driveway.

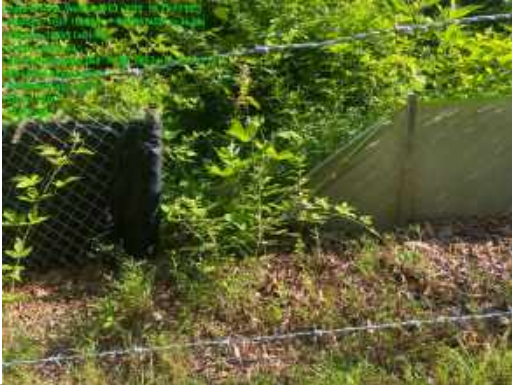
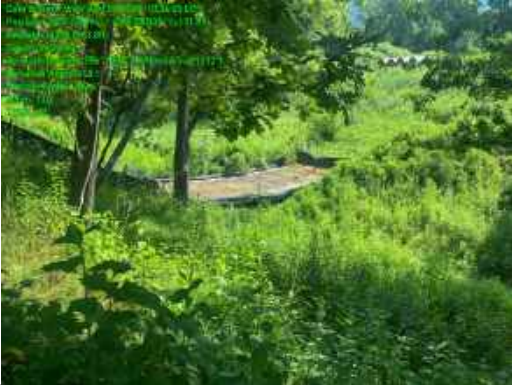
<b>GPS Location</b>	See photo for coordinates.		<b>GPS Location</b>	See photo for coordinates.	
<b>Field Station#</b>	13318+00		<b>Field Station#</b>	13321+47	
<b>Pic 3 Desc.</b>	Silt fence perimeter control down; added to daily Punch List as maintenance item.		<b>Pic 4 Desc.</b>	S-GH15, downstream, stream banks well vegetated.

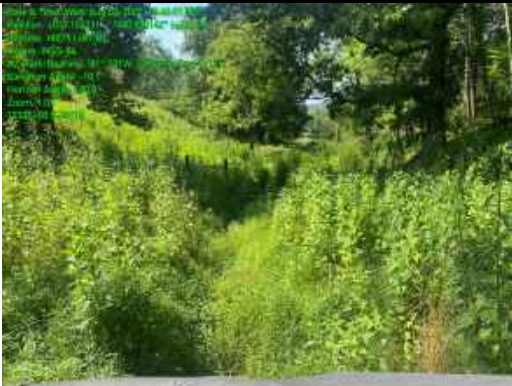
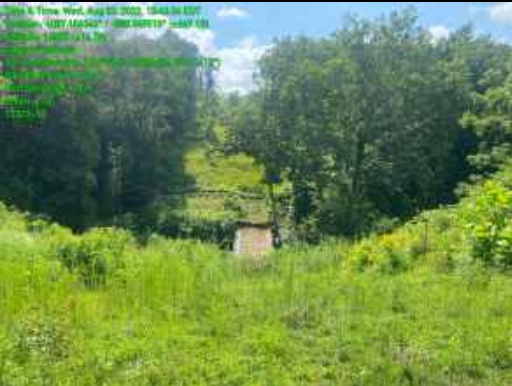
<b>GPS Location</b>	See photo for coordinates.		<b>GPS Location</b>	See photo for coordinates.	
<b>Field Station#</b>	13321+47		<b>Field Station#</b>	13323+59	
<b>Pic 5 Desc.</b>	S-GH15, downstream, no ROW impacts noted.		<b>Pic 6 Desc.</b>	S-GH14, ROW stabilized.

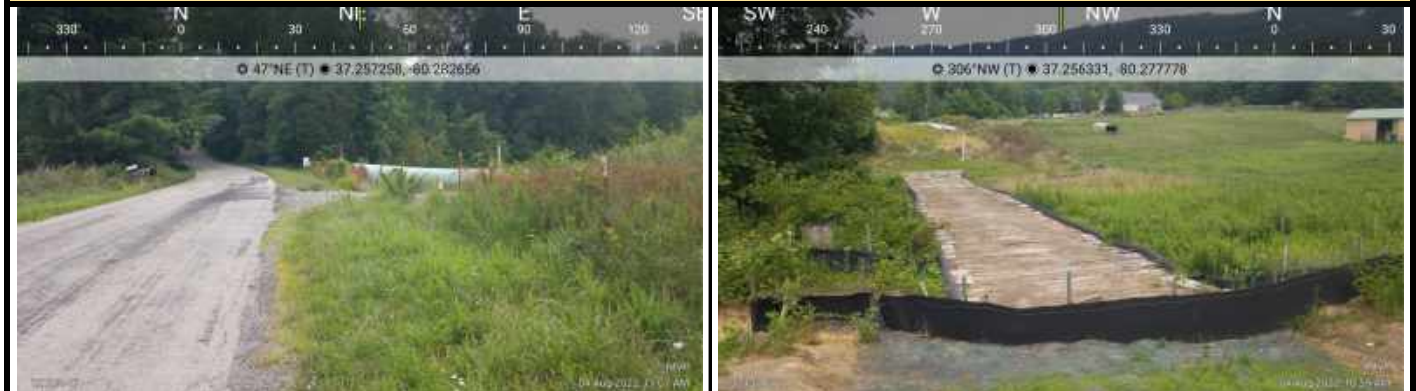
<b>Pic 1 Desc.</b>	Photo shows ST RTE 622 FLATWOODS ROAD crossing and going away side RCE.	<b>Pic 2 Desc.</b>	Photo shows overview of Stream S-C29 and its buffer zone from the going away side.
--------------------	---	--------------------	--

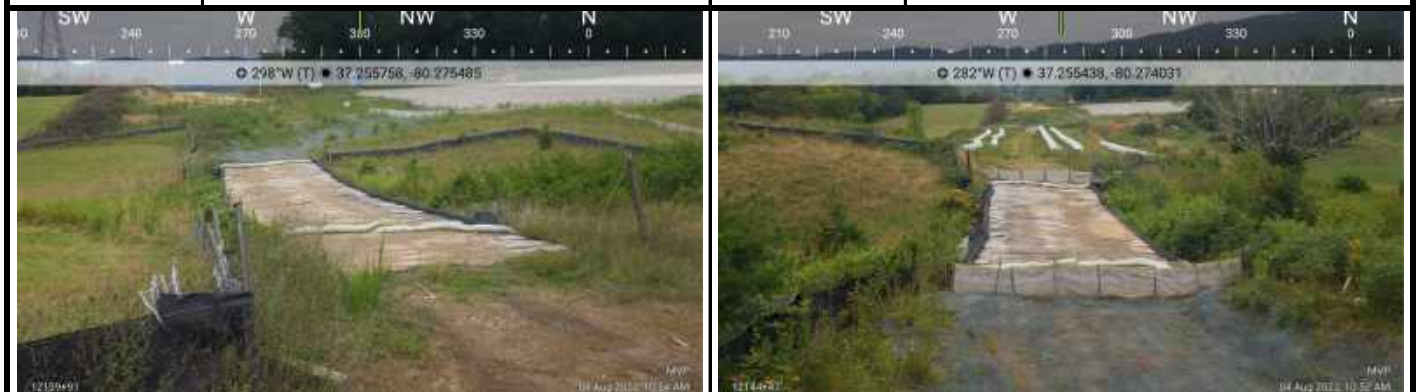
<b>Pic 3 Desc.</b>	Photo shows overview of Wetland W-C6 and its buffer zone from the going away side.	<b>Pic 4 Desc.</b>	Photo shows overview of Wetland W-C5 and its buffer zone from the going away side.
--------------------	--	--------------------	--

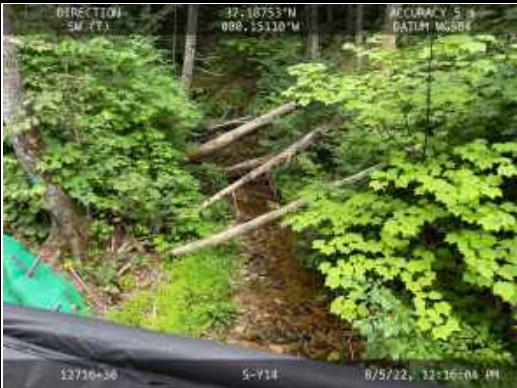
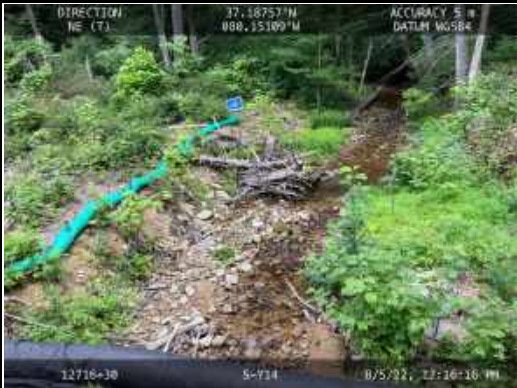
<b>GPS Location</b>	See photo		<b>GPS Location</b>	See photo
<b>Field Station#</b>	12716+30		<b>Field Station#</b>	12716+30
<b>Pic 15 Desc.</b>	Upstream of crossing at Stream S-Y14		<b>Pic 16 Desc.</b>	Downstream of crossing at Stream S-Y14

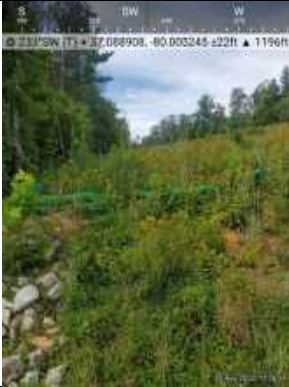
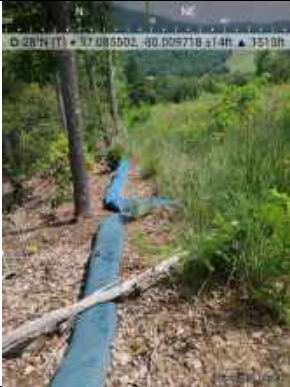
GPS Location 0		GPS Location 0			
Field Station# 13496+00		Field Station# 13490+00			
Pic 1 Desc. CIS Cahas Mtn Rd #2		Pic 2 Desc. Perimeter CFS

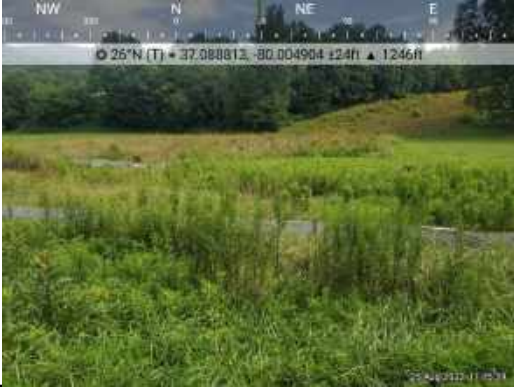
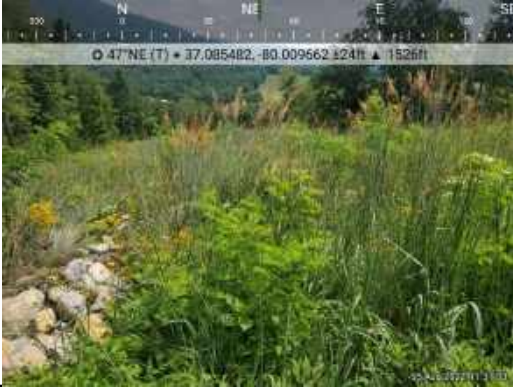
GPS Location 0		GPS Location 0			
Field Station# 13497+00		Field Station# 13484+00			
Pic 3 Desc. CIS S-IJ10 ATWS Silt fence		Pic 4 Desc. Level spreader

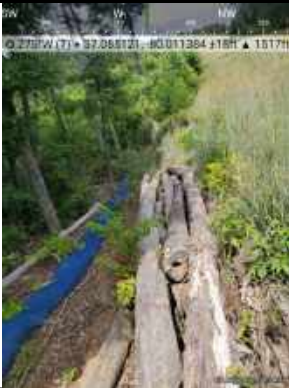
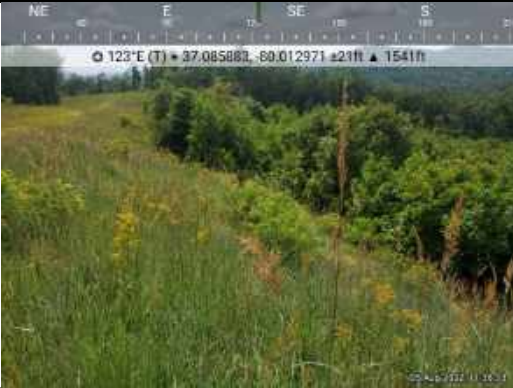
GPS Location 0		GPS Location 0			
Field Station# 13480+00		Field Station# 13475+00			
Pic 5 Desc. Perimeter CFS		Pic 6 Desc. Permanent vegetation on sideslope

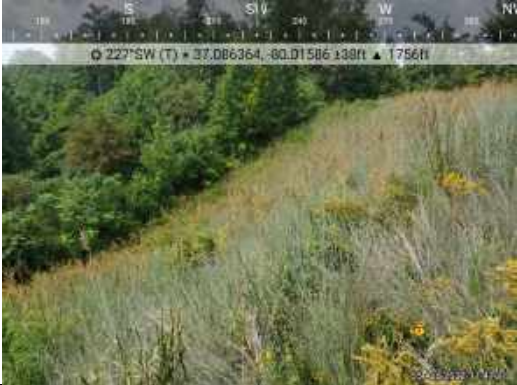
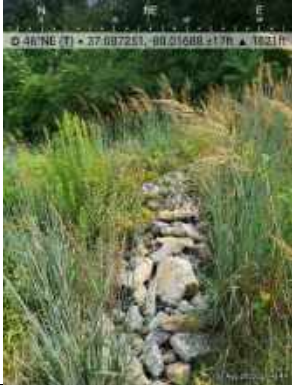
ert image here	
GPS Location 0		GPS Location 0			
Field Station# 13463+00		Field Station# 13458+00			
Pic 7 Desc. Sideslope		Pic 8 Desc. Level spreader

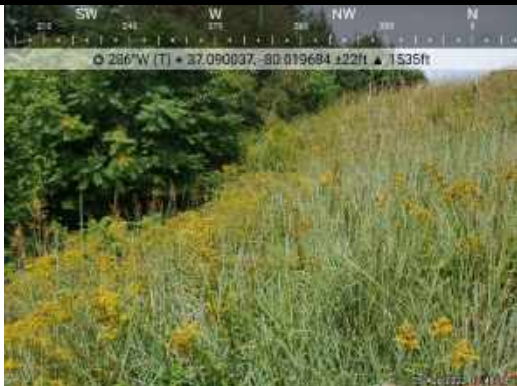
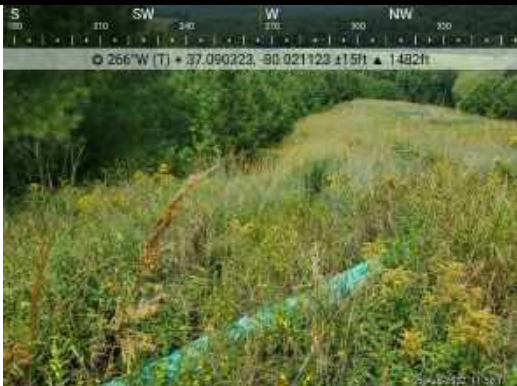
GPS Location 0		GPS Location 0			
Field Station# 13440+00		Field Station# 13435+00			
Pic 9 Desc. Existing slip and vegetation		Pic 10 Desc. Permanent vegetation

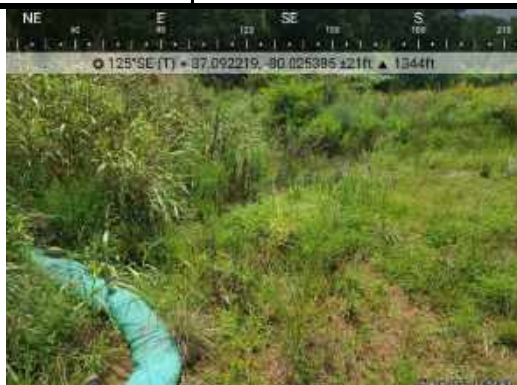
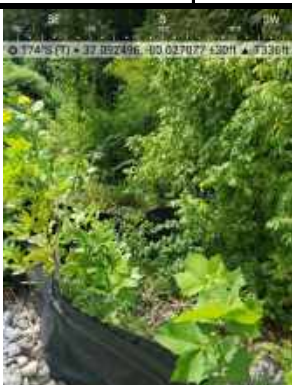
ert image here	
GPS Location 0		GPS Location 0			
Field Station# 13422+00		Field Station# 13416+00			
Pic 11 Desc. CFS Checks		Pic 12 Desc. W-IJ3 Super silt fence

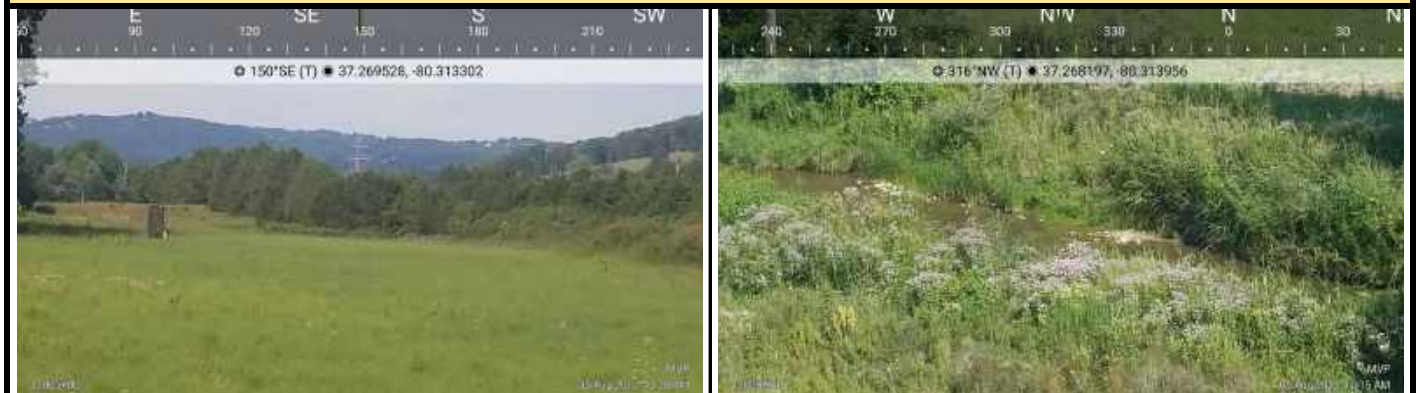
<b>Pic 1 Desc.</b>	ROW Overview. ECDs are functional and ROW is stable.	<b>Pic 2 Desc.</b>	Overview of Waterbody S-G36. ECDs are functional and ROW is stable.
--------------------	--	--------------------	---

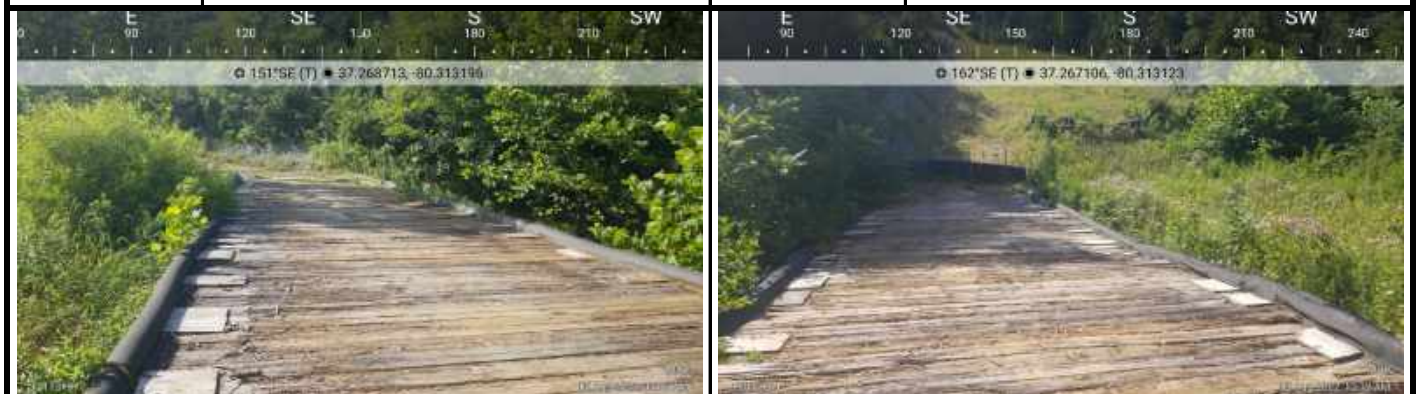
<b>Pic 3 Desc.</b>	Overview of Waterbody S-G36 (Acc Rd 268). ECDs are functional and area is stable.	<b>Pic 4 Desc.</b>	Overview of Waterbody S-G38. ECDs are functional and ROW is stable.
--------------------	---	--------------------	---

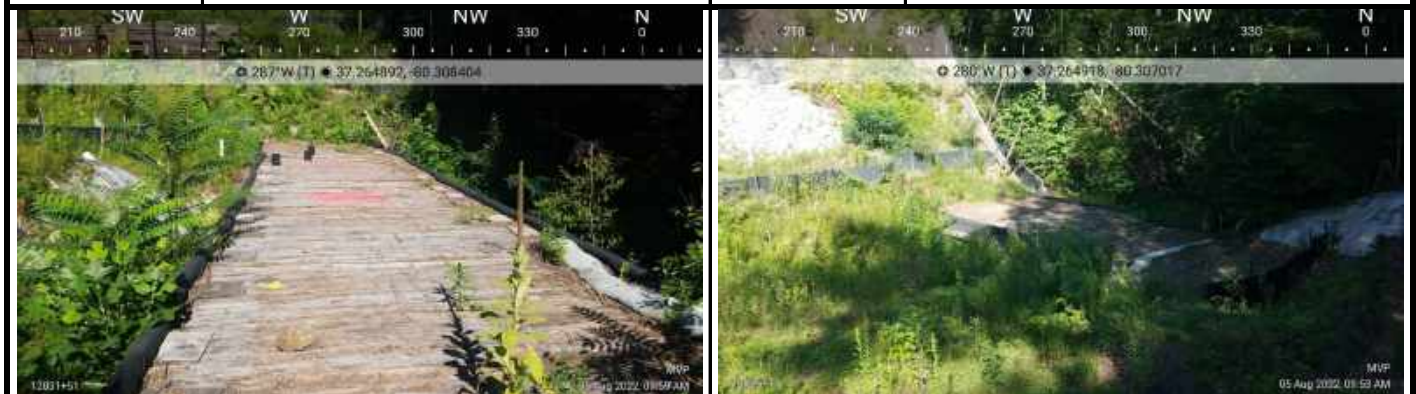
<b>Pic 5 Desc.</b>	Overview of Waterbody S-G39. ECDs are functional and ROW is stable.	<b>Pic 6 Desc.</b>	Overview of Waterbody S-G40. ECDs are functional and ROW is stable.
--------------------	---	--------------------	---

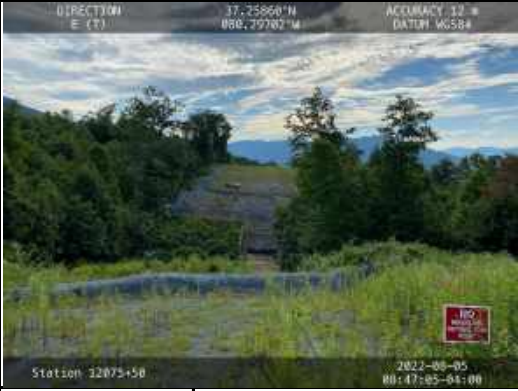
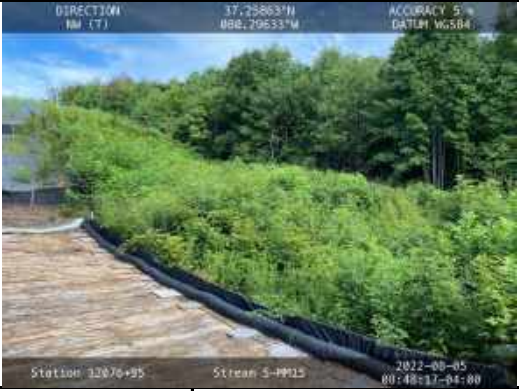
<b>GPS Location</b>	See Above	<b>GPS Location</b>	See Above
<b>Field Station#</b>	12075+50	<b>Field Station#</b>	12076+95
<b>Pic 7 Desc.</b>	ROW Overview. ECDs are functional and ROW is stable.	<b>Pic 8 Desc.</b>	Overview of Waterbody S-MM15. ECDs are functional and ROW is stable.

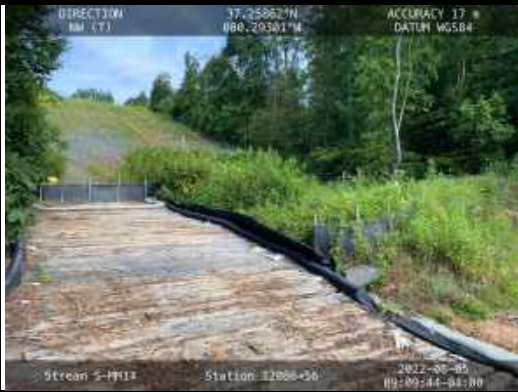
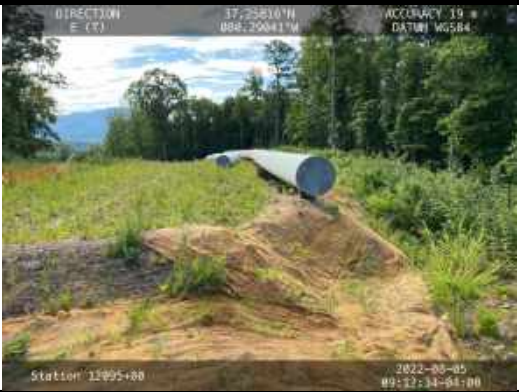
<b>GPS Location</b>	See Above	<b>GPS Location</b>	See Above
<b>Field Station#</b>	12086+56	<b>Field Station#</b>	12095+00
<b>Pic 9 Desc.</b>	Overview of Waterbody S-MM14. ECDs are functional and ROW is stable.	<b>Pic 10 Desc.</b>	ROW Overview. ECDs are functional and ROW is stable.

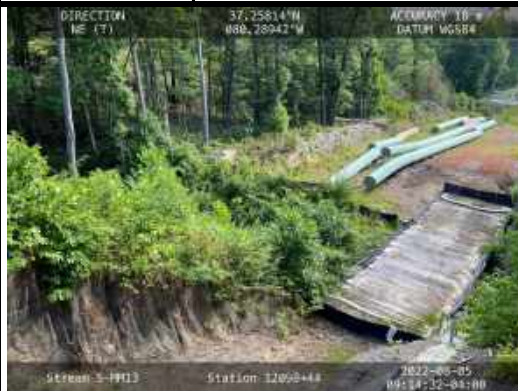
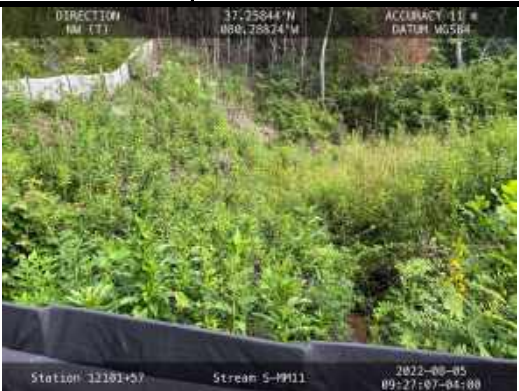
<b>GPS Location</b>	See Above	<b>GPS Location</b>	See Above
<b>Field Station#</b>	12098+44	<b>Field Station#</b>	12101+57
<b>Pic 11 Desc.</b>	Overview of Waterbody S-MM13. ECDs are functional and ROW is stable.	<b>Pic 12 Desc.</b>	Overview of Waterbody S-MM11. ECDs are functional and ROW is stable.

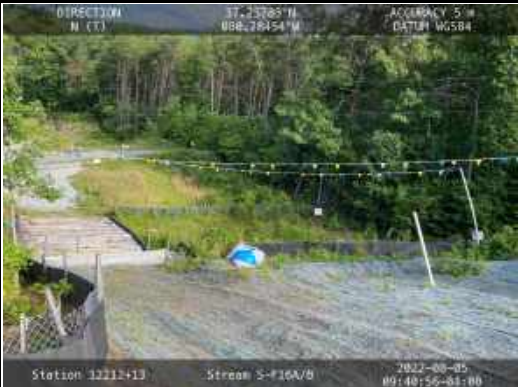
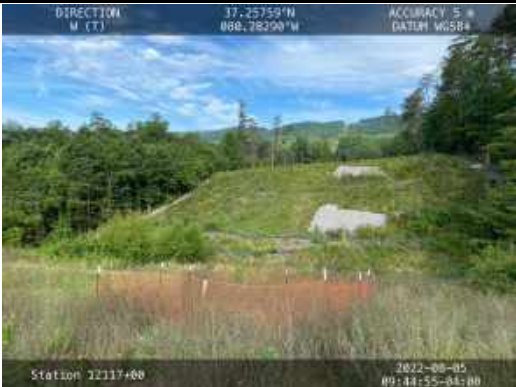
<b>GPS Location</b>	See Above	<b>GPS Location</b>	See Above
<b>Field Station#</b>	12112+13	<b>Field Station#</b>	12117+00
<b>Pic 17 Desc.</b>	Overview of Waterbody S-F16A/B. ECDs are functional and ROW is stable.	<b>Pic 18 Desc.</b>	ROW Overview. ECDs are functional and ROW is stable.
