# Visual Site Inspection Report

<b>Project Name</b> H-600 Pipeline Spread H		<b>AFE</b> 124300138	<b>Spread</b> H-600 Pipeline Spread H
<b>Contractor</b> Precision		<b>Report #</b> 40516	
<b>Inspector</b> Jonathan Altizer		<b>Date/Time</b> 8/1/2022 3:21 PM	
<b>Permit #</b> TBD	<b>Inspection Type</b> VA SWPP	<b>Station Begin</b>	12600+00
<b>State</b> VA	<b>Inspection Area</b> Partial	<b>Station End</b>	12725+00
<b>County</b> Roanoke	<b>Ground</b> Wet	<b>Temperature (°F)</b>	80.00
<b>Municipality</b> N/A	<b>Weather</b> Cloudy	<b>Rain Gauge (in)</b>	0.30
			<b>Rain Accumulation Time (days)</b> 1.00

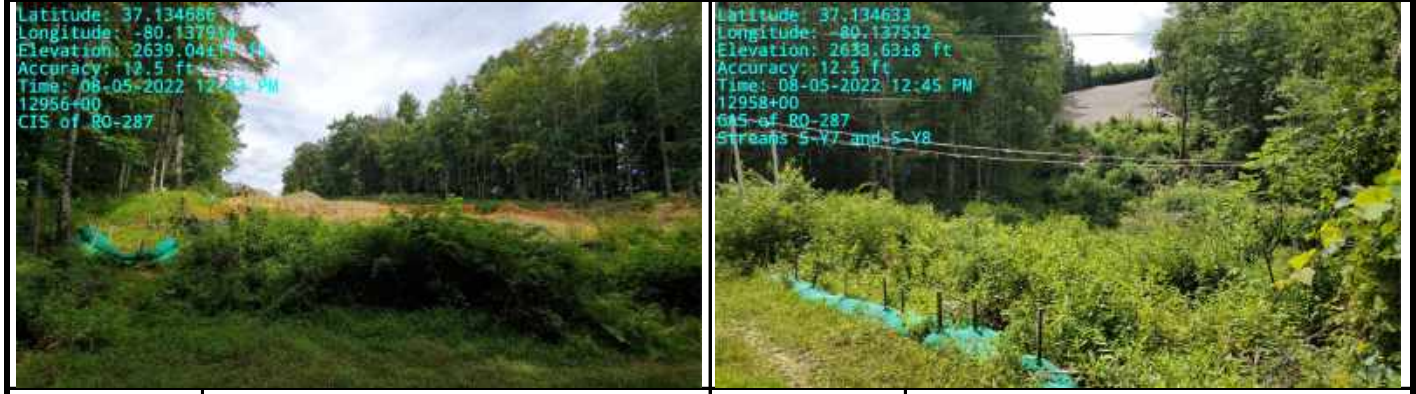
<b>GPS Location</b>	See pic.	<b>GPS Location</b>	See pic.
<b>Field Station#</b>	12956+00	<b>Field Station#</b>	12958+00
<b>Pic 11 Desc.</b>	Current ROW conditions.	<b>Pic 12 Desc.</b>	Streams S-Y7 and S-Y8 from the CIS.

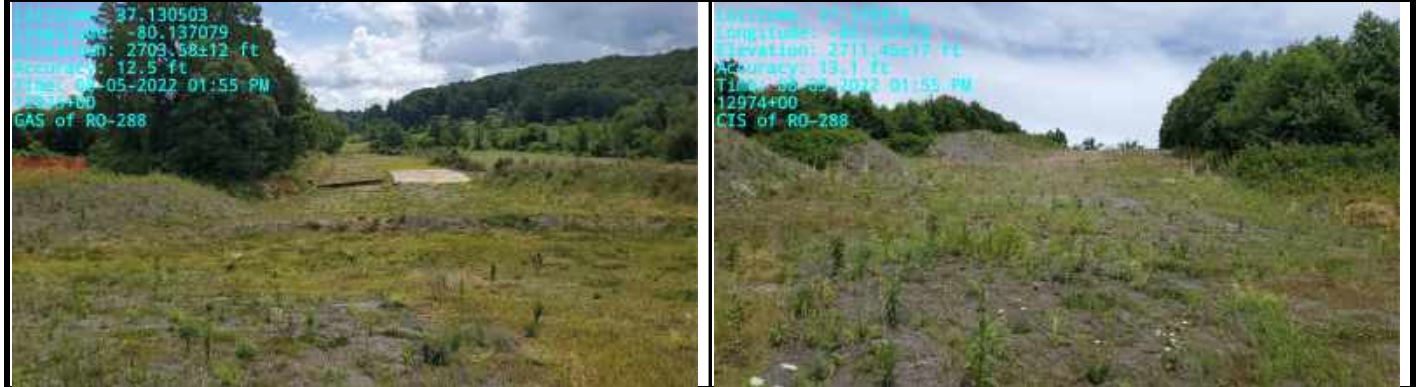
<b>GPS Location</b>	See pic.	<b>GPS Location</b>	See pic.
<b>Field Station#</b>	12975+00	<b>Field Station#</b>	12974+00
<b>Pic 13 Desc.</b>	Current ROW conditions.	<b>Pic 14 Desc.</b>	Current ROW conditions.

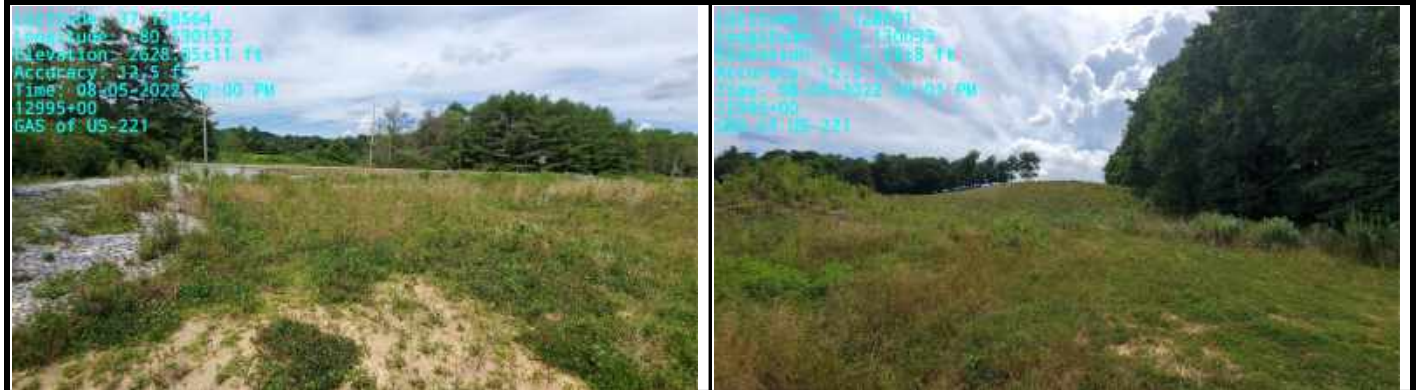
<b>GPS Location</b>	See pic.	<b>GPS Location</b>	See pic.
<b>Field Station#</b>	12995+00	<b>Field Station#</b>	12996+00
<b>Pic 15 Desc.</b>	Current ROW conditions.	<b>Pic 16 Desc.</b>	Current ROW conditions.

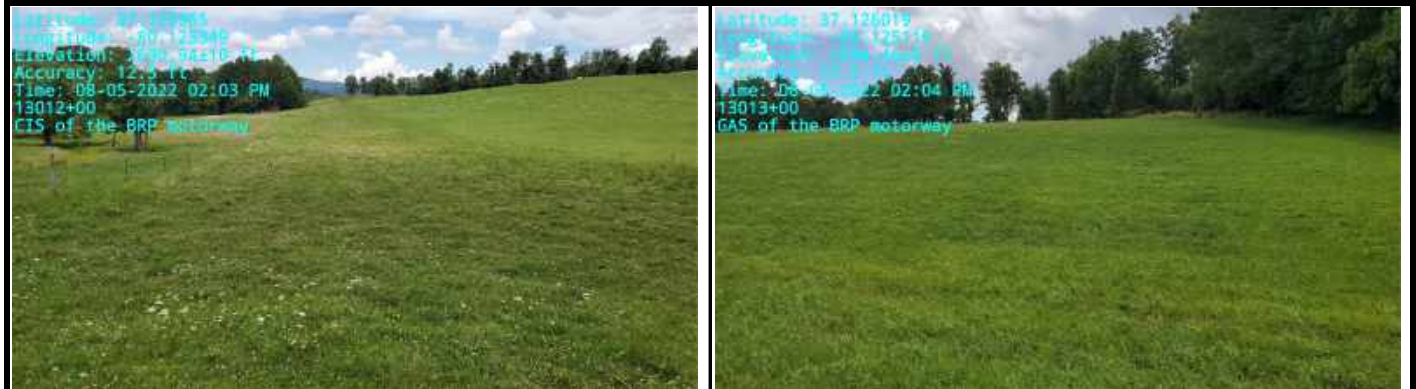
<b>GPS Location</b>	See pic.	<b>GPS Location</b>	See pic.
<b>Field Station#</b>	13012+00	<b>Field Station#</b>	13013+00
<b>Pic 17 Desc.</b>	Current ROW conditions.	<b>Pic 18 Desc.</b>	Current ROW conditions.
