# Visual Site Inspection Report

<b>Project Name</b> H-600 Pipeline Spread H		<b>AFE</b> 124300138	<b>Spread</b> H-600 Pipeline Spread H
<b>Contractor</b> Precision		<b>Report #</b> 41019	
<b>Inspector</b> Dustin Lyons		<b>Date/Time</b> 8/15/2022 4:20 PM	
<b>Permit #</b> TBD	<b>Inspection Type</b> VA SWPP	<b>Station Begin</b> 12443+75	
<b>State</b> VA	<b>Inspection Area</b> Partial	<b>Station End</b> 12544+06	
<b>County</b> Montgomery	<b>Ground</b> Wet	<b>Temperature (°F)</b> 75.00	
<b>Municipality</b> N/A	<b>Weather</b> Cloudy	<b>Rain Gauge (in)</b> 0.50	
<b>Rain Accumulation Time (days)</b>			3.00

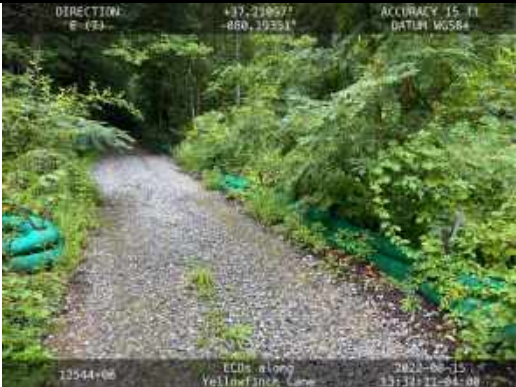
<p>DIRECTION: E (73) +37.21027° -860.19531° ACCURACY 15 FT DATUM WGS84 12544+00 ECDs along Yellowfinch Lane 2022-08-15 13:31:11-04:00</p>

<p>DIRECTION: SE (77) +37.21158° -860.19537° ACCURACY 12 FT DATUM WGS84 12539+00 ROW conditions 2022-08-15 13:19:45-04:00</p>		
<b>GPS Location</b>	See photo for gps location data.		<b>GPS Location</b>	See photo for gps location data.	
<b>Field Station#</b>	12544+06		<b>Field Station#</b>	12539+00	
<b>Pic 1 Desc.</b>	Photo shows the ECDs along Yellowfinch Lane.		<b>Pic 2 Desc.</b>	Photo shows the ROW conditions. ECDs are installed and functioning as designed.

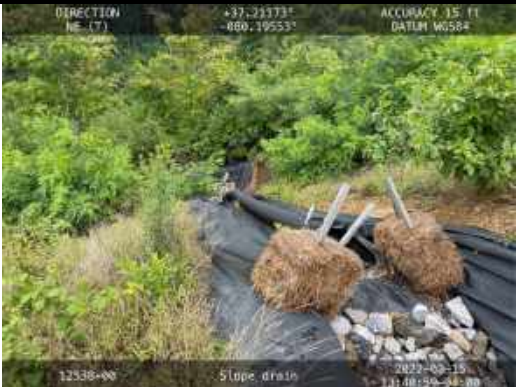
<p>DIRECTION: NE (77) +37.21173° -860.19553° ACCURACY 15 FT DATUM WGS84 12538+00 Slope drain 2022-08-15 13:40:59-04:00</p>

<b>GPS Location</b>	See photo for gps location data.		<b>GPS Location</b>	See photo for gps location data.	
<b>Field Station#</b>	12538+00		<b>Field Station#</b>	12534+00	
<b>Pic 3 Desc.</b>	Photo shows the slope drain.		<b>Pic 4 Desc.</b>	Photo shows the clean water outlet structure.

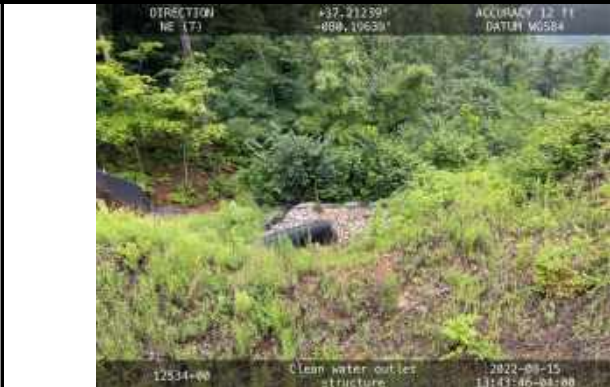
<p>DIRECTION: NE (77) +37.21239° -860.19630° ACCURACY 12 FT DATUM WGS84 12534+00 Clean water outlet structure 2022-08-15 13:43:46-04:00</p>

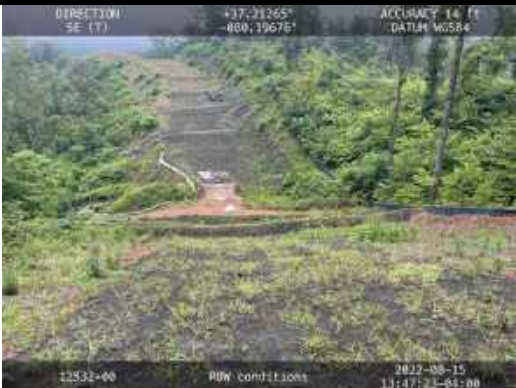
<p>DIRECTION: SE (77) +37.21265° -860.19676° ACCURACY 14 FT DATUM WGS84 12532+00 ROW conditions 2022-08-15 13:47:23-04:00</p>

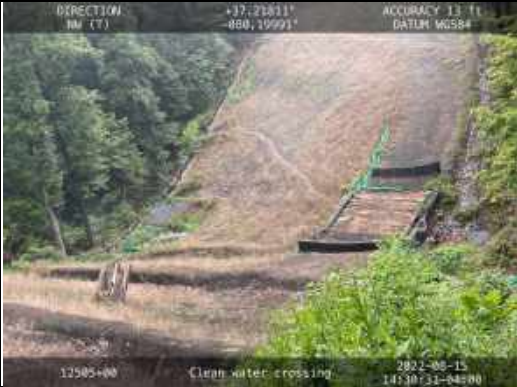
<b>GPS Location</b>	See photo for gps location data.	<b>GPS Location</b>	See photo for gps location data.
<b>Field Station#</b>	12505+00	<b>Field Station#</b>	12499+00
<b>Pic 13 Desc.</b>	Photo shows the ROW conditions and clean water crossing. ECDs are installed and functioning as designed.	<b>Pic 14 Desc.</b>	Photo shows the ROW conditions. ECDs are installed and functioning as designed.

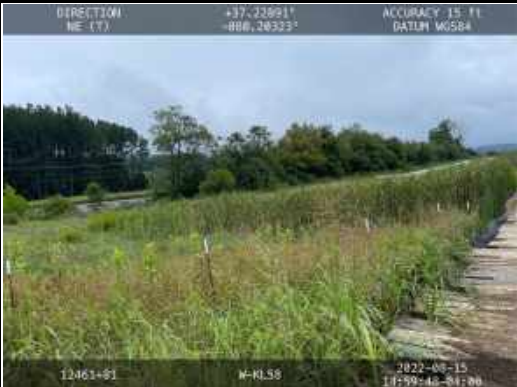
<b>Field Station#</b>	12461+81	<b>Field Station#</b>	12455+21
<b>Pic 17 Desc.</b>	Photo shows W-KL58.	<b>Pic 18 Desc.</b>	Photo shows S-CD12b downstream from the bridge.

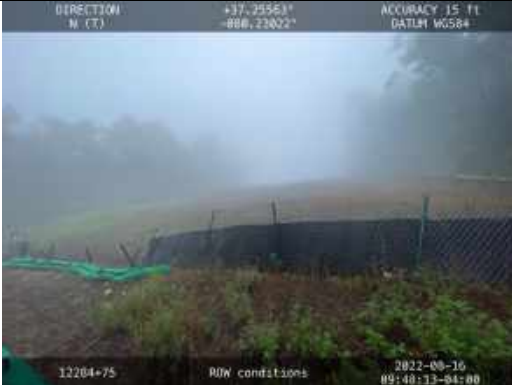
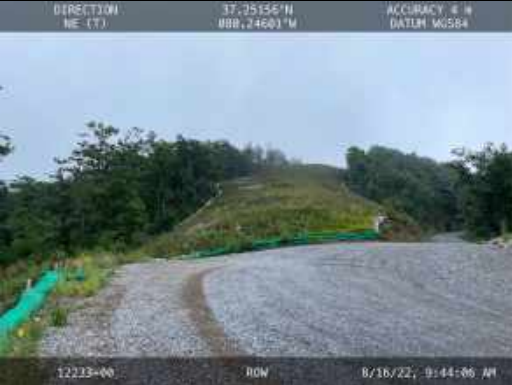
<b>GPS Location</b>	See photo		<b>GPS Location</b>	See photo	
<b>Field Station#</b>	12284+75		<b>Field Station#</b>	12233+00	
<b>Pic 1 Desc.</b>	Current ROW conditions. ROW is stable and ECDs are functional.		<b>Pic 2 Desc.</b>	Current ROW conditions. ROW is stable and ECDs are functional.

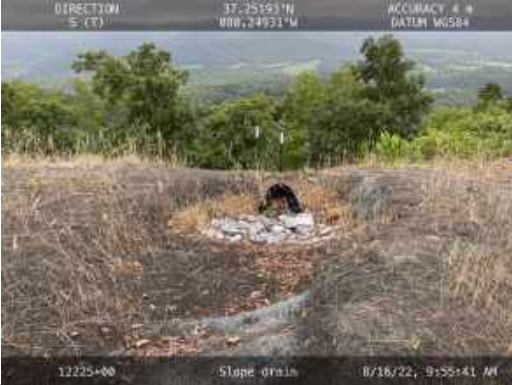
<b>GPS Location</b>	See photo		<b>GPS Location</b>	See photo	
<b>Field Station#</b>	12232+00		<b>Field Station#</b>	12225+00	
<b>Pic 3 Desc.</b>	Current ROW conditions. ROW is stable and ECDs are functional.		<b>Pic 4 Desc.</b>	Slope drain is functional

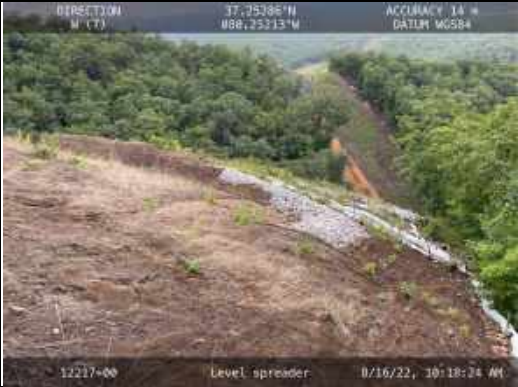
<b>GPS Location</b>	See photo	<b>GPS Location</b>	See photo		
<b>Field Station#</b>	12217+00	<b>Field Station#</b>	12166+47		
<b>Pic 7 Desc.</b>	Permanent ECDs are functional	<b>Pic 8 Desc.</b>	Downstream of crossing at Stream S-C24

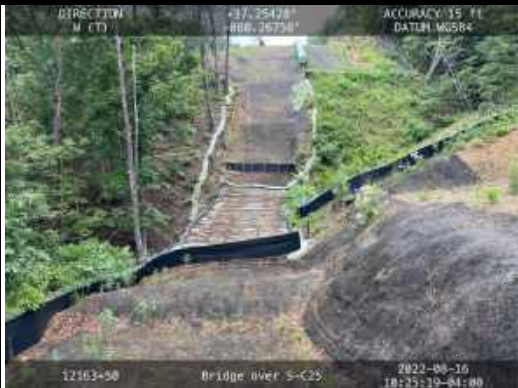
<b>GPS Location</b>	See photo	<b>GPS Location</b>	See photo		
<b>Field Station#</b>	12163+50	<b>Field Station#</b>	12214+00		
<b>Pic 9 Desc.</b>	Bridge over S-C25	<b>Pic 10 Desc.</b>	Current ROW conditions. ROW is stable and ECDs are functional.

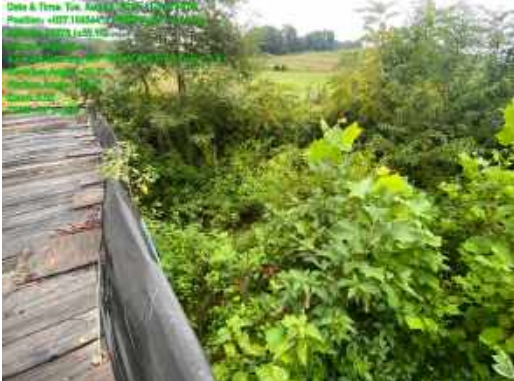
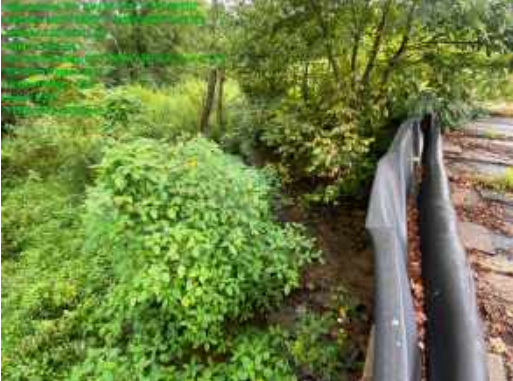
<p>Date &amp; Time: Tue, Aug 16, 2022, 11:00:00 EDT  Position: +037.158544° / -081.050647° (s:791.79)  Altitude: 13309 (s:61.09)  Datum: WGS-84  Azimuth/Bearing: 000° ARWE: 1502m/s True (s:137)  Elevation Angle: -08.1°  Horizon Angle: -03.2°  Status: 0.50  13309+09</p>		<p><b>GPS Location</b> See photo for coordinates.</p> <p><b>GPS Location</b> See photo for coordinates.</p>	
<p><b>Field Station#</b> 13309+09</p> <p><b>Field Station#</b> 13309+09</p>		<p><b>Field Station#</b> 13309+09</p> <p><b>Field Station#</b> 13309+09</p>		<p><b>Pic 3 Desc.</b> S-GH7, upstream, no ROW impacts noted.</p> <p><b>Pic 4 Desc.</b> S-GH7, downstream, slight turbidity noted.</p>

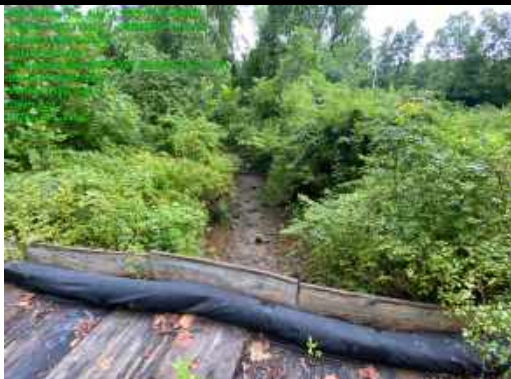
<b>GPS Location</b>	See photo for coordinates.		<b>GPS Location</b>	See photo for coordinates.
<b>Field Station#</b>	13260+60		<b>Field Station#</b>	13260+60
<b>Pic 9 Desc.</b>	S-II4, upstream, no ROW impacts noted; slight turbidity present.		<b>Pic 10 Desc.</b>	S-II4, downstream, no ROW impacts noted.

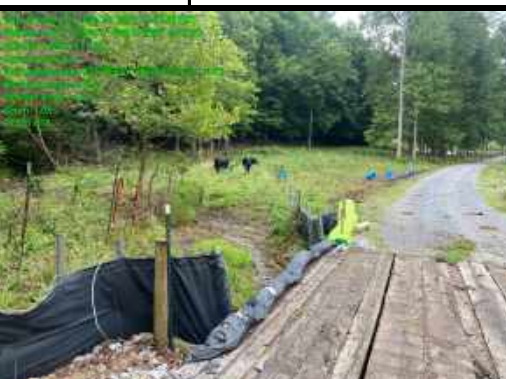
<b>Pic 11 Desc.</b>	Dillons Mill road crossing, ROW stabilized.		<b>Pic 12 Desc.</b>	MVP-AR-29, S-D10 upstream, cattle disturbance noted in stream and along stream banks.

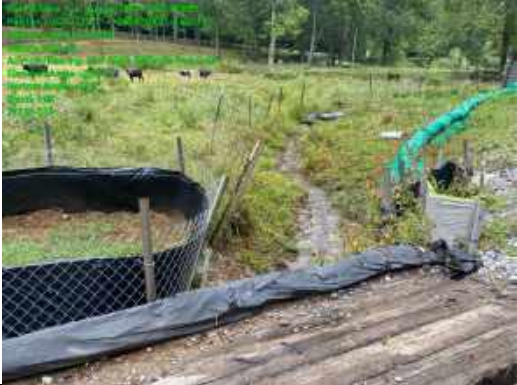
<b>GPS Location</b>	See photo for coordinates.	<b>GPS Location</b>	See photo for coordinates.		
<b>Field Station#</b>	13196+31	<b>Field Station#</b>	13164+00		
<b>Pic 13 Desc.</b>	MVP-AR-29, S-D10 downstream, sediment accumulation noted in stream and wetland W-EF11.	<b>Pic 14 Desc.</b>	ROW stabilized.

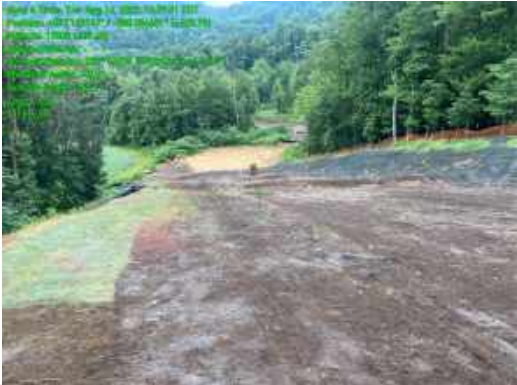
<b>GPS Location</b>	See photo for coordinates.	<b>GPS Location</b>	See photo for coordinates.		
<b>Field Station#</b>	13161+00	<b>Field Station#</b>	13157+13		
<b>Pic 15 Desc.</b>	ROW stabilized, fill slope stable.	<b>Pic 16 Desc.</b>	S-D11, downstream, no ROW impacts noted, slight turbidity present.

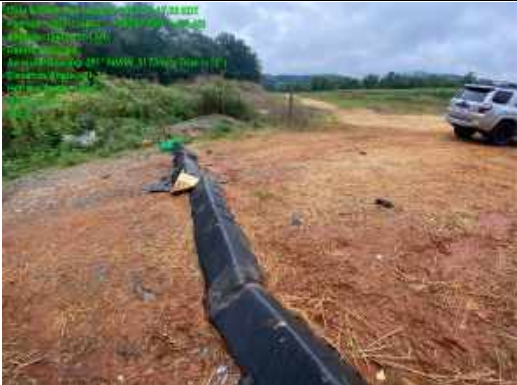
Insert image here			
<b>GPS Location</b>	See photo for coordinates.	<b>GPS Location</b>			
<b>Field Station#</b>	13185+50	<b>Field Station#</b>			
<b>Pic 17 Desc.</b>	Triangular foam dike needing maintenance; added to daily Punch List as a 72 hour maintenance item.	<b>Pic 18 Desc.</b>

E&S BMPs	Compliance Level	Corrective Action	Corrective Time Frame	Date Repaired
Cleanwater Diversion Berm	Acceptable			
Compost Filter Sock	Acceptable			
Erosion Control Blanket	Acceptable			
Rock Construction Entrance	Acceptable			
Sensitive Resource Buffer	Acceptable			
Silt Fence (Filter Fabric Fence)	Acceptable			
Silt Fence (Reinforced Filter Fabric Fence)	Acceptable			
Sump Pit	Acceptable			
Other - Explain in Comments	Acceptable	Foam dike; 72 hr item - repair/replacement	Addressed	8/17/2022

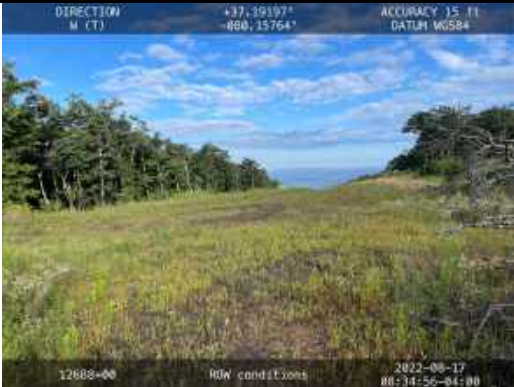
<b>GPS Location</b>	See photo for gps location data.		<b>GPS Location</b>	See photo for gps location data.	
<b>Field Station#</b>	12688+00		<b>Field Station#</b>	12690+00	
<b>Pic 1 Desc.</b>	Photo shows the ROW condition. ECDs are installed and functioning as designed.		<b>Pic 2 Desc.</b>	Photo shows the ROW condition. ECDs are installed and functioning as designed.

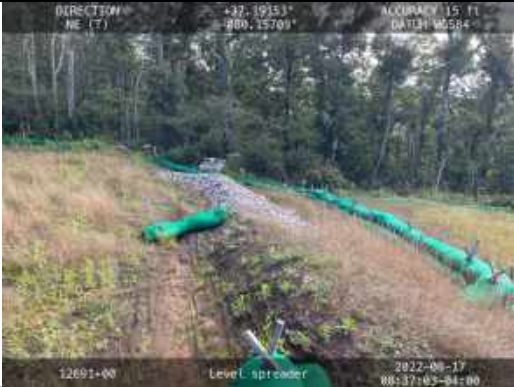
<b>GPS Location</b>	See photo for gps location data.		<b>GPS Location</b>	See photo for gps location data.	
<b>Field Station#</b>	12691+00		<b>Field Station#</b>	12693+00	
<b>Pic 3 Desc.</b>	Photo shows the level spreader.		<b>Pic 4 Desc.</b>	Photo shows the ROW condition. ECDs are installed and functioning as designed.

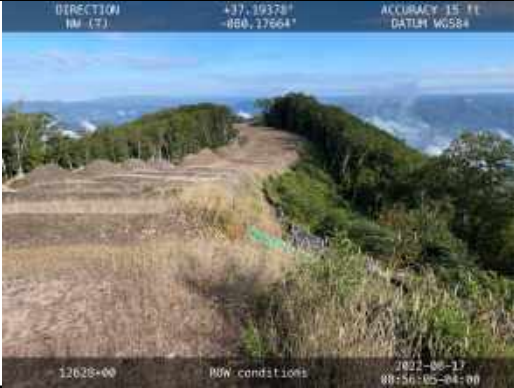
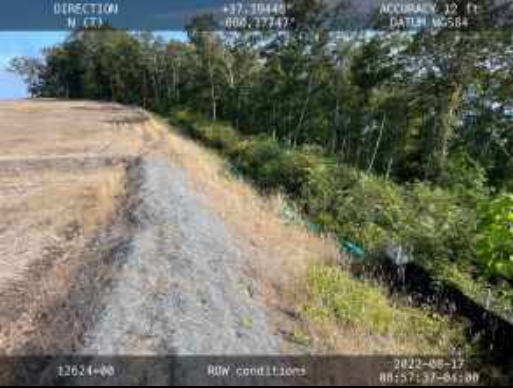
<b>Pic 5 Desc.</b>	Photo shows the ROW condition. ECDs are installed and functioning as designed.		<b>Pic 6 Desc.</b>	Photo shows the ROW condition. ECDs are installed and functioning as designed.

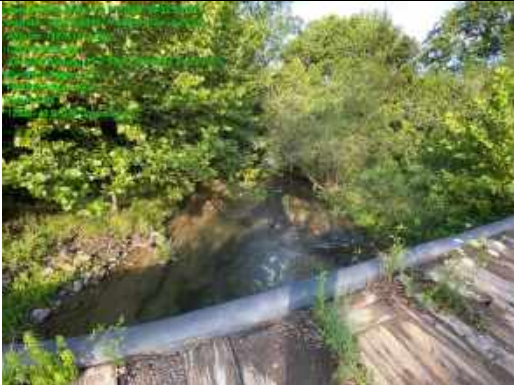
<b>GPS Location</b>	See photo	<b>GPS Location</b>	See photo		
<b>Field Station#</b>	12008+60	<b>Field Station#</b>	12031+51		
<b>Pic 1 Desc.</b>	Downstream of crossing at Stream S-G36	<b>Pic 2 Desc.</b>	Looking at equipment bridge over Stream S-G39

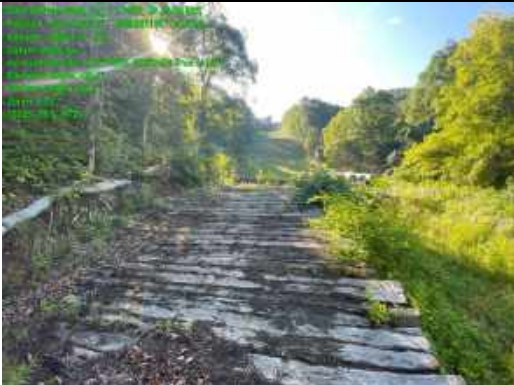
<b>GPS Location</b>	See photo	<b>GPS Location</b>	See photo		
<b>Field Station#</b>	12035+75	<b>Field Station#</b>	12036+00		
<b>Pic 3 Desc.</b>	Equipment bridge over Stream S-PP23	<b>Pic 4 Desc.</b>	Current ROW conditions. ROW is stable and ECDs are functional.

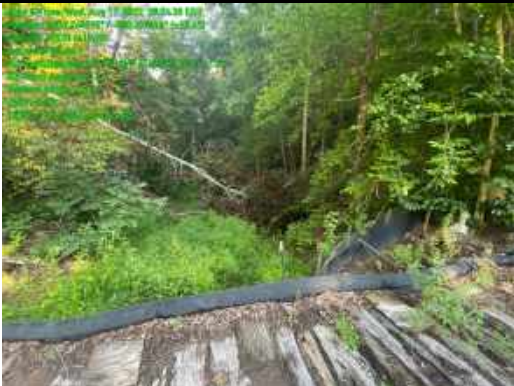
<b>GPS Location</b>	See photo	<b>GPS Location</b>	See photo		
<b>Field Station#</b>	12035+11	<b>Field Station#</b>	12070+00		
<b>Pic 5 Desc.</b>	Downstream of crossing at Stream S-G40	<b>Pic 6 Desc.</b>	Current ROW conditions. ROW is stable and ECDs are functional.

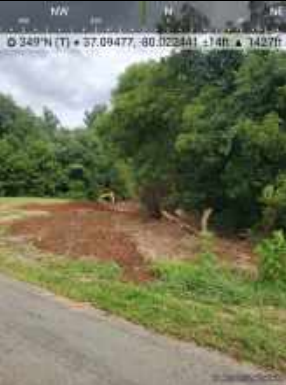
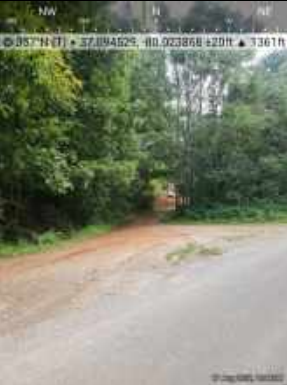
GPS Location 0		GPS Location 0			
Field Station# 0+00		Field Station# 0+00			
Pic 1 Desc. Land grading activity in area of creek channel north of Cahas Mtn Rd #1 crossing		Pic 2 Desc. Land grading activity in area of creek channel north of Cahas Mtn Rd #1 crossing

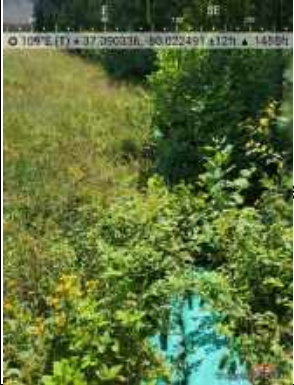
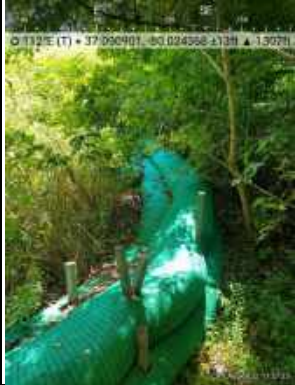
ert image here	
<b>GPS Location</b> 0		<b>GPS Location</b> 0			
<b>Field Station#</b> 13432+00		<b>Field Station#</b> 13425+50			
<b>Pic 7 Desc.</b> Sideslope vegetation and perimeter CFS		<b>Pic 8 Desc.</b> Perimeter CFS

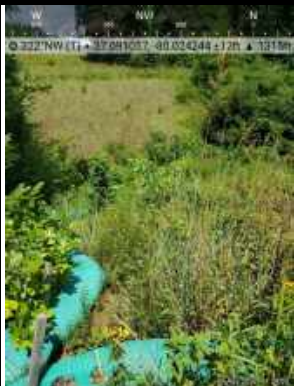
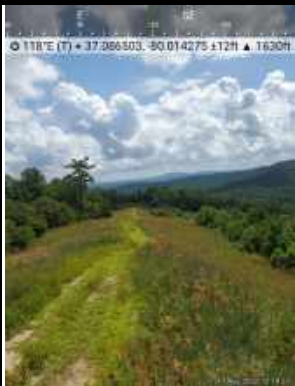
ert image here	
<b>GPS Location</b> 0		<b>GPS Location</b> 0			
<b>Field Station#</b> 13426+50		<b>Field Station#</b> 13463+00			
<b>Pic 9 Desc.</b> GAS S-IJ4 Buffer zone and ECDs		<b>Pic 10 Desc.</b> Vegetation

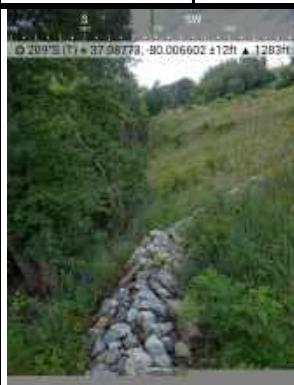
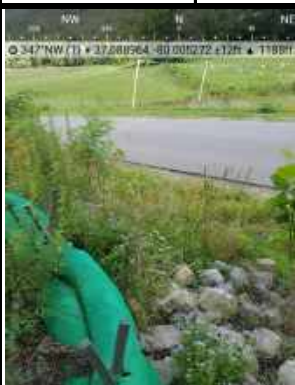
ert image here	
<b>GPS Location</b> 0		<b>GPS Location</b> 0			
<b>Field Station#</b> 13490+00		<b>Field Station#</b> 13496+75			
<b>Pic 11 Desc.</b> Level spreader and perimeter CFS		<b>Pic 12 Desc.</b> CIS Cahas Mtn Rd #2 Bank and ECDs

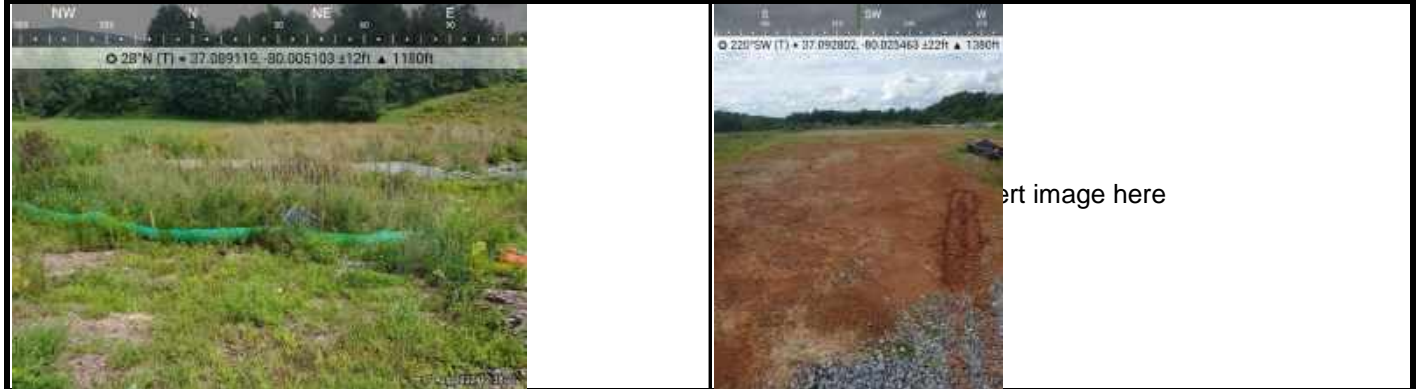
<b>GPS Location</b>	0	<b>GPS Location</b>	0
<b>Field Station#</b>	13497+50	<b>Field Station#</b>	13420+00
<b>Pic 13 Desc.</b>	CIS W-IJ6 ECDs	<b>Pic 14 Desc.</b>	Approach off RCE on GAS Cahas Mtn Rd #1 needs to be stabilized

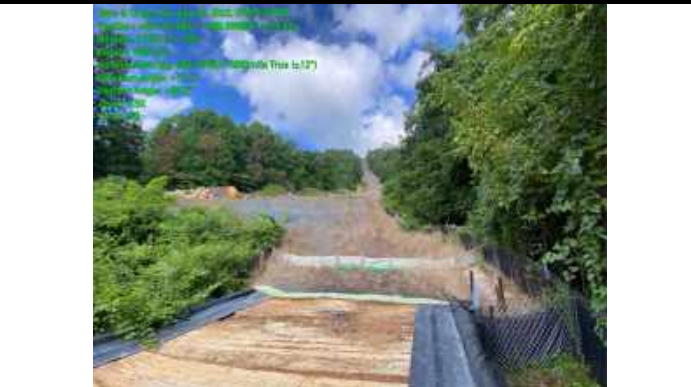
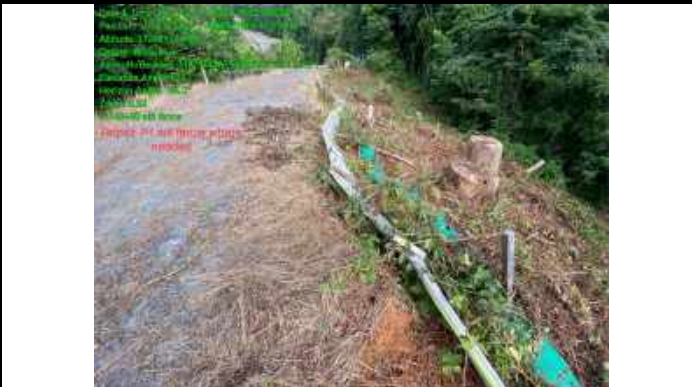
<b>GPS Location</b>		See pic.		<b>GPS Location</b>	
<b>Field Station#</b>		13026+00		<b>Field Station#</b>	
<b>Pic 1 Desc.</b>		Streams S-G24 and S-G25 from the GAS.		<b>Pic 2 Desc.</b>

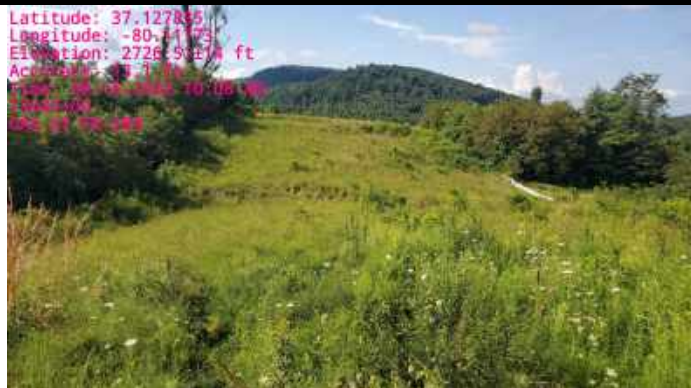
<b>GPS Location</b>		See pic.		<b>GPS Location</b>	
<b>Field Station#</b>		13137+78		<b>Field Station#</b>	
<b>Pic 3 Desc.</b>		Current ROW conditions.		<b>Pic 4 Desc.</b>

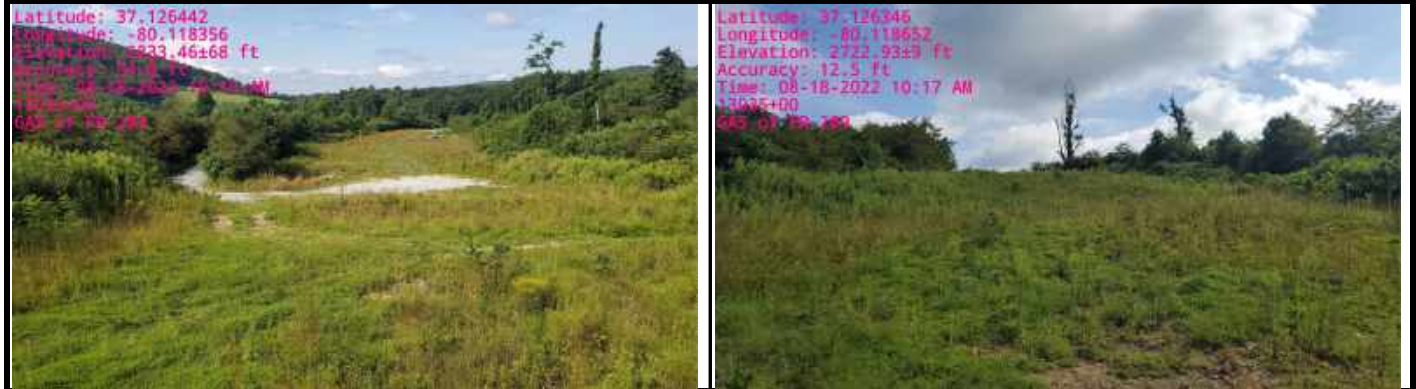
<b>GPS Location</b>	See pic.	<b>GPS Location</b>	See pic.
<b>Field Station#</b>	13035+00	<b>Field Station#</b>	13035+00
<b>Pic 7 Desc.</b>	Current ROW conditions.	<b>Pic 8 Desc.</b>	Current ROW conditions.

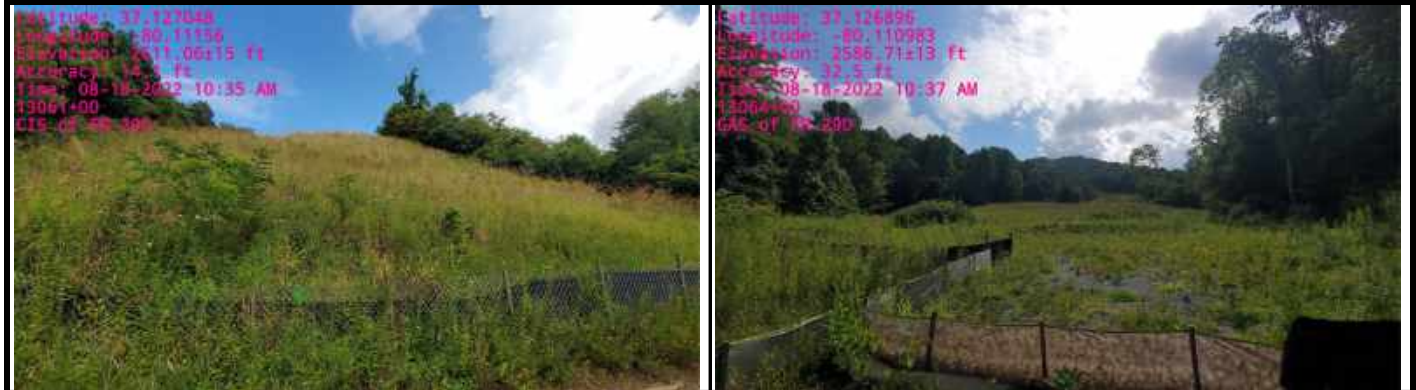
<b>GPS Location</b>	See pic.	<b>GPS Location</b>	See pic.
<b>Field Station#</b>	13061+00	<b>Field Station#</b>	13064+00
<b>Pic 9 Desc.</b>	Current ROW conditions.	<b>Pic 10 Desc.</b>	Current ROW conditions.

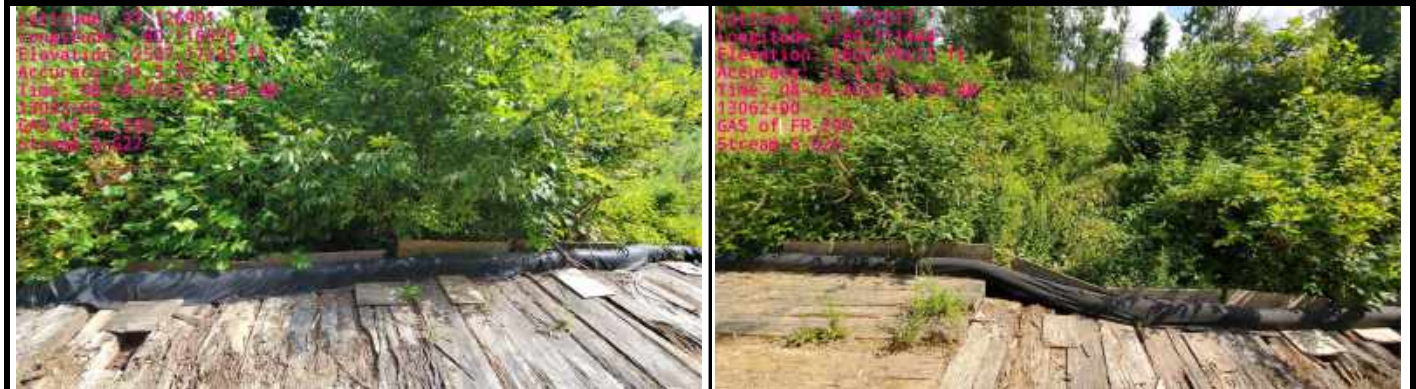
<b>GPS Location</b>	See pic.	<b>GPS Location</b>	See pic.
<b>Field Station#</b>	13063+00	<b>Field Station#</b>	13062+00
<b>Pic 11 Desc.</b>	Upstream side of stream S-G27.	<b>Pic 12 Desc.</b>	Upstream side of stream S-G26.

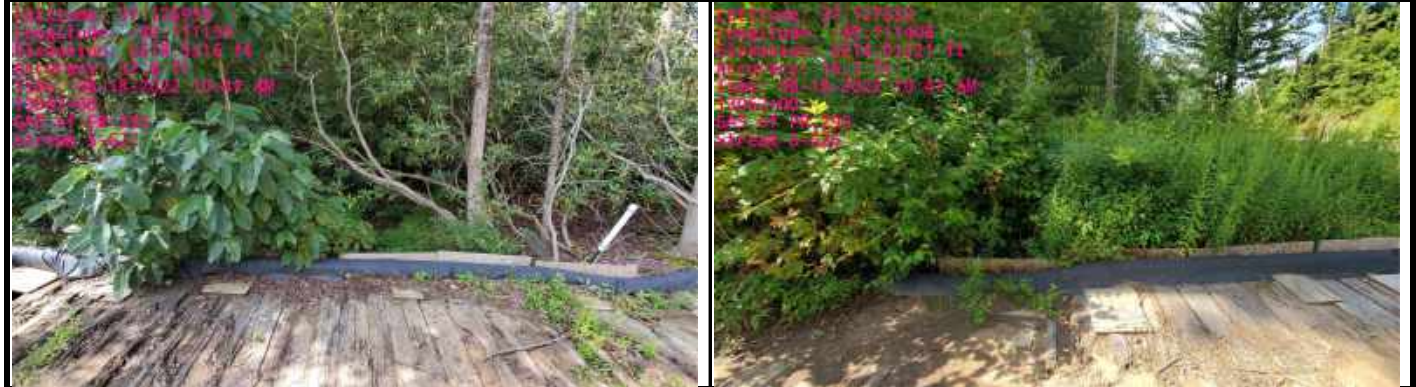
<b>GPS Location</b>	See pic.	<b>GPS Location</b>	See pic.
<b>Field Station#</b>	13063+00	<b>Field Station#</b>	13062+00
<b>Pic 13 Desc.</b>	Downstream side of stream S-G27.	<b>Pic 14 Desc.</b>	Downstream side of stream S-G26.

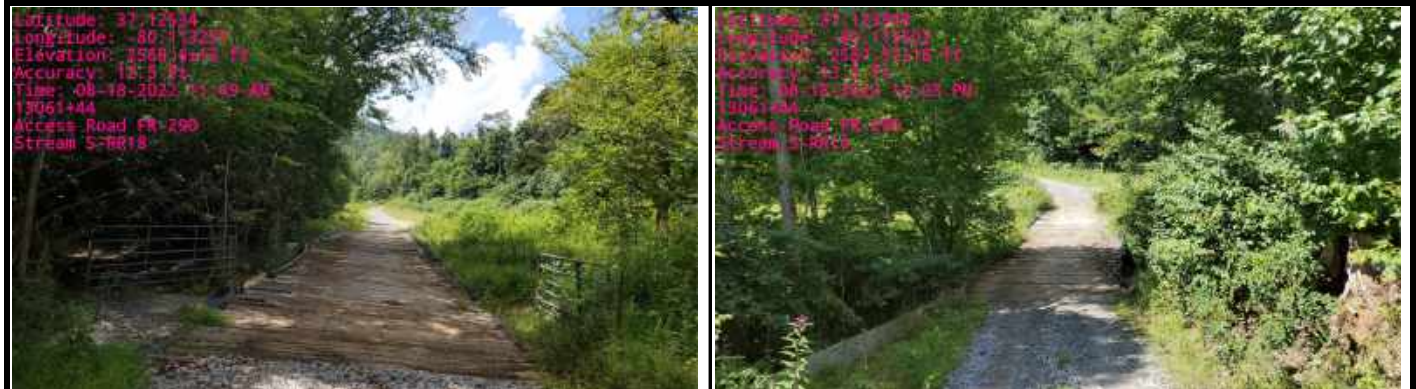
<b>GPS Location</b>	See pic.	<b>GPS Location</b>	See pic.
<b>Field Station#</b>	13061+44	<b>Field Station#</b>	13061+44
<b>Pic 17 Desc.</b>	Stream crossing S-RR18 on FR-290.	<b>Pic 18 Desc.</b>	Stream crossing S-RR16 on FR-290.

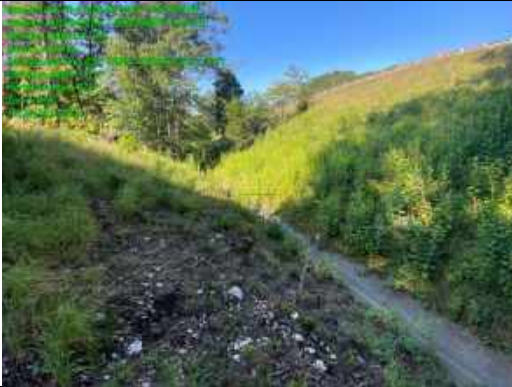
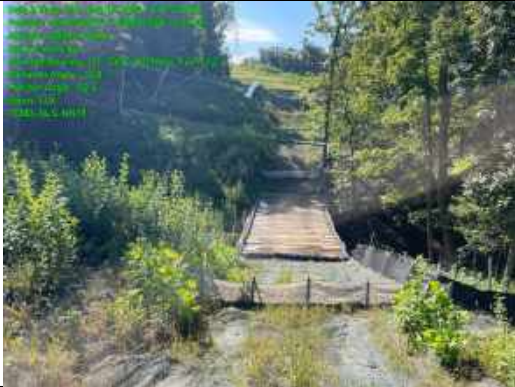
<b>GPS Location</b>	See photo	<b>GPS Location</b>	See photo		
<b>Field Station#</b>	12374+16	<b>Field Station#</b>	12380+04		
<b>Pic 1 Desc.</b>	Looking downstream at Stream S-0016	<b>Pic 2 Desc.</b>	Overview of Stream S-NN19

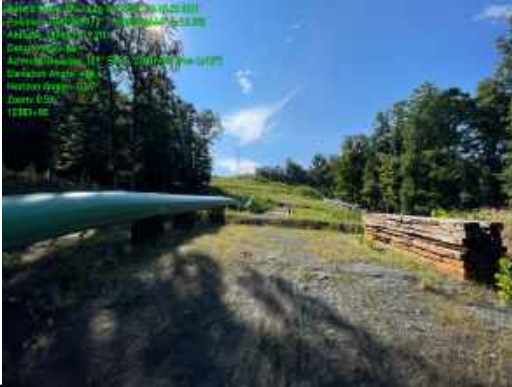
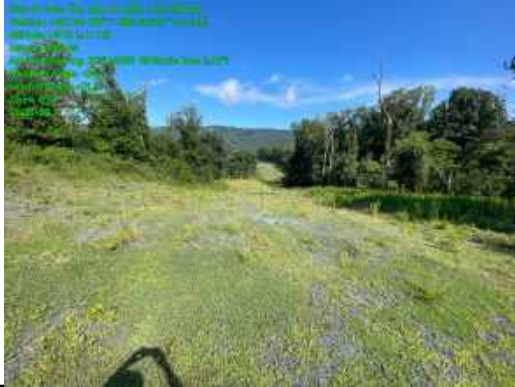
<b>GPS Location</b>	See photo	<b>GPS Location</b>	See photo		
<b>Field Station#</b>	12383+00	<b>Field Station#</b>	12400+00		
<b>Pic 3 Desc.</b>	Current ROW conditions. ROW is stable and ECDs are functional.	<b>Pic 4 Desc.</b>	Current ROW conditions. ROW is stable and ECDs are functional.

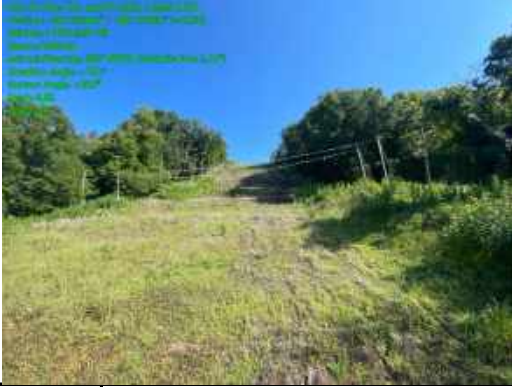
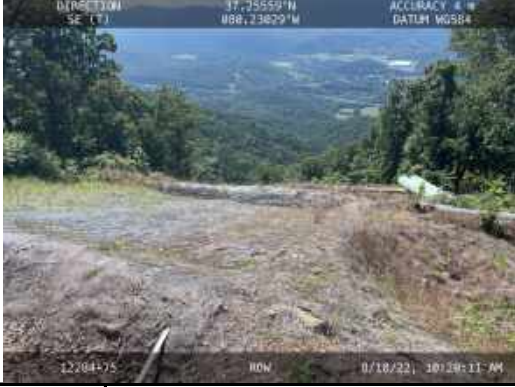
<b>GPS Location</b>	See photo	<b>GPS Location</b>	See photo		
<b>Field Station#</b>	12420+00	<b>Field Station#</b>	12284+75		
<b>Pic 5 Desc.</b>	Current ROW conditions. ROW is stable and ECDs are functional.	<b>Pic 6 Desc.</b>	Current ROW conditions. ROW is stable and ECDs are functional.

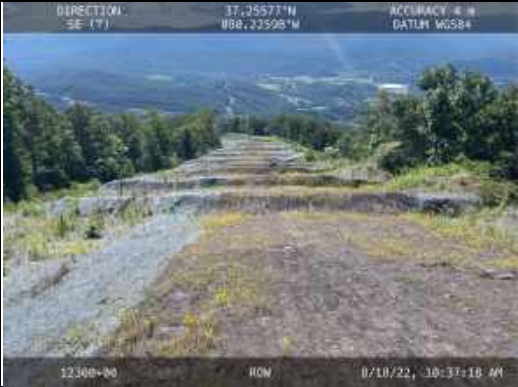
<p>DIRECTION: SE (T) 37.25577°N 088.23598°W ACCURACY: 4 m DATUM: WGS84 12300+00 ROW 8/18/22, 10:37:18 AM</p>

<p>DIRECTION: E (T) 37.25435°N 088.22253°W ACCURACY: 5 m DATUM: WGS84 12310+00 ROW 8/18/22, 10:41:57 AM</p>	
<b>GPS Location</b>	See photo	<b>GPS Location</b>	See photo
<b>Field Station#</b>	12300+00	<b>Field Station#</b>	12310+00
<b>Pic 7 Desc.</b>	Current ROW conditions. ROW is stable and ECDs are functional.	<b>Pic 8 Desc.</b>	Current ROW conditions. ROW is stable and ECDs are functional.

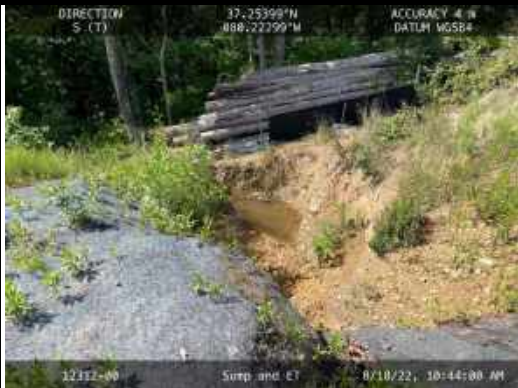
<p>DIRECTION: S (T) 37.25399°N 088.22799°W ACCURACY: 4 m DATUM: WGS84 12312+00 Sump and ET 8/18/22, 10:44:00 AM</p>

<b>Pic 9 Desc.</b>	Sump and End Treatment are functional	<b>Pic 10 Desc.</b>	Current ROW conditions. ROW is stable and ECDs are functional.

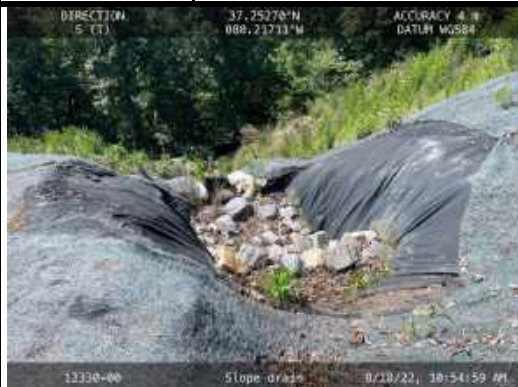
<p>DIRECTION: S (T) 37.25278°N 088.21711°W ACCURACY: 4 m DATUM: WGS84 12330+00 Slope drain 8/18/22, 10:54:59 AM</p>

<p>DIRECTION: E (T) 37.25181°N 088.21505°W ACCURACY: 4 m DATUM: WGS84 12335+00 ROW 8/18/22, 10:58:00 AM</p>	
<b>GPS Location</b>	See photo	<b>GPS Location</b>	See photo
<b>Field Station#</b>	12330+00	<b>Field Station#</b>	12335+00
<b>Pic 11 Desc.</b>	Slope drain is functional.	<b>Pic 12 Desc.</b>	Current ROW conditions. ROW is stable and ECDs are functional.

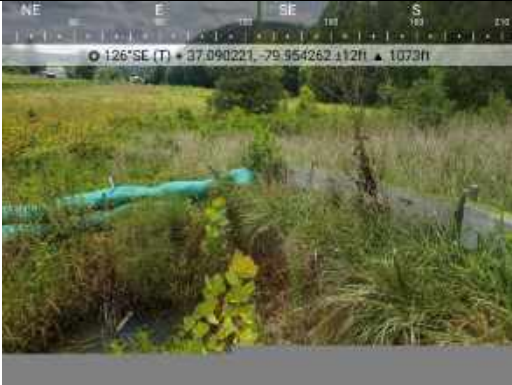
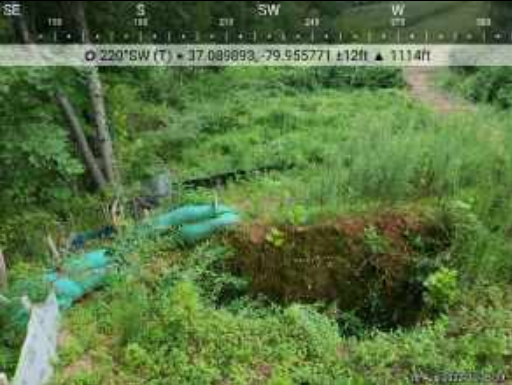
GPS Location 0		GPS Location 0			
Field Station# 13665+50		Field Station# 13660+00			
Pic 1 Desc. CIS S-GH2 Sump and perimeter ECDs		Pic 2 Desc. GAS S-GH3 Sump and perimeter ECDs

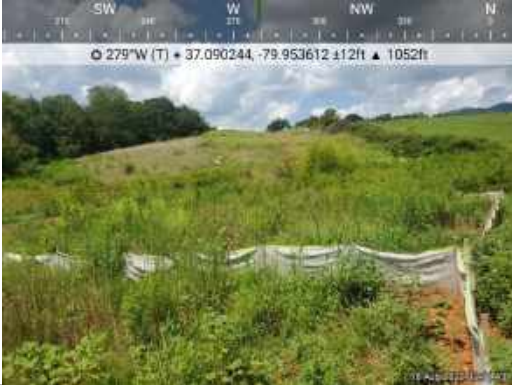
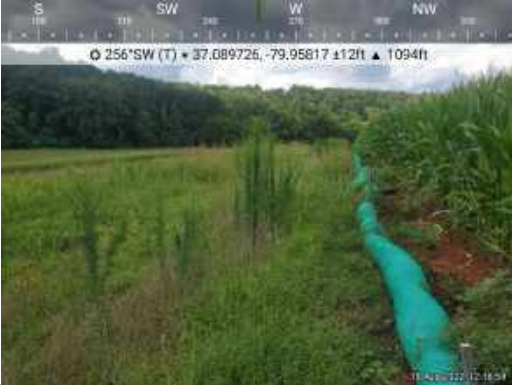
GPS Location 0		GPS Location 0			
Field Station# 13667+00		Field Station# 13655+00			
Pic 3 Desc. GAS S-GH2 Perimeter ECDs and Buffer zone		Pic 4 Desc. Perimeter CFS

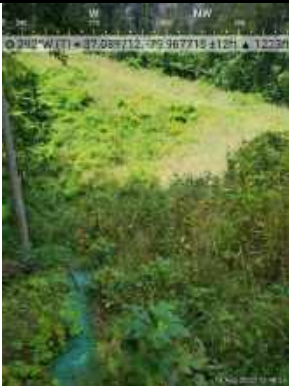
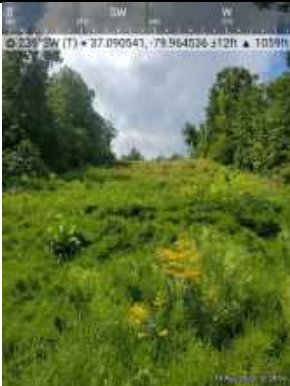
GPS Location 0		GPS Location 0			
Field Station# 13612+00		Field Station# 13632+00			
Pic 5 Desc. Perimeter CFS and vegetation		Pic 6 Desc. Hillside vegetation

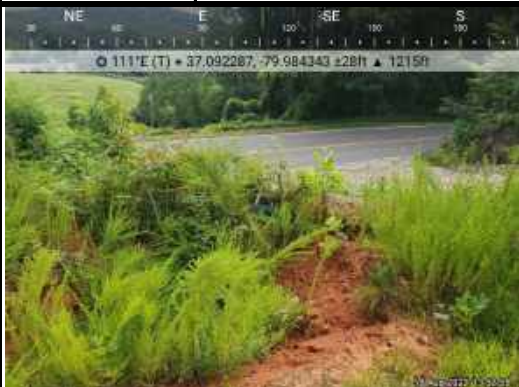
GPS Location	0		GPS Location	0	
Field Station#	13564+00		Field Station#	13562+00	
Pic 11 Desc.	CIS W-GH2 Vegetation and buffer zone ECDs		Pic 12 Desc.	CIS Bethlehem Rd ECDs

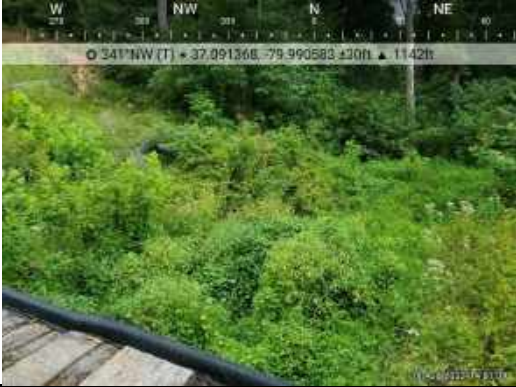
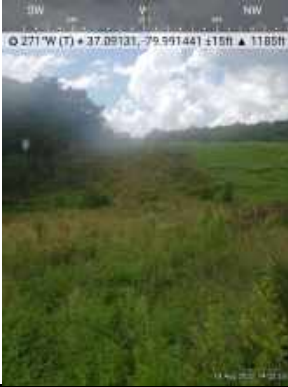
<p>ert image here</p>	
<b>GPS Location</b>	0	<b>GPS Location</b>	0		
<b>Field Station#</b>	13543+25	<b>Field Station#</b>	13541+00		
<b>Pic 13 Desc.</b>	S-II9 Banks	<b>Pic 14 Desc.</b>	CIS House Rock Rd Vegetation		
Insert image here			Insert image here		
<b>GPS Location</b>		<b>GPS Location</b>			
<b>Field Station#</b>		<b>Field Station#</b>			
<b>Pic 15 Desc.</b>		<b>Pic 16 Desc.</b>			
Insert image here			Insert image here		
<b>GPS Location</b>		<b>GPS Location</b>			
<b>Field Station#</b>		<b>Field Station#</b>			
<b>Pic 17 Desc.</b>		<b>Pic 18 Desc.</b>

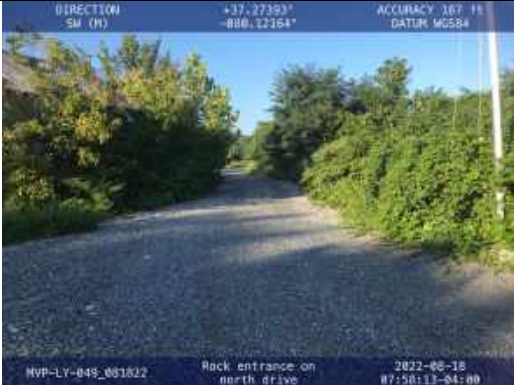
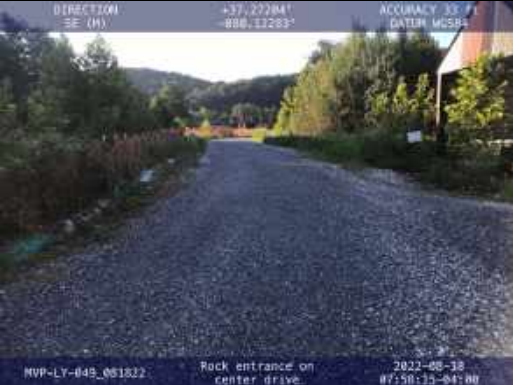
<b>GPS Location</b>	MVP-LY-049 See photo for gps data		<b>GPS Location</b>	MVP-LY-049 See photo for gps data	
<b>Field Station#</b>	+0		<b>Field Station#</b>	+0	
<b>Pic 1 Desc.</b>	Rock entrance on north drive. No sediment or debris on stone. Looking SW.		<b>Pic 2 Desc.</b>	Rock entrance on center drive. Smaller stone applied over larger stone. Looking SE.

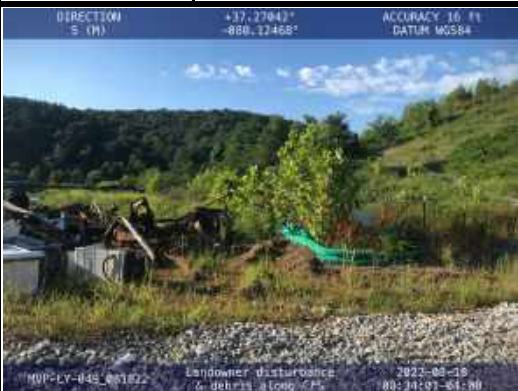
<b>Field Station#</b>	+0		<b>Field Station#</b>	+0
<b>Pic 17 Desc.</b>	Landowner soil disturbance and debris piled along triple stack compost filter sock and east of feature W-CV21B. Looking S.		<b>Pic 18 Desc.</b>	Compost filter sock in place and functioning around sand pile. Looking SW.

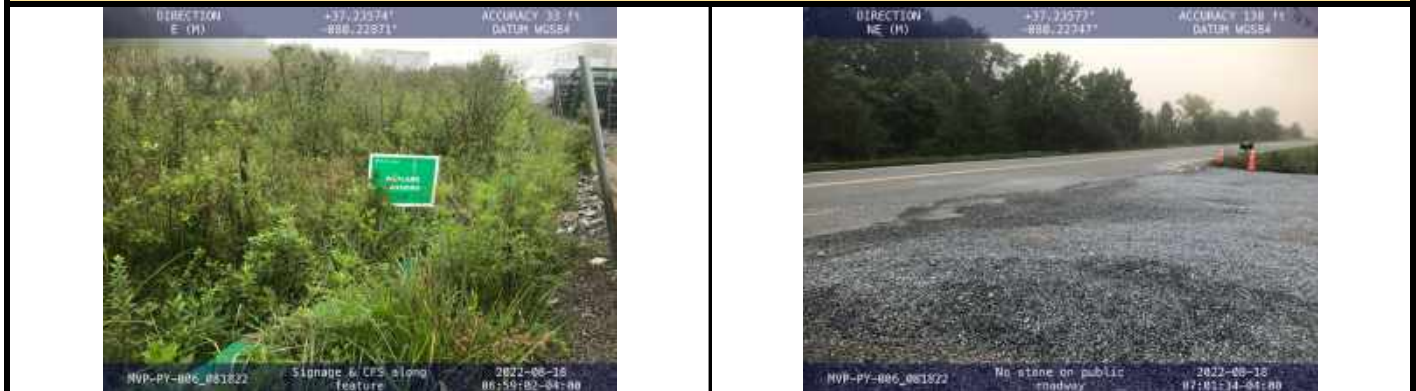
<b>Pic 1 Desc.</b>	Signage and triple stack compost filter sock at feature W-008 Overgrown with vegetation. Looking E.	<b>Pic 2 Desc.</b>	Rock entrance at main entrance no stone on public roadway. Looking NE.
--------------------	---	--------------------	--

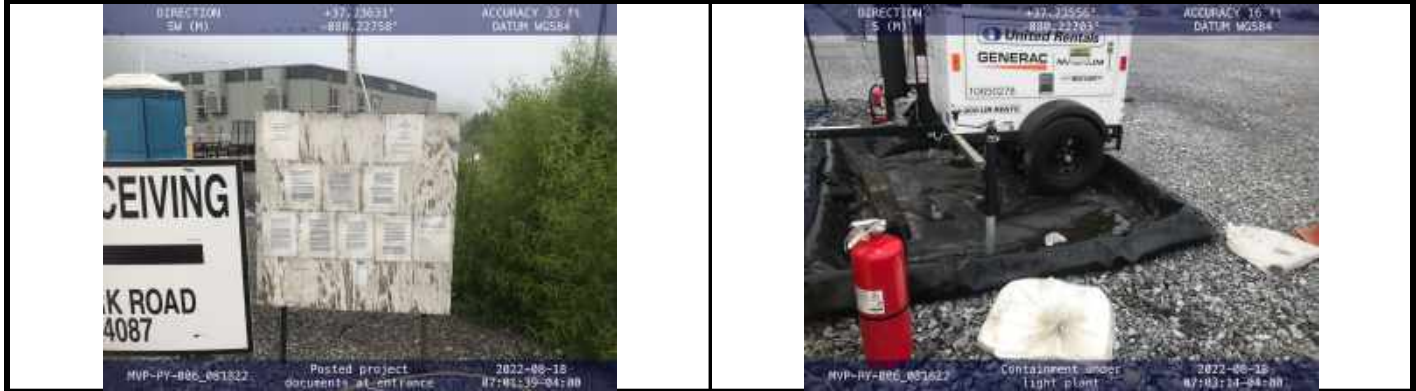
<b>Pic 3 Desc.</b>	Posted project documents at at main entrance. Looking SW.	<b>Pic 4 Desc.</b>	Secondary containment under light plant free of fluids. Looking S.
--------------------	---	--------------------	--

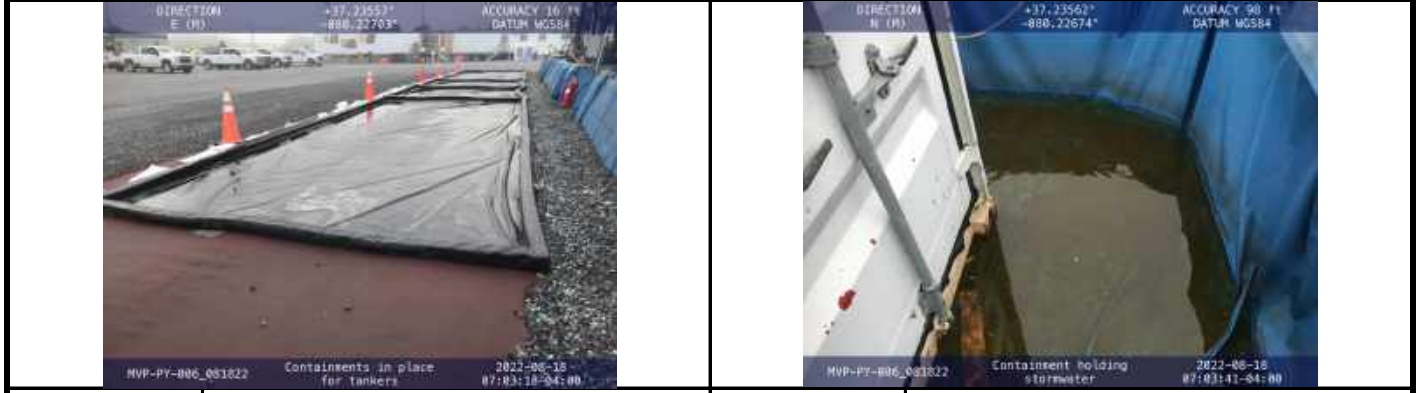
<b>Pic 5 Desc.</b>	Secondary containments in place for tankers offloading fuel. Looking E.	<b>Pic 6 Desc.</b>	Off Road Fuel unit containment holding stormwater. Looking N.
--------------------	---	--------------------	---

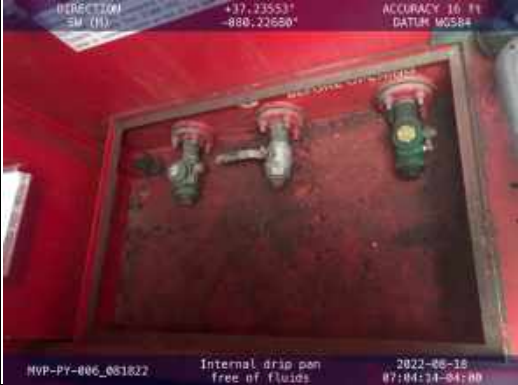
<b>GPS Location</b> MVP-PY-006 See photo for gps data	<b>GPS Location</b> MVP-PY-006 See photo for gps data
<b>Field Station#</b> +0	<b>Field Station#</b> +0
<b>Pic 7 Desc.</b> Off Road Fuel unit internal drip pan free of fluids. Looking SW.	<b>Pic 8 Desc.</b> Off Road Fuel unit no leaky internal fittings. Looking W.

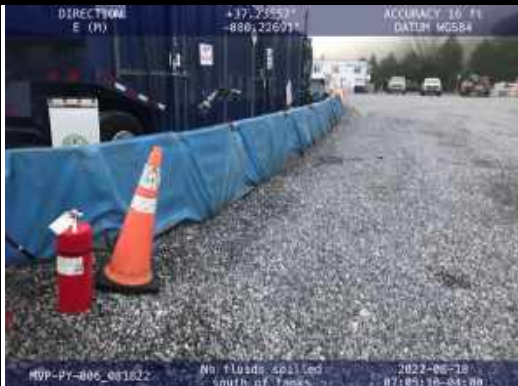
<b>GPS Location</b> MVP-PY-006 See photo for gps data	<b>GPS Location</b> MVP-PY-006 See photo for gps data
<b>Field Station#</b> +0	<b>Field Station#</b> +0
<b>Pic 9 Desc.</b> Blue Bulk Fuel tanks no fuel spills south of the tanks. Looking E.	<b>Pic 10 Desc.</b> Blue Bulk Fuel tanks no leaky fittings or nozzles. Looking NE.

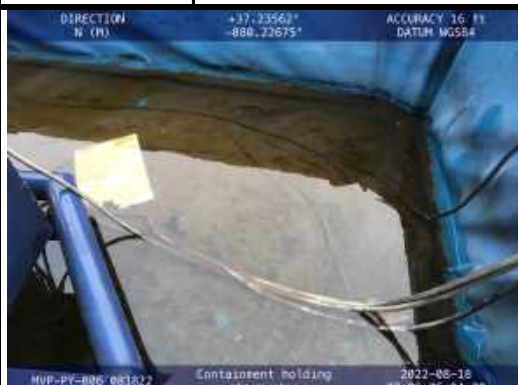
<b>GPS Location</b> MVP-PY-006 See photo for gps data	<b>GPS Location</b> MVP-PY-006 See photo for gps data
<b>Field Station#</b> +0	<b>Field Station#</b> +0
<b>Pic 11 Desc.</b> Blue Bulk Fuel tanks containment holding stormwater. Looking N.	<b>Pic 12 Desc.</b> Blue Bulk Fuel tanks no leaky internal fittings. Looking W.

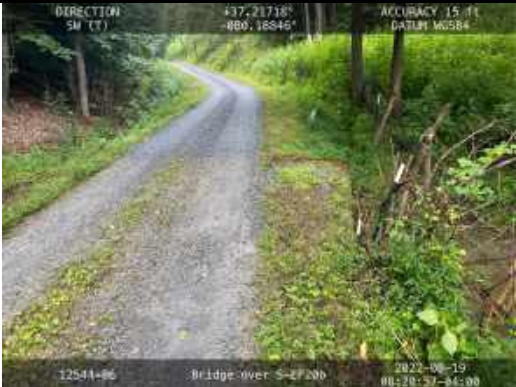
DIRECTION: SW (T) +37.21718° -880.16845° ACCURACY: 15 ft DATUM: WGS84 12544+06 Bridge over S-EF20b 2022-08-19 00:20:57-04:00

DIRECTION: NE (T) +37.21859° -880.19319° ACCURACY: 19 ft DATUM: WGS84 12544+06 ECDs along Yellowfinch Lane 2022-08-19 00:25:33-04:00
<b>GPS Location</b>	See photo for gps location data.		<b>GPS Location</b>	See photo for gps location data.	
<b>Field Station#</b>	12544+06		<b>Field Station#</b>	12544+06	
<b>Pic 1 Desc.</b>	Photo shows the culvert over S-EF20b on Yellowfinch Lane.		<b>Pic 2 Desc.</b>	Photo shows the ECDs along Yellowfinch Lane.

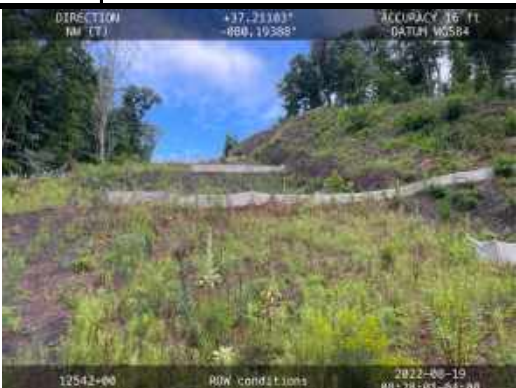
DIRECTION: NW (T) +37.21181° -880.19388° ACCURACY: 16 ft DATUM: WGS84 12542+00 ROW conditions 2022-08-19 00:28:01-04:00

<b>Field Station#</b>	12542+00		<b>Field Station#</b>	12536+00	
<b>Pic 3 Desc.</b>	Photo shows the ROW condition. ECDs are installed and functioning as designed.		<b>Pic 4 Desc.</b>	Photo shows the slope drain.

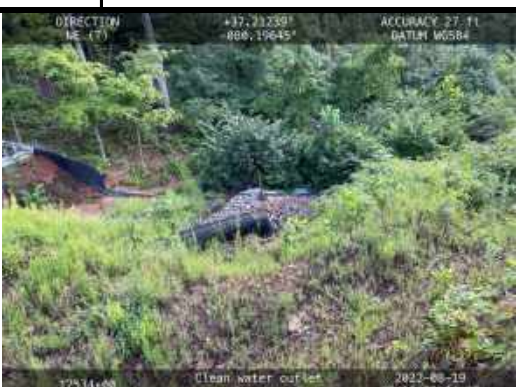
DIRECTION: NE (T) +37.21239° -880.19645° ACCURACY: 27 ft DATUM: WGS84 12534+00 Clean water outlet structure 2022-08-19 00:36:25-04:00

DIRECTION: SE (T) +37.21250° -880.21970° ACCURACY: 23 ft DATUM: WGS84 12531+00 ROW conditions 2022-08-19 00:39:57-04:00
<b>GPS Location</b>	See photo for gps location data.		<b>GPS Location</b>	See photo for gps location data.	
<b>Field Station#</b>	12534+00		<b>Field Station#</b>	12531+00	
<b>Pic 5 Desc.</b>	Photo shows the clean water outlet structure.		<b>Pic 6 Desc.</b>	Photo shows the ROW condition. ECDs are installed and functioning as designed.

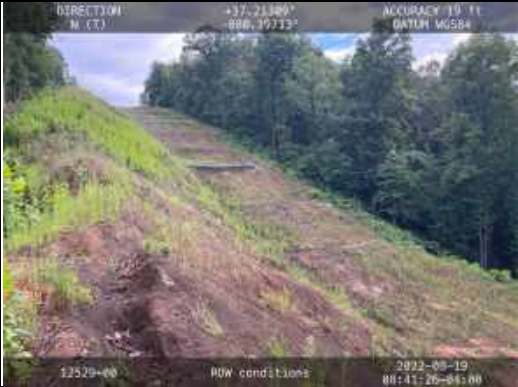
<b>GPS Location</b>	See photo for gps location data.		<b>GPS Location</b>	See photo for gps location data.	
<b>Field Station#</b>	12529+00		<b>Field Station#</b>	12519+74	
<b>Pic 7 Desc.</b>	Photo shows the ROW condition. ECDs are installed and functioning as designed.		<b>Pic 8 Desc.</b>	Photo shows the bridge over stream S-EF19.

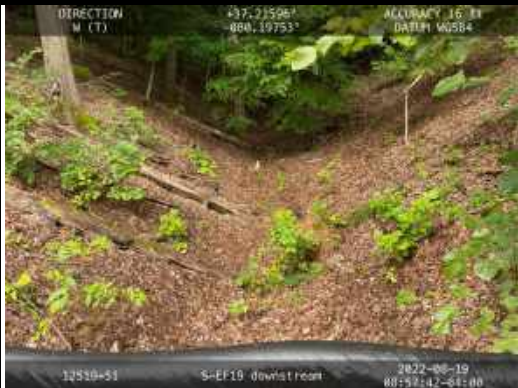
<b>GPS Location</b>	See photo for gps location data.		<b>GPS Location</b>	See photo for gps location data.	
<b>Field Station#</b>	12519+14		<b>Field Station#</b>	12518+00	
<b>Pic 9 Desc.</b>	Photo shows S-EF19 downstream from the bridge.		<b>Pic 10 Desc.</b>	Photo shows the ROW condition. ECDs are installed and functioning as designed.

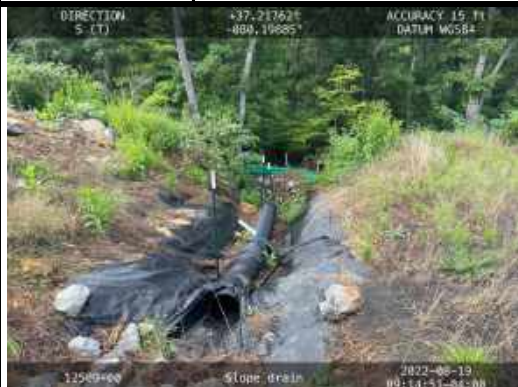
<b>Pic 11 Desc.</b>	Photo shows the slope drain.		<b>Pic 12 Desc.</b>	Photo shows the ROW condition. ECDs are installed and functioning as designed.

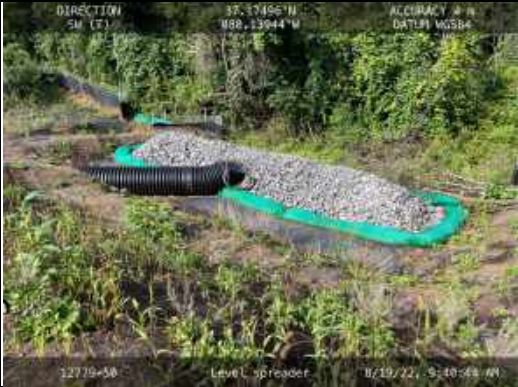
<b>GPS Location</b>	See photo	<b>GPS Location</b>	See photo
<b>Field Station#</b>	12779+50	<b>Field Station#</b>	12782+00
<b>Pic 7 Desc.</b>	Level spreader is functional	<b>Pic 8 Desc.</b>	Current ROW conditions. ROW is stable and ECDs are functional
