# Visual Site Inspection Report

<b>Project Name</b> H-600 Pipeline Spread H		<b>AFE</b> 124300138	<b>Spread</b> H-600 Pipeline Spread H
<b>Contractor</b> Precision		<b>Report #</b> 41019	
<b>Inspector</b> Dustin Lyons		<b>Date/Time</b> 8/15/2022 4:20 PM	
<b>Permit #</b> TBD	<b>Inspection Type</b> VA SWPP	<b>Station Begin</b> 12443+75	
<b>State</b> VA	<b>Inspection Area</b> Partial	<b>Station End</b> 12544+06	
<b>County</b> Montgomery	<b>Ground</b> Wet	<b>Temperature (°F)</b> 75.00	
<b>Municipality</b> N/A	<b>Weather</b> Cloudy	<b>Rain Gauge (in)</b> 0.50	
<b>Rain Accumulation Time (days)</b>			3.00

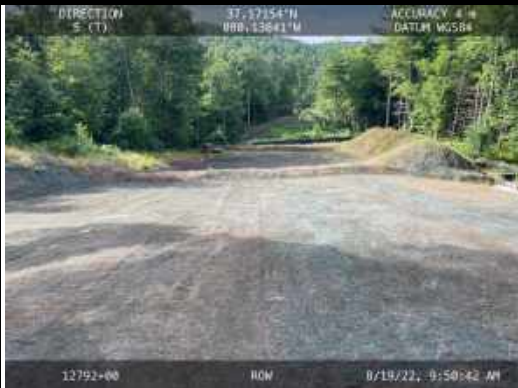
<b>GPS Location</b>	See photo	<b>GPS Location</b>	See photo
<b>Field Station#</b>	12792+00	<b>Field Station#</b>	12793+71
<b>Pic 9 Desc.</b>	Current ROW conditions. ROW is stable and ECDs are functional	<b>Pic 10 Desc.</b>	Equipment bridge over Stream S-IJ82

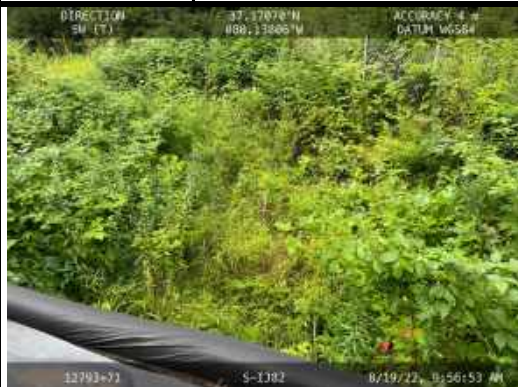
<b>GPS Location</b>	See photo	<b>GPS Location</b>	See photo
<b>Field Station#</b>	12793+71	<b>Field Station#</b>	12794+50
<b>Pic 11 Desc.</b>	Downstream of crossing at Stream S-IJ82	<b>Pic 12 Desc.</b>	Current ROW conditions. ROW is stable and ECDs are functional

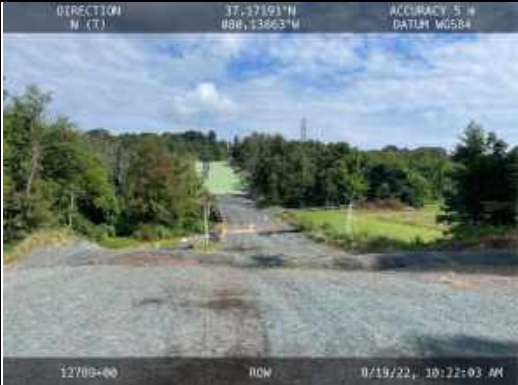
<p>12789+00 ROW 8/19/22, 10:22:03 AM</p>

<p>12785+00 ROW 8/19/22, 10:23:29 AM</p>	
<b>GPS Location</b>	See photo	<b>GPS Location</b>	See photo
<b>Field Station#</b>	12789+00	<b>Field Station#</b>	12785+00
<b>Pic 13 Desc.</b>	Current ROW conditions. ROW is stable and ECDs are functional	<b>Pic 14 Desc.</b>	Current ROW conditions. ROW is stable and ECDs are functional

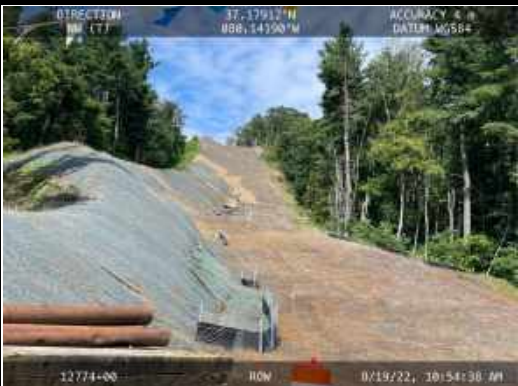
<p>12774+00 ROW 8/19/22, 10:54:38 AM</p>

<p>12737+00 ROW 8/19/22, 11:19:58 AM</p>	
<b>GPS Location</b>	See photo	<b>GPS Location</b>	See photo
<b>Field Station#</b>	12774+00	<b>Field Station#</b>	12737+00
<b>Pic 15 Desc.</b>	Current ROW conditions. ROW is stable and ECDs are functional	<b>Pic 16 Desc.</b>	Current ROW conditions. ROW is stable and ECDs are functional

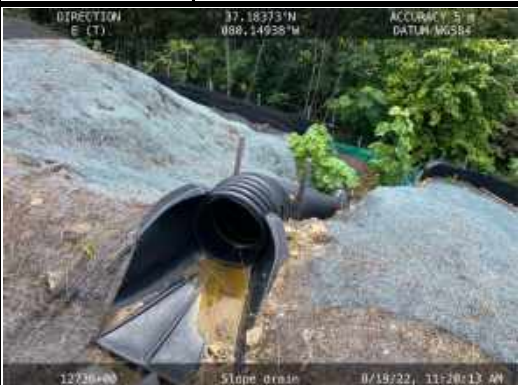
<p>12736+00 Slope drain 8/19/22, 11:20:13 AM</p>

<b>GPS Location</b>	See photo	<b>GPS Location</b>	See photo
<b>Field Station#</b>	12736+00	<b>Field Station#</b>	12728+00
<b>Pic 17 Desc.</b>	Slope drain is functional	<b>Pic 18 Desc.</b>	Current ROW conditions. ROW is stable and ECDs are functional

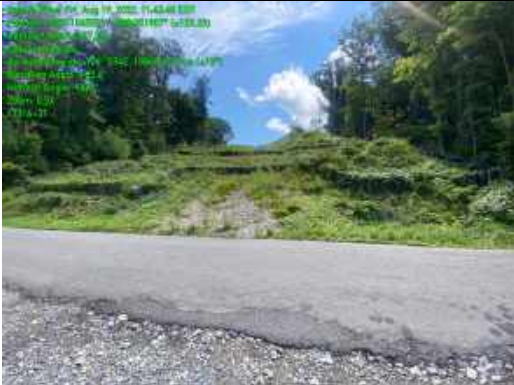
<b>GPS Location</b>	See photo for coordinates.		<b>GPS Location</b>	See photo for coordinates.	
<b>Field Station#</b>	13316+21		<b>Field Station#</b>	13317+02	
<b>Pic 1 Desc.</b>	Wade's Gap road crossing, perimeter controls in acceptable condition along road.		<b>Pic 2 Desc.</b>	Private drive in acceptable condition, with some erosion and rock displacement noted.

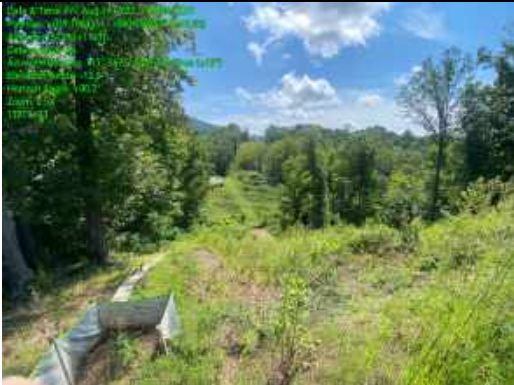
<b>GPS Location</b>	See photo for coordinates.		<b>GPS Location</b>	See photo for coordinates.	
<b>Field Station#</b>	13319+63		<b>Field Station#</b>	13319+63	
<b>Pic 3 Desc.</b>	ROW stabilized.		<b>Pic 4 Desc.</b>	ROW stabilized, no environmental concerns noted at S-GH15.

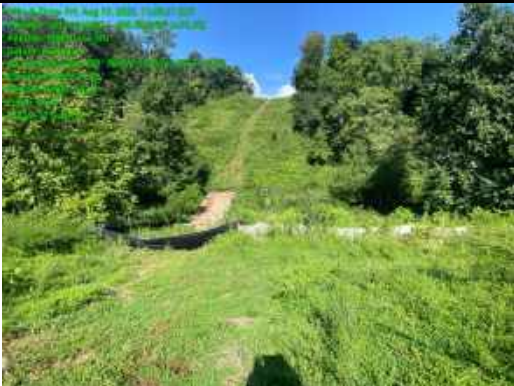
<b>Pic 5 Desc.</b>	No environmental issues noted at S-GH11.		<b>Pic 6 Desc.</b>	ROW stabilized.

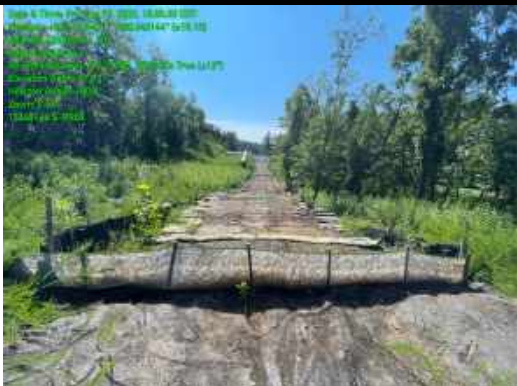
<b>GPS Location</b>	See photo for coordinates.		<b>GPS Location</b>	See photo for coordinates.	
<b>Field Station#</b>	13345+50		<b>Field Station#</b>	13348+46	
<b>Pic 9 Desc.</b>	ROW stabilized.		<b>Pic 10 Desc.</b>	S-RR08, no deficiencies noted at stream crossing.
