Visual Site Inspection Report

Project Name H-600 Pipeline Spread H		AFE 124300138	Spread H-600 Pipeline Spread H
Contractor Precision		Report # 41503	
Inspector Dustin Lyons		Date/Time 8/29/2022 4:18 PM	
Permit # TBD	Inspection Type VA SWPP	Station Begin	12600+00
State VA	Inspection Area Partial	Station End	12725+00
County Roanoke	Ground Damp	Temperature (°F)	73.00
Municipality N/A	Weather Sunny	Rain Gauge (in)	0.50
Rain Accumulation Time (days)			3.00

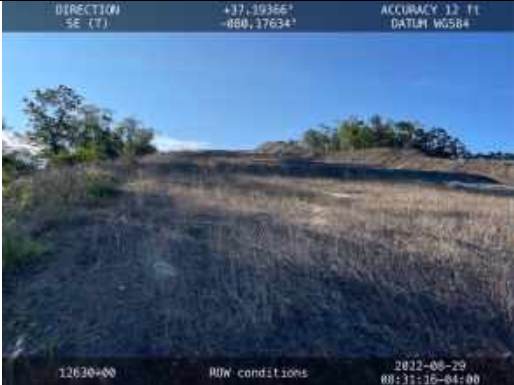
GPS Location	See photo for gps location data.		GPS Location	See photo for gps location data.	
Field Station#	12630+00		Field Station#	12628+00	
Pic 1 Desc.	Photo shows the ROW condition. ECDs are installed and functioning as designed.		Pic 2 Desc.	Photo shows the ROW condition. ECDs are installed and functioning as designed.

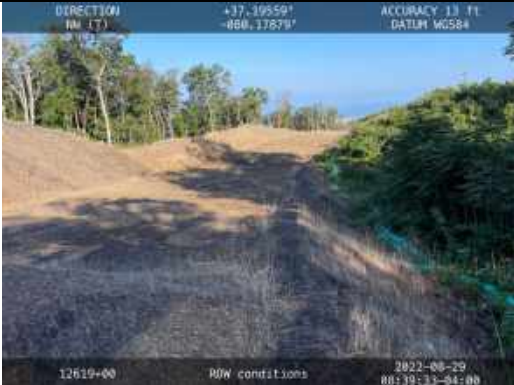
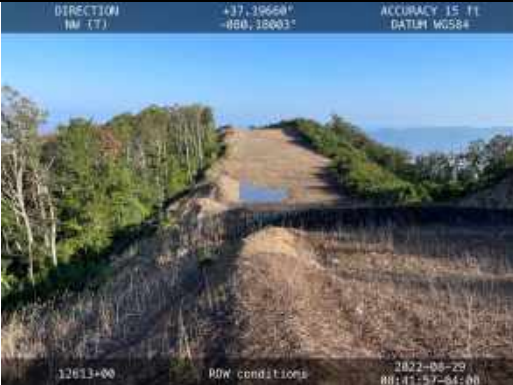
GPS Location	See photo for gps location data.		GPS Location	See photo for gps location data.	
Field Station#	12619+00		Field Station#	12613+00	
Pic 3 Desc.	Photo shows the ROW condition. ECDs are installed and functioning as designed.		Pic 4 Desc.	Photo shows the ROW condition. ECDs are installed and functioning as designed.

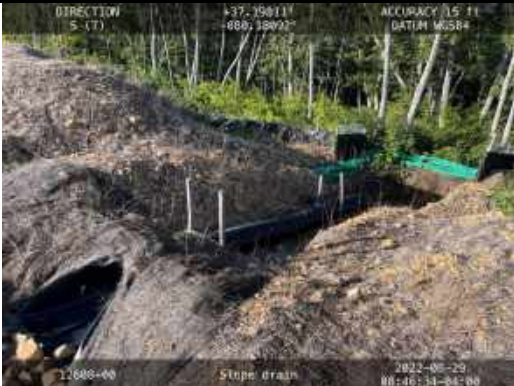
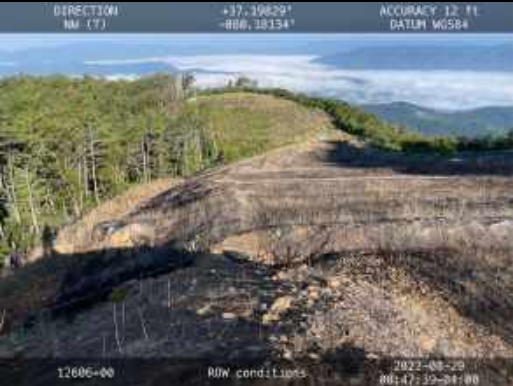
GPS Location	See photo for gps location data.		GPS Location	See photo for gps location data.	
Field Station#	12608+00		Field Station#	12606+00	
Pic 5 Desc.	Photo shows the slope drain.		Pic 6 Desc.	Photo shows the ROW condition. ECDs are installed and functioning as designed.

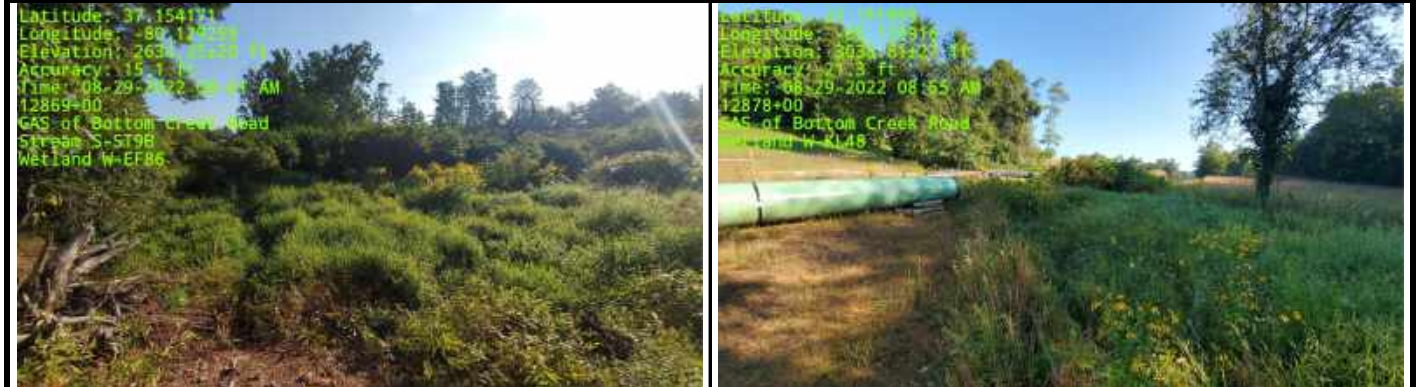
GPS Location	See pic.	GPS Location	See pic.
Field Station#	12869+00	Field Station#	12878+00
Pic 1 Desc.	Stream S-ST9B from the GAS.	Pic 2 Desc.	Wetland W-KL48 from the GAS.

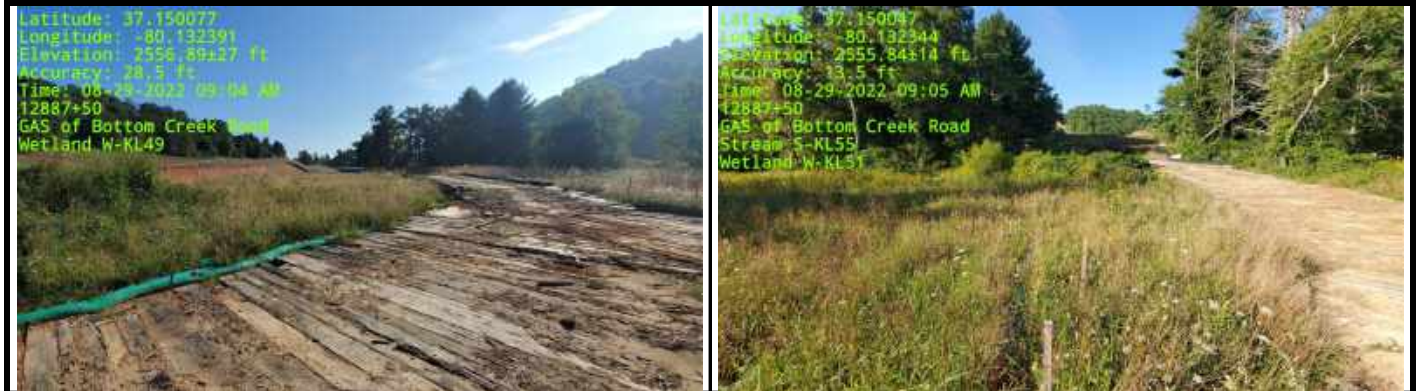
GPS Location	See pic.	GPS Location	See pic.
Field Station#	12887+50	Field Station#	12887+50
Pic 3 Desc.	Wetland W-KL49 from the GAS.	Pic 4 Desc.	Stream S-KL55 from the CIS.

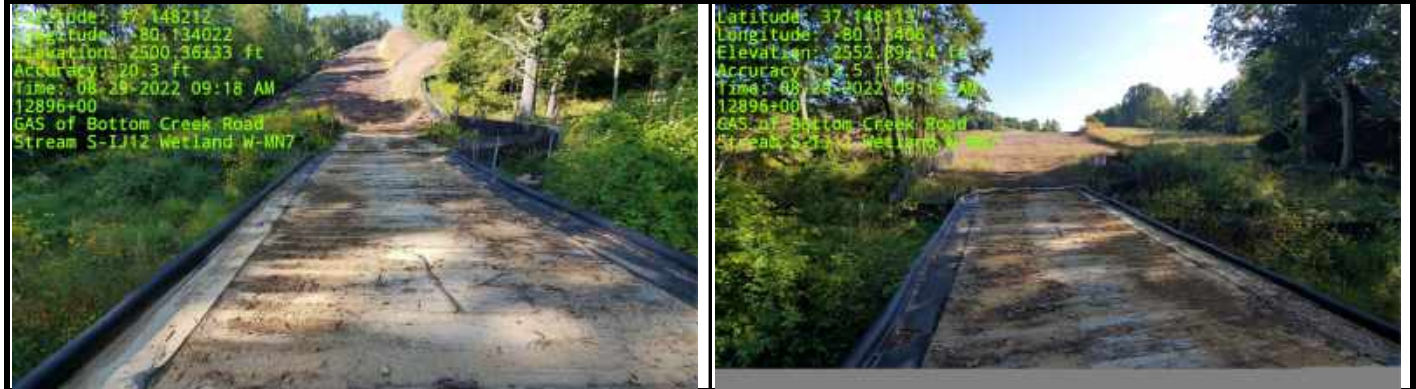
GPS Location	See pic.	GPS Location	See pic.
Field Station#	12896+00	Field Station#	12896+00
Pic 7 Desc.	Stream S-IJ12 from the CIS.	Pic 8 Desc.	Stream S-IJ12 from the GAS.

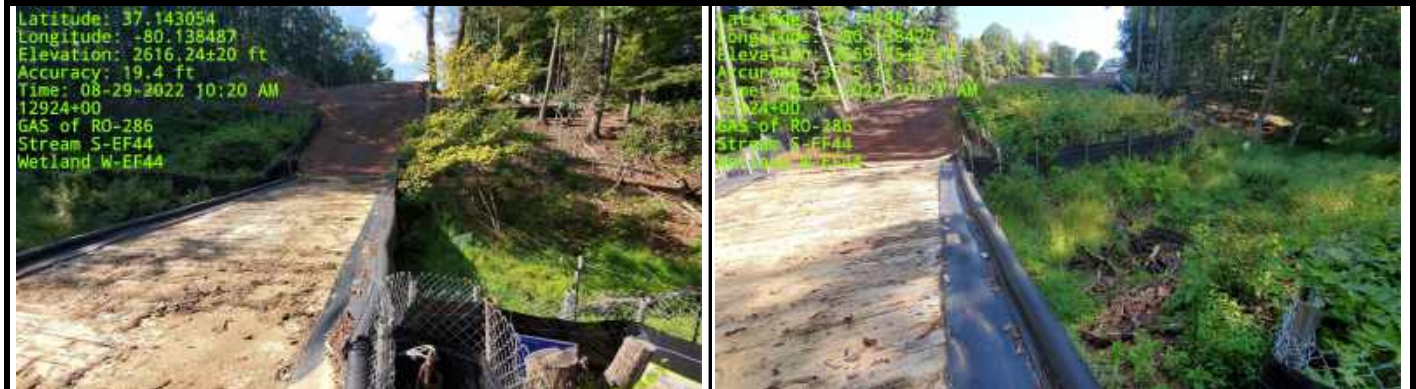
GPS Location	See pic.	GPS Location	See pic.
Field Station#	12924+00	Field Station#	12924+00
Pic 11 Desc.	Downstream side of stream S-EF44.	Pic 12 Desc.	Upstream side of stream S-EF44.

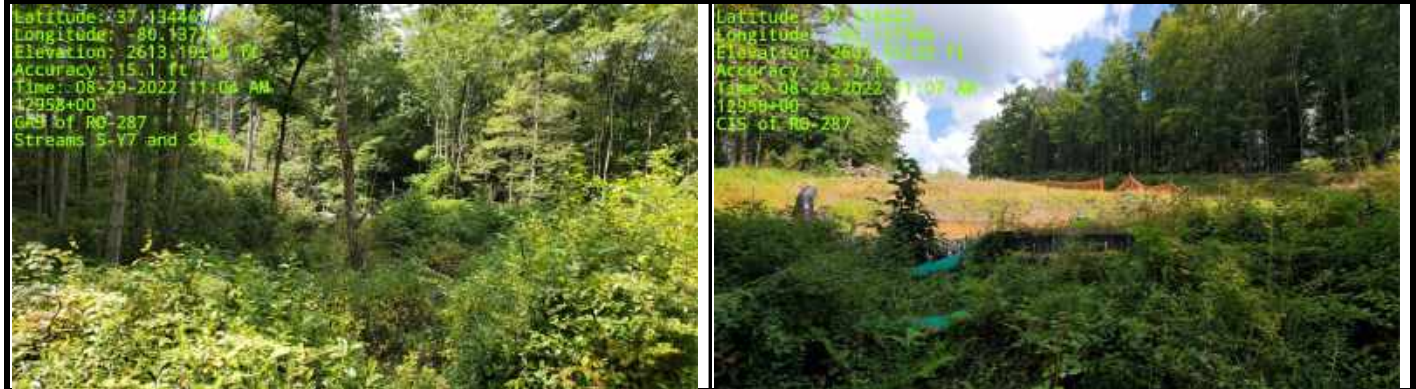
GPS Location	See pic.	GPS Location	See pic.
Field Station#	12958+00	Field Station#	12956+00
Pic 13 Desc.	Streams S-Y7 and S-Y8 from the CIS.	Pic 14 Desc.	Current ROW conditions.

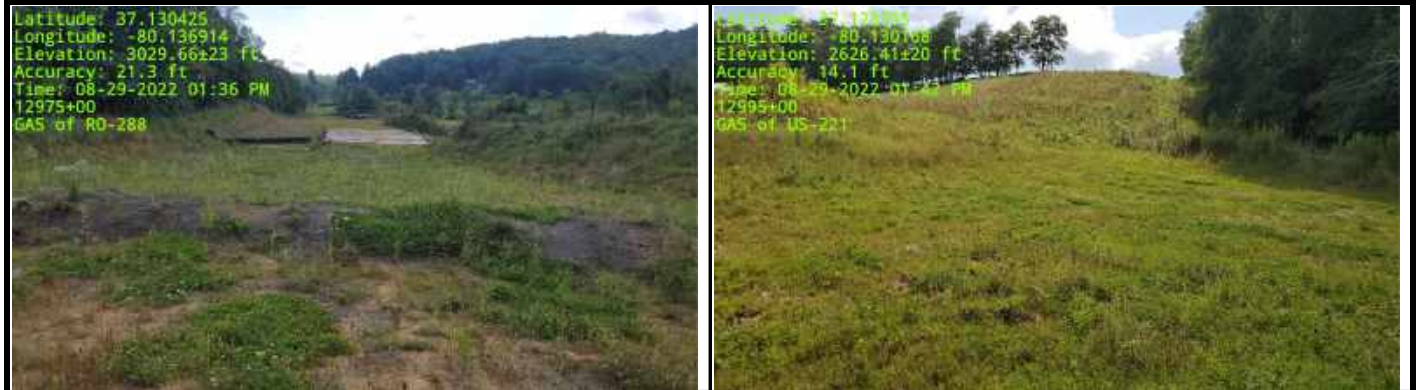
GPS Location	See pic.	GPS Location	See pic.
Field Station#	12975+00	Field Station#	12995+00
Pic 15 Desc.	Current ROW conditions.	Pic 16 Desc.	Current ROW conditions.

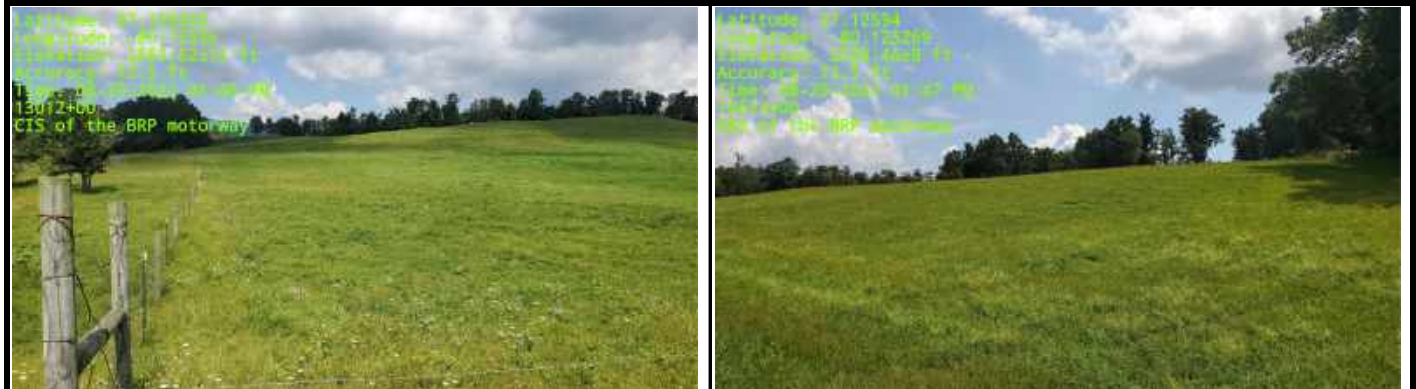
GPS Location	See pic.	GPS Location	See pic.
Field Station#	13012+00	Field Station#	13013+00
Pic 17 Desc.	Current ROW conditions.	Pic 18 Desc.	Current ROW conditions.

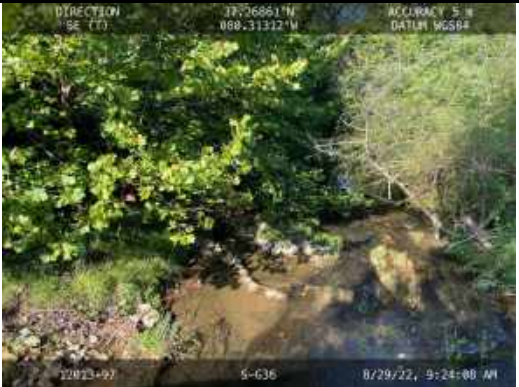
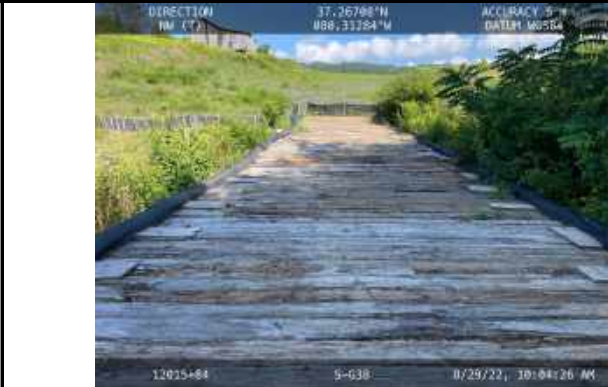
GPS Location	Please see photo for details.		GPS Location	Please see photo for details.	
Field Station#	12013+97		Field Station#	12015+84	
Pic 1 Desc.	Photo shows downstream view of Stream S-G36 on MVP-MN-268.01 from the equipment bridge spanning the stream channel.		Pic 2 Desc.	Photo shows equipment bridge condition that spans the Stream channel of S-G38.

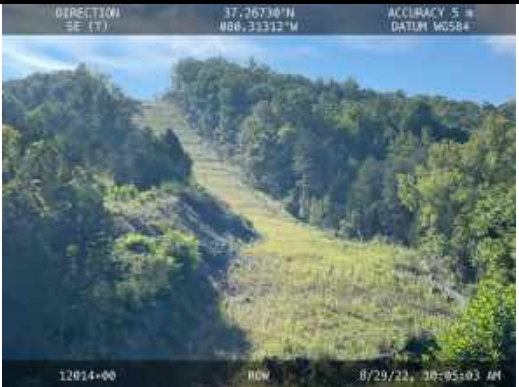
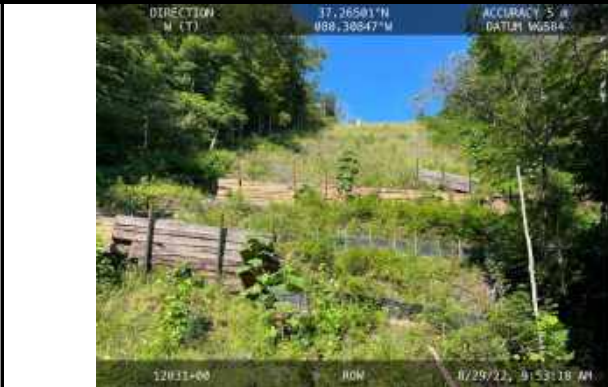
GPS Location	Please see photo for details.		GPS Location	Please see photo for details.	
Field Station#	12014+00		Field Station#	12031+00	
Pic 3 Desc.	Photo shows the stabilized ROW conditions with water bars and that all ECDs are installed and are functioning as designed.		Pic 4 Desc.	Photo shows the stabilized ROW conditions with water bars and that all ECDs are installed and are functioning as designed.

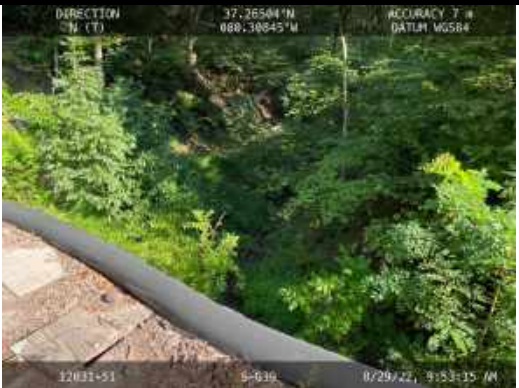
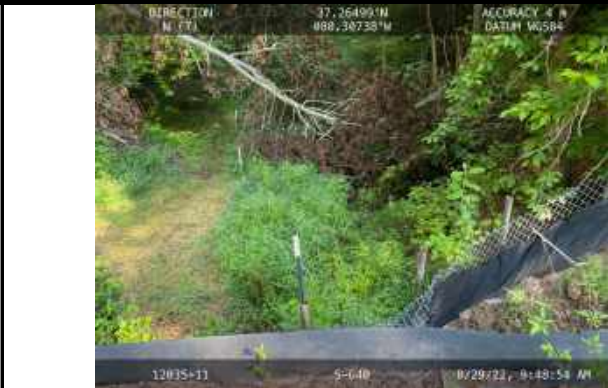
GPS Location	Please see photo for details.		GPS Location	Please see photo for details.	
Field Station#	12031+51		Field Station#	12035+11	
Pic 5 Desc.	Photo shows downstream view of Stream S-G39 from the equipment bridge spanning the stream channel.		Pic 6 Desc.	Photo shows downstream view of Stream S-G40 from the equipment bridge spanning the stream channel.

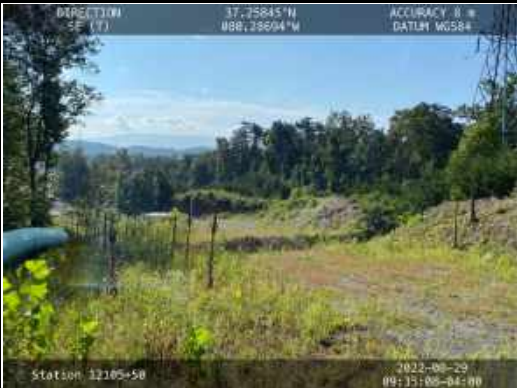
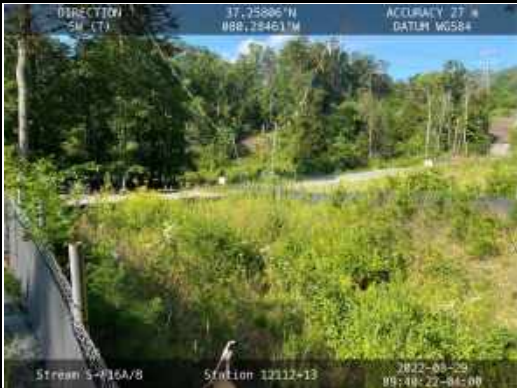
GPS Location	Please see photo for details.		GPS Location	Please see photo for details.	
Field Station#	12105+50		Field Station#	12112+13	
Pic 15 Desc.	Photo shows the stabilized ROW conditions with water bars and that all ECDs are installed and are functioning as designed.		Pic 16 Desc.	Photo show upstream view of Stream S-F16A/B from the corner of the ROW.

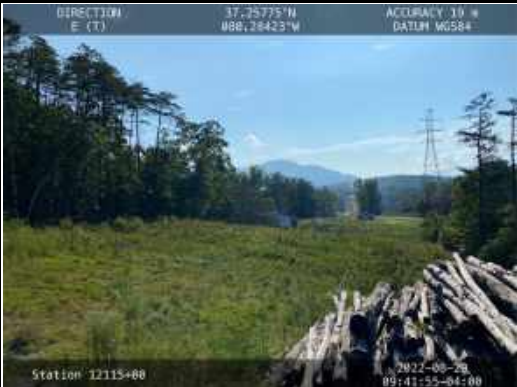
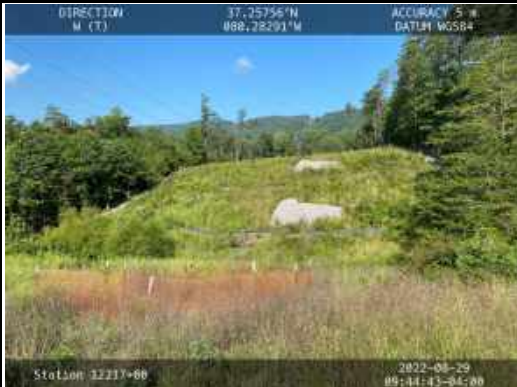
GPS Location	Please see photo for details.		GPS Location	Please see photo for details.	
Field Station#	12115+00		Field Station#	12117+00	
Pic 17 Desc.	Photo shows the stabilized ROW conditions with water bars and that all ECDs are installed and are functioning as designed.		Pic 18 Desc.	Photo shows permanent restoration section of the ROW with permanent waterbars installed equipped with level spreaders.

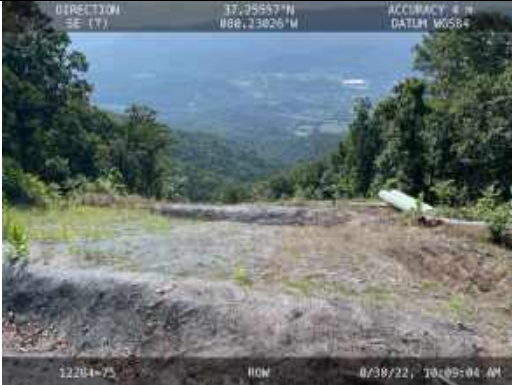
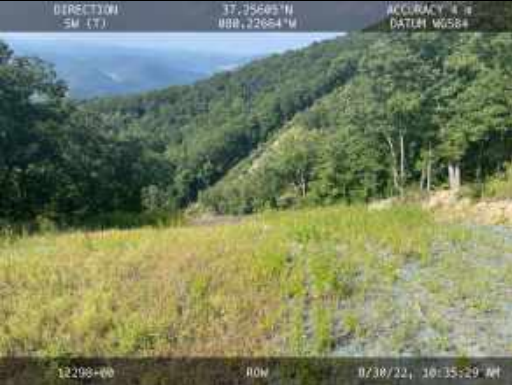
GPS Location	Please see photo for details.		GPS Location	Please see photo for details.	
Field Station#	12284+75		Field Station#	12298+00	
Pic 1 Desc.	Photo shows the stabilized ROW conditions with water bars and that all ECDs are installed and are functioning as designed.		Pic 2 Desc.	Photo shows the stabilized ROW conditions with water bars and that all ECDs are installed and are functioning as designed.

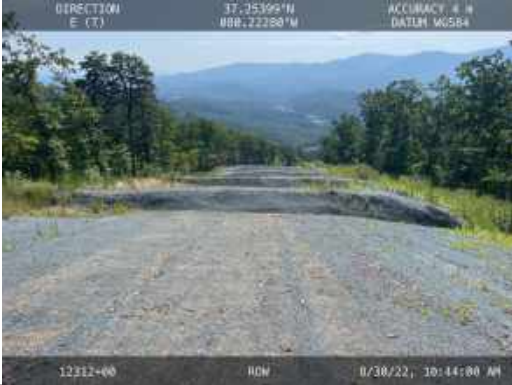
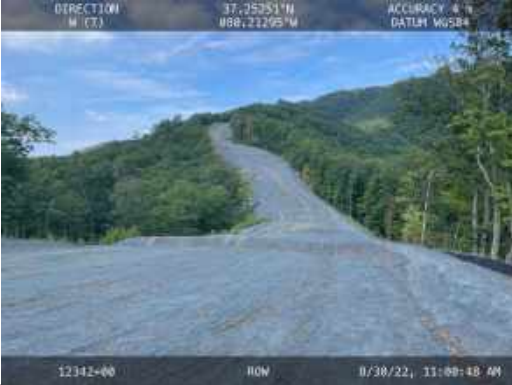
GPS Location	Please see photo for details.		GPS Location	Please see photo for details.	
Field Station#	12312+00		Field Station#	12342+00	
Pic 3 Desc.	Photo shows the stabilized ROW conditions with water bars and that all ECDs are installed and are functioning as designed.		Pic 4 Desc.	Photo shows the stabilized ROW conditions with water bars and that all ECDs are installed and are functioning as designed.

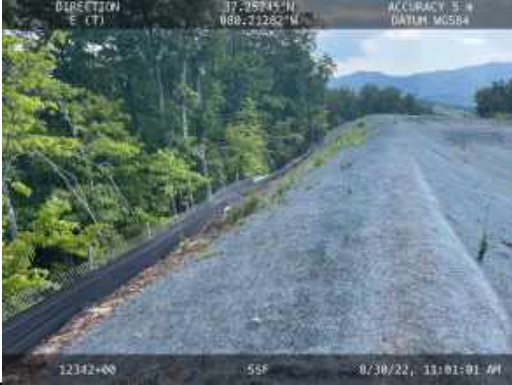
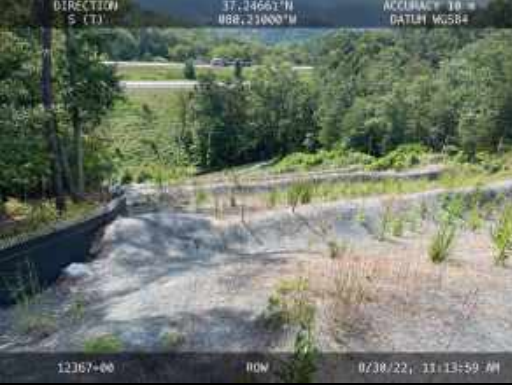
GPS Location	Please see photo for details.		GPS Location	Please see photo for details.	
Field Station#	12342+00		Field Station#	12367+00	
Pic 5 Desc.	Photo shows the stabilized ROW conditions with water bars and that all ECDs are installed and are functioning as designed.		Pic 6 Desc.	Photo shows the stabilized ROW conditions with water bars and that all ECDs are installed and are functioning as designed.

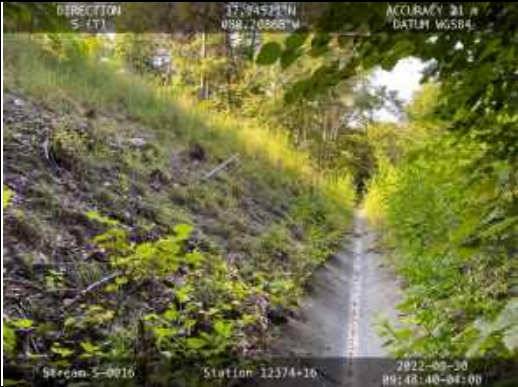
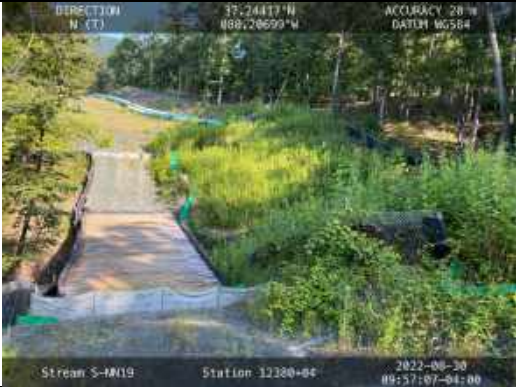
GPS Location	Please see photo for details.		GPS Location	Please see photo for details.	
Field Station#	12374+16		Field Station#	12380+04	
Pic 7 Desc.	Photo shows view of Stream S-0016 from upstream.		Pic 8 Desc.	Photo shows overview of Stream S-NN19 and its buffer zone from the going away side.

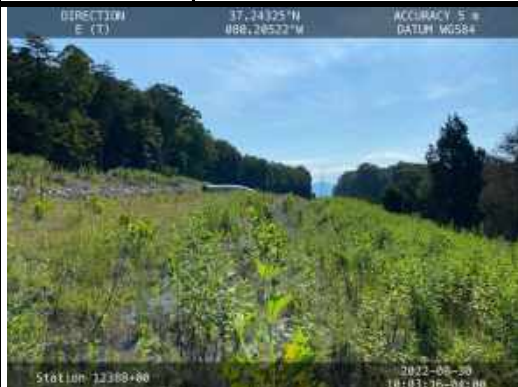
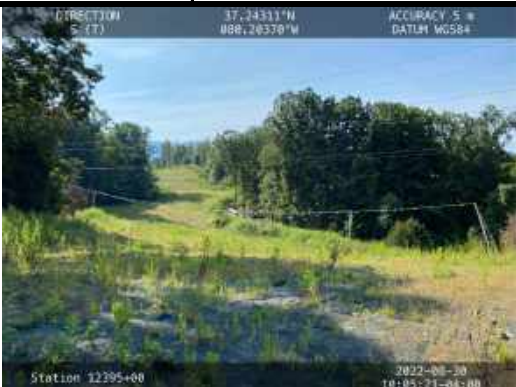
GPS Location	Please see photo for details.		GPS Location	Please see photo for details.	
Field Station#	12388+00		Field Station#	12395+00	
Pic 11 Desc.	Photo shows the stabilized ROW conditions with water bars and that all ECDs are installed and are functioning as designed.		Pic 12 Desc.	Photo shows the stabilized ROW conditions with water bars and that all ECDs are installed and are functioning as designed.

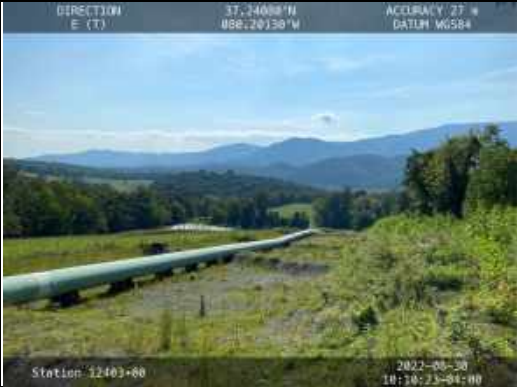
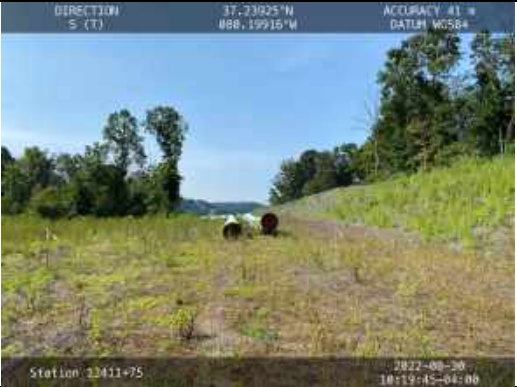
GPS Location	Please see photo for details.		GPS Location	Please see photo for details.	
Field Station#	12403+00		Field Station#	12411+75	
Pic 13 Desc.	Photo shows the stabilized ROW conditions with water bars and that all ECDs are installed and are functioning as designed.		Pic 14 Desc.	Photo shows the stabilized ROW conditions with water bars and that all ECDs are installed and are functioning as designed.

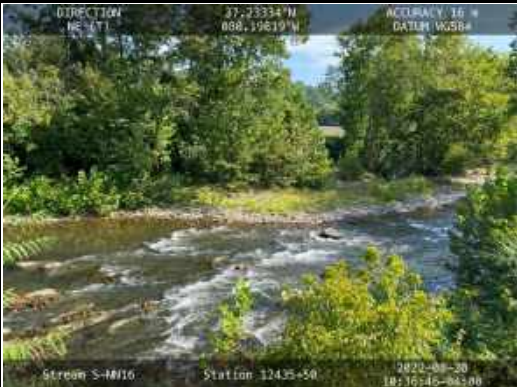
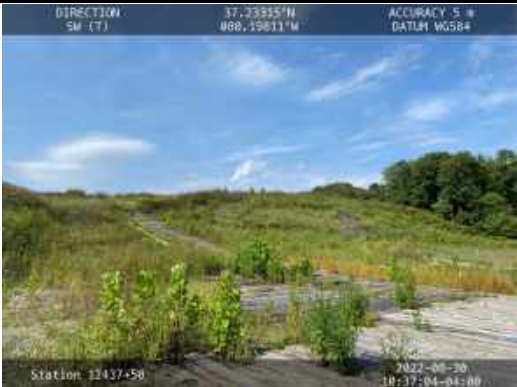
Field Station#	12435+50		Field Station#	12437+50	
Pic 17 Desc.	Photo shows overview of Stream S-NN16 from the going away side.		Pic 18 Desc.	Photo shows the stabilized ROW conditions with water bars and that all ECDs are installed and are functioning as designed.

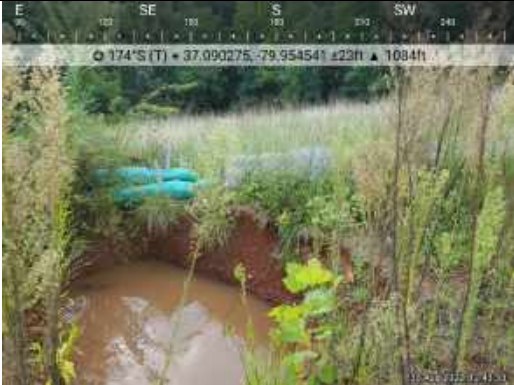
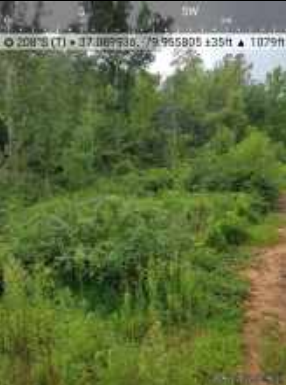
GPS Location 0		GPS Location 0			
Field Station# 13665+00		Field Station# 13659+50			
Pic 1 Desc. Sump and J-hook		Pic 2 Desc. GAS S-GH3 Buffer zone vegetation

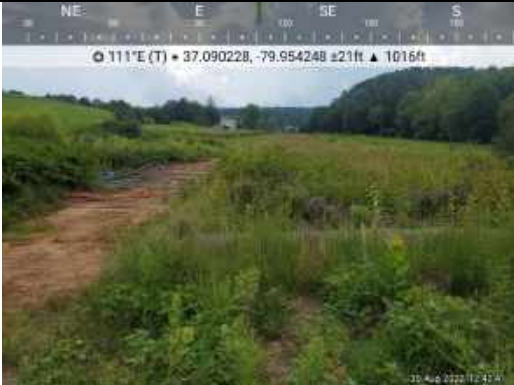
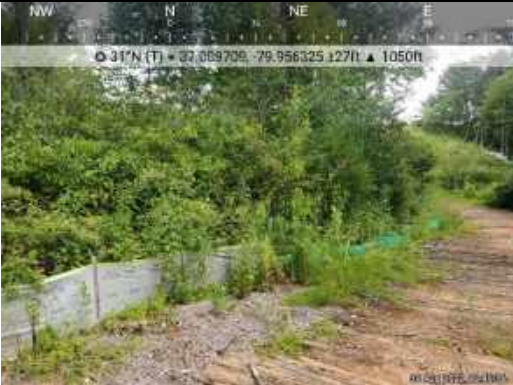
GPS Location 0		GPS Location 0			
Field Station# 13665+75		Field Station# 13658+00			
Pic 3 Desc. CIS S-GH2 Buffer zone and perimeter silt fence		Pic 4 Desc. CIS S-GH4 Travel lane ECDs

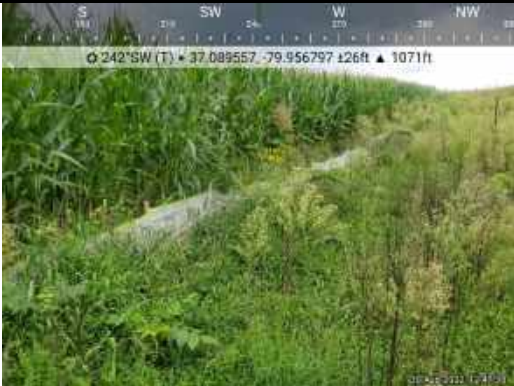
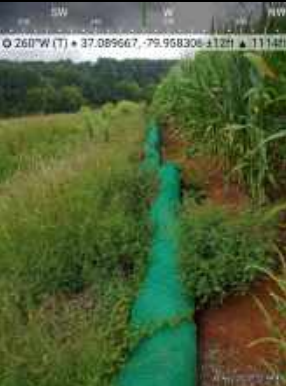
GPS Location 0		GPS Location 0			
Field Station# 13655+00		Field Station# 13654+00			
Pic 5 Desc. Perimeter silt fence		Pic 6 Desc. Perimeter CFS

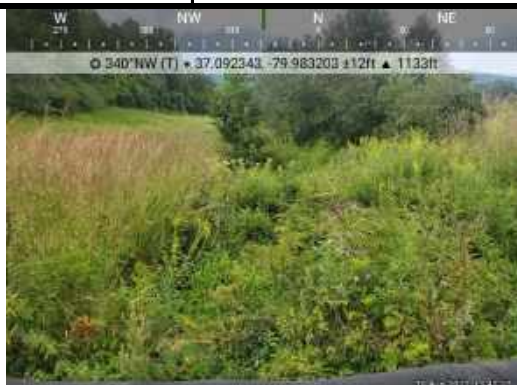
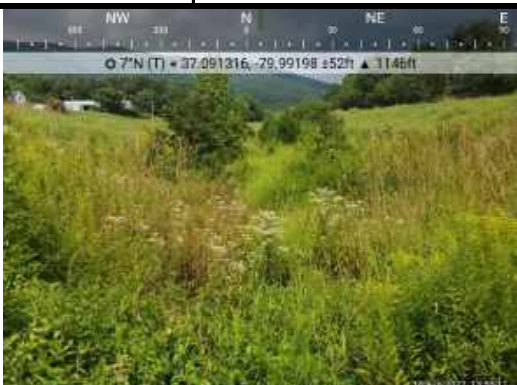
GPS Location 0		GPS Location 0			
Field Station# 13565+30		Field Station# 13539+20			
Pic 11 Desc. S-GH6 Channel and buffer zone vegetation		Pic 12 Desc. W-II8 Vegetation

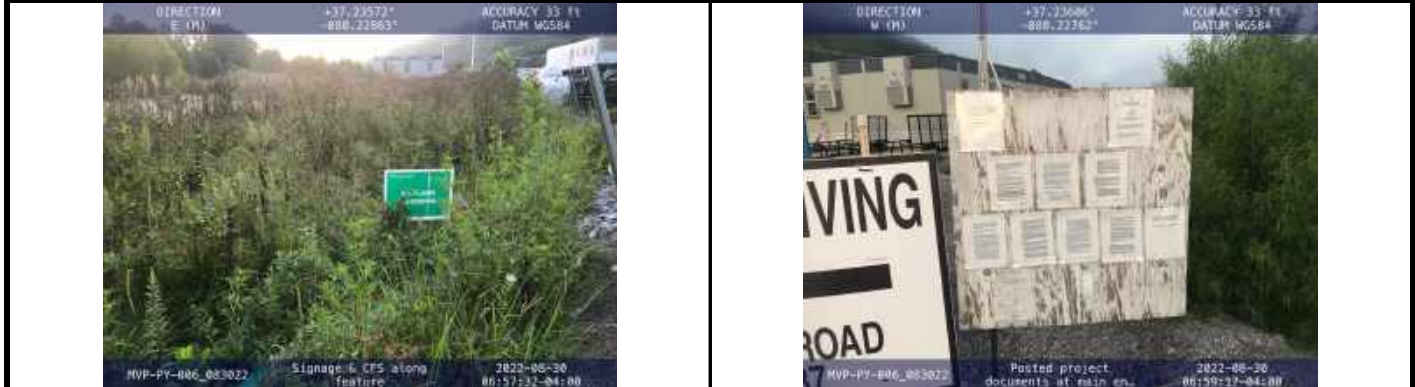
Pic 1 Desc.	Signage and triple stack compost filter sock at feature W-008. Overgrown with vegetation. Looking E.	Pic 2 Desc.	Posted project documents at main entrance. Looking W.
--------------------	--	--------------------	---

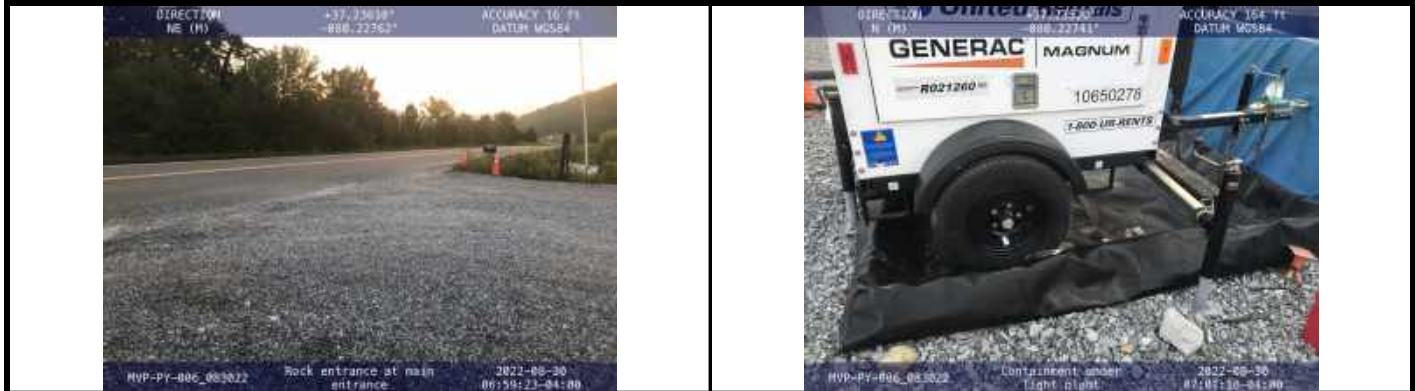
Pic 3 Desc.	Rock entrance at main entrance. No stone on public roadway. Looking NE.	Pic 4 Desc.	Secondary containment under light plant free of fluids. Looking N.
--------------------	---	--------------------	--

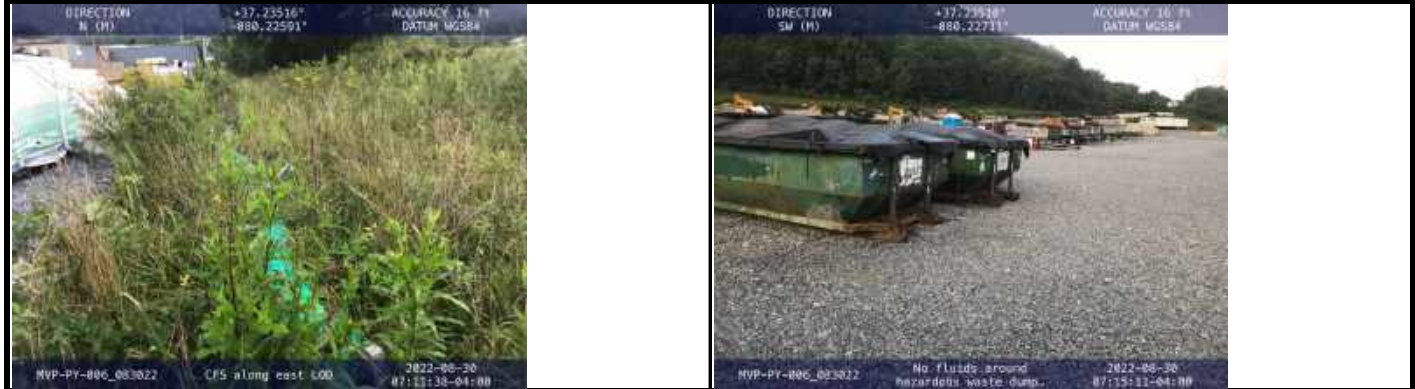
GPS Location	MVP-PY-006 See photo for gps data	GPS Location	MVP-PY-006 See photo for gps data
Field Station#	+0	Field Station#	+0
Pic 13 Desc.	Triple stack compost filter sock along east LOD overgrown with vegetation. Looking N.	Pic 14 Desc.	No fluids or deposits around hazardous waste dumpsters. Looking SW.

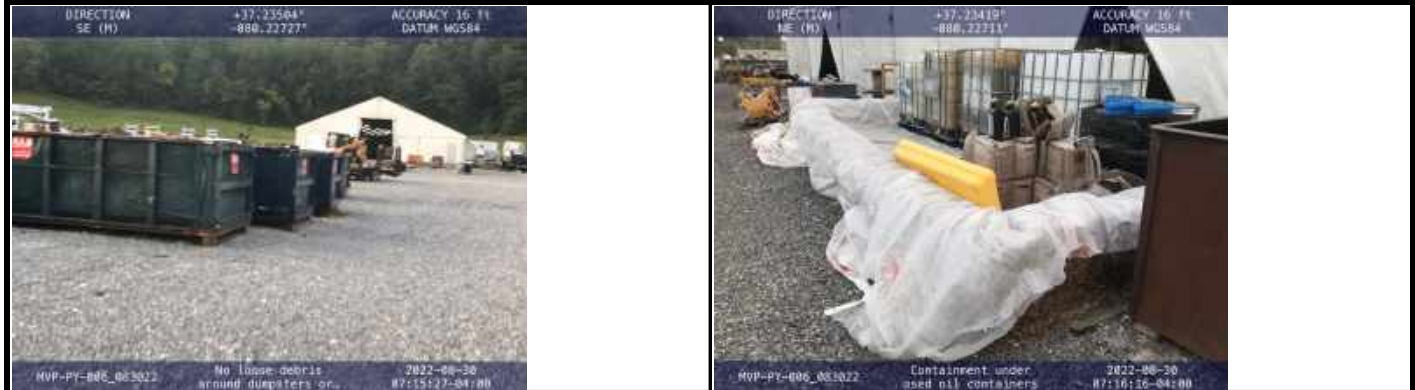
GPS Location	MVP-PY-006 See photo for gps data	GPS Location	MVP-PY-006 See photo for gps data
Field Station#	+0	Field Station#	+0
Pic 15 Desc.	No loose debris around trash dumpsters or in the yard. Looking SE.	Pic 16 Desc.	Secondary containment under used oil containers free of fluids. Looking NE.

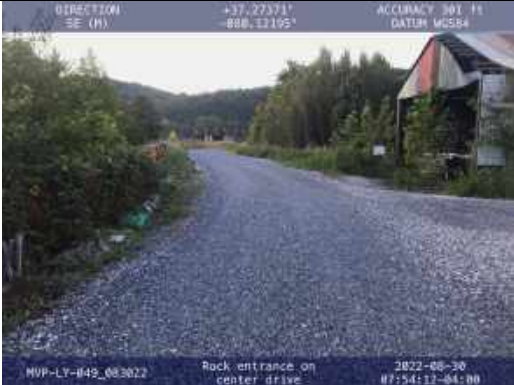
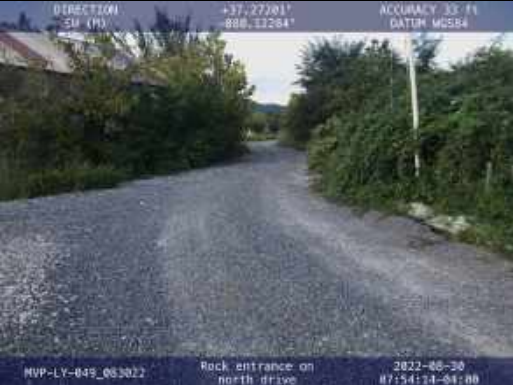
GPS Location	MVP-LY-049 See photo for gps data		GPS Location	MVP-LY-049 See photo for gps data	
Field Station#	+0		Field Station#	+0	
Pic 1 Desc.	Rock entrance on center drive. Larger stone has been covered with smaller stone. No sediment or debris on stone. Looking SE.		Pic 2 Desc.	Rock entrance on north drive. No sediment or debris on stone. Looking SW.

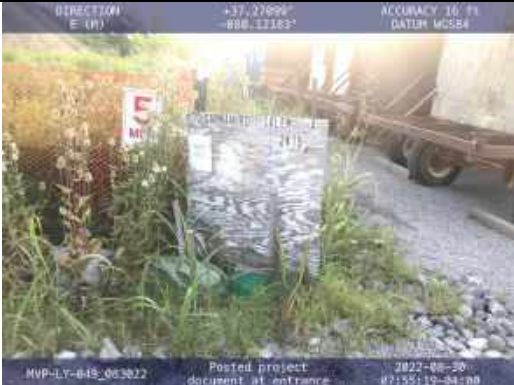
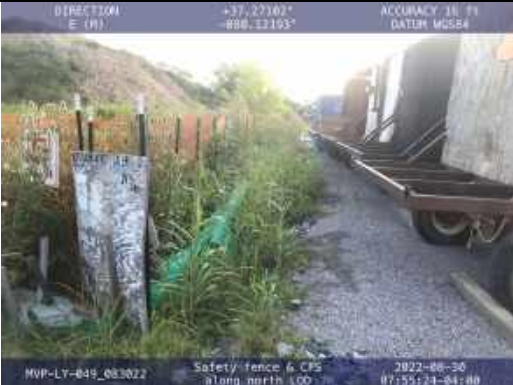
GPS Location	MVP-LY-049 See photo for gps data		GPS Location	MVP-LY-049 See photo for gps data	
Field Station#	+0		Field Station#	+0	
Pic 3 Desc.	Posted project document at main entrance. Looking E.		Pic 4 Desc.	Triple stack compost filter sock and safety fence along north LOD. Overgrown with vegetation. Looking E.

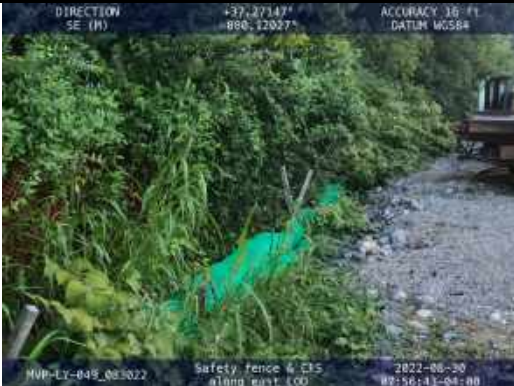
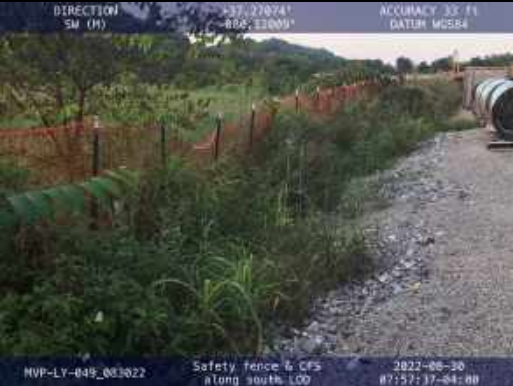
Pic 5 Desc.	Triple stack compost filter sock and safety fence along east LOD. Overgrown with vegetation. Looking SE.		Pic 6 Desc.	Triple stack compost filter sock and safety fence along south LOD. Overgrown with vegetation. Looking SW.

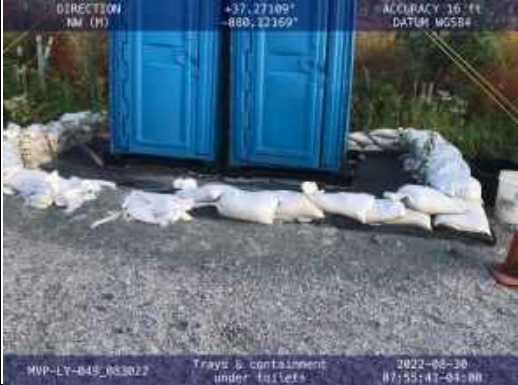
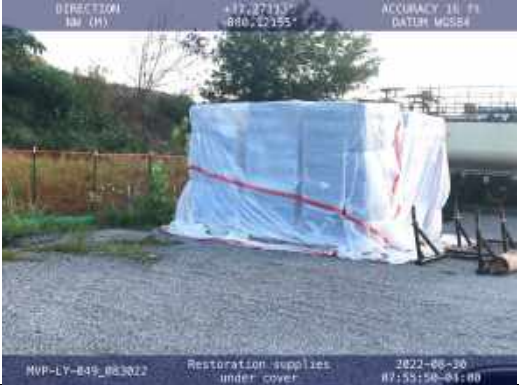
GPS Location MVP-LY-049 See photo for gps data		GPS Location MVP-LY-049 See photo for gps data	
Field Station# +0		Field Station# +0	
Pic 7 Desc. Trays and containment under toilets. Trays holding fluids. Looking NW.		Pic 8 Desc. Restoration supplies covered and cover secured. Looking NW.

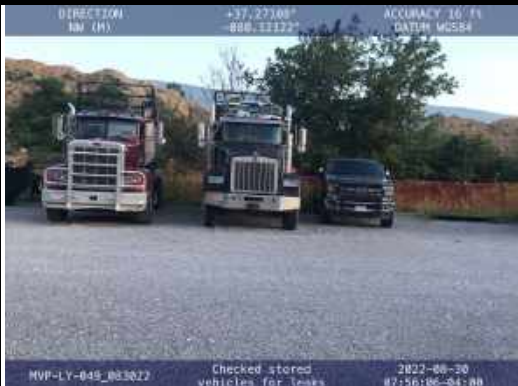
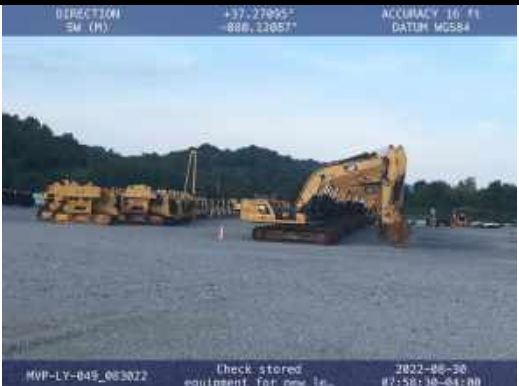
GPS Location MVP-LY-049 See photo for gps data		GPS Location MVP-LY-049 See photo for gps data	
Field Station# +0		Field Station# +0	
Pic 9 Desc. Checked stored vehicles for new leaks. No new leaks noted. Looking N.		Pic 10 Desc. Checked stored equipment for new leaks. No new leaks noted. Looking SW.

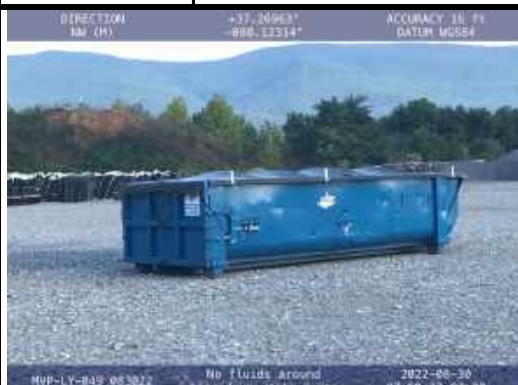
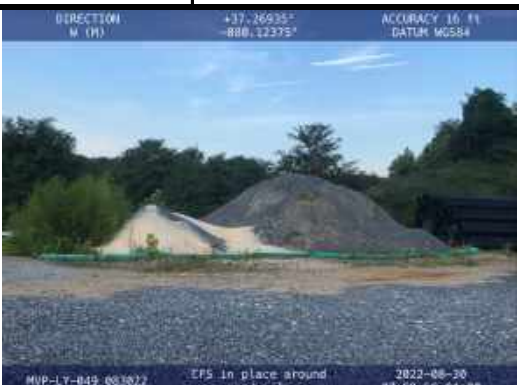
GPS Location MVP-LY-049 See photo for gps data		GPS Location MVP-LY-049 See photo for gps data	
Field Station# +0		Field Station# +0	
Pic 11 Desc. No fluids or deposits around hazardous waste dumpster. Looking NW.		Pic 12 Desc. Compost filter sock in place and functioning around sand pile. Looking W.

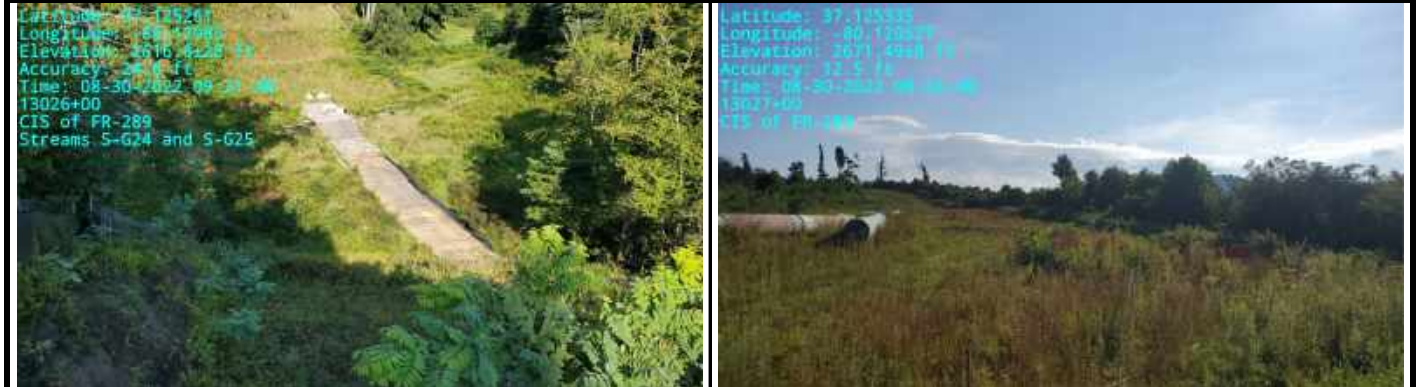
GPS Location	See photo for coordinates.	GPS Location	See photo for coordinates.
Field Station#	13026+00	Field Station#	13027+00
Pic 1 Desc.	S-G24 and S-G25, W-ST2, no new environmental concerns noted at stream or wetland crossings.	Pic 2 Desc.	ROW stabilized with good vegetative cover.

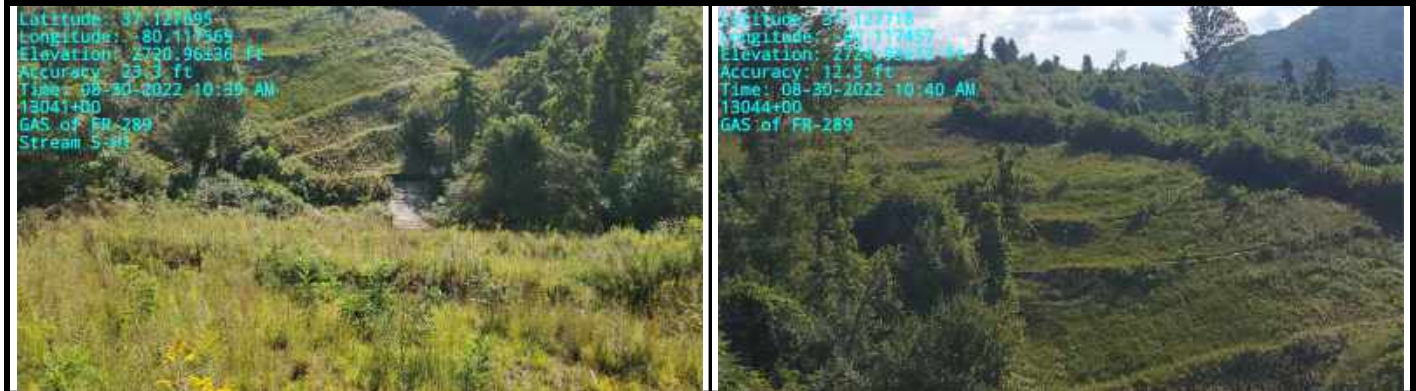
GPS Location	See photo for coordinates.	GPS Location	See photo for coordinates.
Field Station#	13041+00	Field Station#	13044+00
Pic 3 Desc.	S-H1, ROW well vegetated.	Pic 4 Desc.	ROW restored and vegetated.

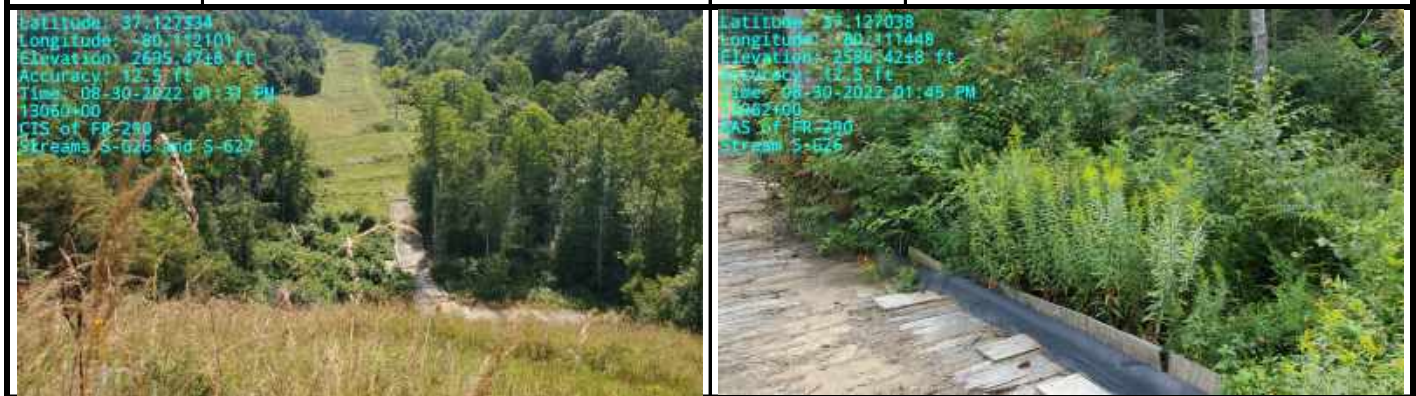
GPS Location	See photo for coordinates.	GPS Location	See photo for coordinates.
Field Station#	13060+00	Field Station#	13062+00
Pic 5 Desc.	S-G26 and S-G27, ROW well vegetated on coming in and going away sides of crossings.	Pic 6 Desc.	S-G26, downstream, no ROW impacts noted.

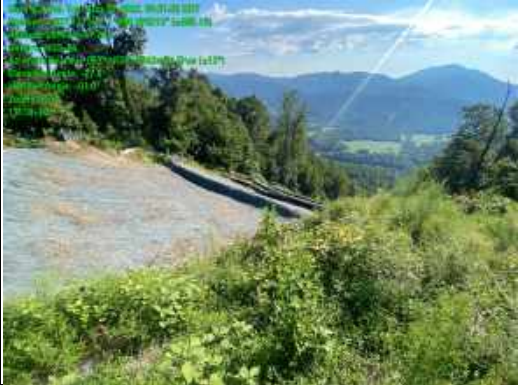
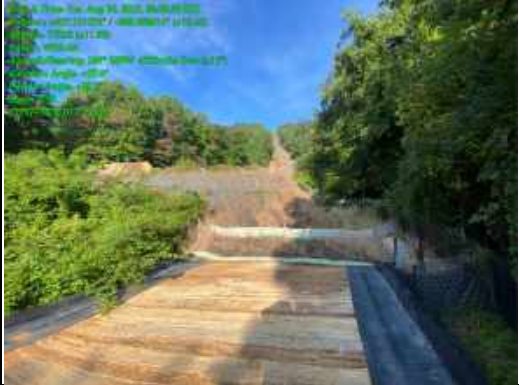
GPS Location	See photo for coordinates.		GPS Location	See photo for coordinates.	
Field Station#	13118+00		Field Station#	13137+78	
Pic 13 Desc.	ROW stabilized.		Pic 14 Desc.	Coming in side of S-D17/14, ROW stabilized with perimeter controls in acceptable condition.

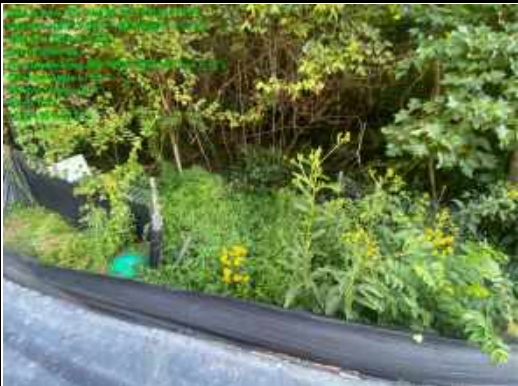
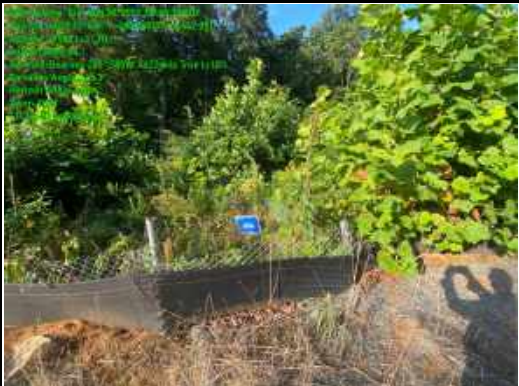
GPS Location	See photo for coordinates.		GPS Location	See photo for coordinates.	
Field Station#	13137+78		Field Station#	13138+50	
Pic 15 Desc.	S-D17/14, upstream, no stream flow noted.		Pic 16 Desc.	S-D17/14 habitat log functioning acceptably.

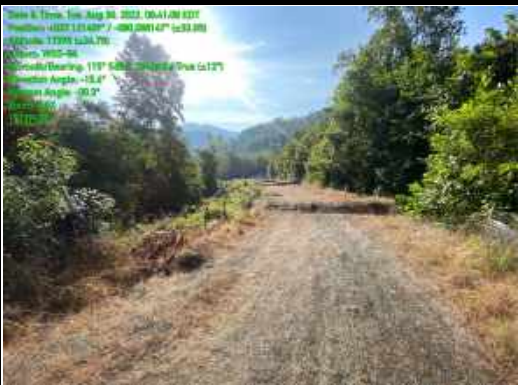
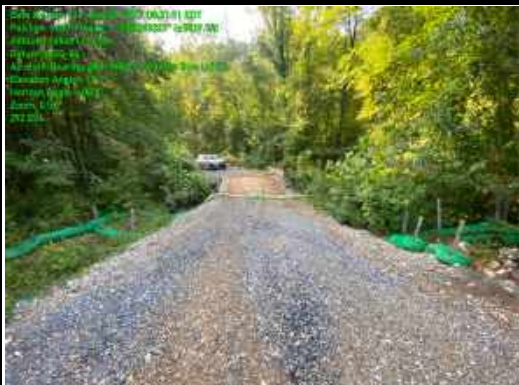
GPS Location	See photo for coordinates.		GPS Location	See photo for coordinates.	
Field Station#	13139+00		Field Station#	13141+53	
Pic 17 Desc.	ROW stabilized, no observable changes noted at slip.		Pic 18 Desc.	MVP-FR-292, S-D14 crossing, access road in acceptable condition; no flow noted in stream channel.

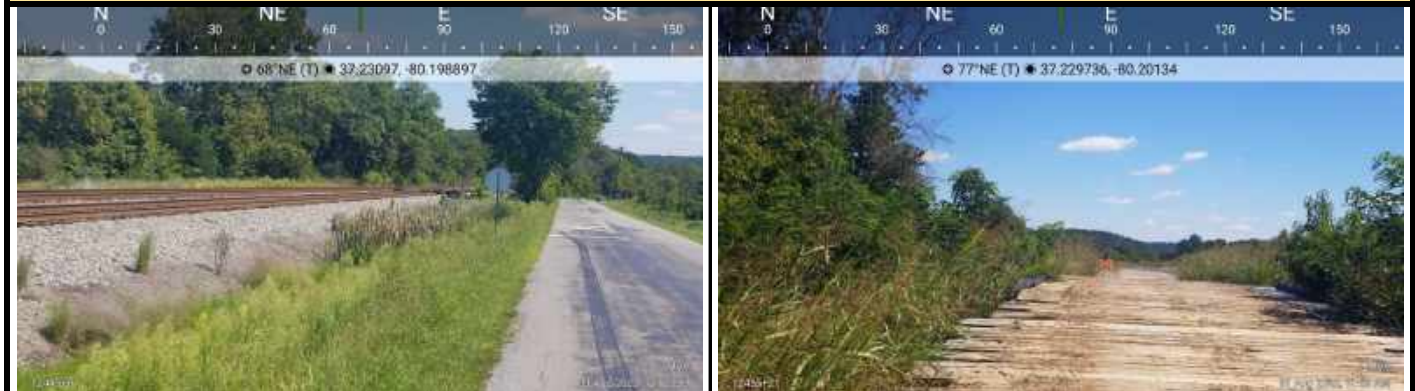
GPS Location	See Above	GPS Location	See Above
Field Station#	12445+01	Field Station#	12455+21
Pic 1 Desc.	Overview of Waterbody S-I1. ROW is stable. ROW is stable. No erosion or sedimentation concerns noted.	Pic 2 Desc.	Overview of Waterbody S-CD12b. ECDs are functional and ROW is stable.
