Visual Site Inspection Report

Project Name H-600 Pipeline Spread H		AFE 124300138	Spread H-600 Pipeline Spread H
Contractor Precision		Report # 41503	
Inspector Dustin Lyons		Date/Time 8/29/2022 4:18 PM	
Permit # TBD	Inspection Type VA SWPP	Station Begin	12600+00
State VA	Inspection Area Partial	Station End	12725+00
County Roanoke	Ground Damp	Temperature (°F)	73.00
Municipality N/A	Weather Sunny	Rain Gauge (in)	0.50
Rain Accumulation Time (days)			3.00

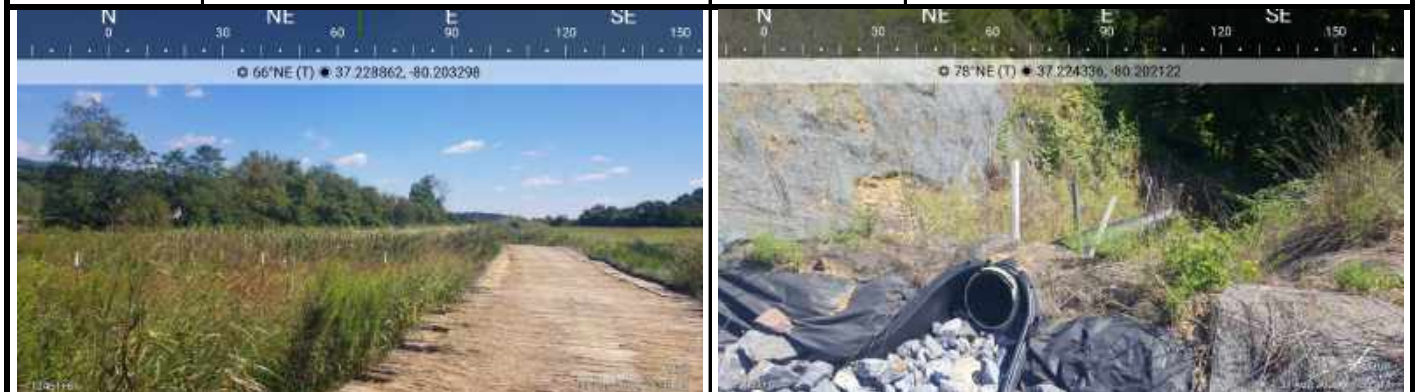
GPS Location	See Above	GPS Location	See Above
Field Station#	12461+81	Field Station#	12481+00
Pic 5 Desc.	Overview of Wetland W-KL58. ECDs are functional and ROW is stable.	Pic 6 Desc.	ROW Overview (temporary stabilization). ECDs are functional and ROW is stable.

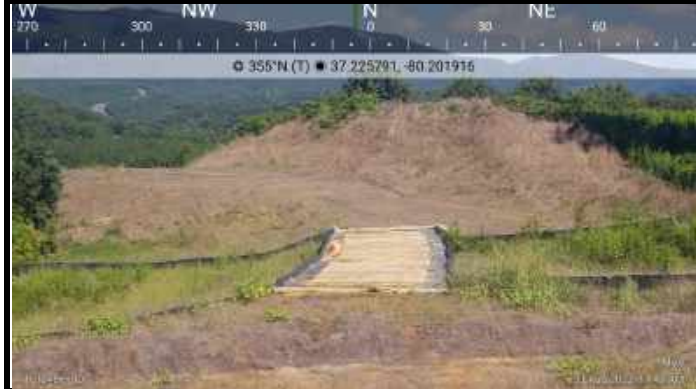
Pic 7 Desc. (reroute stationing) ROW Overview (temporary stabilization).

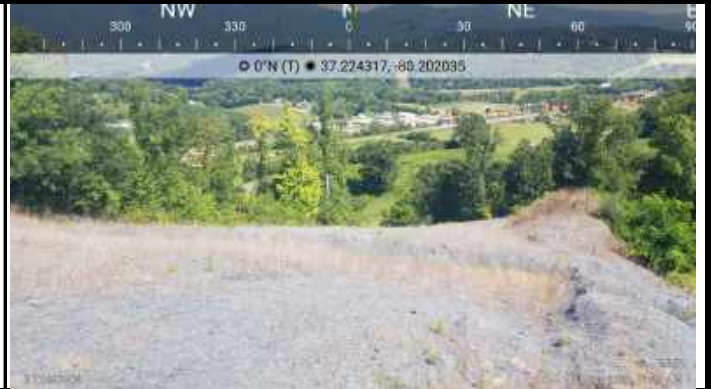
Pic 8 Desc. (reroute stationing) ROW Overview (temporary stabilization).

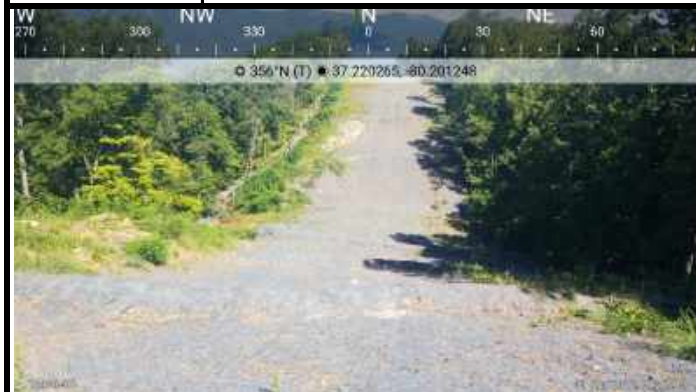
Pic 9 Desc. ROW Overview (temporary stabilization). ECDs are functional and ROW is stable.

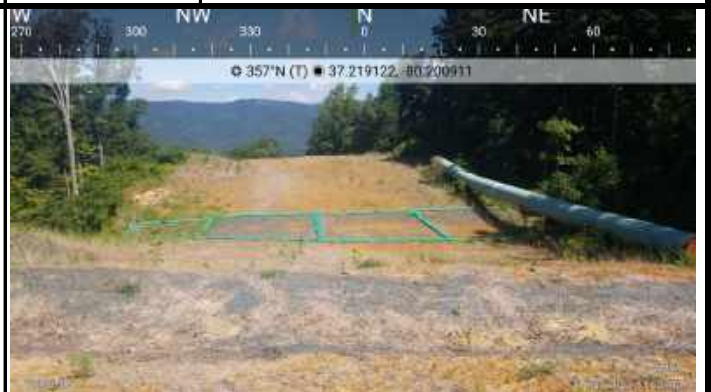
Pic 10 Desc. ROW Overview (temporary stabilization). ECDs are functional and ROW is stable.

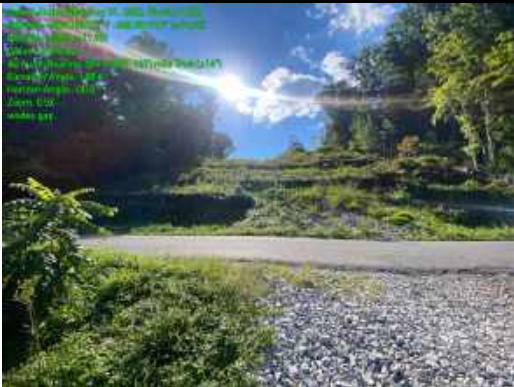
GPS Location	See photo for coordinates.		GPS Location	See photo for coordinates.	
Field Station#	13316+21		Field Station#	13317+02	
Pic 1 Desc.	Wade's Gape road crossing clean of ROW sediment and debris.		Pic 2 Desc.	Private driveway in acceptable condition.

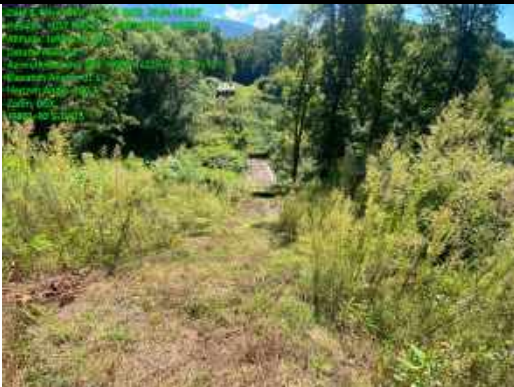
GPS Location	See photo for coordinates.		GPS Location	See photo for coordinates.	
Field Station#	13320+00		Field Station#	13321+47	
Pic 3 Desc.	ROW stabilized.		Pic 4 Desc.	S-GH15, downstream, no impacts noted.

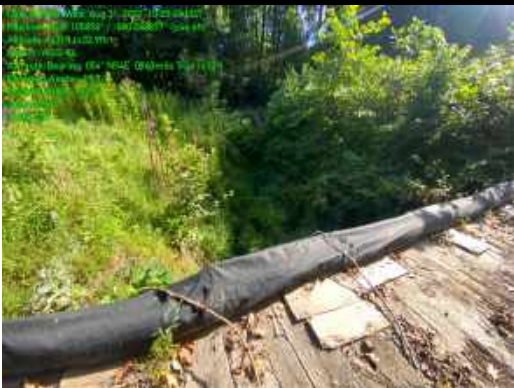
GPS Location	See photo for coordinates.		GPS Location	See photo for coordinates.	
Field Station#	13325+30		Field Station#	13325+30	
Pic 5 Desc.	S-GH14, upstream, no changes observed, banks well vegetated.		Pic 6 Desc.	S-GH14, downstream, no changes observed, no turbidity noted.

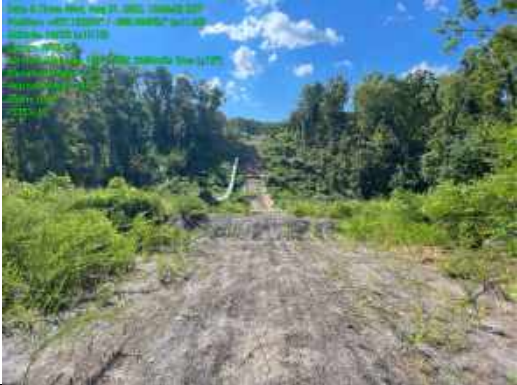
GPS Location	See photo for coordinates.		GPS Location	See photo for coordinates.	
Field Station#	13353+00		Field Station#	13355+33	
Pic 13 Desc.	ROW stabilized.		Pic 14 Desc.	Private road in acceptable condition.

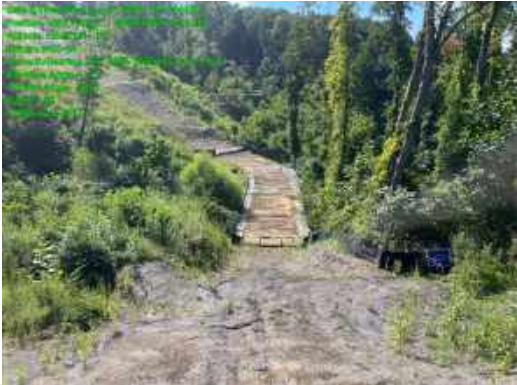
GPS Location	See photo for coordinates.		GPS Location	See photo for coordinates.	
Field Station#	13358+64		Field Station#	13365+50	
Pic 15 Desc.	S-RR11, ROW stabilized, perimeter controls in acceptable condition.		Pic 16 Desc.	ROW stabilized.

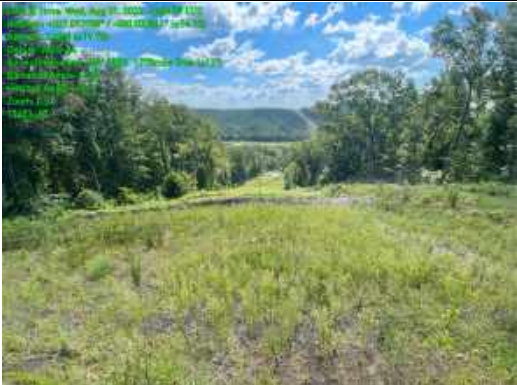
GPS Location	See photo for coordinates.		GPS Location	See photo for coordinates.	
Field Station#	13403+00		Field Station#	13413+05	
Pic 17 Desc.	ROW stabilized.		Pic 18 Desc.	S-IJ1, downstream, no impacts noted.

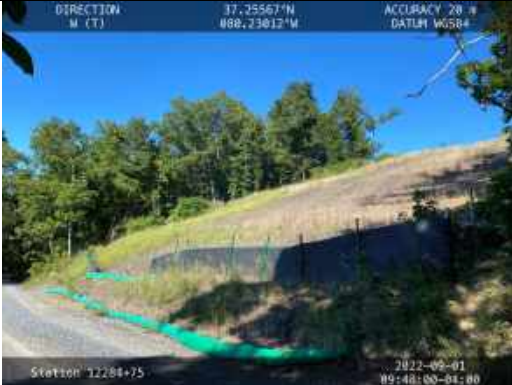
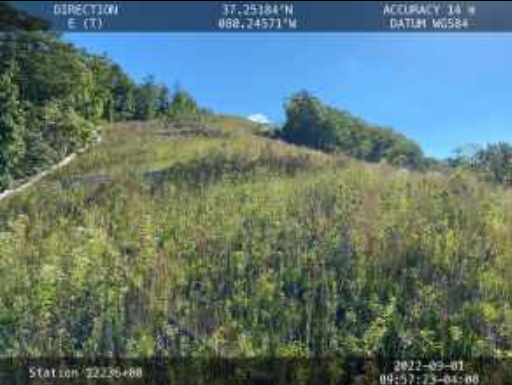
GPS Location	Please see photo for details.		GPS Location	Please see photo for details.	
Field Station#	12284+75		Field Station#	12236+00	
Pic 1 Desc.	Photo shows the stabilized ROW conditions with water bars and that all ECDs are installed and are functioning as designed.		Pic 2 Desc.	Photo shows the stabilized ROW conditions with water bars and that all ECDs are installed and are functioning as designed.

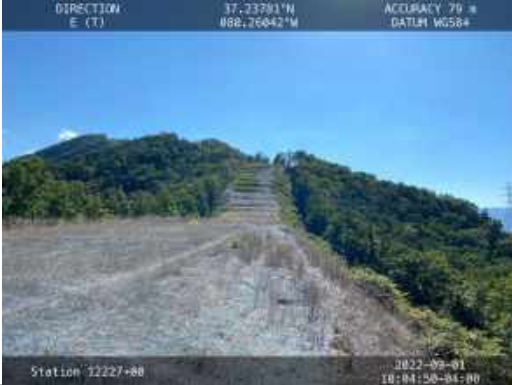
GPS Location	Please see photo for details.		GPS Location	Please see photo for details.	
Field Station#	12227+00		Field Station#	12215+50	
Pic 3 Desc.	Photo shows the stabilized ROW conditions with water bars and that all ECDs are installed and are functioning as designed.		Pic 4 Desc.	Photo shows a installed waterbar, sump and waterbar end treatment

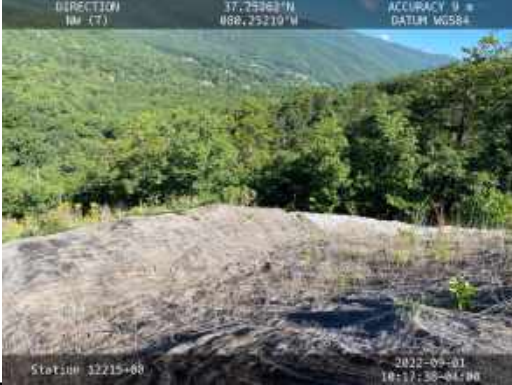
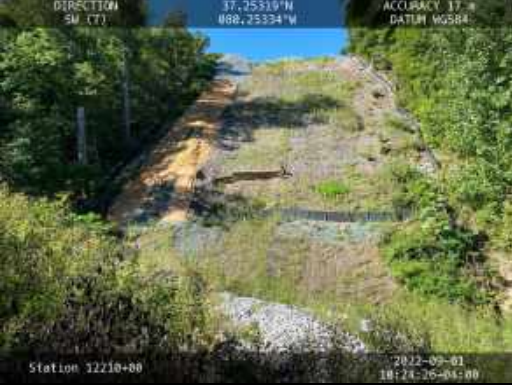
Field Station#	12215+00		Field Station#	12210+00	
Pic 5 Desc.	Photo shows the stabilized ROW conditions with water bars and that all ECDs are installed and are functioning as designed.		Pic 6 Desc.	Photo shows the stabilized ROW conditions with water bars and that all ECDs are installed and are functioning as designed.

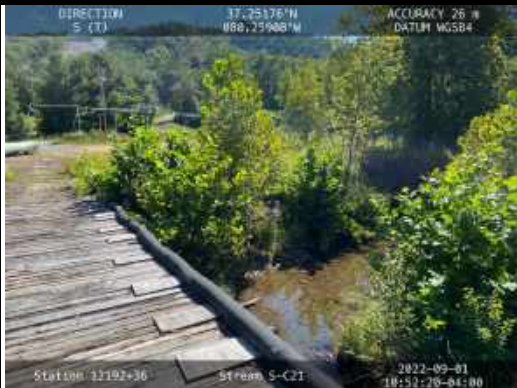
GPS Location	Please see photo for details.		GPS Location	Please see photo for details.	
Field Station#	12192+36		Field Station#	12190+85	
Pic 9 Desc.	Photo shows downstream view of Stream S-C21 from equipment bridge spanning the stream channel.		Pic 10 Desc.	Photo shows ST RTE 629 BRADSHAW ROAD.

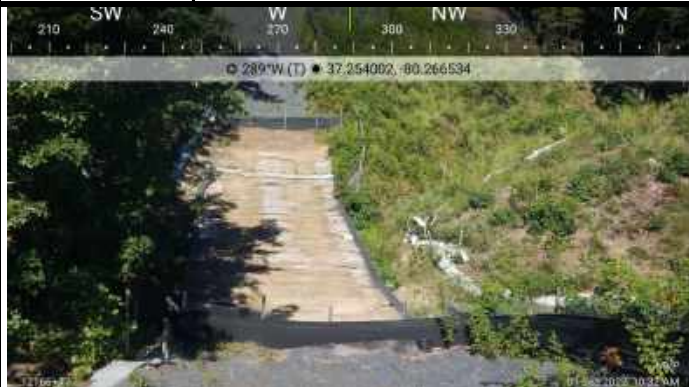
GPS Location	Please see photo for details.		GPS Location	Please see photo for details.	
Field Station#	12166+47		Field Station#	12163+05	
Pic 11 Desc.	Photo shows bridge spanning stream channel of Stream S-C24 along with its buffer zone.		Pic 12 Desc.	Photo shows bridge spanning stream channel of Stream S-C25 along with its buffer zone.

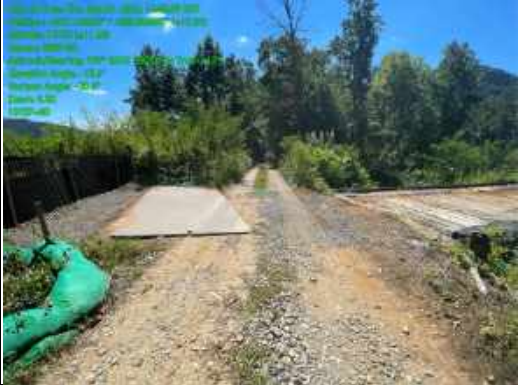
GPS Location		See photo for coordinates.		GPS Location	
				See photo for coordinates.	
Field Station#		13157+50		Field Station#	
				13157+50	
Pic 7 Desc.		Gravel road being used for logging activities north of the ROW.		Pic 8 Desc.	
				Compost filter sock damaged from local/logging traffic repaired during inspection period.

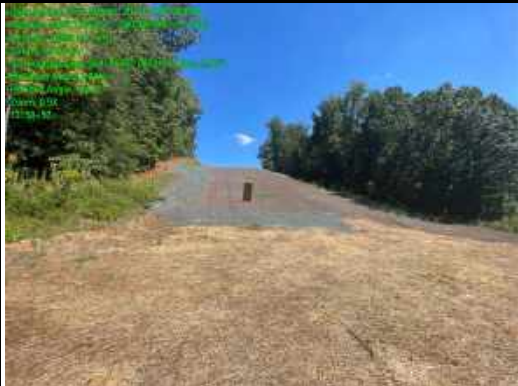
GPS Location		See photo for coordinates.		GPS Location	
				See photo for coordinates.	
Field Station#		13158+50		Field Station#	
				13161+50	
Pic 9 Desc.		ROW stabilized.		Pic 10 Desc.	
				Fill slope stable, slope drains functioning acceptably.

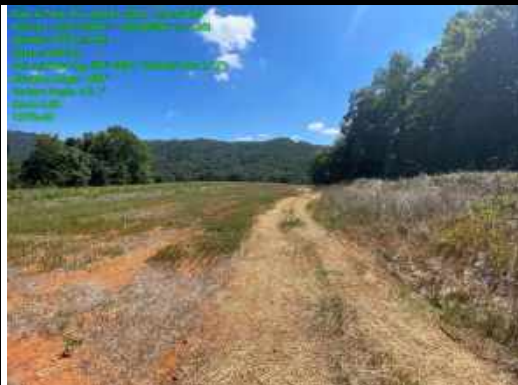
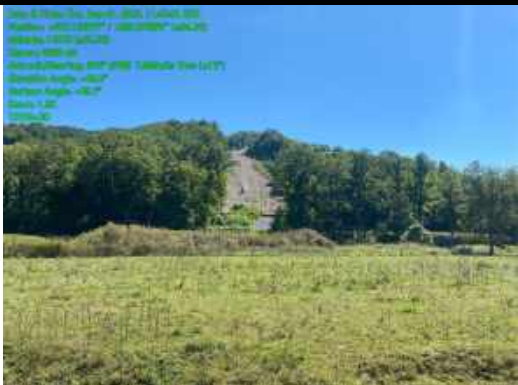
GPS Location		See photo for coordinates.		GPS Location	
				See photo for coordinates.	
Field Station#		13175+00		Field Station#	
				13196+30	
Pic 11 Desc.		ROW stabilized.		Pic 12 Desc.	
				ROW stabilized.

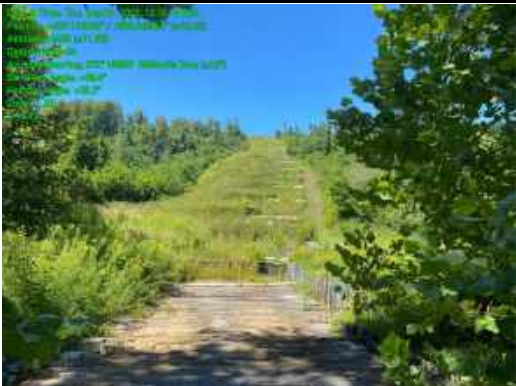
GPS Location	See photo for coordinates.		GPS Location	See photo for coordinates.	
Field Station#	13260+50		Field Station#	13306+00	
Pic 15 Desc.	Coming in side of S-II4, ROW stable with good vegetative cover.		Pic 16 Desc.	ROW restored.

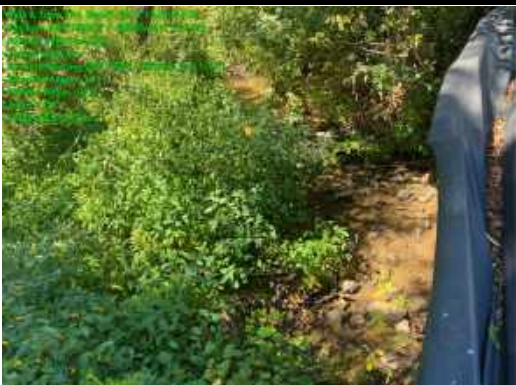
GPS Location	See photo for coordinates.		GPS Location	See photo for coordinates.	
Field Station#	13309+09		Field Station#	13311+00	
Pic 17 Desc.	S-GH7, downstream, no ROW impacts observed.		Pic 18 Desc.	ROW stabilized.

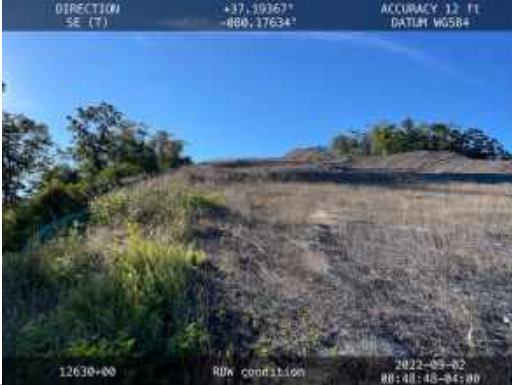
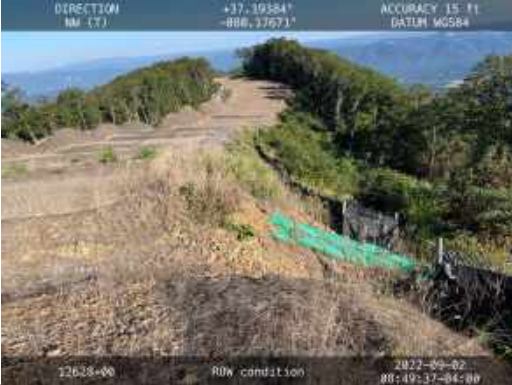
GPS Location	See photo for gps location data.		GPS Location	See photo for gps location data.	
Field Station#	12630+00		Field Station#	12628+00	
Pic 3 Desc.	Photo shows the ROW condition. ECDs are installed and functioning as designed.		Pic 4 Desc.	Photo shows the ROW condition. ECDs are installed and functioning as designed.

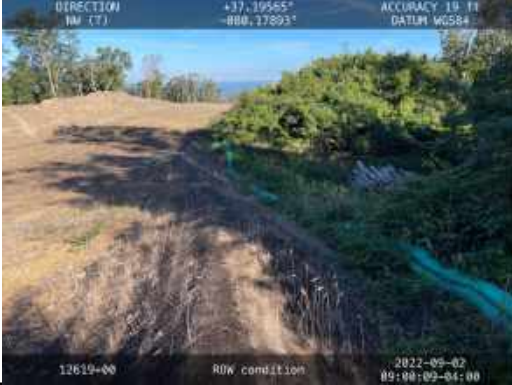
GPS Location	See photo for gps location data.		GPS Location	See photo for gps location data.	
Field Station#	12619+00		Field Station#	12614+00	
Pic 5 Desc.	Photo shows the ROW condition. ECDs are installed and functioning as designed.		Pic 6 Desc.	Photo shows the slope drain.

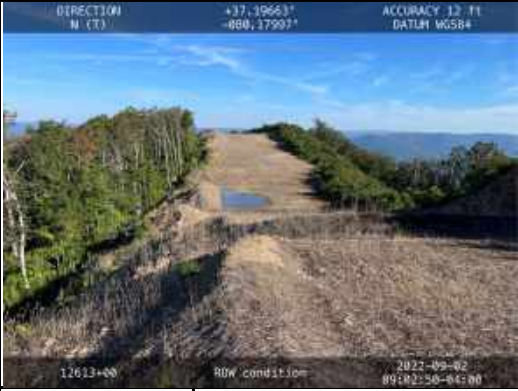
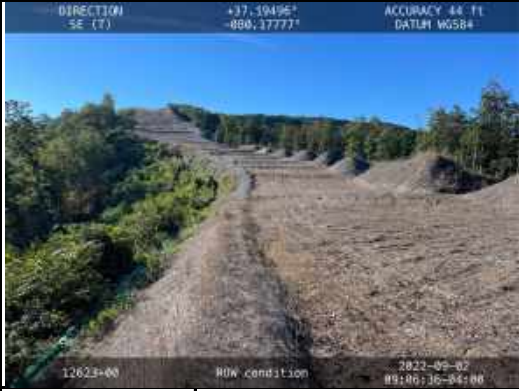
GPS Location	See photo for gps location data.		GPS Location	See photo for gps location data.
Field Station#	12613+00		Field Station#	12623+00
Pic 7 Desc.	Photo shows the ROW condition. ECDs are installed and functioning as designed.		Pic 8 Desc.	Photo shows the ROW condition. ECDs are installed and functioning as designed.

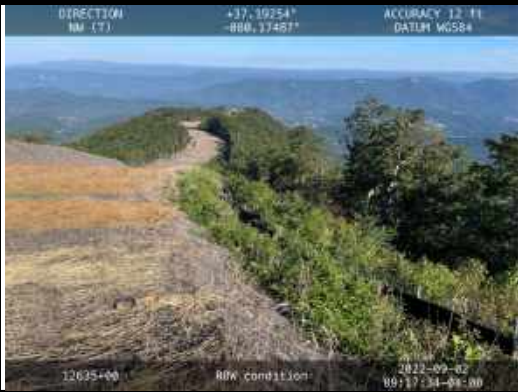
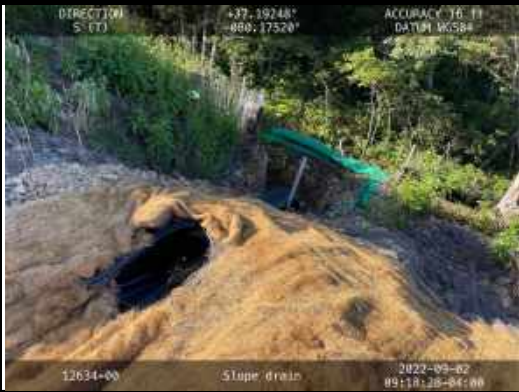
GPS Location	See photo for gps location data.		GPS Location	See photo for gps location data.
Field Station#	12635+00		Field Station#	12634+00
Pic 9 Desc.	Photo shows the ROW condition. ECDs are installed and functioning as designed.		Pic 10 Desc.	Photo shows the slope drain.

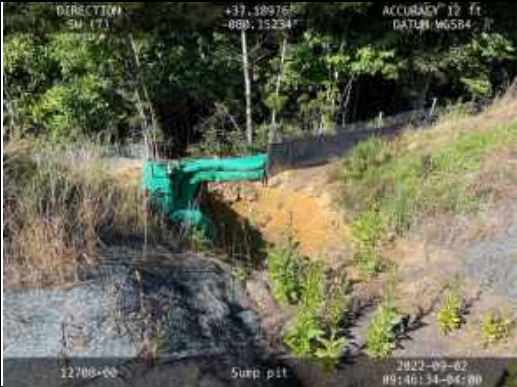
GPS Location	See photo for gps location data.		GPS Location	See photo for gps location data.	
Field Station#	12708+00		Field Station#	12715+00	
Pic 13 Desc.	Photo shows the sump pit.		Pic 14 Desc.	Photo shows the bridge over streams S-Y13 and S-Y14.

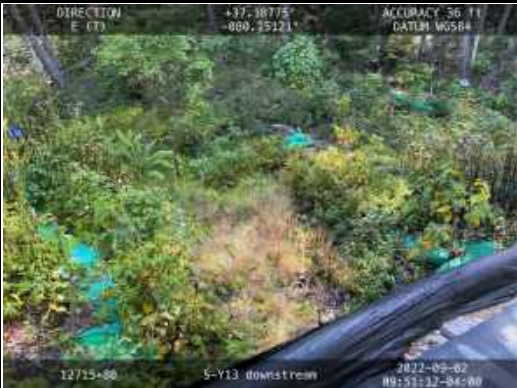
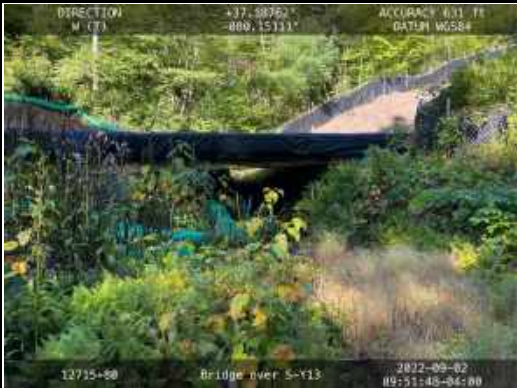
GPS Location	See photo for gps location data.		GPS Location	See photo for gps location data.	
Field Station#	12715+80		Field Station#	12715+80	
Pic 15 Desc.	Photo shows S-Y13 downstream from the bridge.		Pic 16 Desc.	Photo shows the bridge over stream S-Y13.

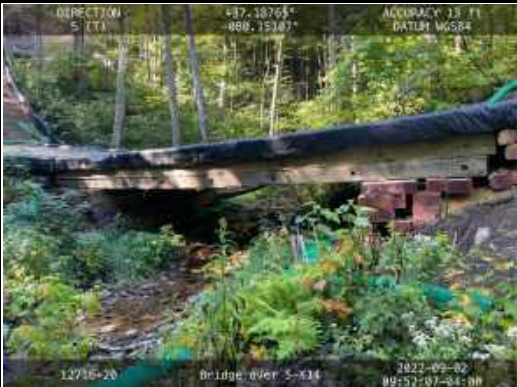
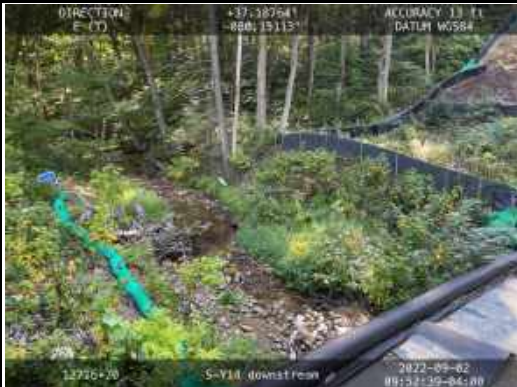
GPS Location	See photo for gps location data.		GPS Location	See photo for gps location data.	
Field Station#	12716+20		Field Station#	12716+20	
Pic 17 Desc.	Photo shows the bridge over stream S-Y14.		Pic 18 Desc.	Photo shows S-Y14 downstream from the bridge.

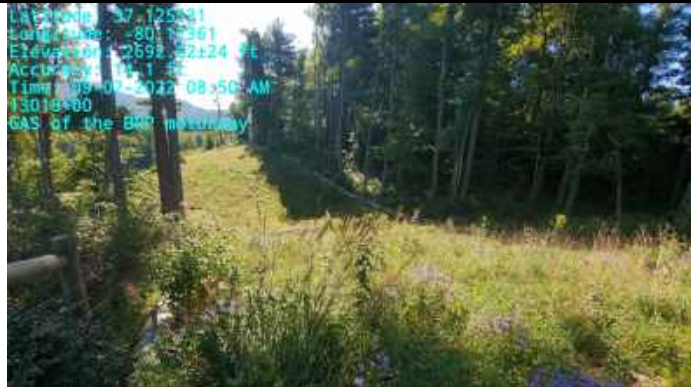
Pic 1 Desc.	Current ROW conditions.
--------------------	-------------------------

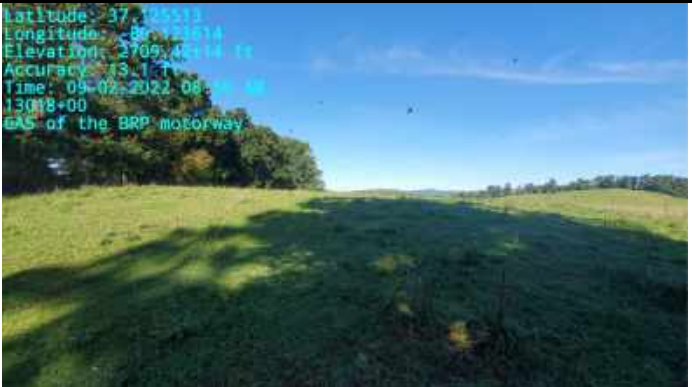
Pic 2 Desc.	Current ROW conditions.
--------------------	-------------------------

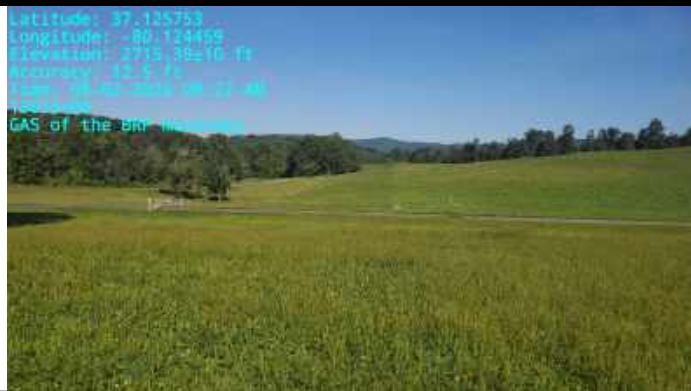
Pic 3 Desc.	Current ROW conditions.
--------------------	-------------------------

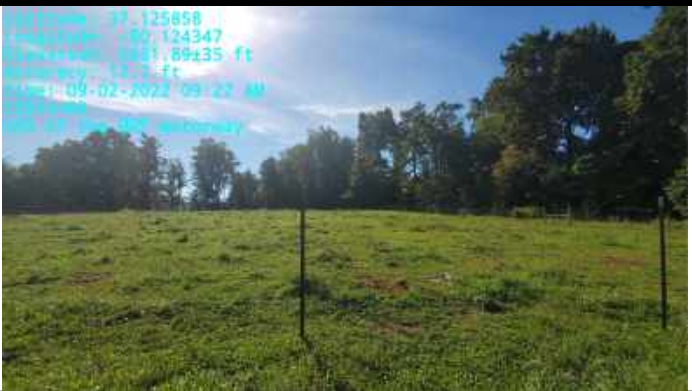
Pic 4 Desc.	Current ROW conditions.
--------------------	-------------------------

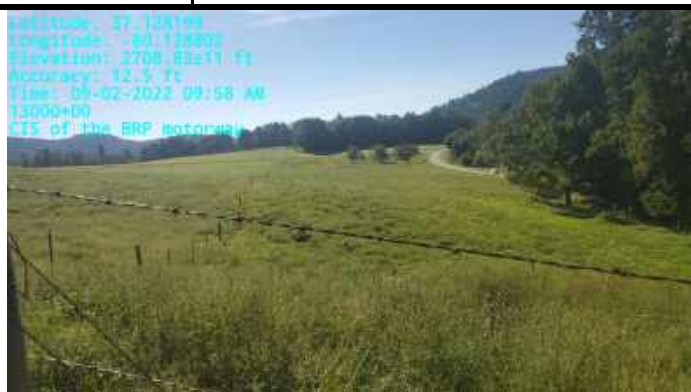
Pic 5 Desc.	Current ROW conditions.
--------------------	-------------------------

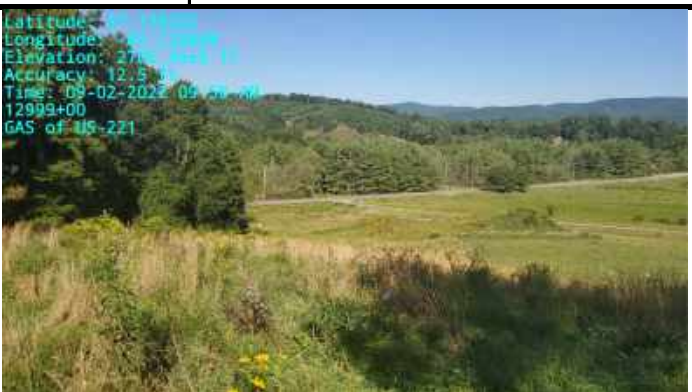
Pic 6 Desc.	Current ROW conditions.
--------------------	-------------------------

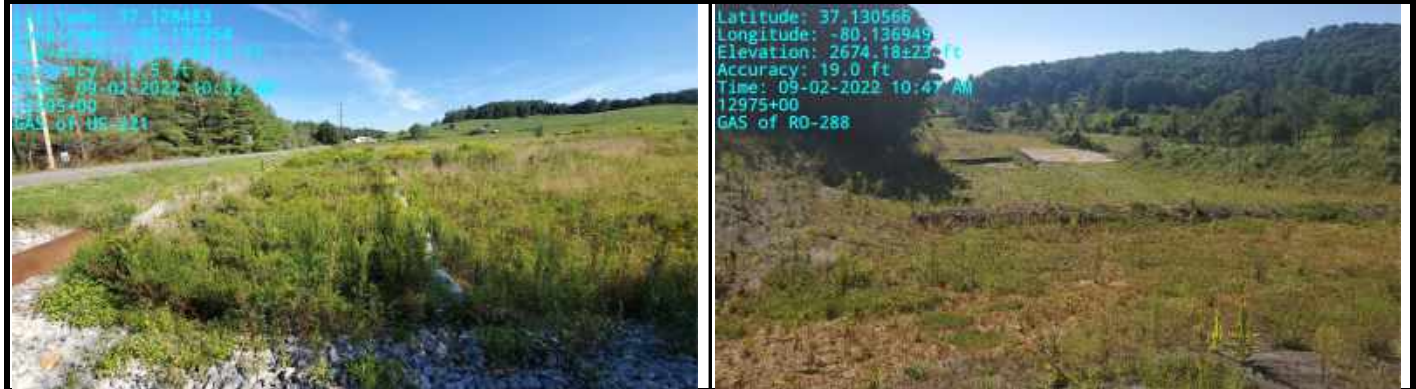
GPS Location	See pic.	GPS Location	See pic.
Field Station#	12995+00	Field Station#	12975+00
Pic 7 Desc.	Current ROW conditions.	Pic 8 Desc.	Current ROW conditions.

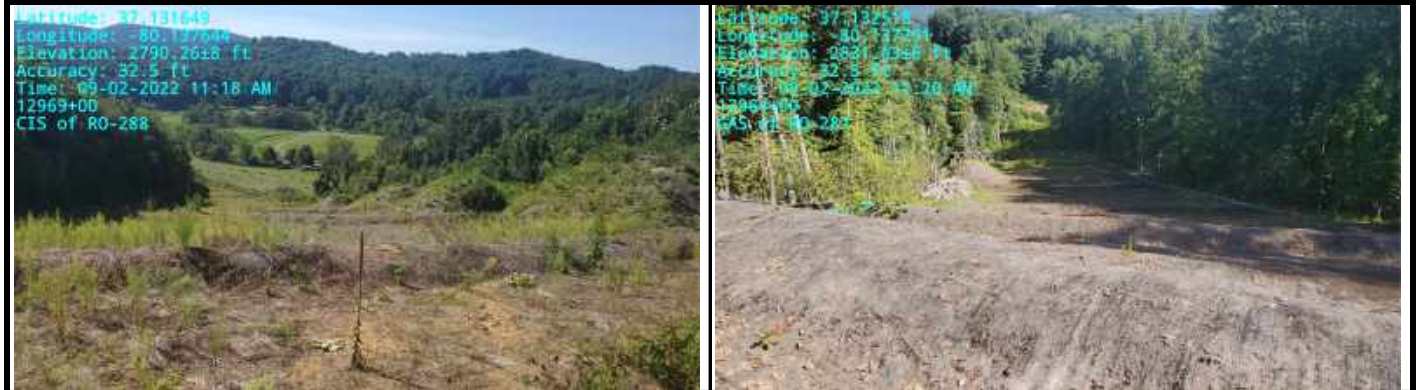
GPS Location	See pic.	GPS Location	See pic.
Field Station#	12969+00	Field Station#	12964+00
Pic 9 Desc.	Current ROW conditions.	Pic 10 Desc.	Current ROW conditions.

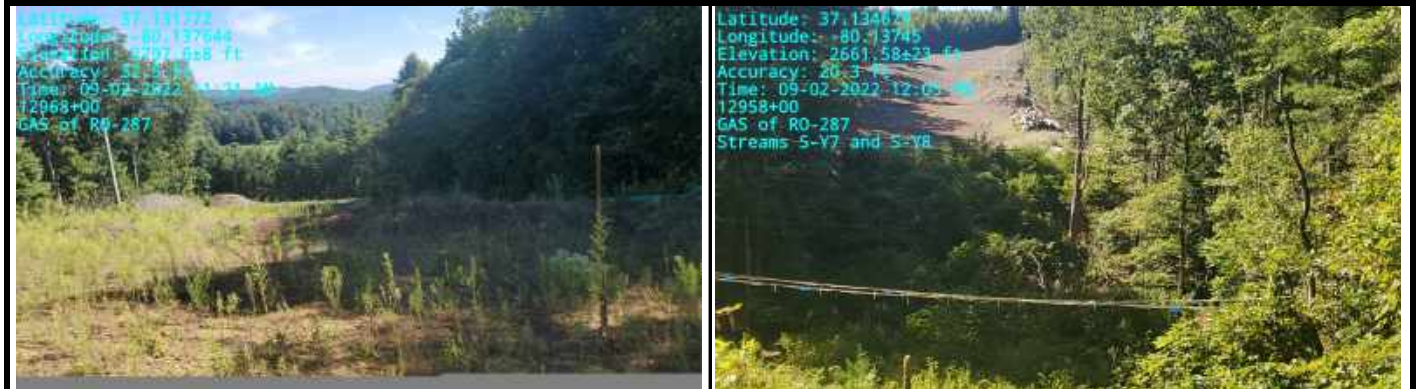
GPS Location	See pic.	GPS Location	See pic.
Field Station#	12968+00	Field Station#	12958+00
Pic 11 Desc.	Current ROW conditions.	Pic 12 Desc.	Current ROW conditions.

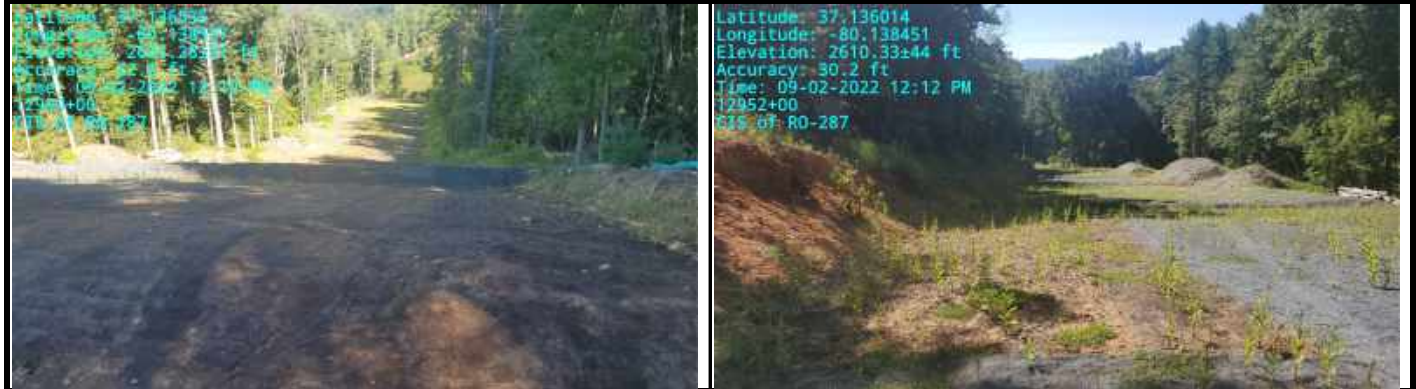
GPS Location	See pic.	GPS Location	See pic.
Field Station#	12950+00	Field Station#	12952+00
Pic 13 Desc.	Current ROW conditions.	Pic 14 Desc.	Current ROW conditions.

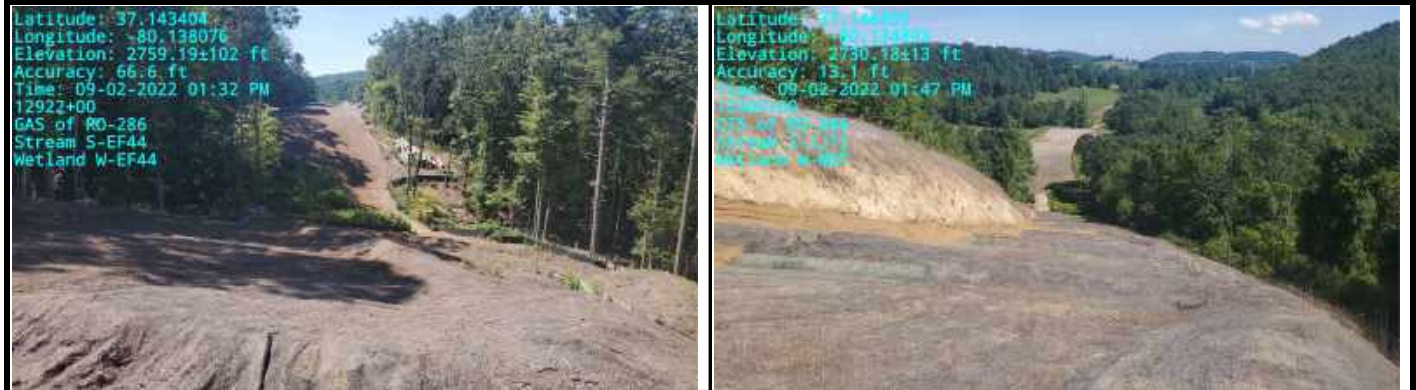
GPS Location	See pic.	GPS Location	See pic.
Field Station#	12922+00	Field Station#	12900+00
Pic 15 Desc.	Current ROW conditions.	Pic 16 Desc.	Current ROW conditions.

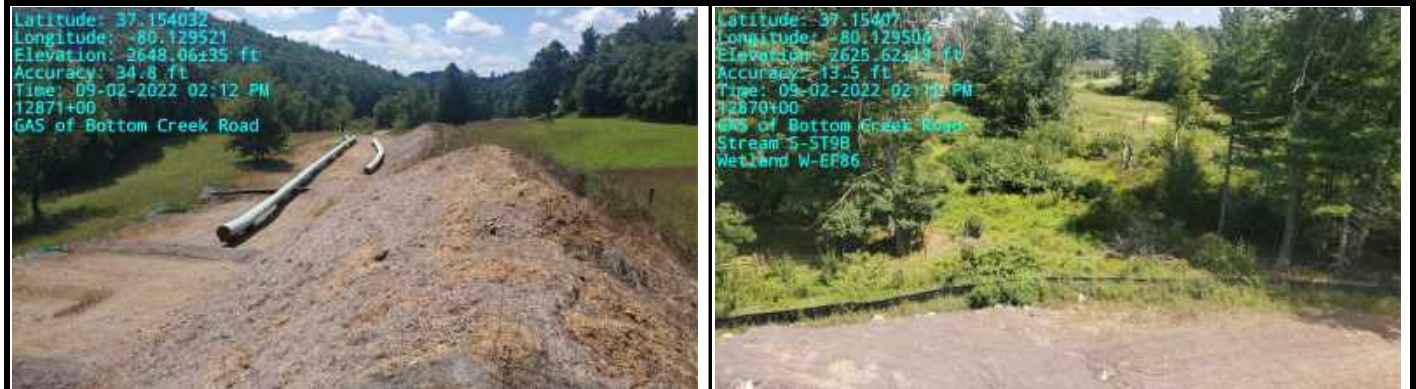
GPS Location	See pic.	GPS Location	See pic.
Field Station#	12871+00	Field Station#	12870+00
Pic 17 Desc.	Current ROW conditions.	Pic 18 Desc.	Current ROW conditions.

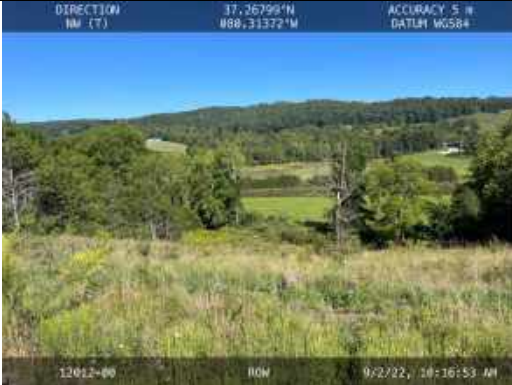
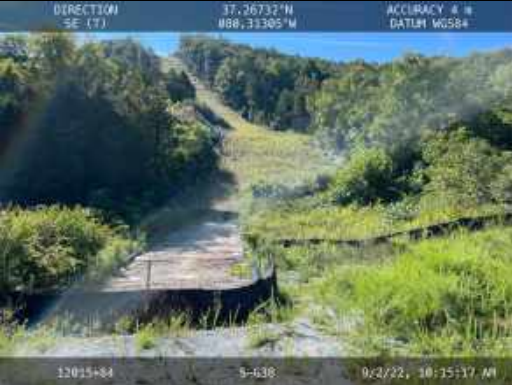
GPS Location	Please see photo for details.		GPS Location	Please see photo for details.	
Field Station#	12012+00		Field Station#	12015+84	
Pic 1 Desc.	Photo shows the stabilized ROW conditions with water bars and that all ECDs are installed and are functioning as designed.		Pic 2 Desc.	Photo shows overview of Stream S-G38 along with its buffer zone.

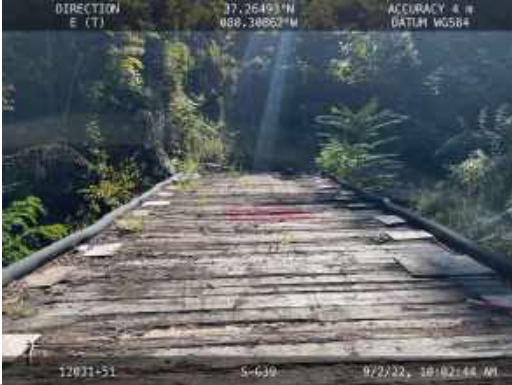
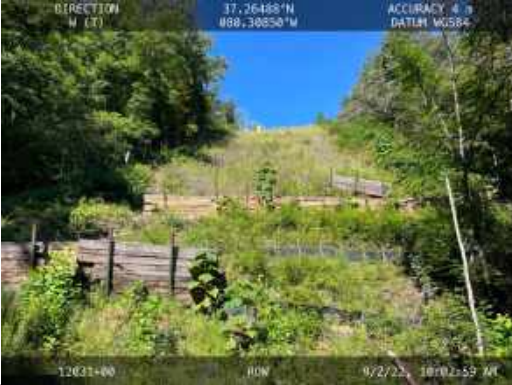
GPS Location	Please see photo for details.		GPS Location	Please see photo for details.	
Field Station#	12031+51		Field Station#	12031+00	
Pic 3 Desc.	Photo shows equipment bridge over Stream S-G39.		Pic 4 Desc.	Photo shows the stabilized ROW conditions with water bars and that all ECDs are installed and are functioning as designed.

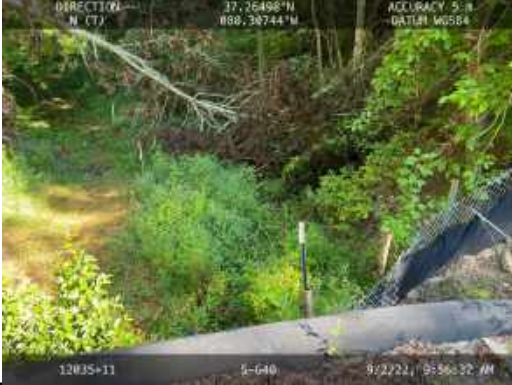
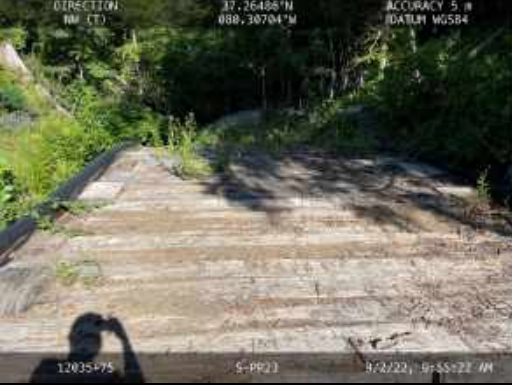
Pic 5 Desc.	Photo downstream of Stream S-G40.		Pic 6 Desc.	Photo shows equipment bridge over Stream S-PP23.

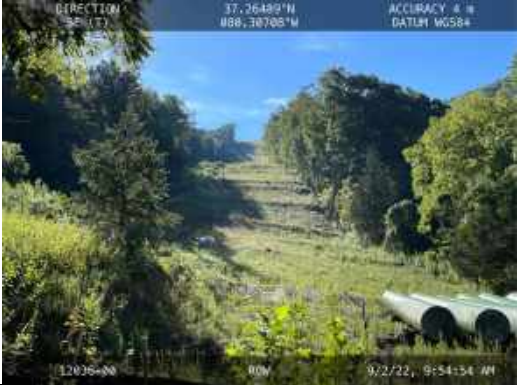
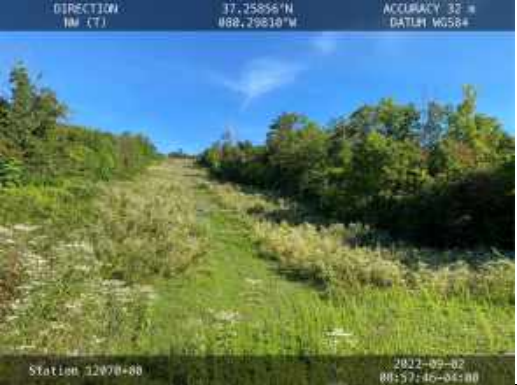
GPS Location	Please see photo for details.		GPS Location	Please see photo for details.	
Field Station#	12036+00		Field Station#	12070+00	
Pic 7 Desc.	Photo shows the stabilized ROW conditions with water bars and that all ECDs are installed and are functioning as designed.		Pic 8 Desc.	Photo shows the stabilized ROW conditions with water bars and that all ECDs are installed and are functioning as designed.

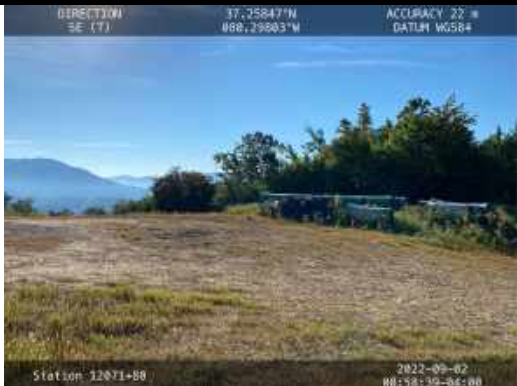
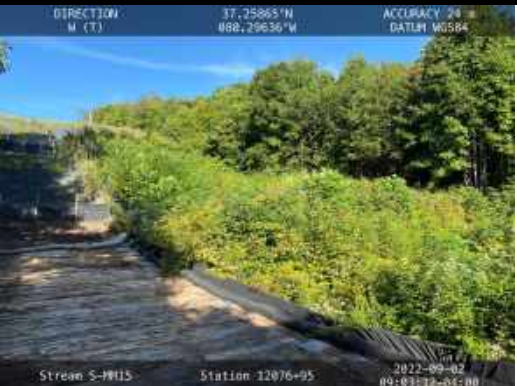
GPS Location	Please see photo for details.		GPS Location	Please see photo for details.	
Field Station#	12071+80		Field Station#	12076+95	
Pic 9 Desc.	Photo shows stabilized ROW conditions where MVP-MN-270 meets the ROW.		Pic 10 Desc.	Photo shows upstream view of Stream S-MM15.

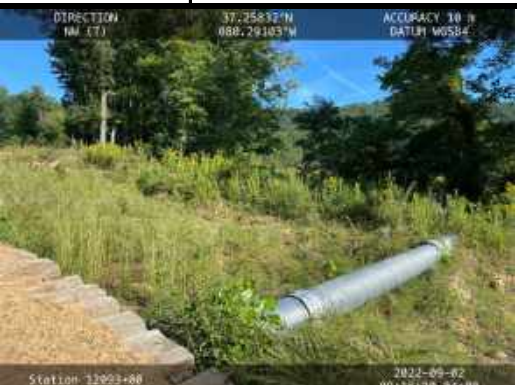
Pic 11 Desc.	Photo shows the stabilized ROW conditions with water bars and that all ECDs are installed and are functioning as designed.		Pic 12 Desc.	Photo shows clean water diversion berm along with inlet side of clean water diversion pipe.

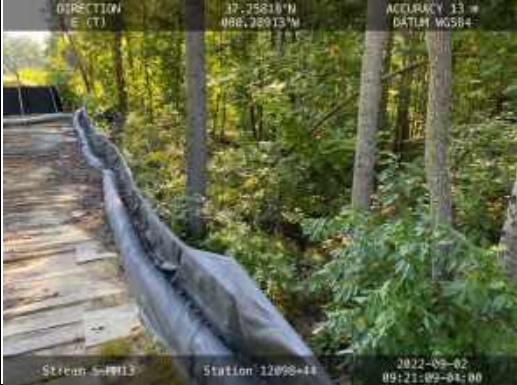
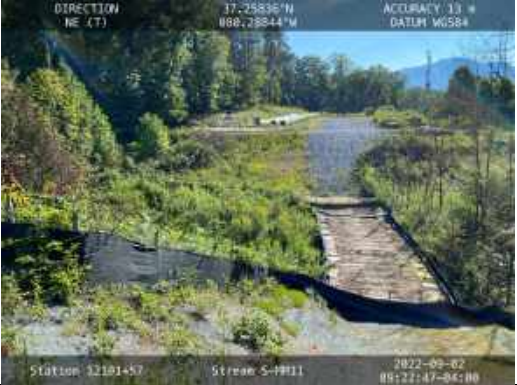
GPS Location	Please see photo for details.	GPS Location	Please see photo for details.
Field Station#	12098+44	Field Station#	12101+57
Pic 13 Desc.	Photo shows downstream view of Steam S-MM14.	Pic 14 Desc.	Photo shows overview of Stream S-MM-11 it's buffer zone.

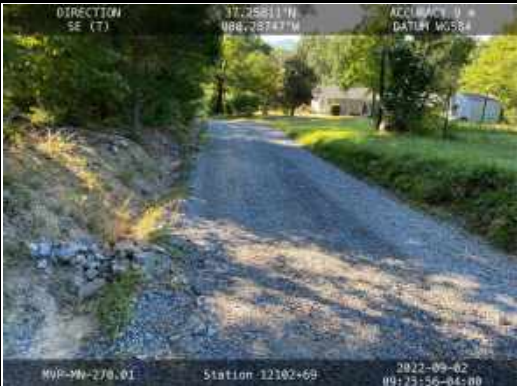
GPS Location	Please see photo for details.	GPS Location	Please see photo for details.
Field Station#	12102+69	Field Station#	12112+13
Pic 15 Desc.	Photo shows maintenance on rock check dams on MVP-MN-270.01.	Pic 16 Desc.	Photo shows upstream view of Stream S-F16A/B from the equipment bridge spanning the stream channel.

One remedial measure was performed since the last VA DEQ SWPPP inspection and was found to be completed. This consisted of maintenance on rock check dams on MVP-MN-270.01.

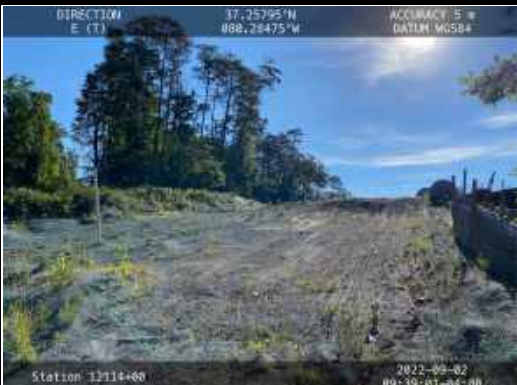
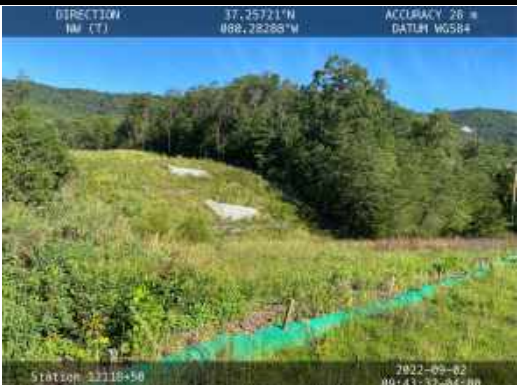
GPS Location	Please see photo for details.	GPS Location	Please see photo for details.
Field Station#	12114+00	Field Station#	12118+50
Pic 17 Desc.	Photo shows the stabilized ROW conditions with water bars and that all ECDs are installed and are functioning as designed.	Pic 18 Desc.	Photo shows the stabilized ROW conditions with water bars and that all ECDs are installed and are functioning as designed.

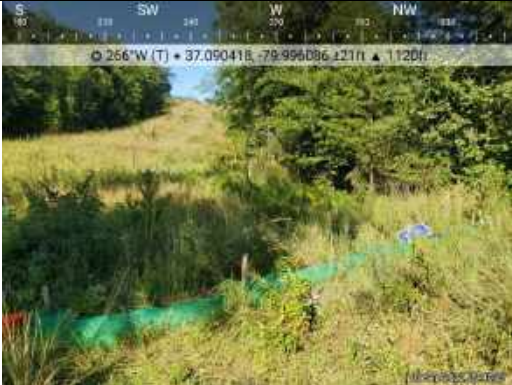
GPS Location 0		GPS Location 0			
Field Station# 13525+50		Field Station# 13525+75			
Pic 1 Desc. GAS S-KL1 Bank vegetation and CFS		Pic 2 Desc. GAS S-KL1 Buffer zone ECDs

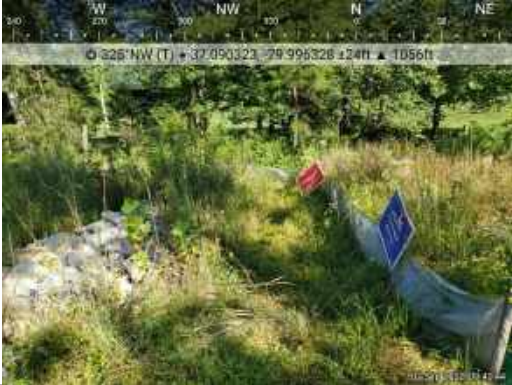
GPS Location 0		GPS Location 0			
Field Station# 13524+50		Field Station# 13523+00			
Pic 3 Desc. CIS S-KL2 Buffer zone ECDs		Pic 4 Desc. Permanent vegetation

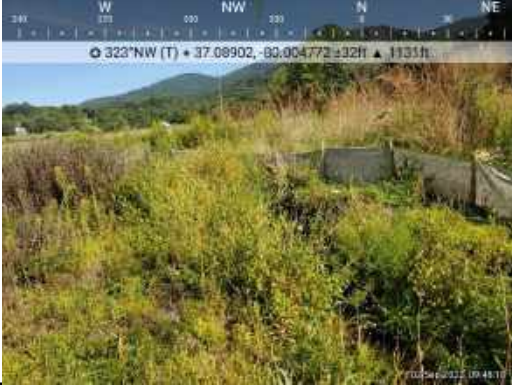
GPS Location 0		GPS Location 0			
Field Station# 13498+00		Field Station# 13495+00			
Pic 5 Desc. S-IJ10 Channel and banks		Pic 6 Desc. CIS Cahas Mtn Rd #2 Permanent vegetation

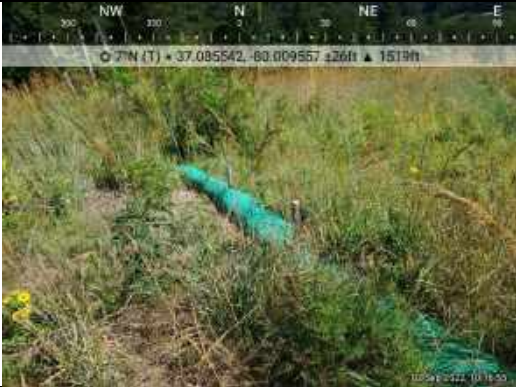
<p>ert image here</p>	
GPS Location 0		GPS Location 0			
Field Station# 13475+00		Field Station# 13482+00			
Pic 7 Desc. Waterbar outlet protection		Pic 8 Desc. Perimeter CFS

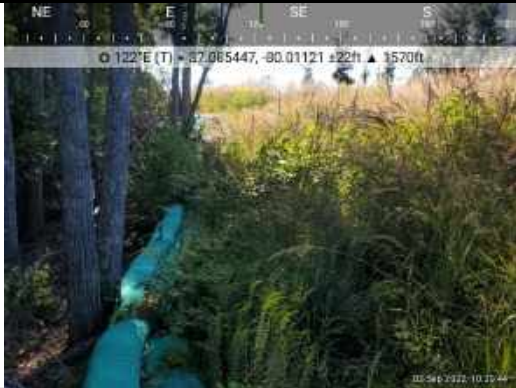
<p>ert image here</p>	
GPS Location 0		GPS Location 0			
Field Station# 13475+00		Field Station# 13468+00			
Pic 9 Desc. Perimeter triple stack CFS		Pic 10 Desc. Permanent vegetation

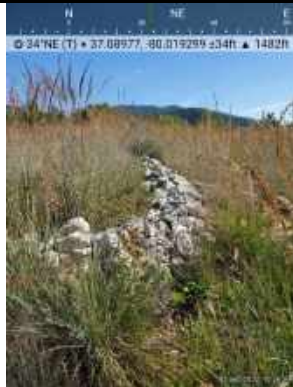
<p>ert image here</p>	
GPS Location 0		GPS Location 0			
Field Station# 13440+00		Field Station# 13416+00			
Pic 11 Desc. Level spreader		Pic 12 Desc. W-IJ3 Perimeter ECDs

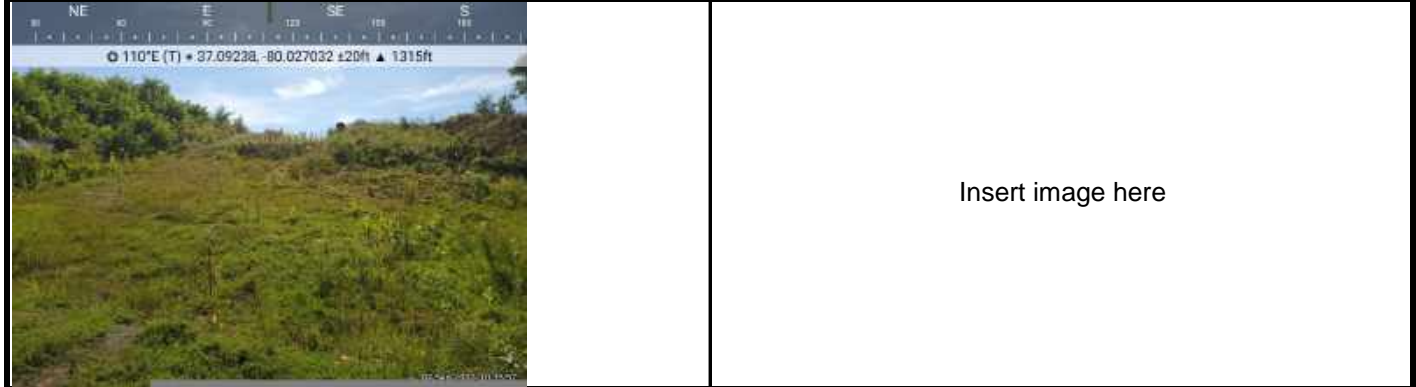
Field Station#	13417+00	Field Station#	
-----------------------	----------	-----------------------	--

Pic 13 Desc.	GAS Cahas Mtn Rd #1 Temporary vegetation	Pic 14 Desc.	
---------------------	--	---------------------	--
