Visual Site Inspection Report

Project Name H-600 Pipeline Spread I		AFE 124300139	Spread H-600 Pipeline Spread I
Contractor Precision		Report # 40496	
Inspector Ben Farmer		Date/Time 8/1/2022 12:54 PM	
Permit # TBD	Inspection Type VA SWPP	Station Begin 13853+45	
State VA	Inspection Area Partial	Station End 13958+31	
County Franklin	Ground Wet	Temperature (°F) 72.00	
Municipality N/A	Weather Cloudy	Rain Gauge (in) 1.50	
Rain Accumulation Time (days)			0.00

SWPPP Inspection (Cloudy, 72F)
 Rain Gauge= 1.5"
 13853+45-13958+31

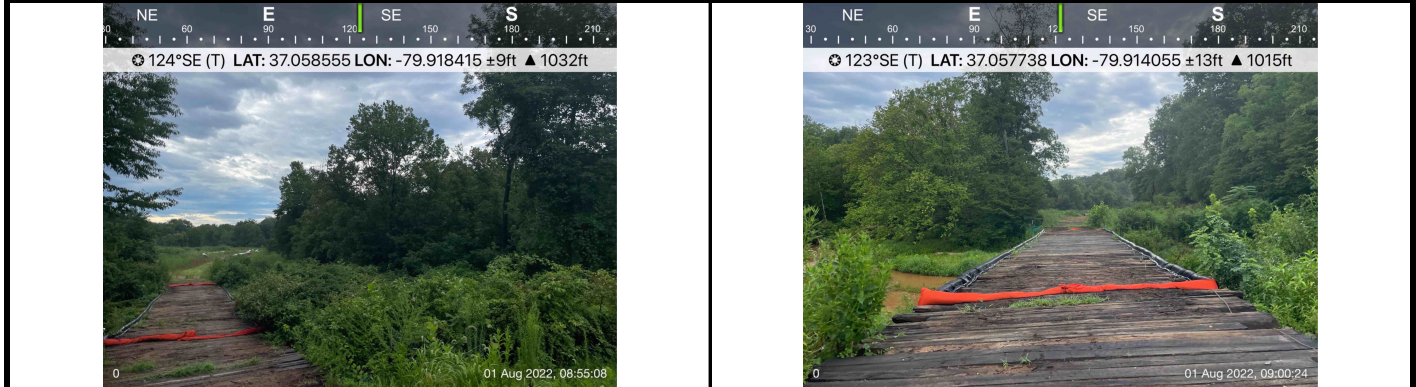
Pic 1 Desc.	Resource buffers remain well vegetated	Pic 2 Desc.	Equipment bridge ECDs are in good condition
--------------------	--	--------------------	---

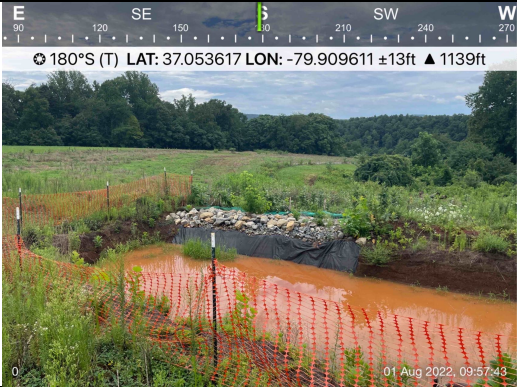
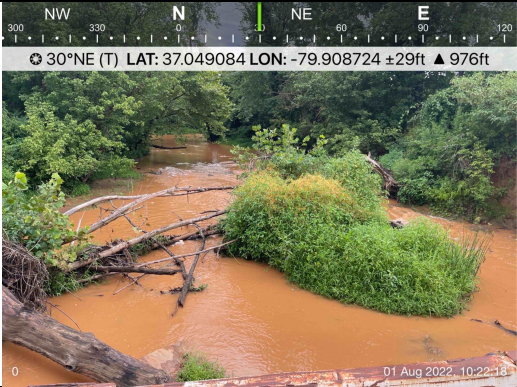
GPS Location	See photo	GPS Location	See photo
Field Station#	13897+00	Field Station#	13915+12
Pic 7 Desc.	Sediment trap is functioning as intended. No evidence of discharge.	Pic 8 Desc.	Stream S-II2 is turbid entering ROW. This turbidity is a result of upstream disturbance NOT related to MVP construction

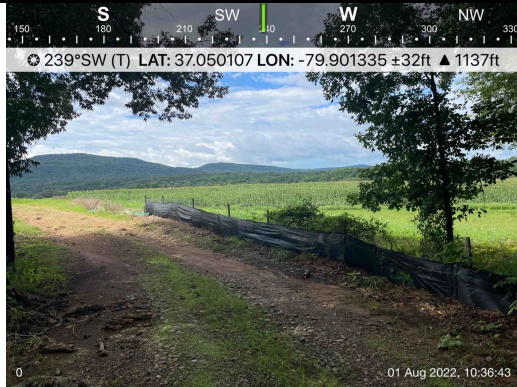
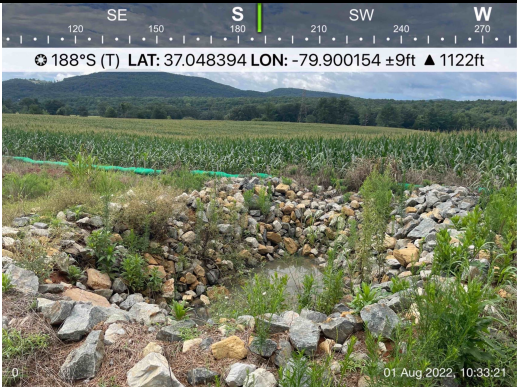
GPS Location	See photo	GPS Location	See photo
Field Station#	13939+50	Field Station#	13942+00
Pic 11 Desc.	SSF is in good condition	Pic 12 Desc.	CWDs are functioning as intended

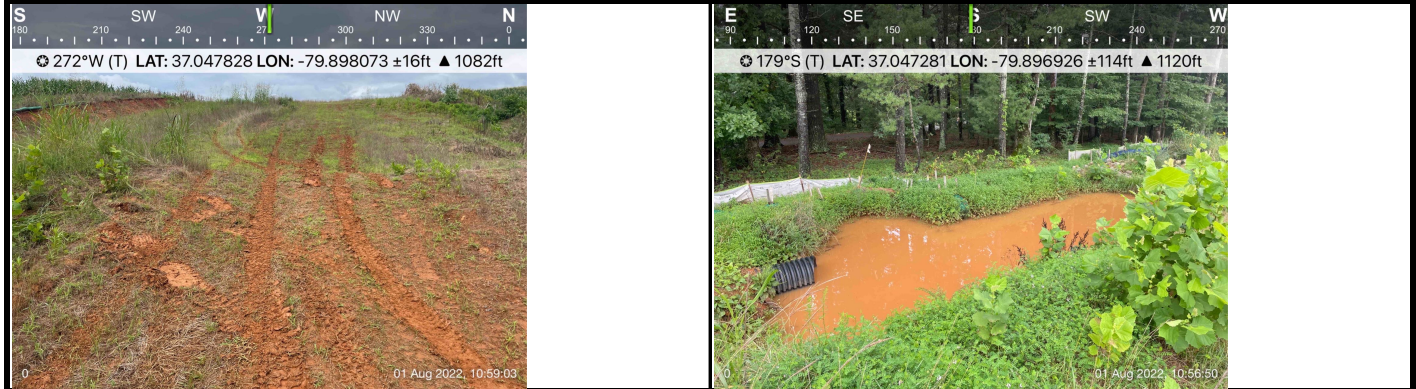
Pic 13 Desc.	ROW has been damaged by 3rd party. Area needs to be re-stabilized.	Pic 14 Desc.	Slope drain outlet is in good condition and functioning
---------------------	--	---------------------	---

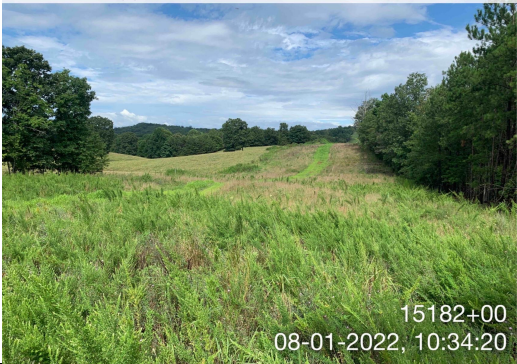
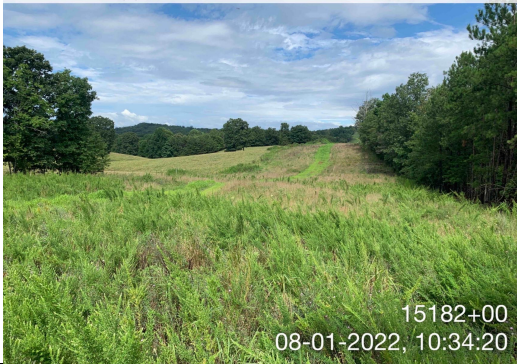
15182+00 08-01-2022, 10:34:20	
GPS Location 0		GPS Location 0		GPS Location 0	
Field Station# 15182+00		Field Station# 15182+00		Field Station# 15182+00	
Pic 7 Desc. Permanent vegetative stabilization in acceptable condition		Pic 8 Desc. Permanent vegetative stabilization in acceptable condition		Pic 8 Desc. Permanent vegetative stabilization in acceptable condition	
314°NW (T) 17 N 627326 4089528 ±13ft ▲ 812ft   15172+00 08-01-2022, 10:36:32				308°NW (T) 17 N 623236 4082773 ±26699ft ▲ 724ft

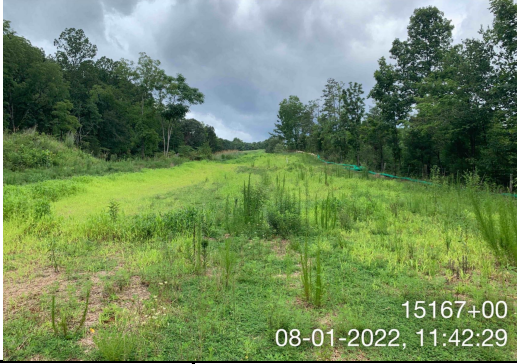
15167+00 08-01-2022, 11:42:29	
GPS Location 0		GPS Location 0		GPS Location 0	
Field Station# 15172+00		Field Station# 15167+00		Field Station# 15167+00	
Pic 9 Desc. Temporary vegetative stabilization in acceptable condition		Pic 10 Desc. Temporary vegetative stabilization in acceptable condition		Pic 10 Desc. Temporary vegetative stabilization in acceptable condition

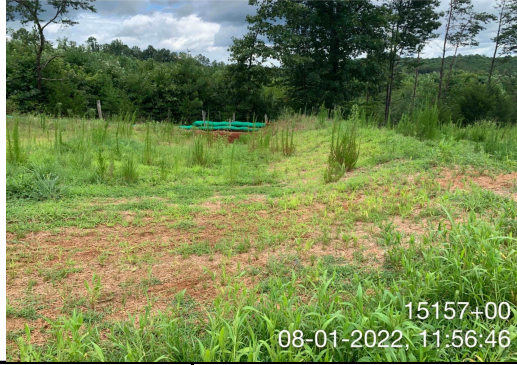
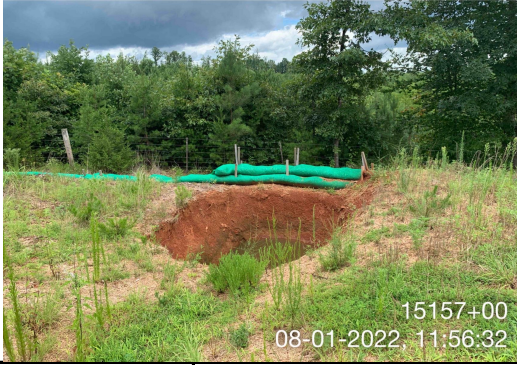
15157+00 08-01-2022, 11:56:32	
GPS Location 0		GPS Location 0		GPS Location 0	
Field Station# 15157+00		Field Station# 15157+00		Field Station# 15157+00	
Pic 11 Desc. Waterbar in acceptable condition		Pic 12 Desc. Waterbar end treatment in acceptable condition		Pic 12 Desc. Waterbar end treatment in acceptable condition

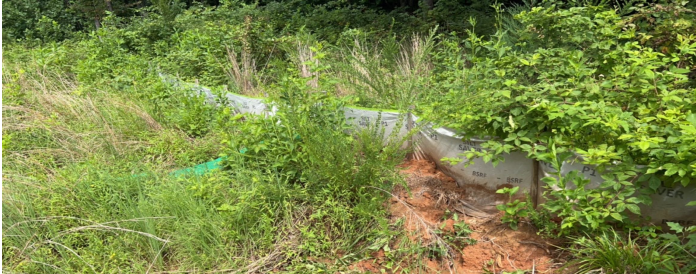
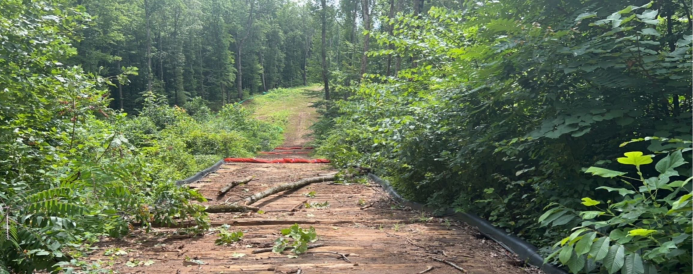
<small>37°2'10" N 79°47'56" W 337°NW COURSE 89° GPS Glade Hill, VA 24092, United States</small>			<small>37°1'51" N 79°46'43" W 163°S COURSE 102° GPS Glade Hill, VA 24092, United States</small>		
<small>08.01.2022 11:18:51 Accur +/-11.8 Ft ALT 1076 Ft</small>			<small>08.01.2022 12:01:26 Accur +/-22.3 Ft ALT 1023 Ft</small>		
GPS Location	1		GPS Location	2	
Field Station#	14354+00		Field Station#	14420+21	
Pic 1 Desc.	Routine maintenance. Perimeter P1 silt fence undermining in resource buffer.		Pic 2 Desc.	Routine maintenance. Tree down on equipment bridge.

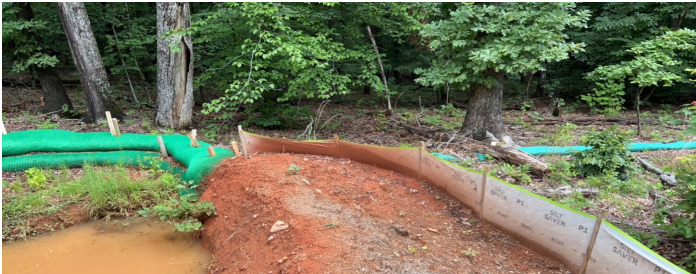
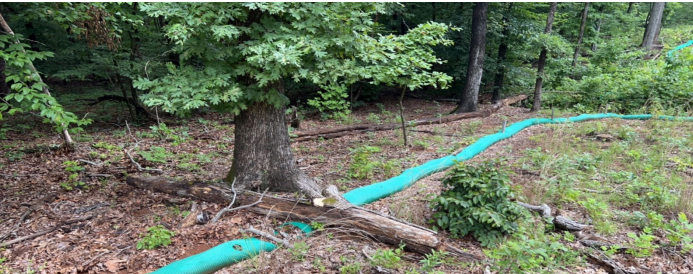
GPS Location	3		GPS Location	4	
Field Station#	14433+00		Field Station#	14433+25	
Pic 3 Desc.	Routine maintenance. Replace row of P1 silt fence beyond effective lifespan behind end treatment.		Pic 4 Desc.	Routine maintenance. Tree down on perimeter CFS; repair/replace damaged CFS.

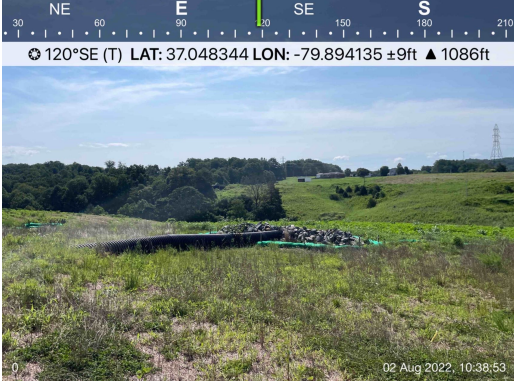
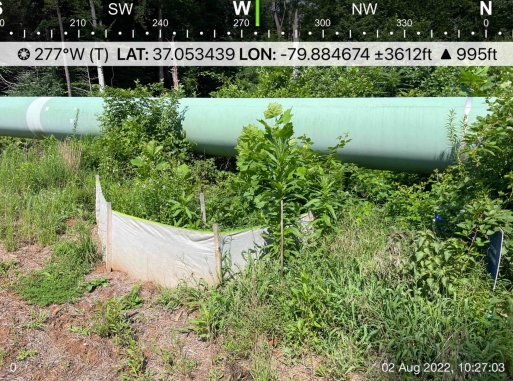
GPS Location	See photo		GPS Location	See photo	
Field Station#	13960+00		Field Station#	13997+50	
Pic 1 Desc.	CWDs are functioning as intended		Pic 2 Desc.	P1 is in good condition at all stream and wetland buffers

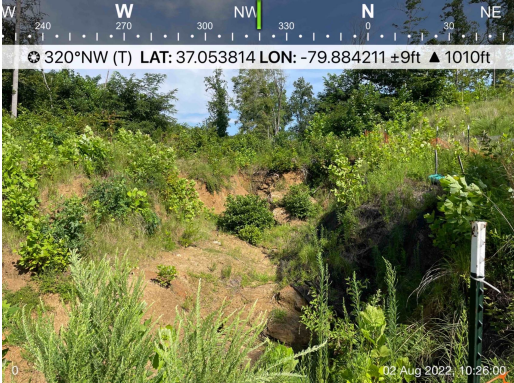
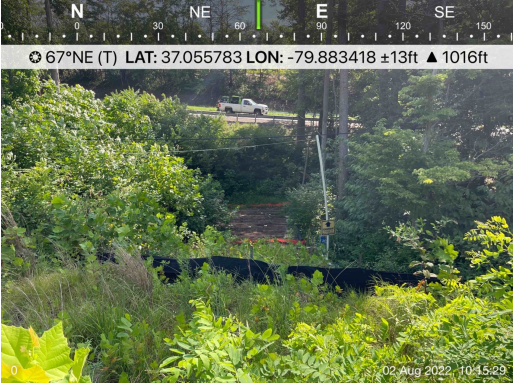
GPS Location	See photo		GPS Location	See photo	
Field Station#	14000+00		Field Station#	14009+11	
Pic 3 Desc.	No evidence of 3rd party pond discharging onto ROW		Pic 4 Desc.	SSF is in good condition

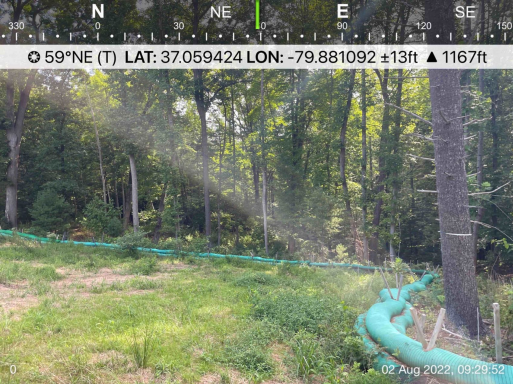
GPS Location	See photo		GPS Location	See photo	
Field Station#	14018+47		Field Station#	14027+00	
Pic 5 Desc.	RCEs are in good condition at all road crossings		Pic 6 Desc.	CFS is in good condition throughout this section

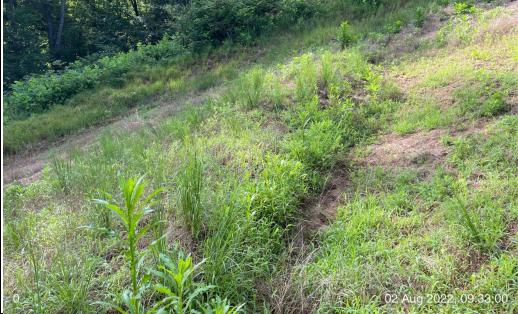
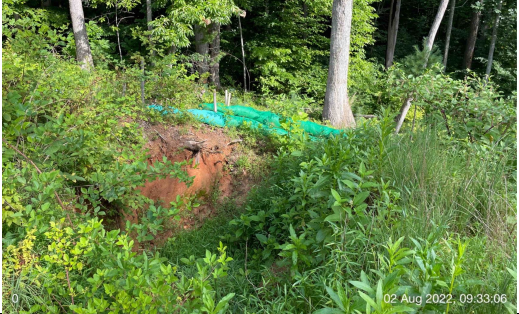
GPS Location	See photo	GPS Location	See photo
Field Station#	14033+00	Field Station#	14033+00
Pic 7 Desc.	Waterbars are in good condition	Pic 8 Desc.	End treatments are functioning as intended

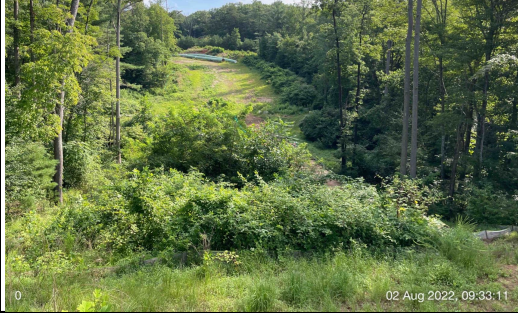
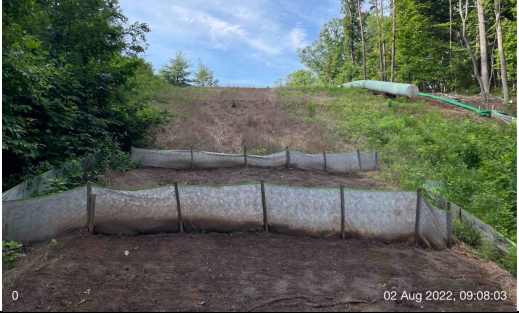
GPS Location	See photo	GPS Location	See photo
Field Station#	14035+00	Field Station#	14050+00
Pic 9 Desc.	Resource buffers remain well vegetated	Pic 10 Desc.	Slope remains stabilized with controls in place

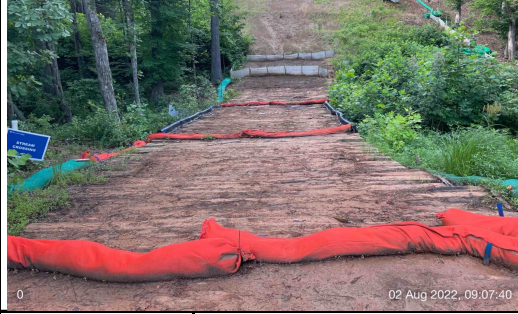
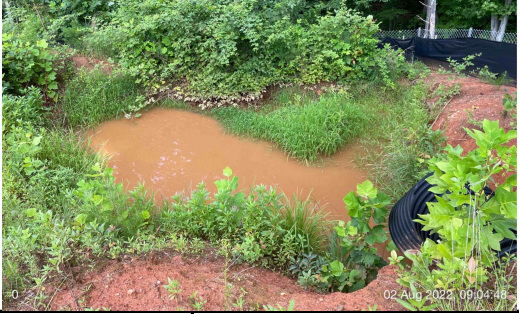
GPS Location	See photo	GPS Location	See photo
Field Station#	14051+00	Field Station#	14057+00
Pic 11 Desc.	Equipment bridge ECDs are in good condition	Pic 12 Desc.	Slope drain outlet is in good condition and functioning

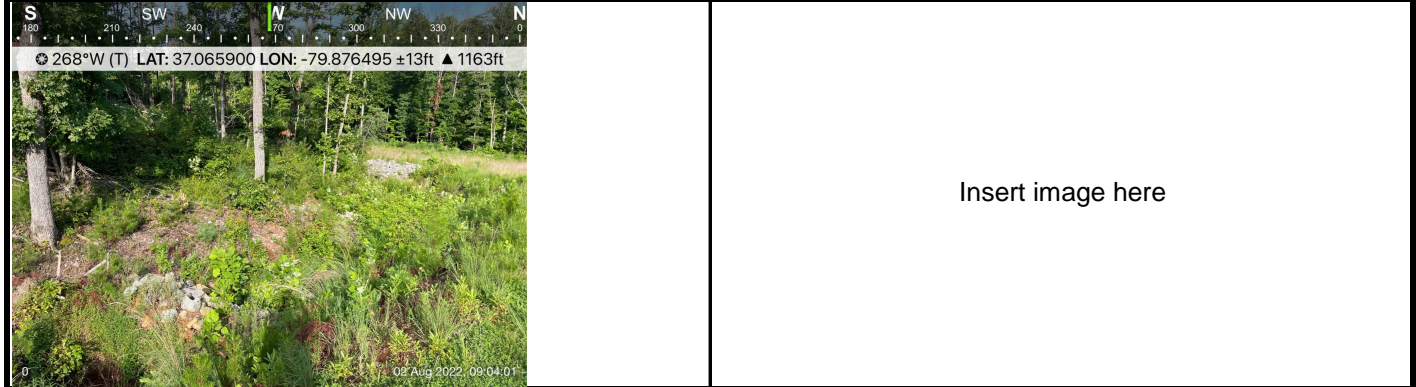
Pic 13 Desc.	RCEs are in good condition and functioning	Pic 14 Desc.	
---------------------	--	---------------------	--

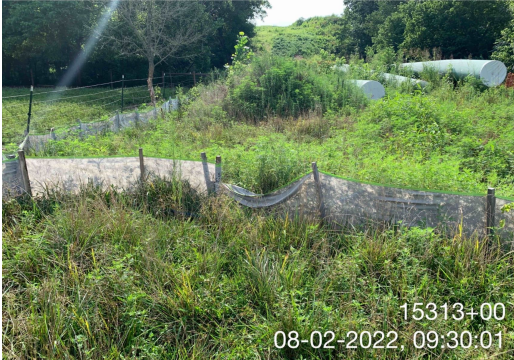
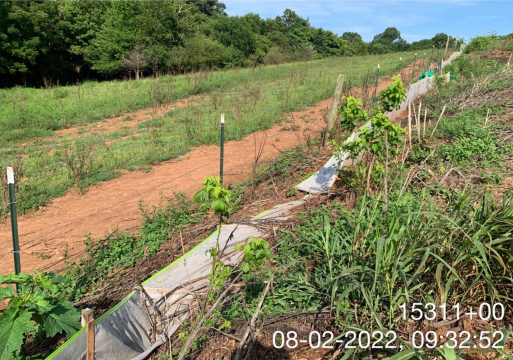
- The EI performed a SWPPP inspection from 15260+00 to 15370+62 (Pigg River HDD Exit to Snowberry Road). Two issues were submitted for the punch list, both of which consisted of P1 silt fence which was damaged by livestock. Other inspected ECDs were observed as in compliance at the time of inspection.
- The EI did not observe that the contractor has worked in the area since the last SWPPP inspection.
- Since the last SWPPP inspection the inspection area has received two rainfall events with a total of 0.80" at Snowberry Road.
- The ROW ground condition is wet.
- At the time of inspection permanent vegetative stabilization was adequately established to inhibit erosion from 15355+00 to 15370+00.
- At the time of inspection temporary vegetative stabilization was adequately established to inhibit erosion.

GPS Location		0		GPS Location		0	
Field Station#		15313+00		Field Station#		15311+00	
Pic 1 Desc.		P1 silt fence damaged by livestock (3 panels)		Pic 2 Desc.		P1 silt fence damaged by livestock (4 panels)

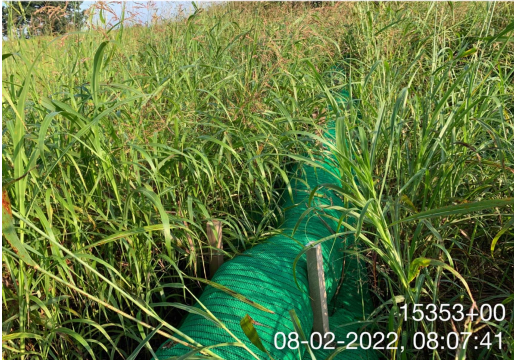
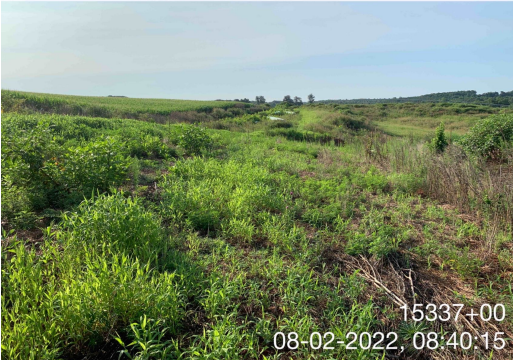
GPS Location		0		GPS Location		0	
Field Station#		15353+00		Field Station#		15337+00	
Pic 3 Desc.		Perimeter CFS in acceptable condition		Pic 4 Desc.		Temporary vegetative stabilization in acceptable condition

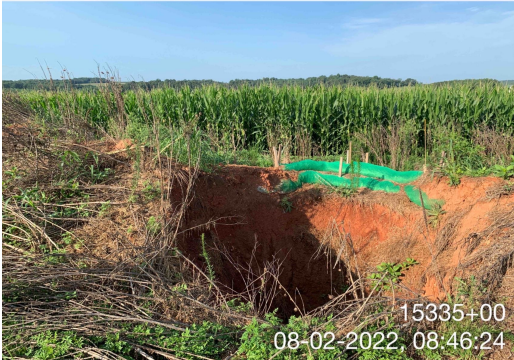
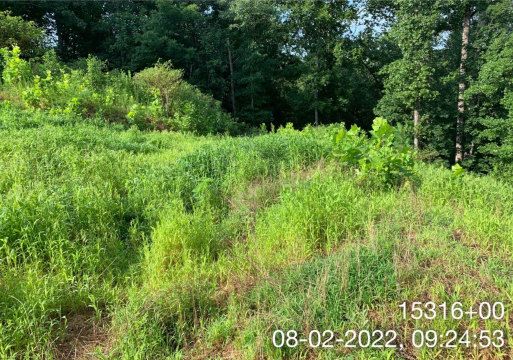
GPS Location		0		GPS Location		0	
Field Station#		15335+00		Field Station#		15316+00	
Pic 5 Desc.		Sump pit in acceptable condition		Pic 6 Desc.		Waterbar in acceptable condition

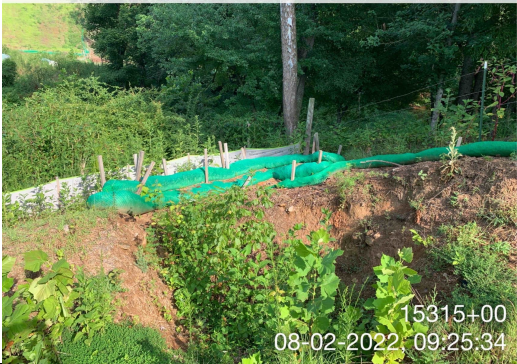
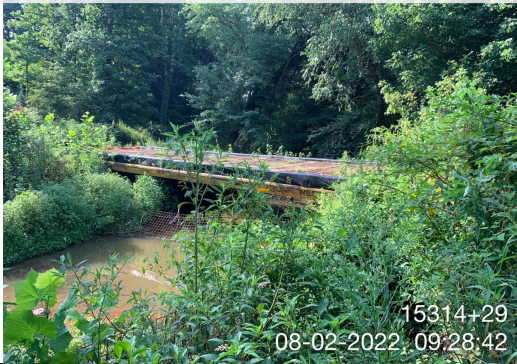
<small>15315+00 08-02-2022 09:25:34</small>		<small>15314+29 08-02-2022 09:28:42</small>			
GPS Location	0		GPS Location	0	
Field Station#	15315+00		Field Station#	15314+29	
Pic 7 Desc.	Waterbar end treatment in acceptable condition		Pic 8 Desc.	Equipment bridge in acceptable condition	
<small>☺ 299°NW (T) ● 17 N 631190 4088102 ±561ft ▲ 671ft</small>

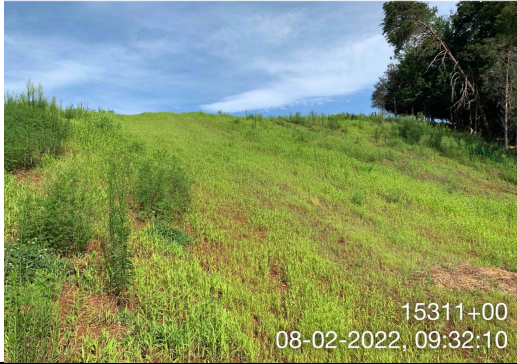
<small>15311+00 08-02-2022 09:32:10</small>		<small>15310+00 08-02-2022 09:37:09</small>			
GPS Location	0		GPS Location	0	
Field Station#	15311+00		Field Station#	15310+00	
Pic 9 Desc.	Temporary vegetative stabilization in acceptable condition		Pic 10 Desc.	Waterbar in acceptable condition

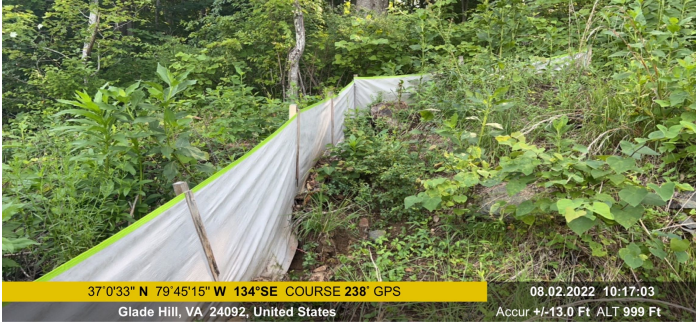
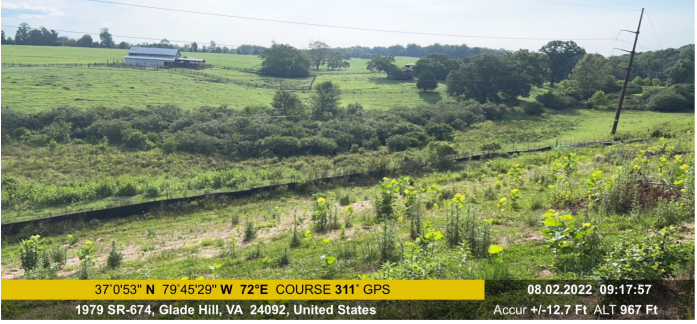
37°0'33" N 79°45'15" W 134' SE COURSE 238' GPS Glade Hill, VA 24092, United States 08.02.2022 10:17:03 Accur +/-13.0 Ft ALT 999 Ft		37°0'53" N 79°45'29" W 72' E COURSE 311' GPS 1979 SR-674, Glade Hill, VA 24092, United States 08.02.2022 09:17:57 Accur +/-12.7 Ft ALT 967 Ft			
GPS Location	5	GPS Location	6		
Field Station#	14532+00	Field Station#	14507+00		
Pic 5 Desc.	Routine maintenance. P1 silt fence in resource buffer undermining and needs repaired.	Pic 6 Desc.	ROW stabilized and vegetated in temporary area; perimeter SSF in place and functional.

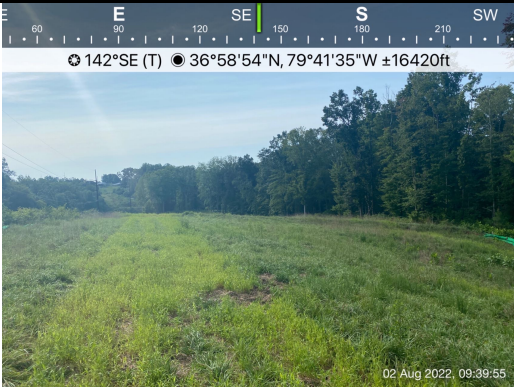
GPS Location 0		GPS Location 0			
Field Station# 14809+00		Field Station# 14845+68			
Pic 1 Desc. Approximately 14809+00. Overview of ROW. Permanent vegetation.		Pic 2 Desc. Approximately 14845+68. Overview of road crossing and RCEs.

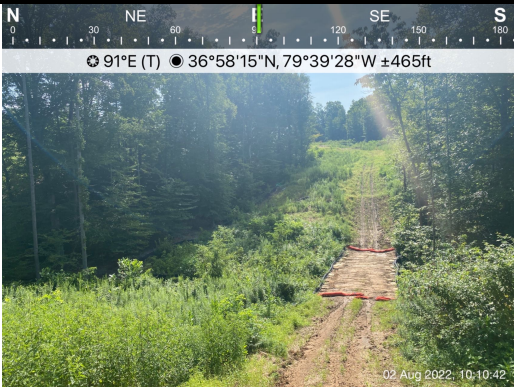
GPS Location 0		GPS Location 0			
Field Station# 14870+00		Field Station# 14907+60			
Pic 3 Desc. Approximately 14870+00. Overview of stream crossing, equipment bridge and ECDs at stream S-SS8.		Pic 4 Desc. Approximately 14907+60. Overview of stream crossing, equipment bridge and ECDs at stream S-DD3.

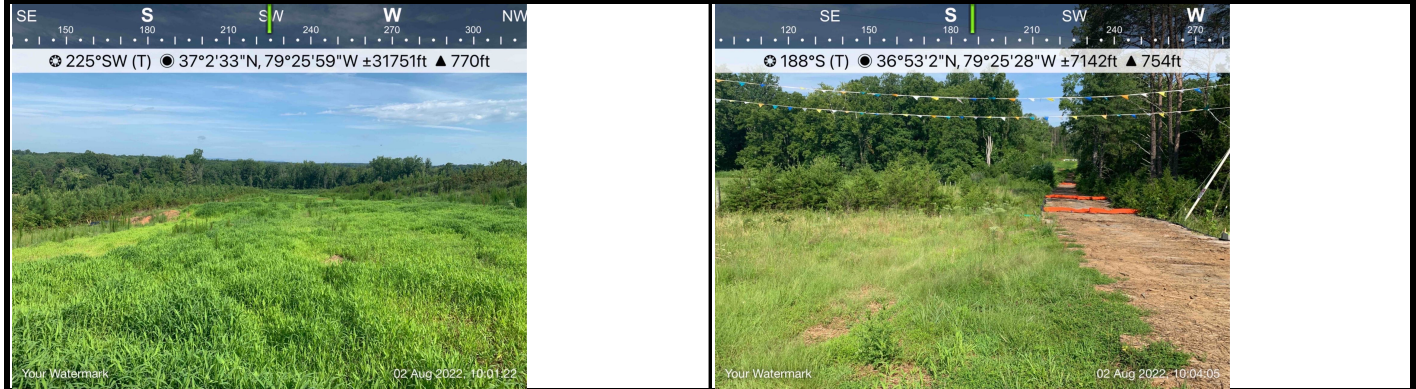
GPS Location	O	GPS Location	O
Field Station#	15690+00	Field Station#	15671+93
Pic 7 Desc.	Observing temporary stabilization and water bars	Pic 8 Desc.	Observing temporary stabilization,buffer, equipment crossing and ECD's

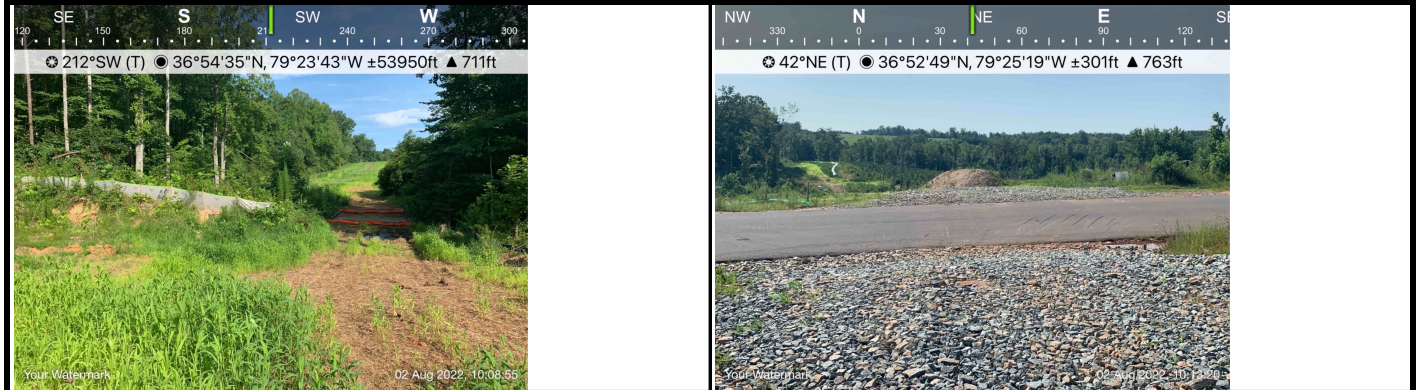
GPS Location	O	GPS Location	O
Field Station#	15658+43	Field Station#	15693+89
Pic 9 Desc.	Observing temporary stabilization,buffer, equipment crossing and ECD's	Pic 10 Desc.	Observing road crossing and RCE's

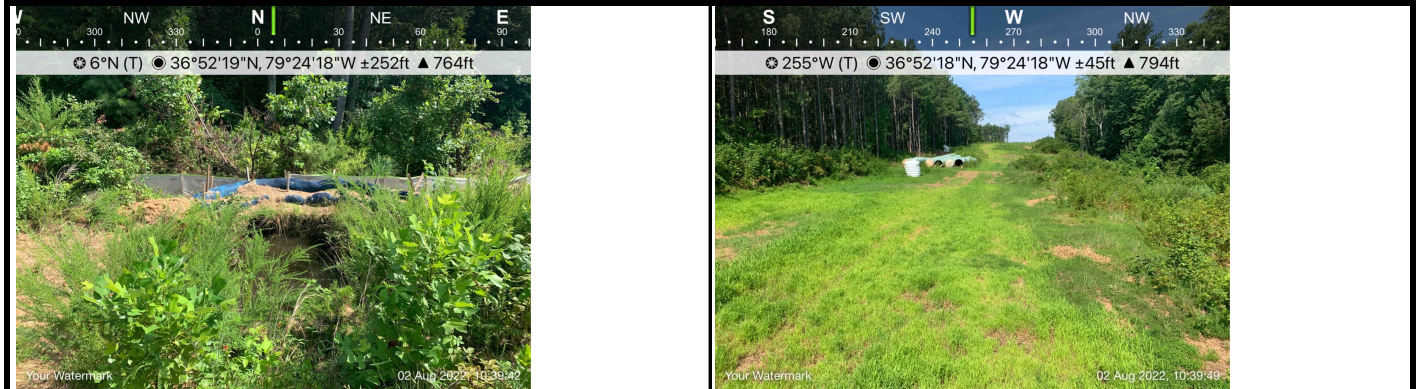
GPS Location	O	GPS Location	O
Field Station#	15755+00	Field Station#	15752+00
Pic 11 Desc.	Observing temporary stabilization, sump, end treatment and ECD's	Pic 12 Desc.	Observing temporary stabilization and water bars

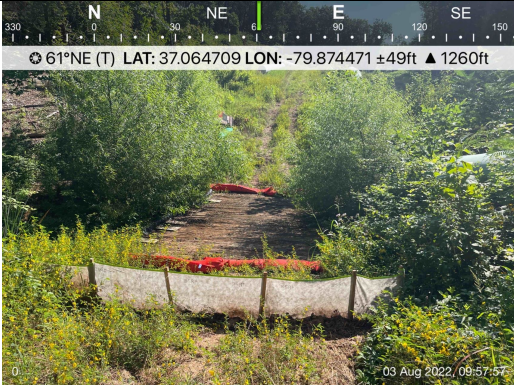
GPS Location See photo		GPS Location See photo			
Field Station# 14066+00		Field Station# 14070+00			
Pic 1 Desc. Equipment bridge ECDs are in good condition and functioning		Pic 2 Desc. CWDs are functioning as intended

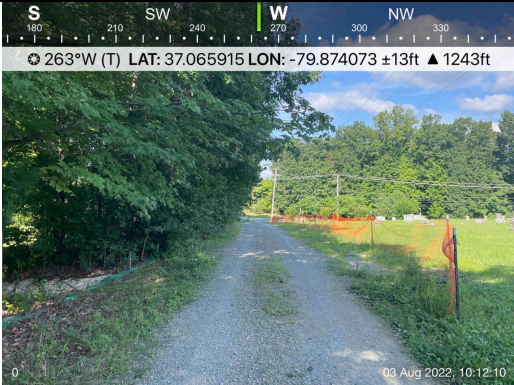
GPS Location See photo		GPS Location See photo			
Field Station# 14081+53		Field Station# 14090+00			
Pic 3 Desc. MVP-FR-309.05 is in good condition with controls in place		Pic 4 Desc. Topsoil berms remain stabilized

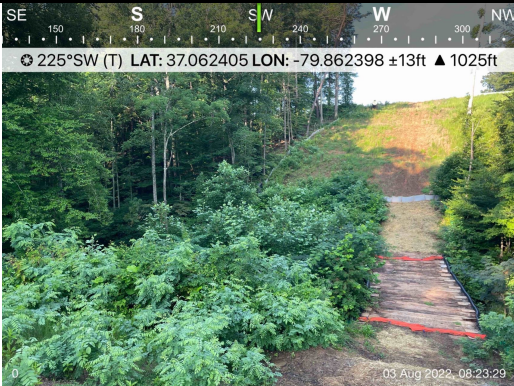
GPS Location See photo		GPS Location See photo			
Field Station# 14105+20		Field Station# 14109+00			
Pic 5 Desc. Resource buffers remain well vegetated		Pic 6 Desc. End treatments are functioning as intended

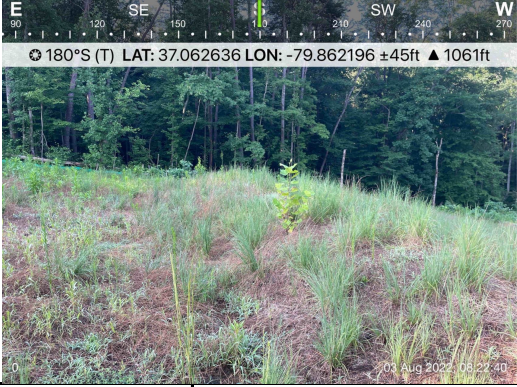
GPS Location	See photo	GPS Location	See photo
Field Station#	14109+00	Field Station#	14120+00
Pic 7 Desc.	Waterbars are in good condition	Pic 8 Desc.	CFS is in good condition throughout this section

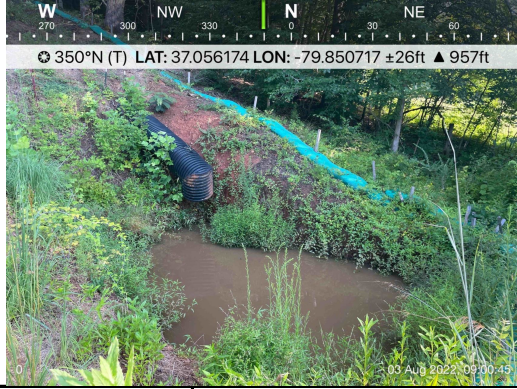
GPS Location	See photo	GPS Location	See photo
Field Station#	14156+00	Field Station#	14171+36
Pic 11 Desc.	Slope drain is in good condition and functioning	Pic 12 Desc.	SSF is in good condition.

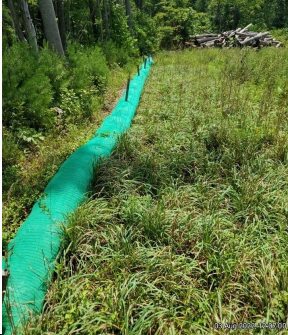
ert image here	
GPS Location 0		GPS Location 00			
Field Station# 13715+00		Field Station# 13707+00			
Pic 7 Desc. Perimeter CFS		Pic 8 Desc. Sump and J-Hook

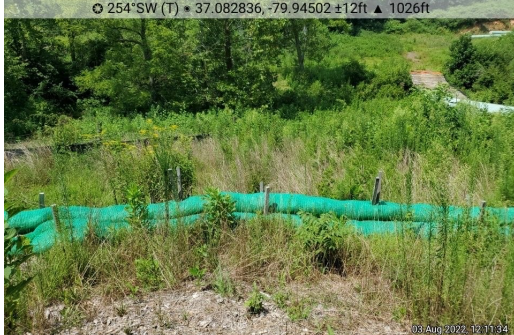
ert image here	
GPS Location 0		GPS Location 0			
Field Station# 13706+00		Field Station# 13705+00			
Pic 9 Desc. GAS S-E28 Buffer zone ECDs		Pic 10 Desc. S-E28 Equipment bridge

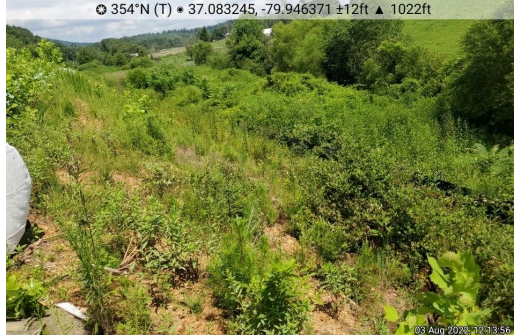
GPS Location 0		GPS Location 0			
Field Station# 13701+00		Field Station# 13695+00			
Pic 11 Desc. Fill slope vegetation and perimeter Super Silt Fence		Pic 12 Desc. CIS W-E7 Silt fence

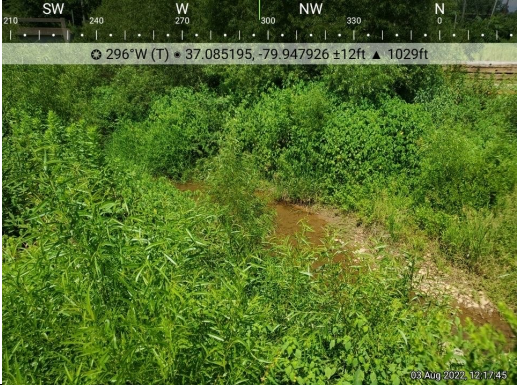
GPS Location 0		GPS Location 0			
Field Station# 13692+70		Field Station# 13720+00			
Pic 13 Desc. S-E28 Channel		Pic 14 Desc. Sideslope vegetation

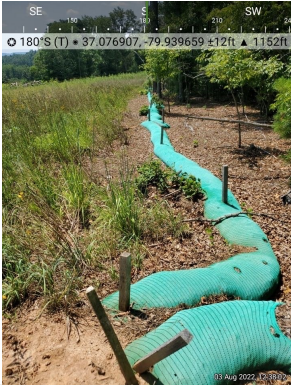
GPS Location 0		GPS Location			
Field Station# 13740+00		Field Station#			
Pic 15 Desc. Perimeter CFS		Pic 16 Desc.

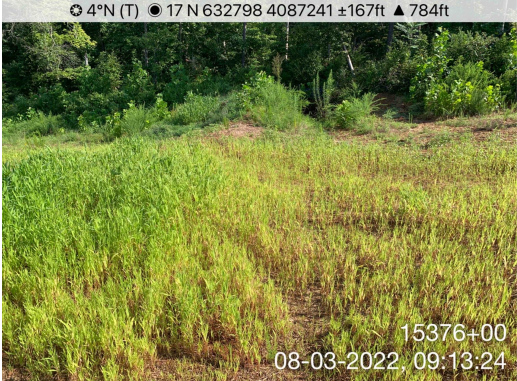
<p>352°N (T) 17 N 632800 4087268 ±597ft ▲ 780ft 15376+00 08-03-2022, 09:13:50</p>			
GPS Location	0	GPS Location	0		
Field Station#	15376+00	Field Station#	15376+00		
Pic 7 Desc.	Waterbar in acceptable condition		Pic 8 Desc.	Waterbar end treatment in acceptable condition

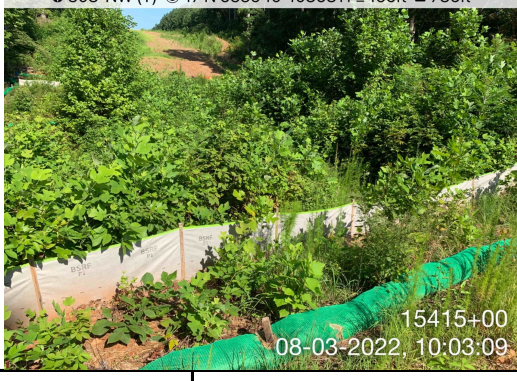
<p>149°SE (T) 17 N 634073 4086786 ±255ft ▲ 817ft 15419+00 08-03-2022, 10:07:25</p>			
GPS Location	0	GPS Location	0		
Field Station#	15415+00	Field Station#	15419+00		
Pic 9 Desc.	P1 silt fence and sensitive resource buffer in acceptable conditions		Pic 10 Desc.	Waterbar end treatment and perimeter CFS in acceptable conditions	
Insert image here			Insert image here		
GPS Location		GPS Location

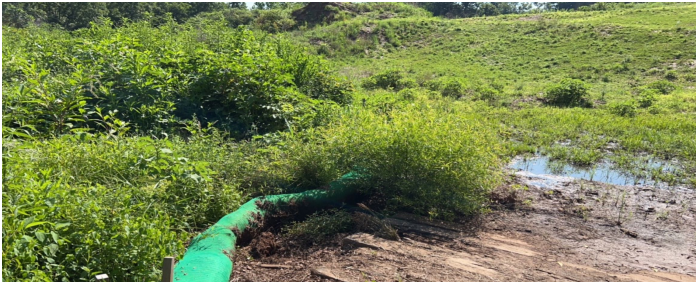
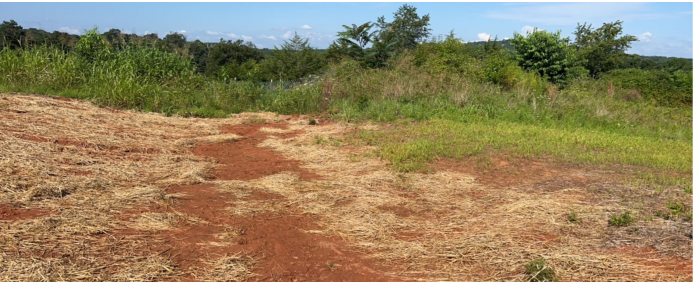
<small>37°0'11" N 79°44'33" W 91°E COURSE 253' GPS Glade Hill, VA 24092, United States</small>		<small>08.03.2022 10:15:24 Accur +/-15.5 Ft ALT 854 Ft</small>		<small>36°59'54" N 79°44'21" W 259°W COURSE 169' GPS 753 Simmons Creek Rd, Union Hall, VA 24176, United States</small>	
<small>08.03.2022 10:26:50 Accur +/-11.6 Ft ALT 948 Ft</small>					
GPS Location	1	GPS Location	2	GPS Location	3
Field Station#	14583+25	Field Station#	14595+00	Field Station#	14553+00
Pic 1 Desc.	Routine maintenance. CFS in resource buffer needs reset and restaked.	Pic 2 Desc.	Routine maintenance. Denuded area in throat of water bar needs seeded and stabilized.	Pic 3 Desc.	ROW stabilized and vegetated in temporary area.

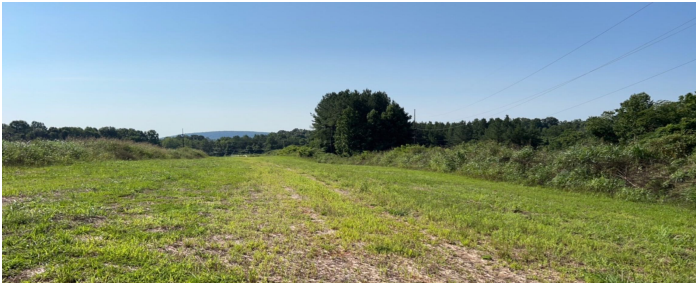
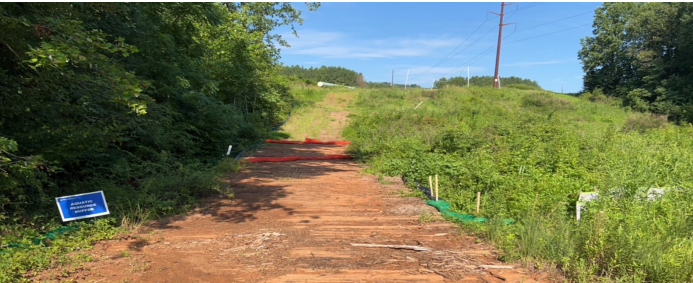
<small>08.03.2022 10:05:09 Accur +/-17.3 Ft ALT 862 Ft</small>					
GPS Location	3	GPS Location	4	GPS Location	5
Field Station#	14553+00	Field Station#	14568+10	Field Station#	14606+00
Pic 4 Desc.	Equipment bridge and surrounding ECDs in place and functional at stream crossing and resource buffer; signage visible and intact.	Pic 5 Desc.	Plunge pool performing intended function.	Pic 6 Desc.	Equipment bridge and surrounding ECDs in place and functional at stream crossing and resource buffer.

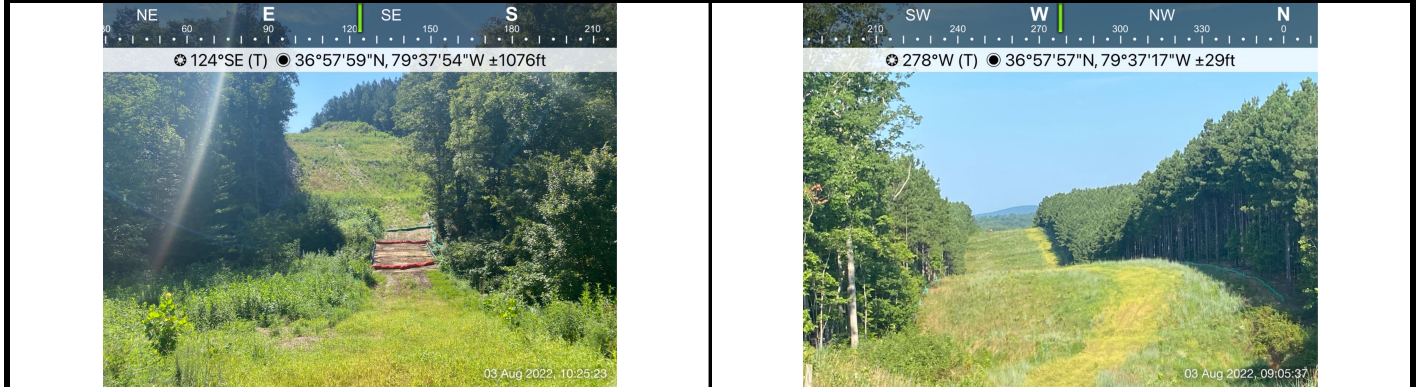
GPS Location	0	GPS Location	0
Field Station#	14950+47	Field Station#	14969+00
Pic 1 Desc.	Approximately 14950+47. Overview of stream crossing, equipment bridge and ECDs at stream S-G13.	Pic 2 Desc.	Approximately 14969+00. Overview of ROW. Permanent vegetation.

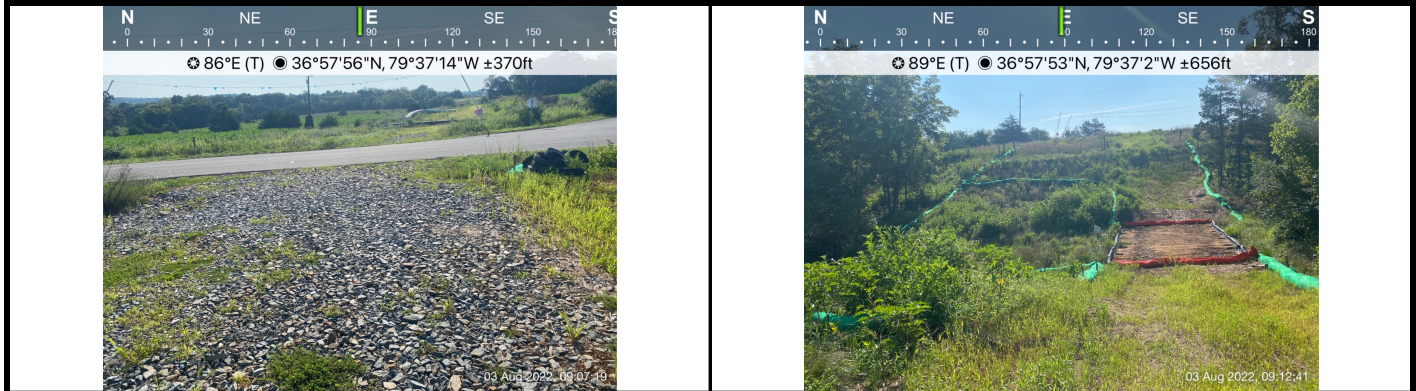
GPS Location	0	GPS Location	0
Field Station#	14981+00	Field Station#	14991+62
Pic 3 Desc.	Approximately 14981+00. Overview of ROW, road crossing and RCEs.	Pic 4 Desc.	Approximately 14991+62. Overview of stream crossing, equipment bridge and ECDs at stream S-D7.

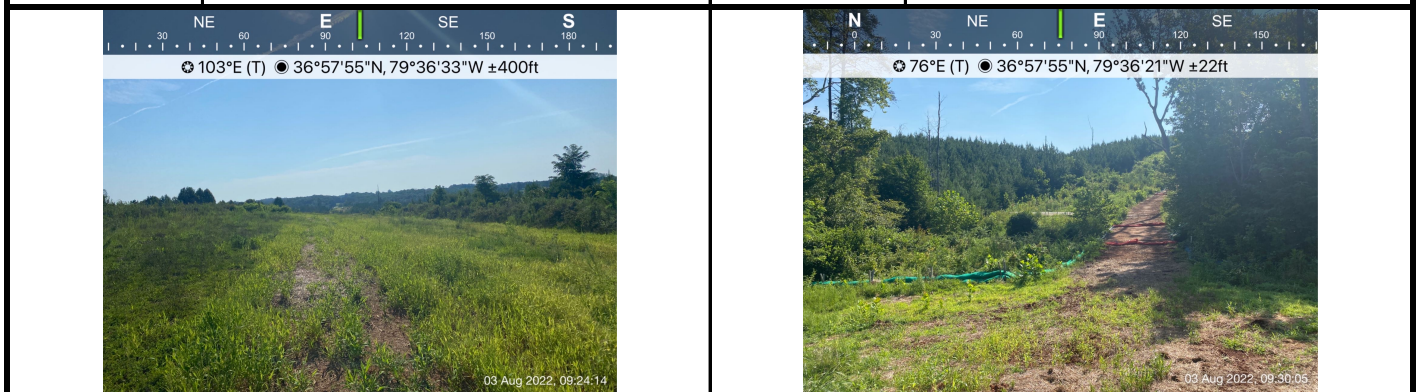
GPS Location	0	GPS Location	0
Field Station#	15016+00	Field Station#	15026+00
Pic 5 Desc.	Approximately 15016+00. Overview of ROW.	Pic 6 Desc.	Approximately 15026+00. Overview of stream crossing, equipment bridge and ECDs at stream S-D3.

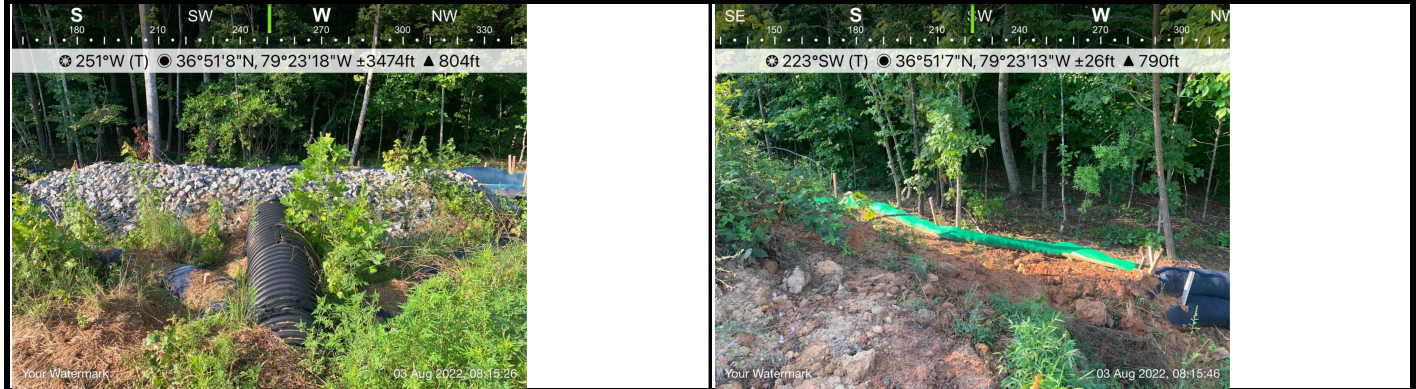
GPS Location	O	GPS Location	O
Field Station#	15803+00	Field Station#	15850+00
Pic 7 Desc.	Observing temporary stabilization,CWD outlet and ECD's	Pic 8 Desc.	Observing end of water bar that needs to be stabilized

Performed SWPPP Inspection on this section. There were issues identified and added to the punch list. The Contractor is working on repairing the identified issues. Other than that there were no issues to report at the time of Inspection.

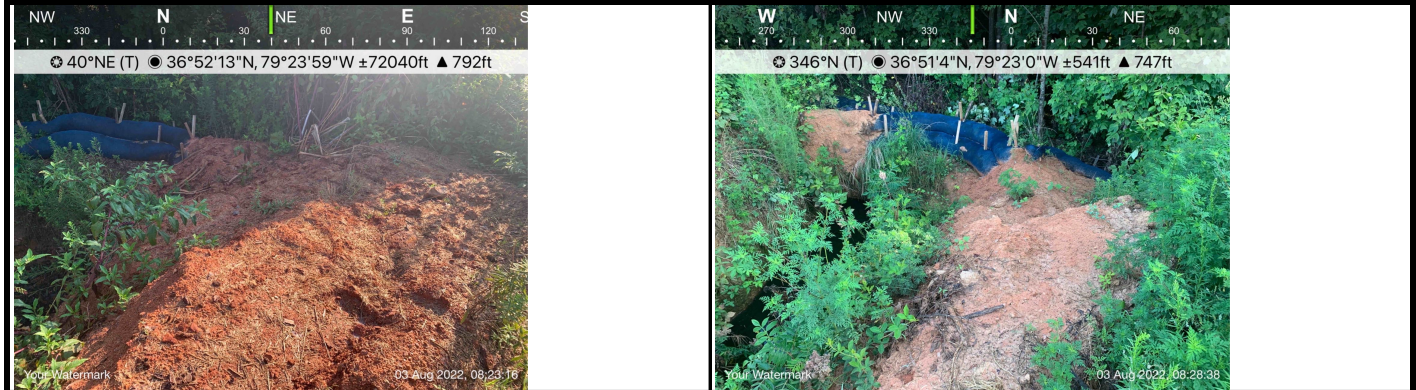
GPS Location	O	GPS Location	O
Field Station#	15925+00	Field Station#	15863+00
Pic 9 Desc.	Observing end of water bar that needs to be stabilized	Pic 10 Desc.	Observing end of water bar that needs to be stabilized

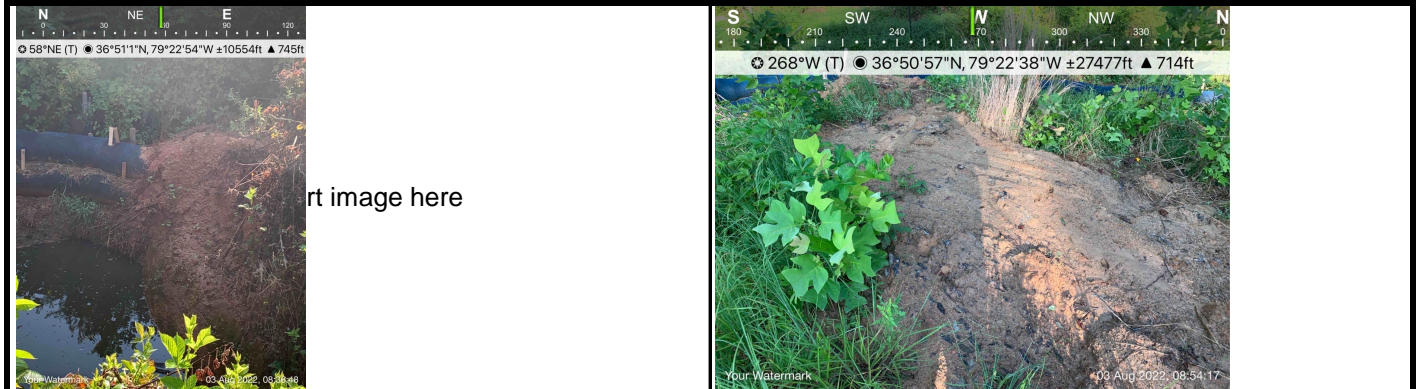
GPS Location	O	GPS Location	O
Field Station#	15875+00	Field Station#	15935+00
Pic 11 Desc.	Observing end of water bar that needs to be stabilized	Pic 12 Desc.	Observing end of water bar that needs to be stabilized

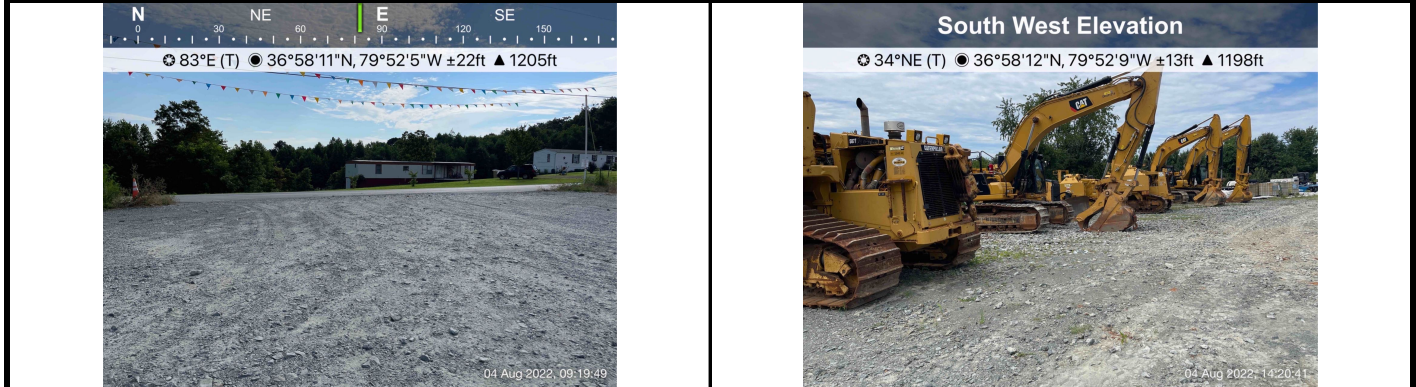
GPS Location	See picture	GPS Location	See picture
Field Station#	0000+00	Field Station#	0000+00
Pic 1 Desc.	RCE at LY-045 in good condition.	Pic 2 Desc.	Equipment at LY-045 inspected and no leaks observed at the time of inspection

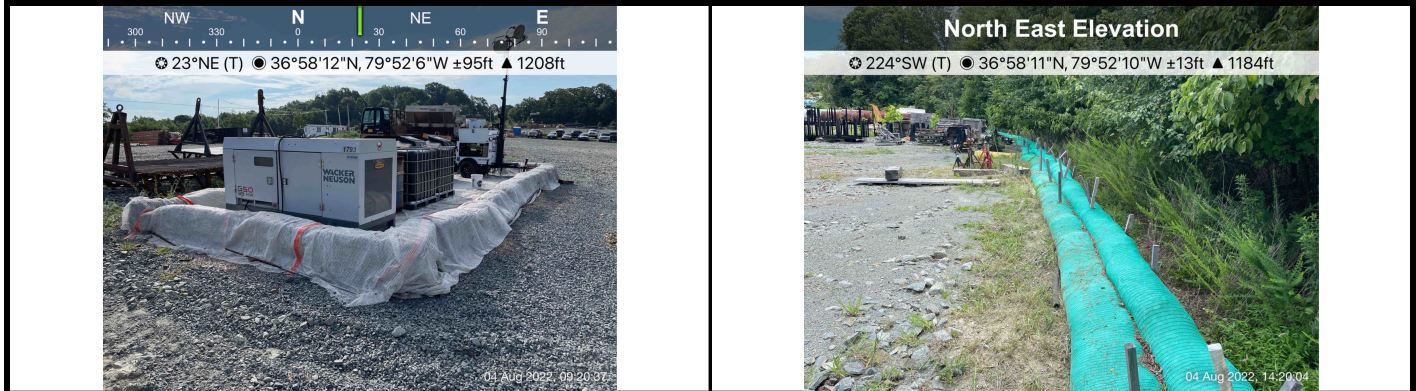
GPS Location	See picture	GPS Location	See picture
Field Station#	0000+00	Field Station#	0000+00
Pic 3 Desc.	Secondary containment structure on south end of tent at LY-045 in acceptable condition.	Pic 4 Desc.	Perimeter ECD's on west side of LY-045 in good condition.

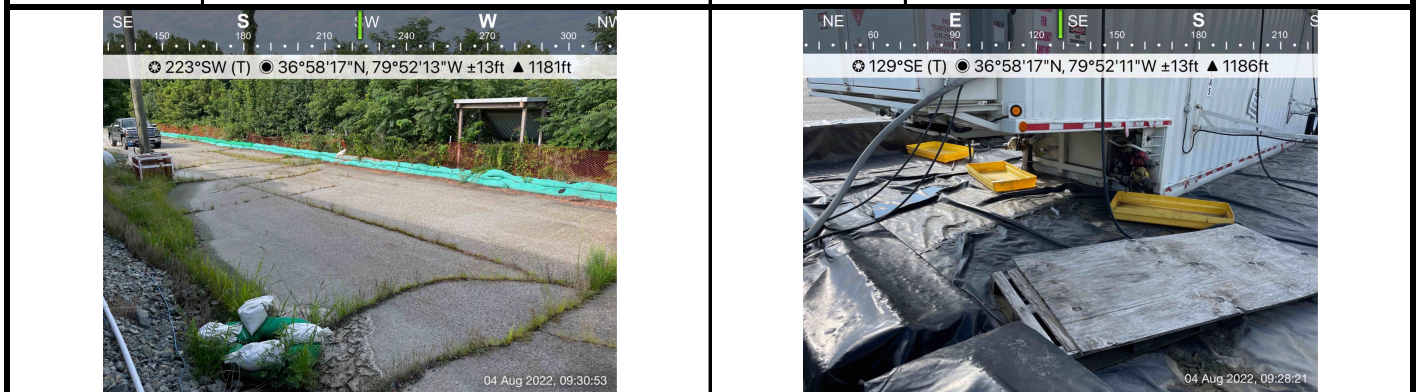
GPS Location	See picture	GPS Location	See picture
Field Station#	0000+00	Field Station#	0000+00
Pic 5 Desc.	Perimeter ECD's and inlet protection near storage building at LY-046 in good condition.	Pic 6 Desc.	Secondary containment structure for fuel cell at LY-046 in good condition.

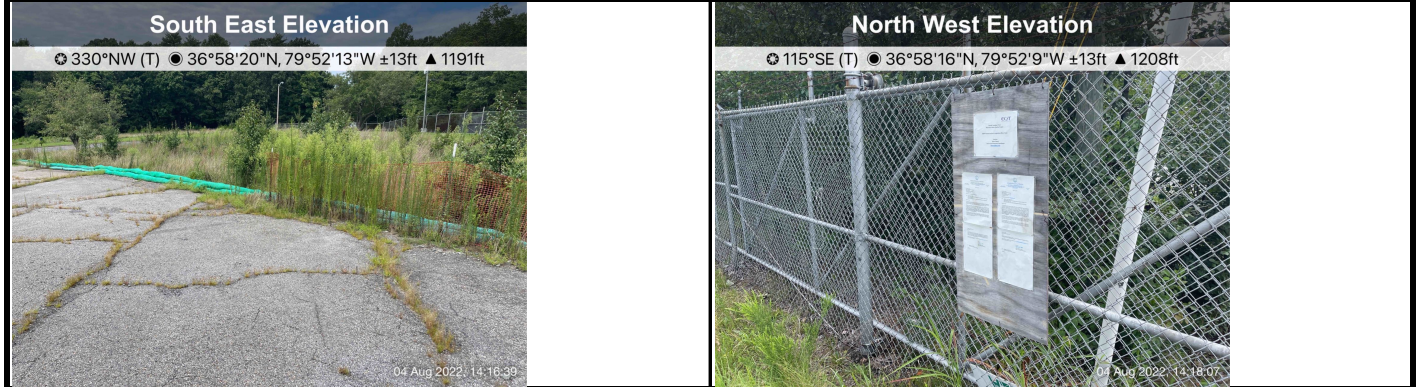
Pic 7 Desc.	Perimeter ECD's on north end of LY-046 in good condition.
--------------------	---
