Visual Site Inspection Report

Project Name H-600 Pipeline Spread I		AFE 124300139	Spread H-600 Pipeline Spread I
Contractor Precision		Report # 40496	
Inspector Ben Farmer		Date/Time 8/1/2022 12:54 PM	
Permit # TBD	Inspection Type VA SWPP	Station Begin 13853+45	
State VA	Inspection Area Partial	Station End 13958+31	
County Franklin	Ground Wet	Temperature (°F) 72.00	
Municipality N/A	Weather Cloudy	Rain Gauge (in) 1.50	
Rain Accumulation Time (days)			0.00

SWPPP Inspection (Cloudy, 72F)
 Rain Gauge= 1.5"
 13853+45-13958+31

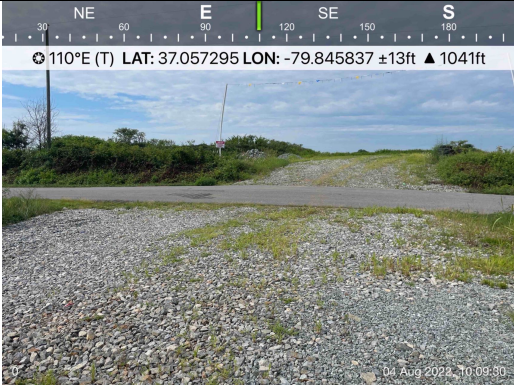
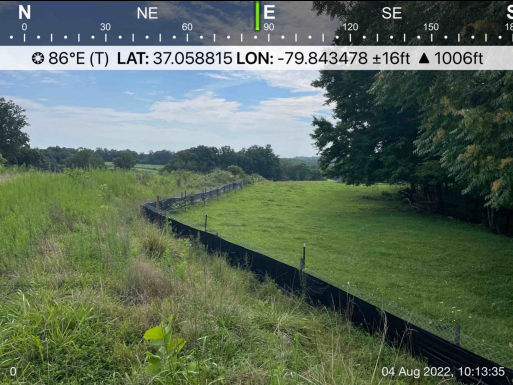
GPS Location		See photo		GPS Location	
Field Station#		14171+36		Field Station#	
Pic 1 Desc.		RCEs are in good condition at all road crossings		Pic 2 Desc.	
				SSF is in good condition

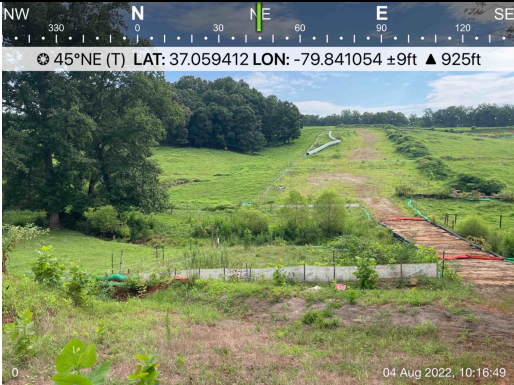
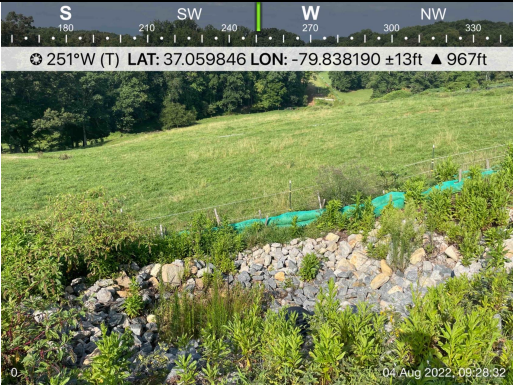
GPS Location		See photo		GPS Location	
Field Station#		14190+00		Field Station#	
Pic 3 Desc.		P1 is in good condition at all stream and wetland buffers		Pic 4 Desc.	
				CWDs are functioning as intended

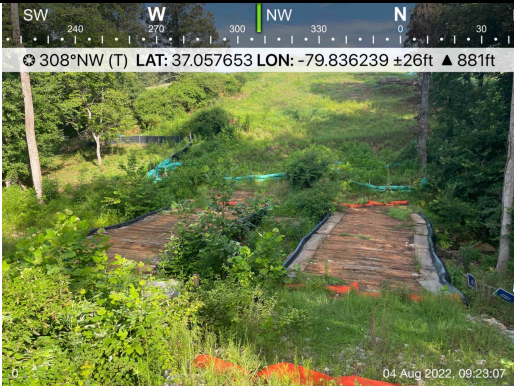
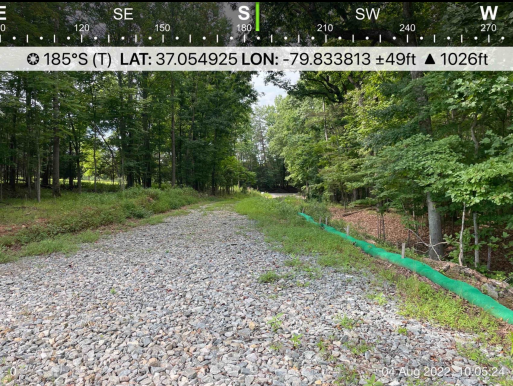
GPS Location		See photo		GPS Location	
Field Station#		14209+00		Field Station#	
Pic 5 Desc.		Equipment bridge ECDs are in good condition and functioning		Pic 6 Desc.	
				MVP-FR-311 remains in good condition with controls in place

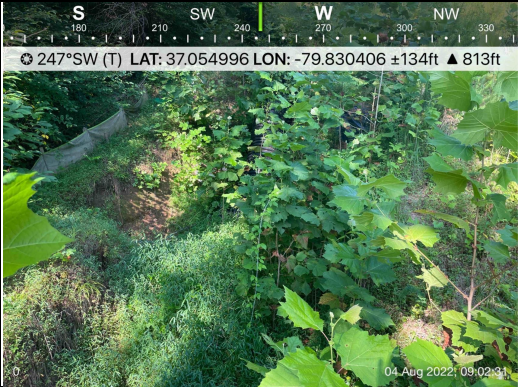
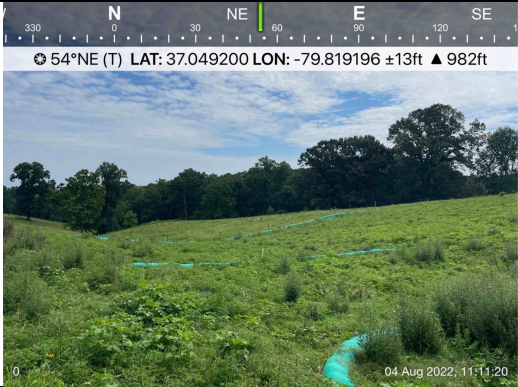
GPS Location	See photo		GPS Location	See photo
Field Station#	14232+00		Field Station#	14274+00
Pic 7 Desc.	Slope drain is in good condition and functioning		Pic 8 Desc.	CFS is in good condition throughout this section

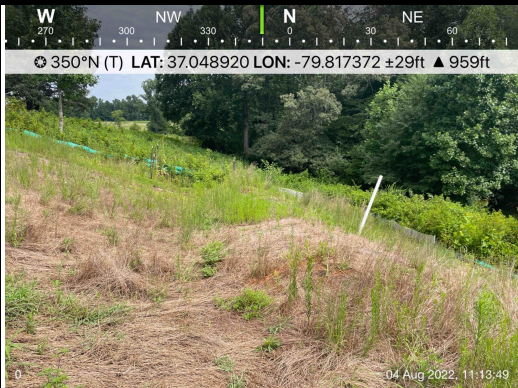
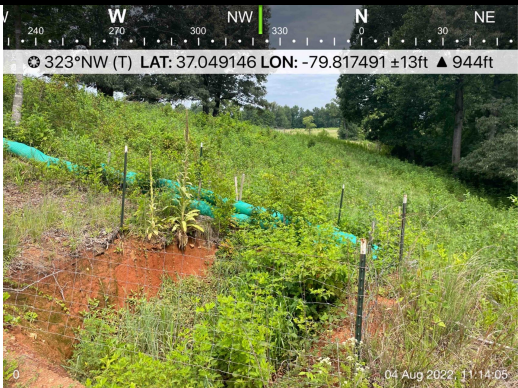
GPS Location	See photo		GPS Location	See photo
Field Station#	14277+00		Field Station#	14277+00
Pic 9 Desc.	Waterbars are in good condition		Pic 10 Desc.	End treatments are functioning as intended

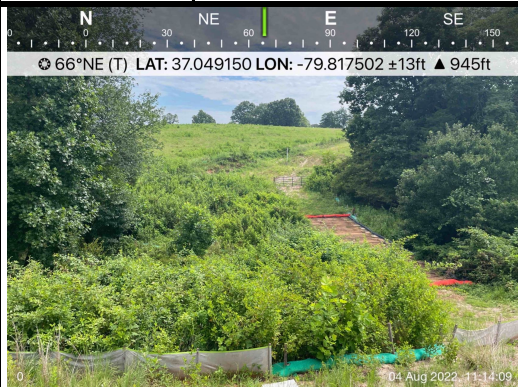
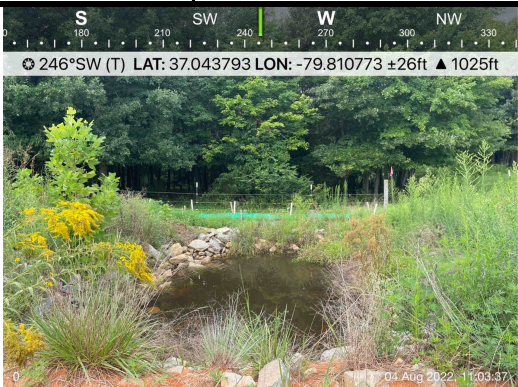
GPS Location	See photo		GPS Location	See photo
Field Station#	14278+93		Field Station#	14305+00
Pic 11 Desc.	Resource buffers remain well vegetated		Pic 12 Desc.	CWDs are functioning as intended.

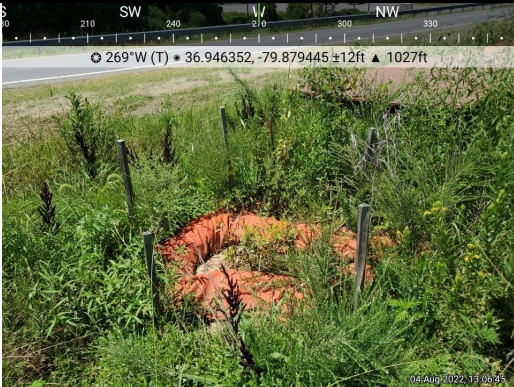
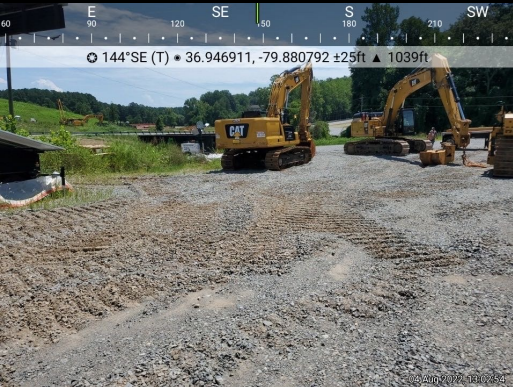
GPS Location			0		
Field Station#			0+00		
Pic 1 Desc.			LY-033 Stormwater drain inlet protection

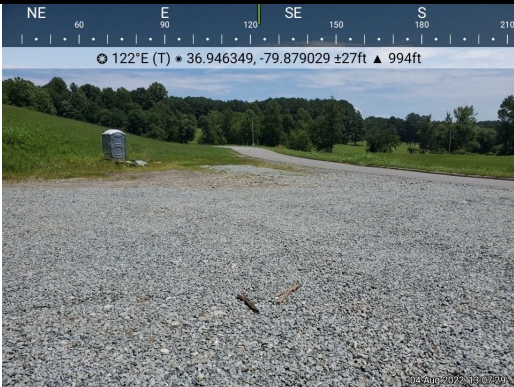
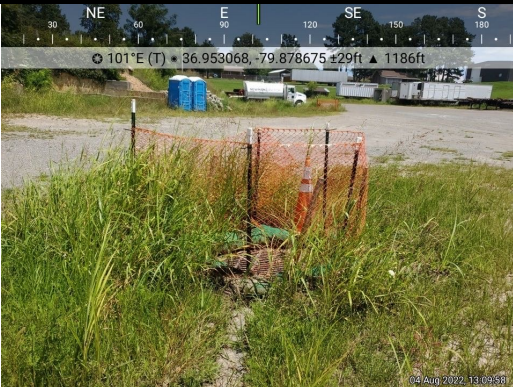
GPS Location			0		
Field Station#			0+00		
Pic 3 Desc.			LY-033 Rock construction entrance

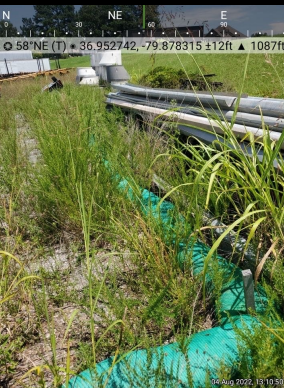
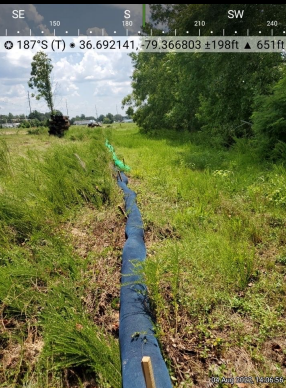
GPS Location			0		
Field Station#			0+00		
Pic 5 Desc.			ANC-006 Southeast perimeter CFS		
Pic 6 Desc.			LY-048 West perimeter CFS

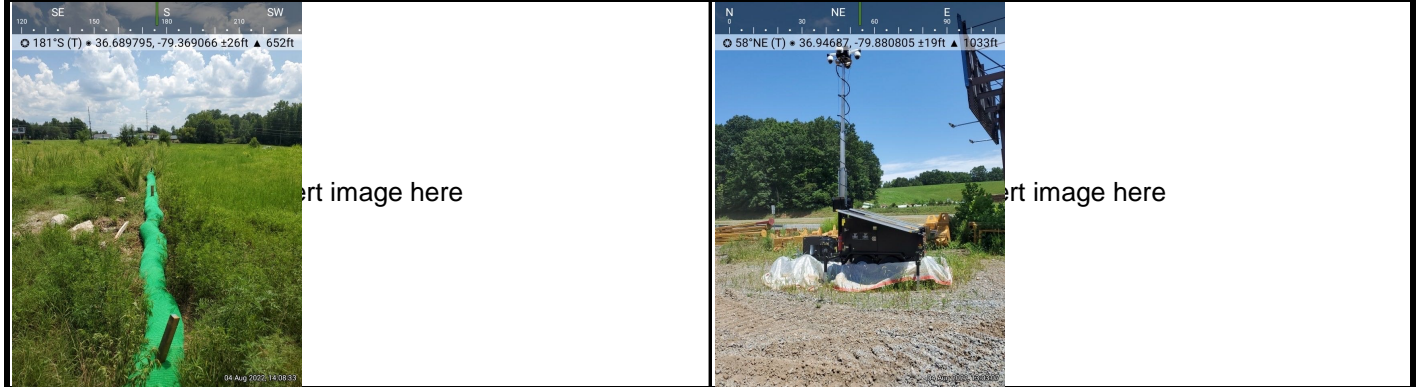
GPS Location	0	GPS Location	0
Field Station#	0+00	Field Station#	0+00
Pic 7 Desc.	LY-048 Southwest perimeter CFS	Pic 8 Desc.	LY-032 Secondary containment

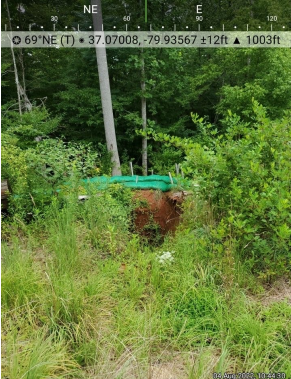
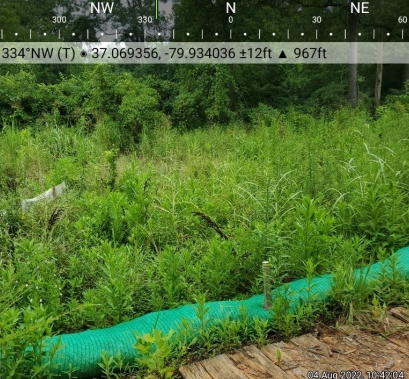
GPS Location	0
Field Station#	13783+00	Field Station#	13781+00	Pic 1 Desc.	Sump
Pic 2 Desc.		Pic 3 Desc.	CIS S-RR15 Buffer zone and ECDs	GPS Location	0

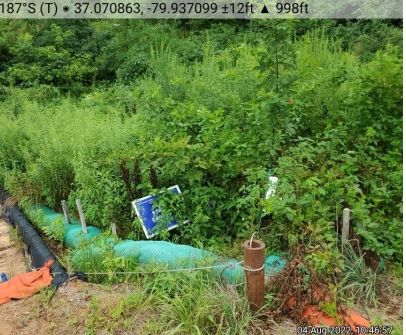
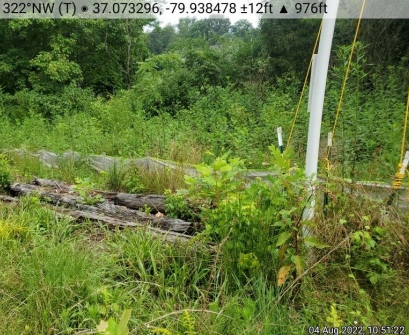
GPS Location	0
Field Station#	13770+00	Field Station#	13760+00	Pic 3 Desc.	CIS S-MM42 Buffer zone
Pic 4 Desc.		Pic 5 Desc.	Perimeter silt fence	GPS Location	0

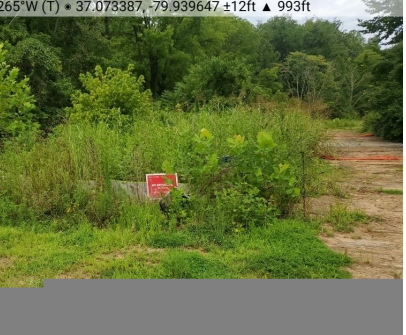
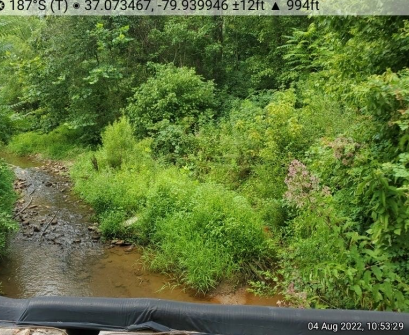
GPS Location	0
Field Station#	13757+00	Field Station#	13755+50	Pic 5 Desc.	GAS S-EF12 Buffer zone vegetation and Silt fence
Pic 6 Desc.		Pic 6 Desc.	S-EF12 Channel and banks

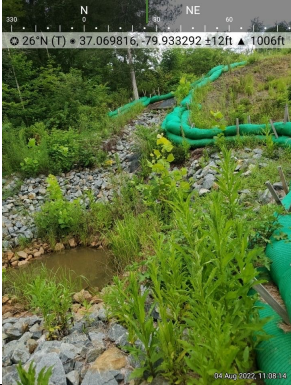
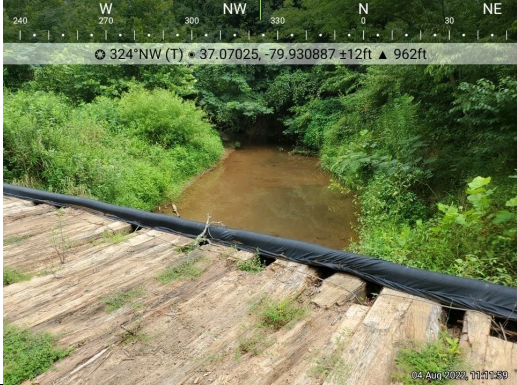
<p>ert image here</p>	
GPS Location 0		GPS Location 0			
Field Station# 13783+00		Field Station# 13790+50			
Pic 7 Desc. Waterbar relay		Pic 8 Desc. S-D23 Channel and banks

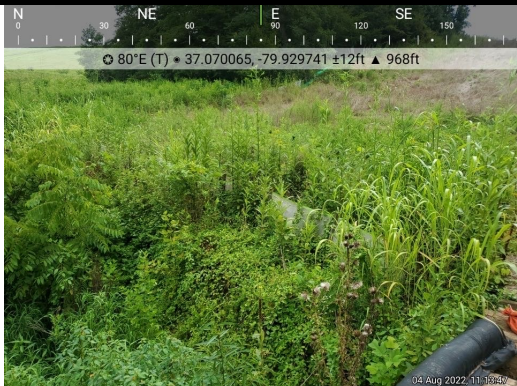
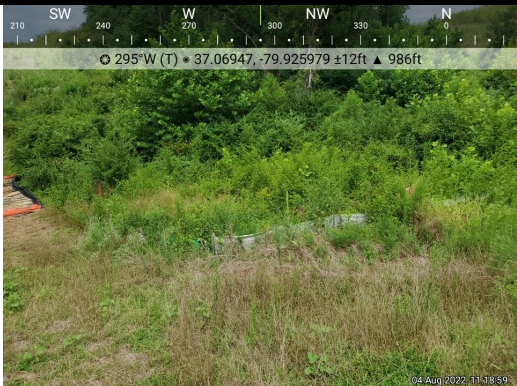
GPS Location 0		GPS Location 0			
Field Station# 13795+00		Field Station# 13806+50			
Pic 9 Desc. GAS S-D22 Buffer zone and silt fence		Pic 10 Desc. GAS S-D18 ECDs

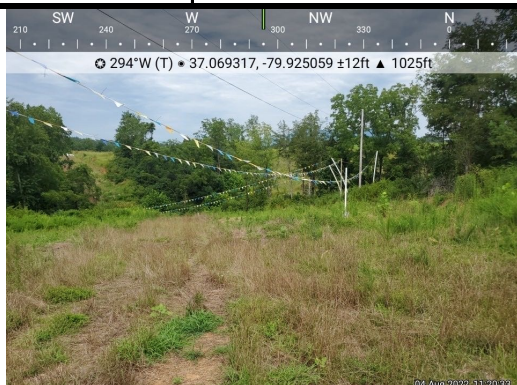
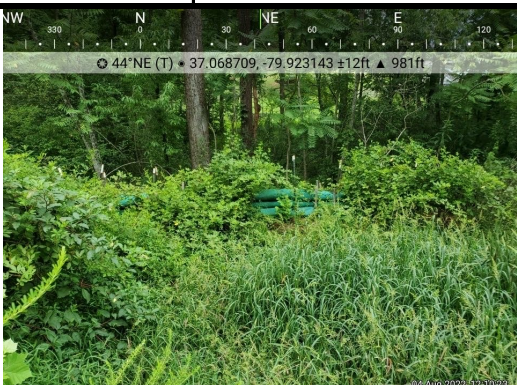
GPS Location 0		GPS Location 0			
Field Station# 13809+00		Field Station# 13815+00			
Pic 11 Desc. COS Brick Church Rd Vegetation		Pic 12 Desc. CFS Triple stack

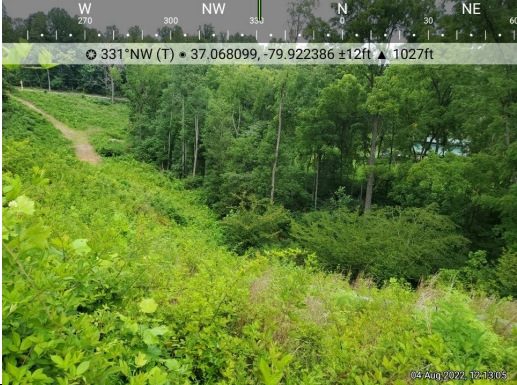
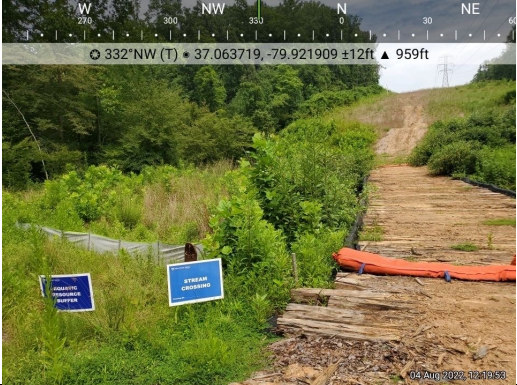
<p>GPS photo showing a stream crossing with a wooden structure and orange silt fence. GPS coordinates: 332°NW (T) • 37.063719, -79.921909 ±12ft ▲ 959ft</p>	
GPS Location 0		GPS Location 0			
Field Station# 13820+00		Field Station# 13835+50			
Pic 13 Desc. Sideslope vegetation		Pic 14 Desc. GAS S-C14 Buffer zone ECDs

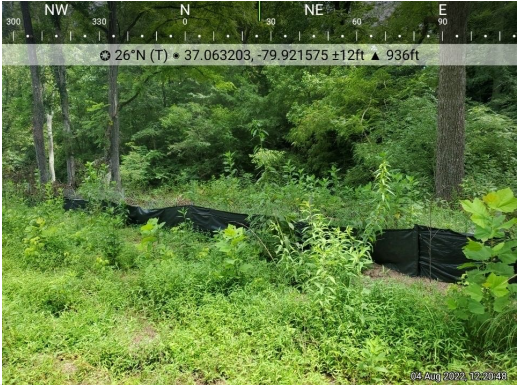
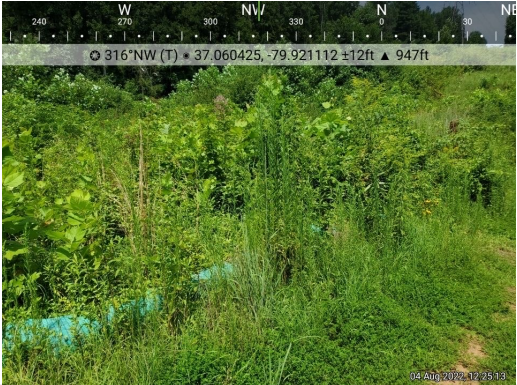
<p>GPS photo showing a GAS S-C16 Buffer zone with CFS. GPS coordinates: 316°NW (T) • 37.060425, -79.921112 ±12ft ▲ 947ft</p>	
GPS Location 0		GPS Location 0			
Field Station# 13840+00		Field Station# 13848+00			
Pic 15 Desc. Super silt fence perimeter of ROW		Pic 16 Desc. GAS S-C16 Buffer zone and CFS

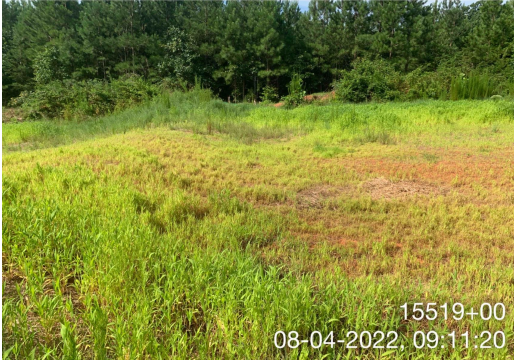
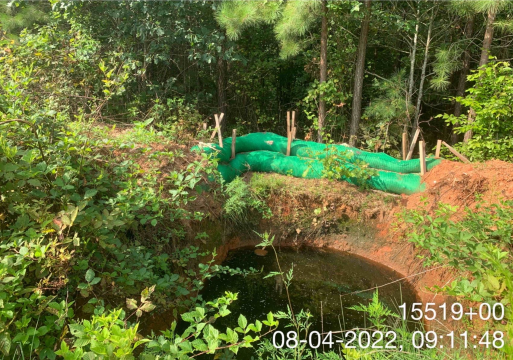
GPS Location		0		GPS Location	
Field Station#		15519+00		Field Station#	
Pic 1 Desc.		Waterbar in acceptable condition		Pic 2 Desc.	
				Waterbar end treatment in acceptable condition

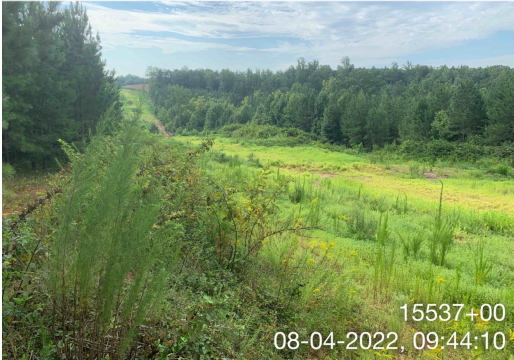
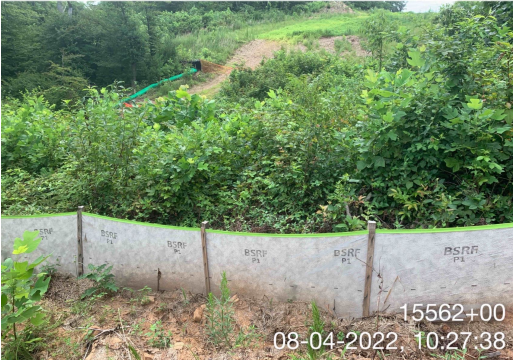
GPS Location		0		GPS Location	
Field Station#		15537+00		Field Station#	
Pic 3 Desc.		Clean water diversion berm and temporary vegetative stabilization in acceptable conditions		Pic 4 Desc.	
				P1 silt fence and sensitive resource buffer in acceptable conditions

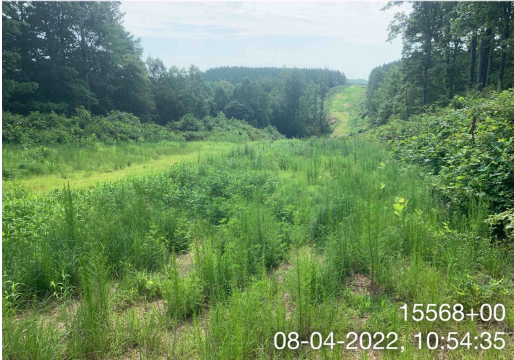
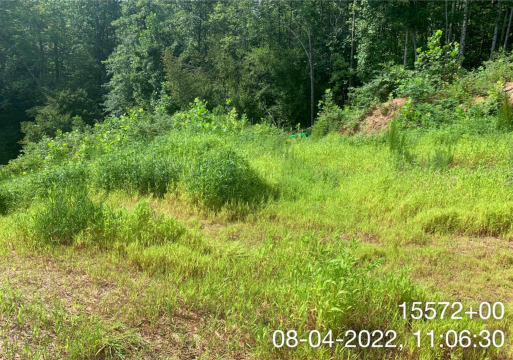
GPS Location		0		GPS Location	
Field Station#		15568+00		Field Station#	
Pic 5 Desc.		Temporary vegetative stabilization in acceptable condition		Pic 6 Desc.	
				Waterbar in acceptable condition

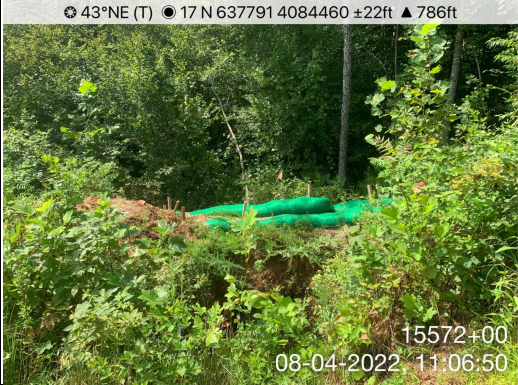
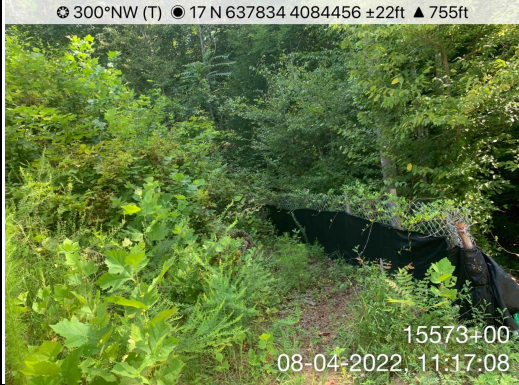
GPS Location	0	GPS Location	0		
Field Station#	15572+00	Field Station#	15573+00		
Pic 7 Desc.	Waterbar end treatment in acceptable condition		Pic 8 Desc.	Super silt fence in acceptable condition

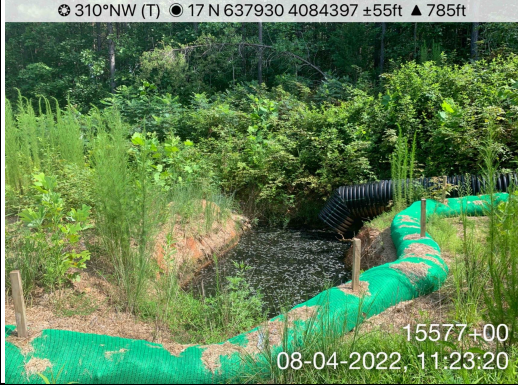
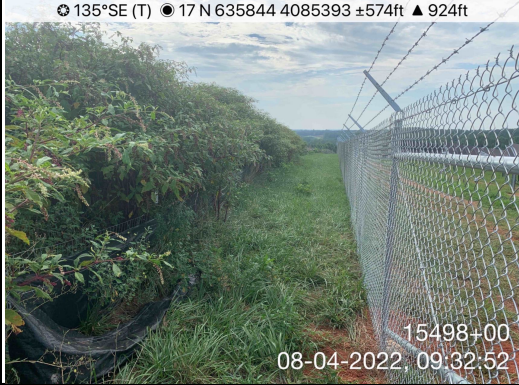
GPS Location	0	GPS Location	0		
Field Station#	15577+00	Field Station#	15498+00		
Pic 9 Desc.	Sump pit and slope drain pipe in acceptable conditions		Pic 10 Desc.	Solar farm perimeter ECDs appear to be in acceptable conditions	
Insert image here			Insert image here		
GPS Location		GPS Location			
Field Station#		Field Station#			
Pic 11 Desc.		Pic 12 Desc.

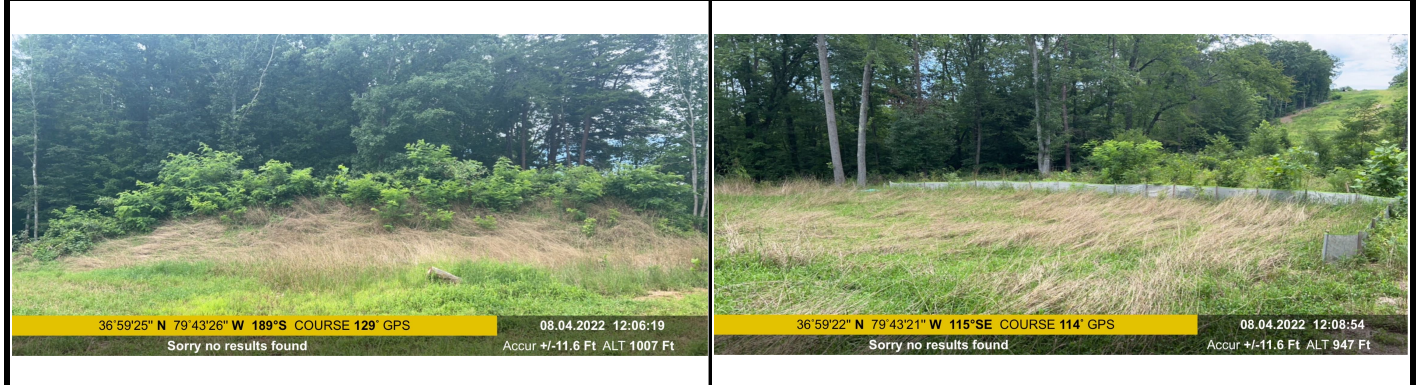
GPS Location	1	GPS Location	2
Field Station#	14650+50	Field Station#	14656+37
Pic 1 Desc.	Spoil pile stabilized and vegetated.	Pic 2 Desc.	Perimeter P1 silt fence in resource buffer in place and functional.

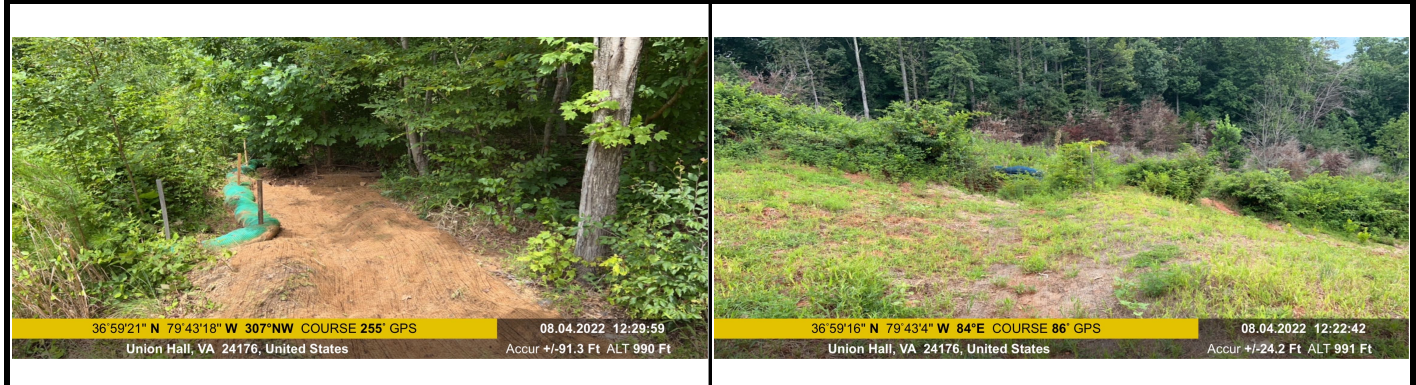
GPS Location	3	GPS Location	4
Field Station#	14658+60	Field Station#	14671+00
Pic 3 Desc.	Contractor installed erosion control blanket per punch list item.	Pic 4 Desc.	Water bar performing intended function; ROW stabilized and vegetated in temporary area.

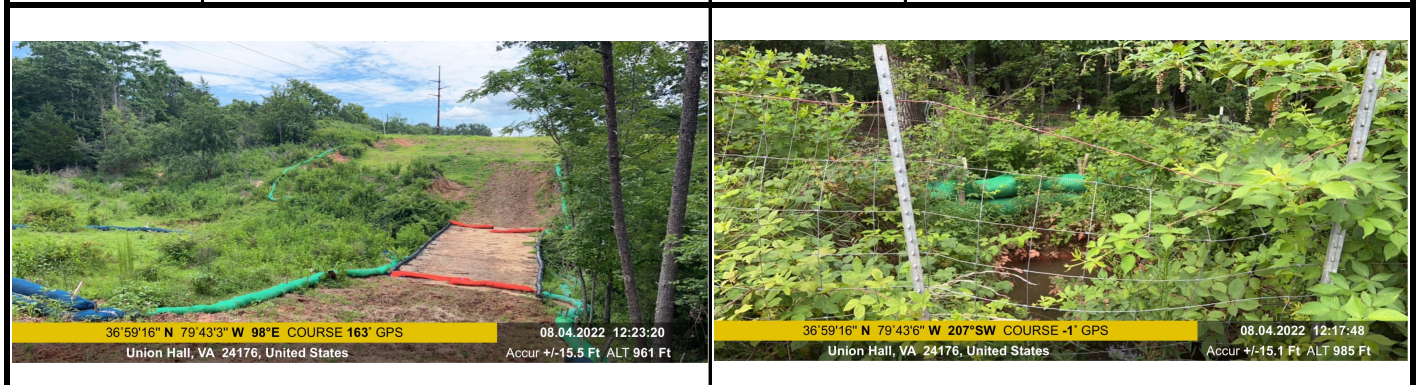
GPS Location	5	GPS Location	6
Field Station#	14673+10	Field Station#	14678+00
Pic 5 Desc.	Equipment bridge and surrounding ECDs in place and functional at stream crossing and resource buffer.	Pic 6 Desc.	Sump pit and CFS end treatment performing intended functions.

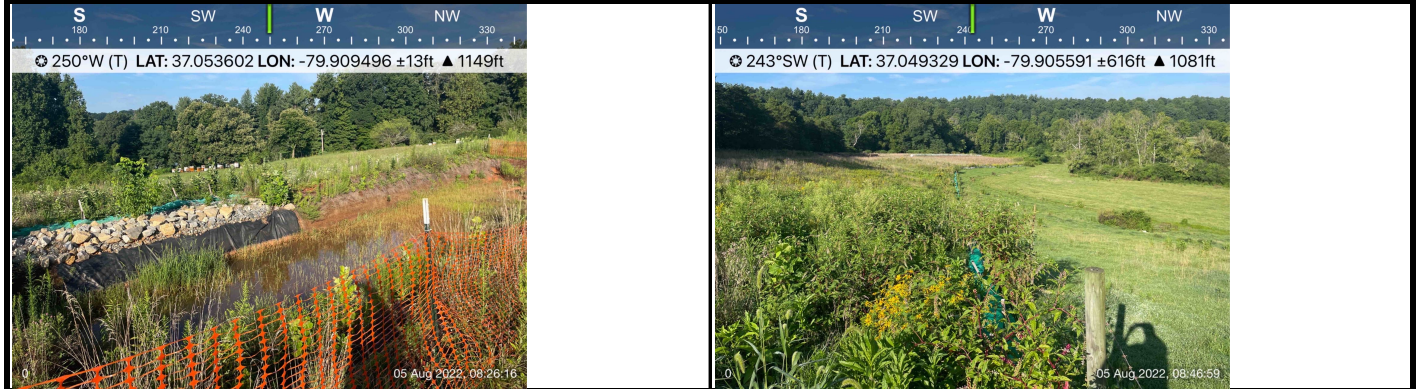
GPS Location	See photo	GPS Location	See photo
Field Station#	13897+00	Field Station#	13925+00
Pic 7 Desc.	Sediment trap is functioning as intended	Pic 8 Desc.	CFS is in good condition throughout this section

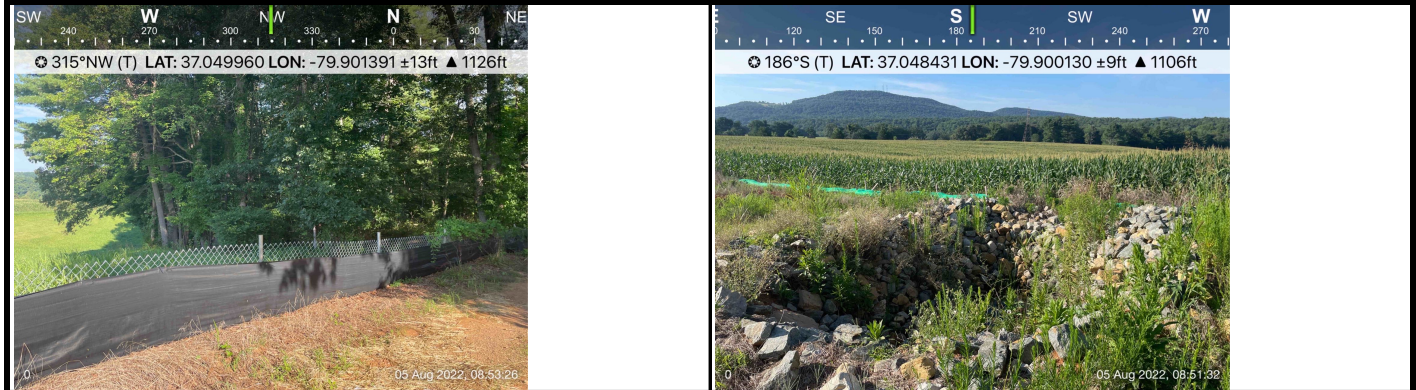
GPS Location	See photo	GPS Location	See photo
Field Station#	13939+50	Field Station#	13942+00
Pic 9 Desc.	SSF is in good condition	Pic 10 Desc.	CWDs are functioning as intended

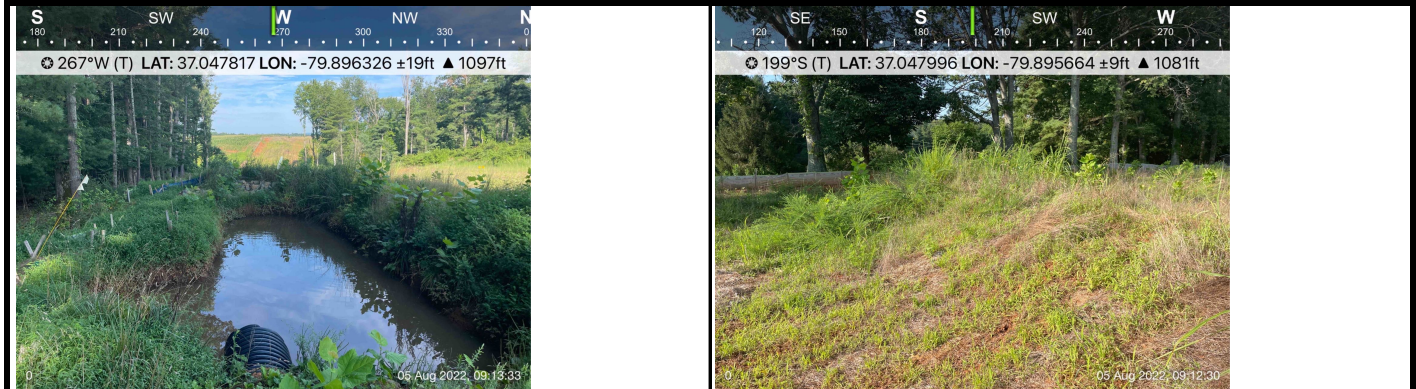
GPS Location	See photo	GPS Location	See photo
Field Station#	13953+00	Field Station#	13955+00
Pic 11 Desc.	Slope drain outlet is in good condition and functioning	Pic 12 Desc.	Waterbars are in good condition

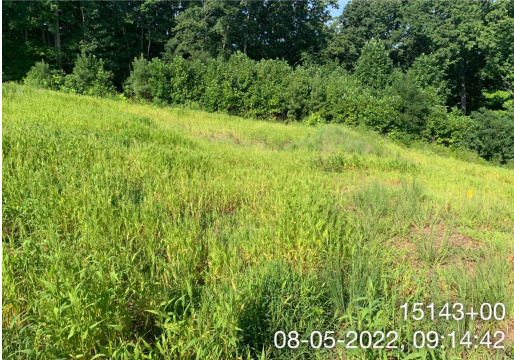
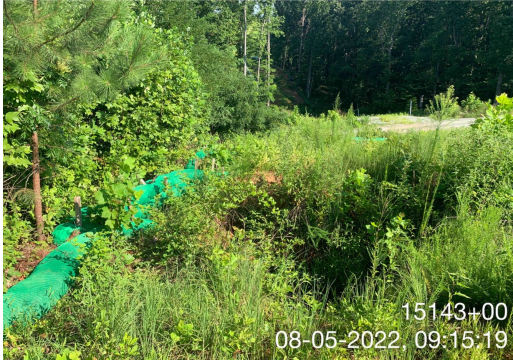
15143+00 08-05-2022, 09:14:42		15143+00 08-05-2022, 09:15:19			
GPS Location 0		GPS Location 0			
Field Station# 15143+00		Field Station# 15143+00			
Pic 1 Desc. Waterbar in acceptable condition		Pic 2 Desc. Waterbar end treatment and perimeter CFS in acceptable conditionS			
<small>☉ 12°N (T) ● 17 N 626682 4089929 ±111ft ▲ 898ft</small>

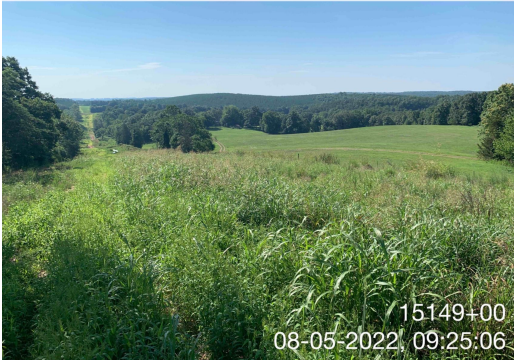
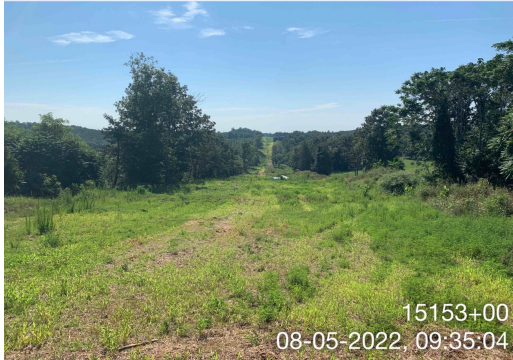
15149+00 08-05-2022, 09:25:06		15153+00 08-05-2022, 09:35:04			
GPS Location 0		GPS Location 0			
Field Station# 15149+00		Field Station# 15153+00			
Pic 3 Desc. Permanent vegetative stabilization in acceptable condition		Pic 4 Desc. Temporary vegetative stabilization in acceptable condition

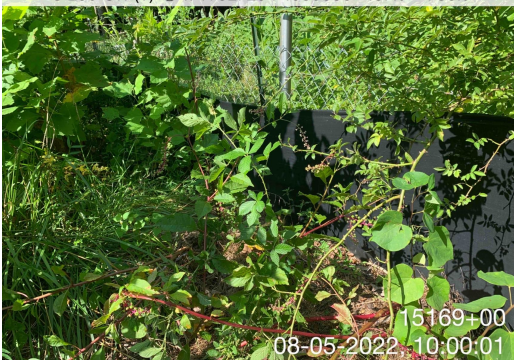
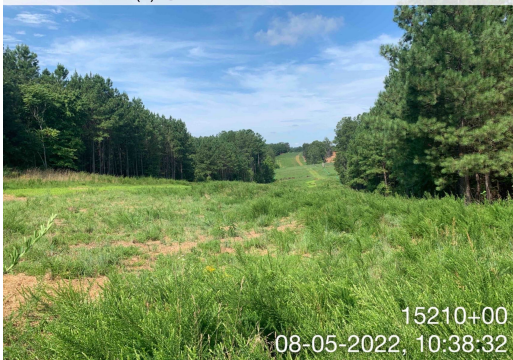
15169+00 08-05-2022, 10:00:01		15210+00 08-05-2022, 10:38:32			
GPS Location 0		GPS Location 0			
Field Station# 15169+00		Field Station# 15210+00			
Pic 5 Desc. Super silt fence in acceptable condition		Pic 6 Desc. Permanent vegetative stabilization in acceptable condition

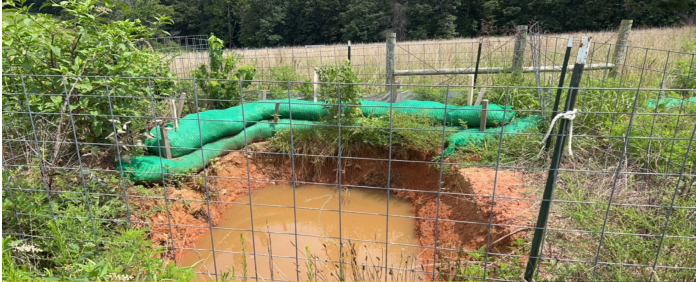
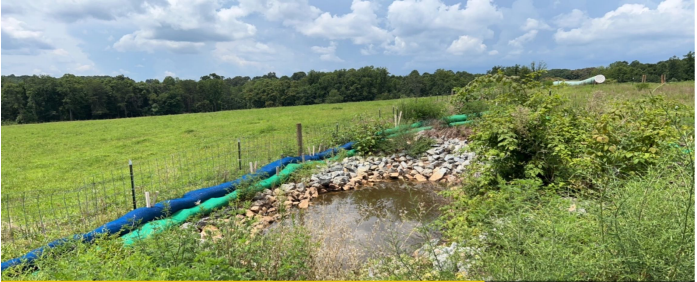
<small>37°29' N 79°47'43" W 129°SE COURSE 347' GPS 08.05.2022 12:37:38 Glade Hill, VA 24092, United States Accur +/-15.5 Ft ALT 1139 Ft</small>			<small>37°2'8" N 79°47'47" W 341°N COURSE 134' GPS 08.05.2022 12:36:11 Glade Hill, VA 24092, United States Accur +/-15.4 Ft ALT 1127 Ft</small>		
GPS Location	1		GPS Location	2	
Field Station#	14346+50		Field Station#	14362+00	
Pic 1 Desc.	Sump pit and CFS end treatment performing intended functions.		Pic 2 Desc.	Plunge pool performing intended function.

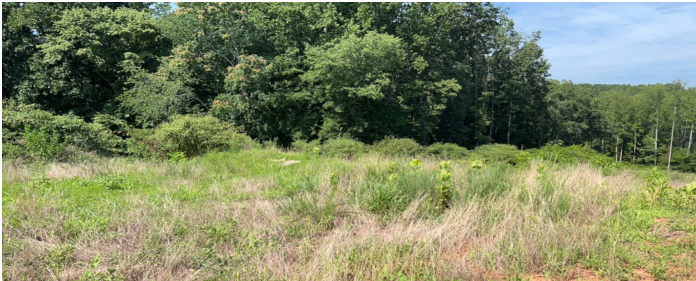
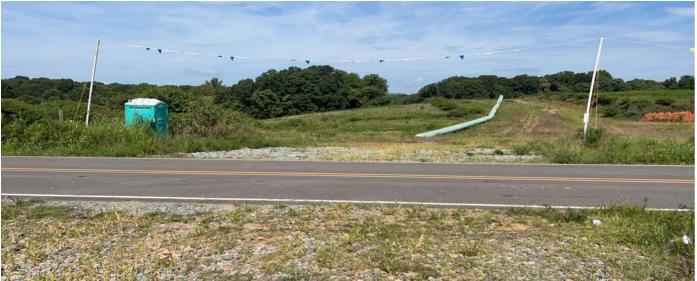
<small>37°1'40" N 79°46'14" W 269°W COURSE -1' GPS 08.05.2022 10:55:59 201-483 Old Carriage Rd, Glade Hill, VA 24092, United States Accur +/-21.7 Ft ALT 1108 Ft</small>			<small>37°1'36" N 79°46'6" W 305°NW COURSE 0' GPS 08.05.2022 10:52:29 2750 Webster Rd, Glade Hill, VA 24092, United States Accur +/-31.3 Ft ALT 0 Ft</small>		
GPS Location	5		GPS Location	6	
Field Station#	14444+00		Field Station#	14454+22	
Pic 5 Desc.	Water bar performing intended function; ROW stabilized and vegetated in temporary area.		Pic 6 Desc.	RCE at Webster Rd in good condition.

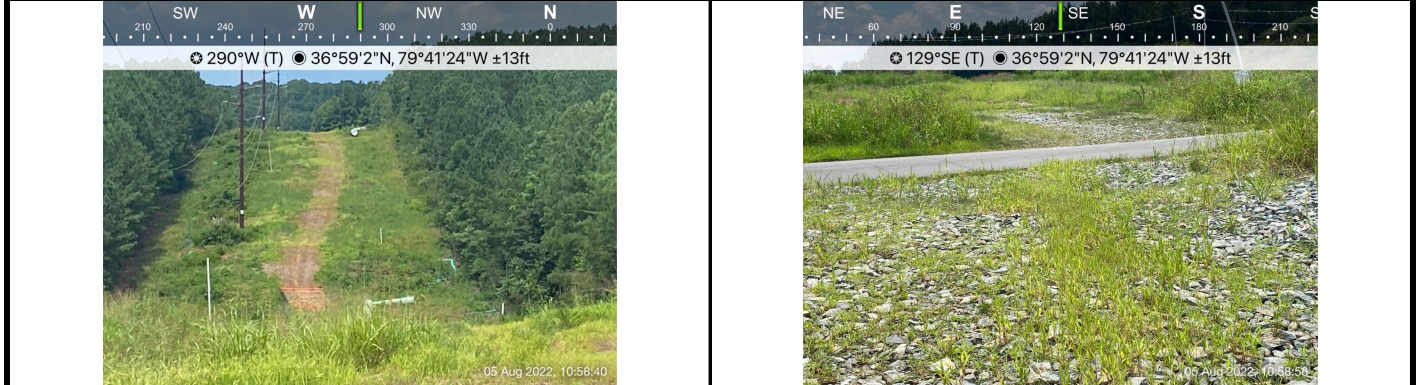
GPS Location	0	GPS Location	0
Field Station#	14748+00	Field Station#	14758+50
Pic 1 Desc.	Approximately 14748+00. Overview of ROW.	Pic 2 Desc.	Approximately 14758+50. Overview of road crossing and RCEs.

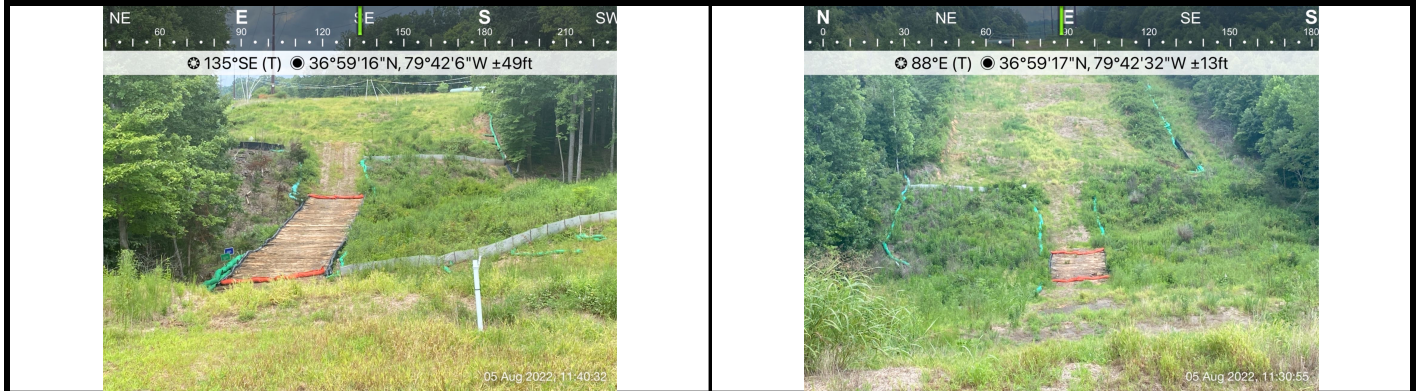
GPS Location	0	GPS Location	0
Field Station#	14716+92	Field Station#	14700+00
Pic 3 Desc.	Approximately 14716+92. Overview of stream crossing, equipment bridge and ECDs at stream S-H30.	Pic 4 Desc.	Approximately 14700+00. Overview of ROW.

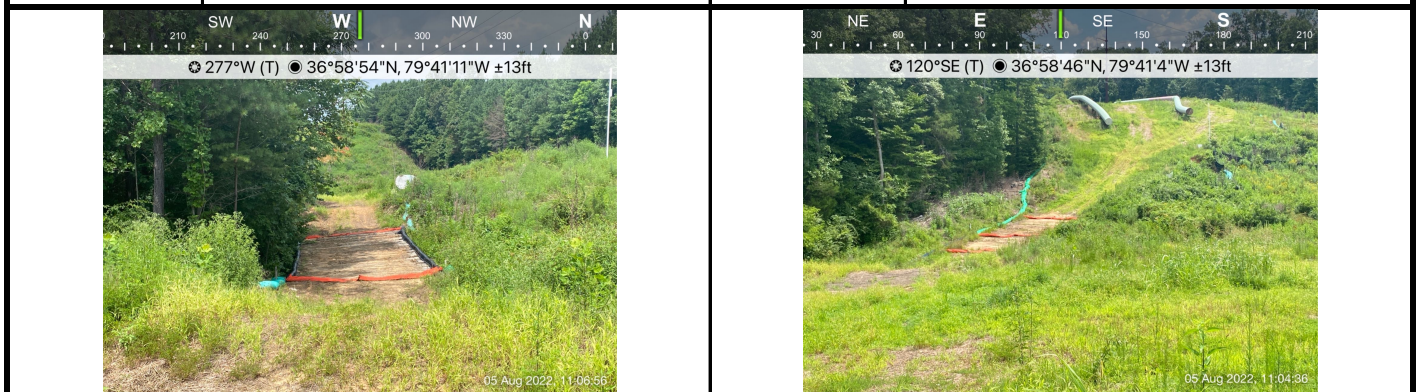
GPS Location	0	GPS Location	0
Field Station#	14769+52	Field Station#	14785+00
Pic 5 Desc.	Approximately 14769+52. Overview of stream crossing, equipment bridge and ECDs at stream S-MM45.	Pic 6 Desc.	Approximately 14785+00. Overview of ROW.

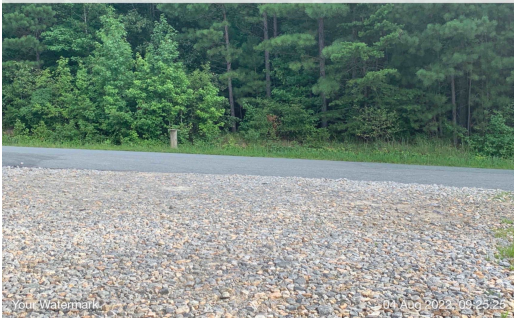
GPS Location O		GPS Location O			
Field Station# 00+00		Field Station# 00+00			
Pic 1 Desc. Observing RCE		Pic 2 Desc. Observing lay down yard

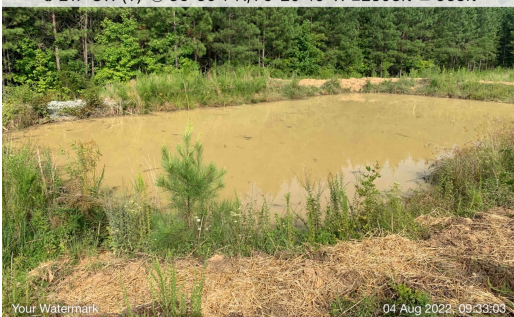
GPS Location O		GPS Location O			
Field Station# 00+00		Field Station# 00+00			
Pic 3 Desc. Observing temporary stabilization and sediment basin		Pic 4 Desc. Observing temporary stabilization and rock drain

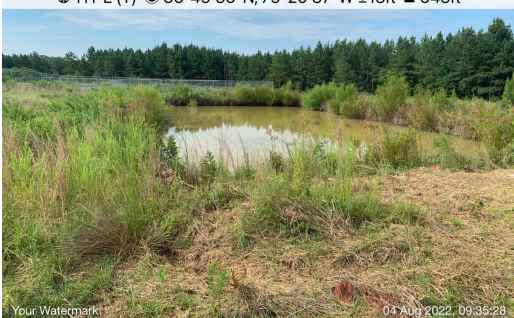
GPS Location O		GPS Location O			
Field Station# 00+00		Field Station# 00+00			
Pic 5 Desc. Observing temporary stabilization and sediment basin		Pic 6 Desc. Observing temporary stabilization and storm water pond
