Visual Site Inspection Report

Project Name H-602 Pipeline Spread I		AFE 124300139	Spread H-602 Pipeline Spread I
Contractor Precision		Report # 41263	
Inspector John White		Date/Time 8/22/2022 10:18 AM	
Permit # TBD	Inspection Type VA SWPP	Station Begin	00+00
State VA	Inspection Area Full	Station End	19+25
County Pittsylvania	Ground Wet	Temperature (°F)	74.00
Municipality Chatham	Weather Cloudy	Rain Gauge (in)	0.60
			Rain Accumulation Time (days) 6.00

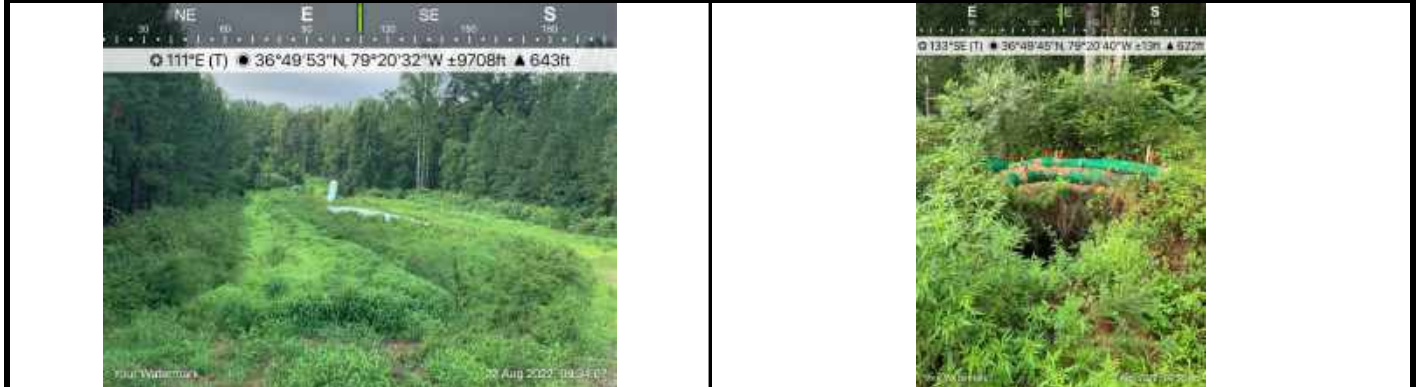
Field Station# 6+00	Field Station# 12+00
----------------------------	-----------------------------

Pic 1 Desc. Observing temporary stabilization	Pic 2 Desc. Observing temporary stabilization, sump and end treatment
--	--

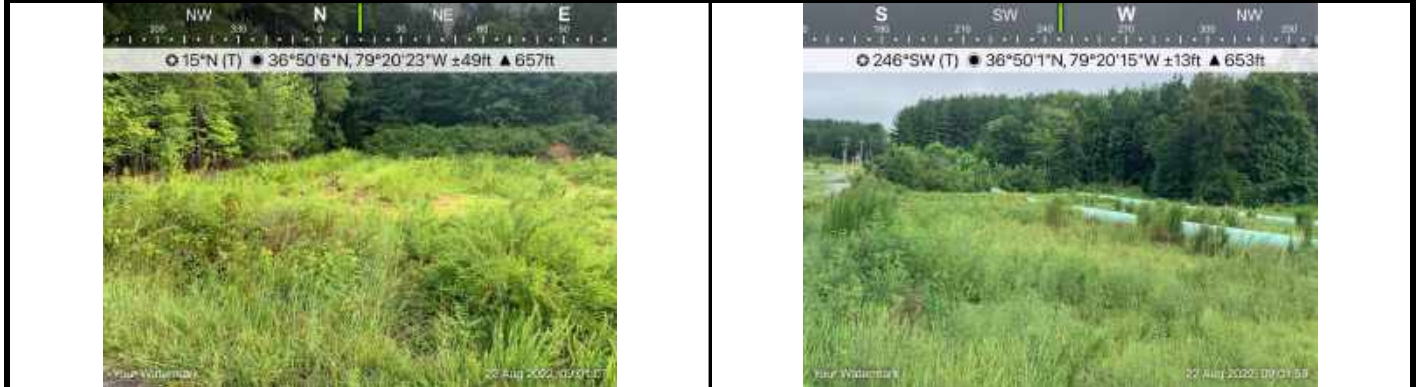
Field Station#	14+00	Field Station#	22+00
-----------------------	-------	-----------------------	-------

Pic 1 Desc.	Observing temporary stabilization and ECD's	Pic 2 Desc.	Observing temporary stabilization and buffer
--------------------	---	--------------------	--

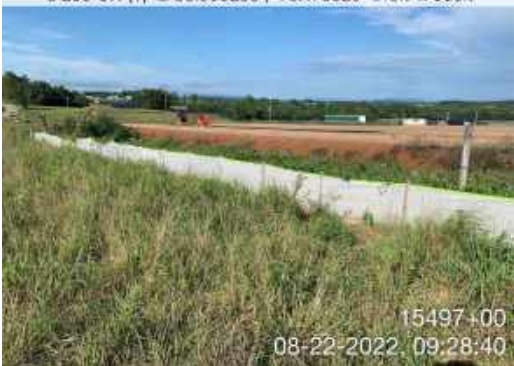
GPS Location	0	GPS Location	0
Field Station#	15497+00	Field Station#	15502+00
Pic 1 Desc.	P1 silt fence in acceptable condition	Pic 2 Desc.	Waterbar in acceptable condition

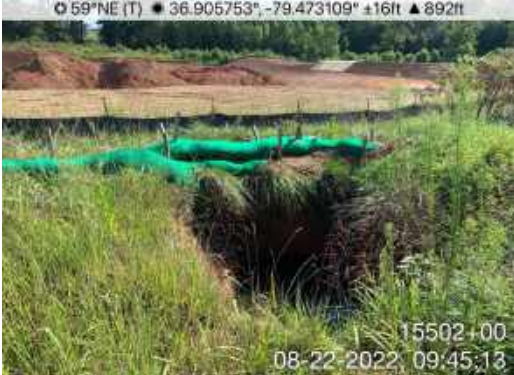
GPS Location	0	GPS Location	0
Field Station#	15502+00	Field Station#	15503+00
Pic 3 Desc.	Waterbar end treatment in acceptable condition	Pic 4 Desc.	Solar farm perimeter ECDs and grading operation

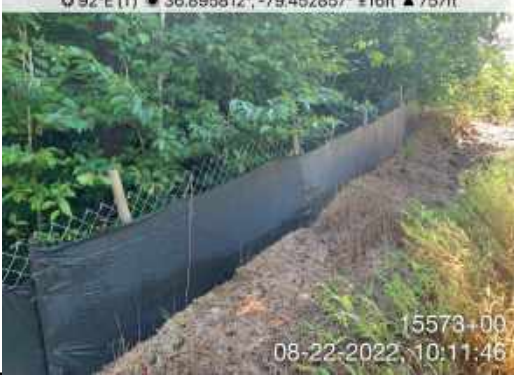
GPS Location	0	GPS Location	0
Field Station#	15573+00	Field Station#	15530+00
Pic 5 Desc.	Super silt fence in acceptable condition	Pic 6 Desc.	Temporary vegetative stabilization in acceptable condition

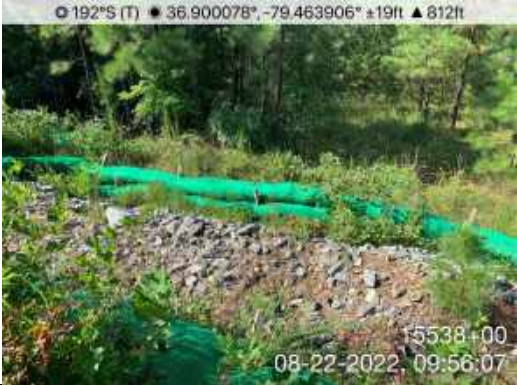
GPS Location	0	GPS Location	0
Field Station#	15538+00	Field Station#	15564+00
Pic 7 Desc.	Clean water diversion pipe and CFS in acceptable conditions	Pic 8 Desc.	Waterbar in acceptable condition

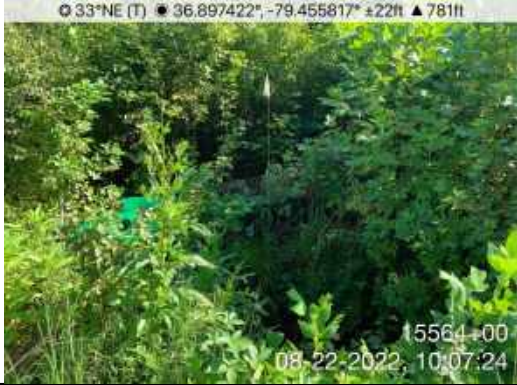
GPS Location	0	GPS Location	0
Field Station#	15564+00	Field Station#	15486+00
Pic 9 Desc.	Waterbar end treatment in acceptable condition	Pic 10 Desc.	Solar farm perimeter super silt fence is down

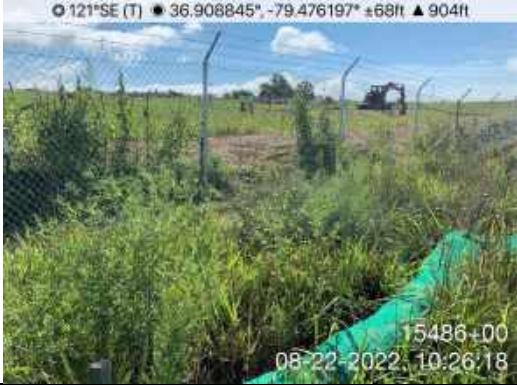
- The EI observed that the solar farm ECDs adjacent to the ROW on GAS of Climax Road appeared to be in acceptable condition and that the super silt fence on the CIS of climax Road was down in multiple locations where the solar farm fencing crew has recently worked.

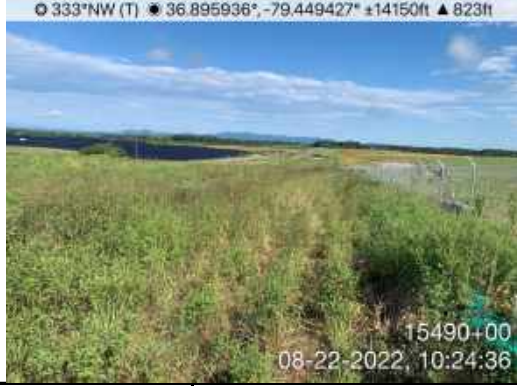
GPS Location	0	GPS Location	0
Field Station#	15490+00	Field Station#	15582+50
Pic 11 Desc.	Permanent vegetative stabilization in acceptable condition	Pic 12 Desc.	Sump pit and CFS in acceptable conditions

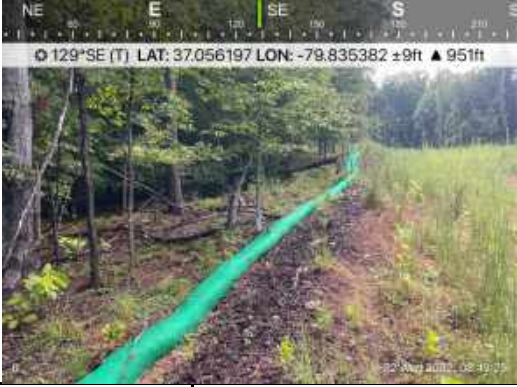
GPS Location	See photo	GPS Location	See photo
Field Station#	14216+00	Field Station#	14223+41
Pic 7 Desc.	Perimeter CFS is in good condition throughout this section	Pic 8 Desc.	MVP-FR-311 is in good condition with controls in place

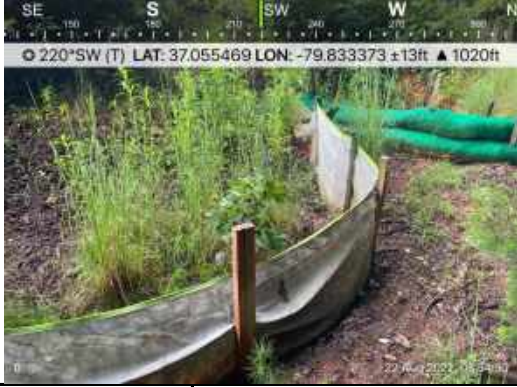
GPS Location	See photo	GPS Location	See photo
Field Station#	14224+00	Field Station#	14230+00
Pic 9 Desc.	Perimeter P1 has been damaged and needs to be replaced	Pic 10 Desc.	Perimeter P1 has been damaged and needs to be replaced

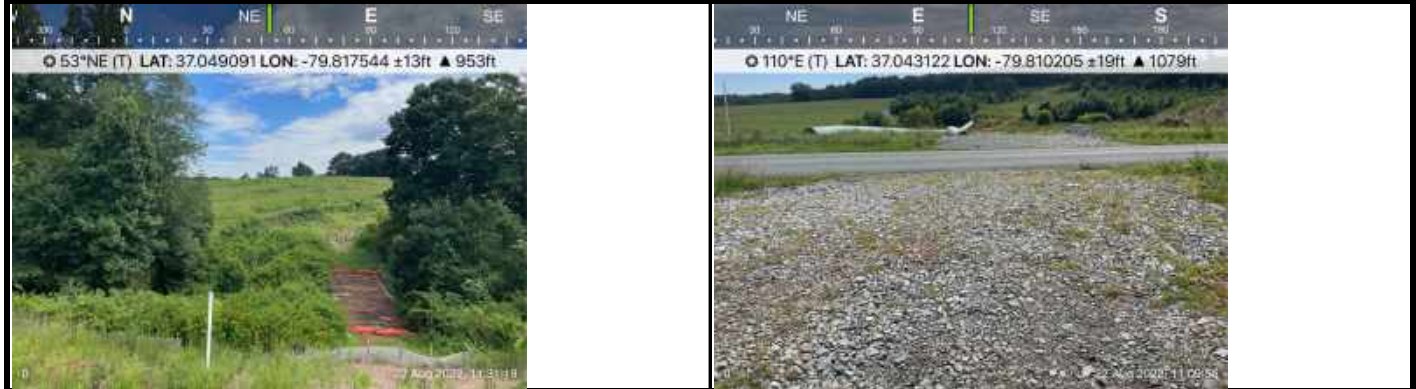
GPS Location	See photo	GPS Location	See photo
Field Station#	14278+93	Field Station#	14311+57
Pic 13 Desc.	Resource buffers remain well vegetated	Pic 14 Desc.	RCEs are in good condition at all road crossings.

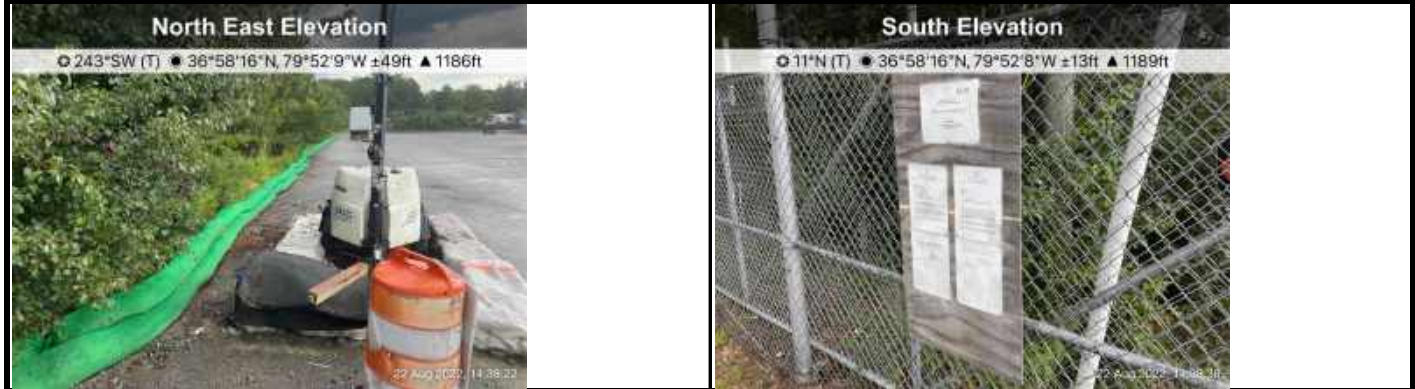
Pic 7 Desc.	Perimeter ECD's and secondary containment structure for light plant at south end of LY-046 in good condition.	Pic 8 Desc.	General construction permits and contact info posted at entrance of LY-046 as required.
--------------------	---	--------------------	---

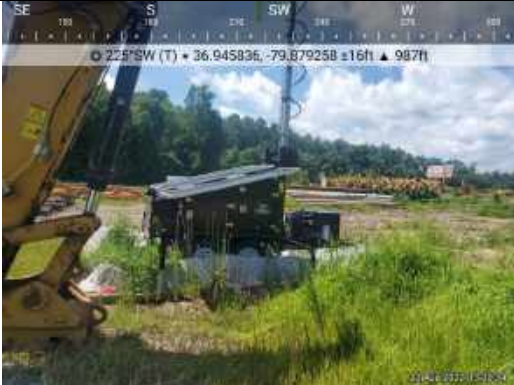
GPS Location 0		GPS Location 0			
Field Station# 0+00		Field Station# 0+00			
Pic 1 Desc. LY-033 Secondary containment		Pic 2 Desc. LY-032 Secondary containment

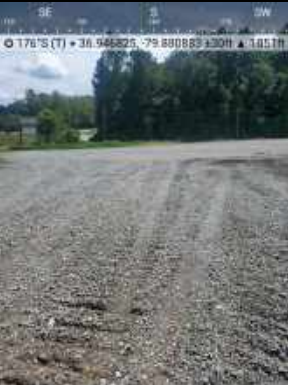
GPS Location 0		GPS Location 0			
Field Station# 0+00		Field Station# 0+00			
Pic 3 Desc. LY-032 Rock construction entrance		Pic 4 Desc. LY-033 Timber mat staging area

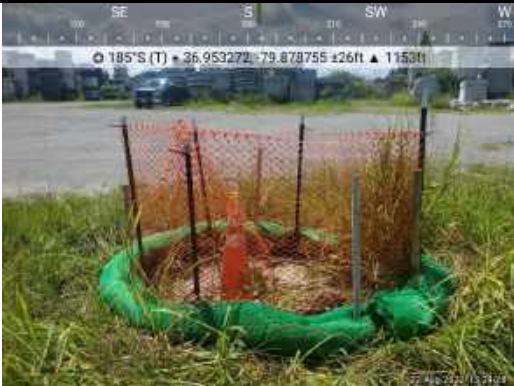
GPS Location 0		GPS Location 0			
Field Station# 0+00		Field Station# 0+00			
Pic 5 Desc. ANC-006 Stormwater drain inlet protection		Pic 6 Desc. ANC-006 Secondary containment

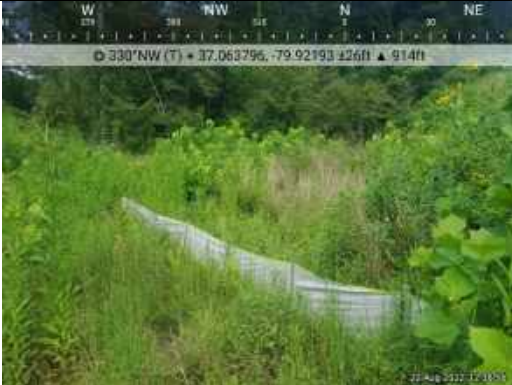
GPS Location 0		GPS Location 0			
Field Station# 13835+50		Field Station# 13834+50			
Pic 1 Desc. GAS S-C14 Buffer zone silt fence		Pic 2 Desc. S-C14 Channel upstream of ROW and banks

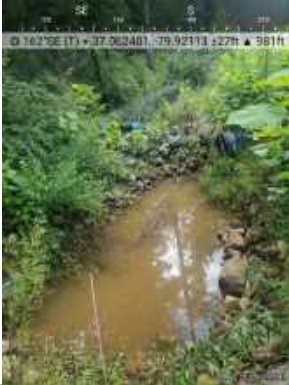
GPS Location 0		GPS Location 0			
Field Station# 13842+00		Field Station# 13830+00			
Pic 3 Desc. Plunge pool		Pic 4 Desc. Sump and J-hook

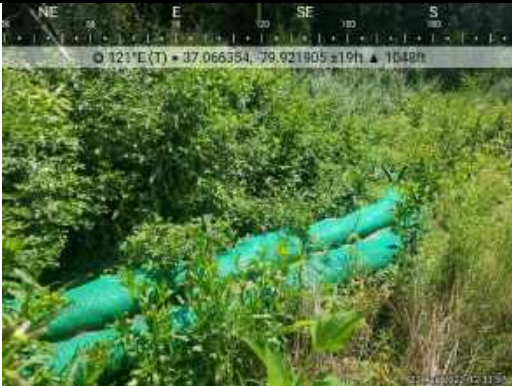
GPS Location 0		GPS Location 0			
Field Station# 13825+00		Field Station# 13794+50			
Pic 5 Desc. Perimeter CFS Triple stack		Pic 6 Desc. S-D22 Channel and buffer zones

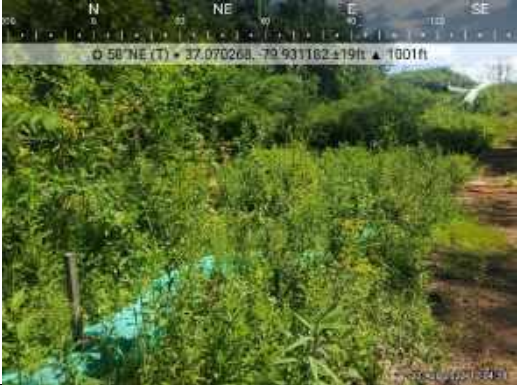
GPS Location	0	GPS Location	0		
Field Station#	13790+00	Field Station#	13786+00		
Pic 7 Desc.	CIS S-D23 Buffer zone and CFS	Pic 8 Desc.	Perimeter CFS

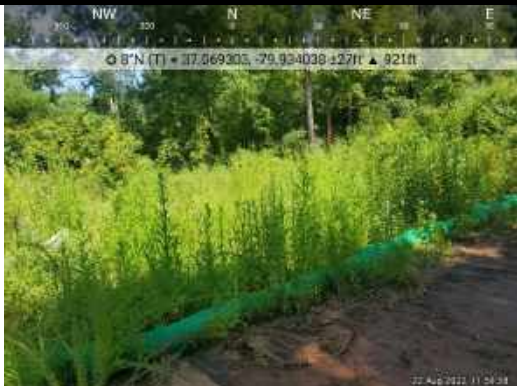
GPS Location	0	GPS Location	0		
Field Station#	13781+00	Field Station#	13783+00		
Pic 9 Desc.	CIS S-RR15 Buffer zone and CFS	Pic 10 Desc.	Perimeter silt fence

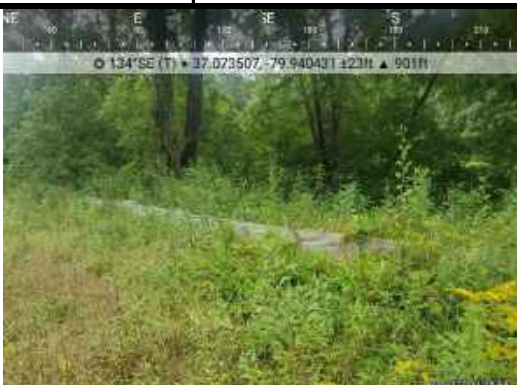
rt image here	
GPS Location	0	GPS Location	0		
Field Station#	13784+00	Field Station#	13755+00		
Pic 11 Desc.	Sump and J-hook	Pic 12 Desc.	CIS S-EF12 Buffer zone silt fence

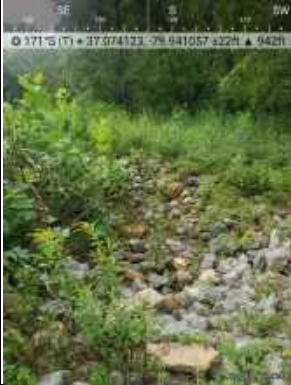
GPS Location	0	GPS Location	0		
Field Station#	13752+00	Field Station#	13748+50		
Pic 13 Desc.	Plunge pool	Pic 14 Desc.	S-EF7 Silt fence		
Insert image here		Insert image here			
GPS Location		GPS Location			
Field Station#		Field Station#			
Pic 15 Desc.		Pic 16 Desc.			
Insert image here		Insert image here			
GPS Location		GPS Location			
Field Station#		Field Station#			
Pic 17 Desc.		Pic 18 Desc.

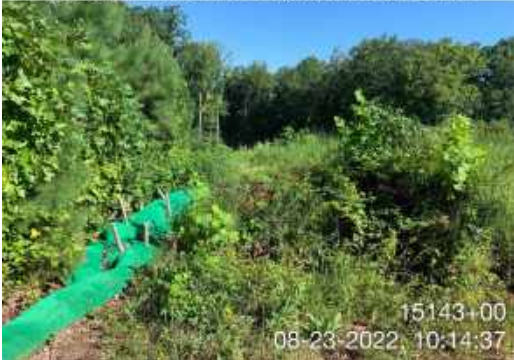
GPS Location	0	GPS Location	0
Field Station#	15143+00	Field Station#	15143+00
Pic 1 Desc.	Waterbar end treatment in acceptable condition	Pic 2 Desc.	Waterbar in acceptable condition

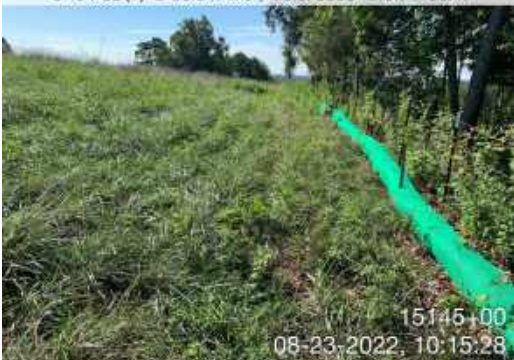
GPS Location	0	GPS Location	0
Field Station#	15145+00	Field Station#	15163+00
Pic 3 Desc.	Permanent vegetative stabilization and perimeter CFS in acceptable conditions	Pic 4 Desc.	P1 silt fence in acceptable condition

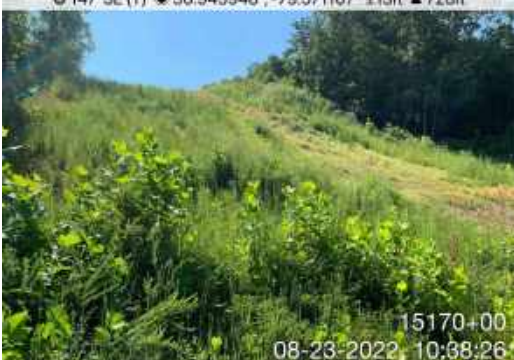
GPS Location	0	GPS Location	0
Field Station#	15170+00	Field Station#	15183+00
Pic 5 Desc.	Temporary vegetative stabilization in acceptable condition	Pic 6 Desc.	Waterbar and permanent vegetative stabilization in acceptable conditions

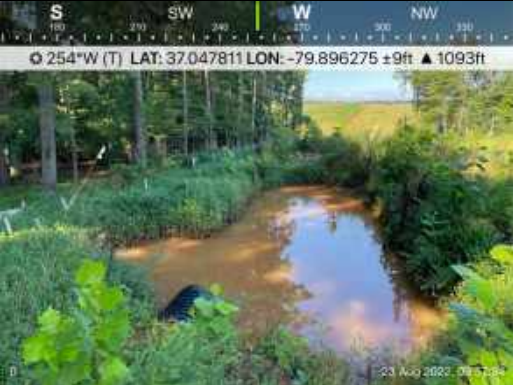
GPS Location See photo		GPS Location See photo			
Field Station# 13955+00		Field Station# 13954+00			
Pic 1 Desc. P1 has been damaged and needs to be replaced		Pic 2 Desc. Slope drain outlet is in good condition and functioning

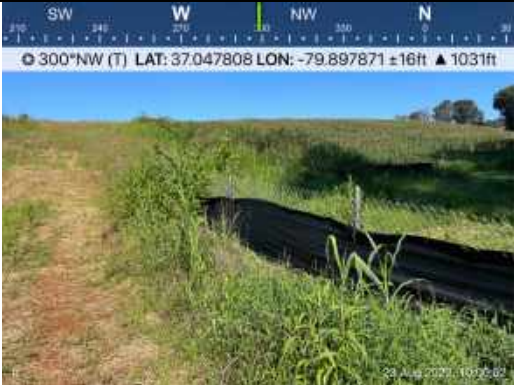
GPS Location See photo		GPS Location See photo			
Field Station# 13949+00		Field Station# 13943+00			
Pic 3 Desc. SSF is in good condition throughout this section		Pic 4 Desc. Topsoil berms remain stabilized

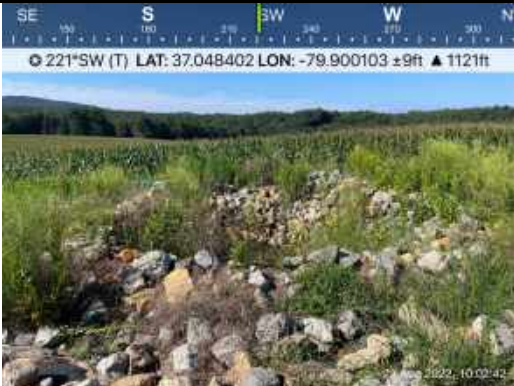
GPS Location See photo		GPS Location See photo			
Field Station# 13942+00		Field Station# 13907+00			
Pic 5 Desc. CWDs are functioning as intended		Pic 6 Desc. CFS has been damaged by 3rd party and needs to be repaired

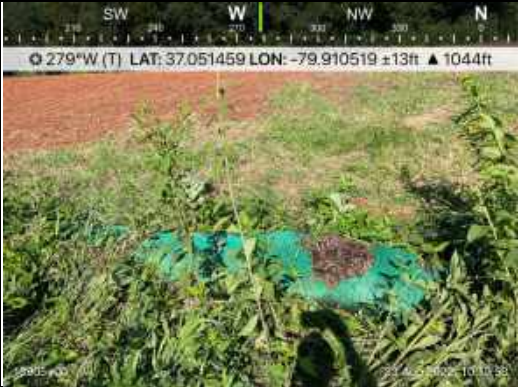
- Resource buffers remain well vegetated at all stream and wetland crossings.
- CWDs are in good condition and functioning as intended
- Equipment bridge ECDs are in good condition and functioning.
- P1 has been damaged at 13955+00/13889+50/13889+00 and needs to be replaced.
- P1 has been damaged by 3rd party and needs to be replaced at 13900+00/13888+00.
- CFS has been damaged by 3rd party at 13907+00/13905+00
- Steep slope at 13889+00 remains stabilized.
- RCEs are in good condition at all road crossings.
- Topsoil berms remain stabilized.
- Sediment trap at 13897+00 is in good condition with no evidence of discharge.
- SSF is in good condition
- Waterbars/end treatments are in good condition.
- Slope drain is functioning at 13955+00.

<p>73°E (T) LAT: 37.052512 LON: -79.909931 ±13ft ▲ 1084ft</p>	
GPS Location	See photo	GPS Location	See photo
Field Station#	13905+00	Field Station#	13900+00
Pic 7 Desc.	CFS has been damaged by 3rd party and needs to be repaired	Pic 8 Desc.	P1 has been damaged by 3rd party and needs to be replaced

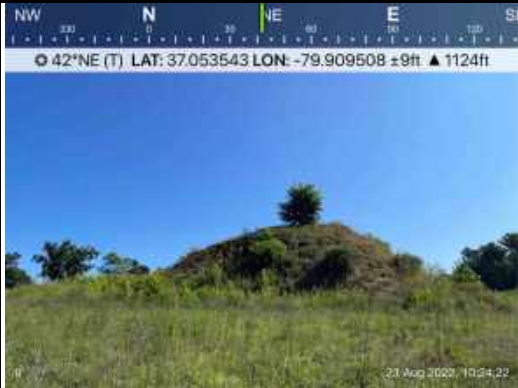
<p>247°SW (T) LAT: 37.053577 LON: -79.909501 ±9ft ▲ 1123ft</p>	
GPS Location	See photo	GPS Location	See photo
Field Station#	13897+00	Field Station#	13897+00
Pic 9 Desc.	Topsoil pile remains stabilized	Pic 10 Desc.	Sediment trap is functioning as intended

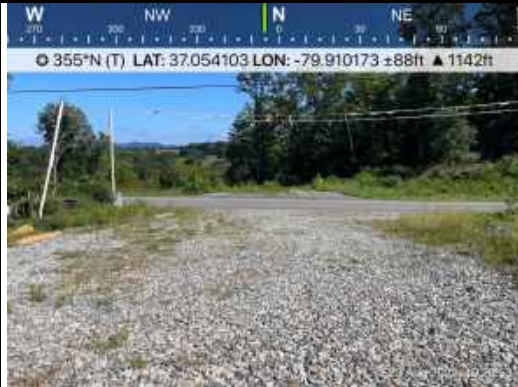
Field Station#	13892+45	Field Station#	13890+00
Pic 11 Desc.	RCEs are in good condition at all road crossings	Pic 12 Desc.	Waterbars are functioning as intended

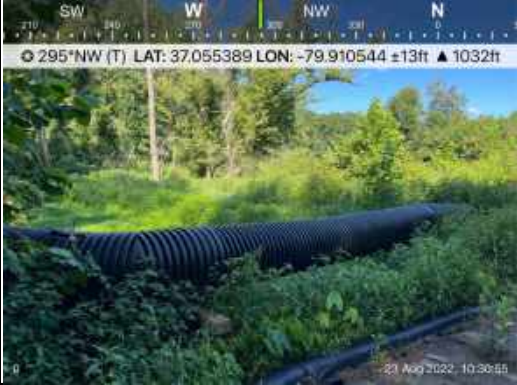
GPS Location	See photo	GPS Location	See photo
Field Station#	13888+50	Field Station#	13888+00
Pic 15 Desc.	Slope drain is functioning as intended	Pic 16 Desc.	P1 has been damaged by 3rd party and needs to be replaced

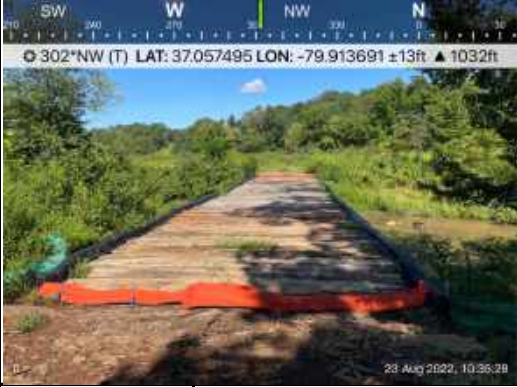
GPS Location	See photo	GPS Location	See photo
Field Station#	13875+73	Field Station#	13863+00
Pic 17 Desc.	Equipment bridge ECDs are in good condition and functioning	Pic 18 Desc.	Resource buffers remain well vegetated

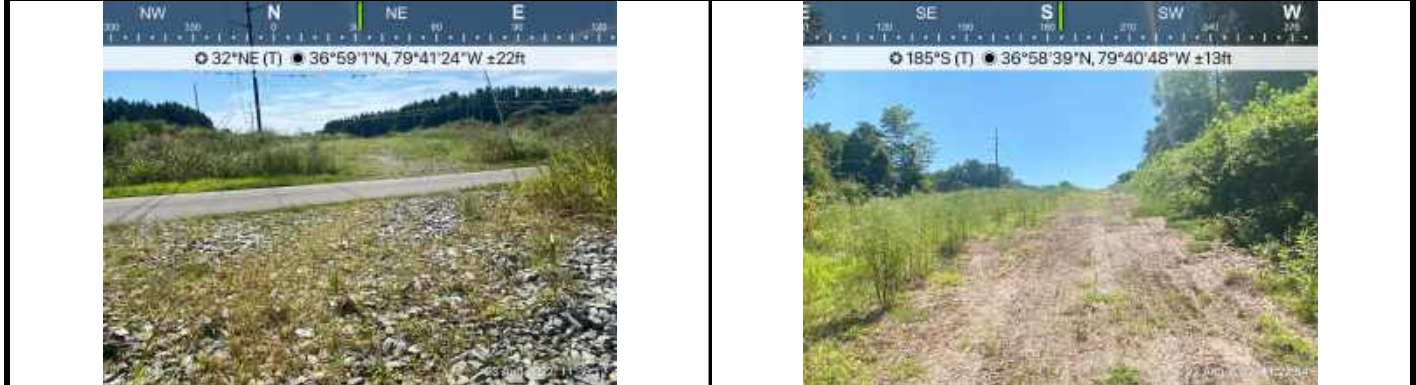
Pic 1 Desc.	Approximately 14758+00. Overview of road crossing and RCEs.	Pic 2 Desc.	Approximately 14799+00. Overview of ROW.
--------------------	---	--------------------	--

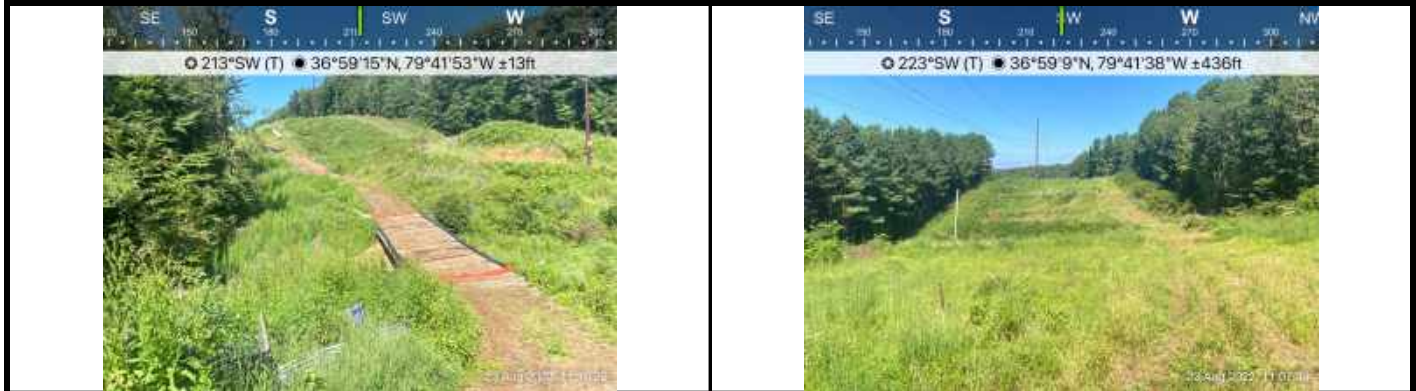
Pic 3 Desc.	Approximately 14729+19. Overview of stream crossing, equipment bridge and ECDs at stream S-A20.	Pic 4 Desc.	Approximately 14743+00. Overview of ROW.
--------------------	---	--------------------	--

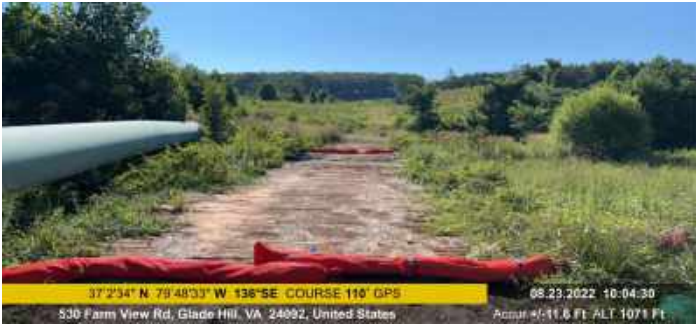
GPS Location	1	GPS Location	2
Field Station#	14314+79	Field Station#	14322+85
Pic 1 Desc.	Equipment bridge and surrounding ECDs in place and functional at stream crossing and resource buffer.	Pic 2 Desc.	ROW stabilized and vegetated in temporary area; perimeter controls in good condition.

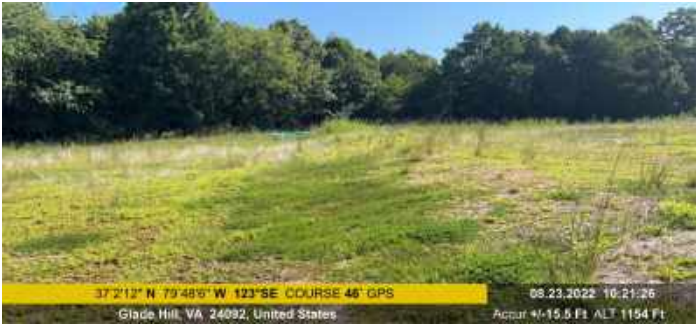
GPS Location	3	GPS Location	4
Field Station#	14347+00	Field Station#	14354+03
Pic 3 Desc.	Water bar performing intended function; ROW stabilized and vegetated in temporary area.	Pic 4 Desc.	Perimeter P1 silt fence repaired per punch list item.

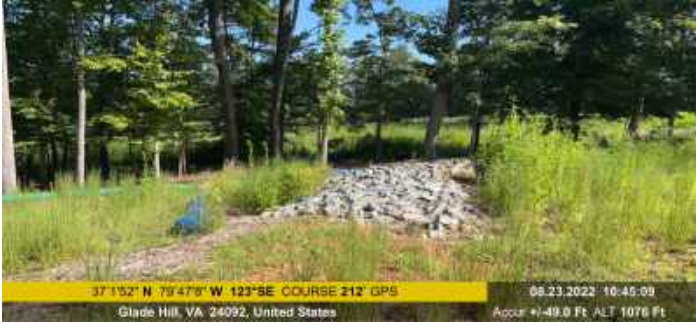
GPS Location	5	GPS Location	6
Field Station#	14399+00	Field Station#	14420+70
Pic 5 Desc.	Rock end treatment performing intended function.	Pic 6 Desc.	Equipment bridge and surrounding ECDs in place and functional at stream crossing and resource buffer.

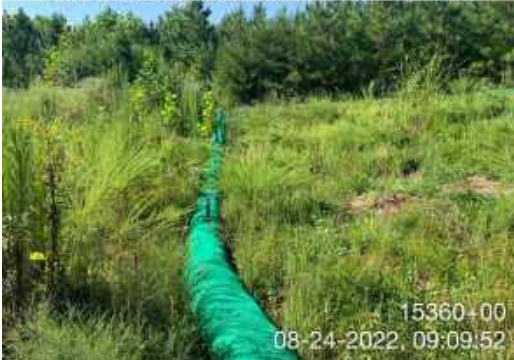
GPS Location	0	GPS Location	0
Field Station#	15360+00	Field Station#	15345+00
Pic 1 Desc.	CFS in acceptable condition	Pic 2 Desc.	Waterbar in acceptable condition

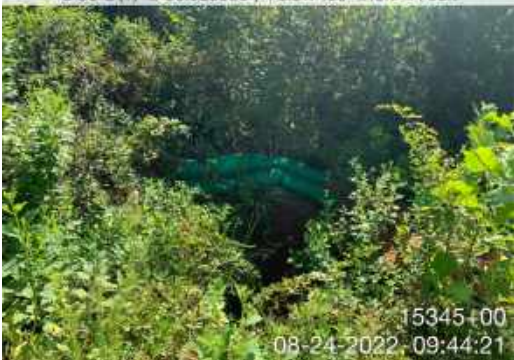
GPS Location	0	GPS Location	0
Field Station#	15345+00	Field Station#	15338+00
Pic 3 Desc.	Waterbar end treatment in acceptable condition	Pic 4 Desc.	Sump pit in acceptable condition

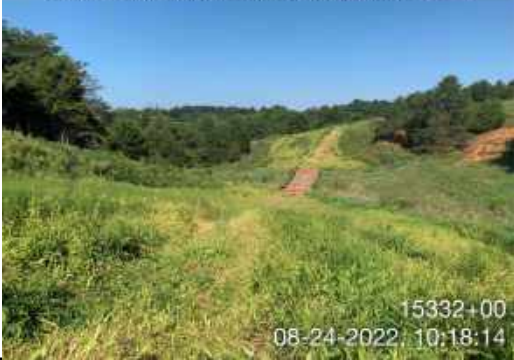
GPS Location	0	GPS Location	0
Field Station#	15332+00	Field Station#	15314+18
Pic 5 Desc.	Temporary vegetative stabilization in acceptable condition	Pic 6 Desc.	Equipment bridge in acceptable condition

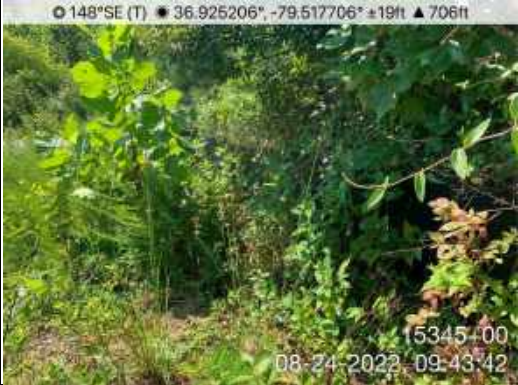
GPS Location	0	GPS Location	0		
Field Station#	15345+00	Field Station#	15313+00		
Pic 7 Desc.	Super silt fence in acceptable condition		Pic 8 Desc.	P1 silt fence and temporary vegetative stabilization in acceptable conditions

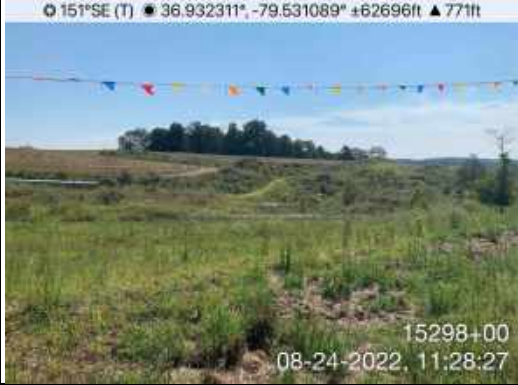
GPS Location	0	GPS Location	0		
Field Station#	15298+00	Field Station#	15311+00		
Pic 9 Desc.	Temporary vegetative stabilization in acceptable condition		Pic 10 Desc.	P1 silt fence in acceptable condition	
Insert image here			Insert image here		
GPS Location		GPS Location			
Field Station#		Field Station#			
Pic 11 Desc.		Pic 12 Desc.

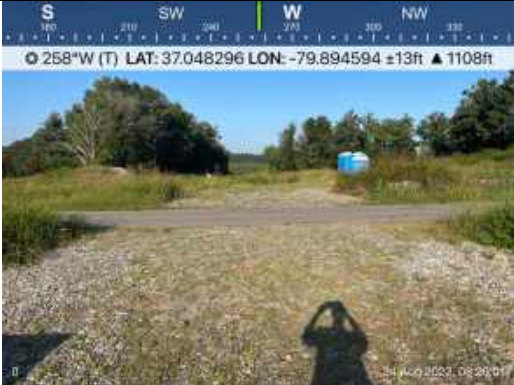
GPS Location		See photo		GPS Location	
Field Station#		13958+31		Field Station#	
Pic 1 Desc.		RCEs are in good condition at all road crossings		Pic 2 Desc.	
				CWDs are functioning as intended

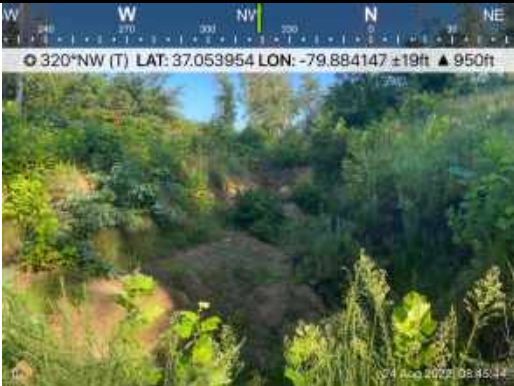
GPS Location		See photo		GPS Location	
Field Station#		14000+00		Field Station#	
Pic 5 Desc.		No evidence of 3rd party pond discharging onto ROW		Pic 6 Desc.	
				CFS is in good condition throughout this section

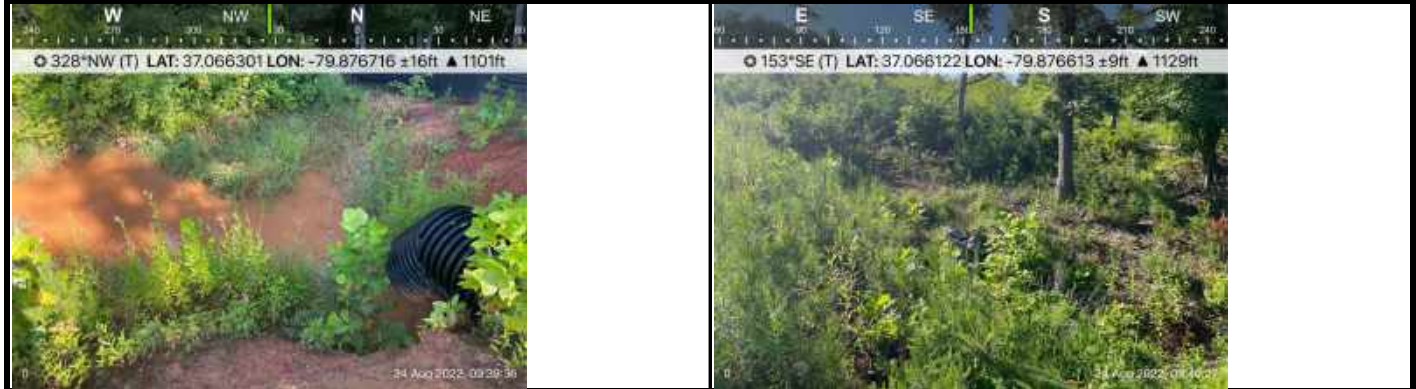
Pic 13 Desc.	Slope drain is in good condition and functioning	Pic 14 Desc.	Rock check dams are functioning as intended
---------------------	--	---------------------	---

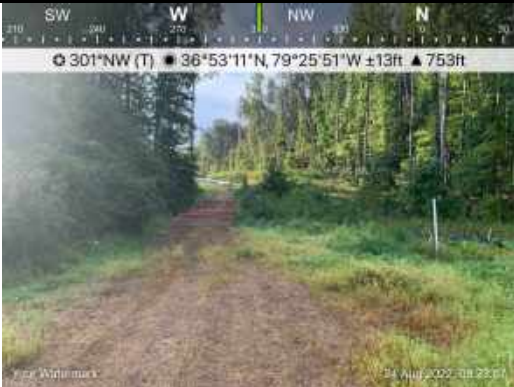
GPS Location	O	GPS Location	O		
Field Station#	15658+43	Field Station#	15665+50		
Pic 1 Desc.	Observing temporary stabilization,buffer, equipment crossing and ECD's	Pic 2 Desc.	Observing temporary stabilization,buffer, equipment crossing and ECD's

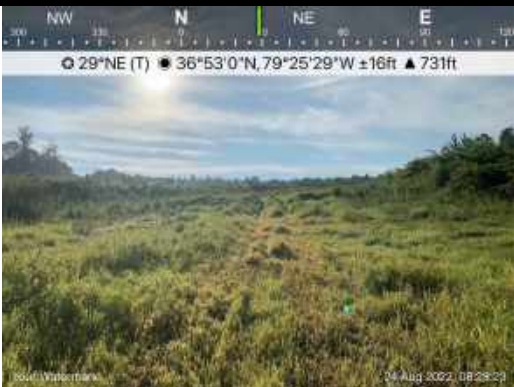
GPS Location	O	GPS Location	O		
Field Station#	15680+00	Field Station#	15693+89		
Pic 3 Desc.	Observing temporary stabilization CWD berm and water bars	Pic 4 Desc.	Observing road crossing and RCE's

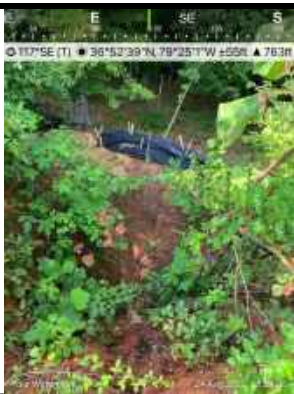
GPS Location	O	GPS Location	O		
Field Station#	15710+00	Field Station#	15735+00		
Pic 5 Desc.	Observing temporary stabilization, sump and end treatment	Pic 6 Desc.	Observing temporary stabilization, CWD outlet and ECD's

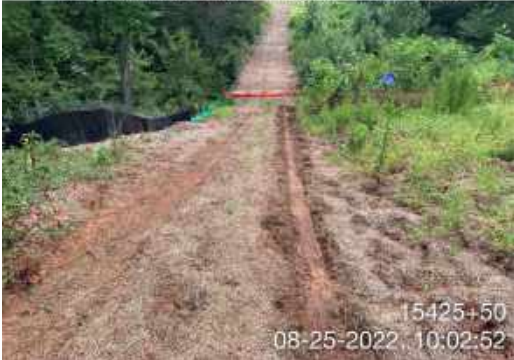
- The EI performed a SWPPP inspection from 15370+62 to 15480+67 (Snowberry Road to Toshes Road). One punch list item was submitted which consisted of a location where temporary stabilization was damaged by a third party. Other inspected ECDs were observed as being in compliance at the time of inspection.

GPS Location	0	GPS Location	0
Field Station#	15425+50	Field Station#	15384+74
Pic 1 Desc.	Temporary vegetative stabilization damaged by third party from 15425+50 to 15426+00	Pic 2 Desc.	Equipment bridge in acceptable condition

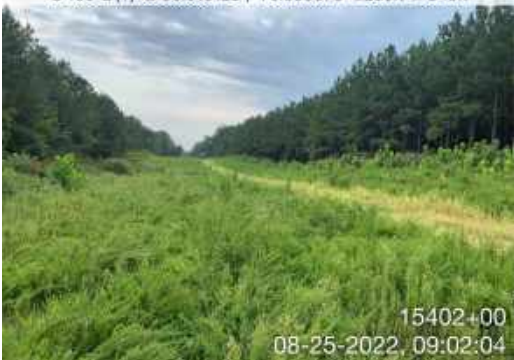
GPS Location	0	GPS Location	0
Field Station#	15402+00	Field Station#	15404+00
Pic 3 Desc.	Temporary vegetative stabilization in acceptable condition	Pic 4 Desc.	Clean water diversion pipe in acceptable condition

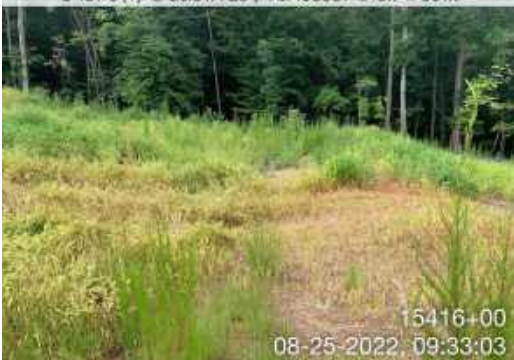
GPS Location	0	GPS Location	0
Field Station#	15416+00	Field Station#	15416+00
Pic 5 Desc.	Waterbar in acceptable condition	Pic 6 Desc.	Waterbar end treatment in acceptable condition

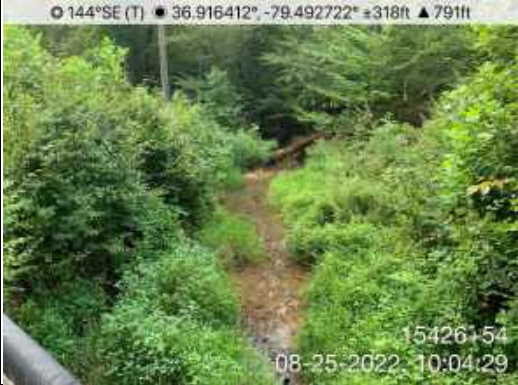
- The EI did not observe that the contractor has worked in the area since the last SWPPP inspection.
- The EI observed that stream S-G4 (15426+54) was running clear. This stream has been impacted in the past by upstream activities not related to MVP.

GPS Location	0		GPS Location	0	
Field Station#	15426+54		Field Station#	15427+00	
Pic 7 Desc.	Stream S-G4 is running clear		Pic 8 Desc.	P1 silt fence and sensitive resource buffer in acceptable conditions

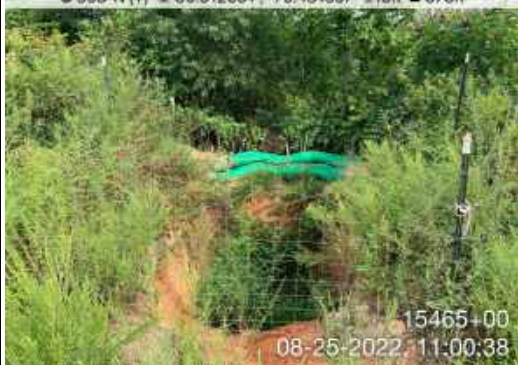
GPS Location	0		GPS Location	0	
Field Station#	15465+00		Field Station#	15472+00	
Pic 9 Desc.	Sump pit in acceptable condition		Pic 10 Desc.	Solar farm perimeter ECDs appear to be in acceptable conditions	
Insert image here			Insert image here		
GPS Location			GPS Location		
Field Station#			Field Station#		
Pic 11 Desc.			Pic 12 Desc.

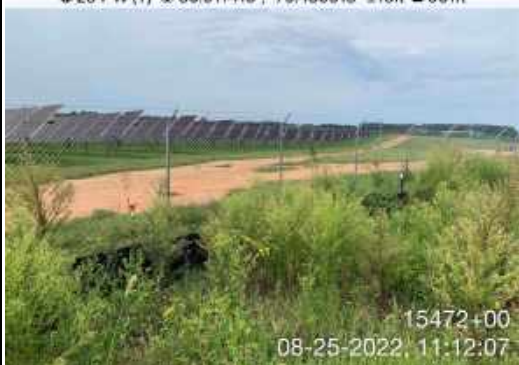
- The EI observed that the solar farm perimeter ECDs on the CIS of Toshes Road appeared to be in acceptable condition.
- Since the last SWPPP inspection the inspection area has received two rain events with a total of 0.90" at Snowberry Road.

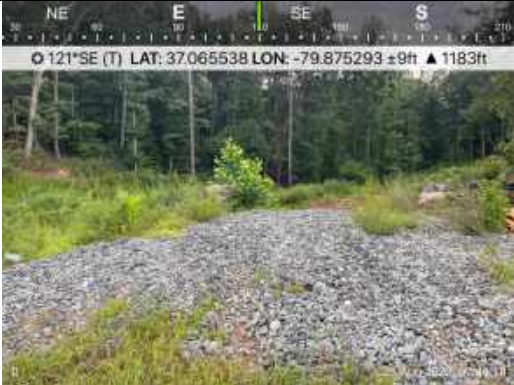
GPS Location	See photo	GPS Location	See photo
Field Station#	14062+17	Field Station#	14066+77
Pic 1 Desc.	RCEs are in good condition at all road crossings	Pic 2 Desc.	Equipment bridge ECDs are functioning as intended

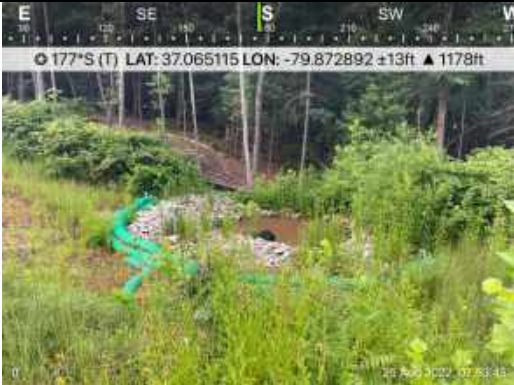
GPS Location	See photo	GPS Location	See photo
Field Station#	14070+00	Field Station#	14085+00
Pic 3 Desc.	CWDs are functioning as intended	Pic 4 Desc.	Topsoil berms remain stabilized

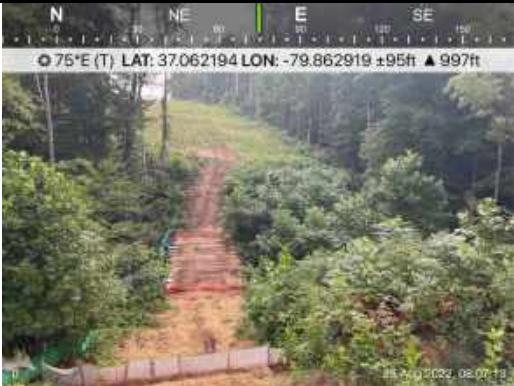
GPS Location	See photo	GPS Location	See photo
Field Station#	14105+20	Field Station#	14110+00
Pic 5 Desc.	Resource buffers remain well vegetated	Pic 6 Desc.	Waterbars are in good condition

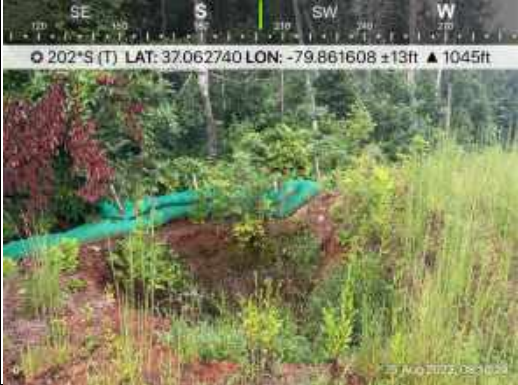
GPS Location	See photo		GPS Location	See photo	
Field Station#	14110+00		Field Station#	14120+00	
Pic 7 Desc.	End treatments are functioning as intended		Pic 8 Desc.	CFS is in good condition throughout this section

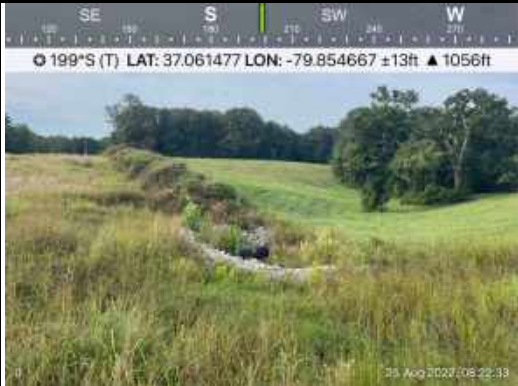
GPS Location	See photo		GPS Location	See photo	
Field Station#	14132+00		Field Station#	14141+00	
Pic 9 Desc.	CWD is functioning as intended		Pic 10 Desc.	P1 is in good condition at all stream and wetland buffers.

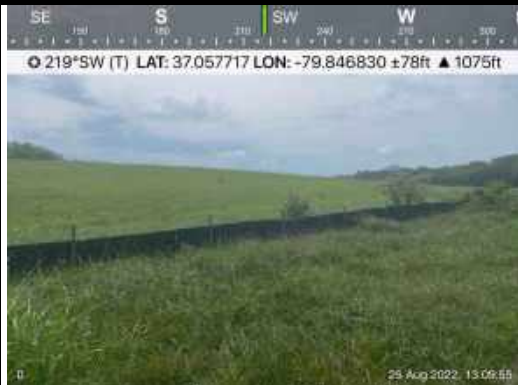
Insert image here			
GPS Location	See photo		GPS Location		
Field Station#	14171+36		Field Station#		
Pic 11 Desc.	SSF is in good condition		Pic 12 Desc.

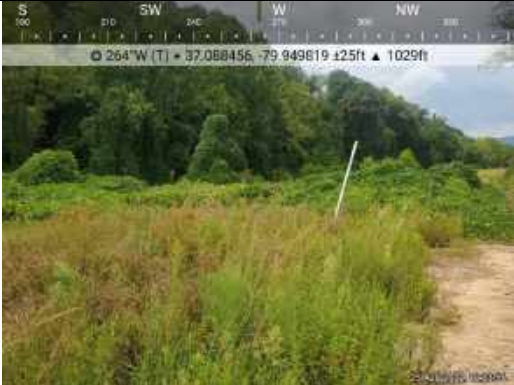
GPS Location	0	GPS Location	0		
Field Station#	13679+50	Field Station#	13690+80		
Pic 1 Desc.	GAS S-E29 Vegetation	Pic 2 Desc.	CIS Grassy Hill Rd Perimeter Silt fence

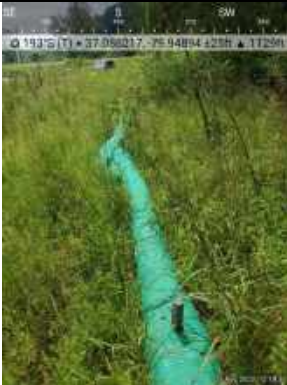
GPS Location	0	GPS Location	0		
Field Station#	13690+00	Field Station#	13692+70		
Pic 3 Desc.	CIS Grassy Hill Rd Perimeter CFS	Pic 4 Desc.	S-E28 Channel and banks

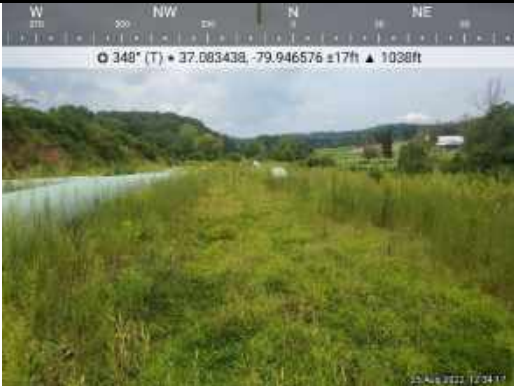
GPS Location	0	GPS Location	0		
Field Station#	13700+00	Field Station#	13693+00		
Pic 5 Desc.	Travel lane vegetation	Pic 6 Desc.	Perimeter silt fence

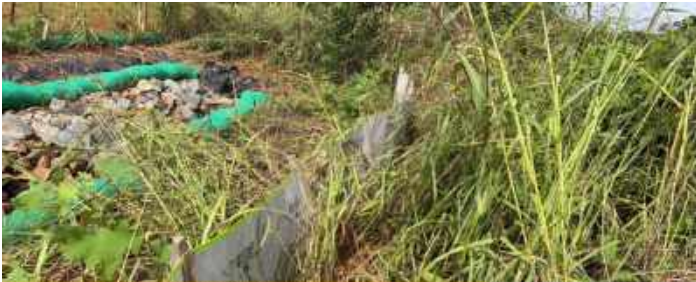
<small>37°02' N 79°44'40" W 1" N COURSE 79° GPS 08.25.2022 10:29:33 Glade Hill, VA 24092, United States Accur +/-15.5 Ft ALT 873 Ft</small>			<small>37°10' N 79°45'2" W 257"W COURSE -1° GPS 08.25.2022 10:18:46 Accur +/-15.1 Ft ALT 922 Ft</small>		
GPS Location	1		GPS Location	2	
Field Station#	14575+00		Field Station#	14556+00	
Pic 1 Desc.	Routine maintenance. Replace damaged panels of P1 silt fence from cattle damage.		Pic 2 Desc.	Erosion control blanket and CFS in place and functional on perimeter.

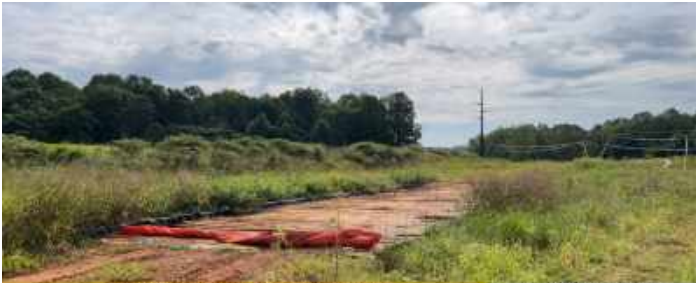
Pic 3 Desc.	Equipment bridge over natural drainage area performing intended function.		Pic 4 Desc.	Equipment bridge and surrounding ECDs in place and functional at stream crossing and resource buffer; signage visible and intact.

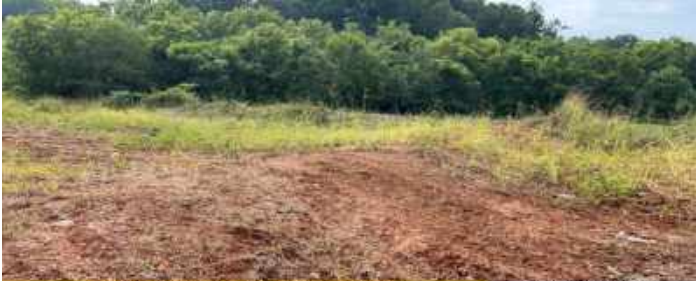
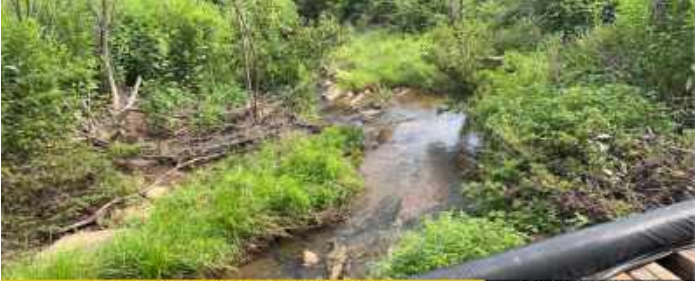
<small>37°02' N 79°44'37" W 145°SE COURSE 136° GPS 08.25.2022 10:31:13 Glade Hill, VA 24092, United States Accur +/-11.8 Ft ALT 866 Ft</small>			<small>37°01' N 79°44'34" W 144°SE COURSE 86° GPS 08.25.2022 10:32:54 Glade Hill, VA 24092, United States Accur +/-15.5 Ft ALT 850 Ft</small>		
GPS Location	5		GPS Location	6	
Field Station#	14570+00		Field Station#	14582+85	
Pic 5 Desc.	Water bar performing intended function.		Pic 6 Desc.	Downstream view of S-E17 at ROW crossing.

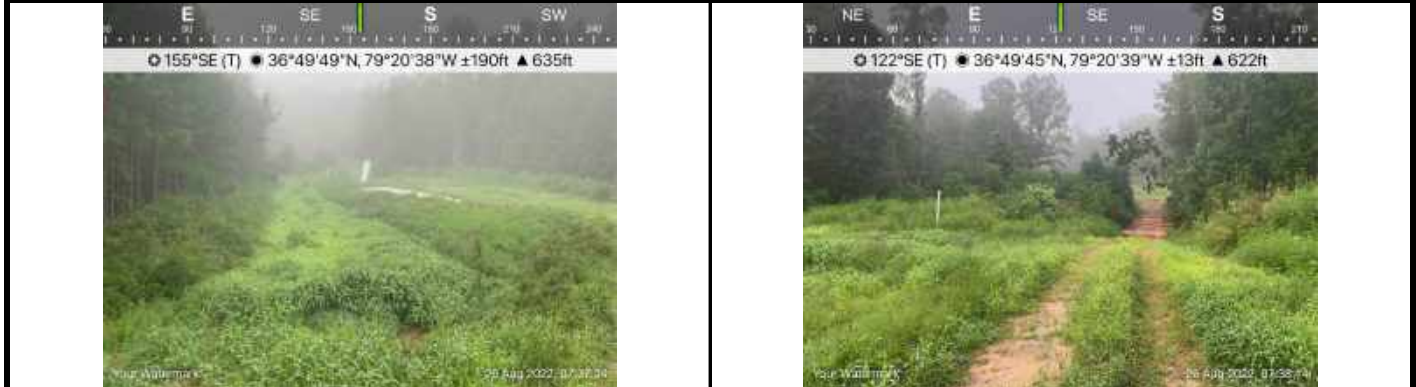
Field Station#	6+00	Field Station#	12+65
-----------------------	------	-----------------------	-------

Pic 1 Desc.	Observing temporary stabilization	Pic 2 Desc.	Observing temporary stabilization,buffer, equipment crossing and ECD's
--------------------	-----------------------------------	--------------------	--

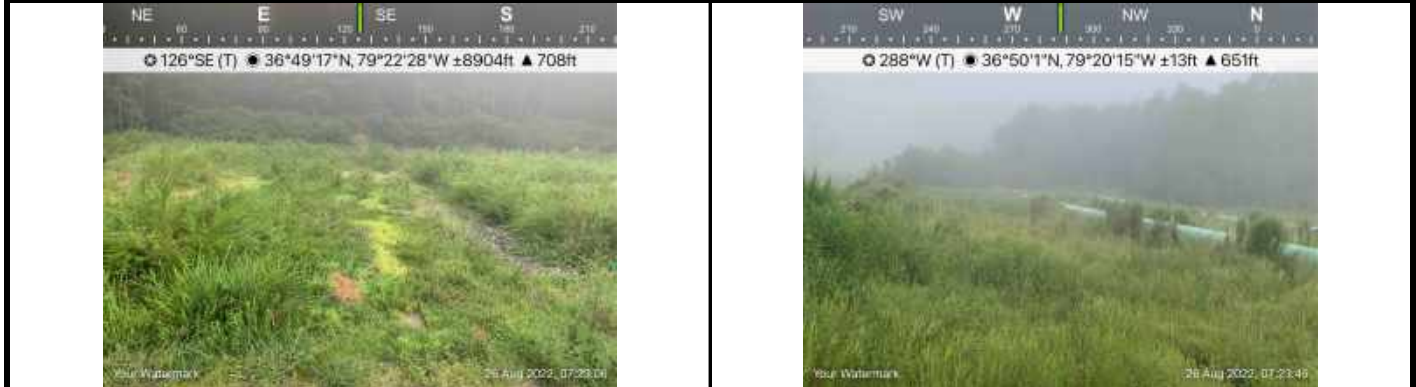
Field Station# 14+00	Field Station# 22+00
-----------------------------	-----------------------------

Pic 1 Desc. Observing temporary stabilization and RCE	Pic 2 Desc. Observing temporary stabilization and buffer
--	---

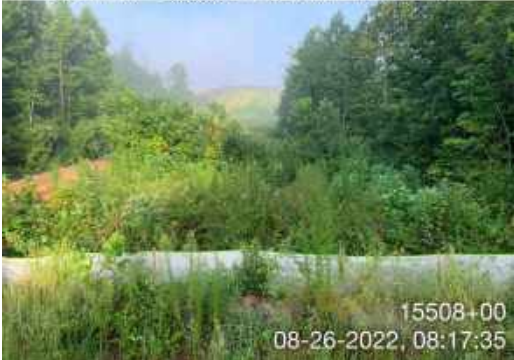
GPS Location		0		GPS Location	
Field Station#		15508+00		Field Station#	
Pic 1 Desc.		P1 silt fence and sensitive resource buffer in acceptable conditions		Pic 2 Desc.

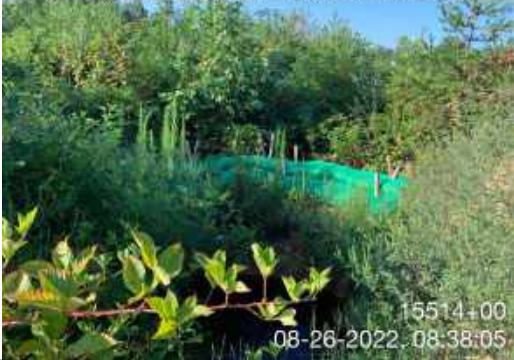
GPS Location		0		GPS Location	
Field Station#		15514+00		Field Station#	
Pic 3 Desc.		Waterbar end treatment in acceptable condition		Pic 4 Desc.

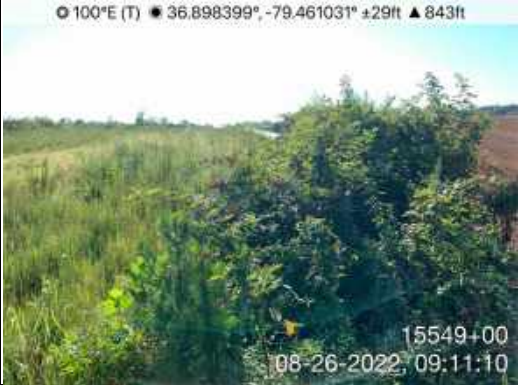
GPS Location	0	GPS Location	0
Field Station#	15549+00	Field Station#	15548+00
Pic 7 Desc.	Clean water diversion berm and temporary vegetative stabilization in acceptable conditions	Pic 8 Desc.	A field that recently had stumps and rocks cleared upslope from streams S-CC5, S-CC9 and S-CC10

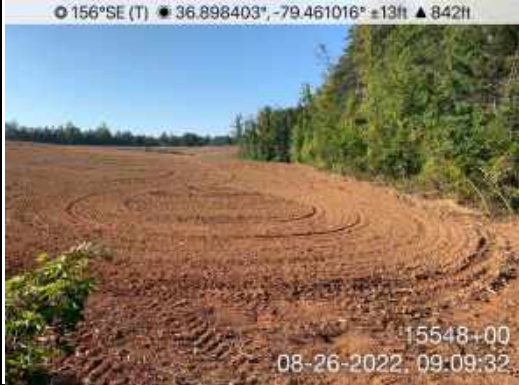
- The EI observed that a land clearing operation has continued from approximate 15548+00 to 15560+00 on the south side of the ROW on the CIS of Anderson Mill Road 1. No perimeter ECDs were observed by the EI and no impacts were observed to streams S-CC5, S-CC9 or S-CC10.
