Visual Site Inspection Report

Project Name H-602 Pipeline Spread I		AFE 124300139	Spread H-602 Pipeline Spread I
Contractor Precision		Report # 41263	
Inspector John White		Date/Time 8/22/2022 10:18 AM	
Permit # TBD	Inspection Type VA SWPP	Station Begin	00+00
State VA	Inspection Area Full	Station End	19+25
County Pittsylvania	Ground Wet	Temperature (°F)	74.00
Municipality Chatham	Weather Cloudy	Rain Gauge (in)	0.60
			Rain Accumulation Time (days) 6.00

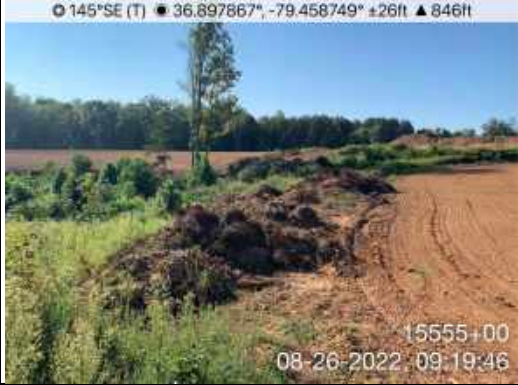
- The EI observed that a land clearing operation has continued from approximate 15548+00 to 15560+00 on the south side of the ROW on the CIS of Anderson Mill Road 1. No perimeter ECDs were observed by the EI and no impacts were observed to streams S-CC5, S-CC9 or S-CC10.

GPS Location	0	GPS Location	0
Field Station#	15555+00	Field Station#	15505+00
Pic 9 Desc.	A field that recently had stumps and rocks cleared upslope from streams S-CC5, S-CC9 and S-CC10	Pic 10 Desc.	Solar farm perimeter ECDs and grading operation on the GAS of Climax Road

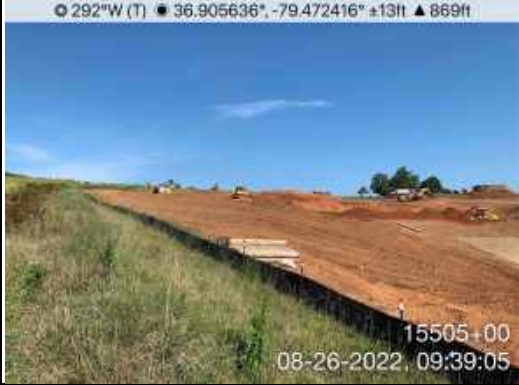
- The EI observed that the solar farm ECDs adjacent to the ROW on GAS of Climax Road appeared to be in acceptable condition and that their super silt fence on the CIS of climax Road was down in multiple locations where the solar farm fencing crew has recently worked. The EI also observed that a grading operation was in progress from approximately 15498+00 to 15506+00 on the north side of the ROW on the GAS of Climax Road.

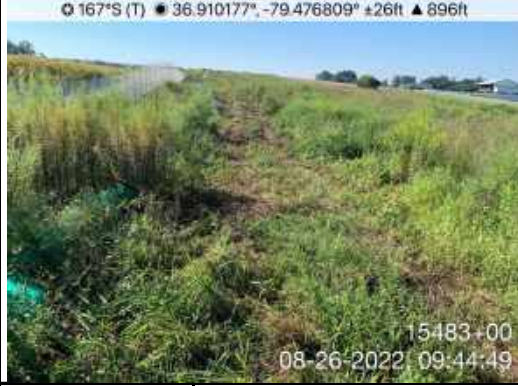
- The EI inspected the MVP ROW at 15483+00 where the solar farm had a dewatering operation draining across MVP ROW yesterday and observed that no sedimentation had occurred.

GPS Location	0	GPS Location	0
Field Station#	15483+00	Field Station#	15573+00
Pic 11 Desc.	No sediment was observed on MVP ROW from yesterday's solar farm dewatering operation	Pic 12 Desc.	Sump pit in acceptable condition

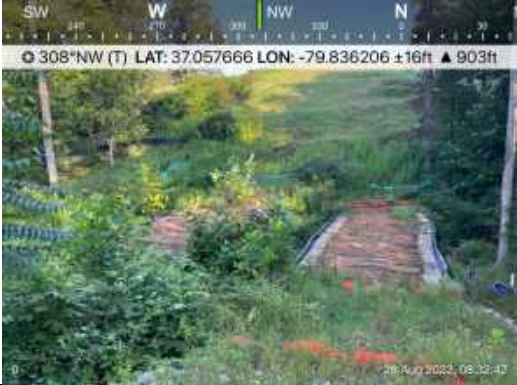
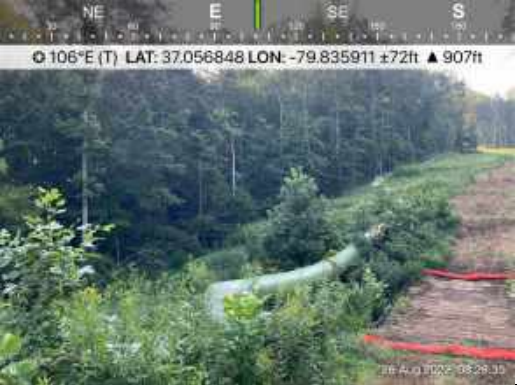
GPS Location	See photo	GPS Location	See photo
Field Station#	14209+00	Field Station#	14213+75
Pic 7 Desc.	Equipment bridge ECDs are functioning as intended	Pic 8 Desc.	Resource buffers remain well vegetated

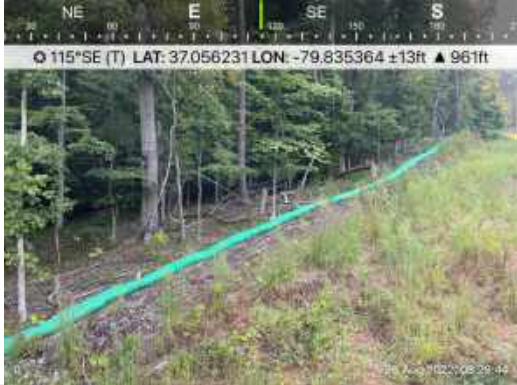
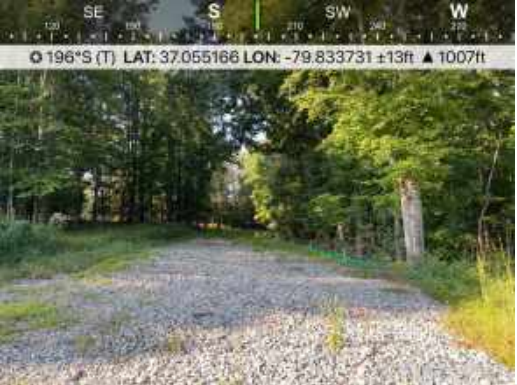
GPS Location	See photo	GPS Location	See photo
Field Station#	14216+00	Field Station#	14223+41
Pic 9 Desc.	CFS is in good condition	Pic 10 Desc.	MVP-FR-311 remains in good condition with controls in place

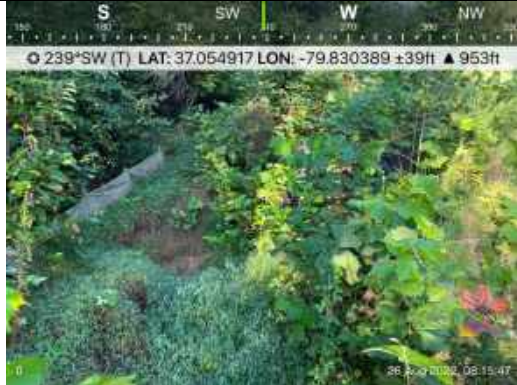
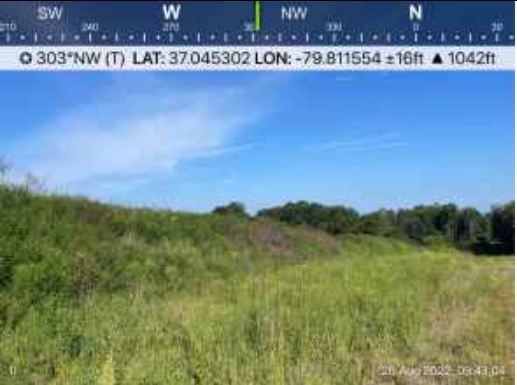
GPS Location	See photo	GPS Location	See photo
Field Station#	14232+00	Field Station#	14300+00
Pic 11 Desc.	Slope drain is functioning as intended	Pic 12 Desc.	Topsoil berms remain stabilized

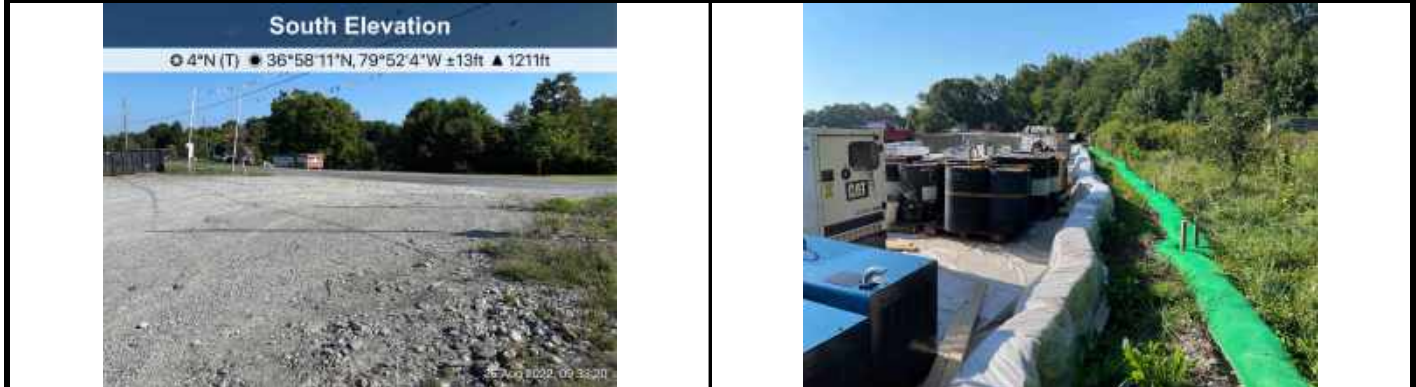
GPS Location	See picture	GPS Location	See picture
Field Station#	0000+00	Field Station#	0000+00
Pic 1 Desc.	RCE at LY-045 in good condition.	Pic 2 Desc.	Secondary containment structure and perimeter ECD's on north end of LY-045 in good condition.

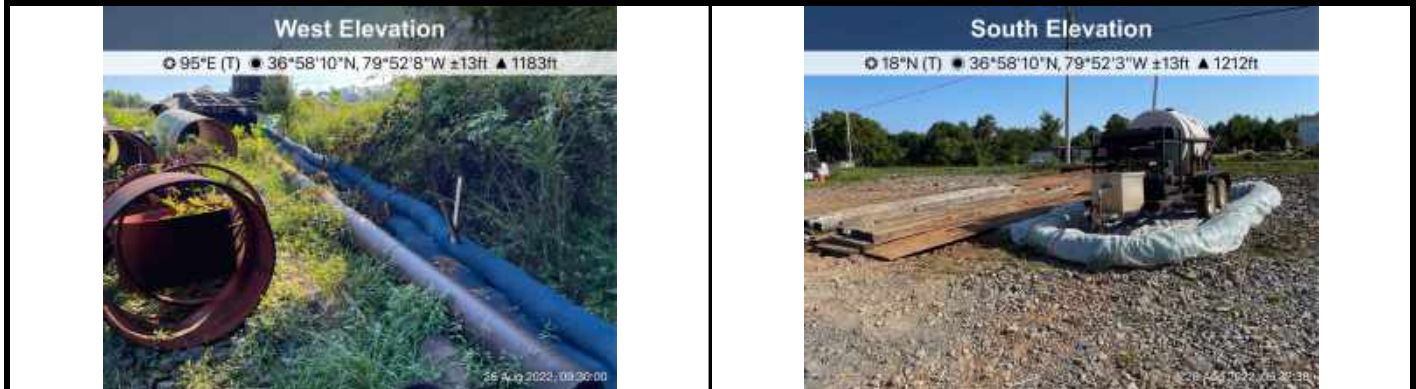
GPS Location	See picture	GPS Location	See picture
Field Station#	0000+00	Field Station#	0000+00
Pic 3 Desc.	Perimeter ECD's on west side of LY-045 in good condition.	Pic 4 Desc.	Secondary containment structure for pressure washer at LY-045 in good condition.

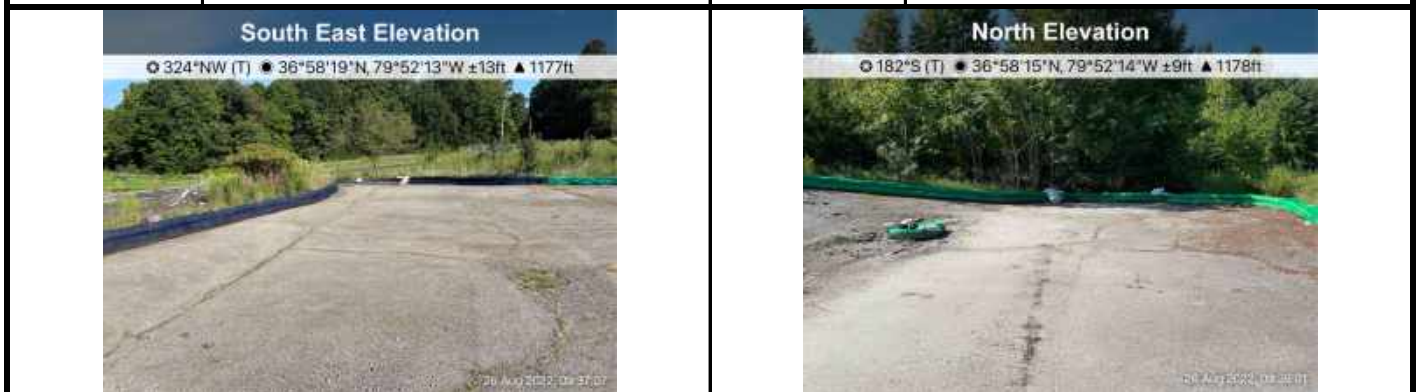
GPS Location	See picture	GPS Location	See picture
Field Station#	0000+00	Field Station#	0000+00
Pic 5 Desc.	Perimeter ECD's on northwest corner of LY-046 in good condition.	Pic 6 Desc.	Perimeter ECD's and inlet protection for catch basin on southwest corner of LY-046 in good condition.

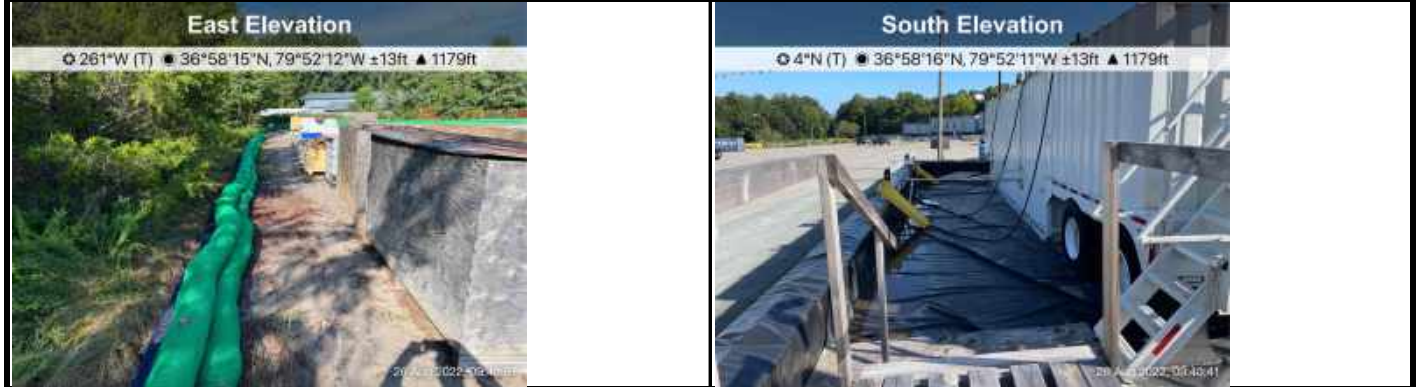
Field Station#	00000+00	Field Station#	0000+00
-----------------------	----------	-----------------------	---------

Pic 7 Desc.	Perimeter ECD's on south end of LY-046 in good condition.	Pic 8 Desc.	Secondary containment structure for fuel cell at LY-046 in good condition.
--------------------	---	--------------------	--

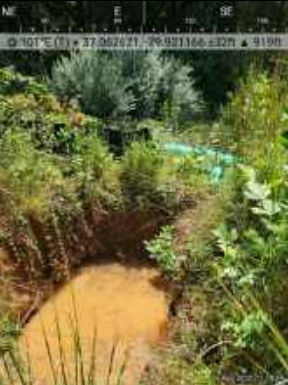
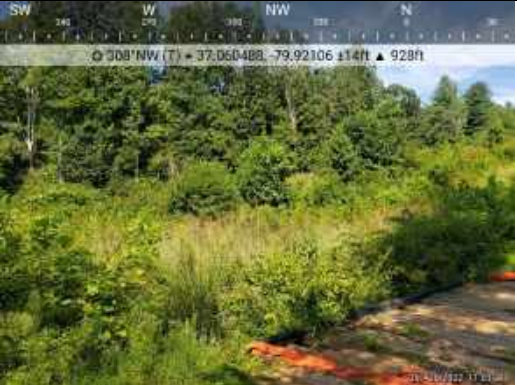
GPS Location 0		GPS Location 0			
Field Station# 13830+00		Field Station# 13847+00			
Pic 1 Desc. Sump and J-hook		Pic 2 Desc. S-C16 Buffer zones

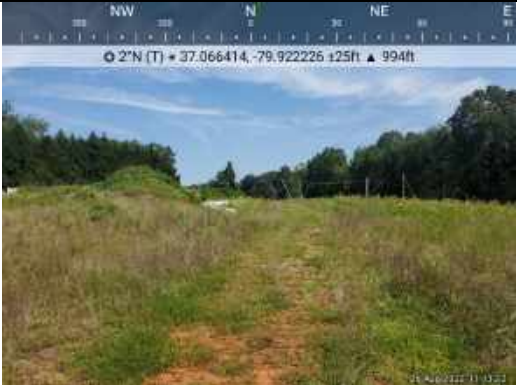
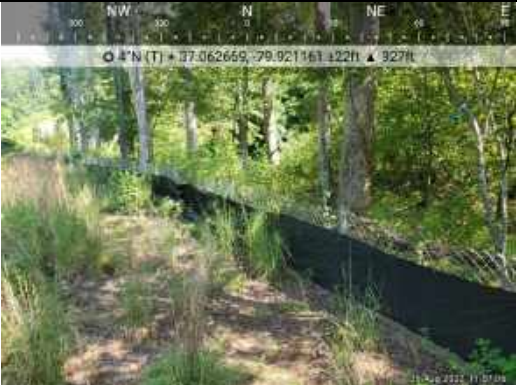
GPS Location 0		GPS Location 0			
Field Station# 13824+00		Field Station# 13839+00			
Pic 3 Desc. Temporary vegetation		Pic 4 Desc. Perimeter Super silt fence

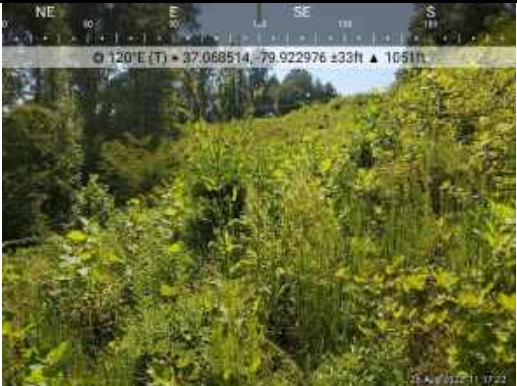
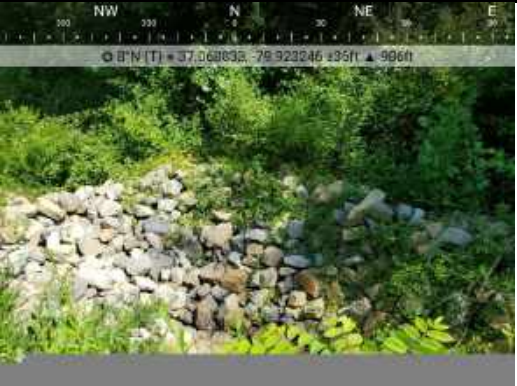
GPS Location 0		GPS Location 0			
Field Station# 13818+00		Field Station# 13815+00			
Pic 5 Desc. Sideslope vegetation		Pic 6 Desc. Plunge pool

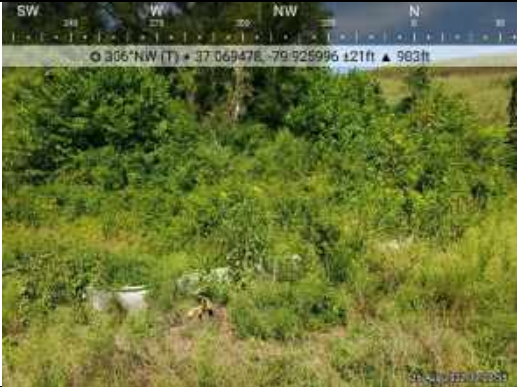
GPS Location	0	GPS Location	0		
Field Station#	13811+75	Field Station#	13806+50		
Pic 7 Desc.	CIS Brick Church Rd CFS	Pic 8 Desc.	GAS S-D20 Buffer zone and silt fence

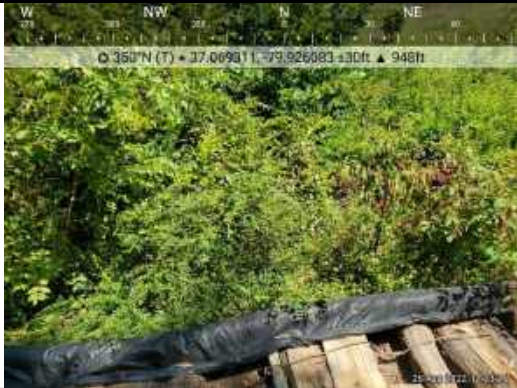
Insert image here			
GPS Location	0	GPS Location			
Field Station#	13805+70	Field Station#			
Pic 9 Desc.	S-D20 Channel and banks	Pic 10 Desc.			
Insert image here			Insert image here		
GPS Location		GPS Location			
Field Station#		Field Station#			
Pic 11 Desc.		Pic 12 Desc.

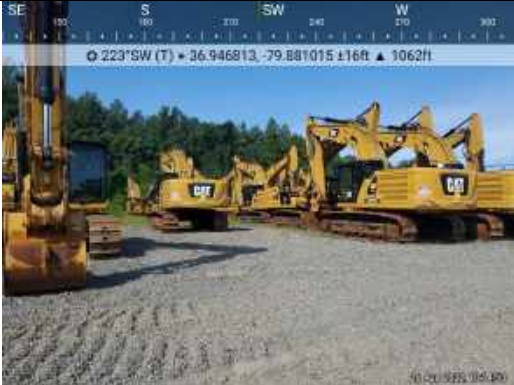
GPS Location	0	GPS Location	0		
Field Station#	0+00	Field Station#	0+00		
Pic 1 Desc.	LY-032 Staging area	Pic 2 Desc.	ANC-006 Stormwater drain inlet protection

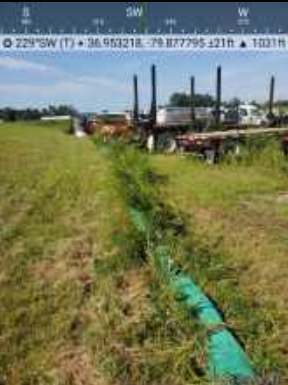
GPS Location	0	GPS Location	0		
Field Station#	0+00	Field Station#	0+00		
Pic 3 Desc.	ANC-006 Perimeter CFS	Pic 4 Desc.	LY-032 Secondary containment

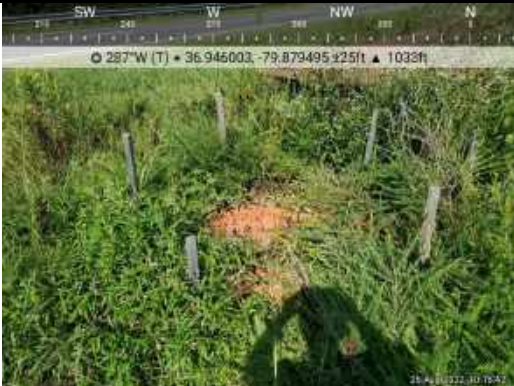
GPS Location	0	GPS Location	0		
Field Station#	0+00	Field Station#	0+00		
Pic 5 Desc.	LY-033 Stormwater drain inlet protection	Pic 6 Desc.	LY-033 Secondary containment

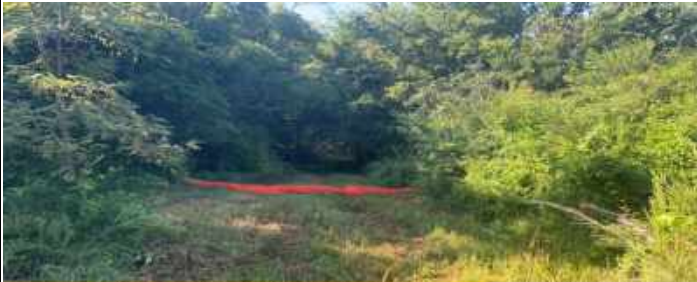
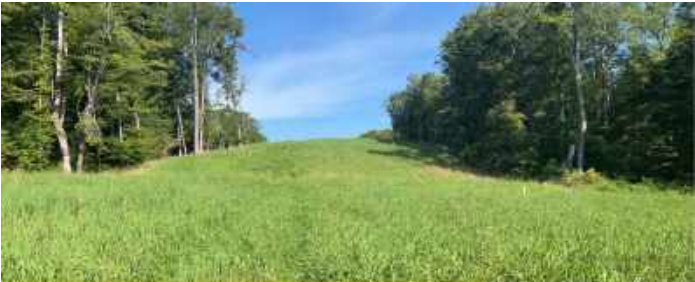
<small>36°59'16" N 79°42'37" W 215°SW COURSE 0° GPS 08.26.2022 09:41:23 Sorry no results found Accur +/-13.5 Ft ALT 0 Ft</small>			<small>36°59'22" N 79°43'27" W 55°NE COURSE -1° GPS 08.26.2022 10:01:07 Union Hall, VA 24176, United States Accur +/-14.1 Ft ALT 944 Ft</small>		
GPS Location	1		GPS Location	2	
Field Station#	14694+50		Field Station#	14651+00	
Pic 1 Desc.	Contractor installed missing perimeter ECD per punch list item.e		Pic 2 Desc.	ROW stabilized and vegetated in final cleanup area.

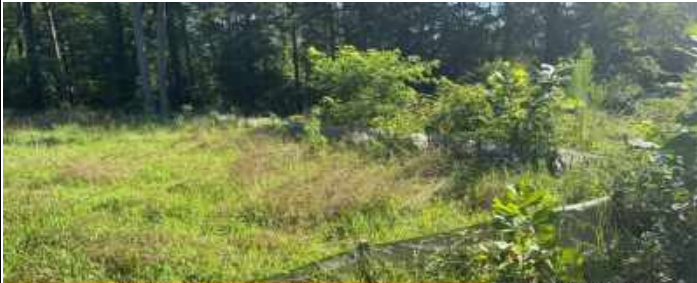
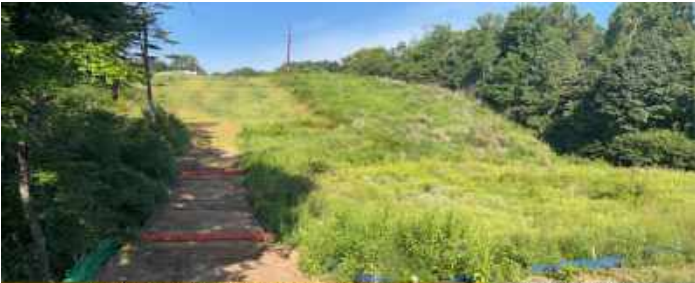
Field Station#	14656+37		Field Station#	14680+29	
Pic 3 Desc.	Perimeter P1 silt fence in resource buffer in good condition.		Pic 4 Desc.	Equipment bridge and surrounding ECDs in place and functional at stream crossing and resource buffer.

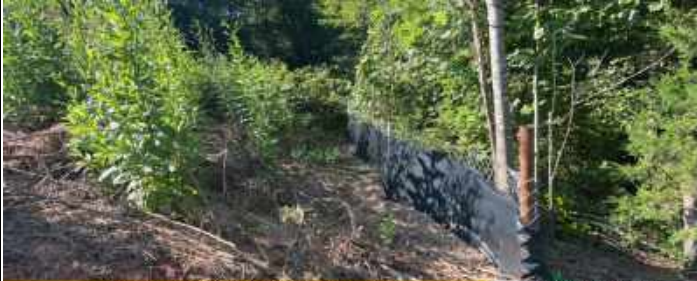
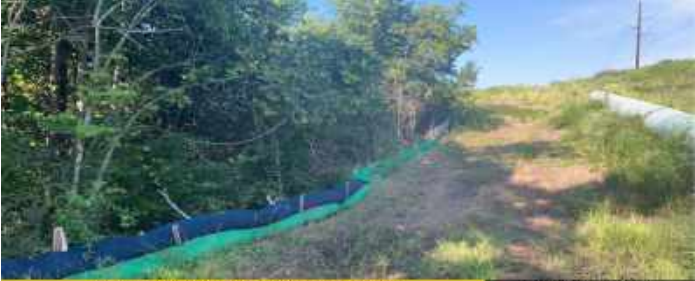
<small>36°59'16" N 79°42'52" W 201°S COURSE -1° GPS 08.26.2022 09:48:45 Sorry no results found Accur +/-15.1 Ft ALT 918 Ft</small>			<small>36°59'16" N 79°42'43" W 275°W COURSE -1° GPS 08.26.2022 09:44:42 Sorry no results found Accur +/-37.7 Ft ALT 953 Ft</small>		
GPS Location	5		GPS Location	6	
Field Station#	14681+25		Field Station#	14688+86	
Pic 5 Desc.	Perimeter SSF in place and functional.		Pic 6 Desc.	Perimeter CFS triple stack in good condition.

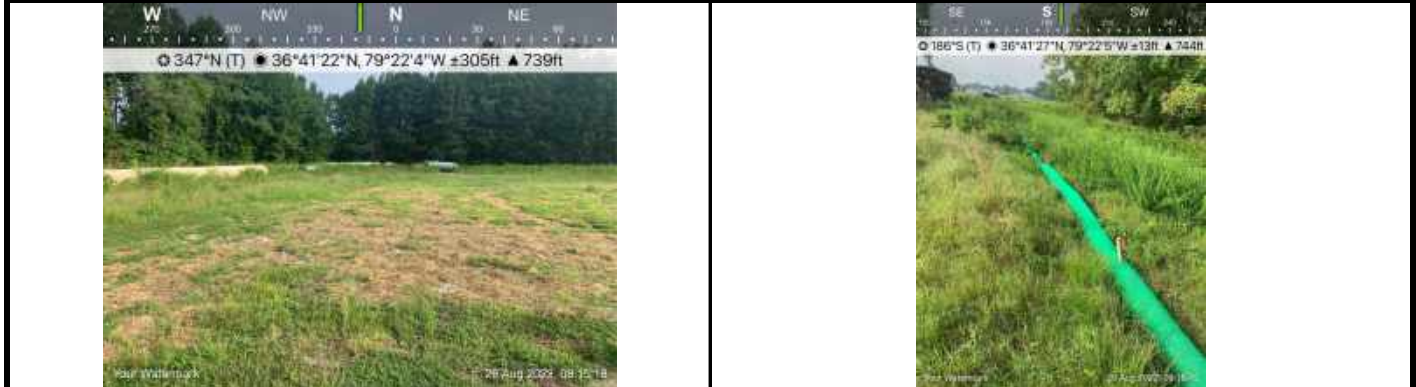
Pic 1 Desc.	Observing temporary stabilization	Pic 2 Desc.	Observing temporary stabilization and ECD's
--------------------	-----------------------------------	--------------------	---

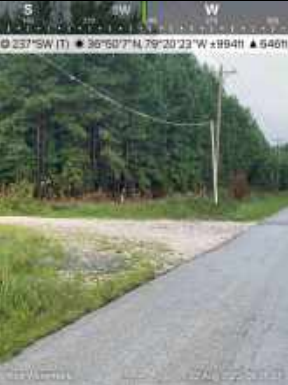
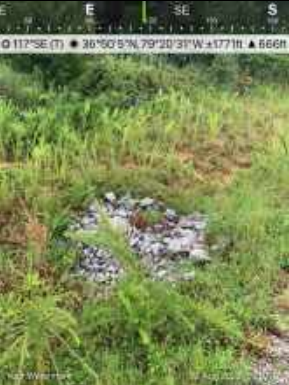
GPS Location	O	GPS Location	O
Field Station#	00+00	Field Station#	00+00
Pic 1 Desc.	Observing RCE	Pic 2 Desc.	Observing temporary stabilization, rock check dam and ECD's

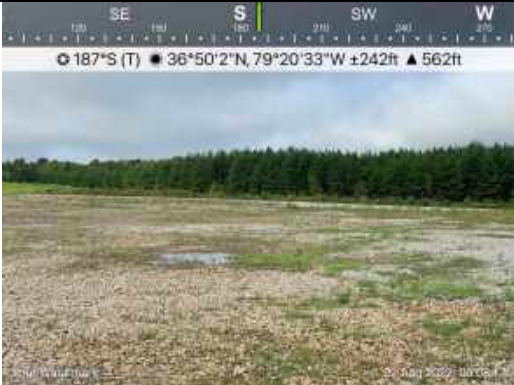
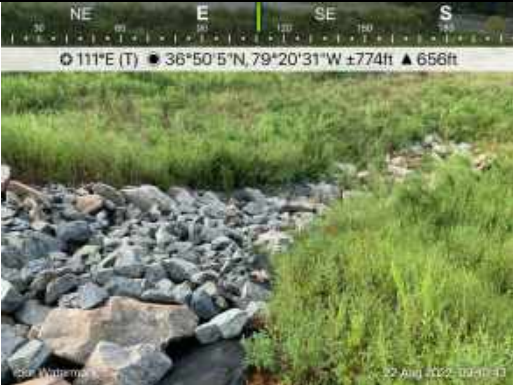
GPS Location	O	GPS Location	O
Field Station#	00+00	Field Station#	00+00
Pic 3 Desc.	Observing lay down yard	Pic 4 Desc.	Observing temporary stabilization, rock drain and CFS check

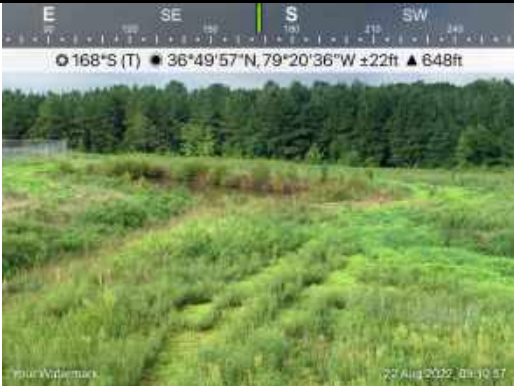
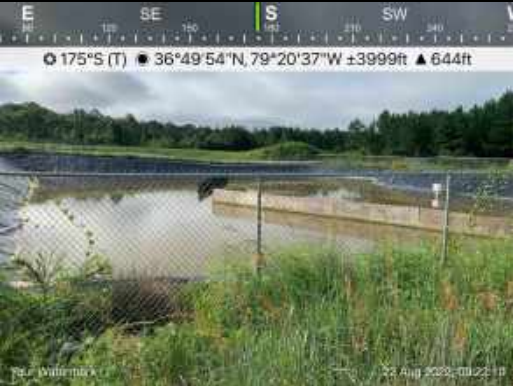
GPS Location	O	GPS Location	O
Field Station#	00+00	Field Station#	00+00
Pic 5 Desc.	Observing temporary stabilization and sediment basin	Pic 6 Desc.	Observing temporary stabilization, storm water pond and ECD's
