Visual Site Inspection Report

Project Name H-600 Pipeline Spread I		AFE 124300139	Spread H-600 Pipeline Spread I
Contractor Precision		Report # 41511	
Inspector Justin Burch		Date/Time 8/29/2022 12:12 PM	
Permit # TBD	Inspection Type VA SWPP	Station Begin	15142+66
State VA	Inspection Area Full	Station End	15260+00
County Pittsylvania	Ground Dry	Temperature (°F)	90.00
Municipality Chatham	Weather Sunny	Rain Gauge (in)	0.00
Rain Accumulation Time (days)			6.00

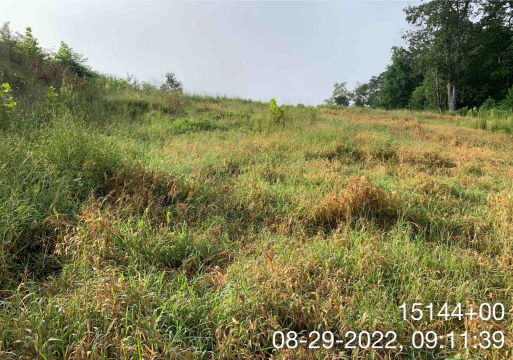
<p>15144+00 08-29-2022 09:11:39</p>	
GPS Location	0	GPS Location	0
Field Station#	15143+00	Field Station#	15144+00
Pic 1 Desc.	Perimeter CFS in acceptable condition	Pic 2 Desc.	Permanent vegetative stabilization in acceptable condition
<p>239°SW (T) 36.945832°, -79.575629° ±13ft ▲ 823ft</p>

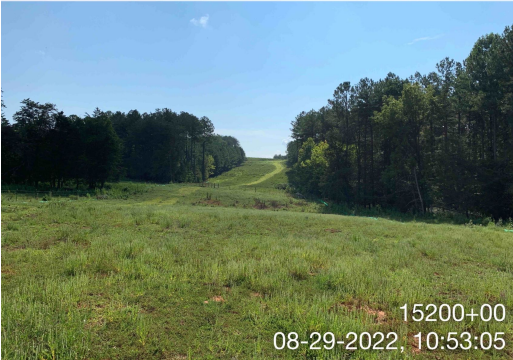
<p>15200+00 08-29-2022 10:53:05</p>	
GPS Location	0	GPS Location	0
Field Station#	15155+00	Field Station#	15200+00
Pic 3 Desc.	Waterbar end treatment in acceptable condition	Pic 4 Desc.	Permanent vegetative stabilization in acceptable condition
<p>220°SW (T) 36.943923°, -79.571599° ±4169ft ▲ 722ft</p>

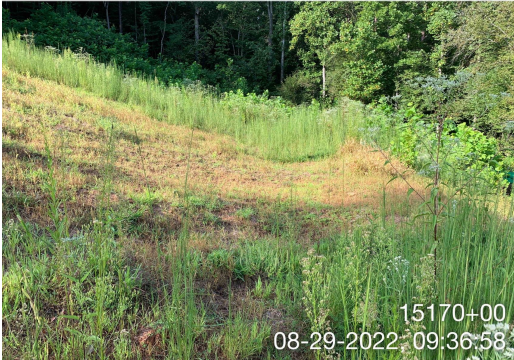
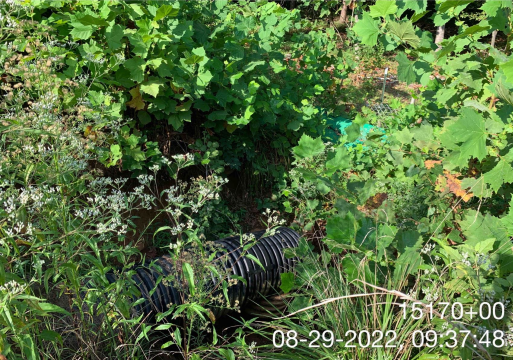
GPS Location	0	GPS Location	0
Field Station#	15170+00	Field Station#	15170+00
Pic 5 Desc.	Waterbar in acceptable condition	Pic 6 Desc.	Sump pit and slope drain pipe in acceptable conditions

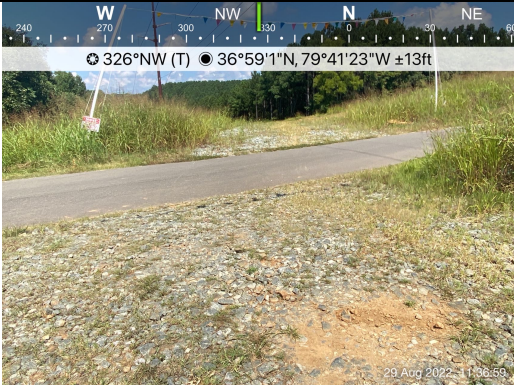
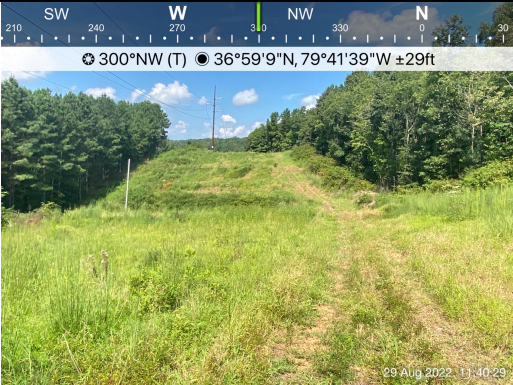
GPS Location	0	GPS Location	0
Field Station#	14758+16	Field Station#	14743+00
Pic 3 Desc.	Approximately 14758+16. Overview of road crossing and RCEs.	Pic 4 Desc.	Approximately 14743+00. Overview of ROW.

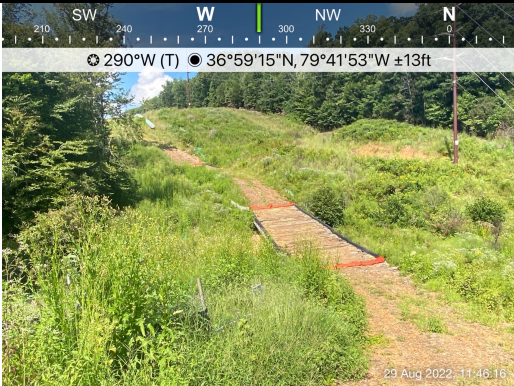
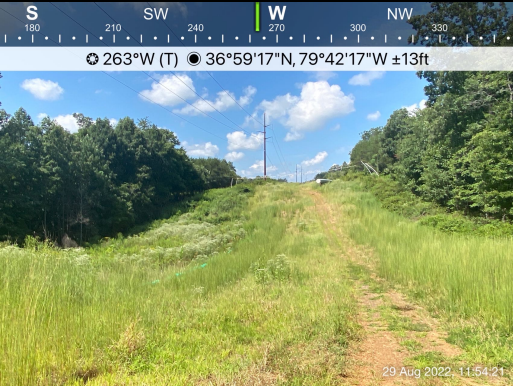
GPS Location	0	GPS Location	0
Field Station#	14729+19	Field Station#	14708+00
Pic 5 Desc.	Approximately 14729+19. Overview of stream crossing, equipment bridge and ECDs at stream S-A20.	Pic 6 Desc.	Approximately 14708+00. Overview of ROW.

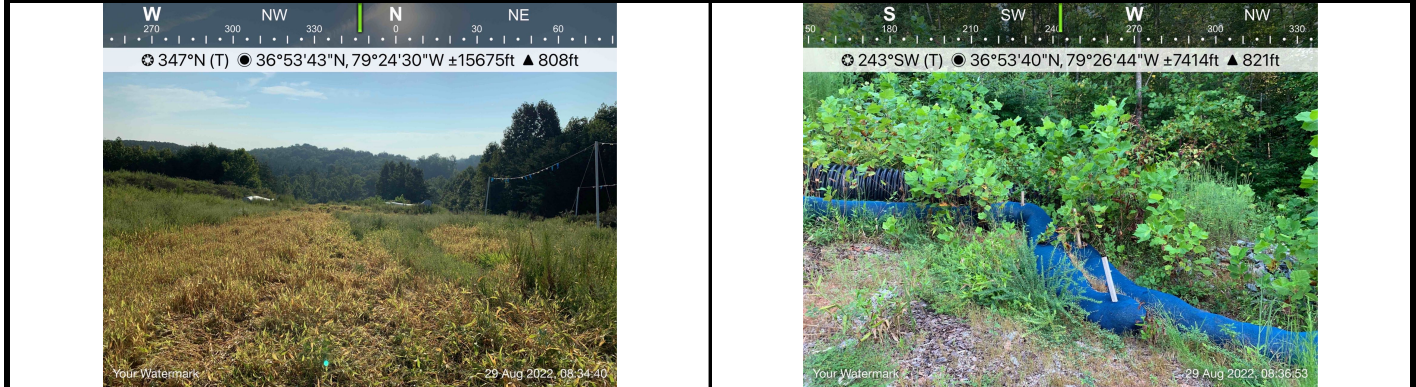
GPS Location	O	GPS Location	O
Field Station#	15590+00	Field Station#	15595+00
Pic 1 Desc.	Observing temporary stabilization	Pic 2 Desc.	Observing temporary stabilization, CWD outlet and ECD's

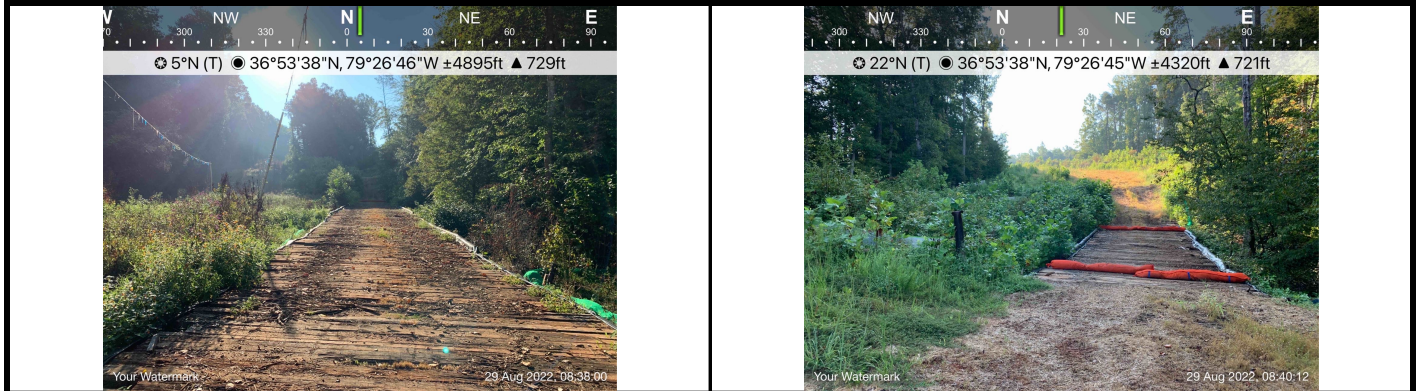
GPS Location	O	GPS Location	O
Field Station#	15595+60	Field Station#	15600+12
Pic 3 Desc.	Observing temporary stabilization, buffer, equipment crossing and ECD's	Pic 4 Desc.	Observing temporary stabilization, buffer, equipment crossing and ECD's

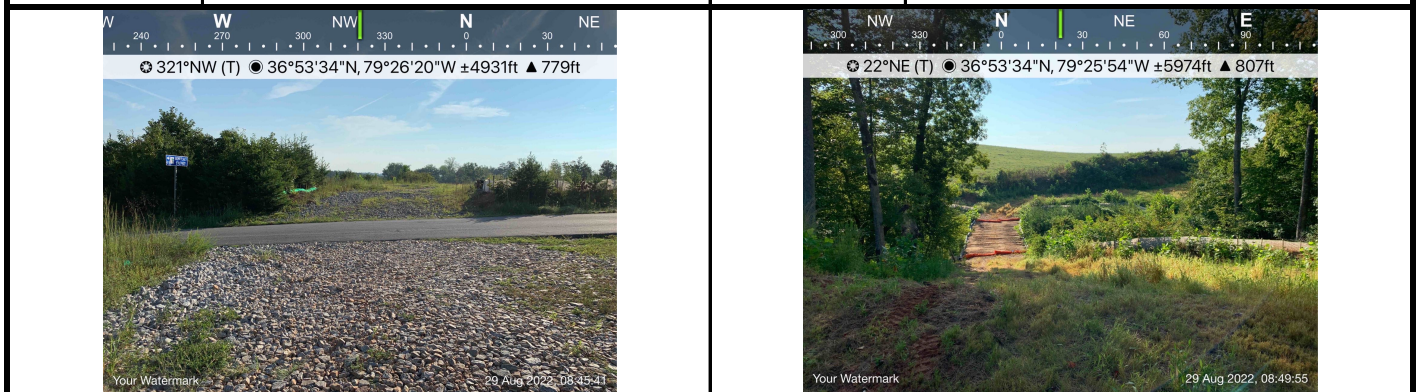
GPS Location	O	GPS Location	O
Field Station#	15619+48	Field Station#	15636+45
Pic 5 Desc.	Observing road crossing and RCE's	Pic 6 Desc.	Observing temporary stabilization, water bar, buffer, equipment crossing and ECD's

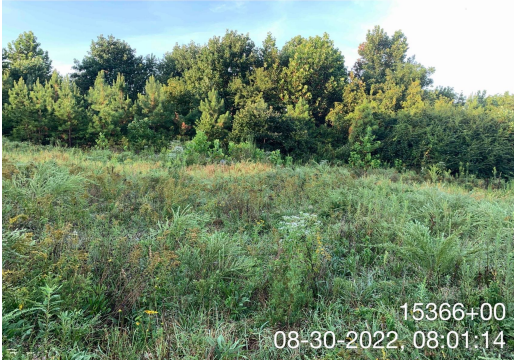
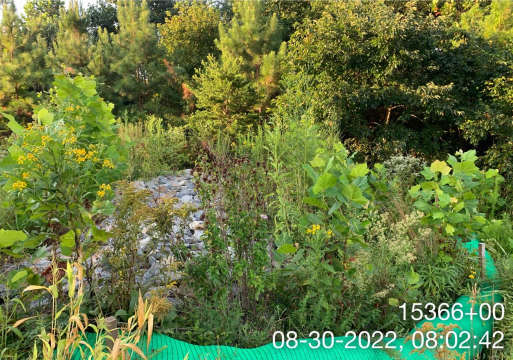
GPS Location		0		GPS Location		0	
Field Station#		15366+00		Field Station#		15366+00	
Pic 1 Desc.		Waterbar in acceptable condition		Pic 2 Desc.		Waterbar end treatment and CFS in acceptable conditions	
☉ 341°N (T) ● 36.909687°, -79.528325° ±22185ft ▲ 750ft

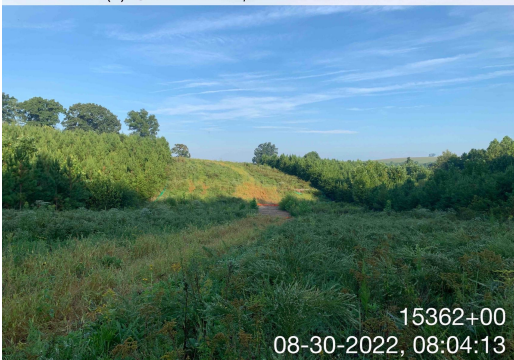
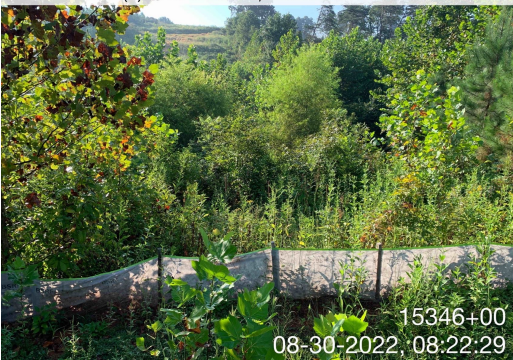
GPS Location		0		GPS Location		0	
Field Station#		15362+00		Field Station#		15346+00	
Pic 3 Desc.		Permanent vegetative stabilization in acceptable condition		Pic 4 Desc.		P1 silt fence and sensitive resource buffer in acceptable conditions	
☉ 225°SW (T) ● 36.926821°, -79.519605° ±16ft ▲ 769ft

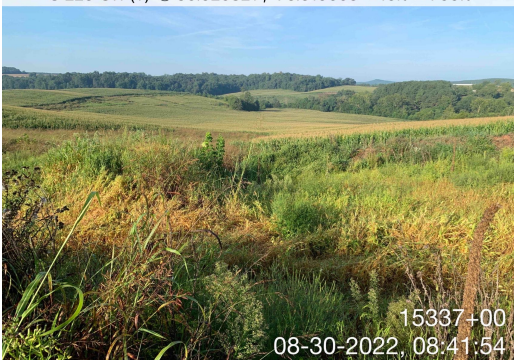
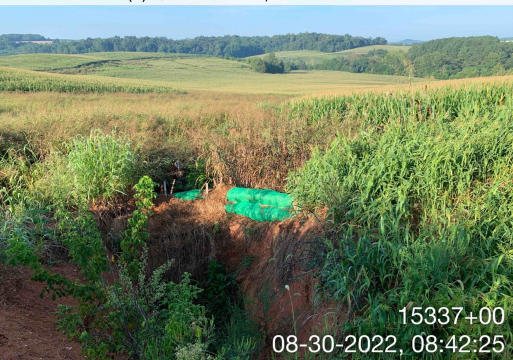
Field Station#		15337+00		Field Station#		15337+00	
Pic 5 Desc.		Waterbar in acceptable condition		Pic 6 Desc.		Waterbar end treatment in acceptable condition

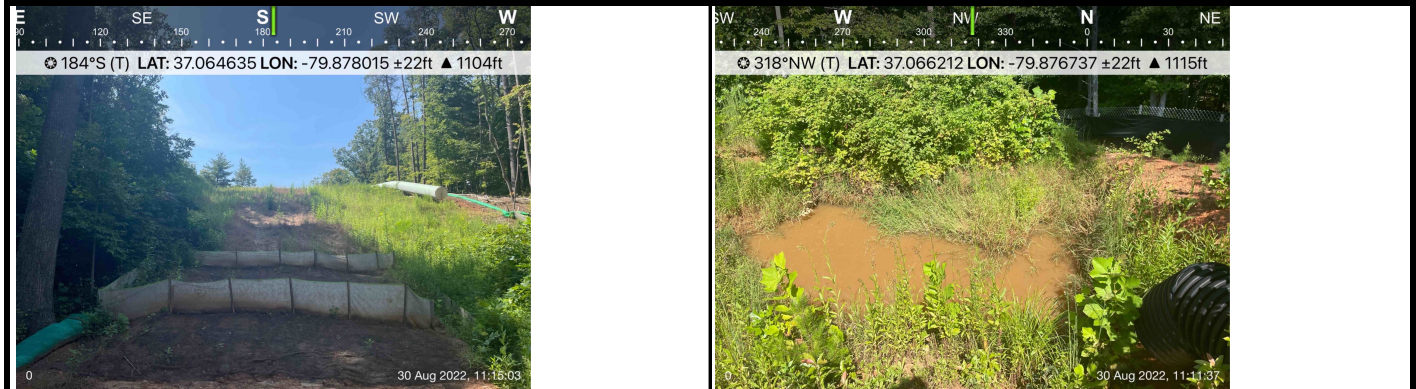
GPS Location	See photo	GPS Location	See photo
Field Station#	14050+00	Field Station#	14057+00
Pic 11 Desc.	Slope remains stabilized with controls in place	Pic 12 Desc.	Slope drain is functioning as intended

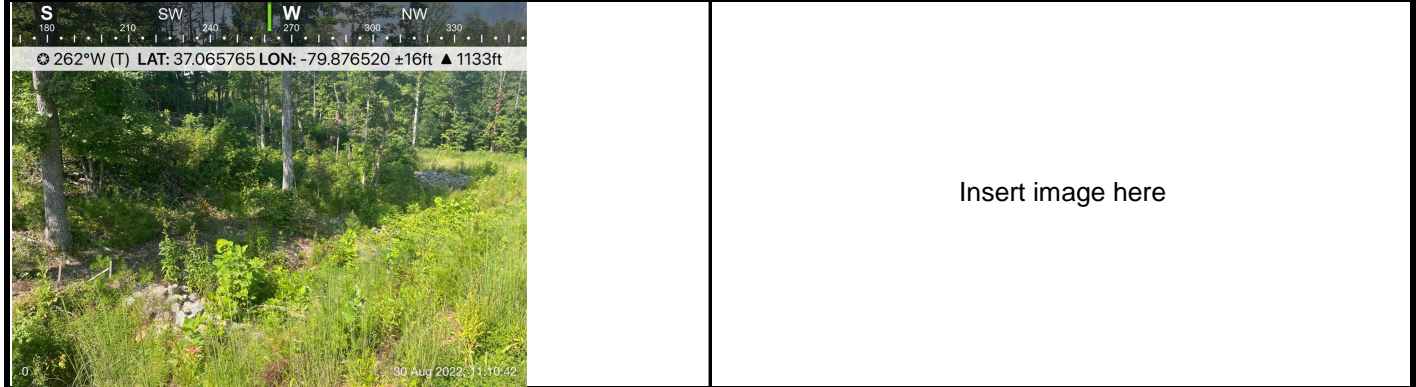
Pic 13 Desc.	Rock check dams are functioning as intended.	Pic 14 Desc.	
---------------------	--	---------------------	--

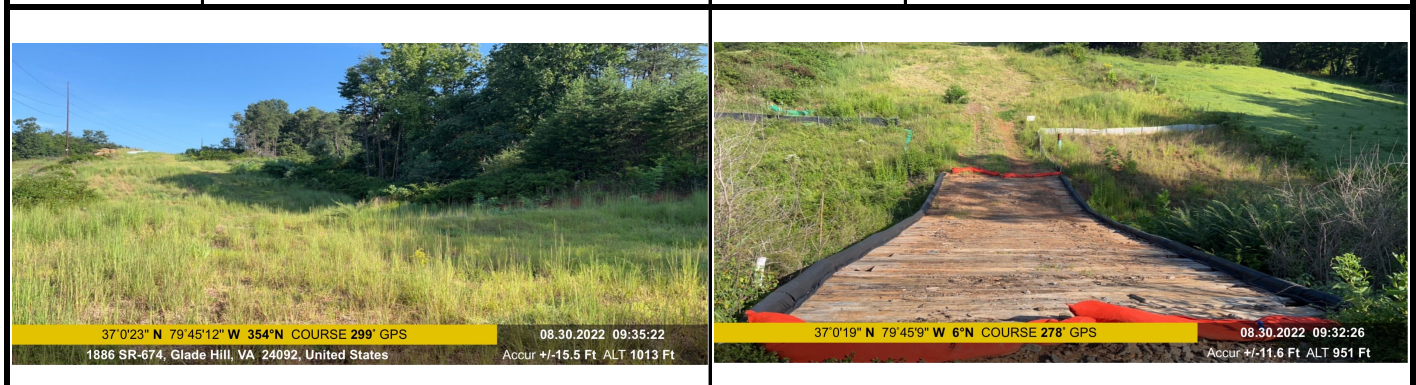
GPS Location	5	GPS Location	6
Field Station#	14542+00	Field Station#	14546+33
Pic 5 Desc.	ROW stabilized and vegetated in temporary area.	Pic 6 Desc.	Equipment bridge and surrounding ECDs in place and functional at stream crossing and resource buffer.

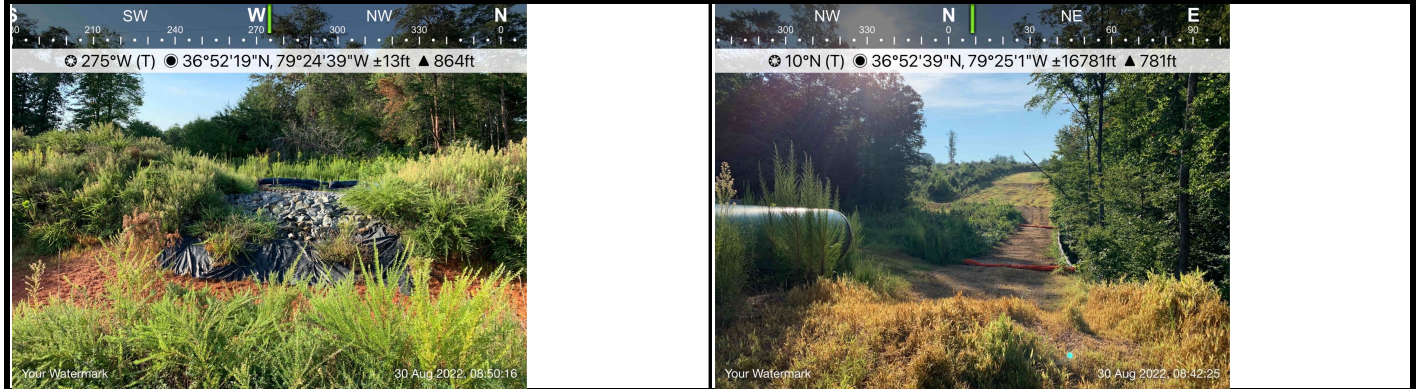
Pic 7 Desc.	Observing temporary stabilization, sump and end treatment	Pic 8 Desc.	Observing temporary stabilization, water bar, buffer, equipment crossing and ECD's
--------------------	---	--------------------	--

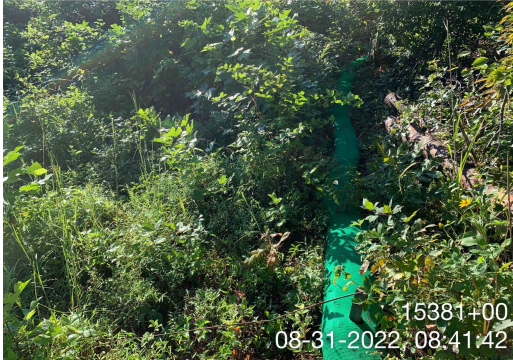
GPS Location		0		GPS Location		0	
Field Station#		15376+00		Field Station#		15381+00	
Pic 1 Desc.		Waterbar end treatment in acceptable condition		Pic 2 Desc.		CFS in acceptable condition

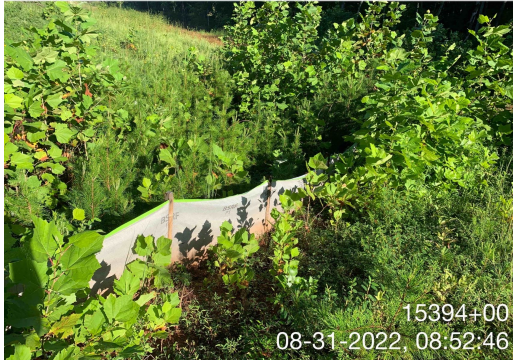
GPS Location		0		GPS Location		0	
Field Station#		15386+00		Field Station#		15394+00	
Pic 3 Desc.		CFS and sensitive resource buffer in acceptable conditions		Pic 4 Desc.		P1 silt fence in acceptable condition

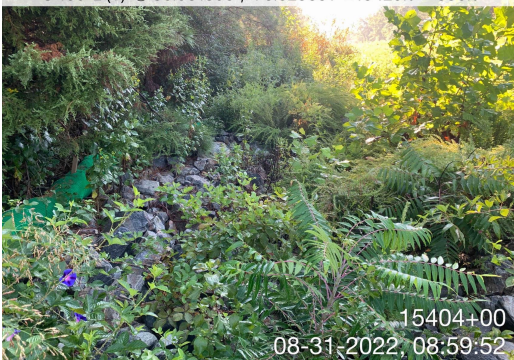
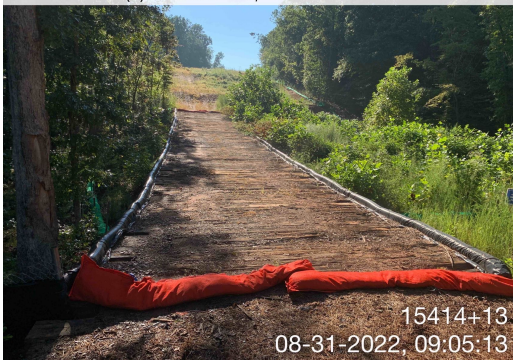
GPS Location		0		GPS Location		0	
Field Station#		15404+00		Field Station#		15414+13	
Pic 5 Desc.		Plunge pool in acceptable condition		Pic 6 Desc.		Equipment bridge in acceptable condition

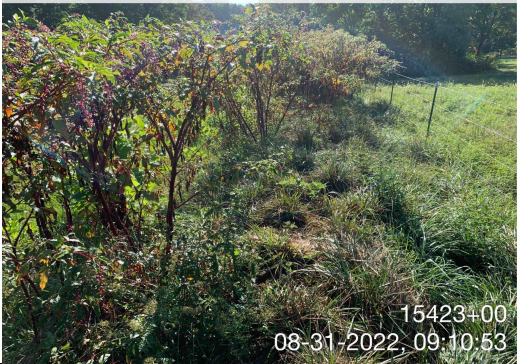
<p style="text-align: right;">15423+00 08-31-2022, 09:10:53</p>				357°N (T) 36.916686°, -79.492690° ±131ft ▲ 764ft   <p style="text-align: right;">15426+54 08-31-2022, 09:21:57</p>	
GPS Location 0		GPS Location 0			
Field Station# 15423+00		Field Station# 15426+54			
Pic 7 Desc. Clean water diversion berm in acceptable condition		Pic 8 Desc. Stream S-G4 running without elevated turbidity			
21°N (T) 36.915446°, -79.489686° ±29ft ▲ 804ft   <p style="text-align: right;">15435+00 08-31-2022, 09:34:37</p>				327°NW (T) 36.929725°, -79.526295° ±16420ft ▲ 795ft   <p style="text-align: right;">15435+00 08-31-2022, 09:34:02</p>	
GPS Location 0		GPS Location 0			
Field Station# 15435+00		Field Station# 15435+00			
Pic 9 Desc. Waterbar in acceptable condition		Pic 10 Desc. Waterbar end treatment in acceptable condition

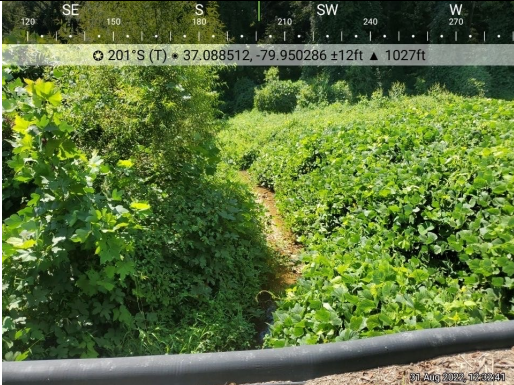
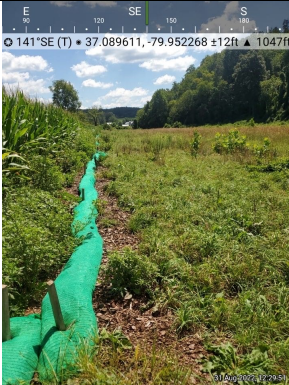
GPS Location 0		GPS Location 0			
Field Station# 13678+71		Field Station# 13672+00			
Pic 1 Desc. S-E29 Channel and banks		Pic 2 Desc. Perimeter CFS

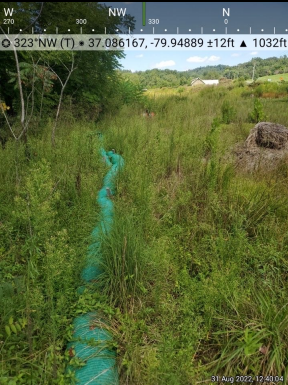
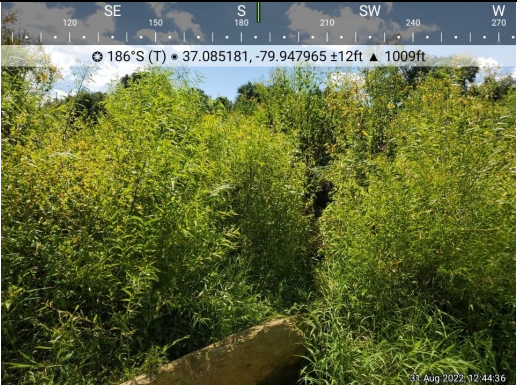
GPS Location 0		GPS Location 0			
Field Station# 13688+00		Field Station# 13692+75			
Pic 3 Desc. Perimeter CFS		Pic 4 Desc. GAS S-E28 Banks

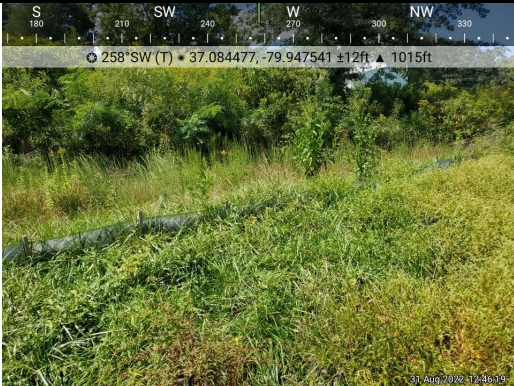
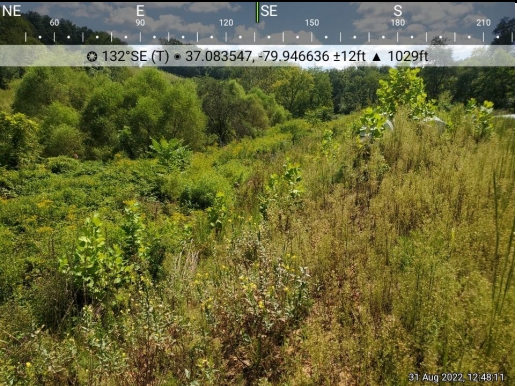
GPS Location 0		GPS Location 0			
Field Station# 13697+00		Field Station# 13699+00			
Pic 5 Desc. GAS W-E7 Buffer zone and silt fence		Pic 6 Desc. Sideslope vegetation

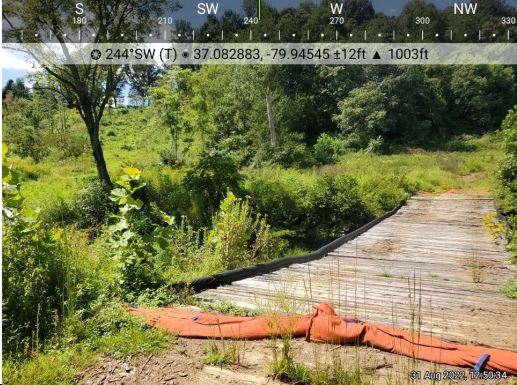
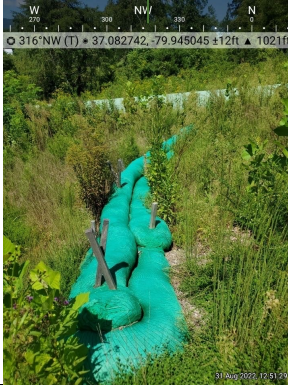
<p>ert image here</p>	
GPS Location 0		GPS Location 0			
Field Station# 13705+50		Field Station# 13706+50			
Pic 7 Desc. GAS S-E28 Equipment bridge and banks		Pic 8 Desc. GAS S-E28 Buffer zone CFS Triple stack

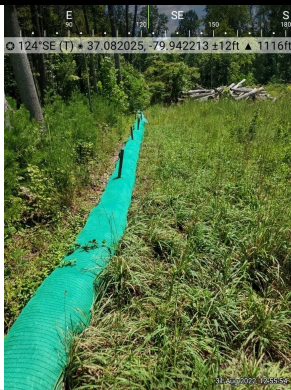
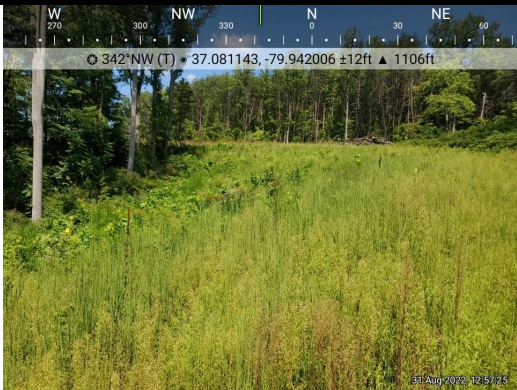
<p>ert image here</p>	
GPS Location 0		GPS Location 0			
Field Station# 13710+00		Field Station# 13720+00			
Pic 9 Desc. Perimeter CFS		Pic 10 Desc. Vegetation

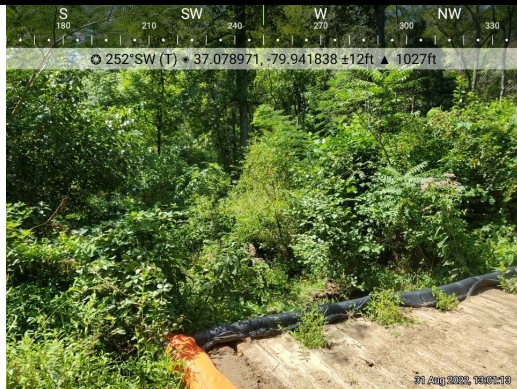
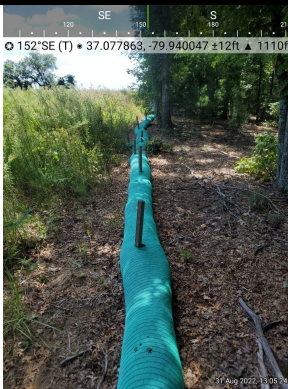
<p>ert image here</p>	
GPS Location 0		GPS Location 0			
Field Station# 13728+20		Field Station# 13738+00			
Pic 11 Desc. S-EF4 Channel and banks		Pic 12 Desc. Perimeter CFS

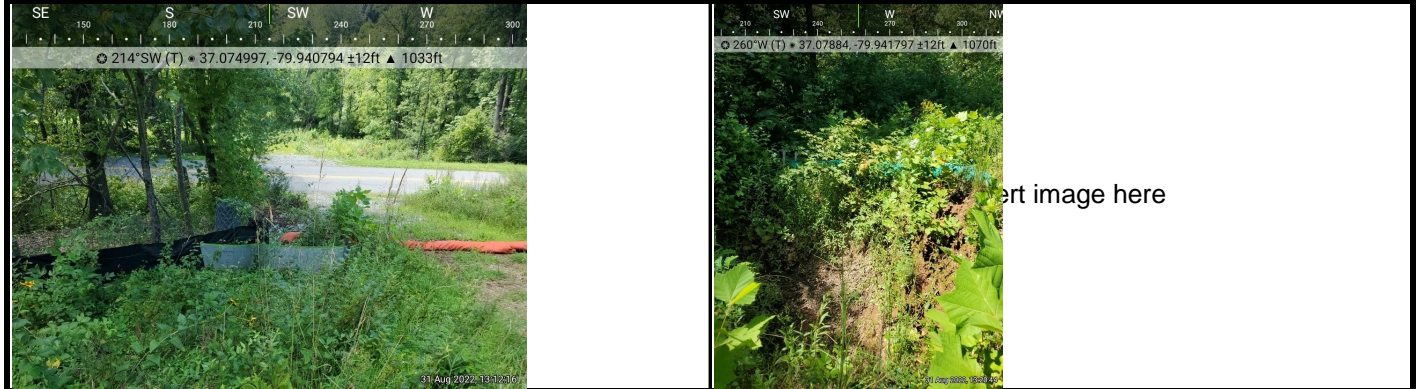
GPS Location	0	GPS Location	0
Field Station#	13747+50	Field Station#	13730+00
Pic 13 Desc.	CIS Green Level Rd Travel lane and ECDs	Pic 14 Desc.	Sump and J-hook

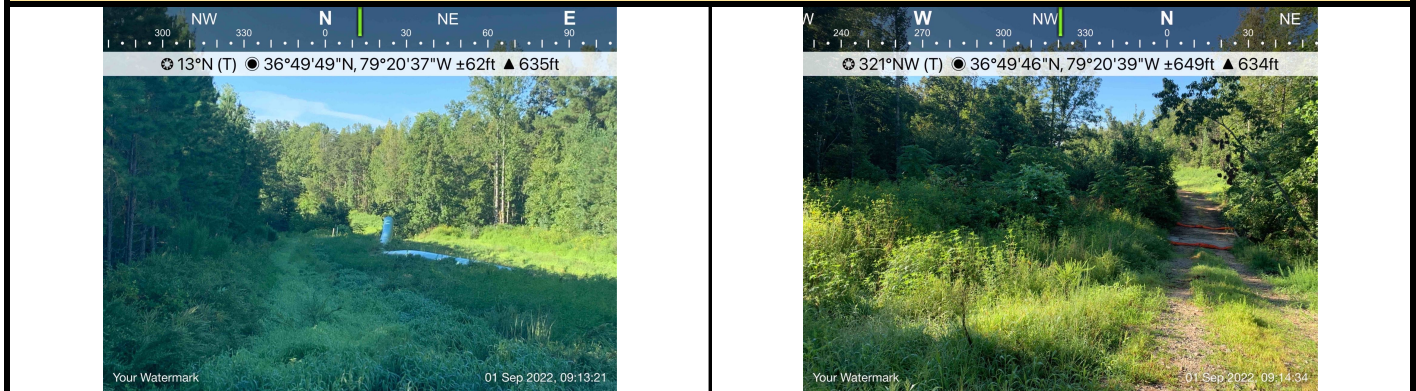
Field Station#	6+00	Field Station#	12+65
-----------------------	------	-----------------------	-------

Pic 1 Desc.	Observing temporary stabilization	Pic 2 Desc.	Observing temporary stabilization,buffer, equipment crossing and ECD's
--------------------	-----------------------------------	--------------------	--

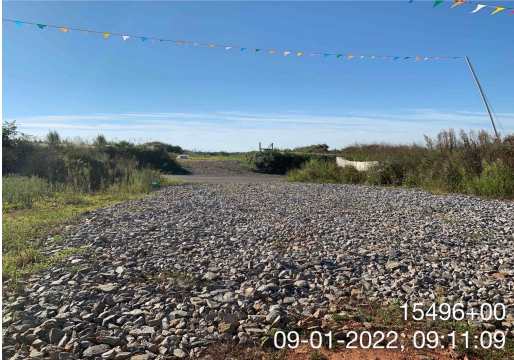
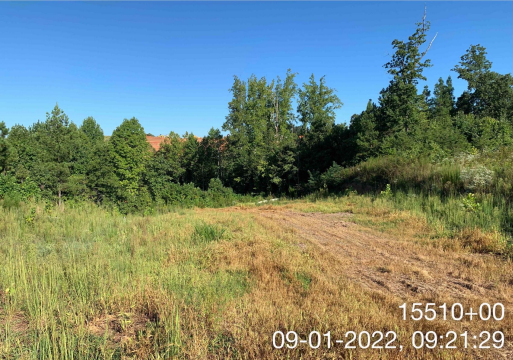
GPS Location	0	GPS Location	0
Field Station#	15496+00	Field Station#	15510+00
Pic 1 Desc.	Rock construction entrance in acceptable condition	Pic 2 Desc.	Temporary vegetative stabilization in acceptable condition

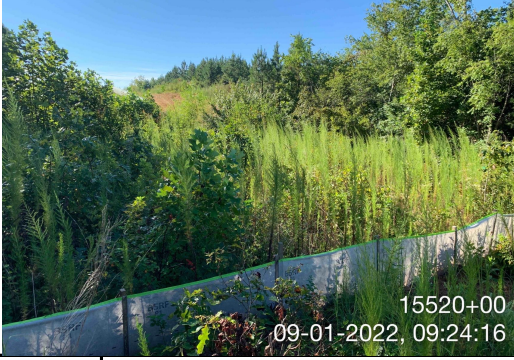
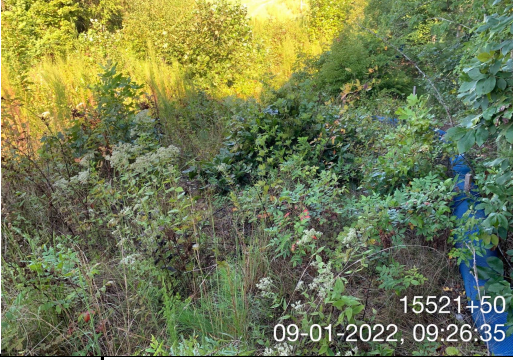
GPS Location	0	GPS Location	0
Field Station#	15520+00	Field Station#	15521+50
Pic 3 Desc.	P1 silt fence and sensitive resource buffer in acceptable conditions	Pic 4 Desc.	Perimeter CFS and sensitive resource buffer in acceptable conditions

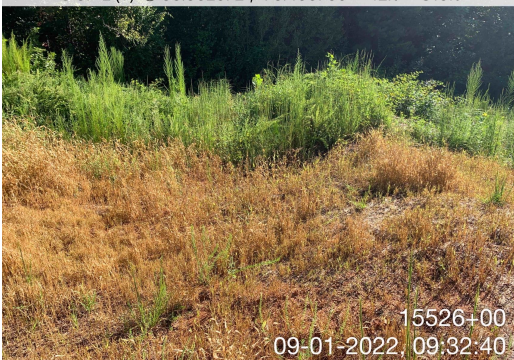
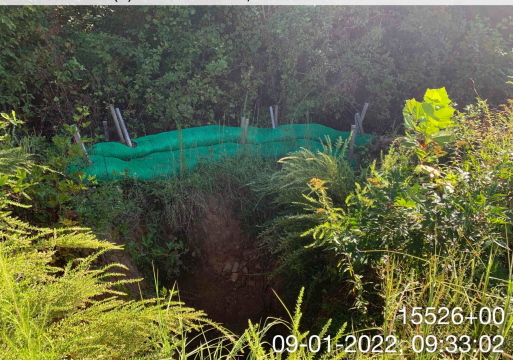
GPS Location	0	GPS Location	0
Field Station#	15526+00	Field Station#	15526+00
Pic 5 Desc.	Waterbar in acceptable condition	Pic 6 Desc.	Waterbar end treatment in acceptable condition

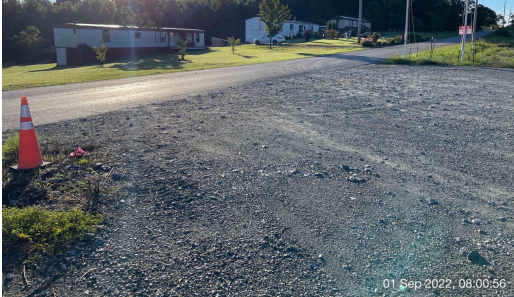
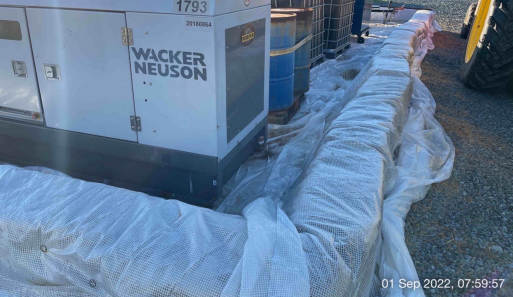
<p style="text-align: right; font-size: small;">01 Sep 2022, 07:59:57</p>				
GPS Location		See picture		GPS Location		See picture	
Field Station#		0000+00		Field Station#		0000+00	
Pic 1 Desc.		RCE at LY-045 in good condition.		Pic 2 Desc.		Secondary containment structure on south end of tent at LY-045 in good condition.	
<p style="text-align: center;">South East Elevation</p> <p style="text-align: center;">📍 328°NW (T) ● 36°58'13"N, 79°52'9"W ±13ft ▲ 1196ft</p>

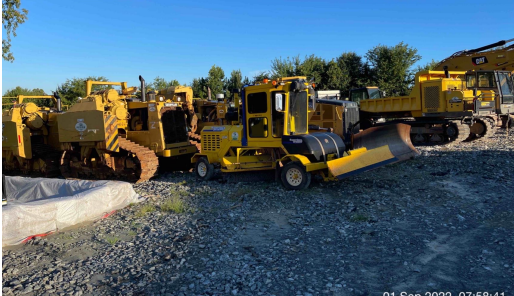
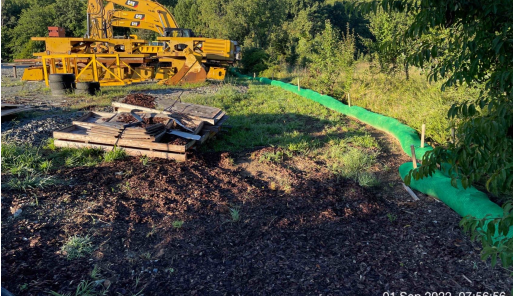
GPS Location		See picture		GPS Location		See picture	
Field Station#		0000+00		Field Station#		0000+00	
Pic 3 Desc.		Equipment inspected at LY-045 no leaks observed during inspections.		Pic 4 Desc.		Perimeter ECD's on north end of LY-045 in good condition.	
<p style="text-align: center;">North East Elevation</p> <p style="text-align: center;">📍 226°SW (T) ● 36°58'16"N, 79°52'9"W ±13ft ▲ 1194ft</p>

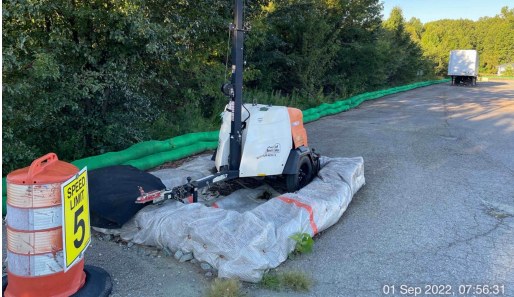
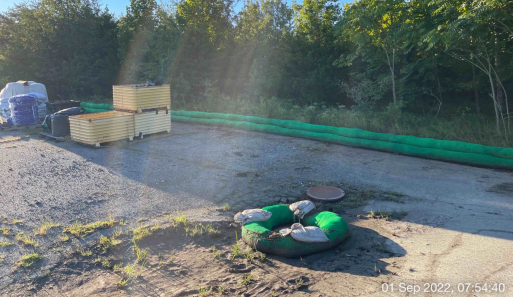
<p style="text-align: right; font-size: small;">01 Sep 2022, 07:54:40</p>				
GPS Location		See picture		GPS Location		See picture	
Field Station#		0000+00		Field Station#		0000+00	
Pic 5 Desc.		Perimeter ECD's and secondary containment structure for light plant on south end of LY-046 in good condition.		Pic 6 Desc.		Inlet protection and perimeter ECD's on south end of LY-046 in good condition.

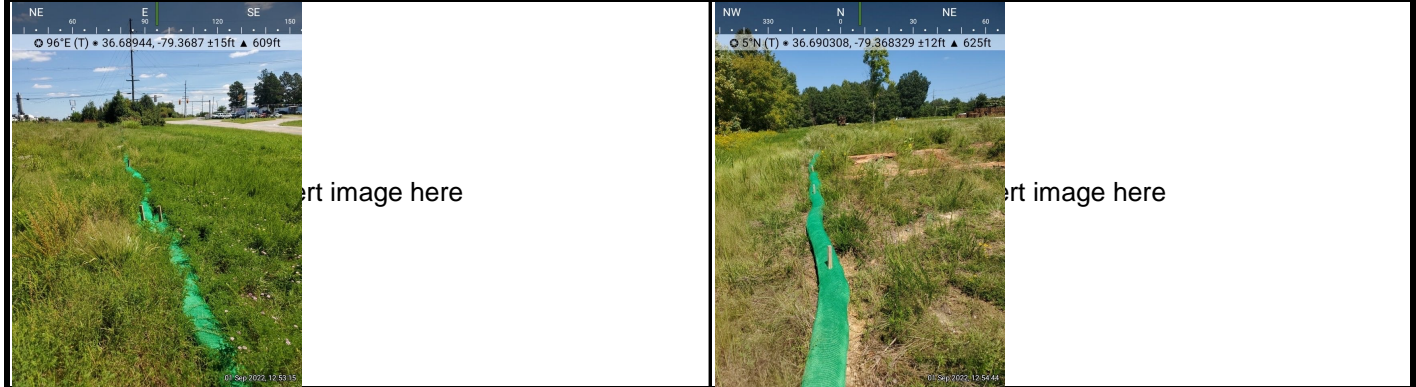
GPS Location	0	GPS Location	0
Field Station#	0+00	Field Station#	0+00
Pic 7 Desc.	LY-048 South perimeter CFS	Pic 8 Desc.	LY-048 West perimeter CFS

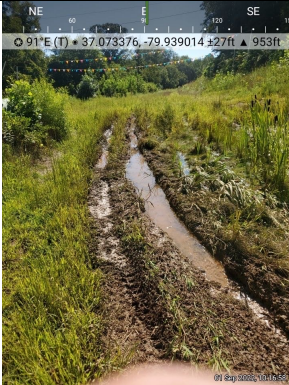
GPS Location	0	GPS Location	0		
Field Station#	13755+60	Field Station#	13757+00		
Pic 1 Desc.	S-EF12 Channel and banks	Pic 2 Desc.	Third party rutting in ROW

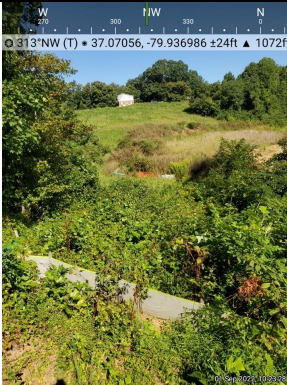
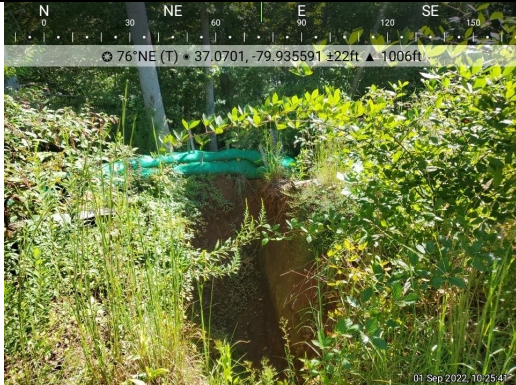
GPS Location	0	GPS Location	0		
Field Station#	13772+00	Field Station#	13776+00		
Pic 3 Desc.	GAS S-MM42 Buffer zone and silt fence	Pic 4 Desc.	Sump and J-hook

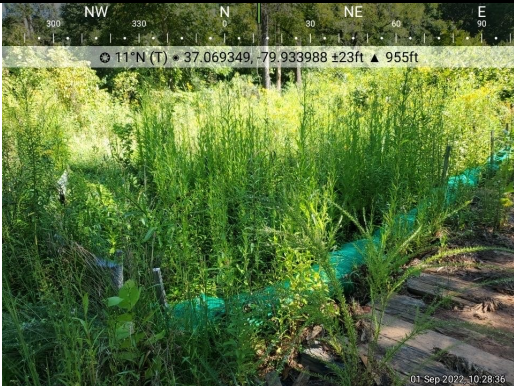
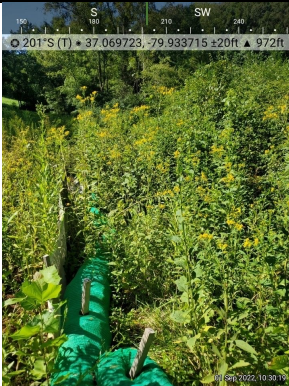
GPS Location	0	GPS Location	0		
Field Station#	13781+00	Field Station#	13782+50		
Pic 5 Desc.	CIS S-RR15 Buffer zone and ECDs	Pic 6 Desc.	GAS S-RR15 ECDs

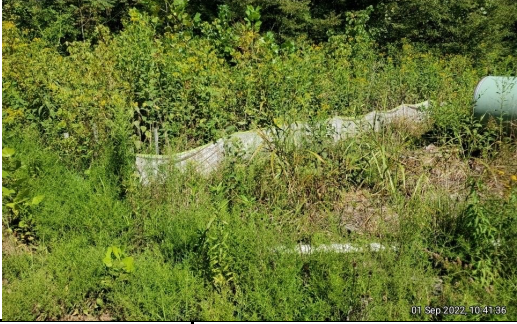
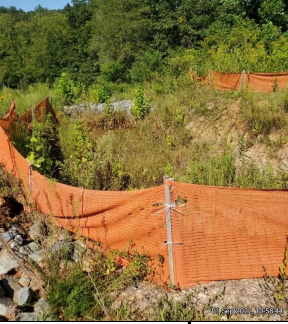
<p>ert image here</p>	
GPS Location	0	GPS Location	0		
Field Station#	13756+50	Field Station#	13784+00		
Pic 7 Desc.	GAS S-EF12 Silt fence		Pic 8 Desc.	Waterbar relay sump

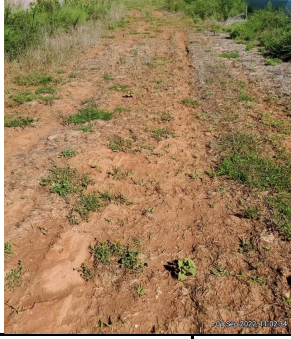
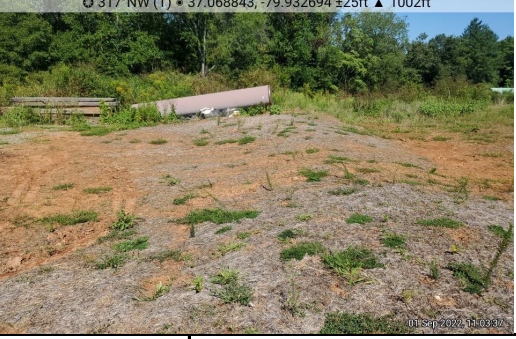
<p>ert image here</p>	
GPS Location	0	GPS Location	0		
Field Station#	13784+35	Field Station#	13784+35		
Pic 9 Desc.	MVP-FR-300 Stabilize access road from RCE to ROW		Pic 10 Desc.	MVP-FR-300 Stabilize access road from RCE to ROW

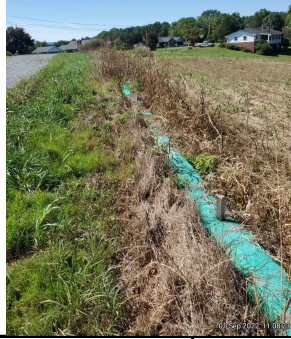
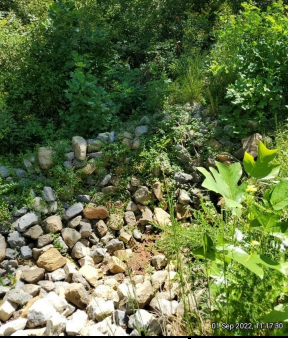
<p>ert image here</p>	
GPS Location	0	GPS Location	0		
Field Station#	13784+35	Field Station#	13815+00		
Pic 11 Desc.	MVP-FR-300 Perimeter CFS near Brick Church Rd		Pic 12 Desc.	Plunge pool

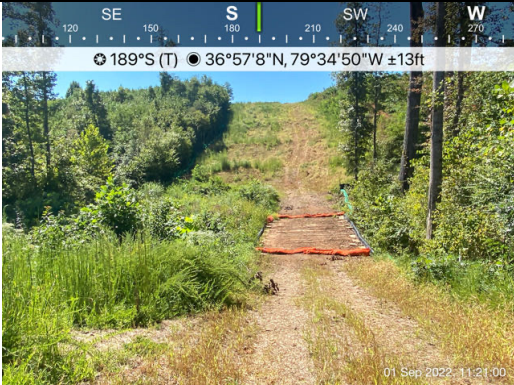
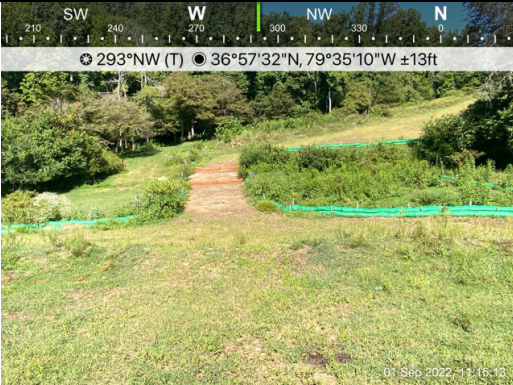
GPS Location	0	GPS Location	0
Field Station#	15126+40	Field Station#	15092+95
Pic 3 Desc.	Approximately 15126+40. Overview of stream crossing, equipment bridge and ECDs at stream S-A6.	Pic 4 Desc.	Approximately 15092+95. Overview of stream crossing, equipment bridge and ECDs at stream S-G9.

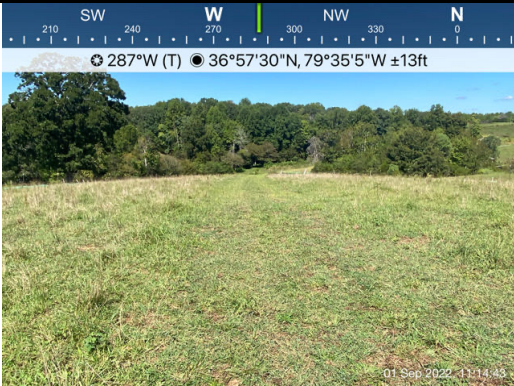
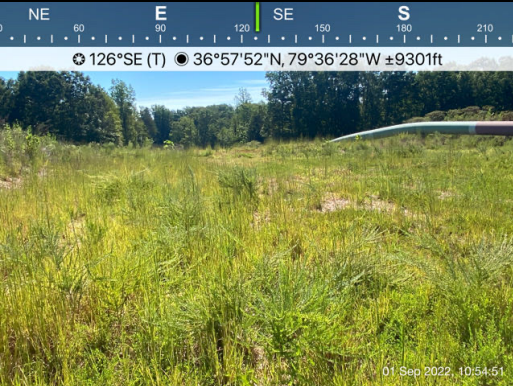
GPS Location	0	GPS Location	0
Field Station#	15102+00	Field Station#	15068+00
Pic 5 Desc.	Approximately 15102+00. Overview of ROW. Permanent vegetation. Grazed by livestock.	Pic 6 Desc.	Approximately 15068+00. Overview of ROW.

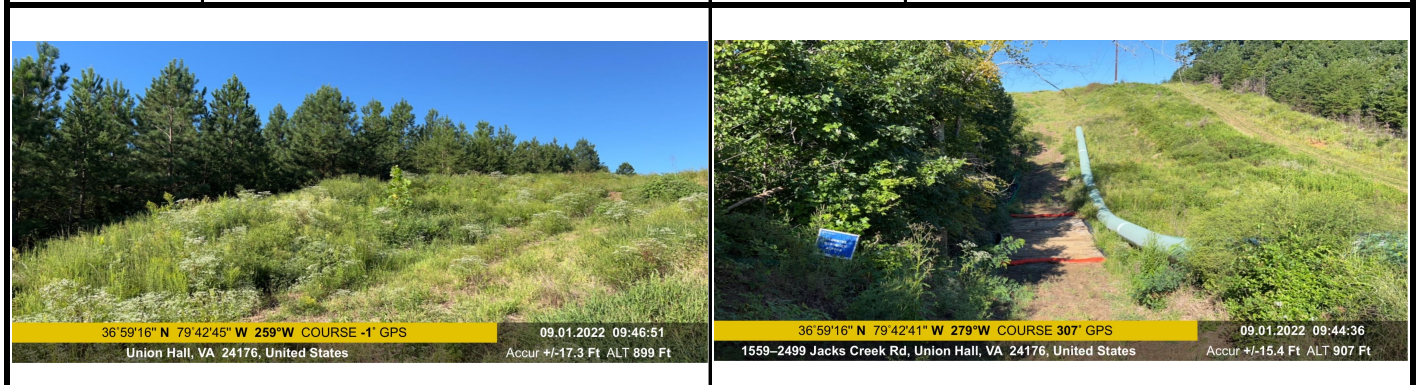
GPS Location	5	GPS Location	6
Field Station#	14686+00	Field Station#	14689+36
Pic 5 Desc.	Temporary diversion berm stabilized and vegetated.	Pic 6 Desc.	Equipment bridge and surrounding ECDs in place and functional at stream crossing and resource buffer.

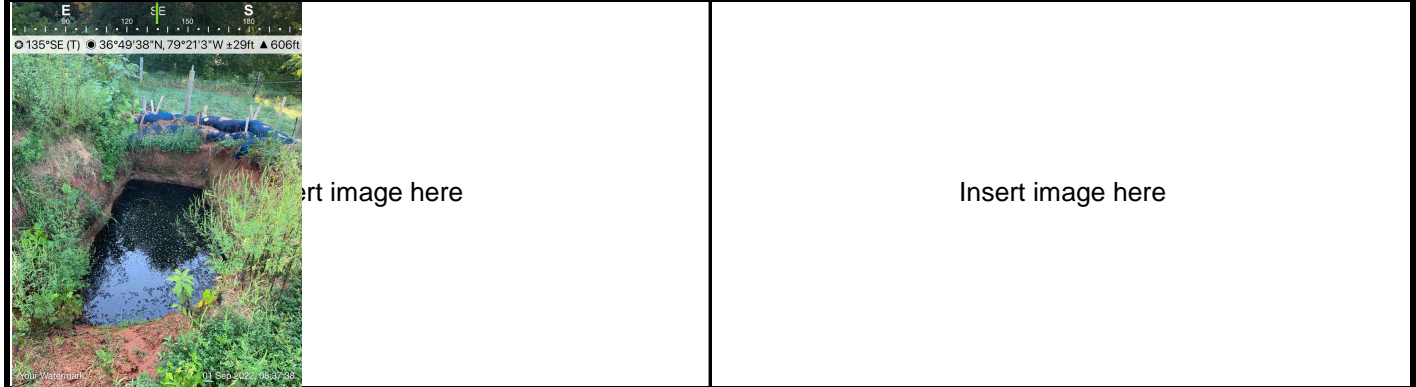
GPS Location	O	GPS Location	
Field Station#	15998+00	Field Station#	
Pic 7 Desc.	Observing temporary stabilization, sump and end treatment	Pic 8 Desc.

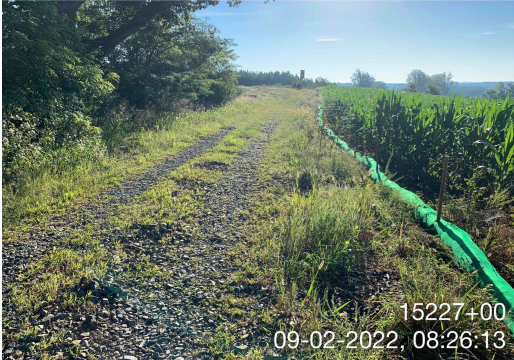
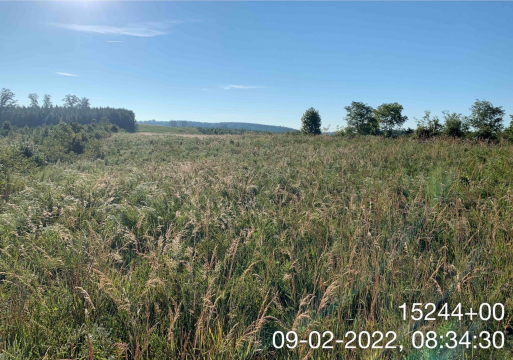
<p>121°SE (T) ● 36.935707°, -79.548627° ±4353ft ▲ 778ft 15244+00 09-02-2022, 08:34:30</p>				
GPS Location 0					GPS Location 0				
Field Station# 15227+00					Field Station# 15244+00				
Pic 1 Desc. Perimeter CFS in acceptable condition					Pic 2 Desc. Permanent vegetative stabilization in acceptable condition

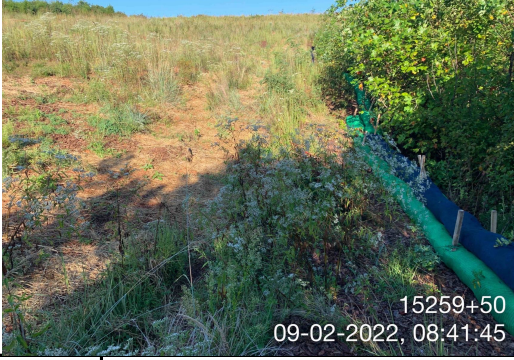
<p>261°W (T) ● 36.939480°, -79.556482° ±19ft ▲ 831ft 15215+00 09-02-2022, 09:11:09</p>				
GPS Location 0					GPS Location 0				
Field Station# 15259+50					Field Station# 15215+00				
Pic 3 Desc. Perimeter CFS in acceptable condition					Pic 4 Desc. Permanent vegetative stabilization in acceptable condition

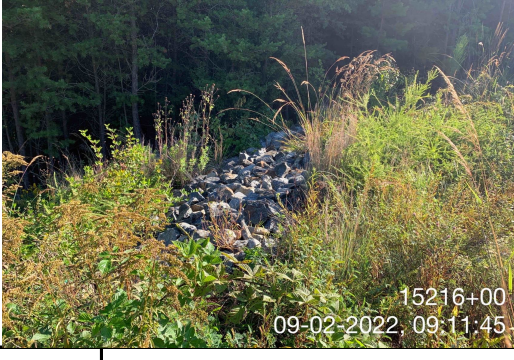
<p>59°NE (T) ● 36.939301°, -79.556730° ±13ft ▲ 829ft 15216+00 09-02-2022, 09:12:16</p>				
GPS Location 0					GPS Location 0				
Field Station# 15216+00					Field Station# 15216+00				
Pic 5 Desc. Waterbar end treatment in acceptable condition					Pic 6 Desc. Waterbar in acceptable condition

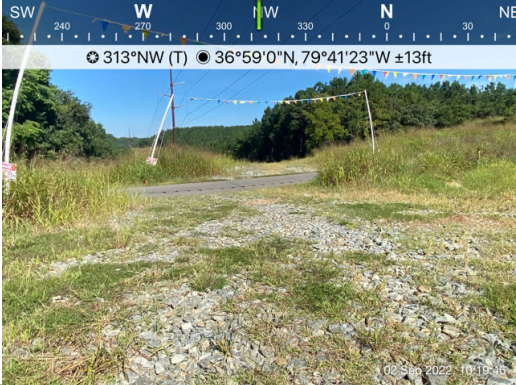
GPS Location 0		GPS Location 0			
Field Station# 14758+16		Field Station# 14751+50			
Pic 3 Desc. Approximately 14758+16. Overview of road crossing and RCEs.		Pic 4 Desc. Approximately 14751+50. Overview of stream crossing, equipment bridge and ECDs at stream S-A22.

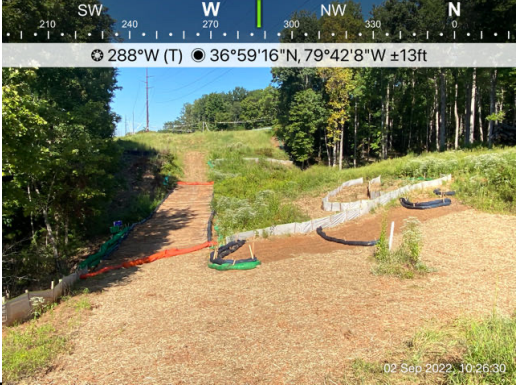
GPS Location 0		GPS Location 0			
Field Station# 14716+50		Field Station# 14737+68			
Pic 5 Desc. Approximately 14716+50. Overview of wetland crossing, equipment bridge and ECDs at wetland W-H11. Crews have installed new and additional ECDs to try and prevent further		Pic 6 Desc. Approximately 14737+68. Overview of ROW. Third party timber harvesting activities continue. Will continue to monitor.

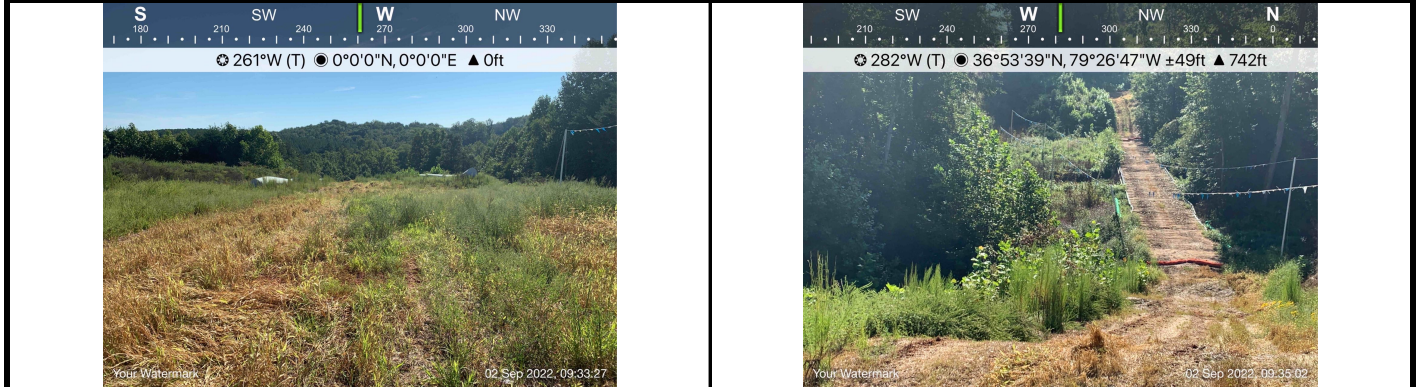
Pic 1 Desc.	Observing temporary stabilization and water bars	Pic 2 Desc.	Observing temporary stabilization,buffer, equipment crossing and ECD's
--------------------	--	--------------------	--

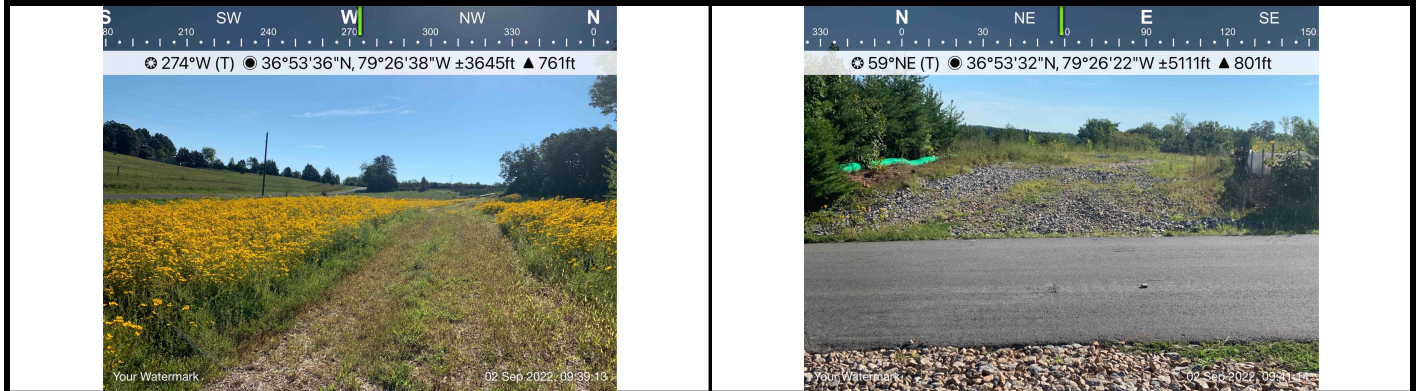
Pic 3 Desc.	Observing temporary stabilization	Pic 4 Desc.	Observing road crossing and RCE's
--------------------	-----------------------------------	--------------------	-----------------------------------

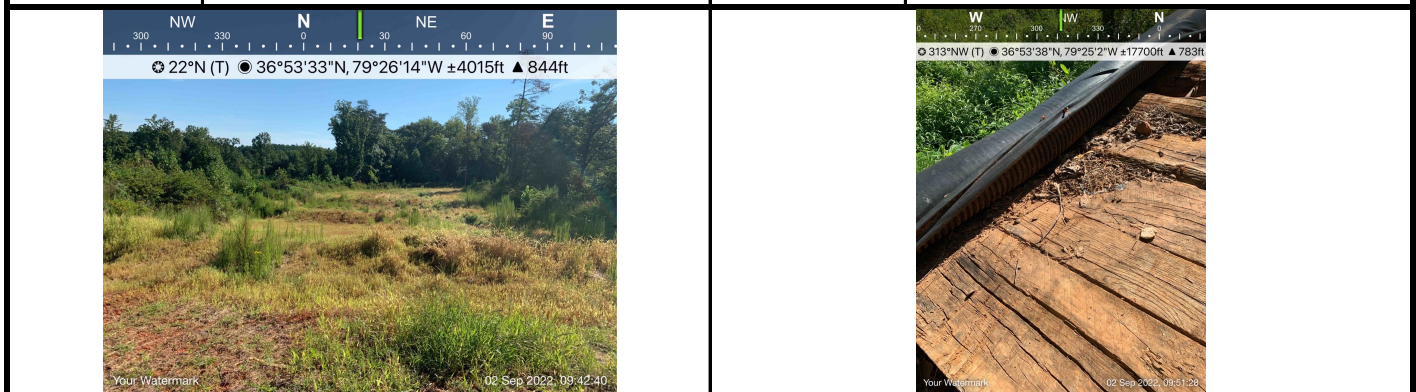
Pic 5 Desc.	Observing temporary stabilization and water bars	Pic 6 Desc.	Observing geo tech that required maintenance
--------------------	--	--------------------	--

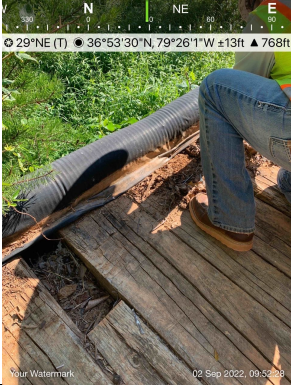
<p>ert image here</p>			
GPS Location	O	GPS Location	O		
Field Station#	15636+45	Field Station#	15640+00		
Pic 7 Desc.	Observing the Contractor performing maintenance		Pic 8 Desc.	Observing temporary stabilization, sump and end treatment
