Visual Site Inspection Report

Project Name H-600 Pipeline Spread I		AFE 124300139	Spread H-600 Pipeline Spread I
Contractor Precision		Report # 41511	
Inspector Justin Burch		Date/Time 8/29/2022 12:12 PM	
Permit # TBD	Inspection Type VA SWPP	Station Begin	15142+66
State VA	Inspection Area Full	Station End	15260+00
County Pittsylvania	Ground Dry	Temperature (°F)	90.00
Municipality Chatham	Weather Sunny	Rain Gauge (in)	0.00
Rain Accumulation Time (days)			6.00

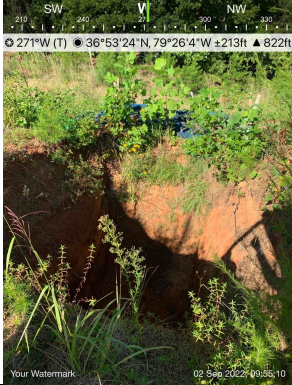
<p>ert image here</p>			
GPS Location	O	GPS Location	O		
Field Station#	15636+45	Field Station#	15640+00		
Pic 7 Desc.	Observing the Contractor performing maintenance		Pic 8 Desc.	Observing temporary stabilization, sump and end treatment

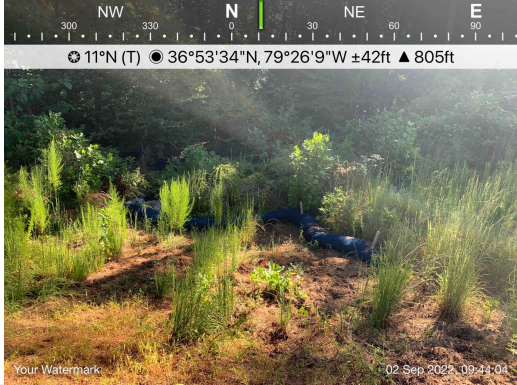
<p>Insert image here</p>			
GPS Location	O	GPS Location			
Field Station#	15630+00	Field Station#			
Pic 9 Desc.	Observing temporary stabilization, CWD outlet and ECD's		Pic 10 Desc.		
<p>Insert image here</p>			<p>Insert image here</p>		
GPS Location		GPS Location			
Field Station#		Field Station#			
Pic 11 Desc.			Pic 12 Desc.
