Visual Site Inspection Report

Project Name H-600 Pipeline Spread I		AFE 124300139	Spread H-600 Pipeline Spread I
Contractor Precision		Report # 40732	
Inspector Justin Burch		Date/Time 8/8/2022 9:17 AM	
Permit # TBD	Inspection Type VA SWPP	Station Begin	15260+00
State VA	Inspection Area Full	Station End	15370+62
County Pittsylvania	Ground Wet	Temperature (°F)	90.00
Municipality Chatham	Weather Sunny	Rain Gauge (in)	1.20
			Rain Accumulation Time (days) 6.00

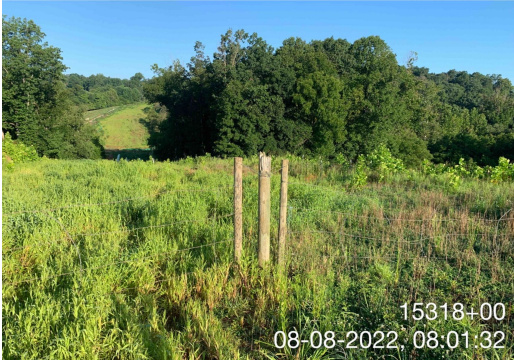
GPS Location		0		GPS Location		0	
Field Station#		15318+00		Field Station#		15317+00	
Pic 1 Desc.		Temporary vegetative stabilization in acceptable condition		Pic 2 Desc.		Waterbar in acceptable condition	
☉ 335°NW (T) ● 17 N 631341 4088089 ±22ft ▲ 696ft

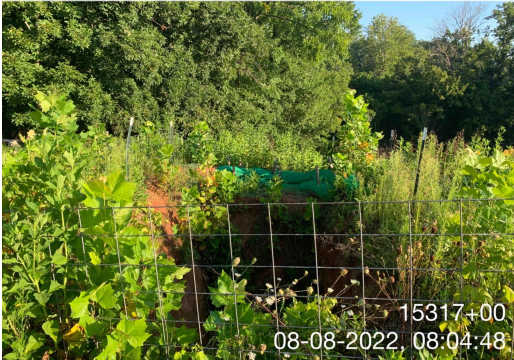
GPS Location		0		GPS Location		0	
Field Station#		15317+00		Field Station#		15314+00	
Pic 3 Desc.		Waterbar end treatment in acceptable condition		Pic 4 Desc.		CFS and sensitive resource buffer in acceptable conditions	
☉ 157°SE (T) ● 17 N 630775 4088276 ±239ft ▲ 777ft

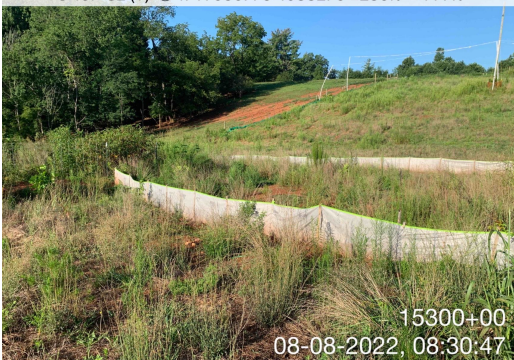
Pic 5 Desc.		P1 silt fence in acceptable condition		Pic 6 Desc.		Waterbar in acceptable condition

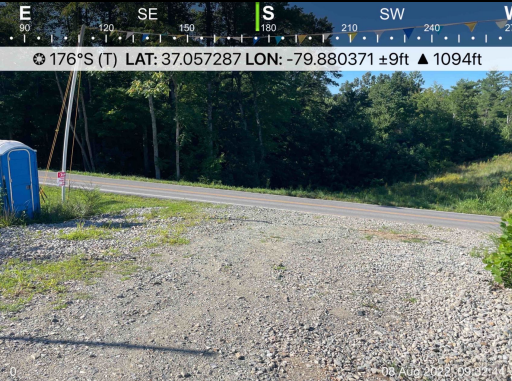
GPS Location See photo		GPS Location See photo			
Field Station# 14009+11		Field Station# 14018+47			
Pic 5 Desc. SSF is in good condition		Pic 6 Desc. RCEs are in good condition at all stream and wetland buffers

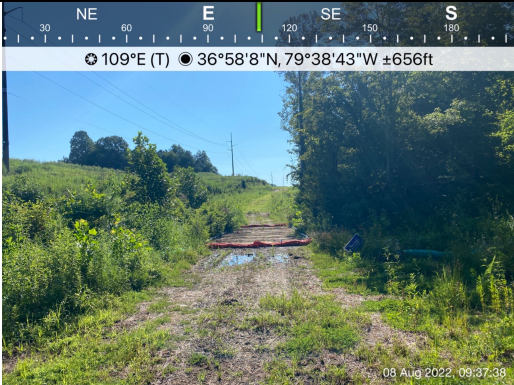
GPS Location	0	GPS Location	0
Field Station#	14907+57	Field Station#	14897+00
Pic 3 Desc.	Approximately 14907+57. Overview of stream crossing, equipment bridge and ECDs at stream S-DD3.	Pic 4 Desc.	Approximately 14897+00. Overview of ROW.

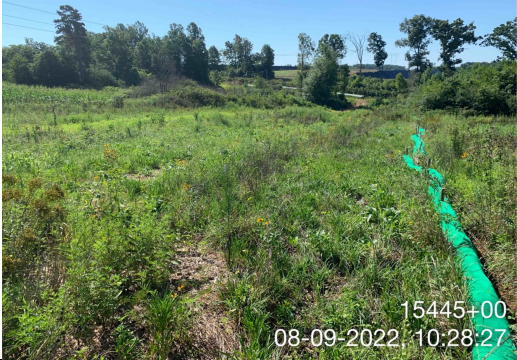
<p>15445+00 08-09-2022 10:28:27</p>

<p>15453+00 08-09-2022 10:37:21</p>	
GPS Location	0	GPS Location	0		
Field Station#	15445+00	Field Station#	15453+00		
Pic 7 Desc.	Permanent vegetative stabilization and perimeter CFS in acceptable conditions		Pic 8 Desc.	Clean water diversion pipe in acceptable condition

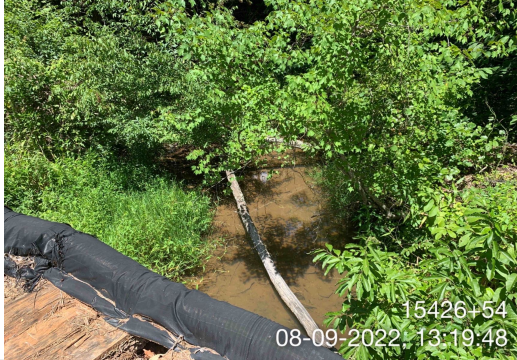
- The EI observed that stream water at S-G4 (15426+54) was running clear. This stream has been impacted in the past by upstream activities not related to MVP.

<p>15426+54 08-09-2022 13:19:48</p>		Insert image here			
GPS Location	0	GPS Location			
Field Station#	15426+54	Field Station#			
Pic 9 Desc.	Stream water in S-G4 is running clear.		Pic 10 Desc.		
Insert image here			Insert image here		
GPS Location		GPS Location			
Field Station#		Field Station#			
Pic 11 Desc.			Pic 12 Desc.

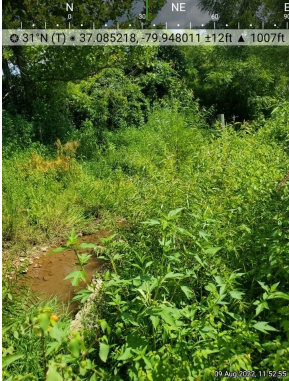
GPS Location	0		GPS Location	0	
Field Station#	13693+00		Field Station#	13689+00	
Pic 1 Desc.	GAS S-E28 Banks and channel		Pic 2 Desc.	CIS Grassy Hill Rd ATWS CFS

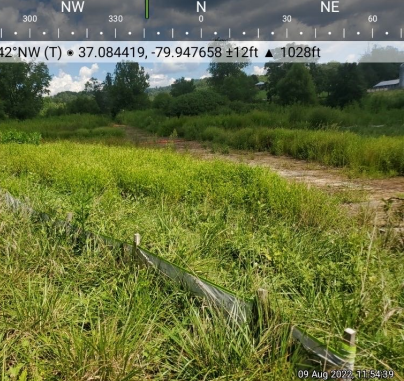
GPS Location	0		GPS Location	0	
Field Station#	13697+00		Field Station#	13700+00	
Pic 3 Desc.	GAS W-E7 Silt fence		Pic 4 Desc.	Temporary vegetation

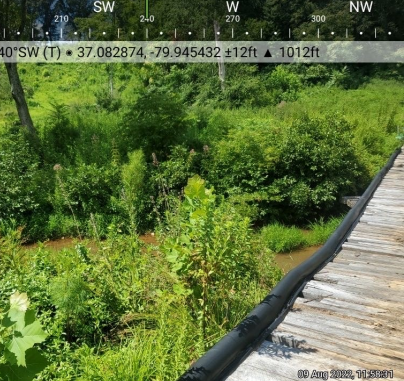
GPS Location	0		GPS Location	0	
Field Station#	13705+25		Field Station#	13706+00	
Pic 5 Desc.	GAS S-E28 Banks and channel		Pic 6 Desc.	GAS S-E28 Buffer zone ECDs

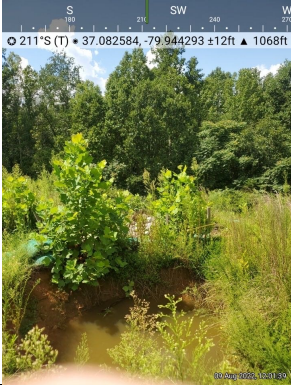
<p>52°NE (T) • 37.082426, -79.943822 ±12ft ▲ 1066ft</p>		ert image here	
GPS Location 0		GPS Location 0			
Field Station# 13708+00		Field Station# 13708+50			
Pic 7 Desc. Sump		Pic 8 Desc. Sump outlet

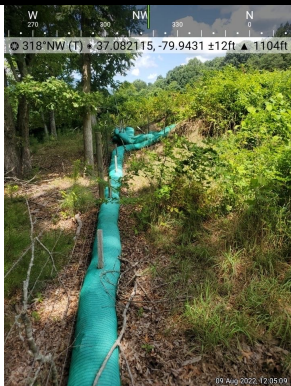
<p>150°SE (T) • 37.079206, -79.941934 ±12ft ▲ 1040ft</p>		ert image here	
GPS Location 0		GPS Location 0			
Field Station# 13712+00		Field Station# 13720+00			
Pic 9 Desc. Perimeter CFS		Pic 10 Desc. Perimeter SSF

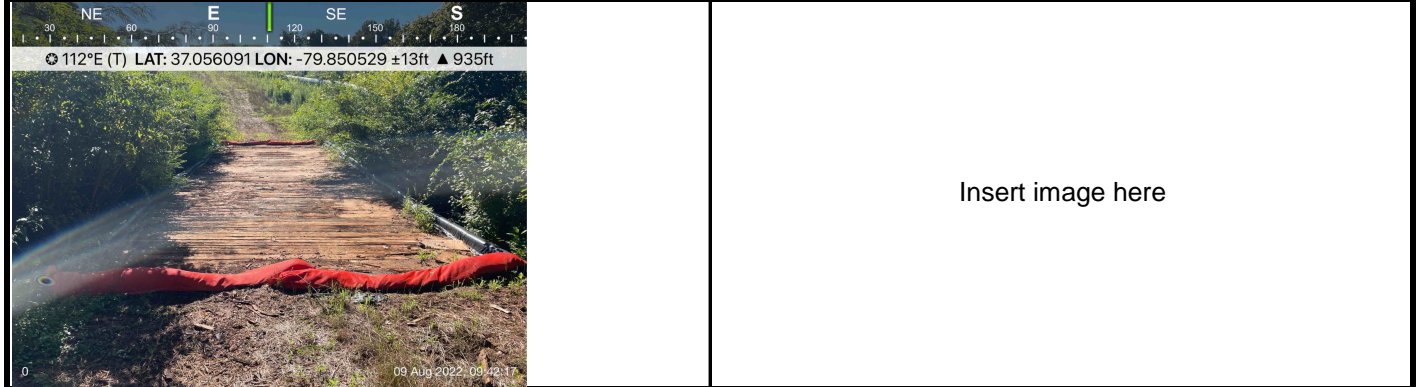
Pic 13 Desc.	Equipment bridge ECDs are functioning as intended	Pic 14 Desc.	
---------------------	---	---------------------	--

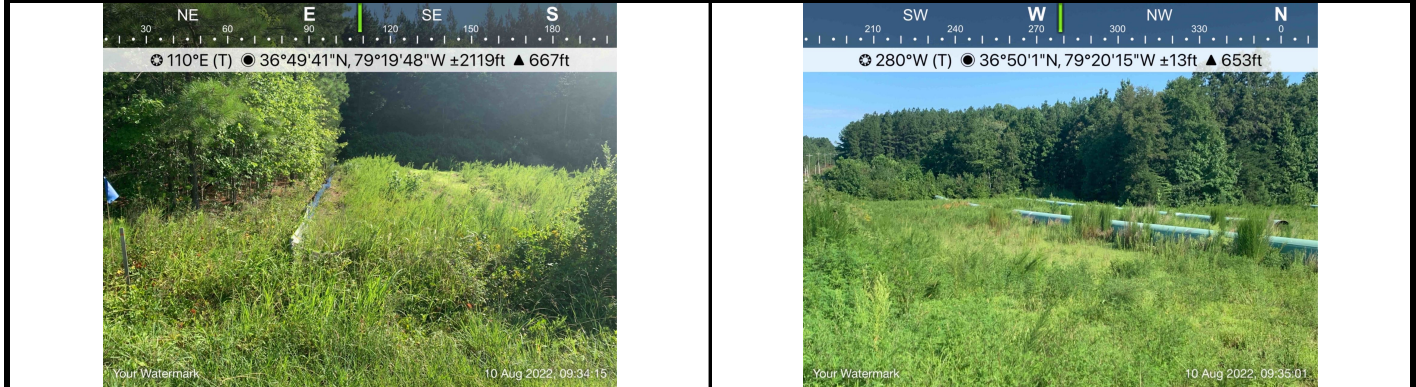
Pic 1 Desc.	Observing temporary stabilization and ECD's	Pic 2 Desc.	Observing temporary stabilization and buffer
--------------------	---	--------------------	--

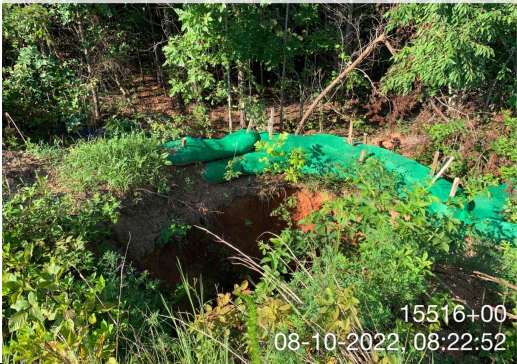
GPS Location 0		GPS Location 0			
Field Station# 15516+00		Field Station# 15538+00			
Pic 7 Desc. Waterbar end treatment in acceptable condition		Pic 8 Desc. Temporary vegetative stabilization in acceptable condition			
302°NW (T) ● 36.898054°, -79.459628° ±13ft ▲ 853ft

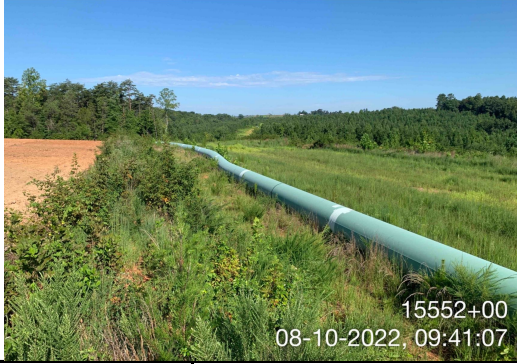
GPS Location 0		GPS Location 0			
Field Station# 15552+00		Field Station# 15573+00			
Pic 9 Desc. Clean water diversion berm and temporary vegetative stabilization in acceptable conditions		Pic 10 Desc. P1 silt fence and sensitive resource buffer in acceptable conditions			
49°NE (T) ● 36.903137°, -79.468209° ±337ft ▲ 807ft

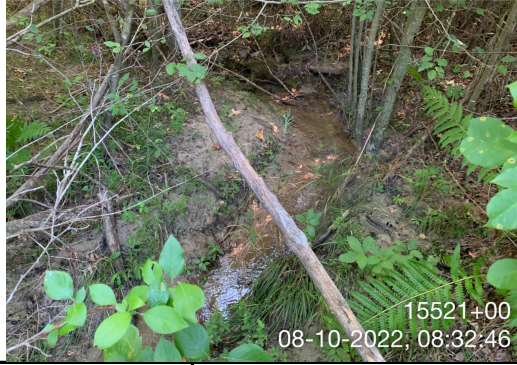
GPS Location 0		GPS Location 0			
Field Station# 15521+00		Field Station# 15542+50			
Pic 11 Desc. Stream running clear at S-MM8		Pic 12 Desc. Elevated turbidity in stream S-CC5 due to upstream activities not related to MVP

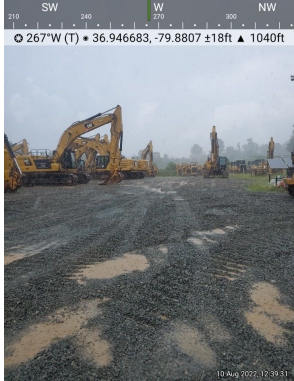
GPS Location	0		GPS Location	0	
Field Station#	0+00		Field Station#	0+00	
Pic 1 Desc.	LY-032 Rock construction entrance during shower		Pic 2 Desc.	LY-032 Secondary containment

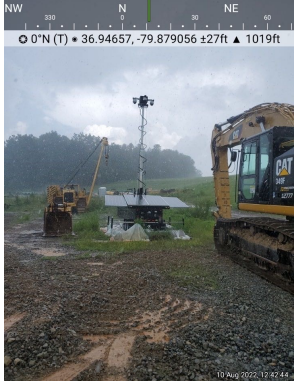
GPS Location	0		GPS Location	0	
Field Station#	0+00		Field Station#	0+00	
Pic 3 Desc.	LY-033 Secondary containment		Pic 4 Desc.	LY-033 Rock construction entrance during shower

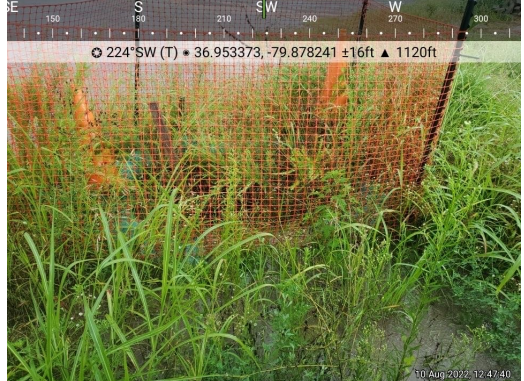
GPS Location	0		GPS Location	0	
Field Station#	0+00		Field Station#	0+00	
Pic 5 Desc.	ANC-006 Stormwater drain inlet		Pic 6 Desc.	ANC-006 Third party soil stockpile with runoff during shower

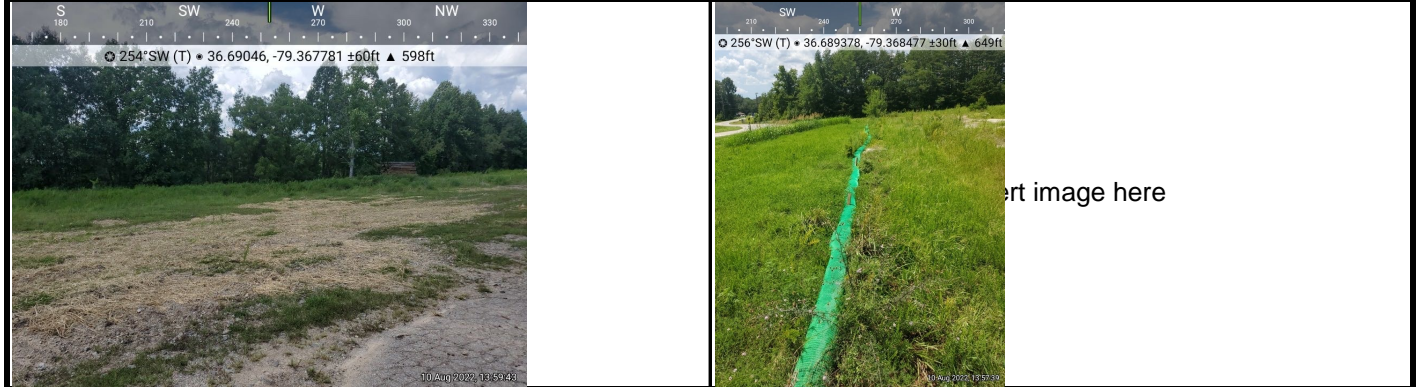
GPS Location	0	GPS Location	0
Field Station#	0+00	Field Station#	0+00
Pic 7 Desc.	LY-048 Temporary stabilization	Pic 8 Desc.	LY-048 South perimeter CFS

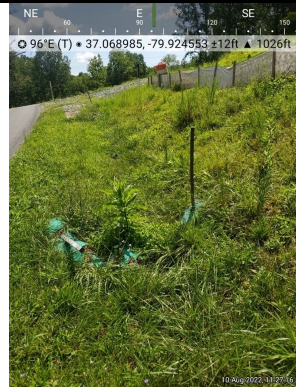
GPS Location	0		GPS Location	0	
Field Station#	13812+10		Field Station#	13811+90	
Pic 1 Desc.	Replace damaged silt fence and CFS between Brick Church Rd and private driveway.		Pic 2 Desc.	Remove damaged CFS in borrow ditch

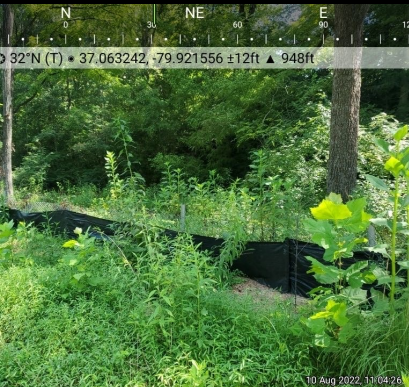
GPS Location	0		GPS Location	0	
Field Station#	13848+00		Field Station#	13840+00	
Pic 3 Desc.	GAS S-C16 Buffer zone Super Silt fence		Pic 4 Desc.	Perimeter Super Silt fence

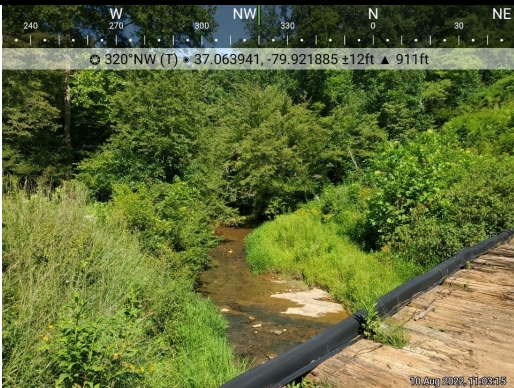
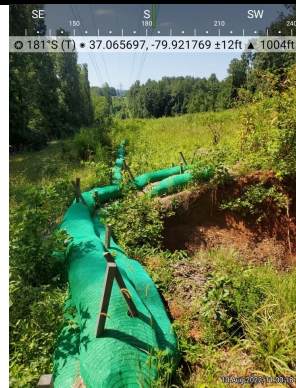
GPS Location	0		GPS Location	0	
Field Station#	13834+50		Field Station#	13830+00	
Pic 5 Desc.	S-C14 Banks and channel		Pic 6 Desc.	Perimeter CFS

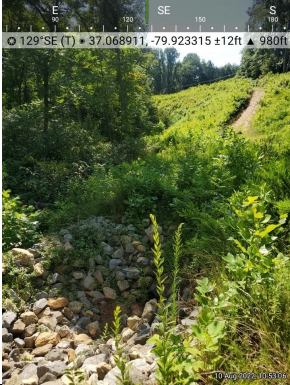
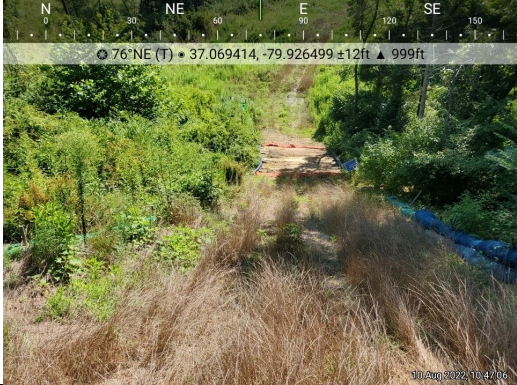
<p>ert image here</p>	
GPS Location 0		GPS Location 0			
Field Station# 13815+00		Field Station# 13805+00			
Pic 7 Desc. Cleanwater diversion plunge pool		Pic 8 Desc. CIS S-D18 Travel lane vegetation and buffer zone ECDs

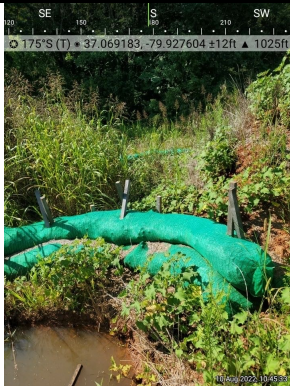
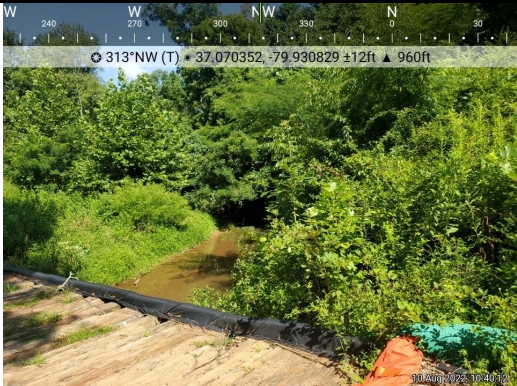
<p>ert image here</p>	
GPS Location 0		GPS Location 0			
Field Station# 13801+00		Field Station# 13791+00			
Pic 9 Desc. Sump and J-hook		Pic 10 Desc. S-D23 Banks and channel

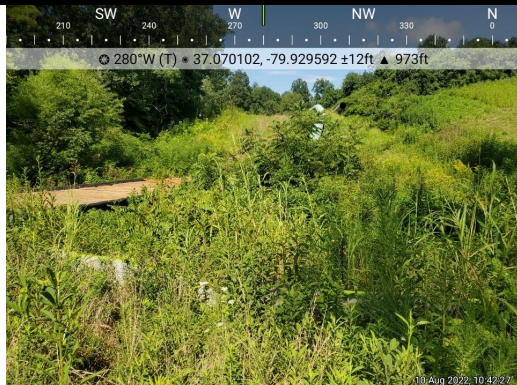
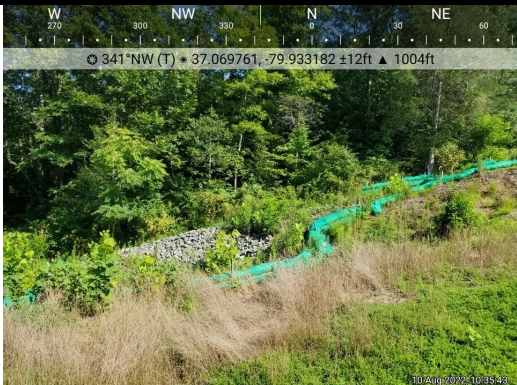
<p>ert image here</p>	
GPS Location 0		GPS Location 0			
Field Station# 13795+50		Field Station# 13783+50			
Pic 11 Desc. GAS S-D22 Buffer zone and silt fence		Pic 12 Desc. Rock lined Waterbar outlets and CFS

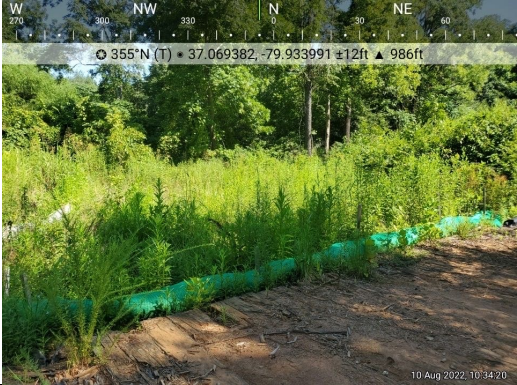
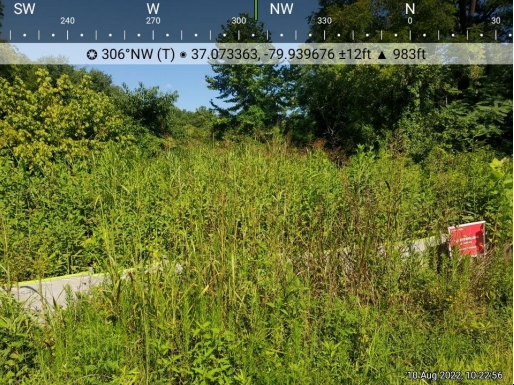
<p>GPS: 306°NW (T) • 37.073363, -79.939676 ±12ft ▲ 983ft 10 Aug 2022, 10:22:56</p>	
GPS Location	0	GPS Location	0	Field Station#	13780+50
Field Station#	13780+50	Field Station#	13756+50	Pic 13 Desc.	CIS S-RR15 Buffer zone ECDs
Pic 13 Desc.	CIS S-RR15 Buffer zone ECDs	Pic 14 Desc.	GAS S-EF12 Buffer zone silt fence and vegetation	Pic 14 Desc.	GAS S-EF12 Buffer zone silt fence and vegetation

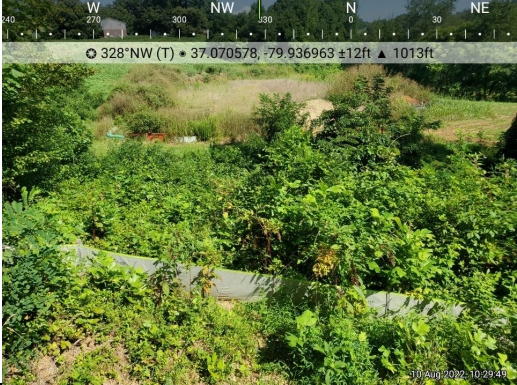
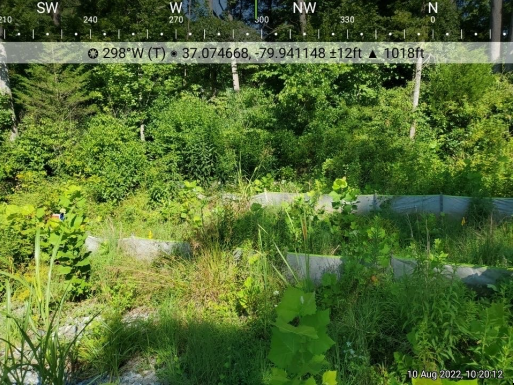
<p>GPS: 298°W (T) • 37.074668, -79.941148 ±12ft ▲ 1018ft 10 Aug 2022, 10:20:12</p>	
GPS Location	0	GPS Location	0	Field Station#	13771+50
Field Station#	13771+50	Field Station#	13750+00	Pic 15 Desc.	GAS S-MM42 Silt fence and buffer zone vegetation
Pic 15 Desc.	GAS S-MM42 Silt fence and buffer zone vegetation	Pic 16 Desc.	GAS Green Level Rd S-EF7 Perimeter silt fence	Pic 16 Desc.	GAS Green Level Rd S-EF7 Perimeter silt fence

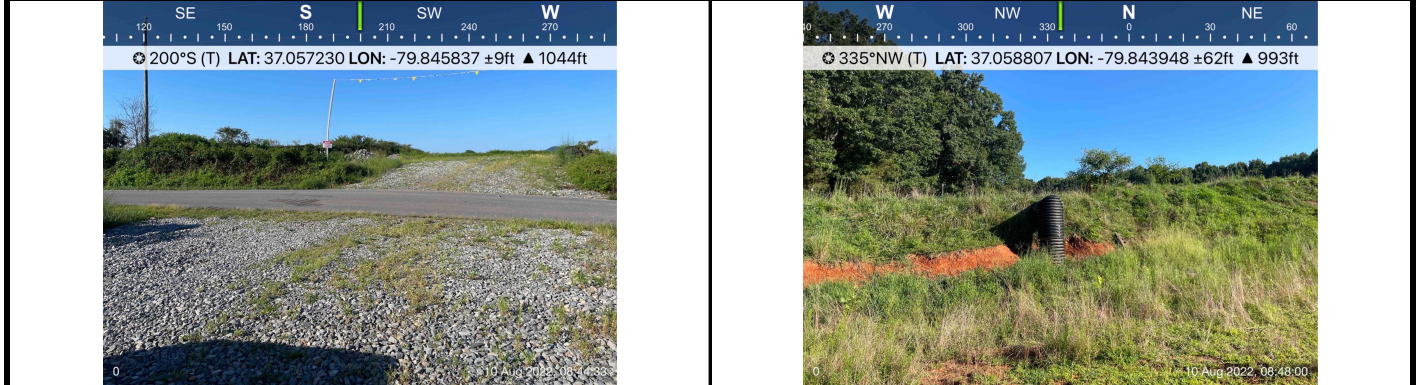
Pic 1 Desc.	RCEs are in good condition at all road crossings	Pic 2 Desc.	CWDs are functioning as intended
--------------------	--	--------------------	----------------------------------

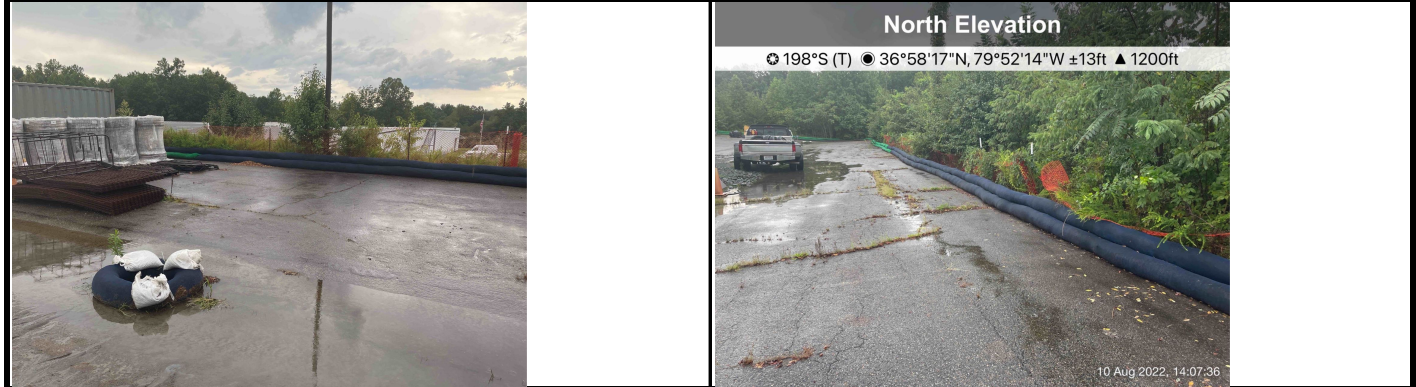
Pic 7 Desc.	Inlet protection for catch basin and perimeter ECD's on west side of LY-046 in good condition.	Pic 8 Desc.	Perimeter ECD's on south end of LY-046 in good condition.
--------------------	--	--------------------	---

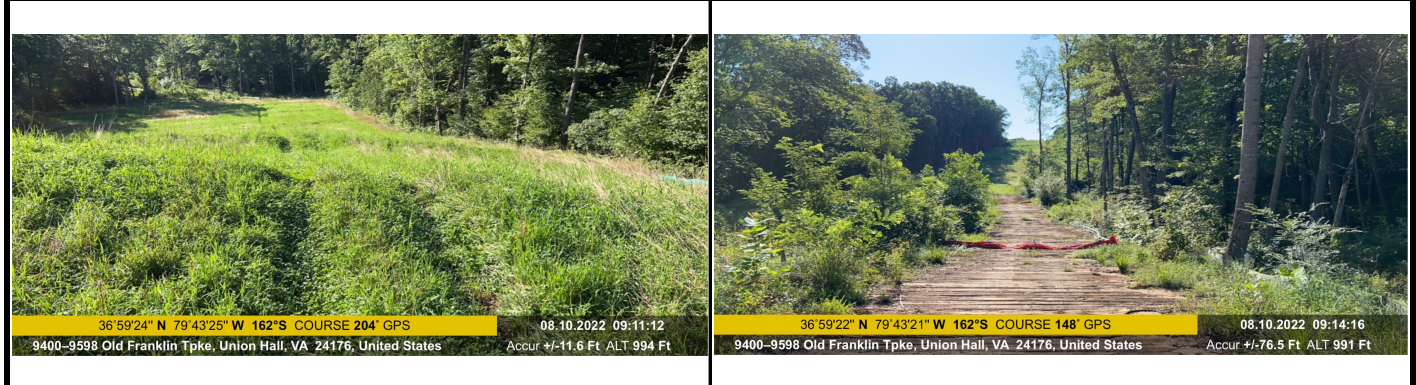
GPS Location	1	GPS Location	2
Field Station#	14654+00	Field Station#	14656+87
Pic 1 Desc.	ROW stabilized and vegetated in final cleanup area.	Pic 2 Desc.	Equipment bridge and surrounding ECDs in place and functional at stream crossing and resource buffer.

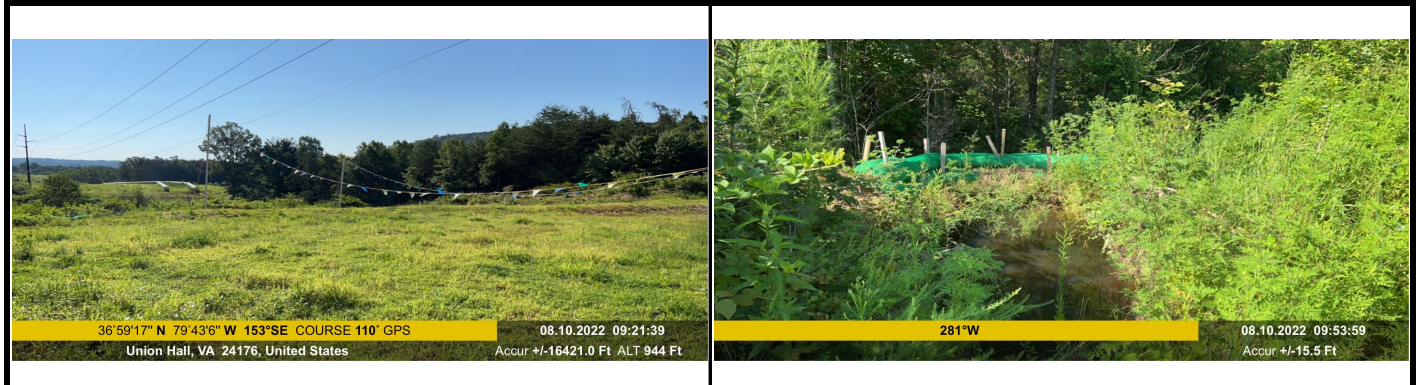
GPS Location	3	GPS Location	4
Field Station#	14669+50	Field Station#	14683+00
Pic 3 Desc.	ROW stabilized and vegetated in temporary area; perimeter controls in place and functional.	Pic 4 Desc.	Sump pit and CFS end treatment performing intended functions.

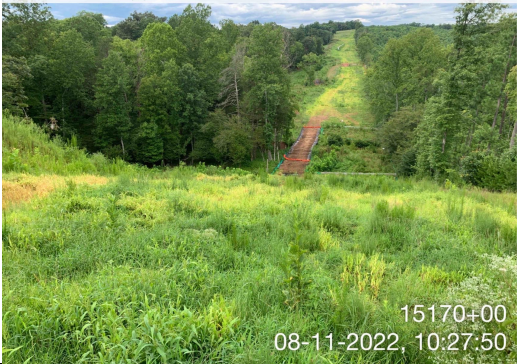
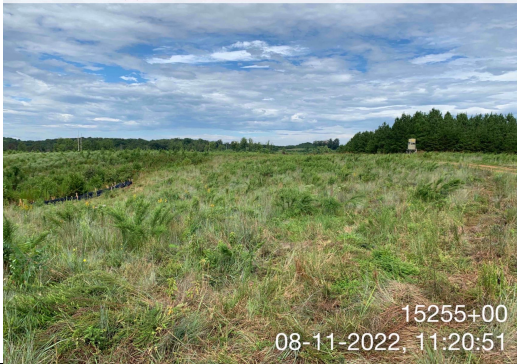
15255+00 08-11-2022, 11:20:51		
GPS Location 0			GPS Location 0		
Field Station# 15170+00			Field Station# 15255+00		
Pic 7 Desc. Temporary vegetative stabilization in acceptable condition			Pic 8 Desc. Permanent vegetative stabilization in acceptable condition		
166°S (T) ● 36.945163°, -79.573900° ±26ft ▲ 786ft

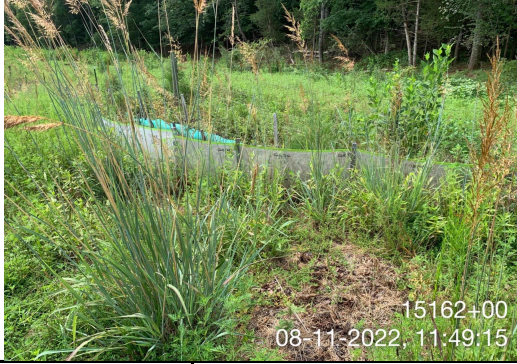
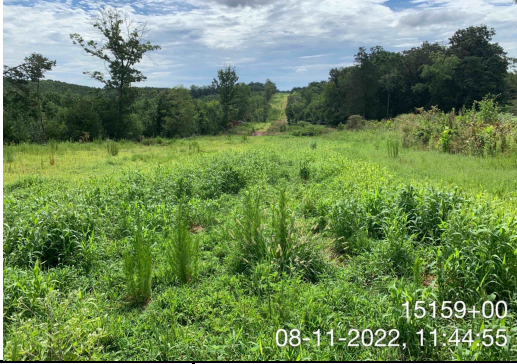
15159+00 08-11-2022, 11:44:55		
GPS Location 0			GPS Location 0		
Field Station# 15162+00			Field Station# 15159+00		
Pic 9 Desc. P1 silt fence in acceptable condition			Pic 10 Desc. Temporary vegetative stabilization in acceptable condition		
185°S (T) ● 36.943693°, -79.571321° ±13ft ▲ 731ft

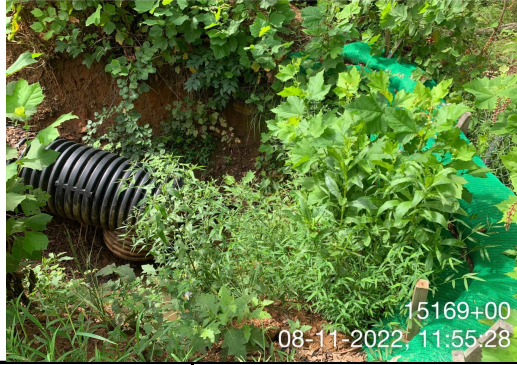
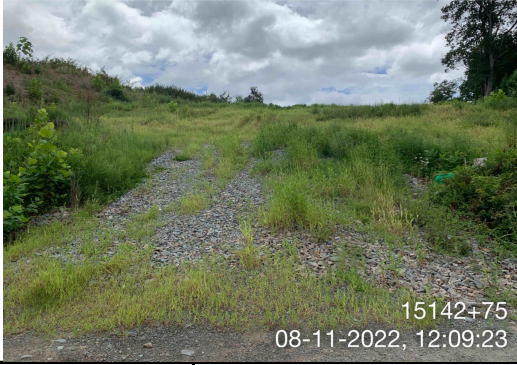
GPS Location 0			GPS Location 0		
Field Station# 15169+00			Field Station# 15142+75		
Pic 11 Desc. Sump pit and slope drain pipe in acceptable conditions			Pic 12 Desc. Rock construction entrance in acceptable condition

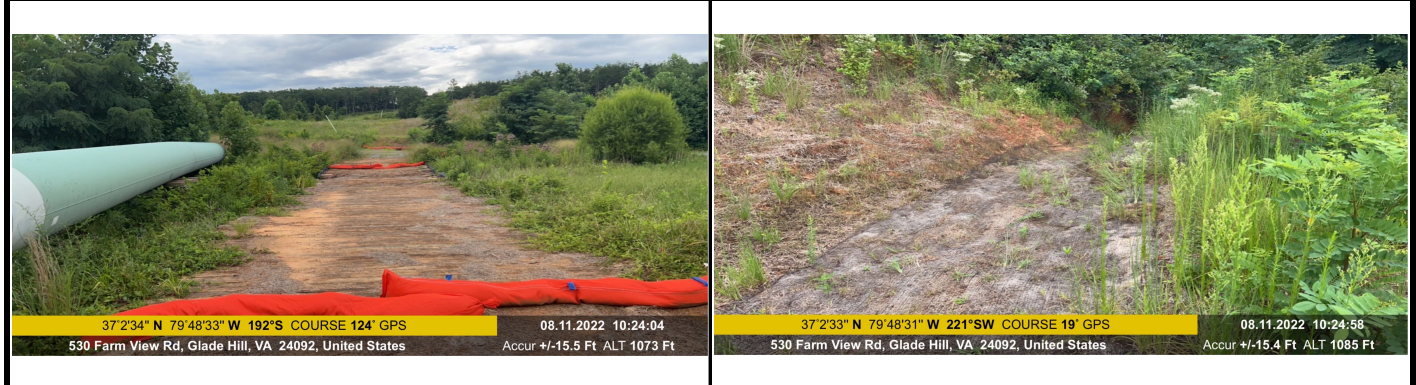
GPS Location 1	GPS Location 2
Field Station# 14314+79	Field Station# 14316+00
Pic 1 Desc. Equipment bridge and surrounding ECDs in place and functional at stream crossing and resource buffer.	Pic 2 Desc. Erosion control blanket in throat of water bar performing intended function.

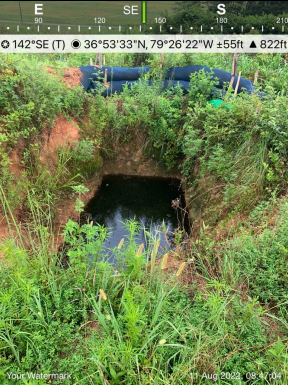
GPS Location	O	GPS Location	O		
Field Station#	15616+00	Field Station#	15614+94		
Pic 1 Desc.	Observing temporary stabilization, sump and end treatment	Pic 2 Desc.	Observing temporary stabilization, signage, buffer, equipment crossing and ECD's

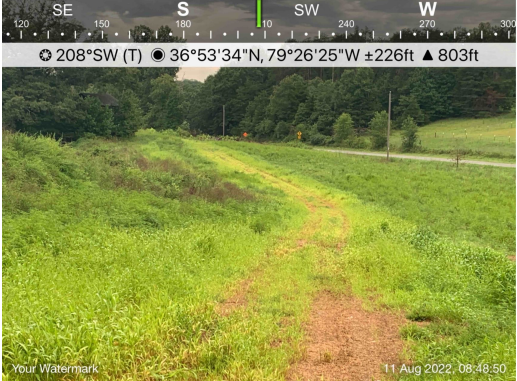
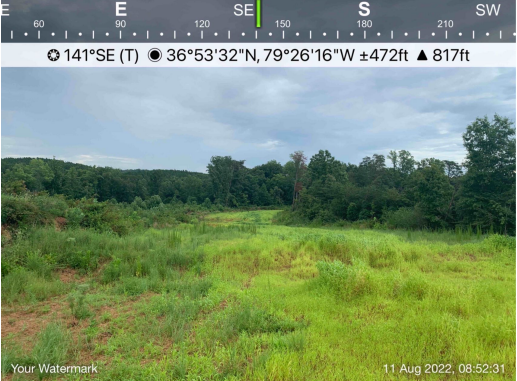
GPS Location	O	GPS Location	O		
Field Station#	15610+00	Field Station#	15623+00		
Pic 3 Desc.	Observing temporary stabilization	Pic 4 Desc.	Observing temporary stabilization and water bars

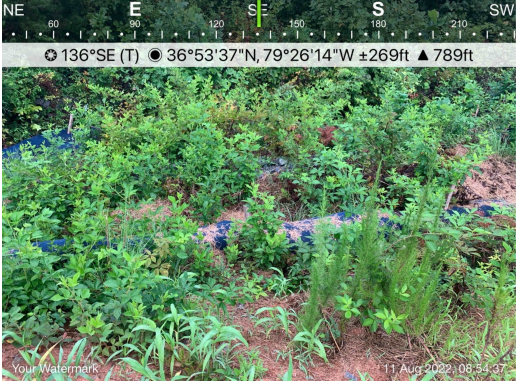
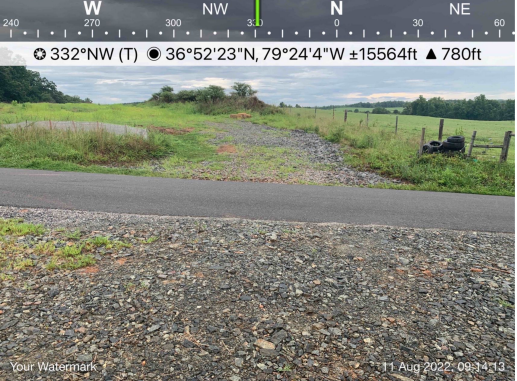
GPS Location	O	GPS Location	O		
Field Station#	15625+00	Field Station#	15647+03		
Pic 5 Desc.	Observing temporary stabilization, CWD outlet and ECD's	Pic 6 Desc.	Observing road crossing and RCE's

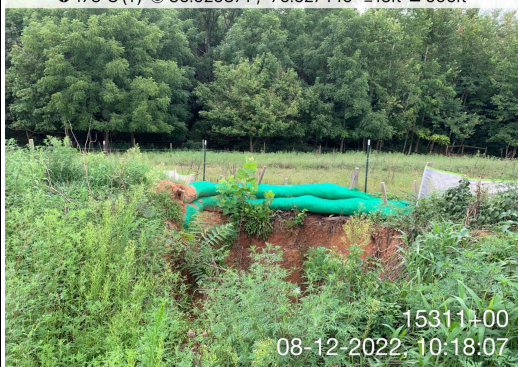
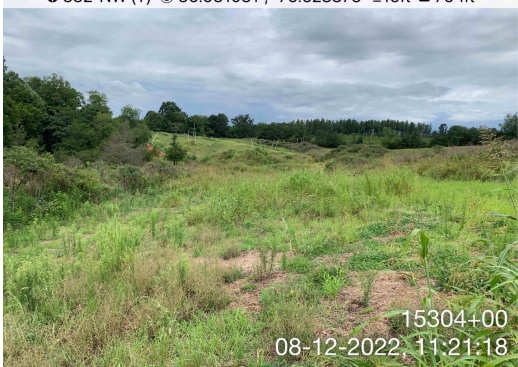
GPS Location 0		GPS Location 0			
Field Station# 15311+00		Field Station# 15304+00			
Pic 9 Desc. Waterbar end treatment in acceptable condition		Pic 10 Desc. Temporary vegetative stabilization in acceptable condition

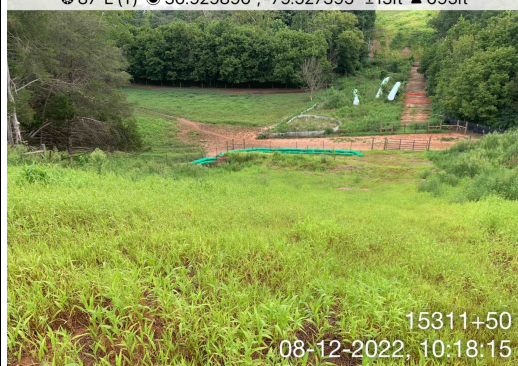
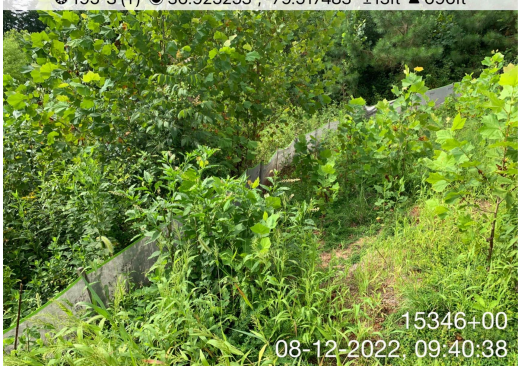
GPS Location 0		GPS Location 0			
Field Station# 15311+50		Field Station# 15346+00			
Pic 11 Desc. Temporary vegetative stabilization in acceptable condition		Pic 12 Desc. P1 silt fence in acceptable condition
