## Stream Biological Conditions EA Report

<b>Project Name</b>	H-600 Pipeline Spread A	<b>AFE</b>	124300129	<b>Spread</b>	H-600 Pipeline Spread A
<b>Contractor</b>	Precision	<b>Report #</b>	79		
<b>Environmental Auditor</b>	Samantha Felix	<b>Date/Time</b>	8/21/2023 10:09 AM		
<b>Stream ID</b>	S-A3a	<b>Crossing Start Date</b>	8/18/2023	<b>Crossing Completion Date</b>	8/20/2023
<b>Milepost</b>	0.81	<b>Pre-Con Assessment Date</b>	8/17/2023	<b>Post-Con Assessment Date</b>	8/20/2023
<b>Station</b>	42+62	<b>Bankfull Width (ft.)</b>	9.0	<b>Riffle:Pool Complexes Present?</b>	No
<b>State</b>	WV	<b>Stream Classification</b>	Intermittent		
<b>County</b>	Wetzel	<b>303(d) Impairment Listing</b>	No

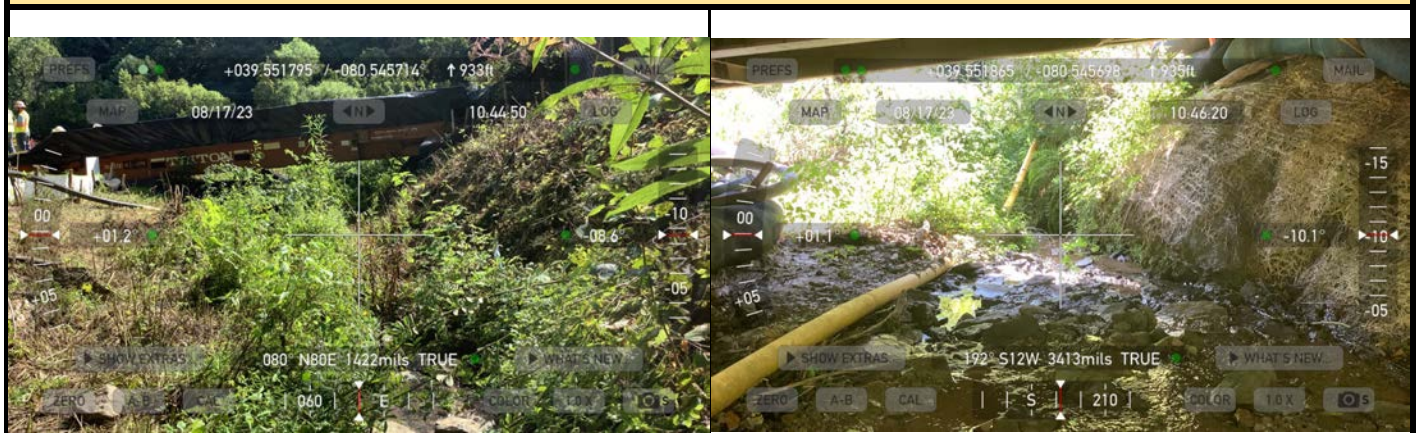
**GPS Location** see photo  
**Description** Downstream view of permitted impact area during pre-construction assessment.

**GPS Location** see photo  
**Description** Downstream view of unimpacted area during pre-construction assessment.
