Moun	V	ain Valley		Visu	ıal S	Site Ins	specti	on Re	epo	rt			
Project Nan	ne	H-600 Pipe	eline Spread	П	Al	FE 124300	139	Spre	ead	H-600 Pip	eline	Spread I	
Contract	or	Precision			-			Repo	ort # 38641				
Inspect	or	Ben Dave	nport					Date/Time 6/13/2022 1:59				PM	
Permit #	ТВІ	D		Inspection Type VA SWPP Station						n 14546	3+75		
State	VA			Inspection Area Partial Station End 14649+67									
County	Fra	nklin		Gr	Ground Dry Temperature (°F)						89.00		
Municipality	N/A	١		We	/eather Sunny Rain Gauge (in)						0.00		
					Rain Accumulation Time (days)						0.00

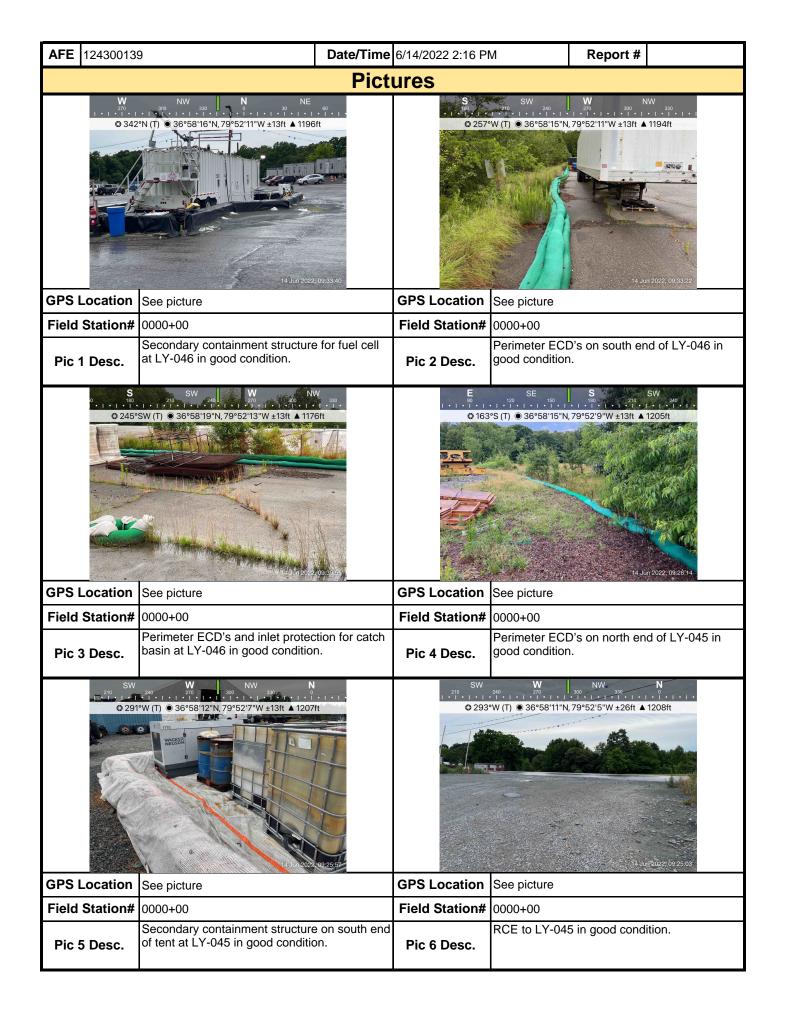
AFE 124300139	9	Date/Time	e 6/14/2022 2:16 PM Report #				
		Pictu	ıres				
South West Elevation			Insert image here				
GPS Location	See picture	1	GPS Location				
Field Station#			Field Station#				
Pic 7 Desc.	Perimeter ECD's on west side of employee parking area at LY-045		Pic 8 Desc.				
	Insert image here			Insert im	age here		
GPS Location			GPS Location				
Field Station#			Field Station#				
Pic 9 Desc.			Pic 10 Desc.				
	Insert image here			Insert im	age here		
GPS Location			GPS Location				
Field Station#			Field Station#				
Pic 11 Desc.			Pic 12 Desc.

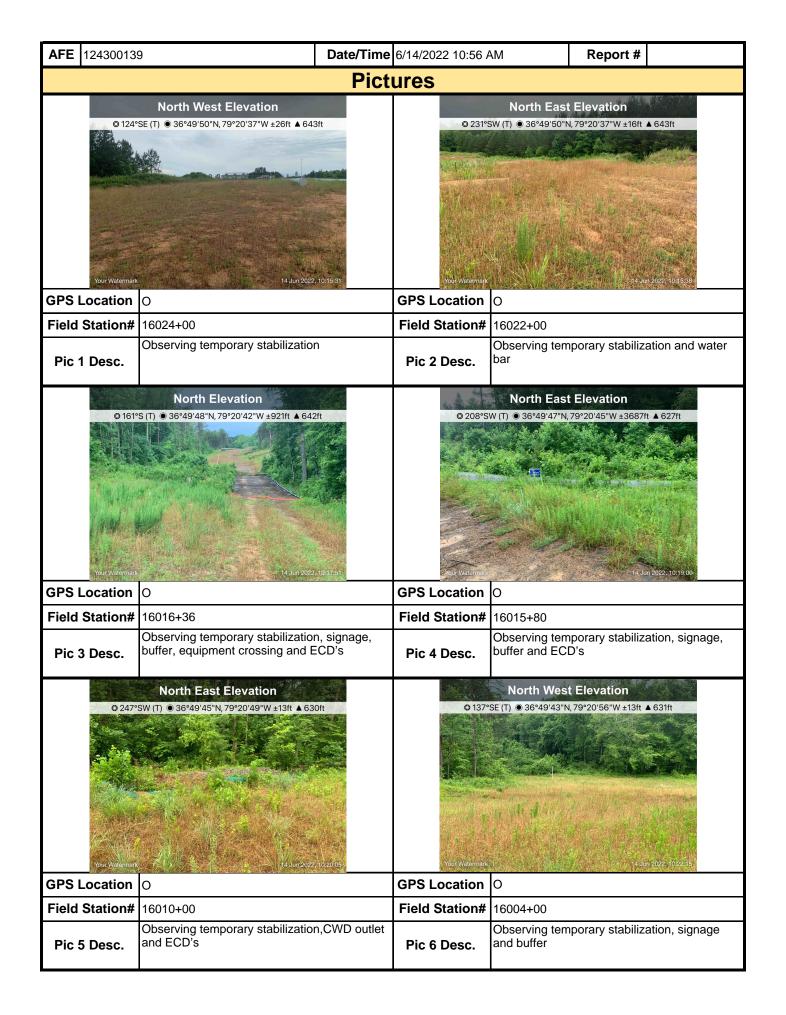
AFE 124300139	9	Date/Time 6/14	1/2022 10:56 A							
		Picture	es							
	Vest Elevation 19'43"N, 79°20'56"W ±118ft ▲ 628ft 14 Jin 2022 10'22.40		Insert image here							
GPS Location	0	GP	S Location							
Field Station#			eld Station#							
Pic 7 Desc.	Observing temporary stabilization sump and end treatment	n,water bar,	ic 8 Desc.							
	Insert image here		· · ·	Insert im	age here					
GPS Location			S Location							
Field Station#		Fie	eld Station#							
Pic 9 Desc.		Pio	c 10 Desc.							
	Insert image here			Insert im	age here					
GPS Location		GP	S Location							
Field Station#		Fie	eld Station#							
Pic 11 Desc.		Pic	c 12 Desc.

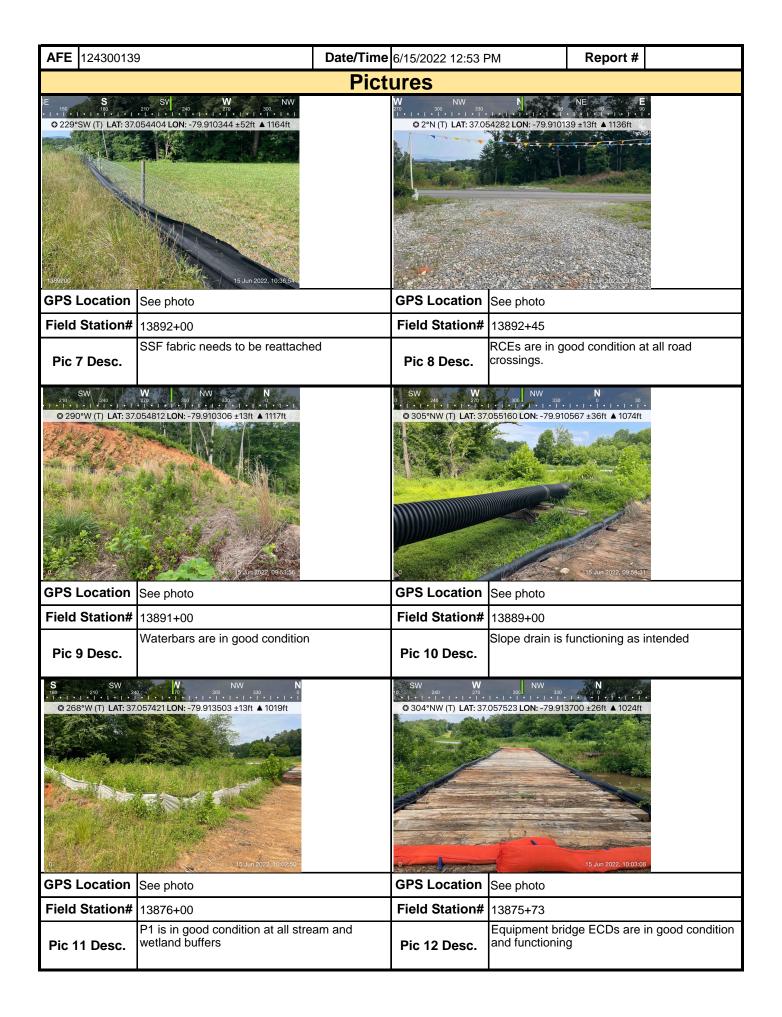
AFE 12430013	9	Date/Time	6/15/2022 12:53 F	PM	Report #			
		Pict	ures					
20 ≥ 247°SW(T) LAT: 37	SW 210 300 NW 330 058395 LON: -79.917733 ±26ft ▲ 1021ft		Insert image here					
	See photo		GPS Location					
Field Station#			Field Station#					
Pic 13 Desc.	Resource buffers remain well veg	getated	Pic 14 Desc.					
	Insert image here			Insert im	age here			
GPS Location			GPS Location					
Field Station#			Field Station#					
Pic 15 Desc.			Pic 16 Desc.					
	Insert image here			Insert im	age here			
GPS Location			GPS Location					
Field Station#			Field Station#					
Pic 17 Desc.			Pic 18 Desc.

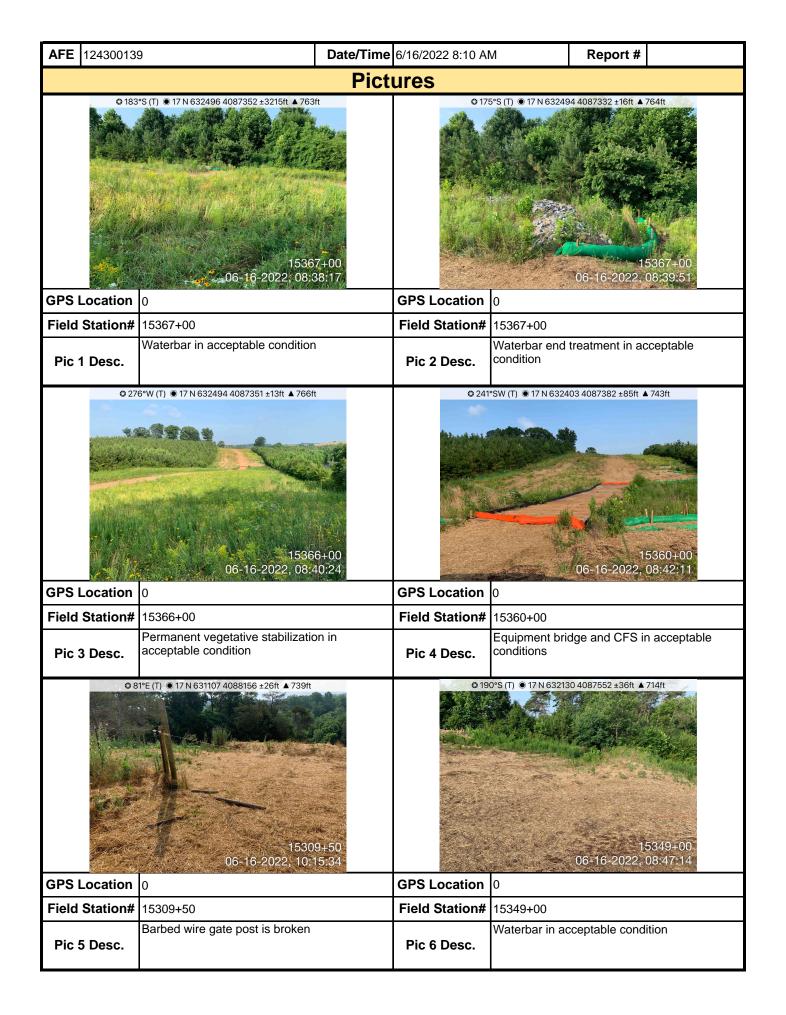
AFE 124	4300139		Date/Time	6/16/2022 8:10 AM	И	Report #	
			Pict	ures			
© 300°	NW (T) © 1	7 N 632120 4087541 ±19ft ▲ 715ft 15349+00 06-16-2022, 08:48-11		• 188°S (T) • 17	7 N 631590 4088004 06-16-1	±42ft ▲ 709ft 15327+00 2022, 08:55:30	
GPS Loc	ation	0		GPS Location	0		
Field Sta	ation#	15349+00		Field Station#			
Pic 7 De		Waterbar end treatment in accept condition	table	Pic 8 Desc.	CFS and equip conditions	oment bridge in	acceptable
		7 N 631212 4088101 ±22ft ▲ 664ft 15313+50 06-16-2022, 09:40:36				3±36ft \$ 660ft 15312+50 2022 09 40 54	
GPS Loc	ation	0		GPS Location	0		
Field Sta		15313+50		Field Station#			
Pic 9 De		P1 silt fence in acceptable condit	ion	Pic 10 Desc.	Super silt fence	e in acceptable	condition
© 287	7°W (T) ● 1	7 N 631071 4088193 ±13ft ▲ 760ft 15307+00 06-16-2022, 10:13:38			Insert im	age here	
GPS Loc	ation			GPS Location			
Field Sta	ation#	15307+00		Field Station#			
Pic 11 D		Clean water diversion berm in accondition	ceptable	Pic 12 Desc.

- The EI performed a SWPPP inspection from 15260+00 to 15370+62 (Pigg River HDD Exit to Snowberry Road). One punch list item was submitted consisting of a broken post on a barbed wire gate. Other inspected ECDs were observed as being in compliance at the time of inspection.
- Since the last SWPPP the contractor has worked in the area and addressed punch list items and performed seeding and mulching.
- Since the last SWPPP inspection the area has received one rain event with totals of 0.30" at Armstrong Road and 0.10" at Snowberry Road.
- The ROW ground condition is dry.
- At the time of inspection permanent vegetative stabilization was adequately established to inhibit erosion from 15355+00 to 15370+00
- At the time of inspection temporary vegetative stabilization was adequately established to inhibit erosion.

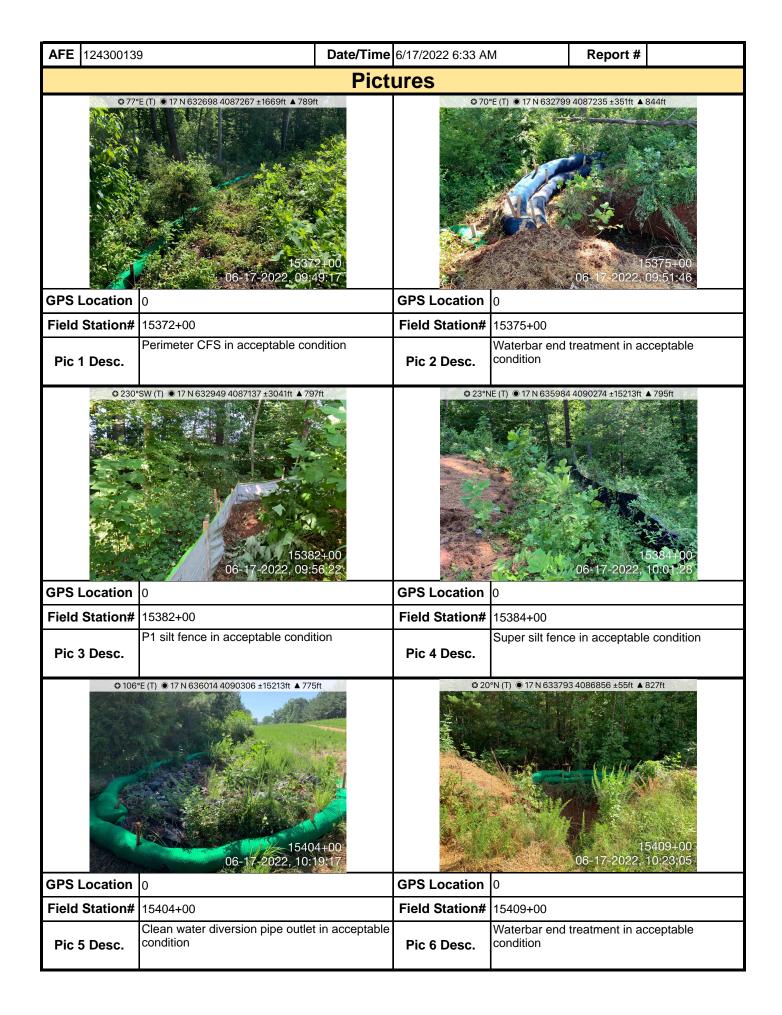
AFE 12430013	9	Date/Time 6/17/2022 6:33 A	M	Report #				
		Pictures	ctures					
● 18°N (T) ● 17	7 N 633797 4086847 ±59ft ▲ 827ft 15409+00 06-17-2022, 10:23:43	© 291°W (T)	© 291°W (T) ● 17 N 635854 4090163 ±15213ft ▲ 788ft 15420+00 06-17-2022, 10:40:59					
GPS Location	0	GPS Location	0					
Field Station#		Field Station#						
Pic 7 Desc.	Waterbar in acceptable condition	Pic 8 Desc.	Mulching in ac	ceptable condit	tion			
	7 N 634180 4086686 ±45ft ▲ 819ft 15423+00 06-17-2022, 10:42:43		计划的	15426+54 2022, 10:52:38				
GPS Location		GPS Location						
Field Station# Pic 9 Desc.	15423+00 Clean water diversion berm in accondition	reptable Pic 10 Desc.	15426+54 Equipment brid	dge in acceptab	ole condition			
●182°S(T) ● 17	N 634754 4087635 ±9055ft ▲ 771ft 15426+54 06-17-2022, 10:48:35		Insert im	age here				
GPS Location	0	GPS Location						
Field Station#		Field Station#						
Pic 11 Desc.	Stream entering ROW is turbid fro disturbance not related to MVP ac	om upstream pic 12 Desc.

- The EI observed that stream S-G4 (15426+53) was turbid entering the ROW. This is a result of an upstream disturbance not related to MVP activities.
- The contractor has been in this area addressing punch list items and performing seeding and mulching since the last SWPPP inspection.
