Baseline Assessment – Stream Attributes

Reach S-E46 TM (Timber Mat Crossing) Perennial Spread D Webster County, West Virginia

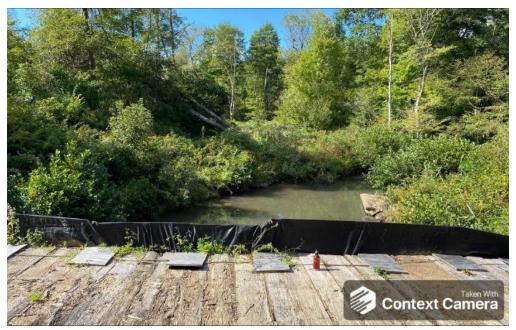
Photo Type: DS, US View Location, Orientation, Photographer Initials: Downstream Edge of ROW, Upstream View, RC/CC Lat: 38.363374 Long: -80.617277

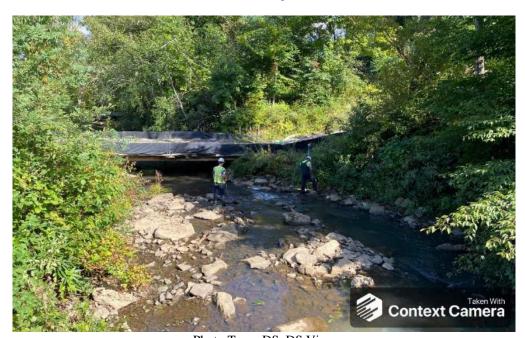
Photo Type: DS, DS View Location, Orientation, Photographer Initials: Downstream Edge of ROW, Downstream View, RC/CC Lat: 38.363374 Long: -80.617277

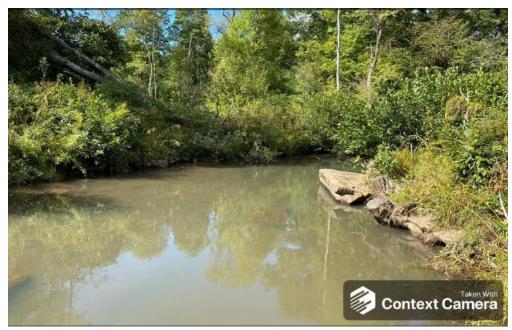
Photo Type: US View at Center Location, Orientation, Photographer Initials: Center ROW, Upstream View, RC/CC Lat: 38.363374 Long: -80.617277

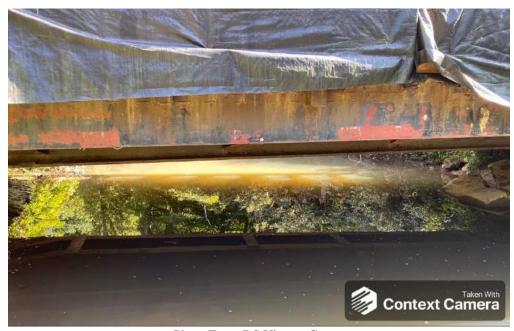
Photo Type: DS View at Center Location, Orientation, Photographer Initials: ROW Center, Downstream View, RC/CC Lat: 38.363374 Long: -80.617277

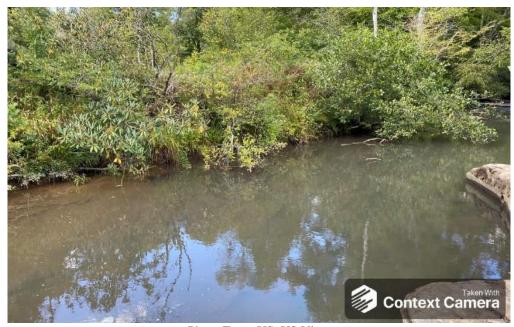
Photo Type: US, US View Location, Orientation, Photographer Initials: Upstream Edge of ROW, Upstream View, RC/CC Lat: 38.363374 Long: -80.617277

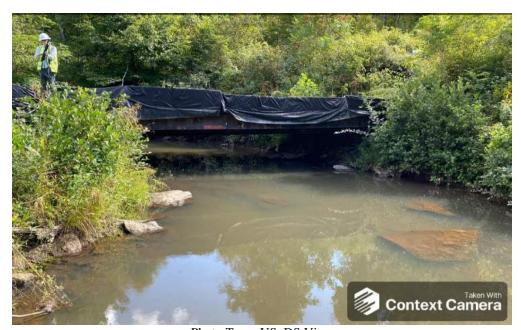
Photo Type: US, DS View Location, Orientation, Photographer Initials: Upstream Edge of ROW, Downstream View, RC/CC Lat: 38.363374 Long: -80.617277

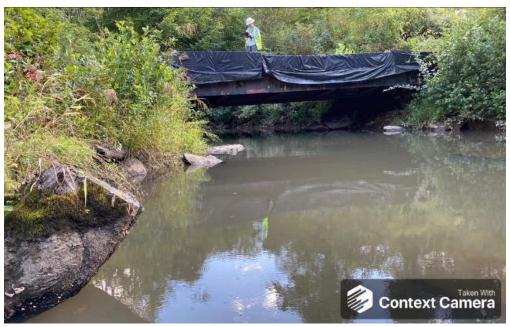
Photo Type: Pool, DS View
Location, Orientation, Photographer Initials: Upstream of Pool, Downstream View, RC/CC
Lat: 38.363374 Long: -80.617277

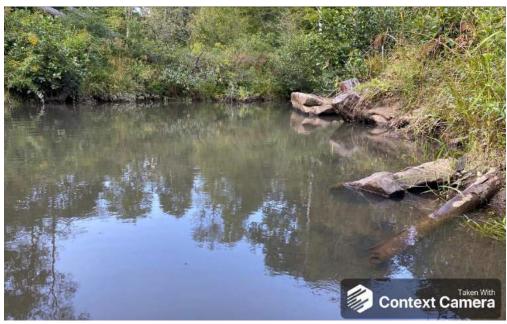
Photo Type: Pool, US View Location, Orientation, Photographer Initials: Downstream of Pool, Upstream View, RC/CC Lat: 38.363374 Long: -80.617277

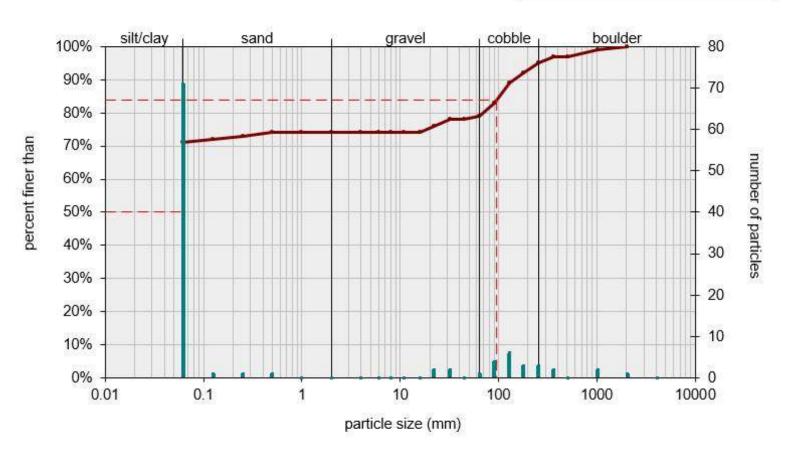
WOLMAN PEBBLE COUNT FORM

Size (r	mm)	•
904	D16	0.062	-13
	D35	0.062	
	D50	0.062	
	D65	0.062	
	D84	95	
	D95	260

Size Distr	ribution
mean	2.4
dispersion	766.6
skewness	0.89

Туре		
silt/clay	71%	
sand	3%	
gravel	5%	
cobble	16%	
boulder	5%

LE COUNT				
Inches	PARTICLE	Millimeters		Particle Count	Total #	Item %	% Cun
	Silt/Clay	< .062	S/C	A	71	71.00	71.00
	Very Fine	.062125		-	1	1.00	72.00
	Fine	.12525]	A	1	1.00	73.00
	Medium	.255	SAND	*	1	1.00	74.00
	Coarse	.50-1.0		A	0	0.00	74.00
.0408	Very Coarse	1.0-2		-	0	0.00	74.00
.0816	Very Fine	2 -4	GRAVEL	•	0	0.00	74.00
.1622	Fine	4 -5.7		-	0	0.00	74.00
.2231	Fine	5.7 - 8		A	0	0.00	74.00
.3144	Medium	8 -11.3		A	0	0.00	74.00
.4463	Medium	11.3 - 16		A	0	0.00	74.00
.6389	Coarse	16 -22.6			2	2.00	76.00
.89 - 1.26	Coarse	22.6 - 32			2	2.00	78.00

1.26 - 1.77	Vry Coarse	32 - 45	1		0	0.00	78.00
1.77 -2.5	Vry Coarse	45 - 64	1		1	1.00	79.00
2.5 - 3.5	Small	64 - 90		-	4	4.00	83.00
3.5 - 5.0	Small	90 - 128	1		6	6.00	89.00

5.0 - 7.1	Large	128 - 180	COBBLE	^	3	3.00	92.00
7.1 - 10.1	Large	180 - 256	_		3	3.00	95.00
10.1 - 14.3	Small	256 - 362		A	2	2.00	97.00
14.3 - 20	Small	362 - 512	BOULDER		0	0.00	97.00
20 - 40	Medium	512 - 1024		A	2	2.00	99.00
40 - 80	Large	1024 -2048		^	1	1.00	100.0
80 - 160	Vry Large	2048 -4096		A	0	0.00	100.0
	Bedrock		BDRK	<u> </u>	0	0.00	100.0
				Totals:	100

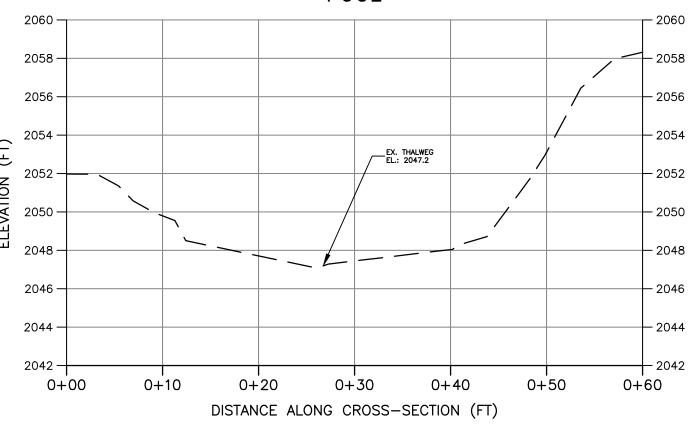
S-E46 TM BASELINE CROSS-SECTION A POOL 2058 -2050 -2044 -0+30 DISTANCE ALONG CROSS-SECTION (FT)

CROSS SECTION LEGEND — EXISTING GRADE CROSS SECTION
H: 1"=10'
V: 1"=5'

NOTE: ALL SECTIONS VIEWS SHOWN LEFT TO RIGHT FACING DOWNSTREAM.

AS-BUILT TABLE: S-E46 TM CROSS SECTION A					
	PRE-CROSSING		AŞ-BUILT		
PT. LOC.	NORTHING	EASTING	ELEV	VERT. DIFF.	HORZ. DIFF.
TS-L	13931093.6300	1750125.8710	2050.156'		
BS-L	13931092.6200	1750123.58401	2048.834'		
THW	13931085.9900	1750111.4670	2047.135'		
BS-R	13931077.6700	1750094.3670	2048.839'		
TS-R	13931077.1500	1750093.35501	2050.306'

- 4. ALL SECTION VIEWS SHOWN LEFT TO RIGHT FACING DOWNSTREAM.
- 5. POST-CROSSING SURVEY INFORMATION SHOWN IN RED. DATA PENDING.
- 6. POST-CROSSING SURVEY POINTS FOR CROSS SECTIONS AND THALWEG ARE PROJECTED ONTO PRE-CROSSING SECTION AND PROFILE VIEWS FOR COMPARISON.

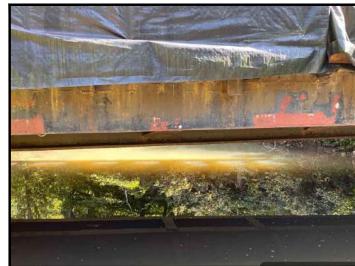
PHOTO TAKEN LOOKING DOWNSTREAM FROM UPSTREAM IMPACT LIMITS

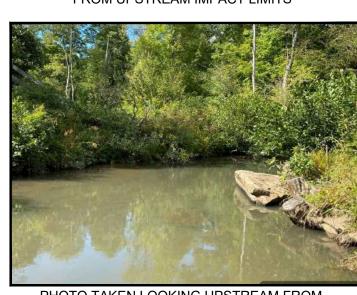
PHOTO TAKEN LOOKING UPSTREAM FROM DOWNSTREAM IMPACT LIMITS
