Baseline Assessment – Stream Attributes

Reach S-J46 (Timber Mat Crossing)

Spread B

Lewis County, West Virginia

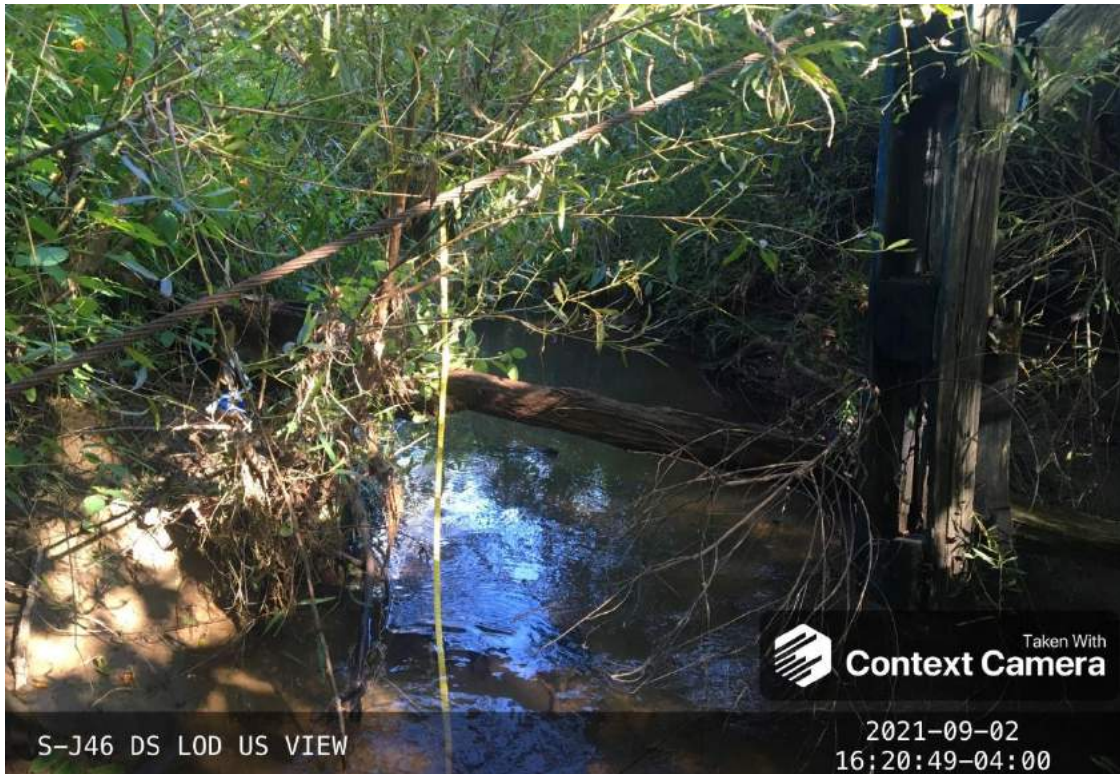
Photo Type: DS, US View
Location, Orientation, Photographer Initials: Downstream Edge of ROW, Upstream View, DP, HK, VM
Lat: 39.094778 Long: -80.584826

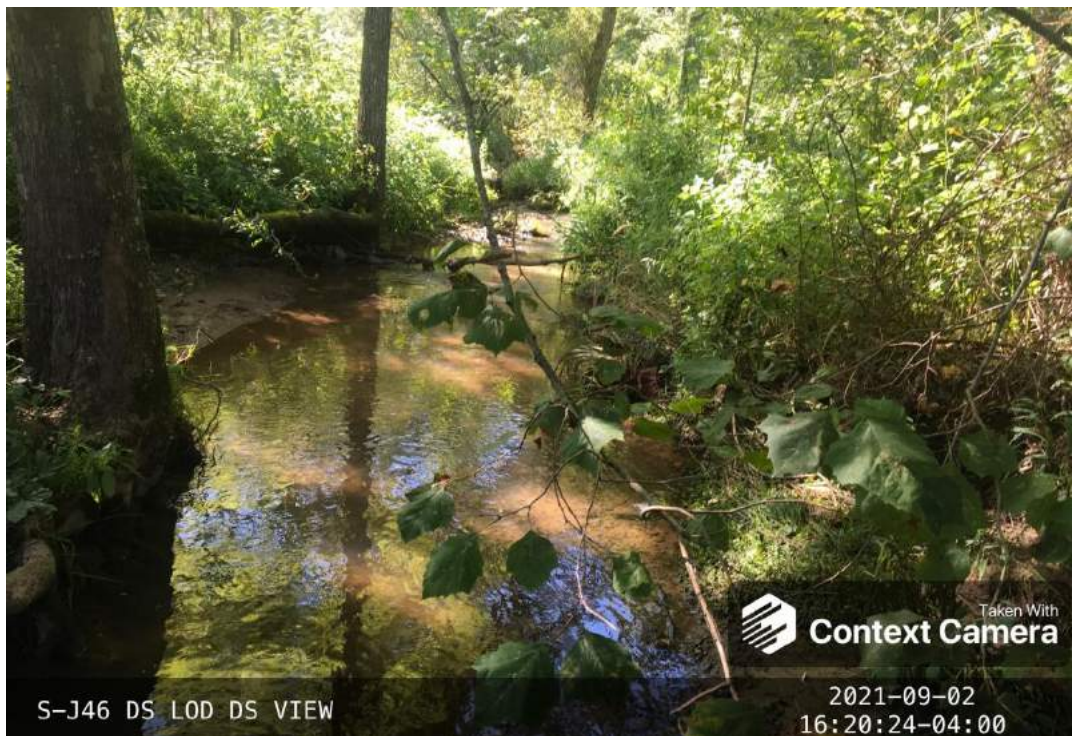
Photo Type: DS, DS View
Location, Orientation, Photographer Initials: Downstream Edge of ROW, Downstream View, DP, HK, VM
Lat: 39.094778 Long: -80.584826

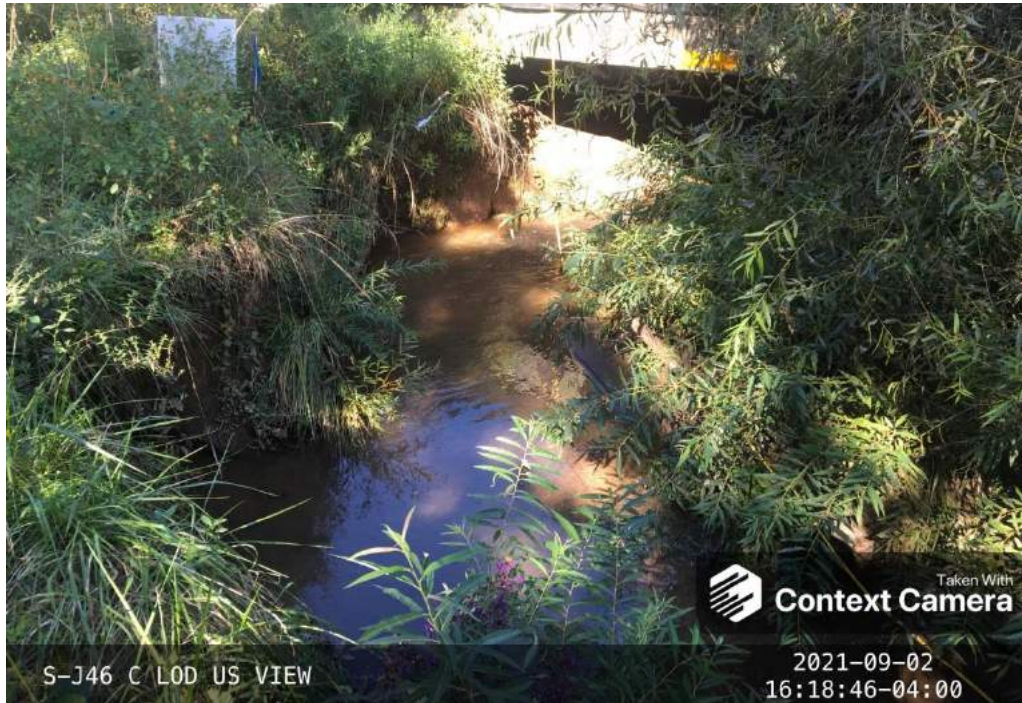
Photo Type: US View at Center
Location, Orientation, Photographer Initials: Center ROW, Upstream View, DP, HK, VM
Lat: 39.094778 Long: -80.584826

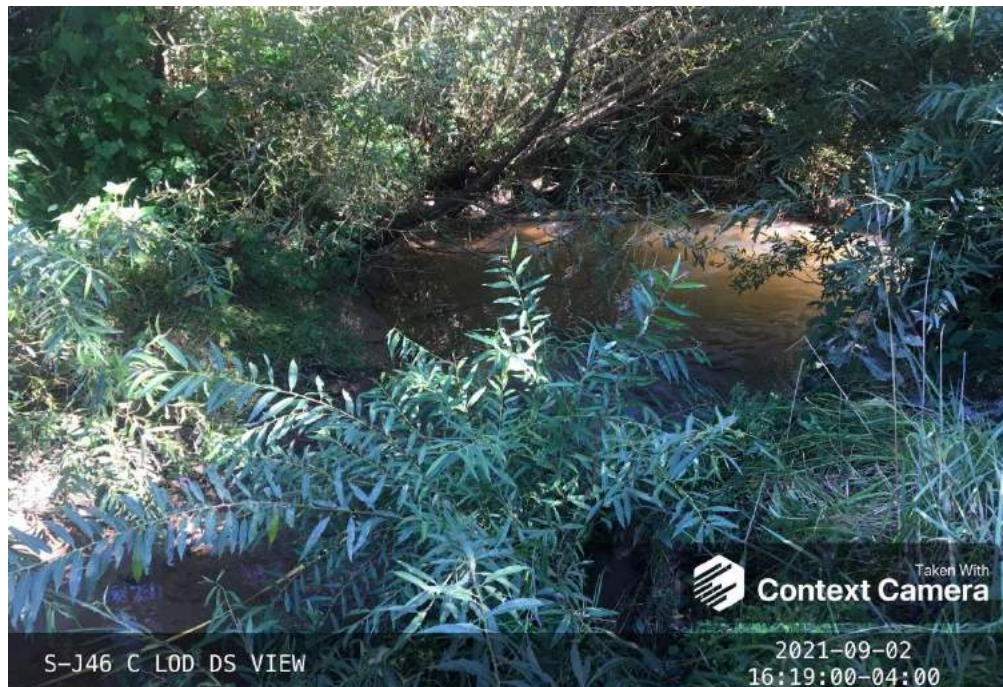
Photo Type: DS View at Center
Location, Orientation, Photographer Initials: ROW Center, Downstream View, DP, HK, VM
Lat: 39.094778 Long: -80.584826

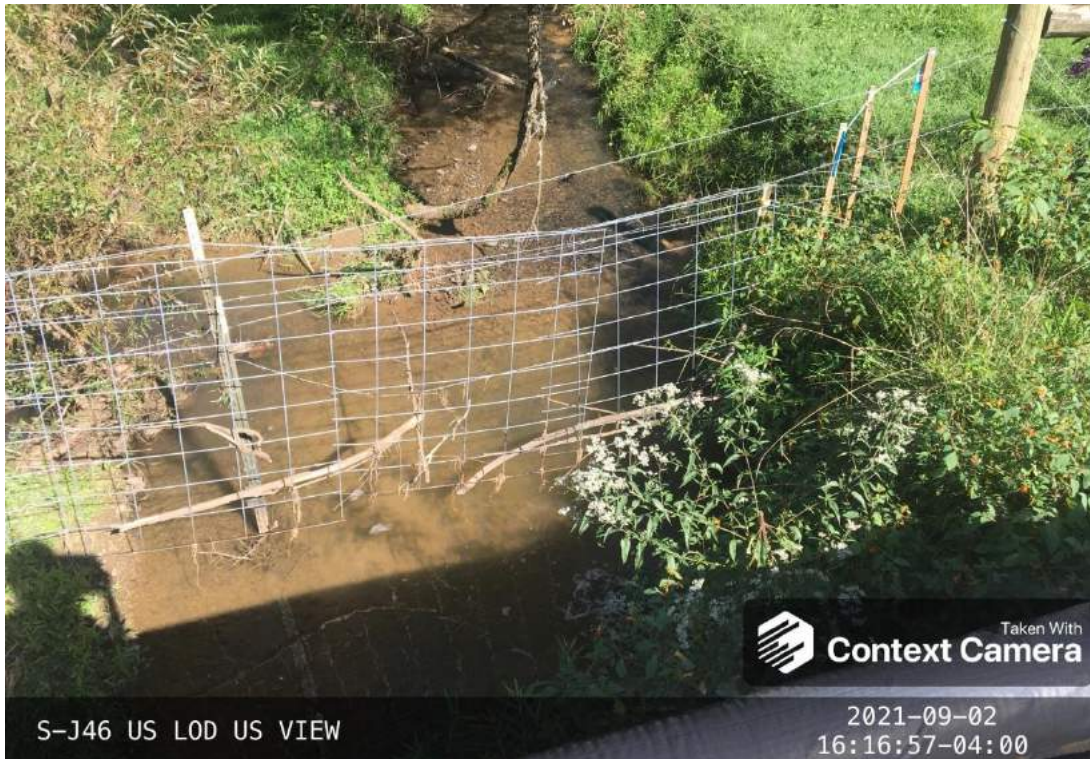
Photo Type: US, US View
Location, Orientation, Photographer Initials: Upstream Edge of ROW, Upstream View, DP, HK, VM
Lat: 39.094778 Long: -80.584826

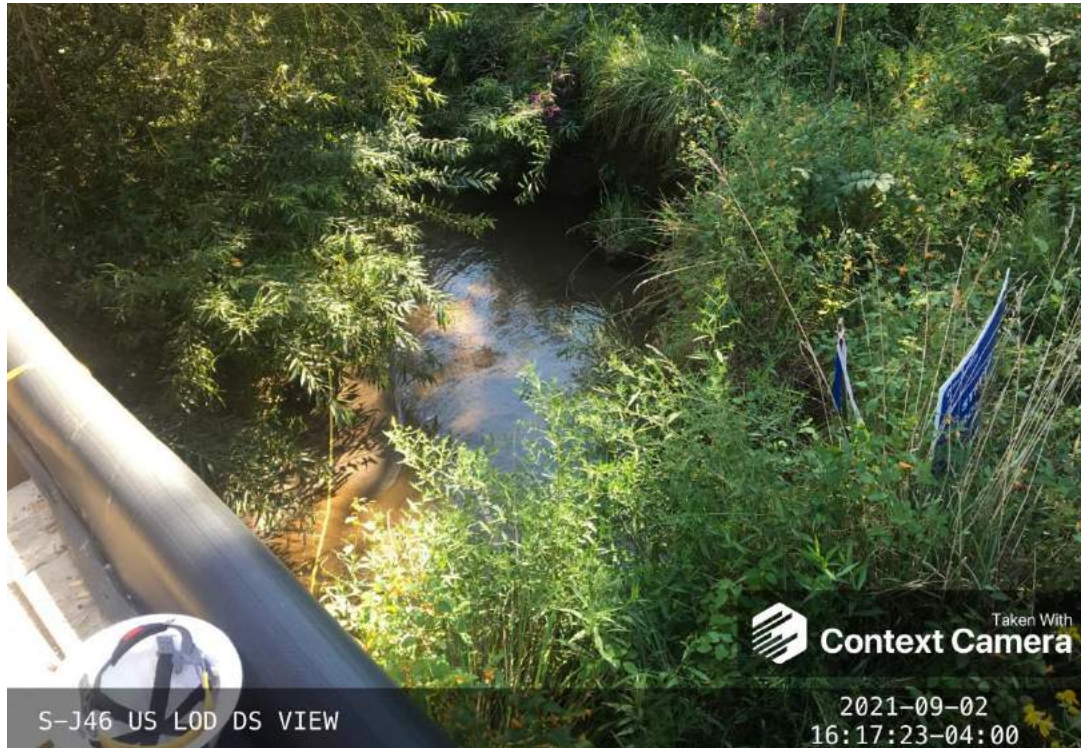
Photo Type: US, DS View
Location, Orientation, Photographer Initials: Upstream Edge of ROW, Downstream View, DP, HK, VM
Lat: 39.094778 Long: -80.584826

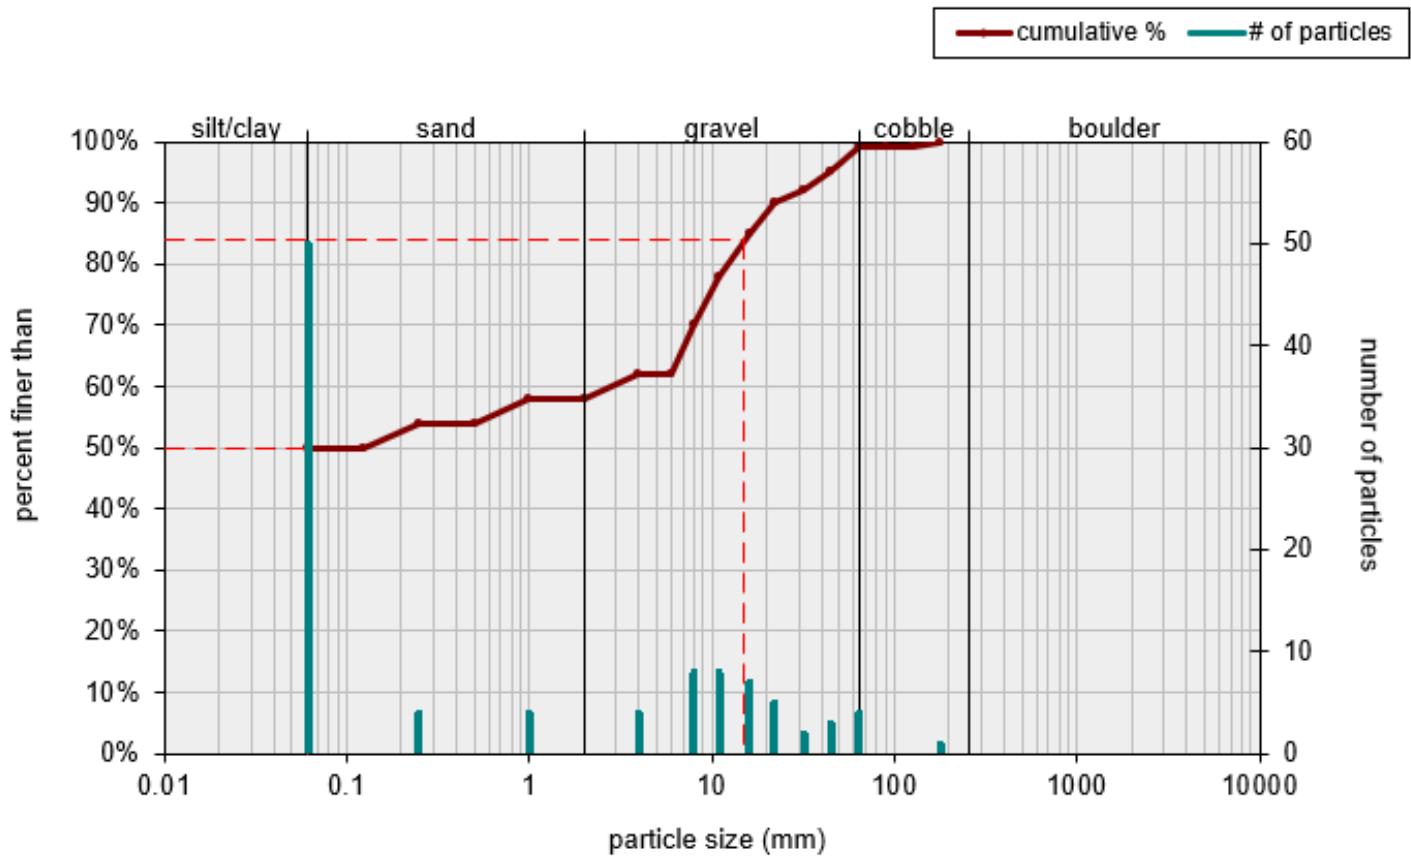
Bankfull Channel Pebble Count, S-J46

Size (mm)		Size Distribution		Type	
D16	0.062	mean	1.0	silt/clay	50%
D35	0.062	dispersion	121.5	sand	8%
D50	0.062	skewness	0.77	gravel	41%
D65	6.7			cobble	1%
D84	15			boulder	0%
D95	45

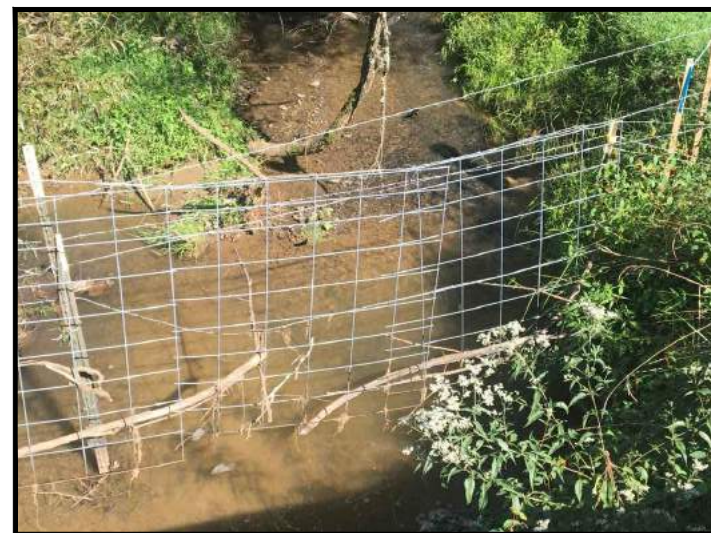
PHOTO TAKEN LOOKING DOWNSTREAM
FROM UPSTREAM IMPACT LIMITS

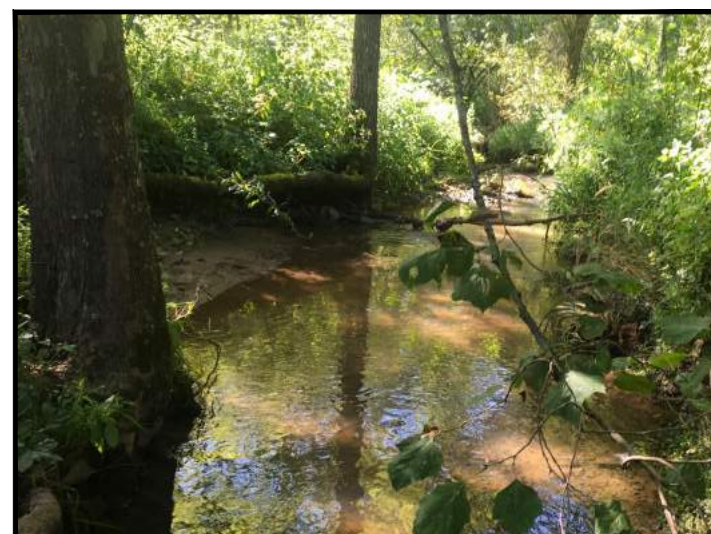
PHOTO TAKEN LOOKING UPSTREAM FROM
DOWNSTREAM IMPACT LIMITS
