Baseline Assessment – Stream Attributes

Reach S-KK5 (1) (Timber Mat Crossing) Intermittent Spread B Lewis County, West Virginia

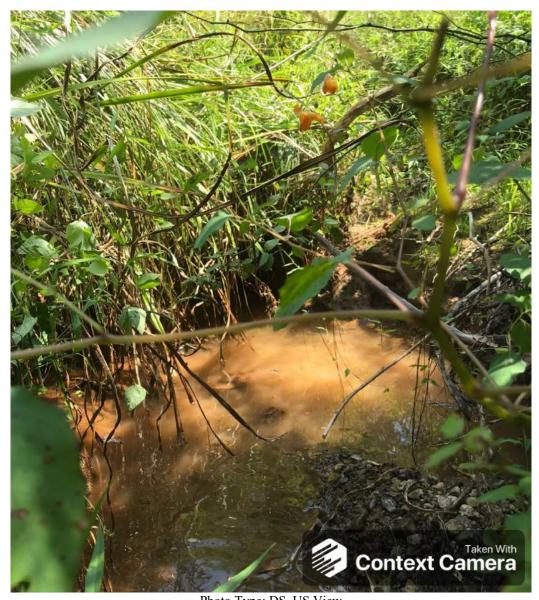
Photo Type: DS, US View
Location, Orientation, Photographer Initials: Downstream Edge of ROW, Upstream View, DD/PL/LC/KP
Lat: 39.017783 Long: -80.596853

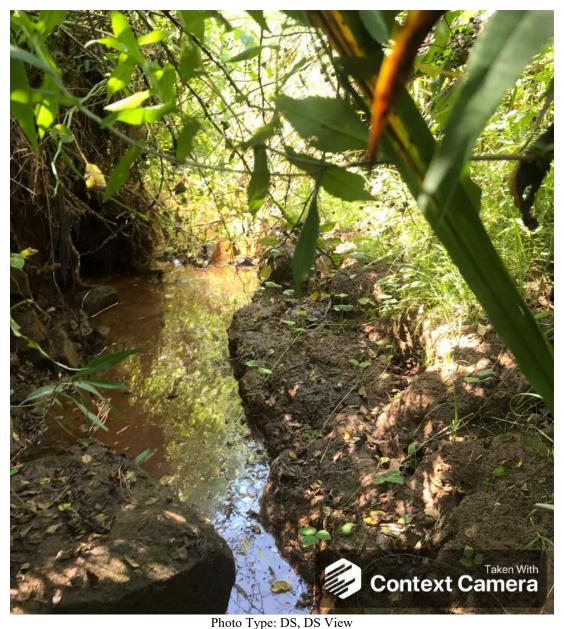
Location, Orientation, Photographer Initials: Downstream Edge of ROW, Downstream View, DD/PL/LC/KP Lat: 39.017783 Long: -80.596853

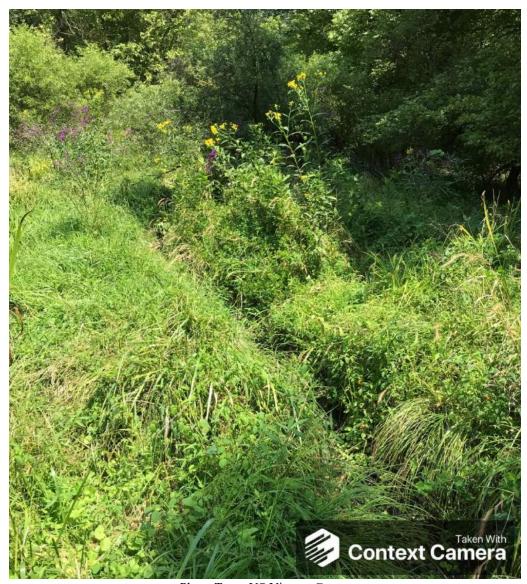
Photo Type: US View at Center Location, Orientation, Photographer Initials: Center ROW, Upstream View, DD/PL/LC/KP Lat: 39.017783 Long: -80.596853

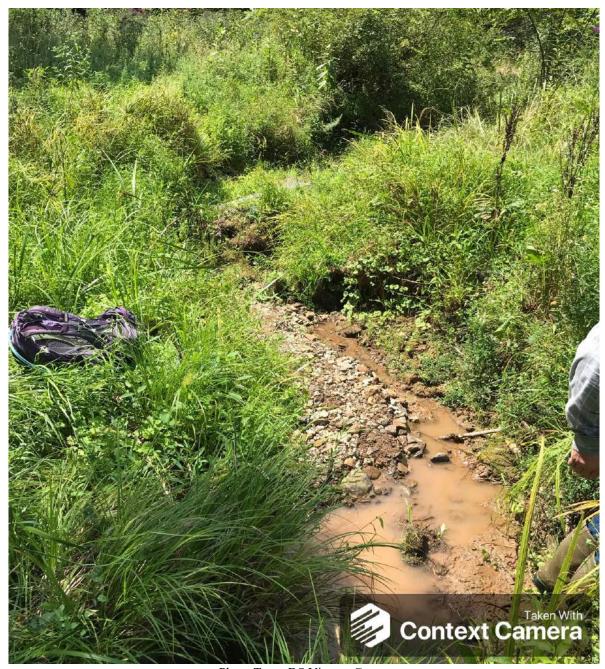
Photo Type: DS View at Center Location, Orientation, Photographer Initials: ROW Center, Downstream View, DD/PL/LC/KP Lat: 39.017783 Long: -80.596853

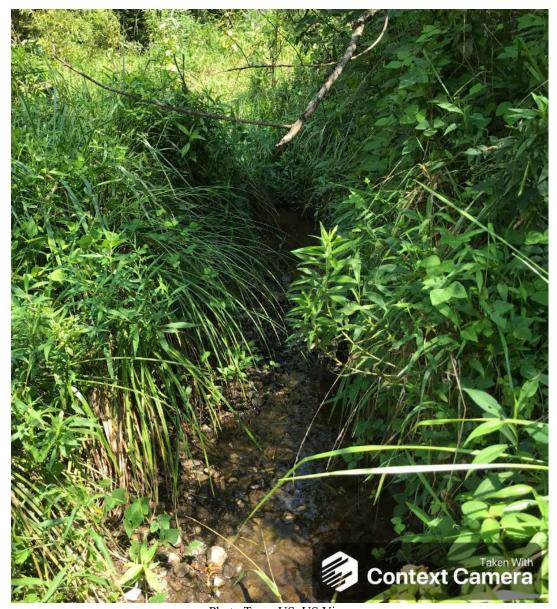
Photo Type: US, US View
Location, Orientation, Photographer Initials: Upstream Edge of ROW, Upstream View, DD/PL/LC/KP
Lat: 39.017783 Long: -80.596853

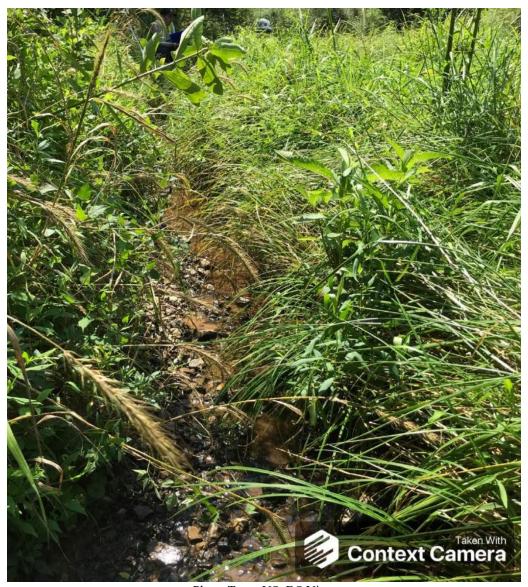
Photo Type: US, DS View
Location, Orientation, Photographer Initials: Upstream Edge of ROW, Downstream View, DD/PL/LC/KP
Lat: 39.017783 Long: -80.596853

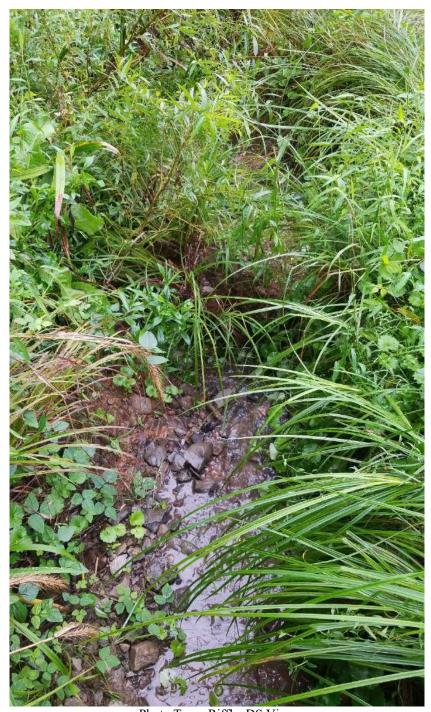
Photo Type: Riffle, DS View
Location, Orientation, Photographer Initials: Upstream of Riffle, Downstream View, DD/PL/LC/KP
Lat: 39.017783 Long: -80.596853

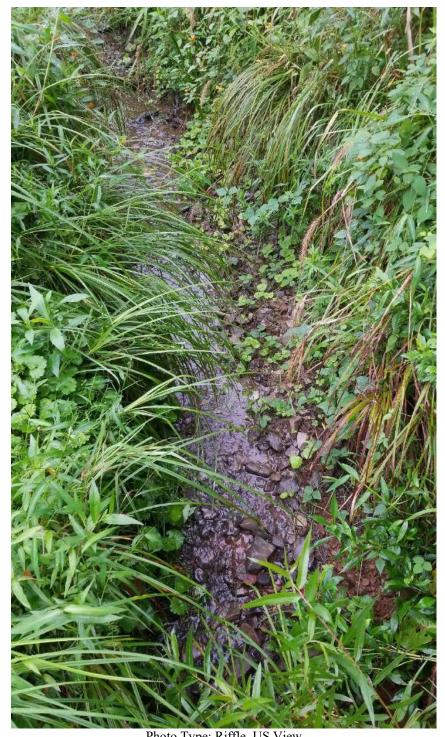
Photo Type: Riffle, US View
Location, Orientation, Photographer Initials: Downstream of Riffle, Upstream View, DD/PL/LC/KP
Lat: 39.017783 Long: -80.596853

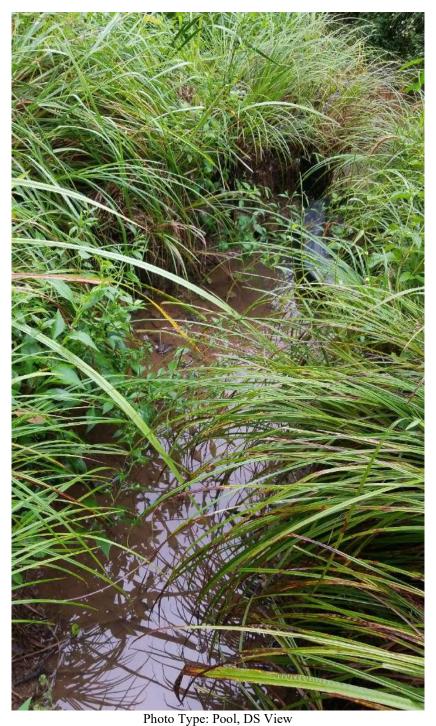
Location, Orientation, Photographer Initials: Upstream of Pool, Downstream View, DD/PL/LC/KP Lat: 39.017783 Long: -80.596853

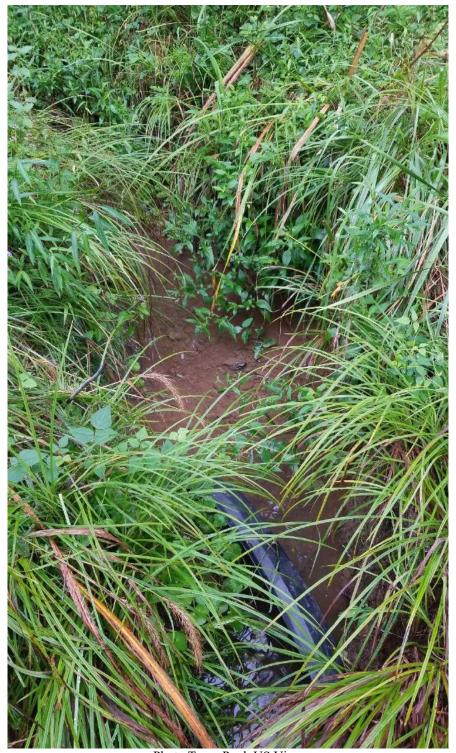
Photo Type: Pool, US View
Location, Orientation, Photographer Initials: Downstream of Pool, Upstream View, DD/PL/LC/KP
Lat: 39.017783 Long: -80.596853

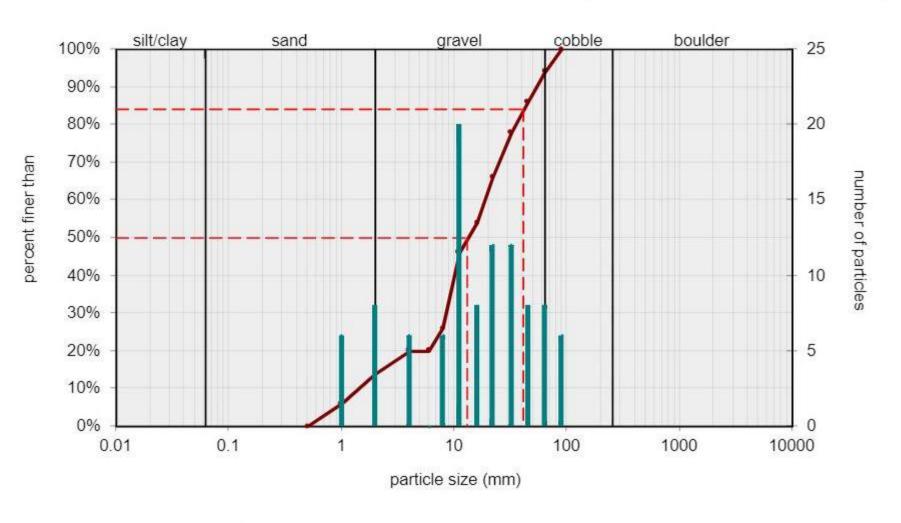
cumulative % ——# of particles

Size (n	nm)	- 67
W.	D16	2.5	.0
	D35	9.2	
	D50	13	
	D65	21	
	D84	41	
	D95	68

I	ype
silt/clay	0%
sand	14%
gravel	80%
cobble	6%
boulder	0%

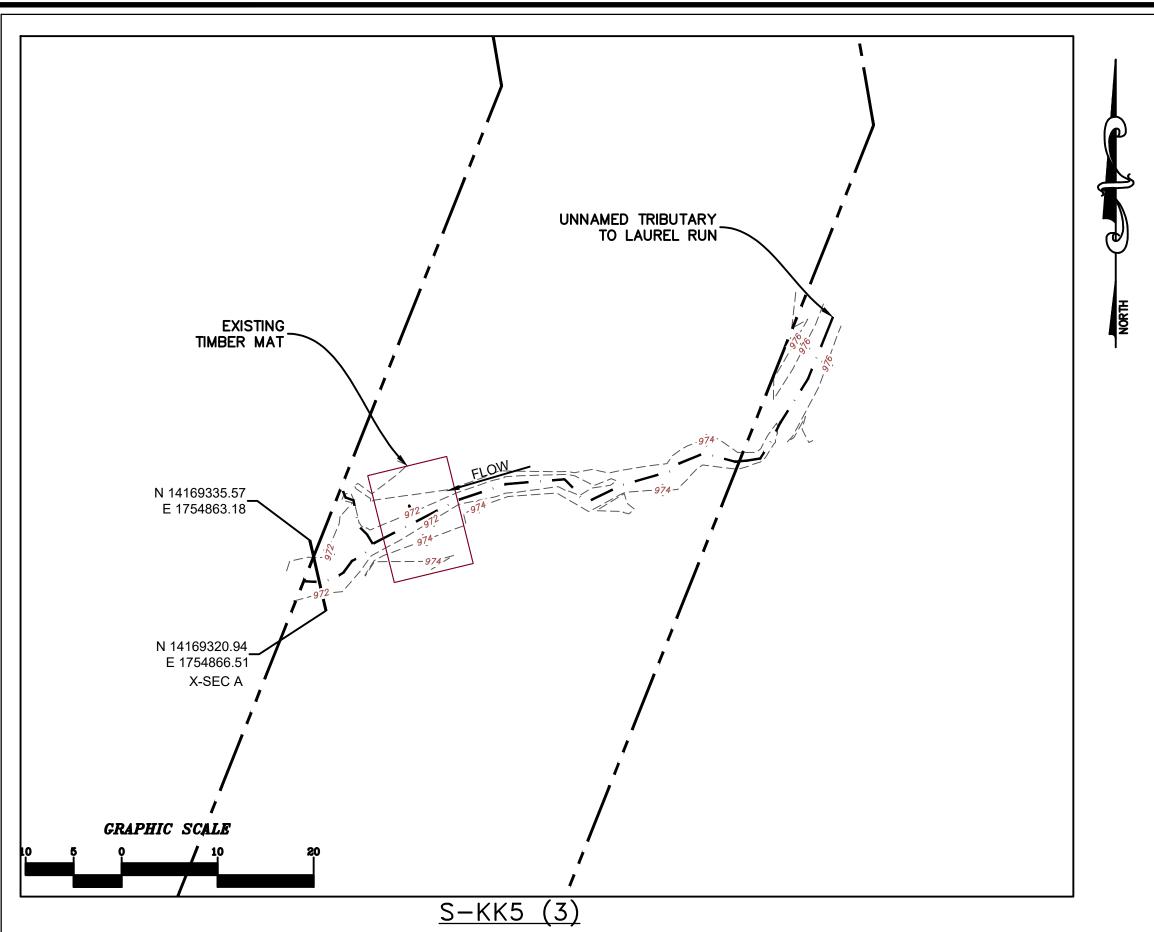
- 2. EASEMENT LINES SHOWN ON PLAN VIEW WERE PROVIDED BY MOUNTAIN VALLEY
- 3. SURVEY POINTS FOR CROSS SECTIONS AND THALWEG PROFILES COLLECTED IN 2021 HAVE BEEN USED IN COMBINATION WITH SURVEY POINTS COLLECTED PREVIOUSLY IN 2020 IN ORDER TO GENERATE THE PRE-CROSSING SURFACE SHOWN IN PLAN. DUE TO NATURAL EROSIONAL STREAM PROCESSES THAT CAN OCCUR OVER TIME, MINOR ADJUSTMENTS TO THE PROFILE ALIGNMENTS MAY HAVE BEEN REQUIRED IN ORDER TO GENERATE A CLEAN PRE-CROSSING SURFACE.

- 4. ALL SECTION VIEWS SHOWN LEFT TO RIGHT FACING DOWNSTREAM.
- 5. POST-CROSSING SURVEY INFORMATION SHOWN IN RED. DATA COLLECTED PENDING
- 6. POST-CROSSING SURVEY POINTS FOR CROSS SECTIONS AND THALWEG ARE PROJECTED ONTO PRE-CROSSING SECTION AND PROFILE VIEWS FOR COMPARISON.

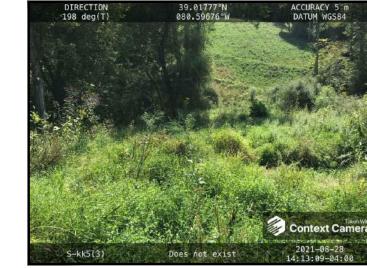
PHOTO TAKEN LOOKING DOWNSTREAM FROM UPSTREAM IMPACT LIMITS

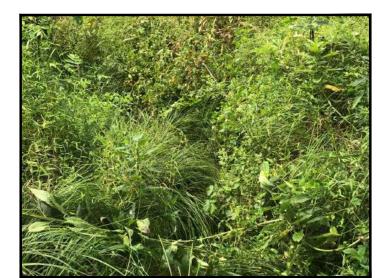
PHOTO TAKEN LOOKING UPSTREAM FROM DOWNSTREAM IMPACT LIMITS
