**Site-Specific Design of Stabilization Measures in Selected  
High-Hazard Portions of the Route of the Proposed Mountain  
Valley Pipeline Project in the Jefferson National Forest**

**Mountain Valley Pipeline, LLC**

**Updated March 13, 2018**

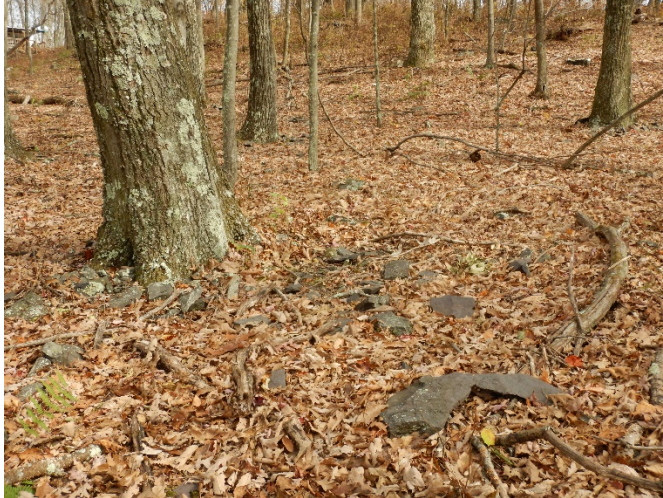
*Photo 1: Red and brown sandstones characteristic of the Rose Hill Formation were observed as float upslope of the JNF Priority Site #1 area (view is toward north-northwest)*

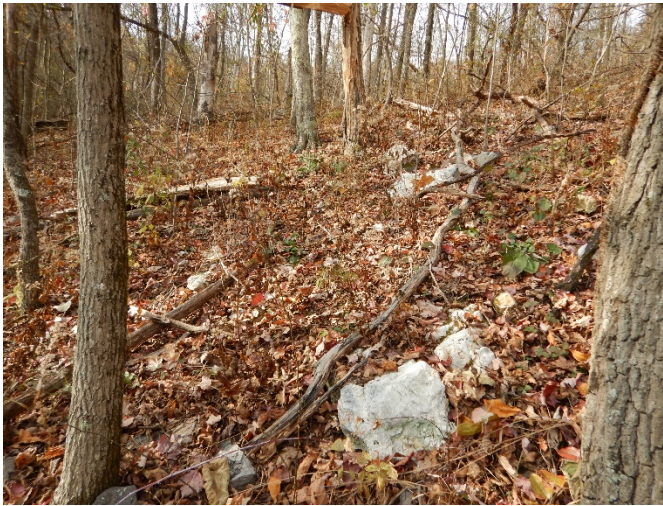
*Photo 2: White to gray sandstone talus blocks characteristic of the Tuscarora Formation observed as abundant float near the vicinity of the JNF Priority Site #1 (view is upslope toward the west)*

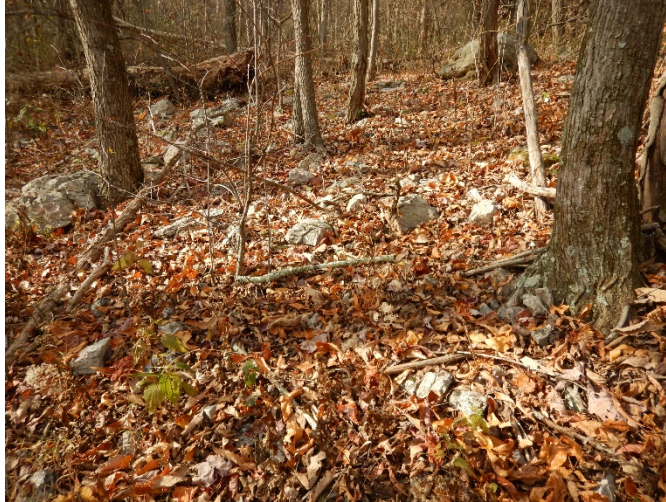
*Photo 3: The JNF Priority Site #1 situated on an ancient colluvial fan composed primarily of Tuscarora sandstone (view is sideslope to the southwest)*

Schultz et al (1986) map these characteristic areas as “Colluvium undifferentiated: boulders, gravel, sand and silt; includes rock fall, talus, debris train, and block field deposits”.

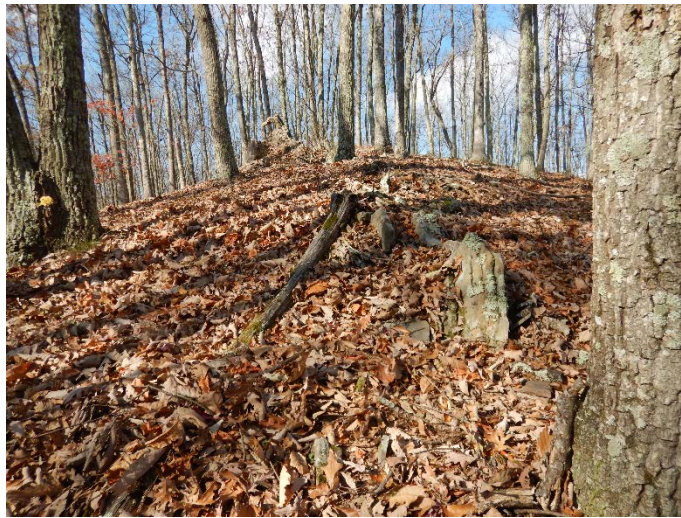
*Photo 6: Exposure of the Price sandstone outcrop at the ridge line near JNF Priority Site #2*

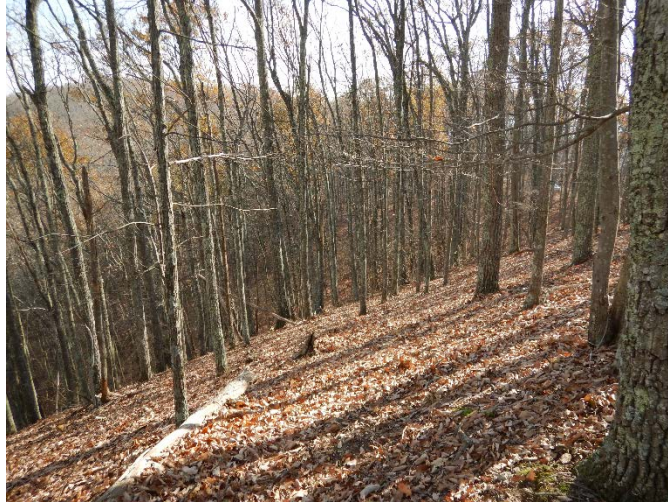
*Photo 7: Downslope exposure of bedrock was not observed, but the steep slopes in the vicinity of the JNF Priority Site #2 suggest only a thin overburden mantle overlies the downslope Devonian age bedrock (view is to the north)*

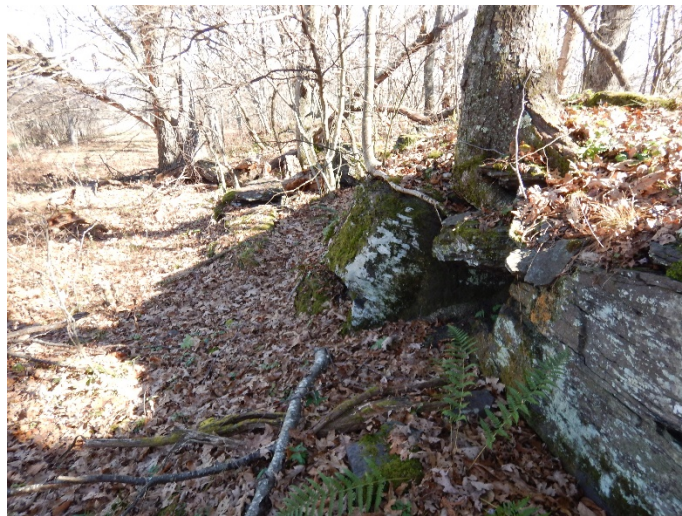
*Photo 8: Rose Hill sandstone outcrop on ridge top north of the JNF Priority Site #3, dipping to the south (view to northeast)*

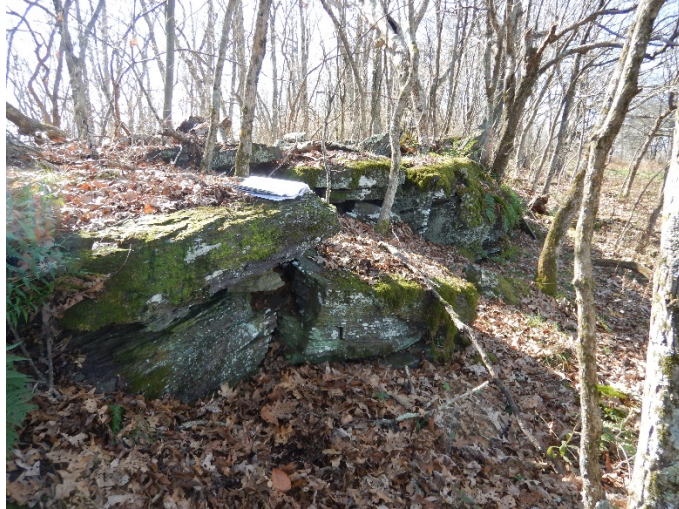
*Photo 9: Rose Hill sandstone outcrop on ridge top north of the JNF Priority Site #3, dipping to the south (view to the southwest)*

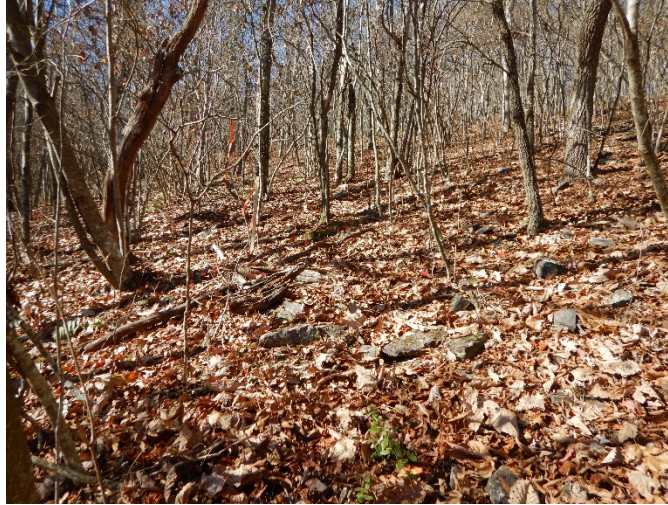
*Photo 11: Colluvial deposit float (predominantly Rose Hill sandstone) at ground surface in the near vicinity of the JNF Priority Site #3 (view is to the west toward the upslope ridgeline)*

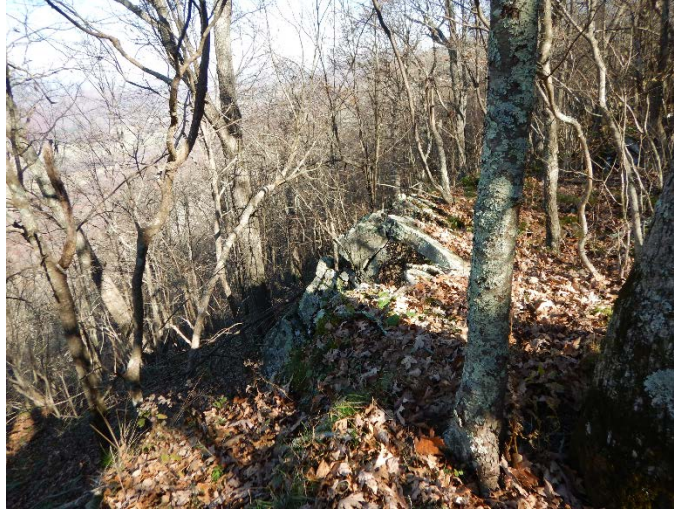
*Photo 12: White Medina (Tuscarora) sandstone forming ridgeline, dipping south-southeast back into the ridge (view is to the north)*

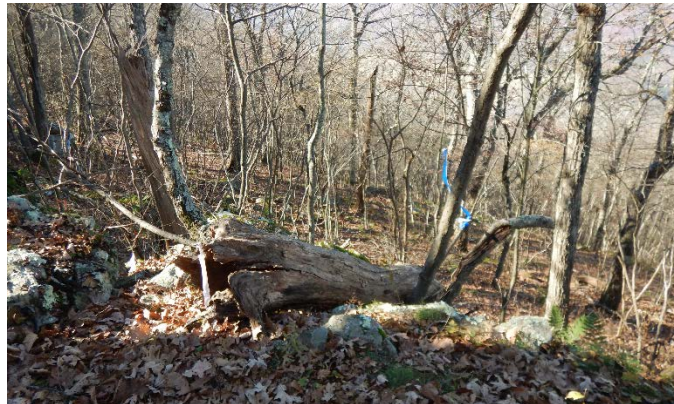
*Photo 13: Downslope to the north-northwest from the ridgeline near where slopes are reduced toward JNF Priority Site #5 (below bore pit), underlain by Martinsburg Series bedrock (view is to the west-southwest)*

As noted above, the JNF Priority Site #5 is located downslope from the ridge line and downslope from the bore pit. This site is analogous to JNF Priority Site #2, with relatively thin residual soil overburden overlying clastic sedimentary bedrock.

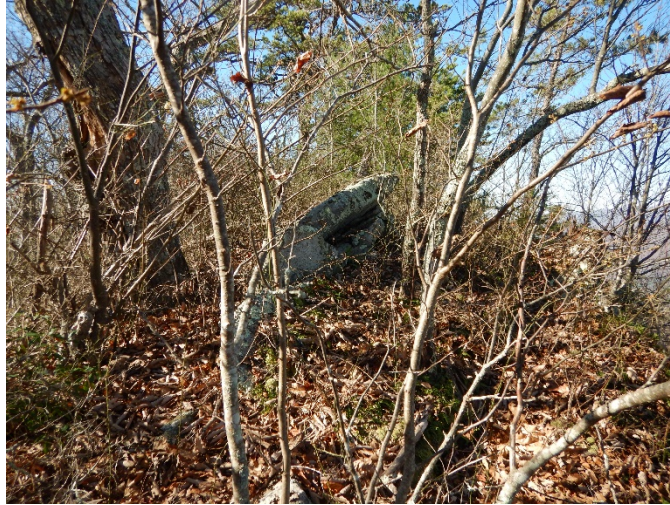
*Photo 14: Tuscarora Formation sandstone observed to outcrop at the ridge line (view is to the southwest)*

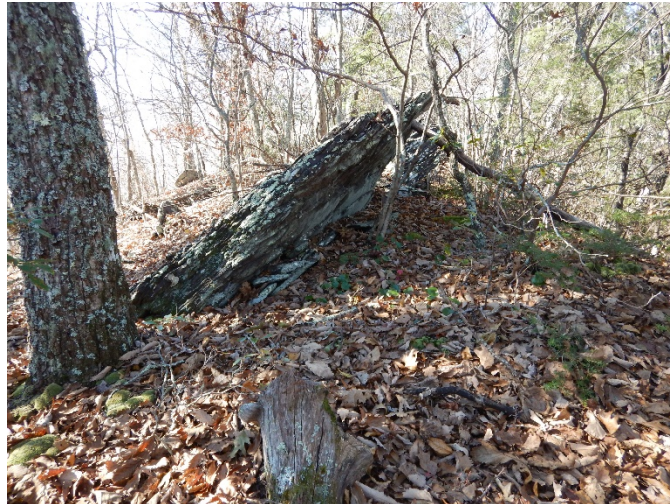
*Photo 15: Further to the southwest, the Rose Hill Formation sandstones outcrop at the ridge line (view is to the southwest)*

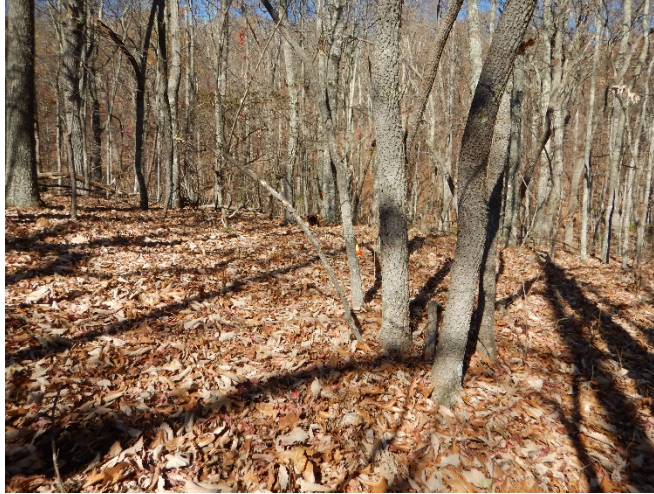
*Photo 17: View of the shallow slope apparently formed by rock-block slump, viewed toward the ridge line that is somewhat visible by trees in background defined by skyline approximately 800 feet to the west (view is to the west-southwest)*

Field reconnaissance of the JNF Priority Site #6 confirmed a near-horizontal portion of the slope within approximately 800 feet downslope (south) of the ridge line that corresponds to the rock-block slump, and a steep slope leading up to the ridge line (north-northwest) that is primarily the result of a release of the rock-block when it slumped.

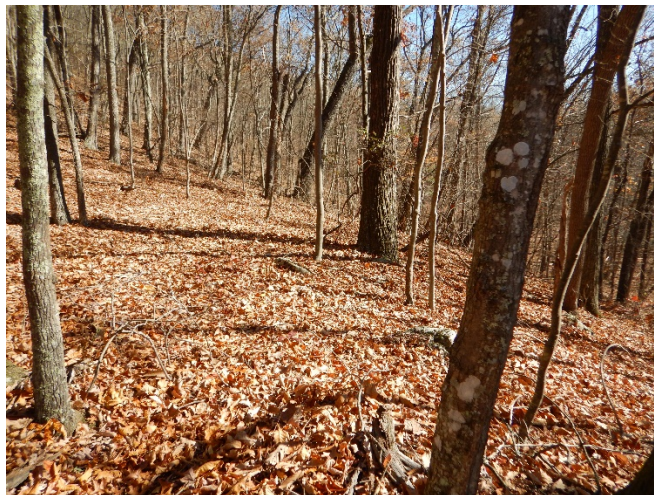
*Photo 16: South extent of the shallow slope formed by an apparent rock-block slump downslope from the ridge line (view is to the northeast)*

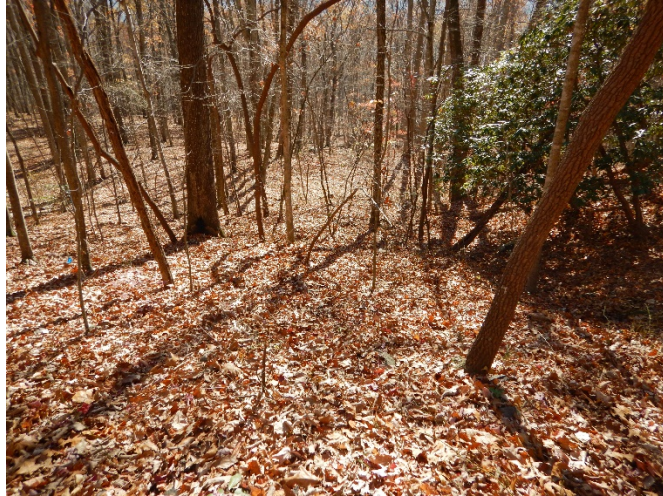
*Photo 17: Hummocky ground with variable size float (boulders, cobbles, pebbles, sand, silt) that corresponds to a mapped debris flow downslope (to the south-southeast) from the rock-block slump feature (view is to the south-southeast)*

Continuing downslope, the pipeline is mapped as crossing colluvium (Qcr in the exhibit above), derived from the Rose Hill Formation and consisting of debris transported downslope from the ridgeline and rock-block slide. Field reconnaissance revealed hummocky terrain, abundant Rose Hill and Tuscarora float at the ground surface and a well graded agglomeration of fine-to-coarse sand, pebbles, cobbles and boulders of Rose Hill and Tuscarora (observed in tree-fall root balls) that are characteristic of the ancient debris flow (see Photo 19, below).

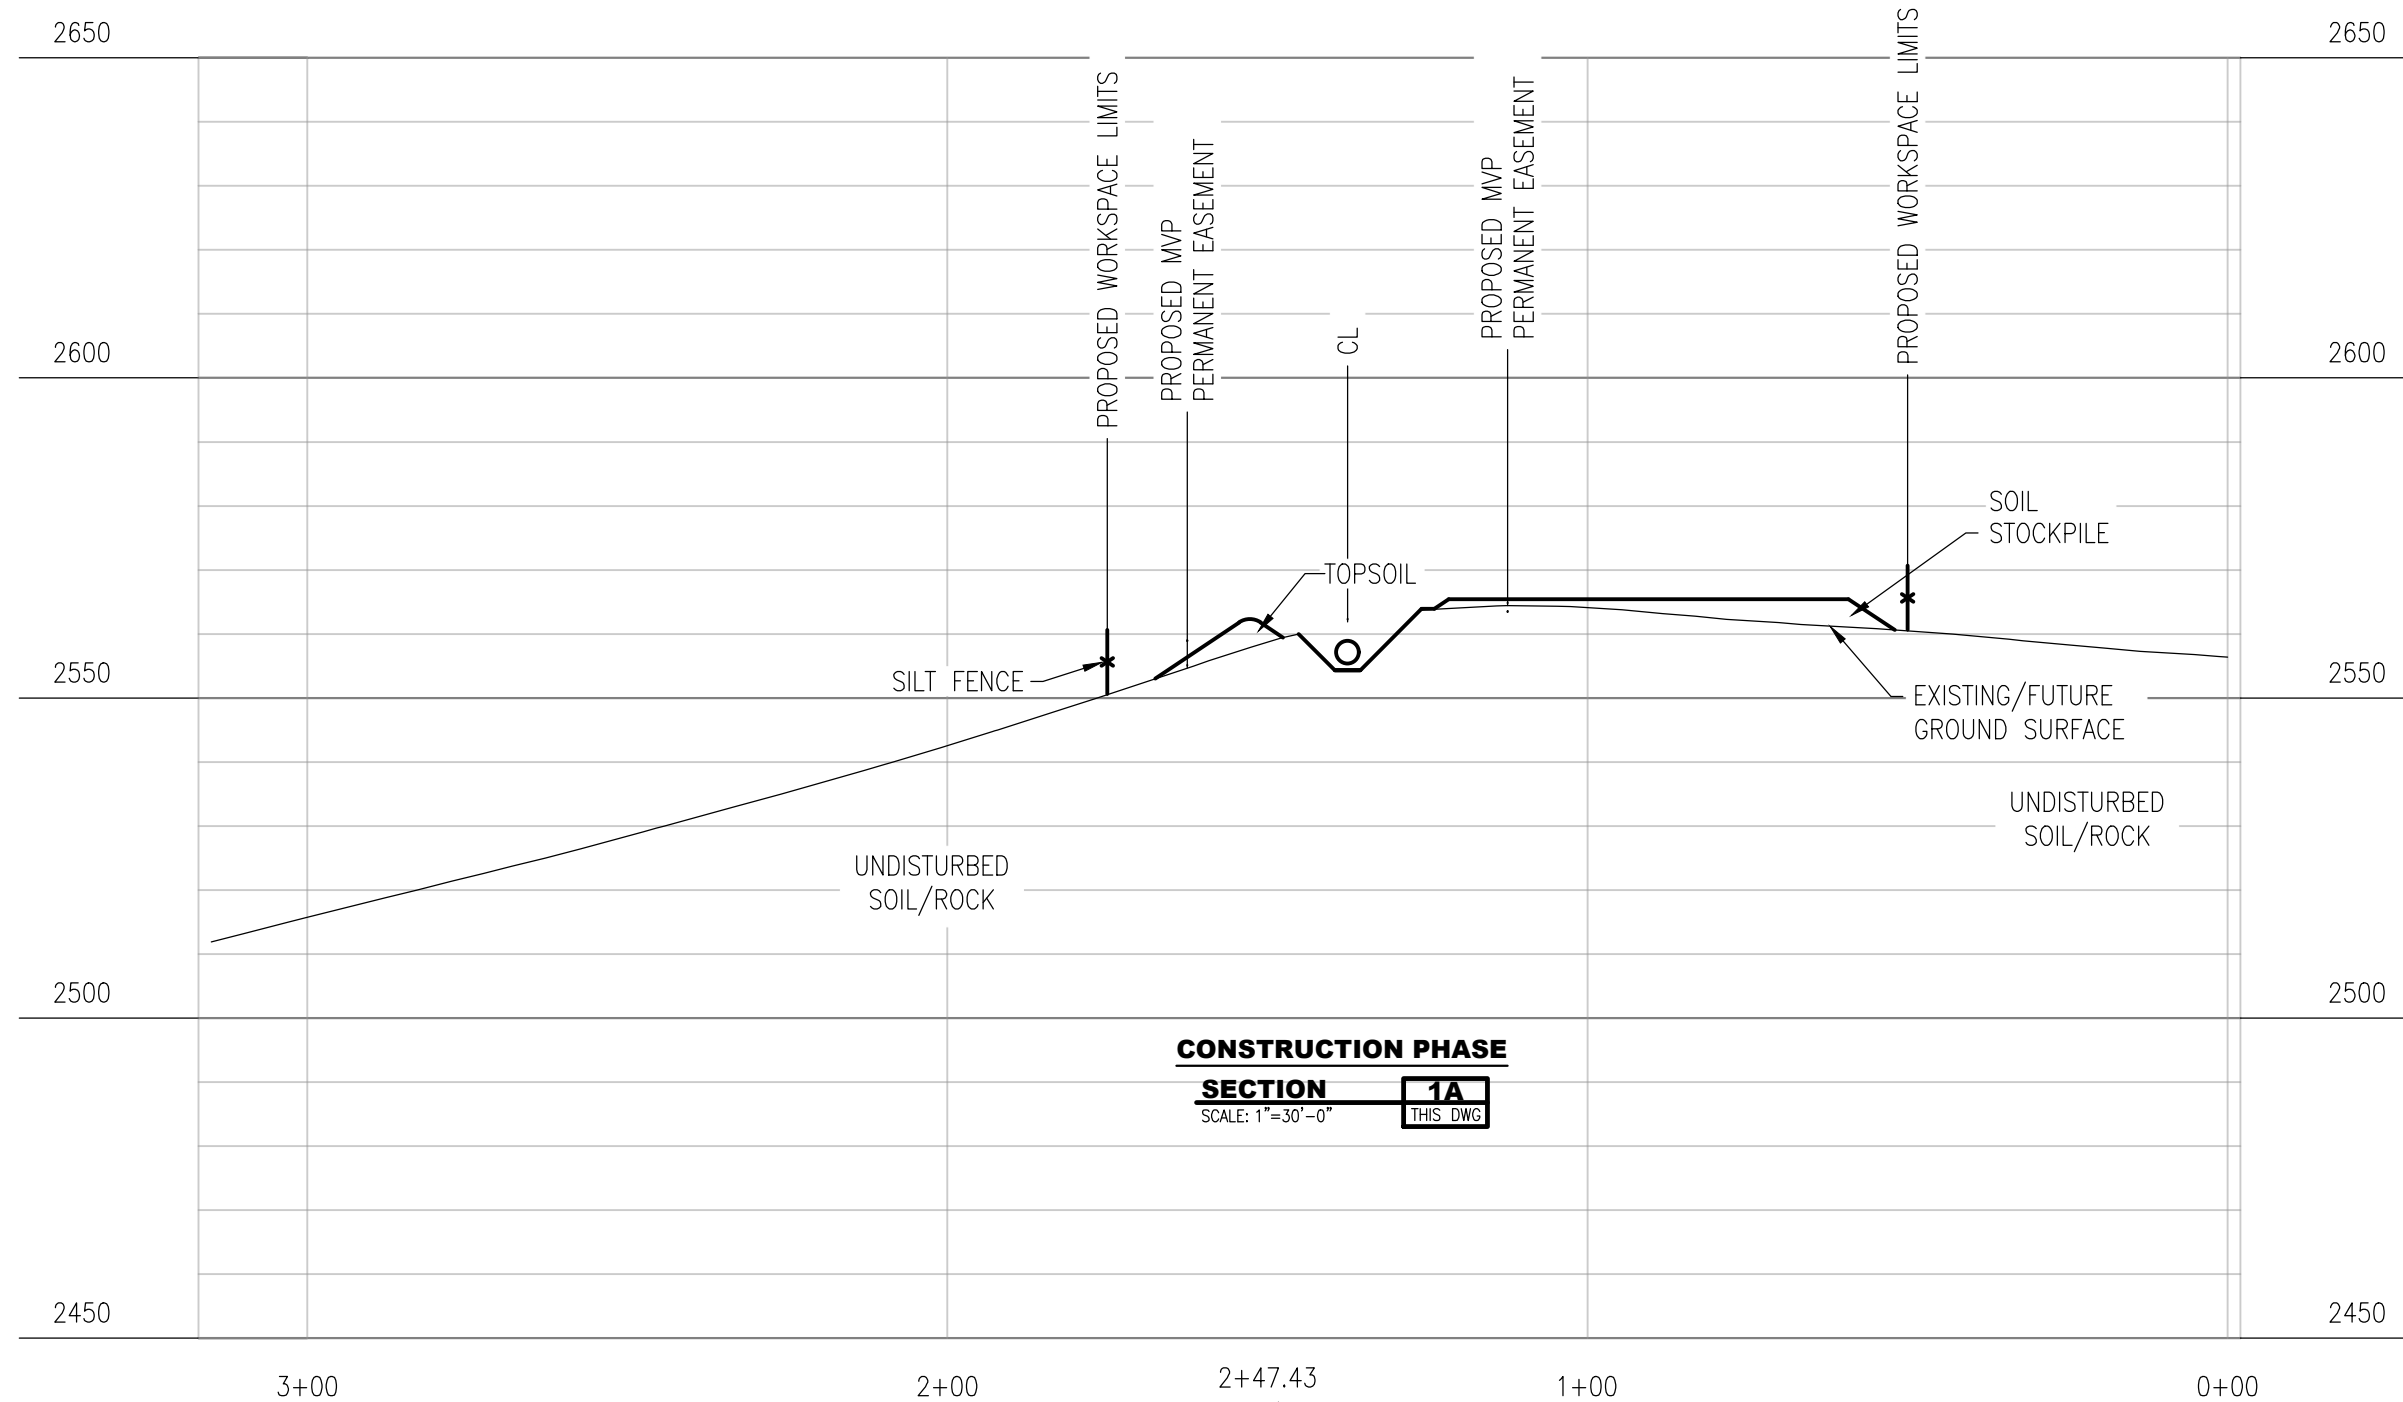
DRAWING TITLE: MOUNTAIN VALLEY PIPELINE  
JEFFERSON NATIONAL FOREST  
PRIORITY SITE #1  
CONSTRUCTION PHASE SECTION - FIGURE 5

**CONSTRUCTION PHASE**

**SECTION 1A**  
SCALE: 1"=30'-0" THIS DWG

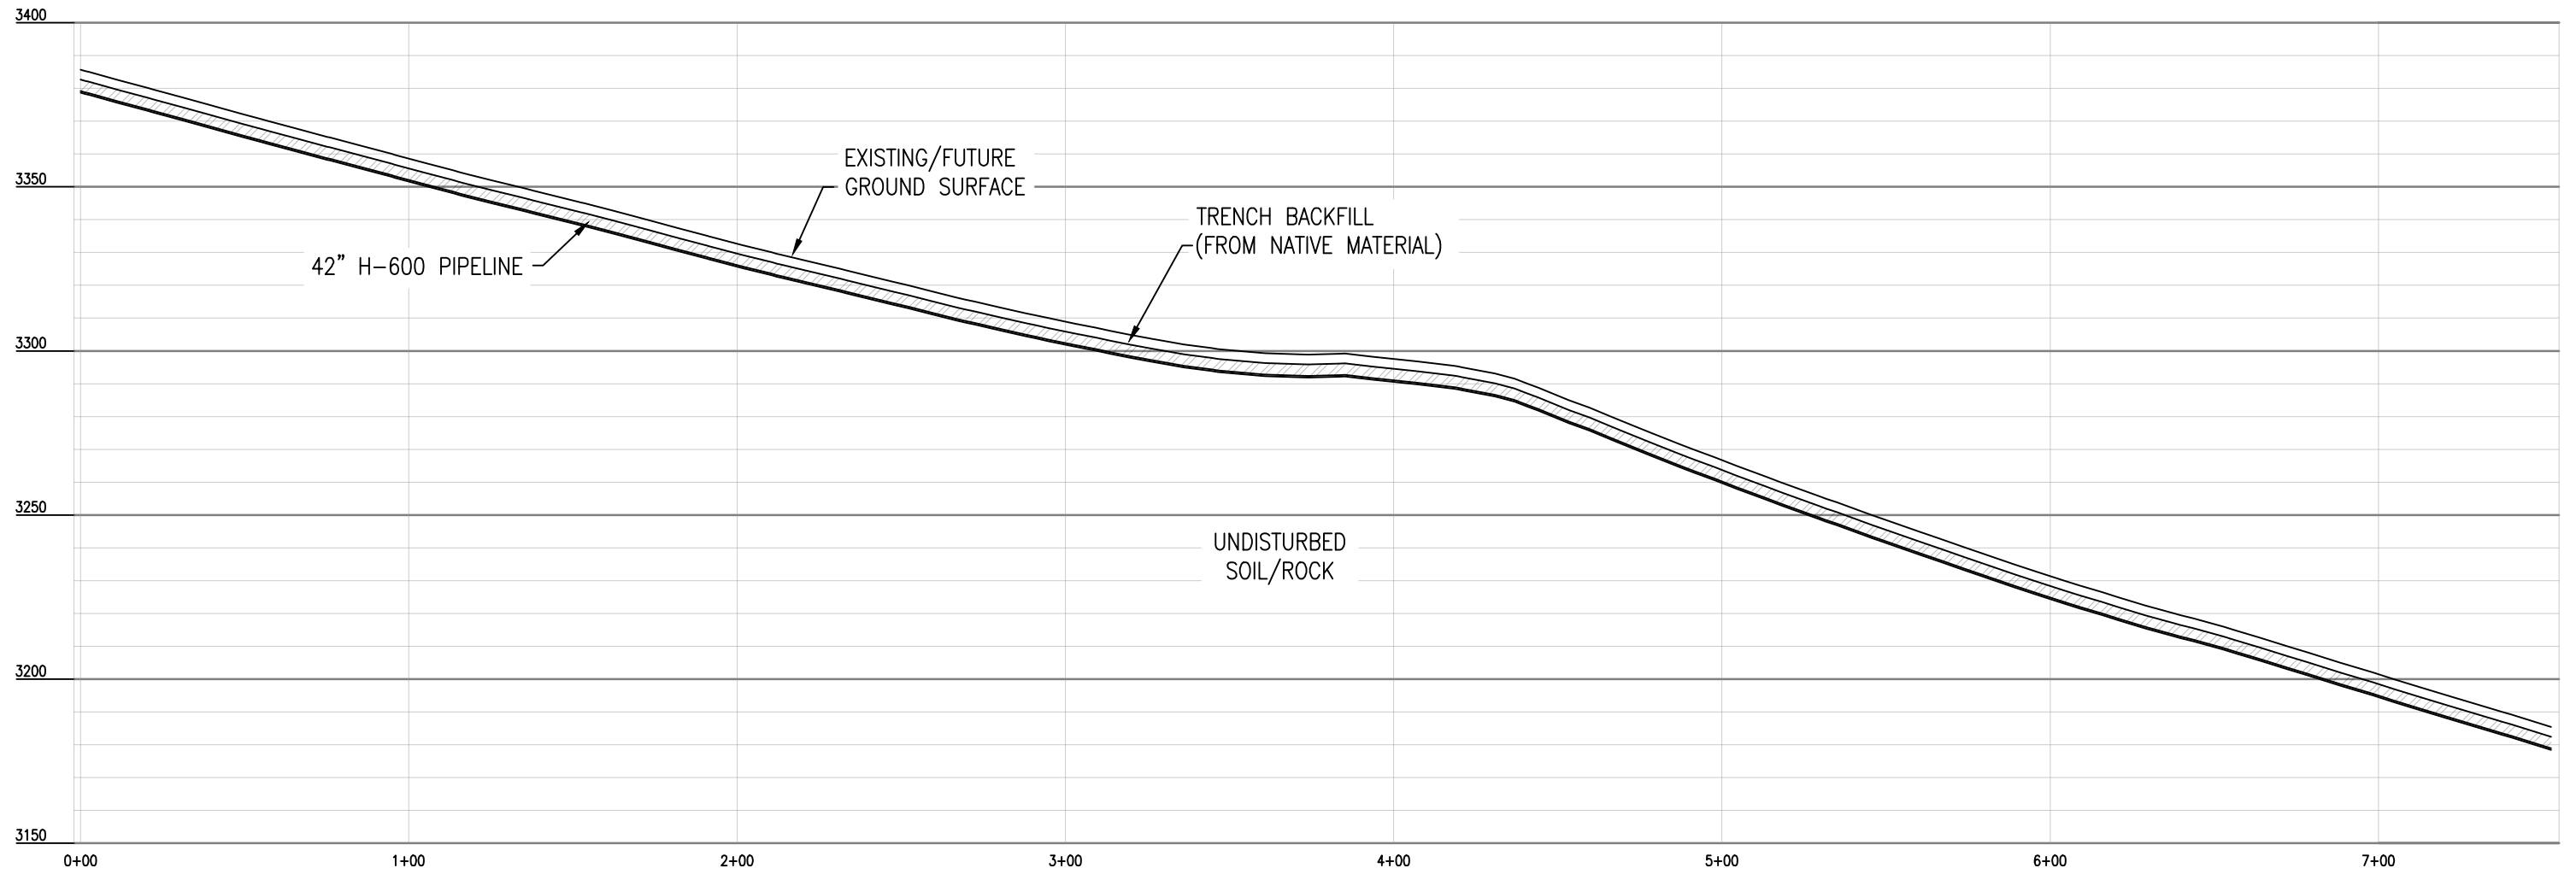
DRAWING TITLE: MOUNTAIN VALLEY PIPELINE JEFFERSON NATIONAL FOREST PRIORITY SITE #3 PROFILE - FIGURE 13

1. EVERY THIRD TRENCH BREAKER AT PRIORITY SITE #3 SHALL BE PROVIDED WITH DAYLIGHT DRAINS AS SHOWN ON TYPICAL DRAWING MVP-35.
2. ALL TRENCH BREAKERS AT PRIORITY SITE #3 NOT PROVIDED WITH DAYLIGHT DRAINS SHALL BE PROVIDED WITH PASS-THROUGH DRAINS AS SHOWN ON TYPICAL DRAWING MVP-43.

A profile of the site is shown on Figure 13. The pipeline will be approximately three feet below grade. The trench will be backfilled with select backfill, which will be shaker bucket material from the native soil and rock. Cross section 3A is shown on Figures 14, 15, and 16, depicting the anticipated extent of trenching and stockpiled material before, during, and after construction in the sidehill portion of JNF

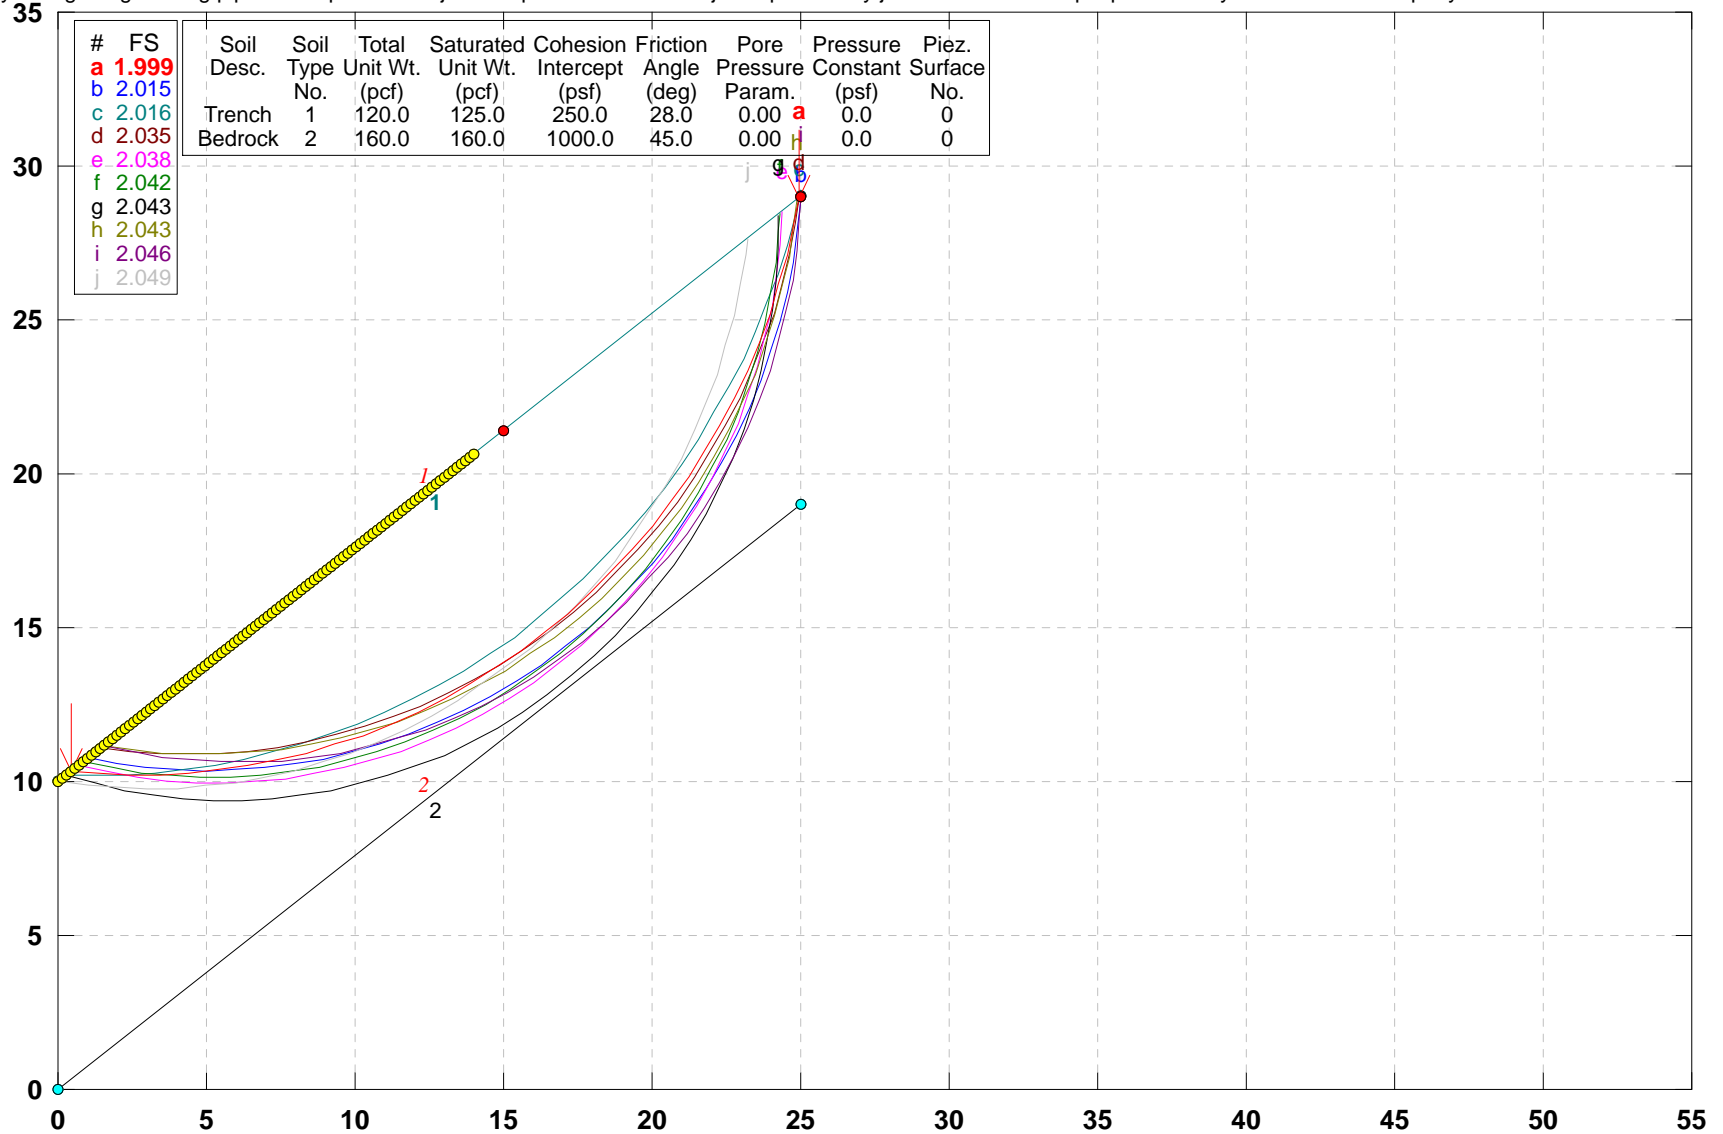
# JNF1: Trench Backfill Stability - 25' Breaker Spacing, 76% Slope

GSTABL7 v.2 FSmin=1.999  
 Safety Factors Are Calculated By The Modified Bishop Method
