**Mountain Valley Pipeline, LLC
Mountain Valley Pipeline Project
Docket No. CP16-10-000**

**Implementation Plan
Dated October 2017**

Landslide Mitigation Plan

Rev. 5, September 2017

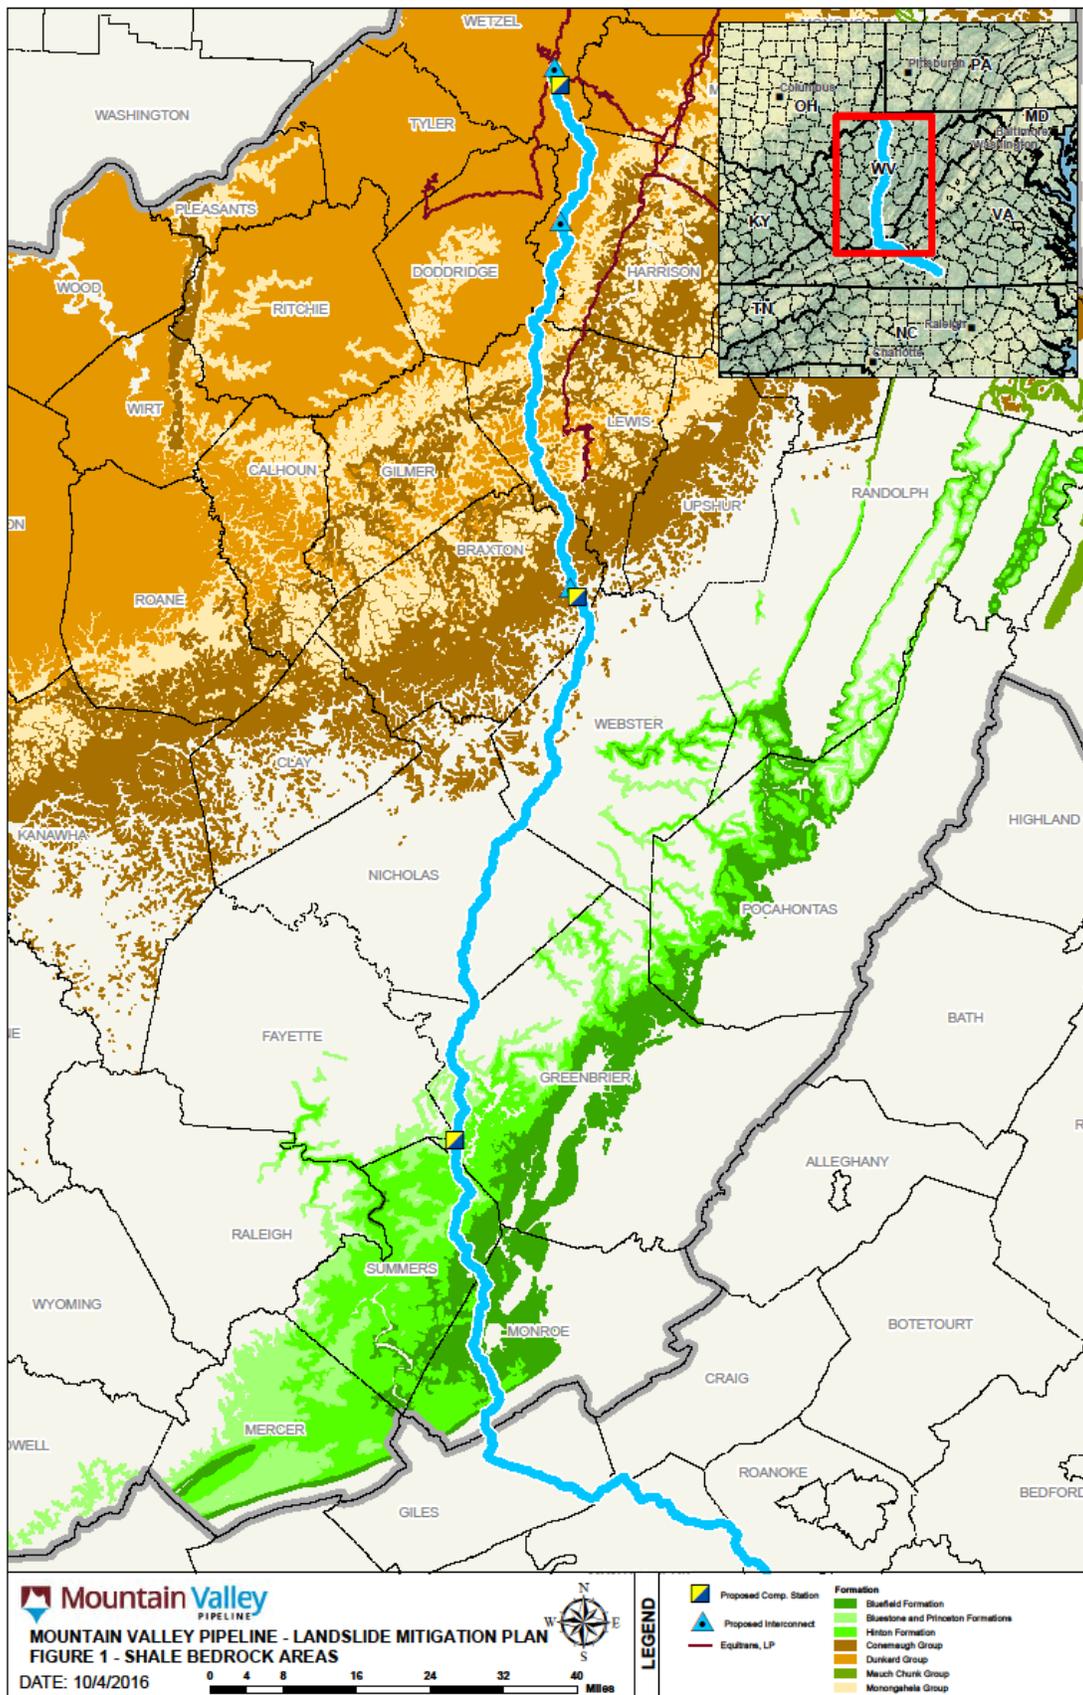
Figure 1 – Shale Bedrock Areas 9

The Bluestone Formation consists of mostly interbedded shale, mudstone, siltstone, sandstone, limestone, and thin, impure coal seams. The lower member of the Bluestone Formation, the gray shale member, consists of gray and black shale which contains some beds of siltstone, sandstone, red shale, and limestone. The shale is calcareous and locally carbonaceous. The upper half of the member is mostly conglomeratic sandstone. The middle member, the red member, is composed of calcareous red shale with some siltstone, small amounts of calcareous sandstone and lenticular beds of limestone. The upper member of the Bluestone Formation consists of white, gray and greenish-gray sandstone. The sandstone is medium- to coarse-grained and locally conglomeratic and contains cross-bedding. The sandstone is interbedded with gray, green, black, and red shale and siltstone.

The Mauch Chunk consists of red and green shales, similar to the red beds found in the Conemaugh and Monongahela Formations. The shales are moderately high in clay minerals, are highly susceptible to weathering, and are prone to mass wasting. The residual soils have a moderate shrink-swell potential and are susceptible to gully erosion.
