ATTACHMENT A

WETZEL COUNTY

WETLAND SWVM FORMS/WETLAND DELINEATION FORM/PHOTOS

USACE FILE NO./Project Name:	Mountain Valley Pipeline			COORDINATES:	Lat.	39.559744	Lon.	-80.546756
STREAM/SITE ID AND SITE DESCRI	PTION:					W-ME1, ATWS		
(% stream slope, watershed size {a	creage}, unaltered	d or impairments)						
FORM OF MITIGATION:								
DATE:	8/10)/2015	WEATHER CONDITIONS:			PRECIPITATION PAST 48 HRS:		
	PART I - Wet	land Indicators						
Impact Wetland ID:	Impact Wetland Classification	Impacts (acreage)	Mitigation Wetland Classification					
W-ME1	Emergent	0.0382	Emergent					
				-			Mitigatio	n
				-		Sustainable Determination Made or	hinguno	••
				-		Advanced Mitigation		Y
Total Impact		0.0382						
	PART II -	Unit Scores				Estimated		
Wetland Cla	assification		Replacement Unit(s)	-		ILF Costs		
I otal Emergent			0.0382	-		* 0.000.00		
I otal Scrub-Shrub			0	-		\$2,292.00	1	
			0	4				
Total Open Water			0

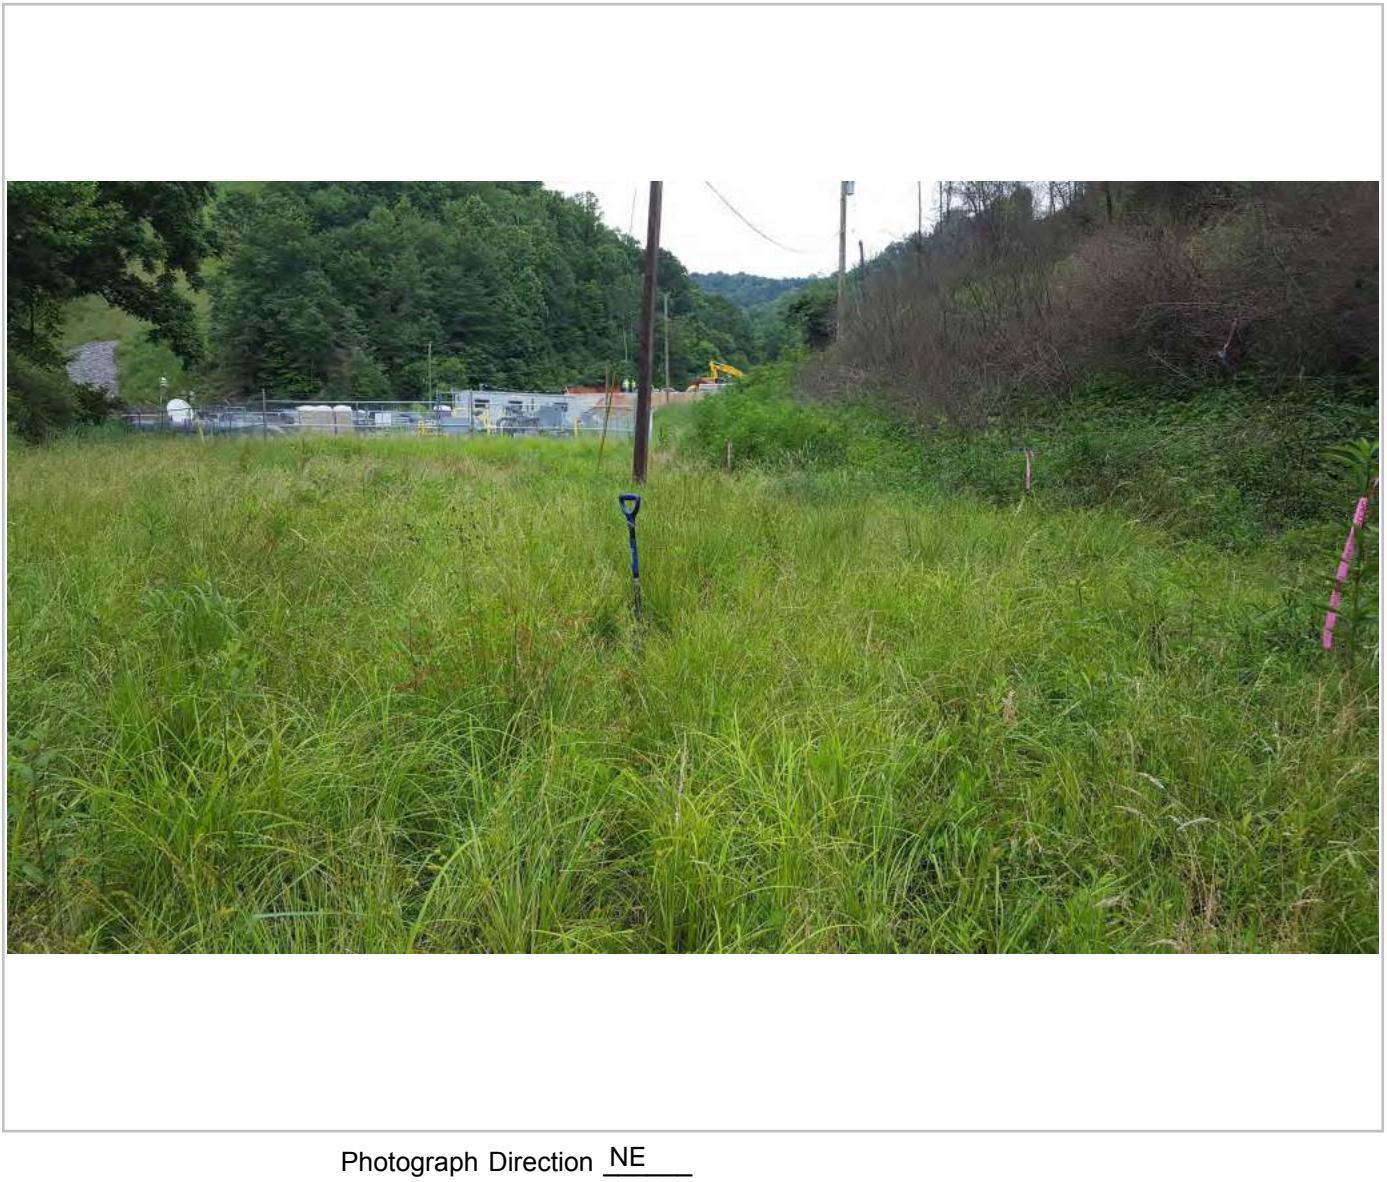
Wetland ID <u>W-ME1</u> Date <u>06/28/2018</u>

Remarks: Cowardin Code: DEM HGM: Do	- Water Type: BBW/W/F	
Maintained ROW for existing pipeline corridor. Wetlan	d is a depression near to Moblev R	, un (S-WX2) Open ended to the
north and southwest of the survey area	u is a depression hear to mobiley it	un (3-W/2). Open ended to the
	Secondar	ulpdiastore (minimum of two required)
Primary Indicators (minimum of one is required; check all that appl	Surfa	y malcalors (minimum or two required)
Surface Water (A1) True Aquatic	<u>v)</u> Sulla Plante (B14) Spare	ce Soli Clacks (B0)
High Water Table (A2)	ulfide Odor (C1)	page Patterns (B10)
✓ Saturation (A3)	izospheres on Living Roots (C3) Moss	Trim Lines (B16)
Water Marks (B1)	Reduced Iron (C4)	Season Water Table (C2)
Sediment Deposits (B2) Recent Iron	Reduction in Tilled Soils (C6) Cravf	ish Burrows (C8)
Drift Deposits (B3)	urface (C7)	ation Visible on Aerial Imagery (C9)
Algal Mat or Crust (B4) Other (Expla	in in Remarks) Stunt	ed or Stressed Plants (D1)

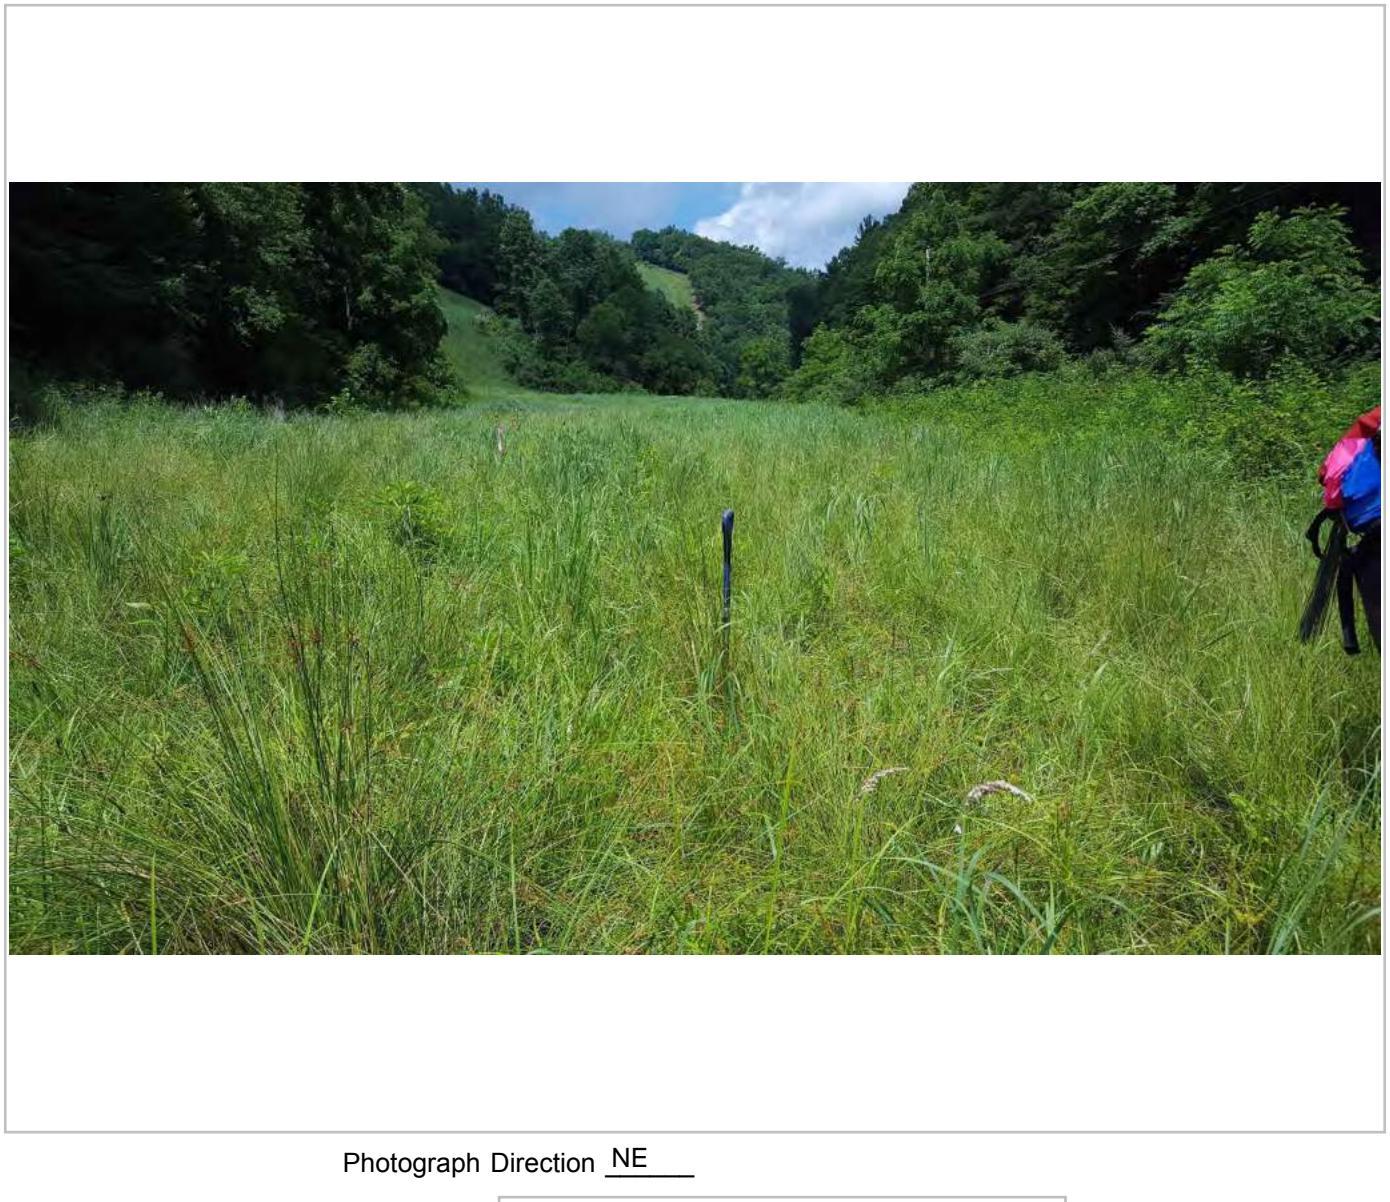
Wetland ID <u>W-ME2</u> Date <u>06/28/2018</u>

Hydrophytic Vegetation Present? Yes V No Hydric Soil Present? Yes V No Wetland Hydrology Present? Yes V No	 Is the Sampled Area within a Wetland? Yes 	s No
Remarks: Cowardin Code: PEM HGM: Dep	ressional Water Type: RPWWN	٨
Maintained ROW for existing pipeline corridor. Open e	nded northeast of the survey area	
HYDROLOGY		
Wetland Hydrology Indicators:	Secondar	y Indicators (minimum of two required)
Primary Indicators (minimum of one is required; check all that apply	<u>)</u> Surfa	ace Soil Cracks (B6)
Surface Water (A1) True Aquatic	Plants (B14) Spars	sely Vegetated Concave Surface (B8)
High Water Table (A2) Hydrogen Su	fide Odor (C1) Drain	age Patterns (B10)
Saturation (A3) Oxidized Rhi	cospheres on Living Roots (C3) Moss	s Trim Lines (B16)
Water Marks (B1) Presence of I	Reduced Iron (C4) Dry-S	Season Water Table (C2)
Sediment Deposits (B2) Recent Iron F	eduction in Tilled Soils (C6) Crayf	fish Burrows (C8)

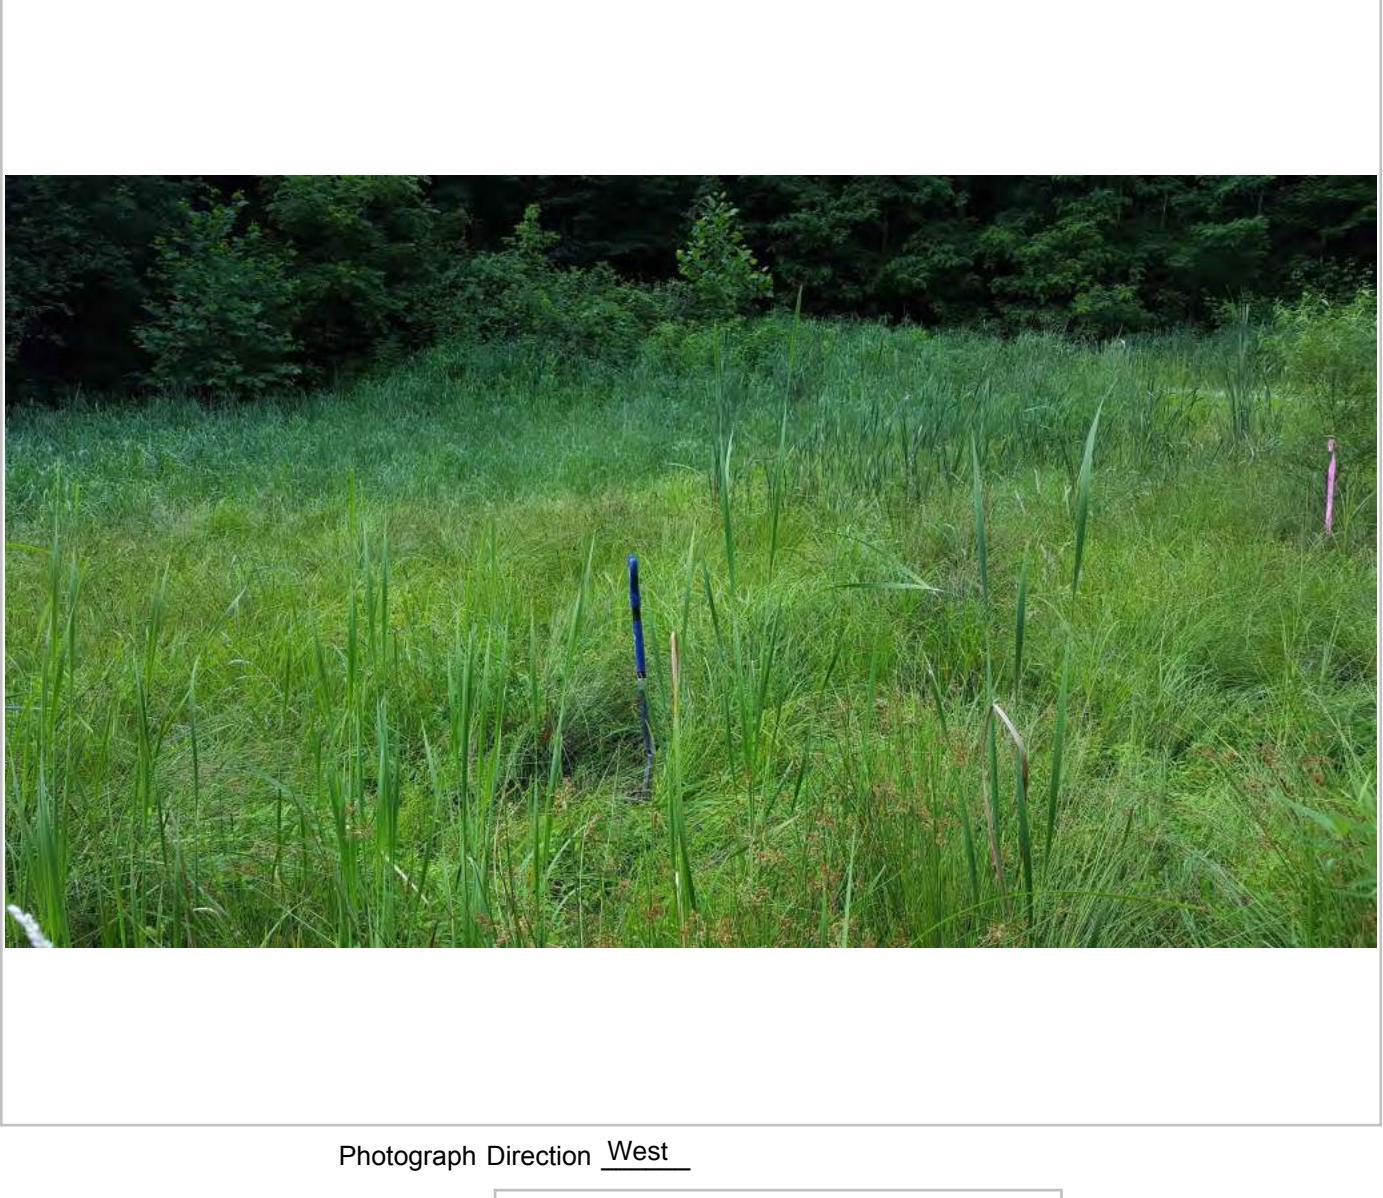
Wetland ID <u>W-ME3</u> Date <u>06/28/2018</u>

Hydrophytic Vegetation Present? Yes V No Hydric Soil Present? Yes V No Wetland Hydrology Present? Yes V No	 Is the Sampled Area within a Wetland? 	Yes 🖌 No
Remarks: Cowardin Code: PEM HGM: De	oressional Water Type: R	PWWN
Maintained ROW for existing pipeline corridor. Open	ended northeast and southea	ast of the survey area.
HYDROLOGY		
Wetland Hydrology Indicators:	<u>S</u>	econdary Indicators (minimum of two required)
Primary Indicators (minimum of one is required; check all that appl	y)	_ Surface Soil Cracks (B6)
✓ Surface Water (A1) True Aquatic	Plants (B14)	_ Sparsely Vegetated Concave Surface (B8)
High Water Table (A2) Hydrogen Su	Ilfide Odor (C1)	_ Drainage Patterns (B10)
Saturation (A3)	zospheres on Living Roots (C3)	_ Moss Trim Lines (B16)
Water Marks (B1) Presence of	Reduced Iron (C4)	_ Dry-Season Water Table (C2)
Sediment Deposits (B2) Recent Iron	Reduction in Tilled Soils (C6)	_ Crayfish Burrows (C8)

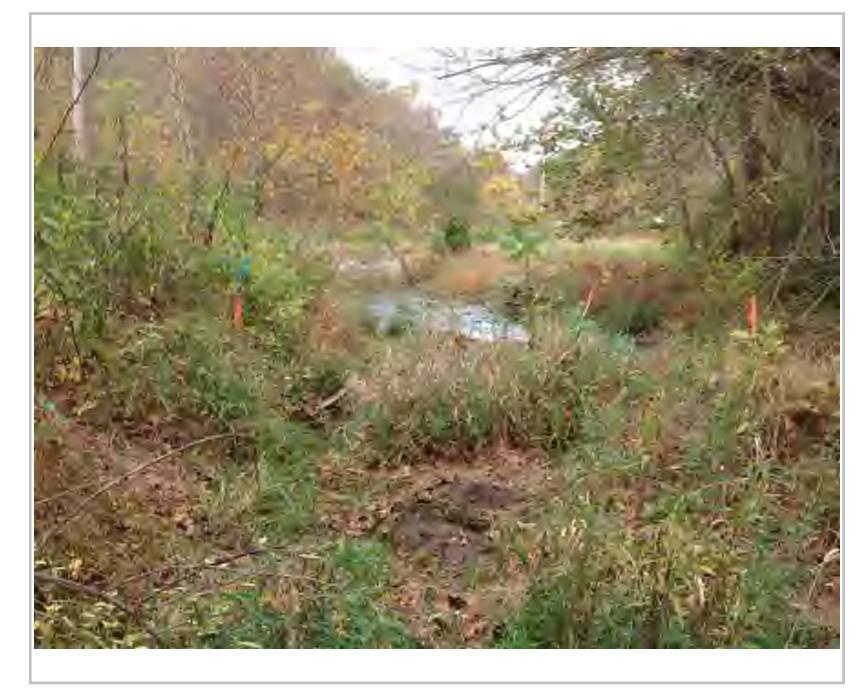
Wetland ID W-A1a

Comments: 2014 wetland delineation.

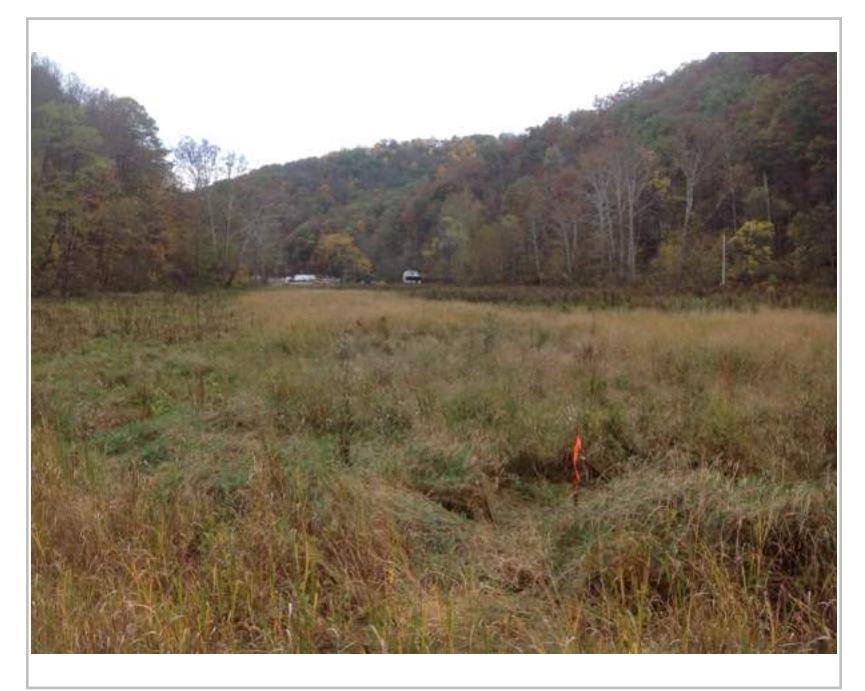
Photograph Direction NW

Comments: 2014 wetland delineation.

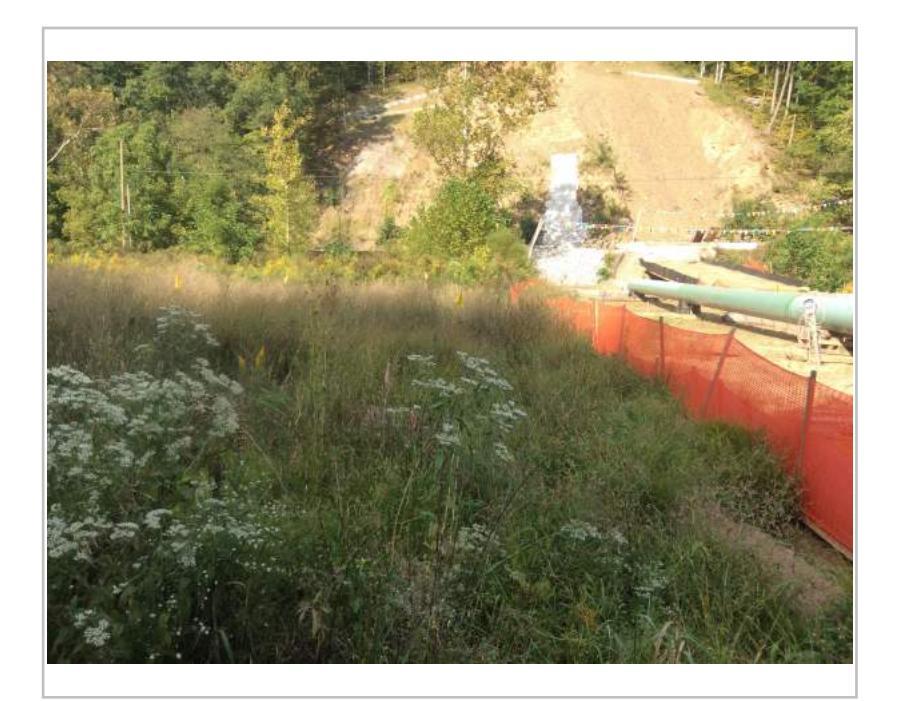
Photograph Direction <u>NNE</u> Date: <u>09/16/19</u>

Comments: 2019 wetland delineation confirmation.

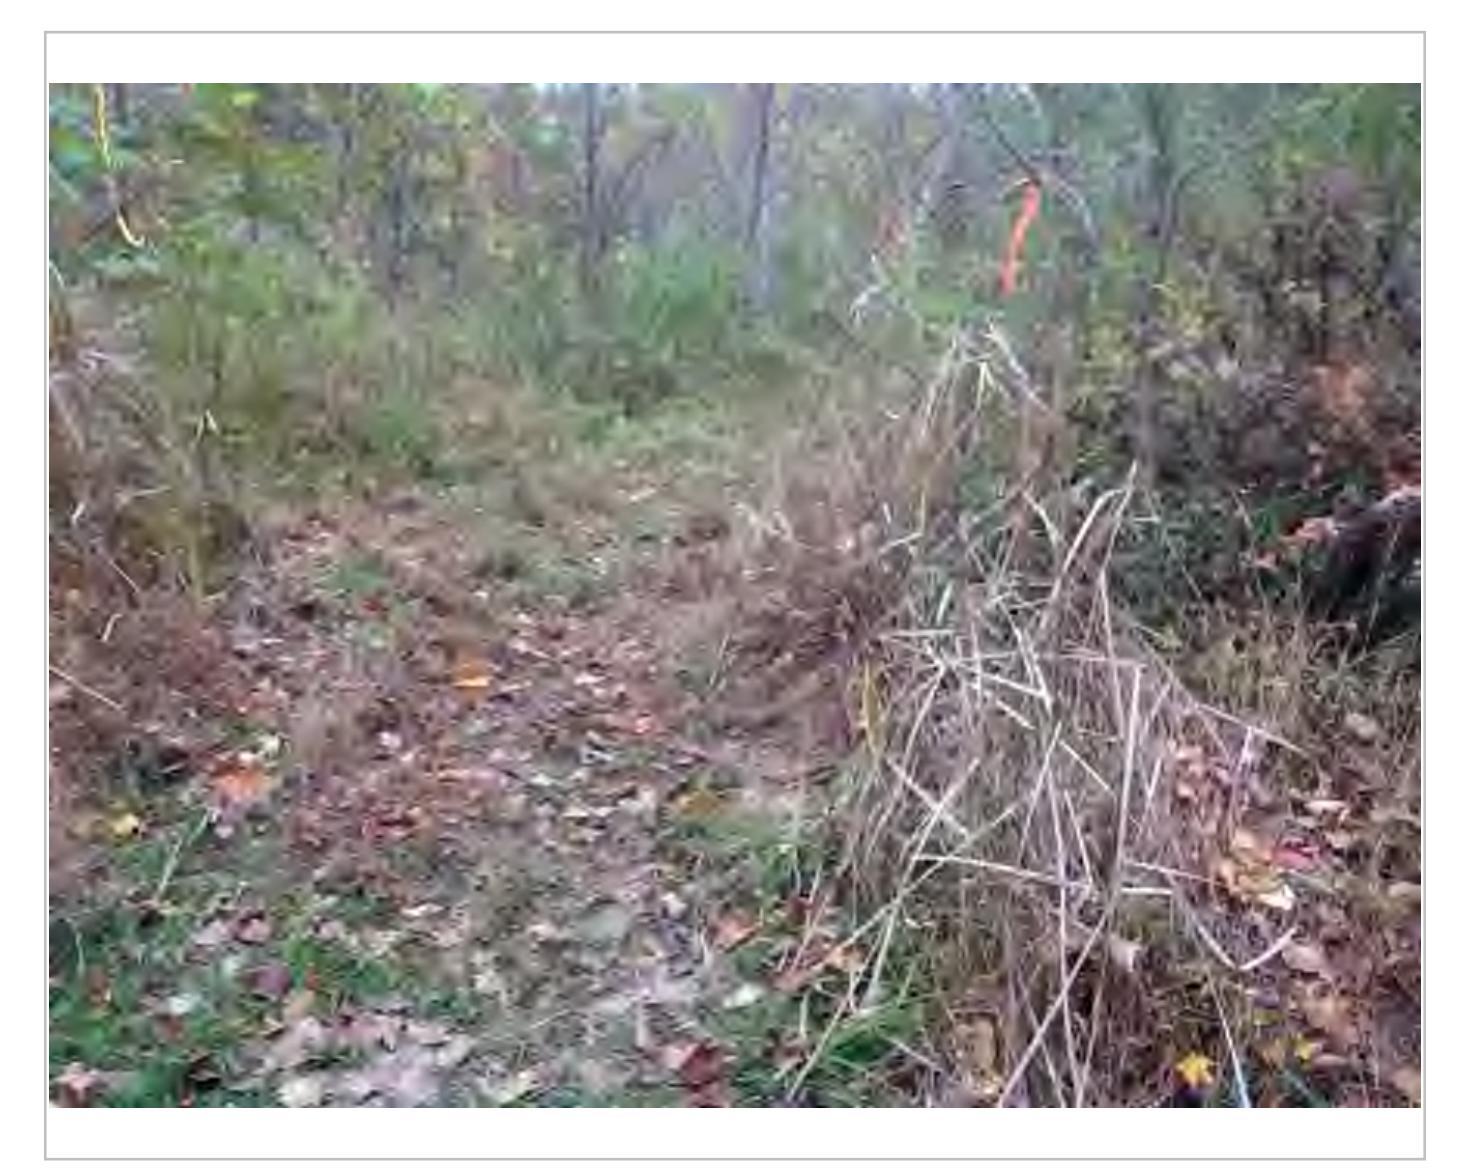
Wetland ID <u>W-A4a</u> Date <u>10/18/201</u>4

Hydrophytic Vegetation Tesent: Tes	V No Is the Sampled Area	Y Y N
Wetland Hydrology Present? Yes	✓ No within a Wetland?	Yes No
Remarks:		
PEM depressional wetland is located o	n the surface of an old logging road that v	vas cut along a hillside.
Cowardin: PEM		
HGM: slope		
WT: NRPWW		
HYDROLOGY		
Wetland Hydrology Indicators:		Secondary Indicators (minimum of two required)
Primary Indicators (minimum of one is required;	check all that apply)	Surface Soil Cracks (B6)
✓ Surface Water (A1)	True Aquatic Plants (B14)	Sparsely Vegetated Concave Surface (B8)
✓ High Water Table (A2)	Hydrogen Sulfide Odor (C1)	Drainage Patterns (B10)
✓ Saturation (A3)	Oxidized Rhizospheres on Living Roots (C3)	Moss Trim Lines (B16)
Water Marks (B1)	Presence of Reduced Iron (C4)	Dry-Season Water Table (C2)
Sediment Deposits (B2)	Recent Iron Reduction in Tilled Soils (C6)	Crayfish Burrows (C8)
Drift Deposits (B3)	Thin Muck Surface (C7)	Saturation Visible on Aerial Imagery (C9)

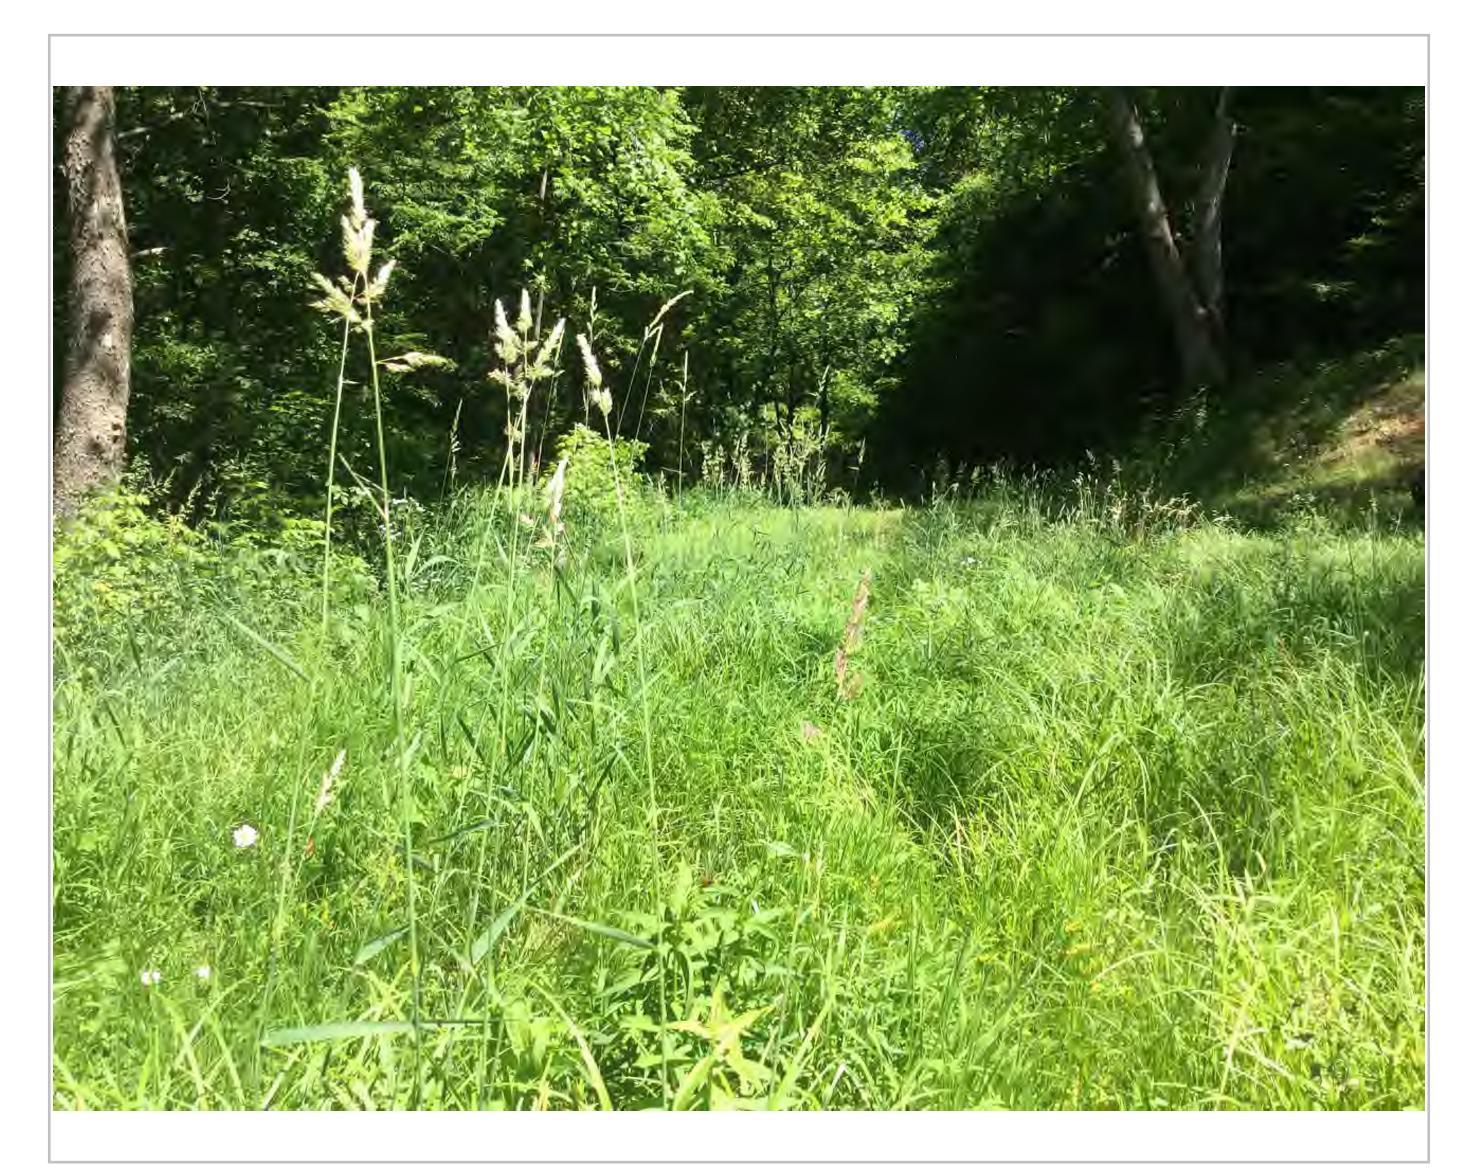
Wetland ID <u>W-IJ31</u> Date <u>06/13/2016</u>

Problematic disturbed roadside swale, possible old borrow pit developing wetland hydrology and vegetation due to compaction. Half gravel fill.

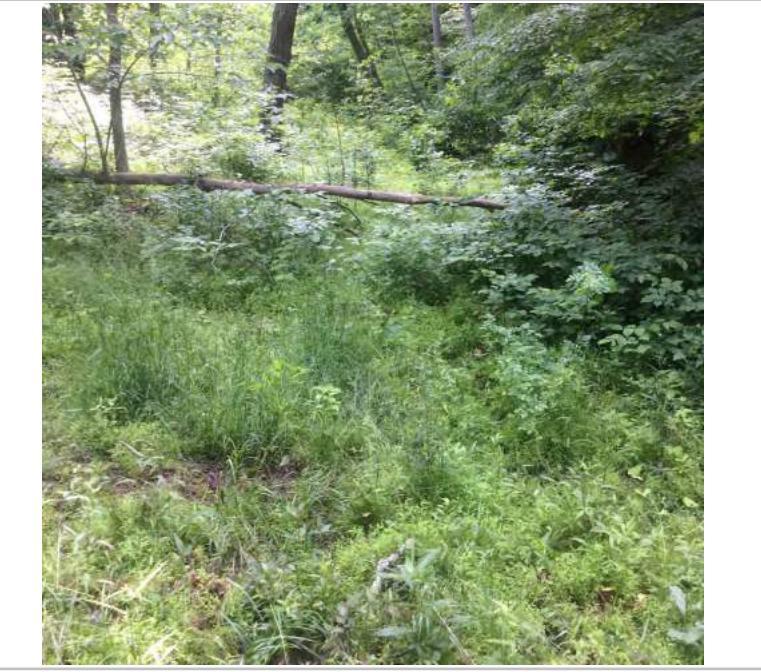
Wetland ID W-A34

Comments: 2015 wetland delineation.
