Baseline Assessment – Stream Attributes

*ADDITIONAL FIELD VISITS WERE COMPLETED ON 3-16-2022. LIMITED ACCESS DUE TO EXISTING SPAN; HOWEVER, ADDITIONAL DATA WAS COLLECTED.

Reach S-UV2 (Permanent Access Road) Perennial Spread F Greenbrier County, West Virginia

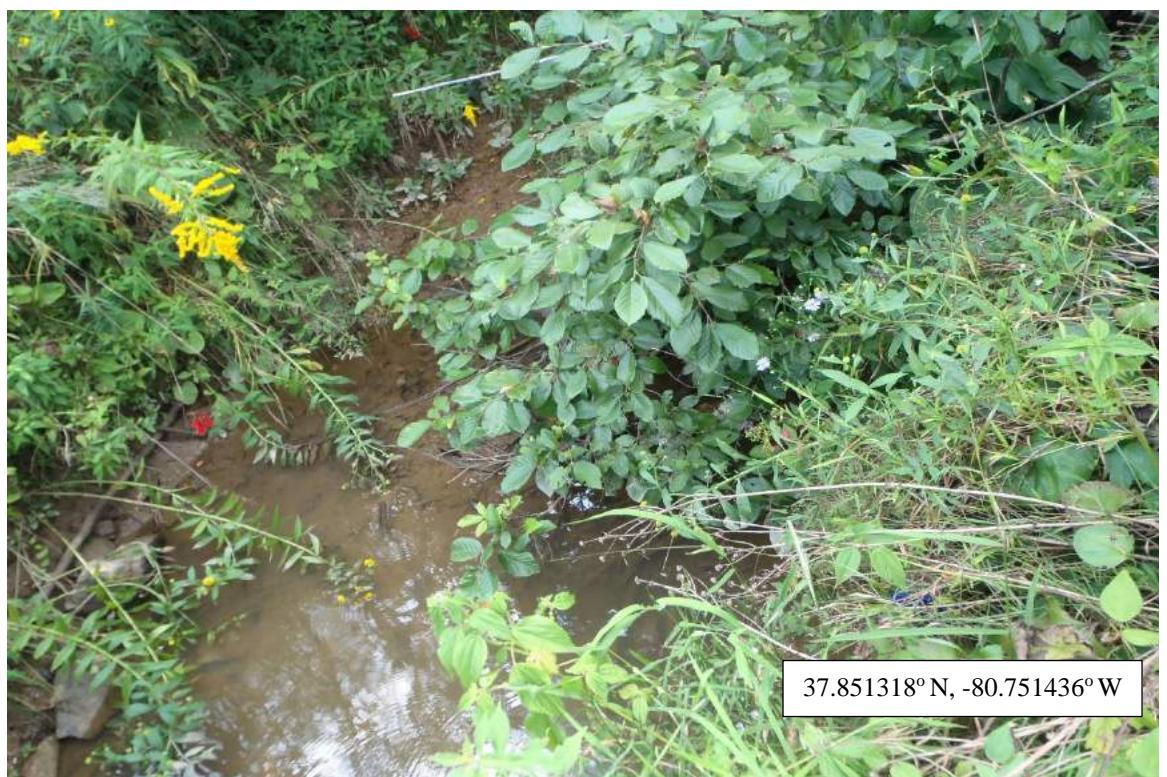
Photo Type: US at US Edge of AR LOD Location, Orientation, Photographer Initials: Upstream Edge of Access Road LOD, Upstream View, CH/AG/EW/WP (8/24/2021)

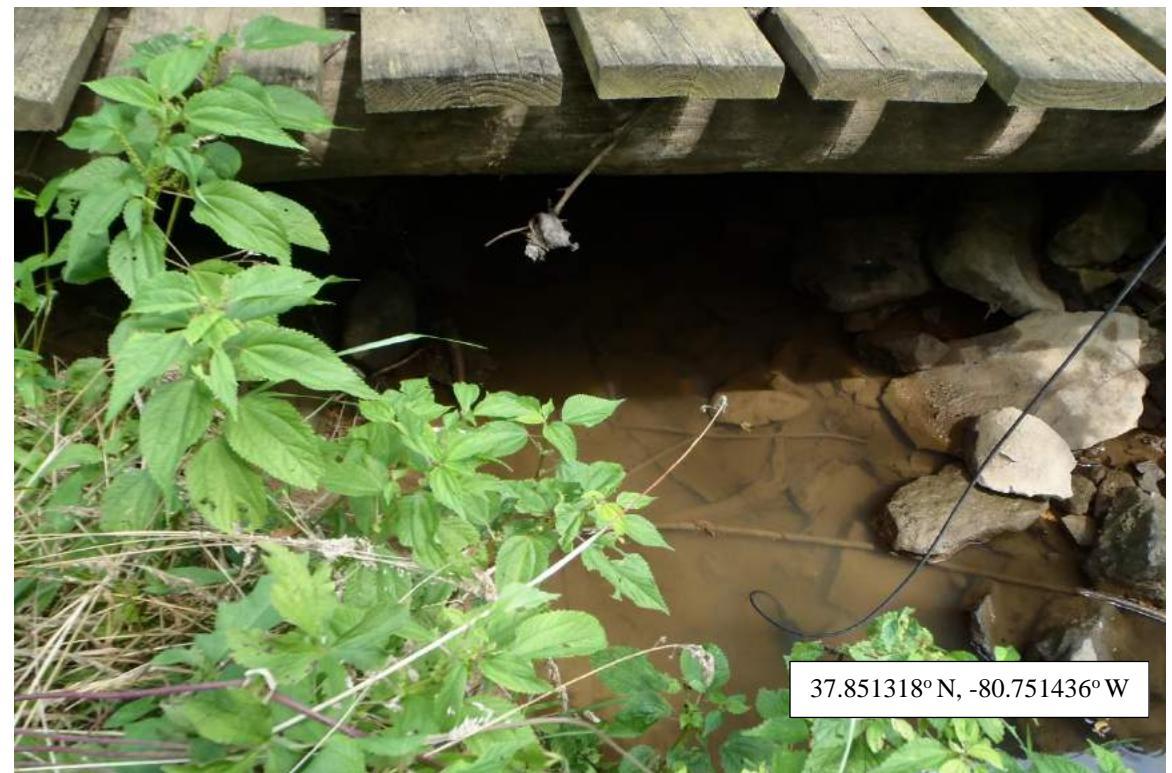
Photo Type: DS at US Edge of AR LOD Location, Orientation, Photographer Initials: Upstream Edge of Access Road LOD, Downstream View, CH/AG/EW/WP (8/24/2021)

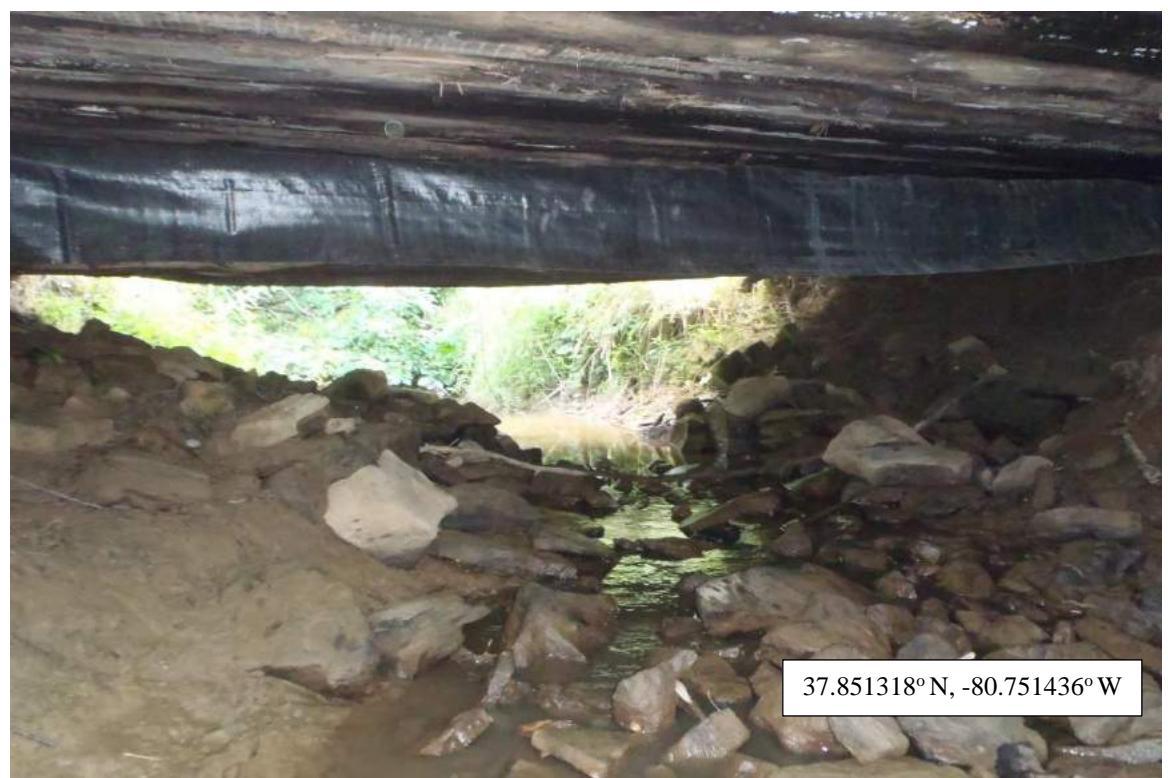
Photo Type: US at DS Edge of AR LOD

Location, Orientation, Photographer Initials: Downstream Edge of Access Road LOD, Upstream View, CH/AG/EW/WP (8/24/2021)

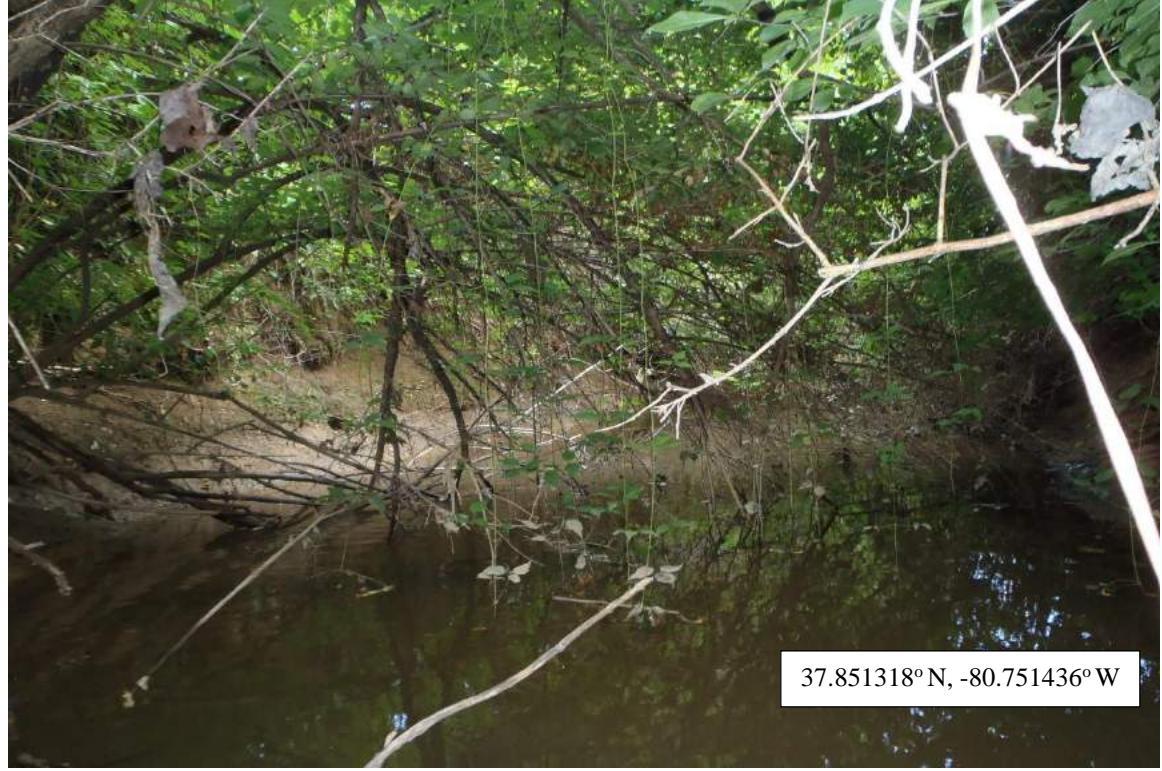
Photo Type: DS at DS Edge of AR LOD Location, Orientation, Photographer Initials: Downstream Edge of Access Road LOD, Downstream View, CH/AG/EW/WP (8/24/2021)

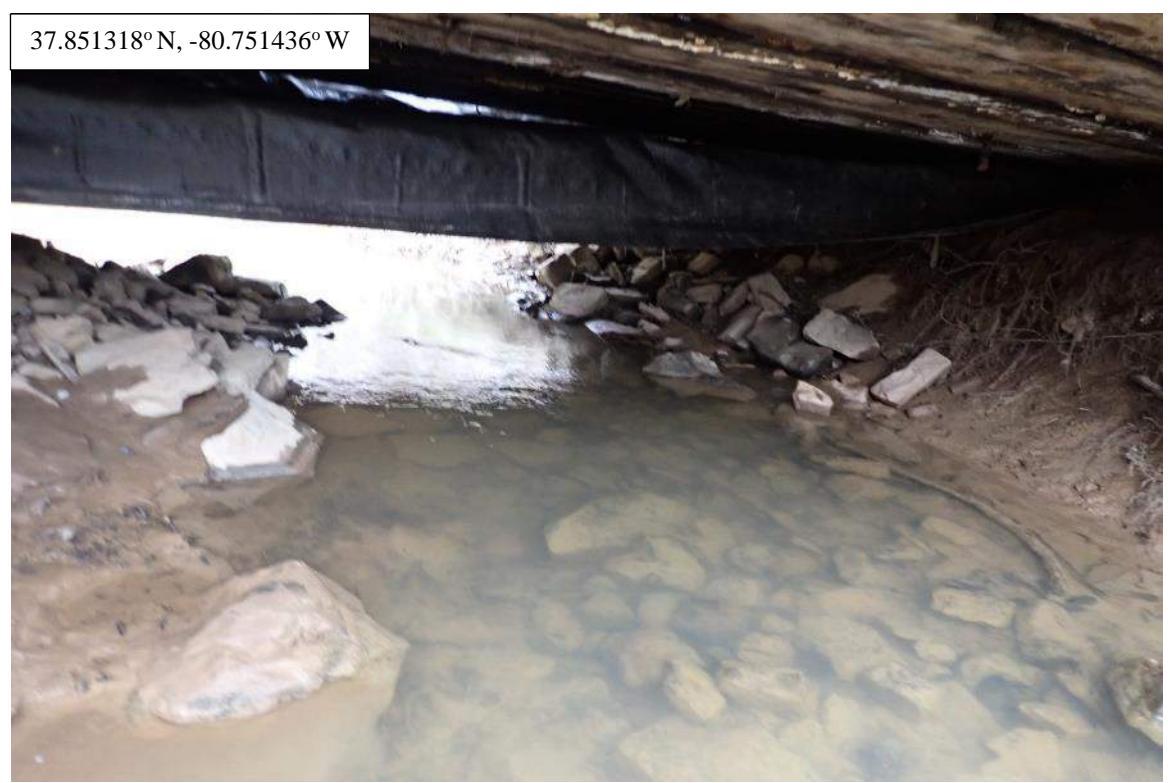
Photo Type: DS, US View Location, Orientation, Photographer Initials: Downstream, Upstream View, ABK/CH (03/16/2022)

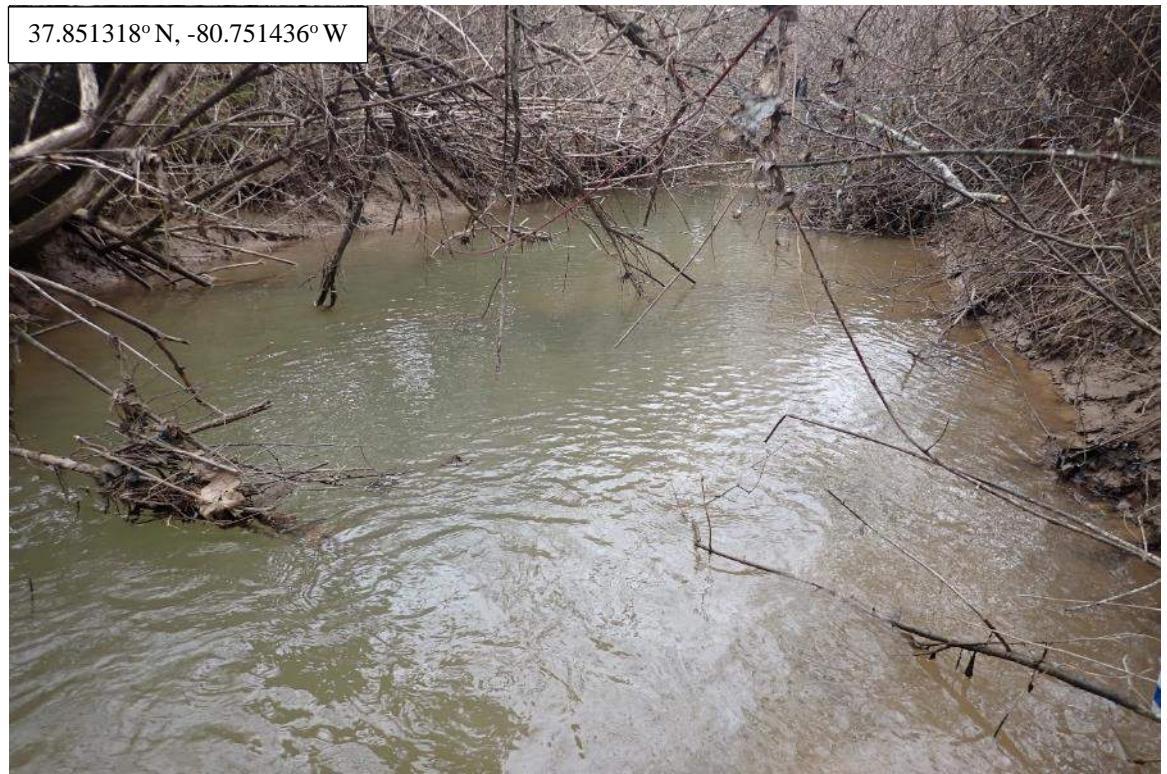
Photo Type: DS, DS View Location, Orientation, Photographer Initials: Downstream, Downstream View, ABK/CH (03/16/2022)

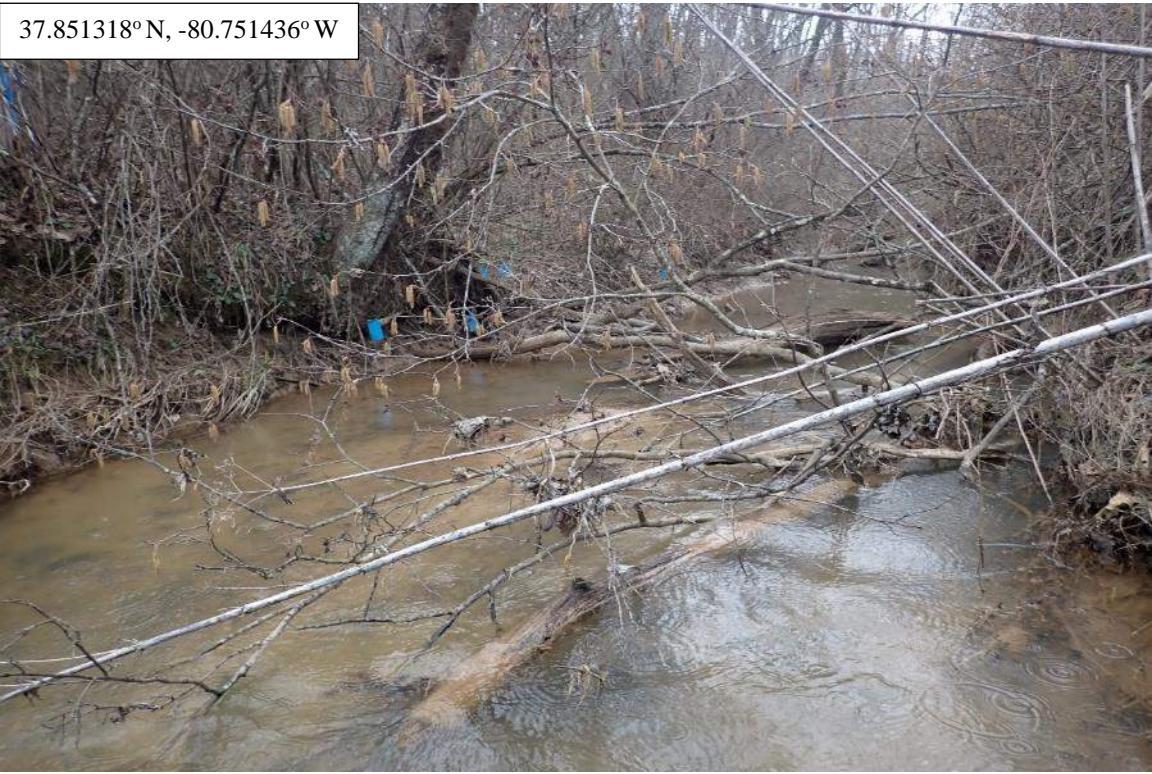
Photo Type: US, US View Location, Orientation, Photographer Initials: Upstream, Upstream View, ABK/CH (03/16/2022)

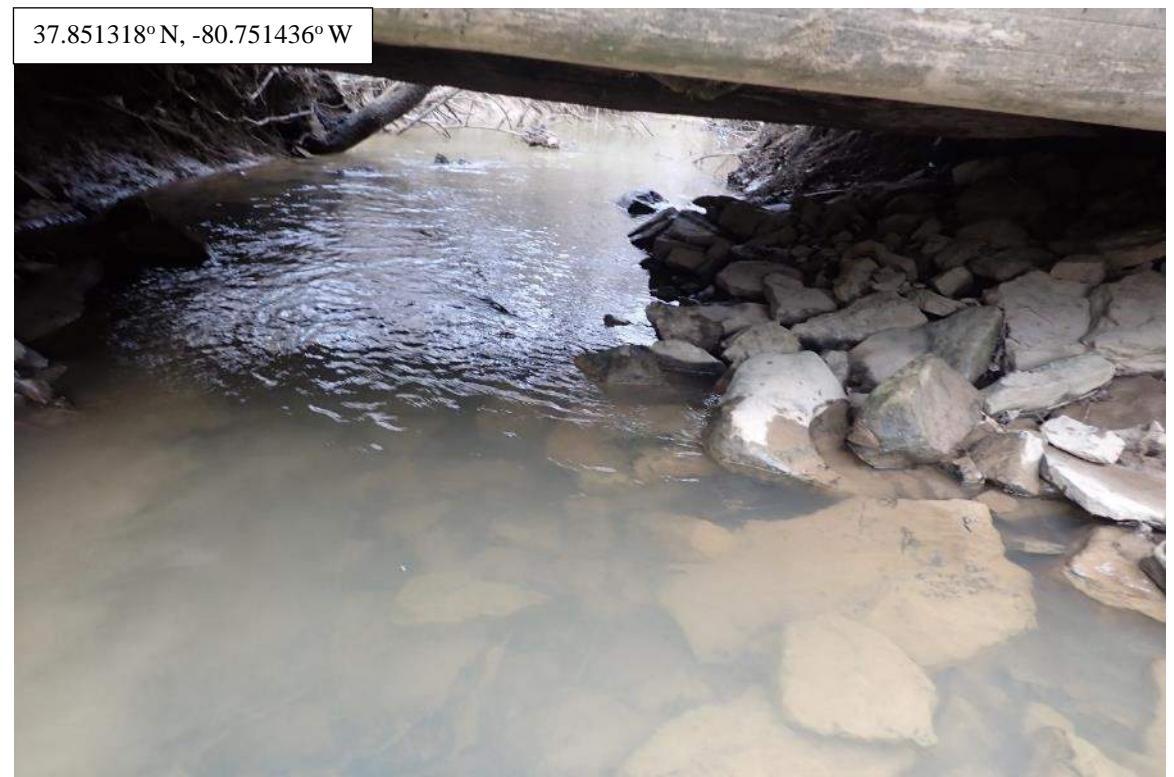
Photo Type: US, DS View Location, Orientation, Photographer Initials: Upstream, Downstream View, ABK/CH (03/16/2022)

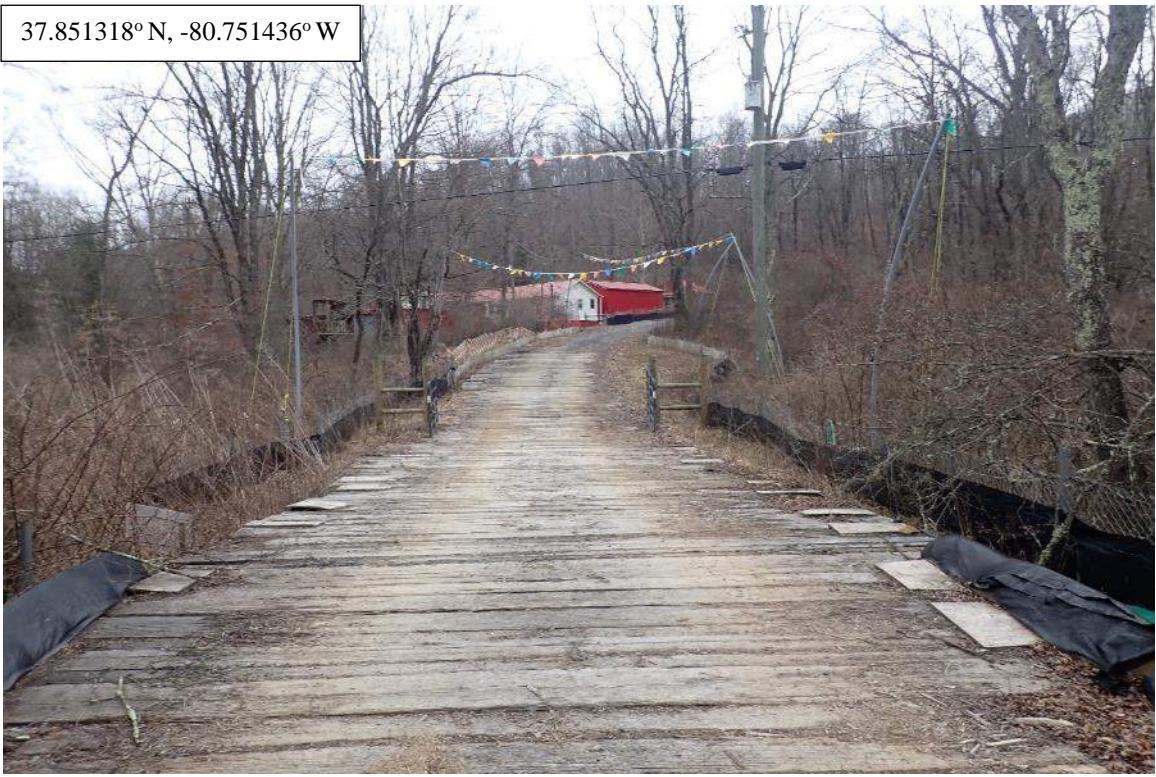
Photo Type: View of AR Away from ROW

Location, Orientation, Photographer Initials: View of Access Road Away from Right of Way, ABK/CH (03/16/2022)

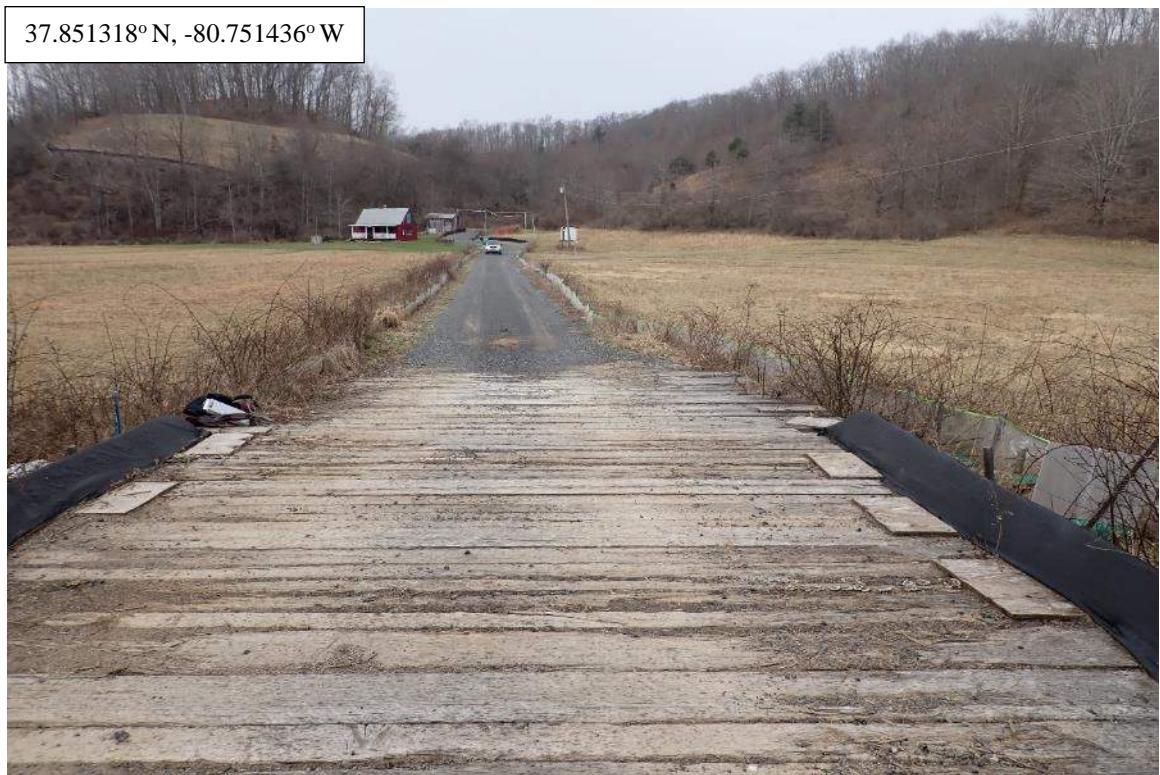
Photo Type: View of AR Toward ROW Location, Orientation, Photographer Initials: View of Access Road Toward Right of Way, ABK/CH (03/16/2022)
