Baseline Assessment – Stream Attributes

Reach S-A61 ROW (Pipeline ROW) Ephemeral Spread F Monroe County, West Virginia

$[&]quot;Q: \label{lem:conditions} \begin{subarray}{l} $"Q: \cite{Charleston} \cite{Conditions} \begin{subarray}{l} ASSESSMENT\ AND\ SURVEY\ PLAN \cite{O02} - Pre-Crossing\ Monitoring \cite{Spread}\ F\cite{S-A61}\ ROW" \end{subarray}$

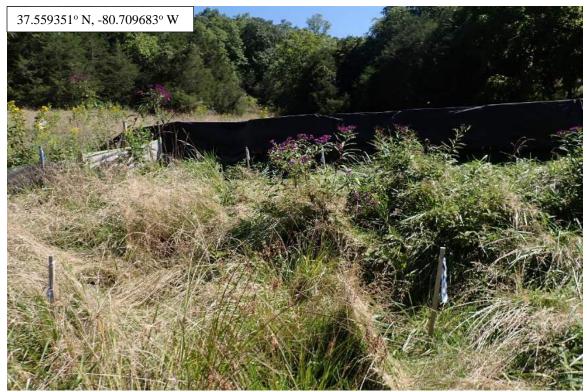
Photo Type: US View, US Reach Location, Orientation, Photographer Initials: Upstream Reach, Upstream View, AAK/SM/TA

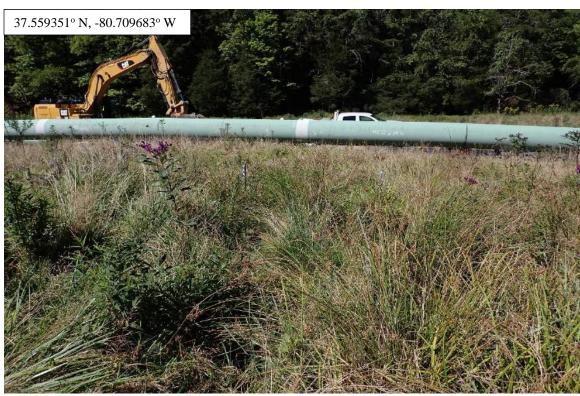
Photo Type: DS View, US Reach Location, Orientation, Photographer Initials: Upstream Reach, Downstream View, AAK/SM/TA

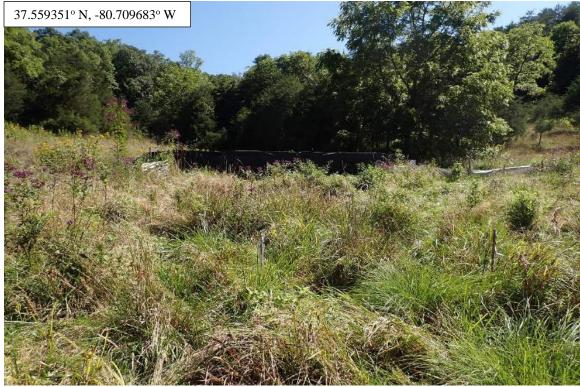
Photo Type: US View, Mid-Reach Location, Orientation, Photographer Initials: Mid-Reach Right of Way, Upstream View, AAK/SM/TA

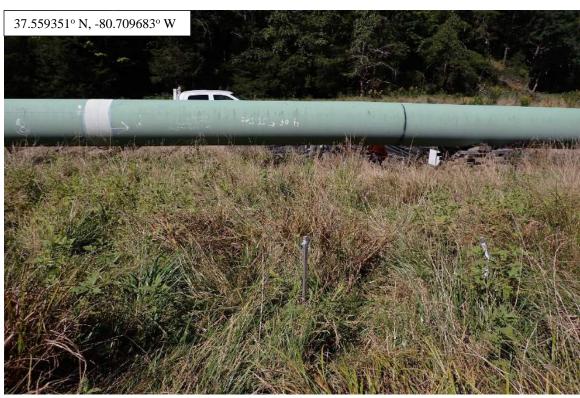
Photo Type: DS View, Mid-Reach Location, Orientation, Photographer Initials: Mid-Reach Right of Way, Downstream View, AAK/SM/TA

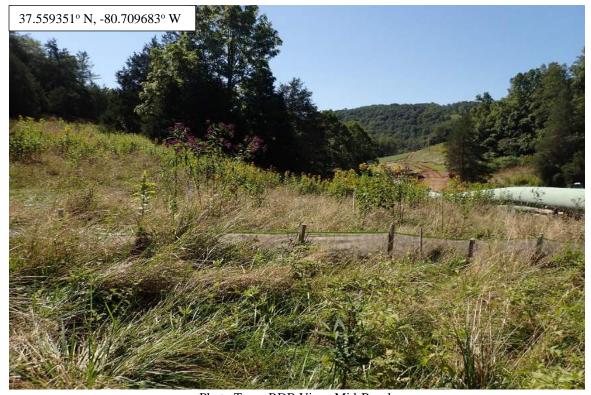
Photo Type: RDB View, Mid-Reach
Location, Orientation, Photographer Initials: Mid-Reach Right of Way, Right Descending Bank View, AAK/SM/TA

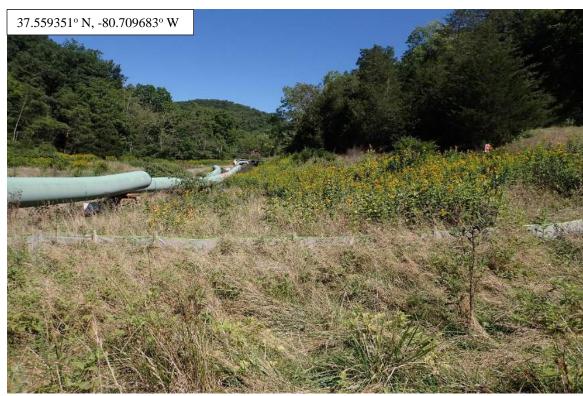
Photo Type: LDB View, Mid-Reach
Location, Orientation, Photographer Initials: Mid-Reach Right of Way, Left Descending Bank View, AAK/SM/TA

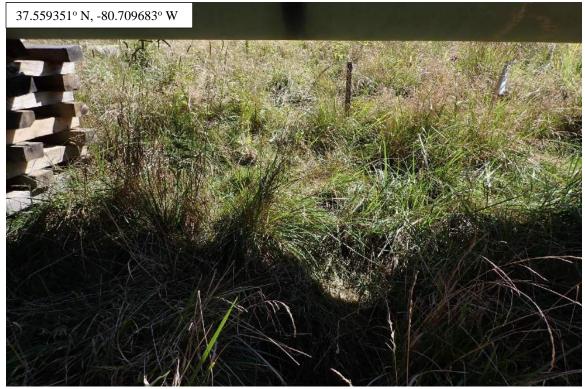
Photo Type: US View, DS Reach Location, Orientation, Photographer Initials: Downstream Reach, Upstream View, AAK/SM/TA

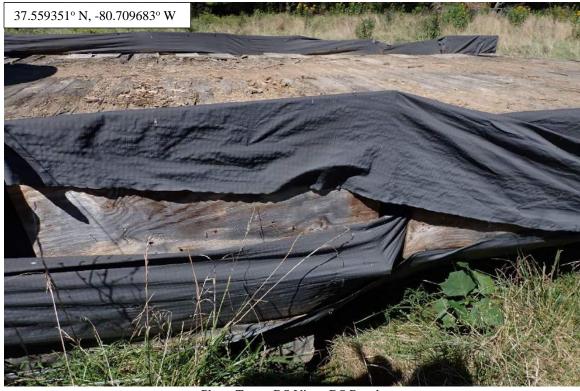
Photo Type: DS View, DS Reach Location, Orientation, Photographer Initials: Downstream Reach, Downstream View, AAK/SM/TA

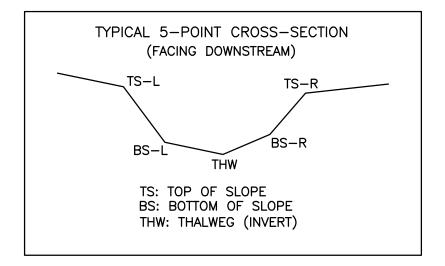
S-A61 ROW BASELINE CROSS-SECTION A

AS-BUILT TABLE: S-A61 ROW CROSS SECTION A								
		PRE-CROSS	AS-BUILT					
PT. LOC.	NORTHING	EASTING	ELEV.	VERT. DIFF.	HORZ. DIFF.			
TS-L	13638301.31	1724423.88	1629.35					
BS-L	13638302.49	1724423.55	1627.64					
THW	13638303.15	1724423.45	1627.69					
BS-R	13638305.42	1724423.19	1627.72					
TS-R	13638306.13	1724422.94	1628.17
