Baseline Assessment – Stream Attributes

Reach S-CV17 (Pipeline ROW) Ephemeral Spread F Summers County, West Virginia

Spread F Stream S-CV17 (Pipeline ROW) Summers County

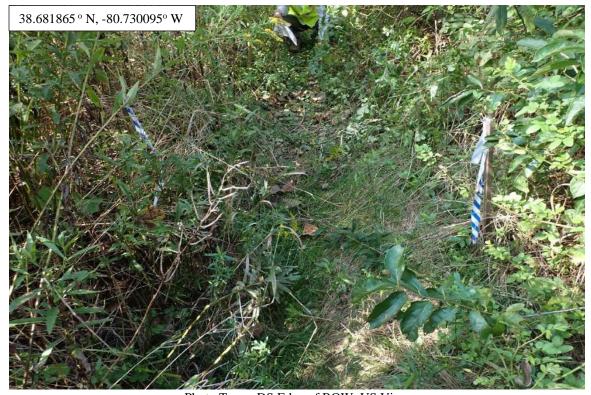
Photo Type: DS Edge of ROW, US View
Location, Orientation, Photographer Initials: Downstream Edge of Right of Way, Upstream View, TF/EW/WP

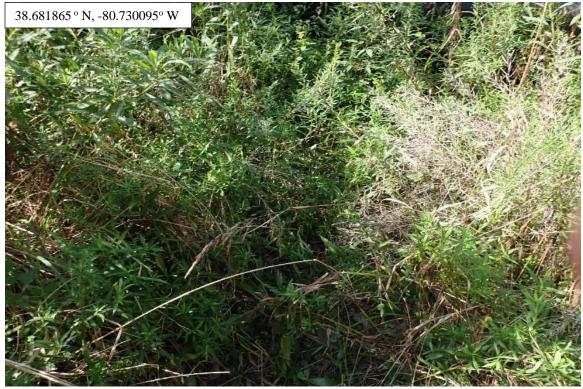
Photo Type: Center ROW, US View
Location, Orientation, Photographer Initials: Center Right of Way, Upstream View, TF/EW/WP

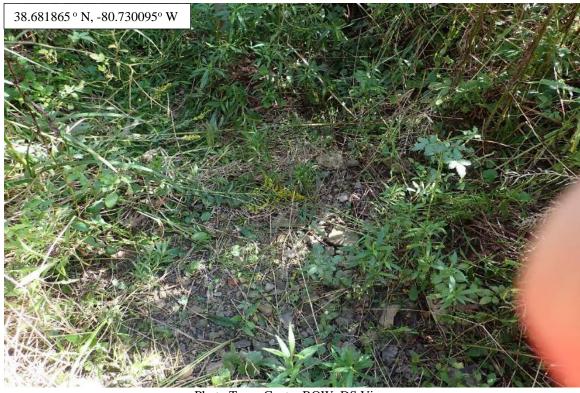
Photo Type: Center ROW, DS View Location, Orientation, Photographer Initials: Center of Right of Way, Downstream View, TF/EW/WP

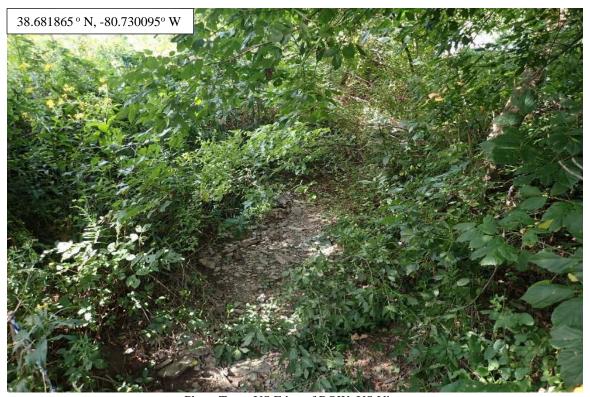
Photo Type: US Edge of ROW, US View Location, Orientation, Photographer Initials: Upstream Edge of Right of Way, Upstream View, TF/EW/WP

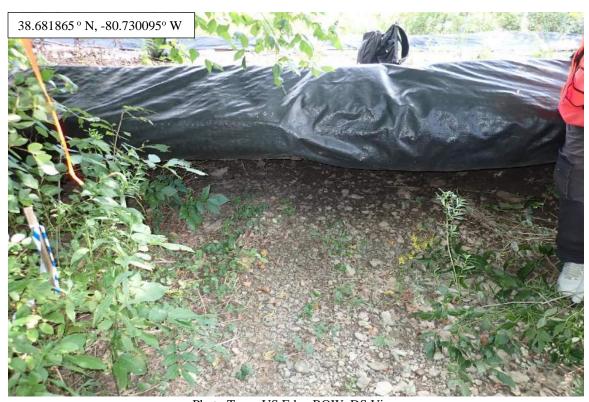
Photo Type: US Edge ROW, DS View
Location, Orientation, Photographer Initials: Upstream Edge of Right of Way, Downstream View, TF/EW/WP

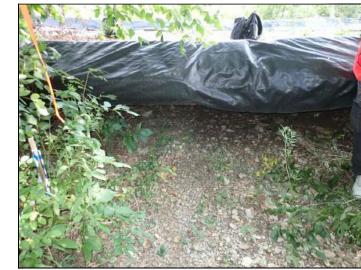
PHOTO TAKEN LOOKING DOWNSTREAM FROM UPSTREAM IMPACT LIMITS

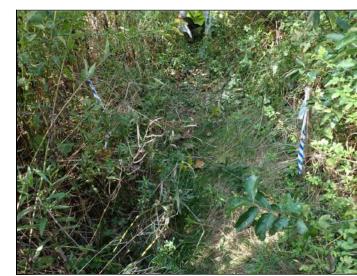
PHOTO TAKEN LOOKING UPSTREAM FROM DOWNSTREAM IMPACT LIMITS
