Baseline Assessment – Stream Attributes

Reach S-H64 (Pipeline ROW) Intermittent Spread E Nicholas County, West Virginia

Title	PROFILE AND CROSS-SECTIONS BASELINE SURVEY CROSSING S-H64 – UNNAMED TRIB. TO HOMINY CREEK (MP 132.10) NICHOLAS COUNTY, WV	Client	MCM 222
--------------	---	---------------	------------

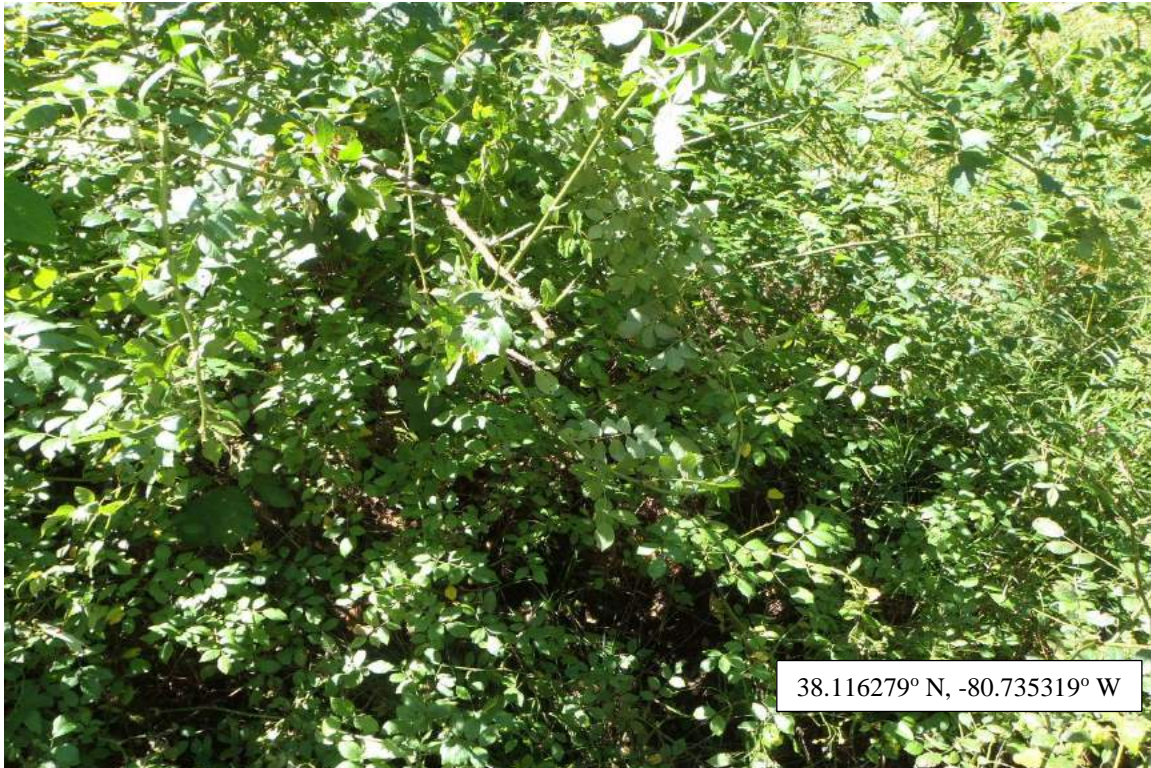
Photo Type: DS Edge ROW, US View

Location, Orientation, Photographer Initials: Downstream Edge of Right of Way, Upstream View, EW/AG/WP

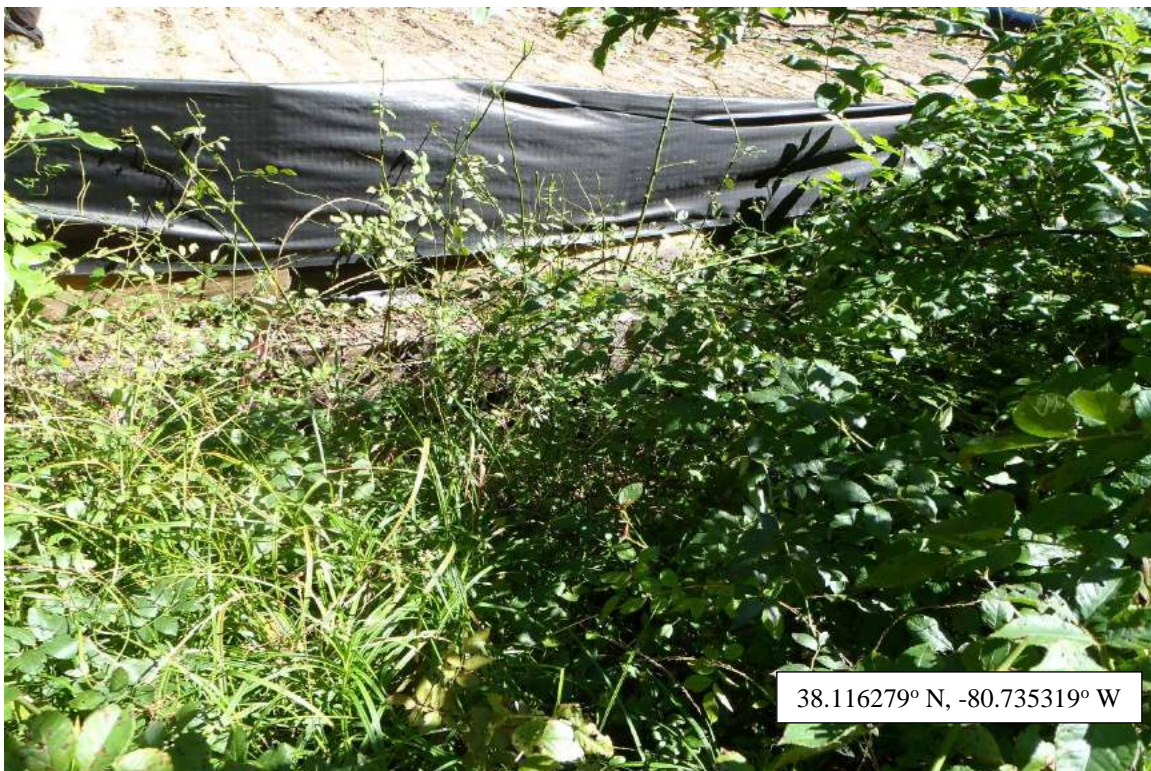
Photo Type: DS Edge ROW, DS View

Location, Orientation, Photographer Initials: Downstream Edge of ROW, Downstream View, EW/AG/WP

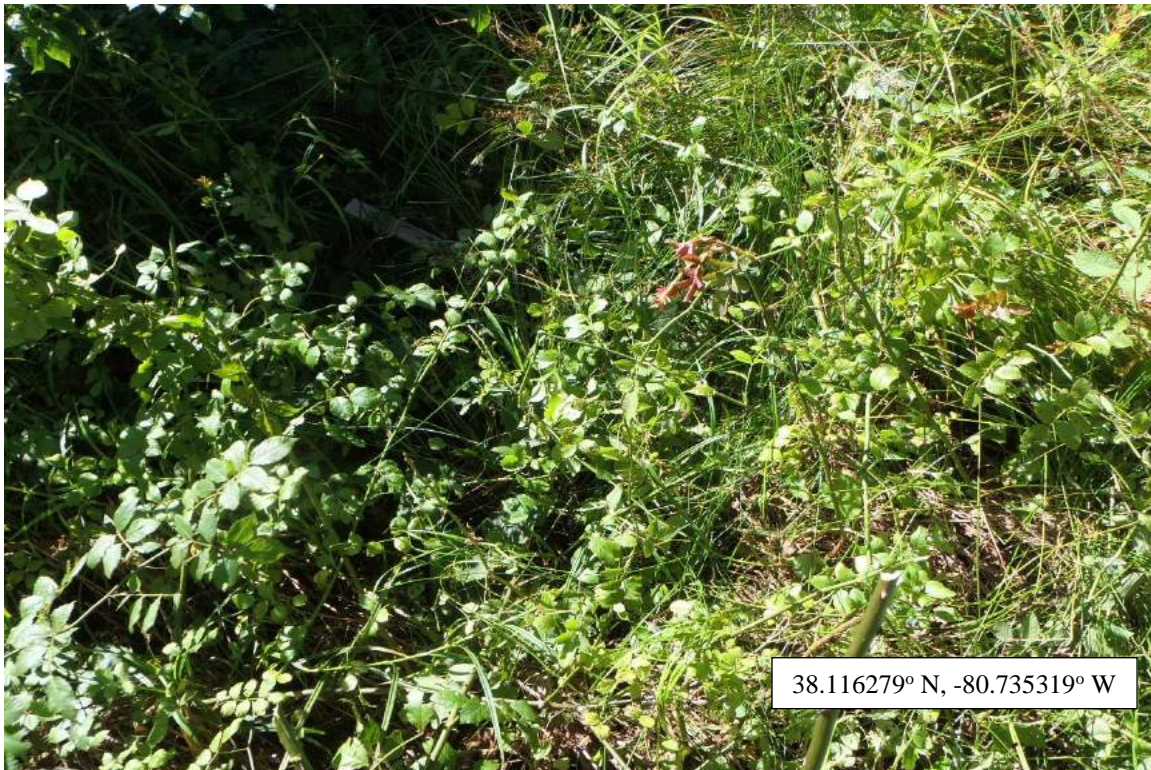
Photo Type: C ROW, US View

Location, Orientation, Photographer Initials: Center Right of Way, Upstream View, EW/AG/WP

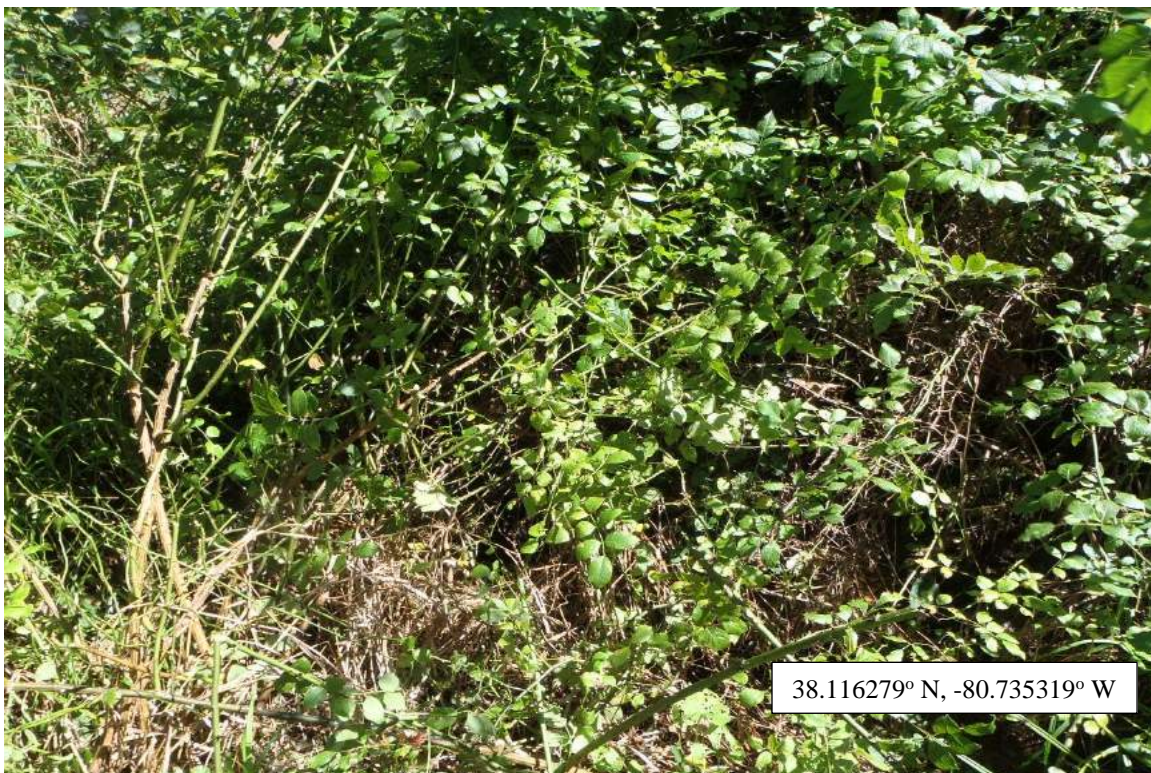
Photo Type: C ROW, DS View

Location, Orientation, Photographer Initials: Center of Right of Way, Downstream View, EW/AG/WP

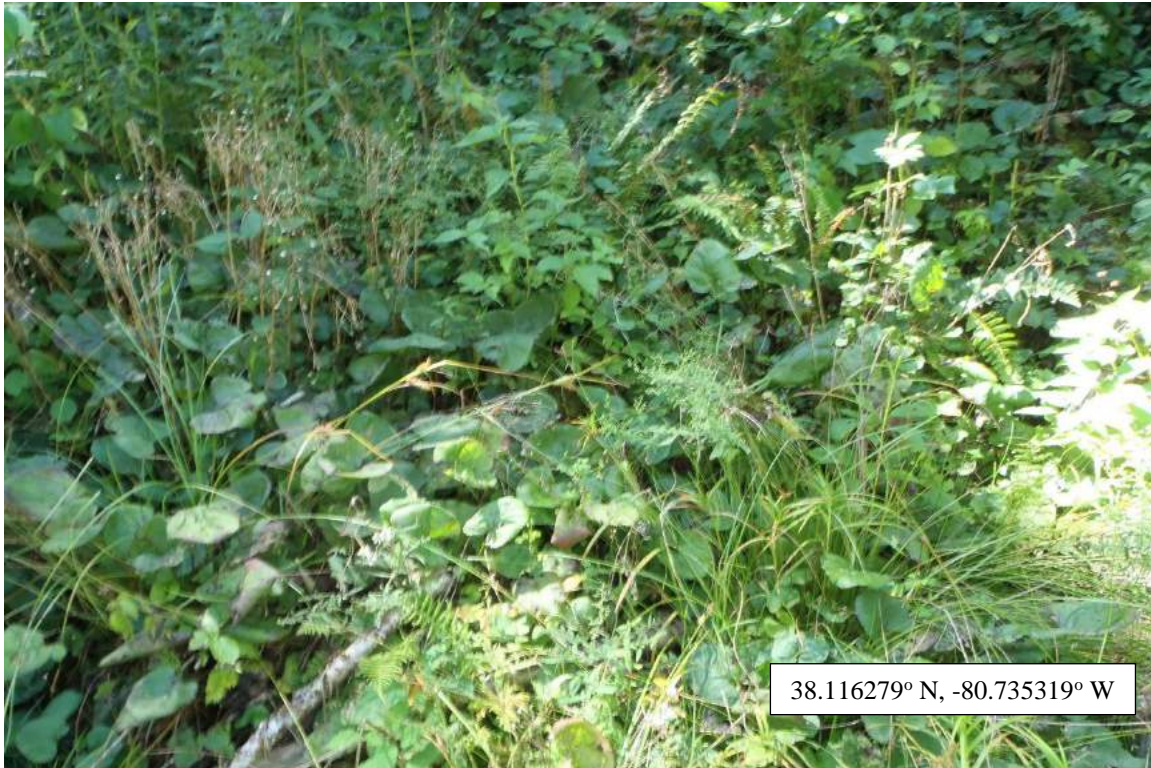
Photo Type: US Edge ROW, US View

Location, Orientation, Photographer Initials: Upstream Edge of Right of Way, Upstream View, EW/AG/WP

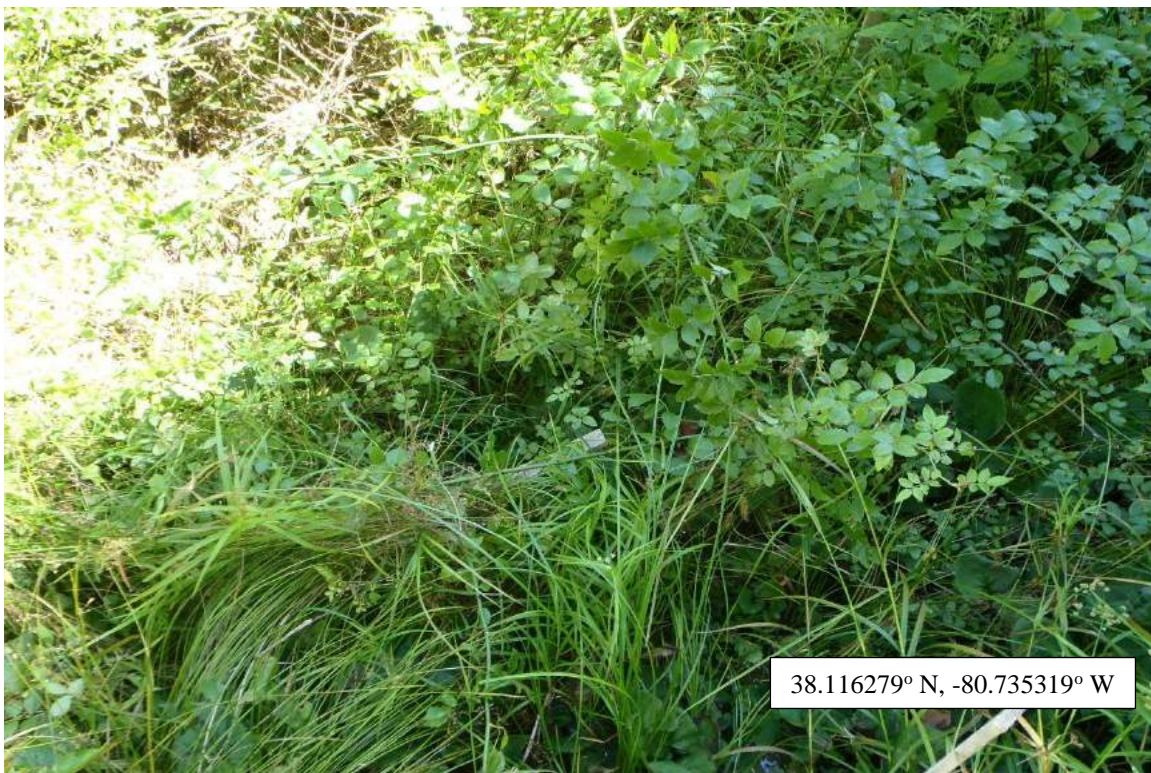
Photo Type: US Edge ROW, DS View

Location, Orientation, Photographer Initials: Upstream Edge Right of Way, Downstream View, EW/AG/WP

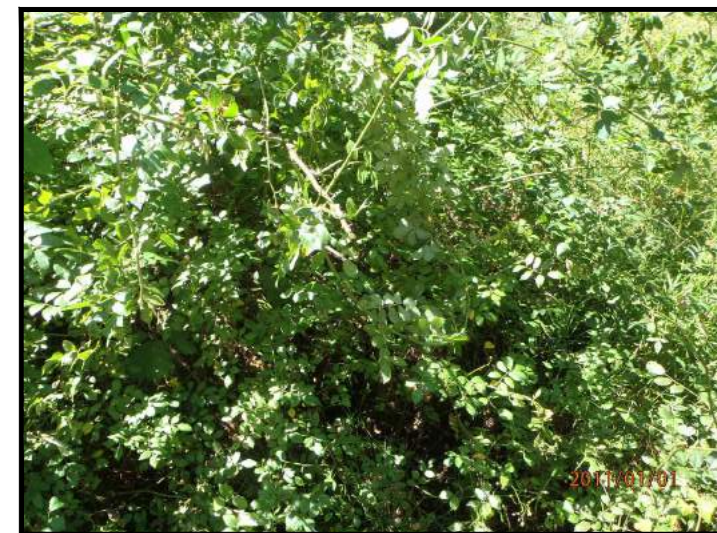
PHOTO TAKEN LOOKING DOWNSTREAM
FROM UPSTREAM IMPACT LIMITS

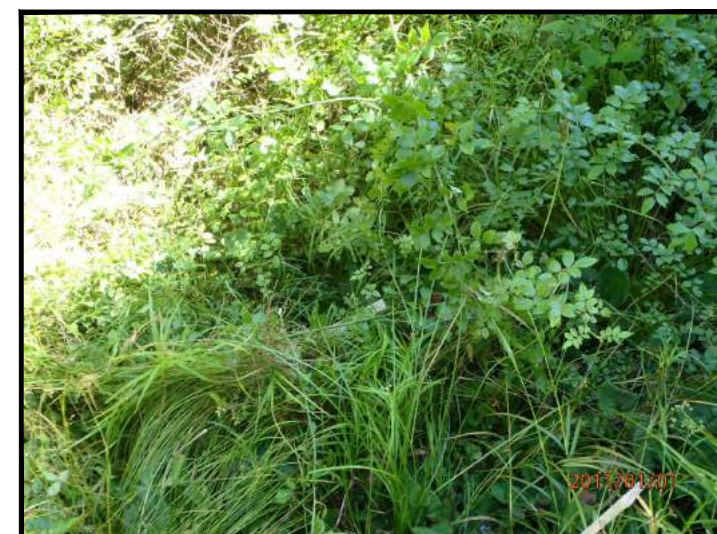
PHOTO TAKEN LOOKING UPSTREAM FROM
DOWNSTREAM IMPACT LIMITS
