## Baseline Assessment – Stream Attributes

### Reach S-I31 (Pipeline ROW) Ephemeral Spread D Nicholas County, West Virginia

Mountain Valley Pipeline- Preliminary Assessment

S-131 UNT to Hominy Creek, Nicholas County, Spread D

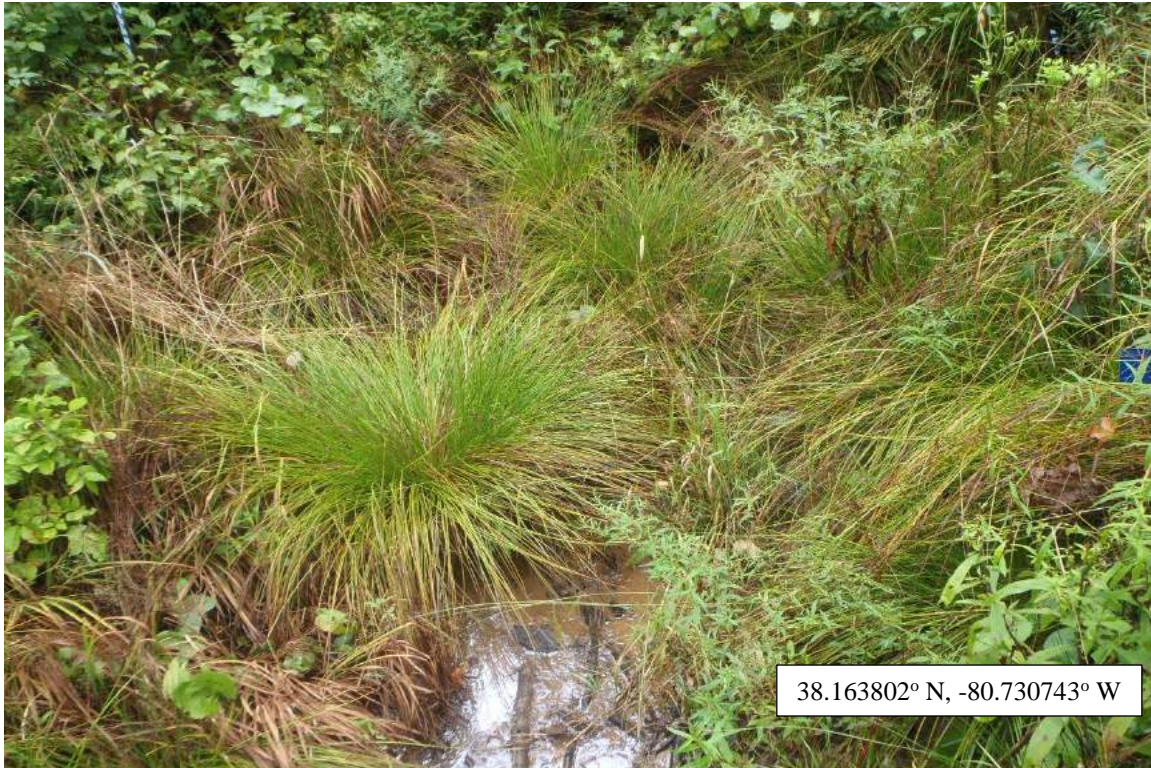
Photo Type: US Edge of ROW, US View  
Location, Orientation, Photographer Initials: Upstream Edge of Right of Way, Upstream View, BB/AG

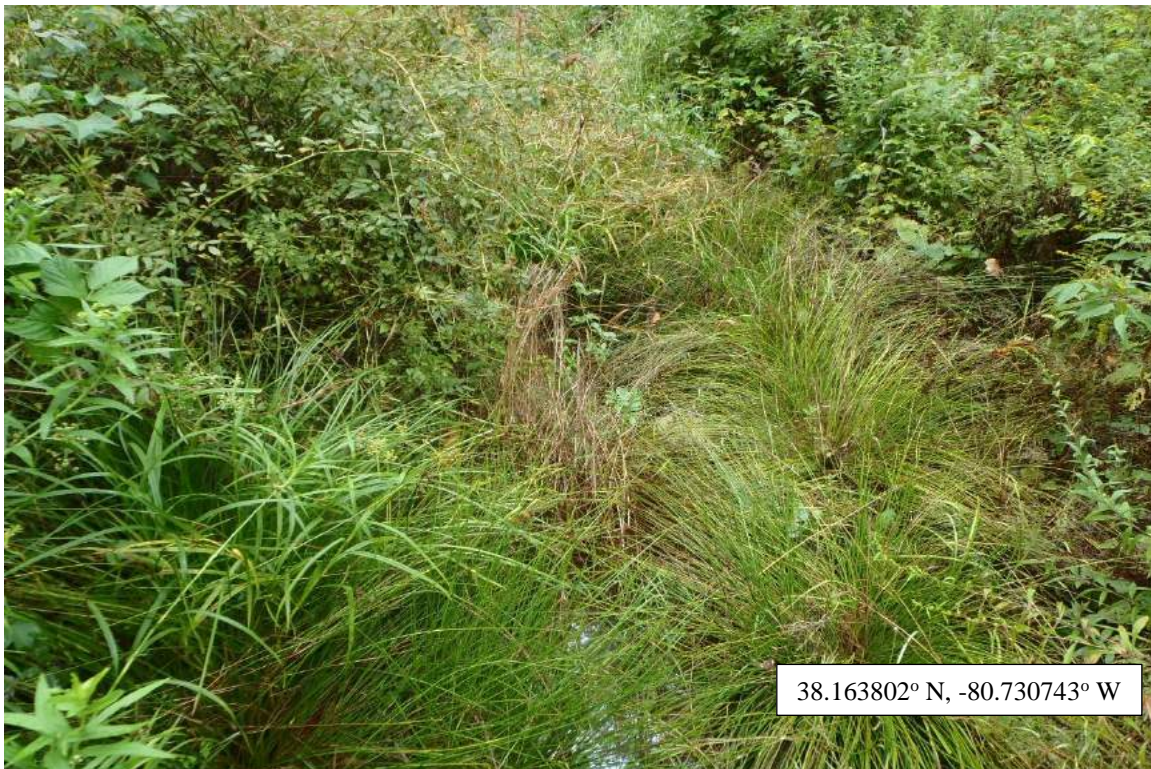
Photo Type: US Edge, DS View  
Location, Orientation, Photographer Initials: Upstream Edge of Right of Way, Downstream View, BB/AG

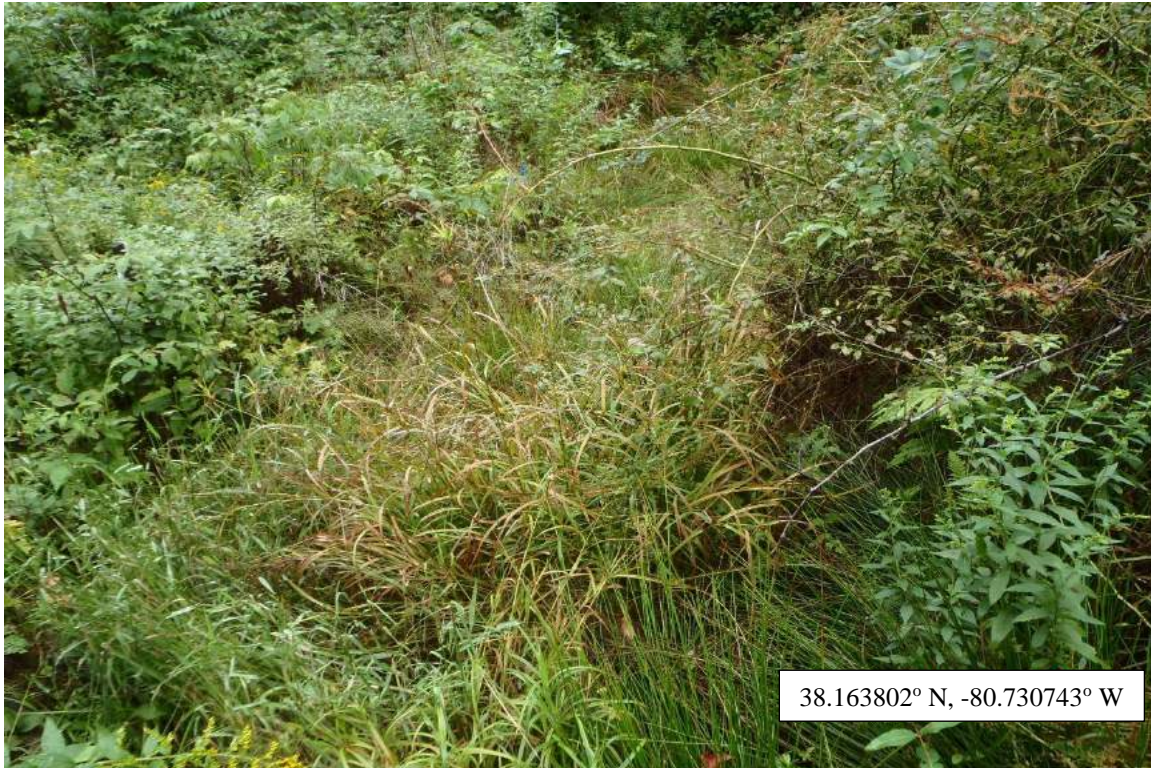
Photo Type: C ROW, US View

Location, Orientation, Photographer Initials: Center of Right of Way, Upstream View, BB/AG

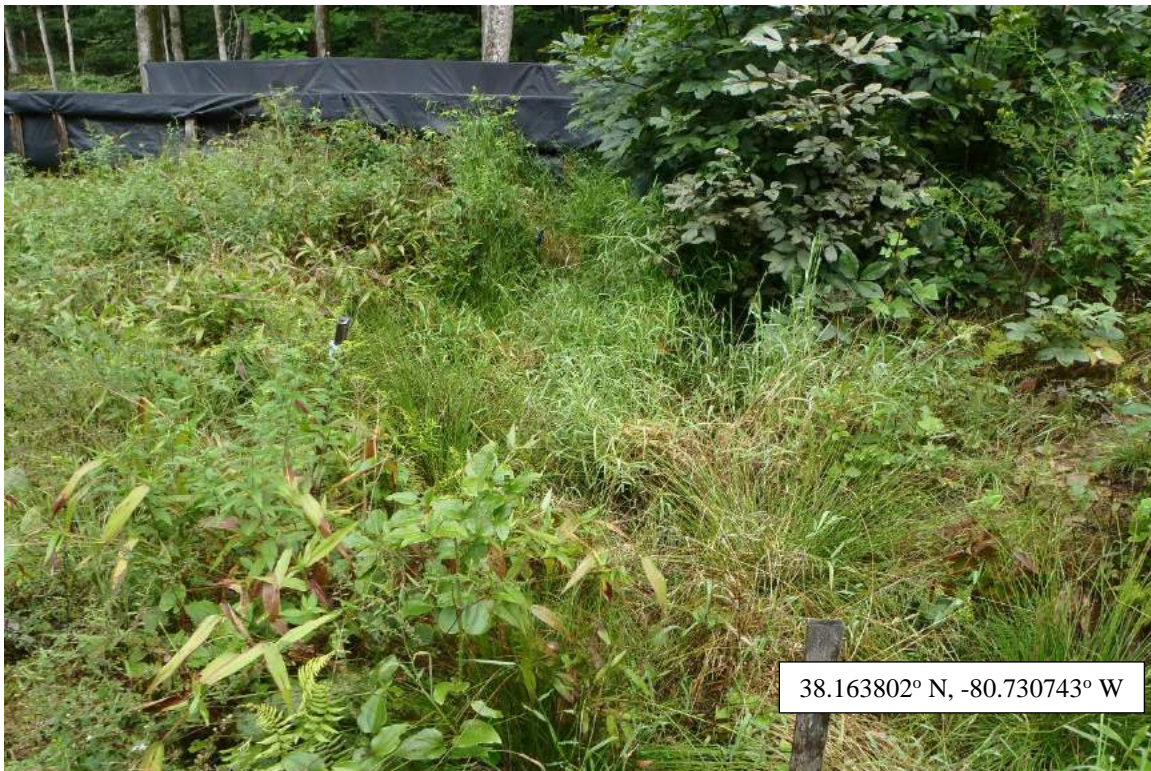
Photo Type: C ROW, DS View

Location, Orientation, Photographer Initials: Center of Right of Way, Downstream View, BB/AG

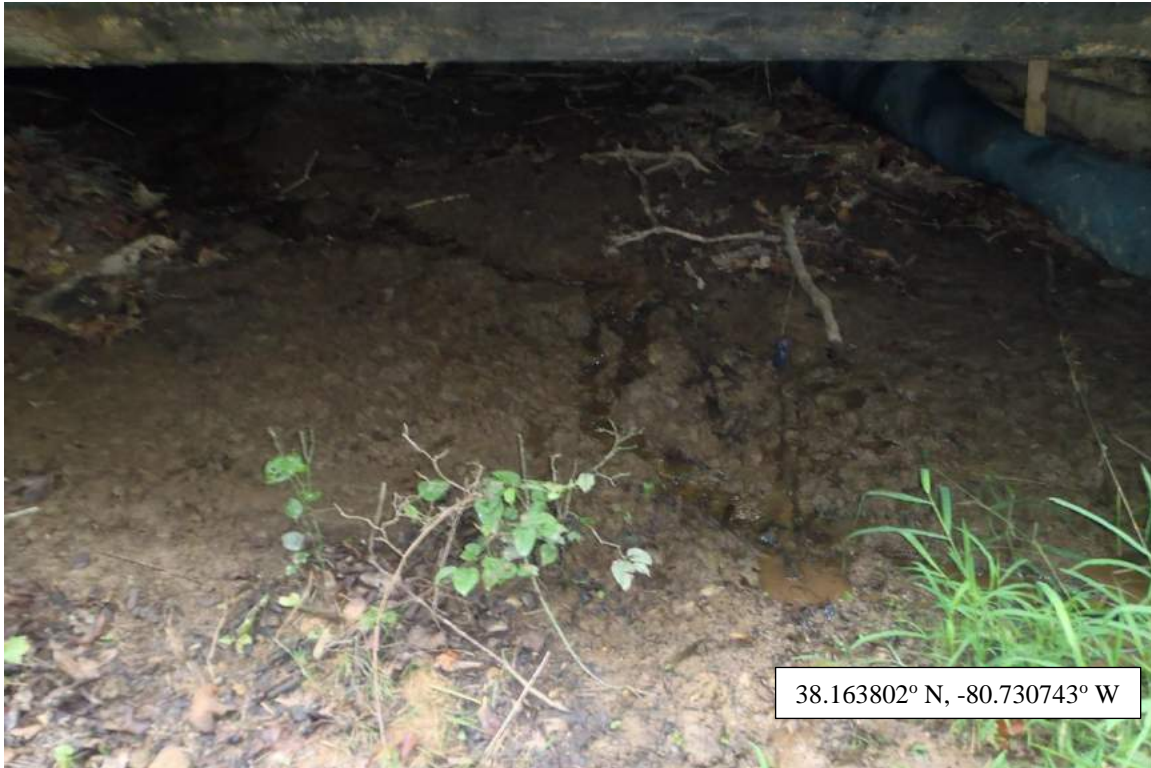
Photo Type: DS Edge, US View

Location, Orientation, Photographer Initials: Downstream Edge of Right of Way, Upstream View, BB/AG

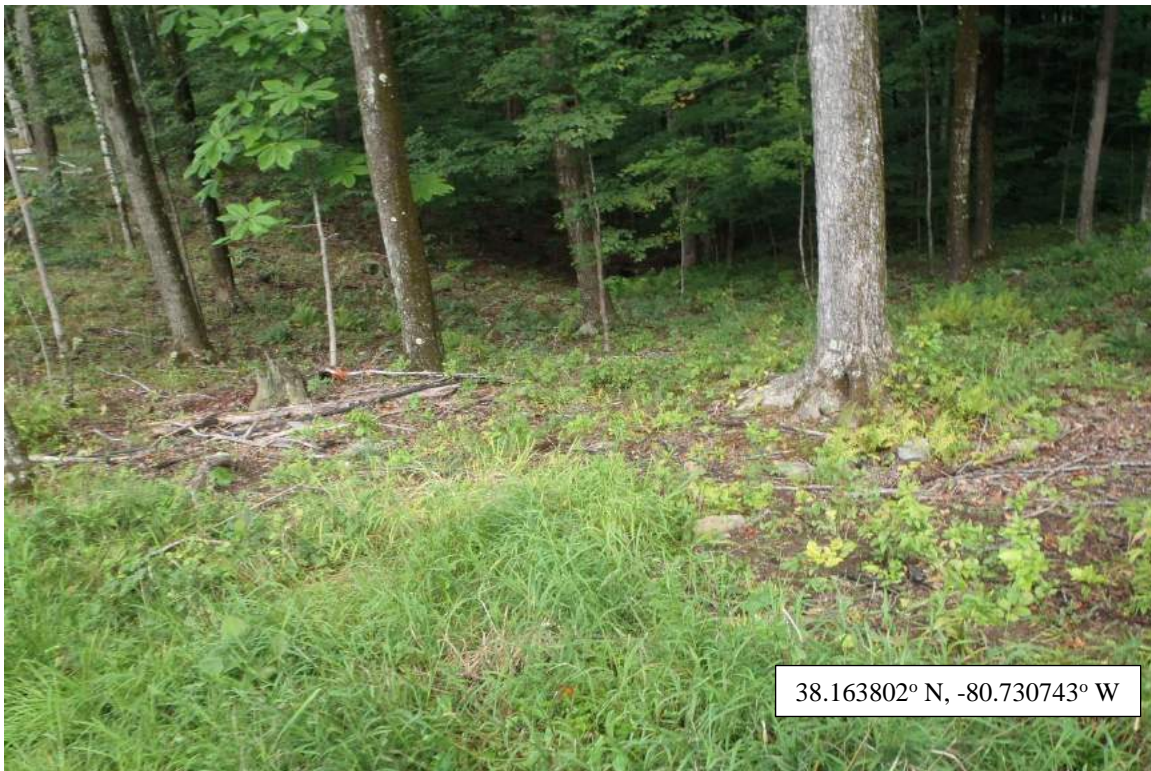
Photo Type: DS Edge, DS View

Location, Orientation, Photographer Initials: Downstream Edge of Right of Way, Downstream View, BB/AG

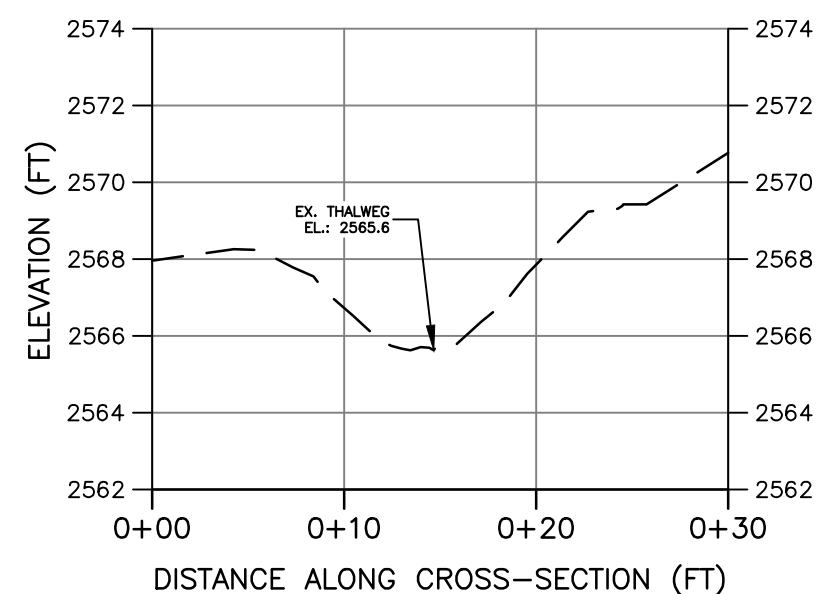
Profile view of the cross-section showing elevation (FT) versus distance along the cross-section (FT). The profile shows a series of points connected by lines, with elevations ranging from 2556.0 to 2570.7 feet. The distance along the cross-section ranges from 0+00 to 0+85 feet.

AS-BUILT TABLE: 5-131 CROSS SECTION A					
PRE-CROSSING				AS-BUILT	
PT. LOC.	NORTHING	EASTING	ELEV	VERT. DIFF.	HORZ. DIFF.
TS-L	13858297.3400	1717825.2210	2567.843'		
BS-L	13858300.1900	1717827.5670	2565.989'		
THW	13858302.6600	1717829.7970	2565.464'		
BS-R	13858304.1700	1717830.7640	2565.969'		
TS-R	13858306.6500	1717832.2160	2567.551'

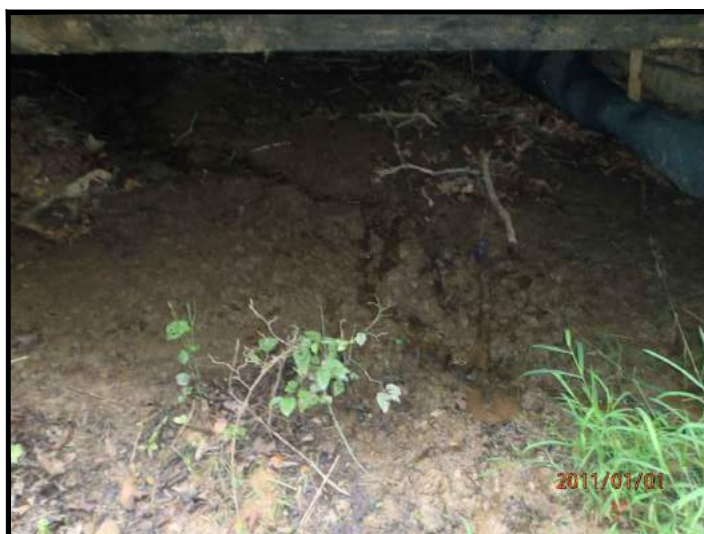
PHOTO TAKEN LOOKING UPSTREAM FROM  
DOWNSTREAM IMPACT LIMITS
