Baseline Assessment – Stream Attributes

Reach S-J70 AR (Temporary Access Road) Perennial Spread C Braxton County, West Virginia

USACE FILE NO./ Project Name: (v2.1, Sept 2015)			Mountain Valley Pipeline			IMPACT COORDINATES: (in Decimal Degrees)			Lat.	38.779630'			Lon.	-80.526221			WEATHER:			Clear/Sunny/35 Degrees F			DATE:			11/22/2022								
IMPACT STREAM/SITE ID AND SITE DESCRIPTION: (watershed size (acreage), unaltered or impairments)						S-J70 AR (FALLS RUN)						MITIGATION STREAM CLASS./SITE ID AND SITE DESCRIPTION: (watershed size (acreage), unaltered or impairments)						11/22/2022						Comments:										
STREAM IMPACT LENGTH:			66			FORM OF MITIGATION:			RESTORATION (Levels I-III)			MIT COORDINATES: (in Decimal Degrees)			Lat.				Lon.				PRECIPITATION PAST 48 HRS:						Mitigation Length:					
Column No. 1- Impact Existing Condition (Debit)						Column No. 2- Mitigation Existing Condition - Baseline (Credit)						Column No. 3- Mitigation Projected at Five Years Post Completion (Credit)						Column No. 4- Mitigation Projected at Ten Years Post Completion (Credit)						Column No. 5- Mitigation Projected at Maturity (Credit)

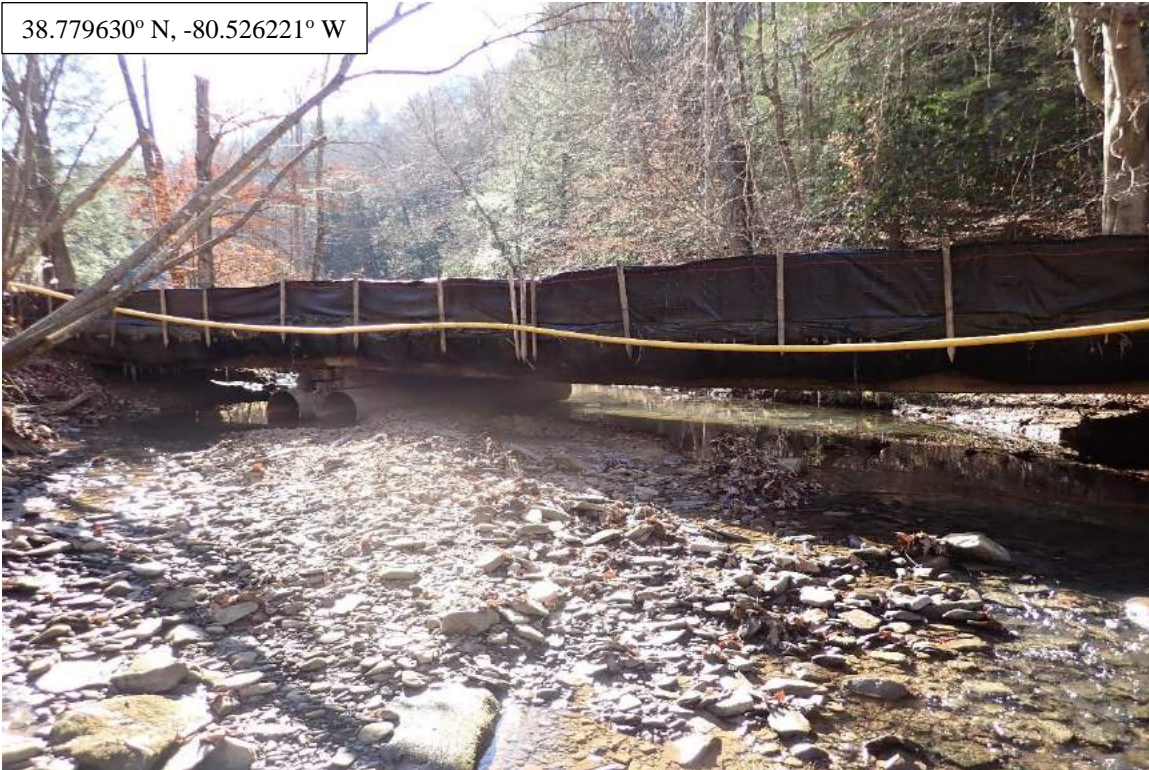
Photo Type: DS, US View

Location, Orientation, Photographer Initials: Downstream Edge of Right of Way, Upstream View, SBB/ABK

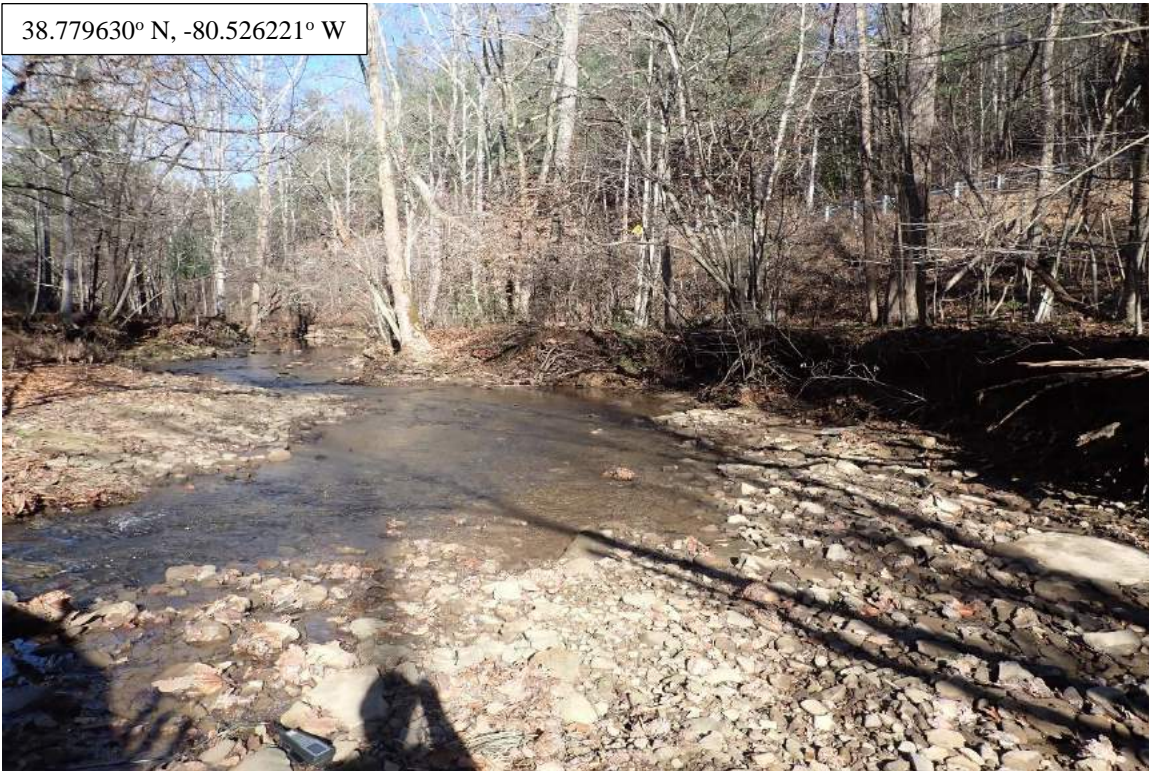
Photo Type: DS, DS View

Location, Orientation, Photographer Initials: Downstream Edge of Right of Way, Downstream View, SBB/ABK

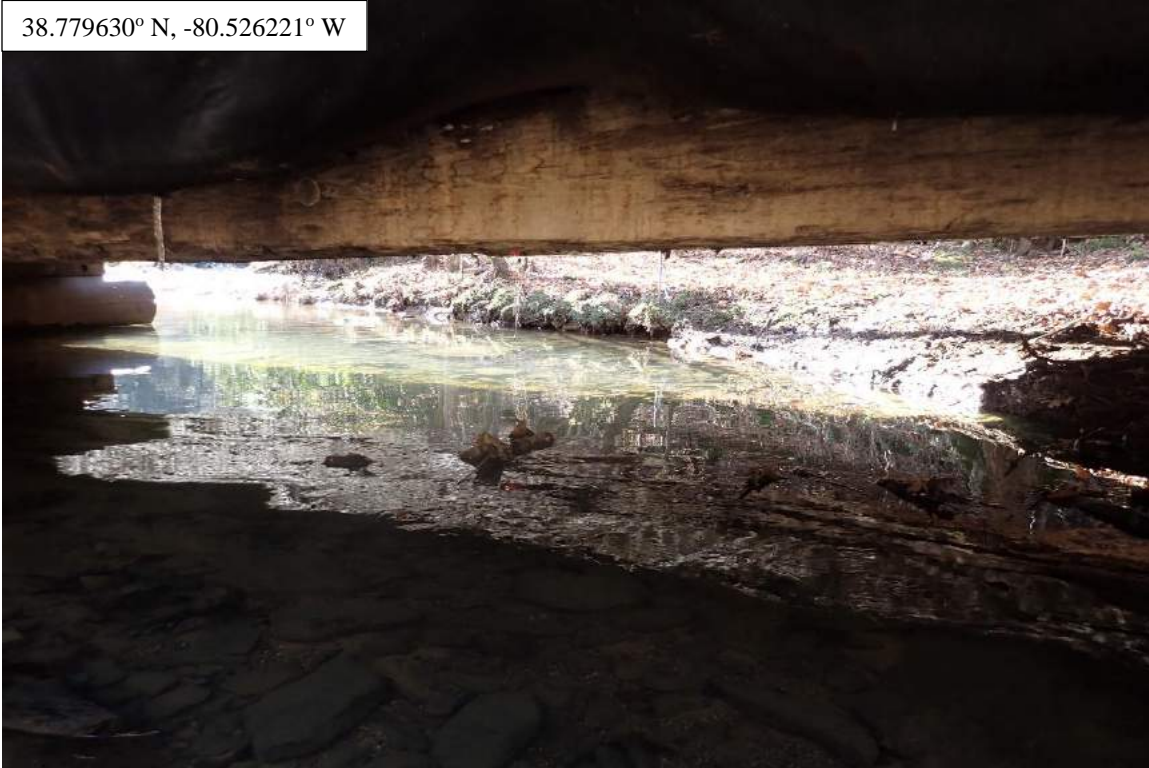
Photo Type: Pool Under TMB, US View

Location, Orientation, Photographer Initials: Upstream View of Pool Under Timber Mat Bridge, SBB/ABK

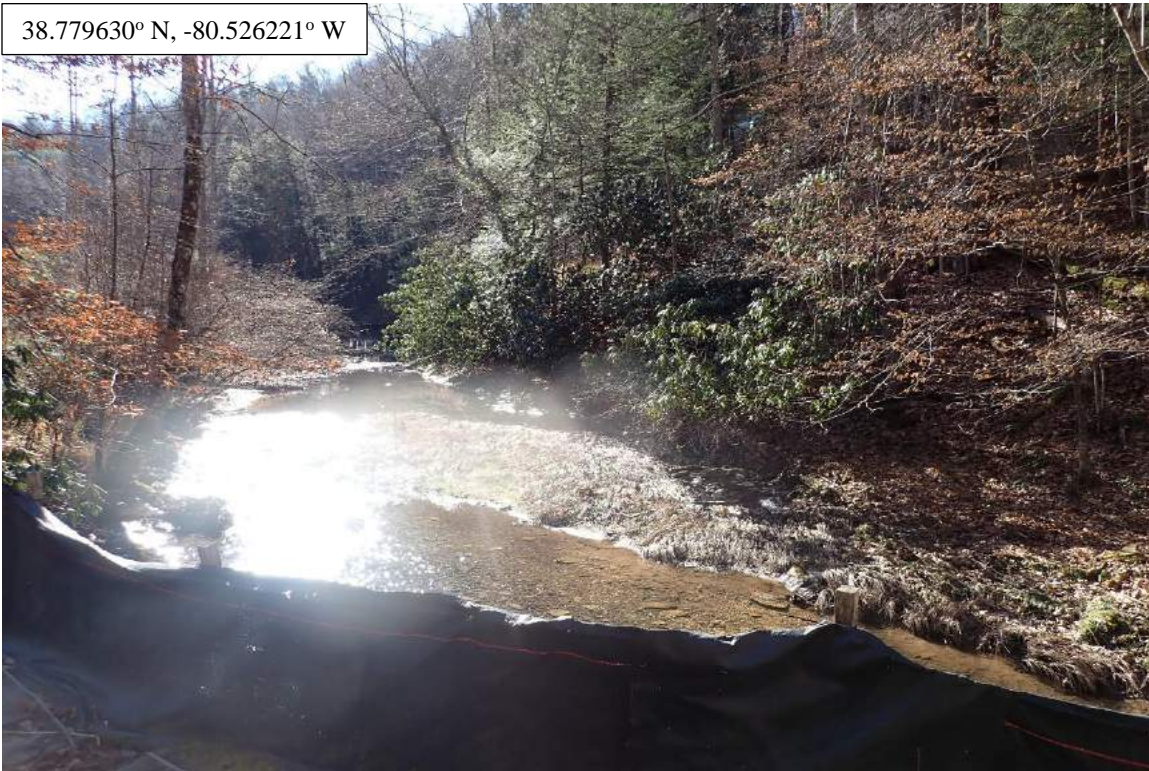
Photo Type: CP, US View

Location, Orientation, Photographer Initials: Center of Right of Way, Upstream View, SBB/ABK

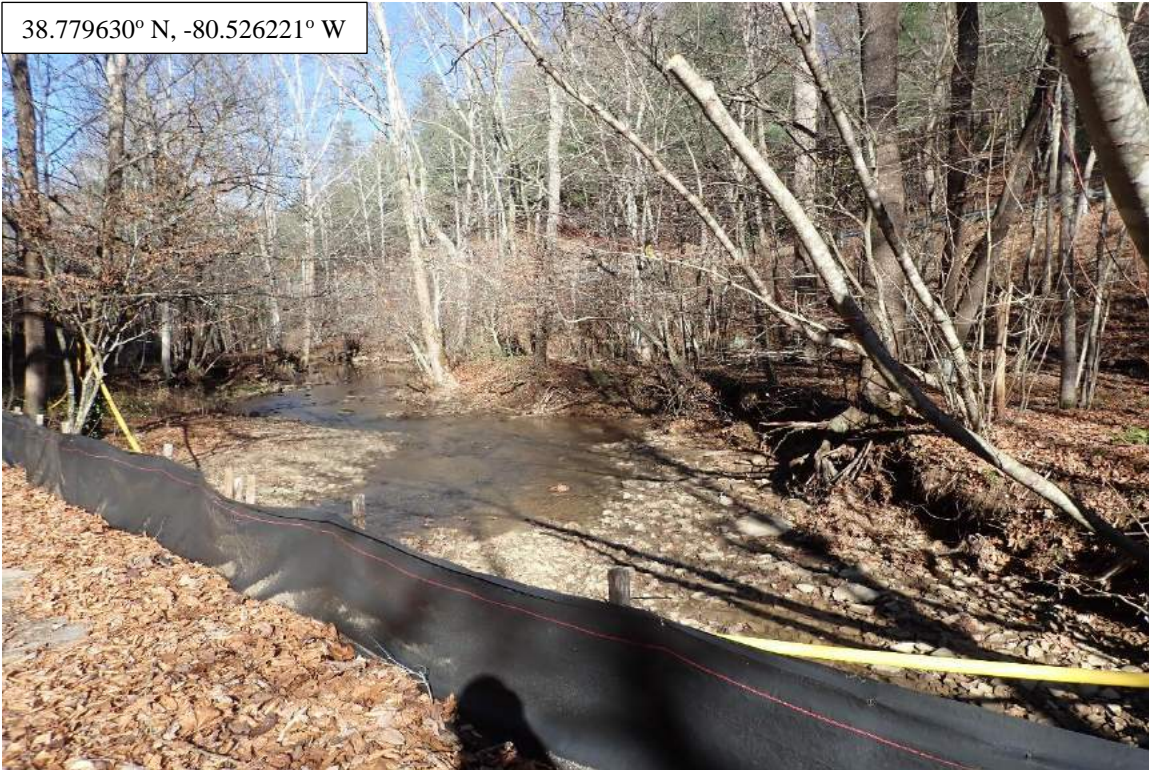
Photo Type: CP, DS View

Location, Orientation, Photographer Initials: Center Point of Right of Way, Downstream View, SBB/ABK

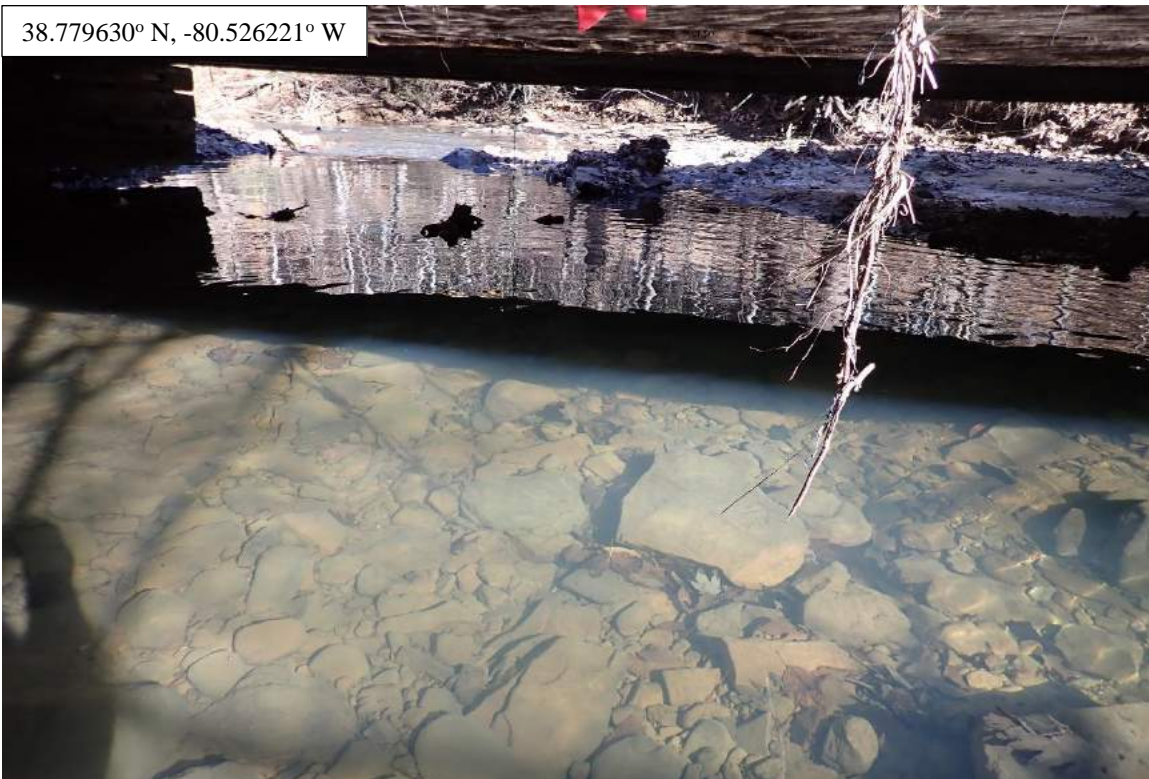
Photo Type: Pool Under TMB, DS View

Location, Orientation, Photographer Initials: Downstream View, Pool Under Timber Mat Bridge, SBB/ABK

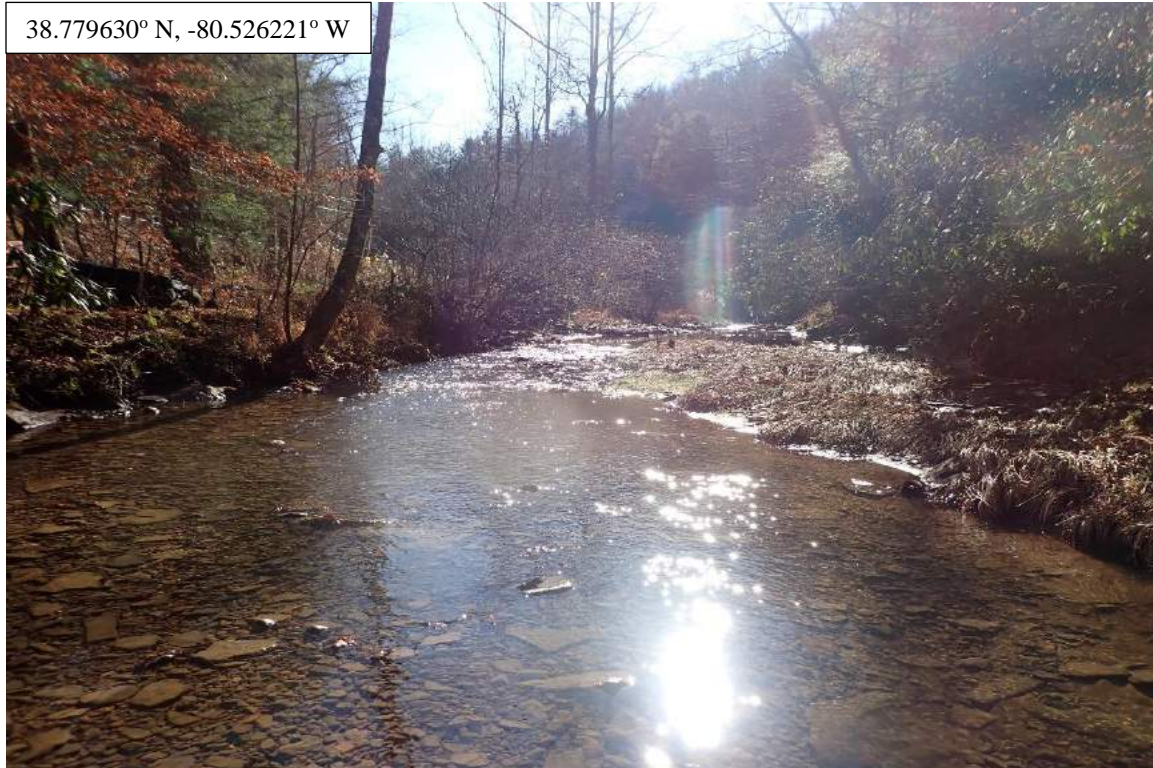
Photo Type: US View, US Edge

Location, Orientation, Photographer Initials: Upstream Edge of Right of Way, Upstream View, SBB/ABK

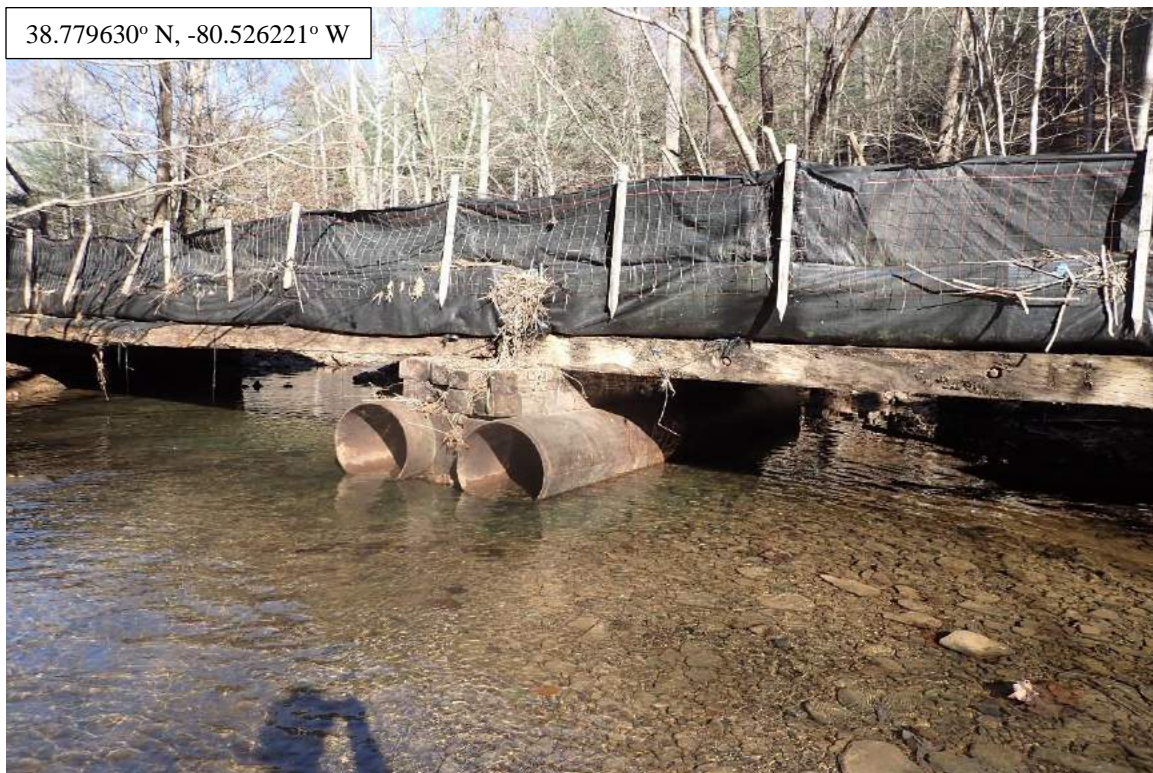
Photo Type: DS View, US Edge

Location, Orientation, Photographer Initials: Downstream View of Right of Way, Upstream Edge, SBB/ABK

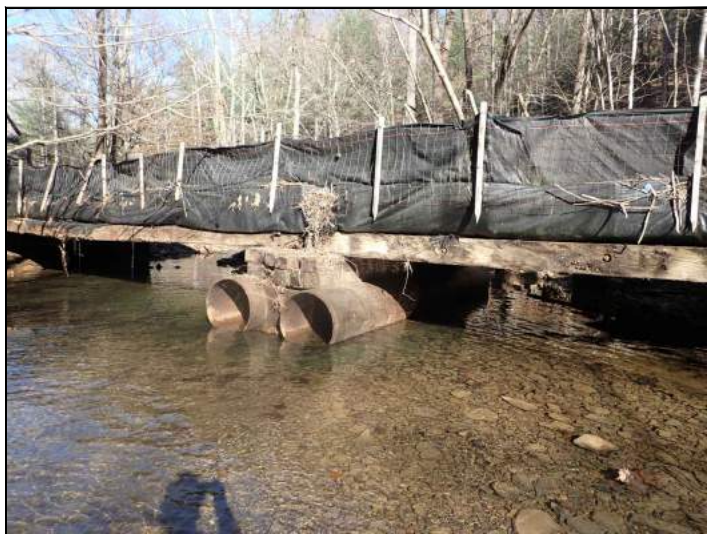
PHOTO TAKEN LOOKING DOWNSTREAM FROM UPSTREAM IMPACT LIMITS

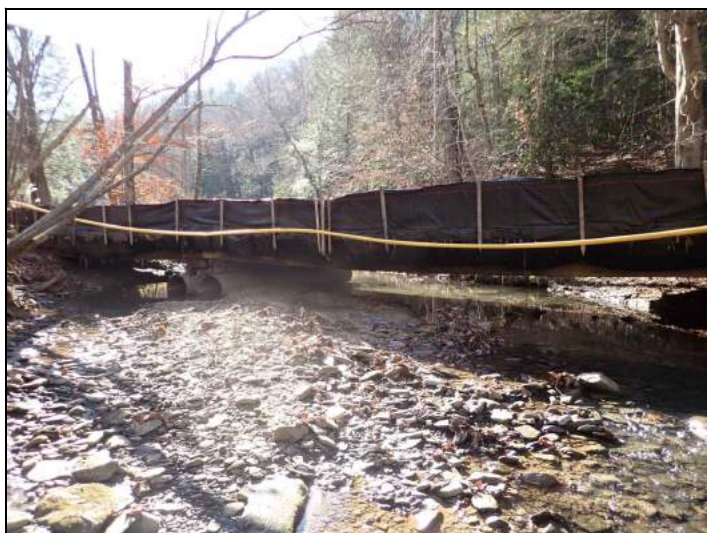
PHOTO TAKEN LOOKING UPSTREAM FROM DOWNSTREAM IMPACT LIMITS
