Baseline Assessment – Stream Attributes

Reach S-A124 (Pipeline ROW) Intermittent Spread A Wetzel County, West Virginia

Client: MOUNTAIN VALLEY PIPELINE, LLC
2200 ENERGY DRIVE, 2ND FLOOR
CANONSBURG, PA 15317
Title: PROFILE AND CROSS-SECTIONS
BASELINE SURVEY
CROSSING S-A124 - UNT TO PRICE
RUN (MP 5.0)
WETZEL COUNTY, WV

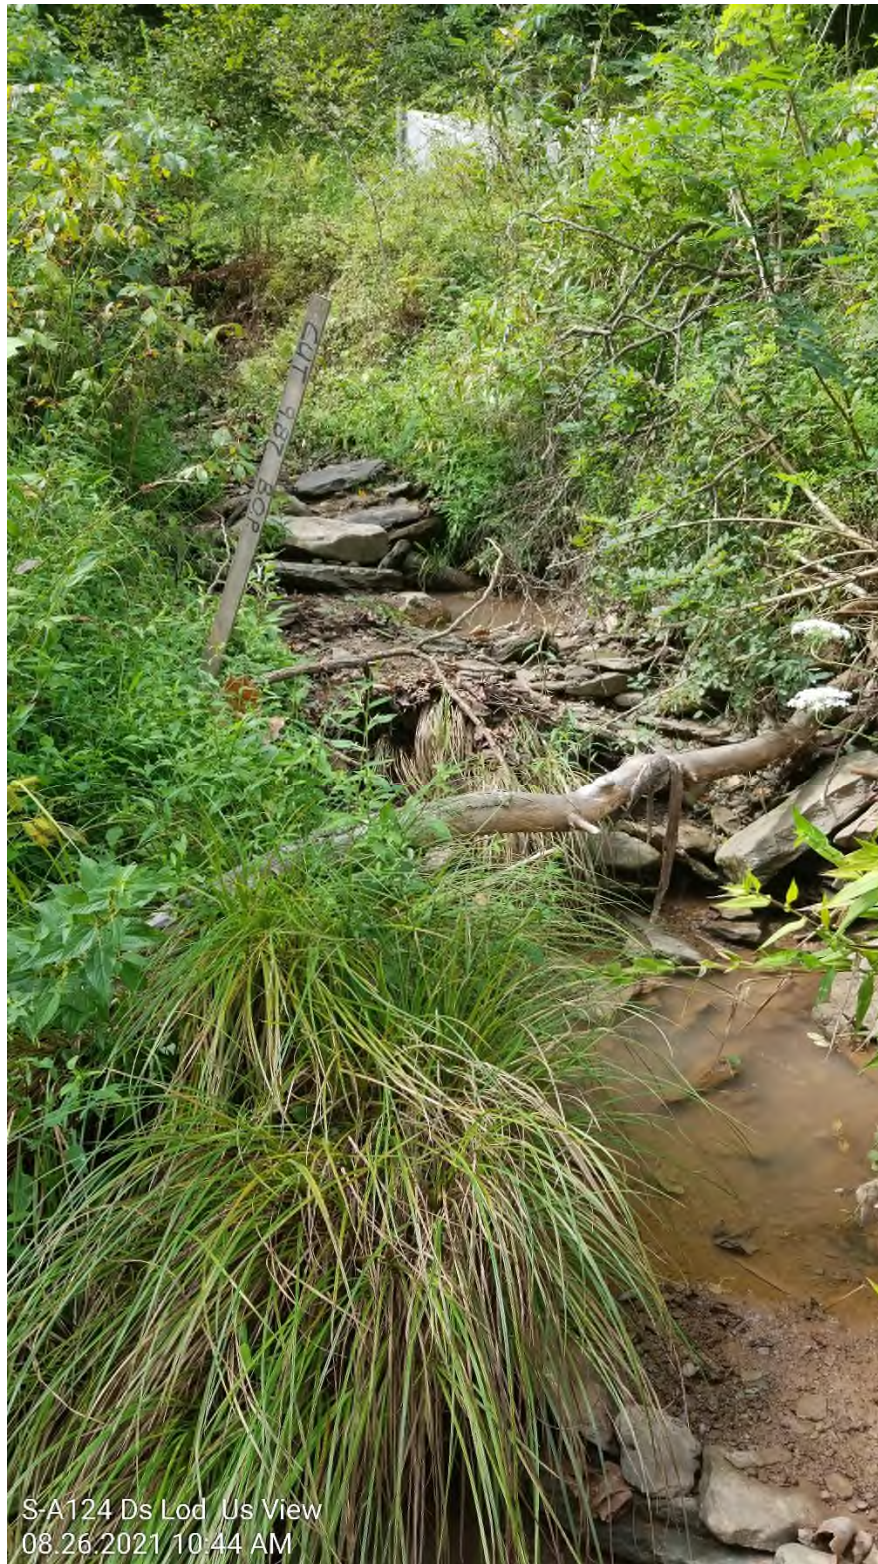
S-A124 Ds Lod Us View
08.26.2021 10:44 AM

Photo Type: DS, US View

Location, Orientation, Photographer Initials: Downstream Edge of ROW, Upstream View, MB/JR

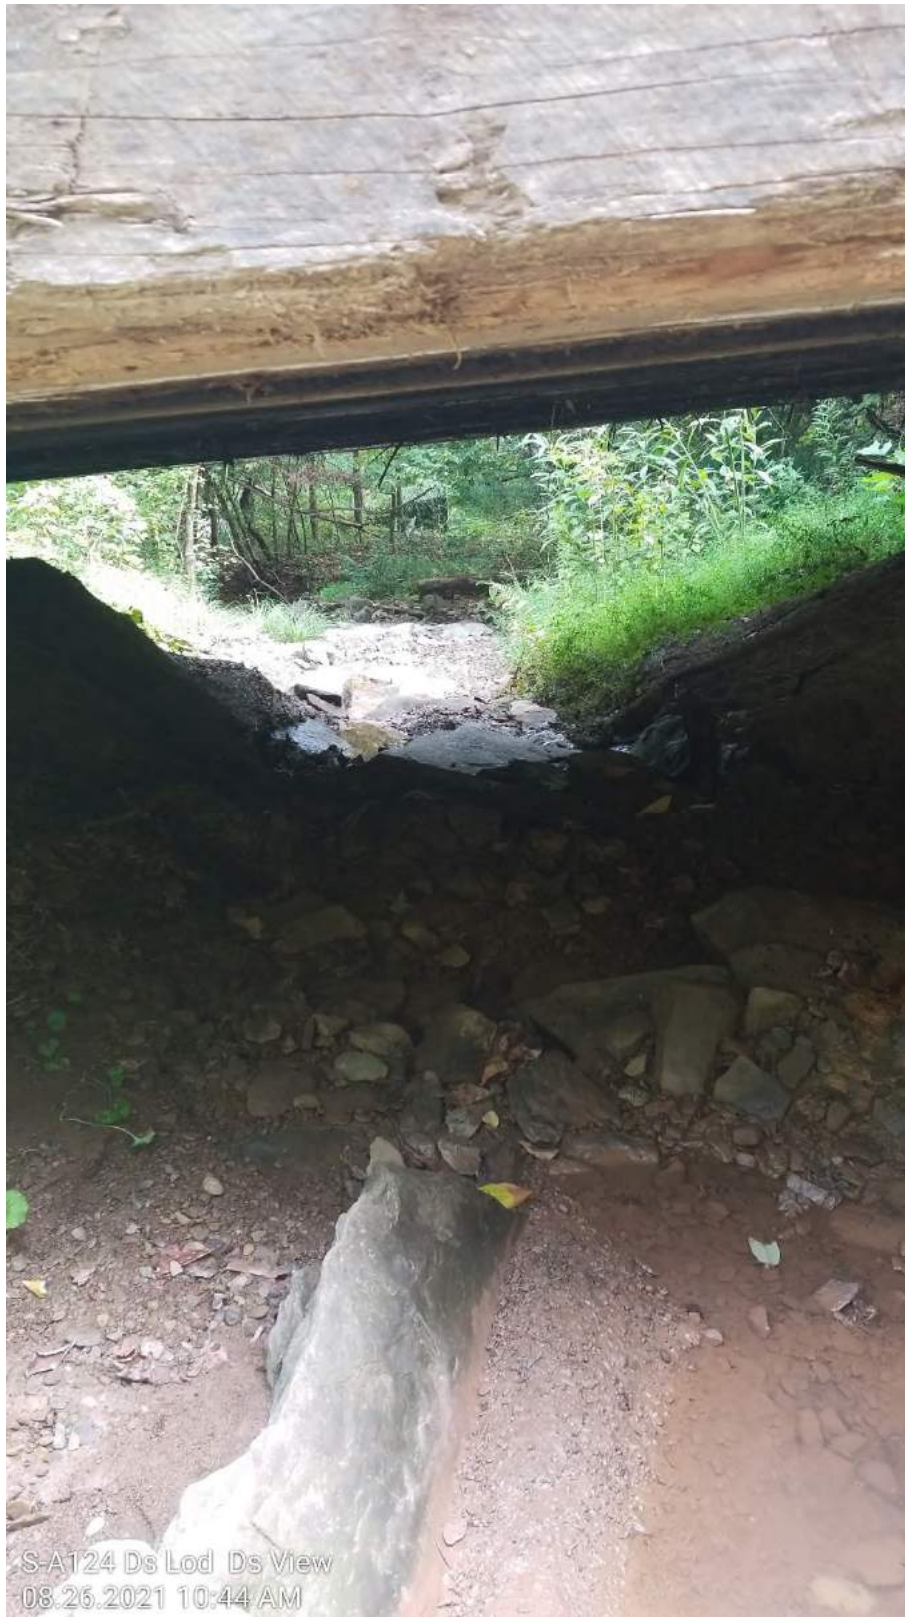
S-A124 Ds Lod Ds View
08.26.2021 10:44 AM

Photo Type: DS, DS View

Location, Orientation, Photographer Initials: Downstream Edge of ROW, Downstream View, MB/JR

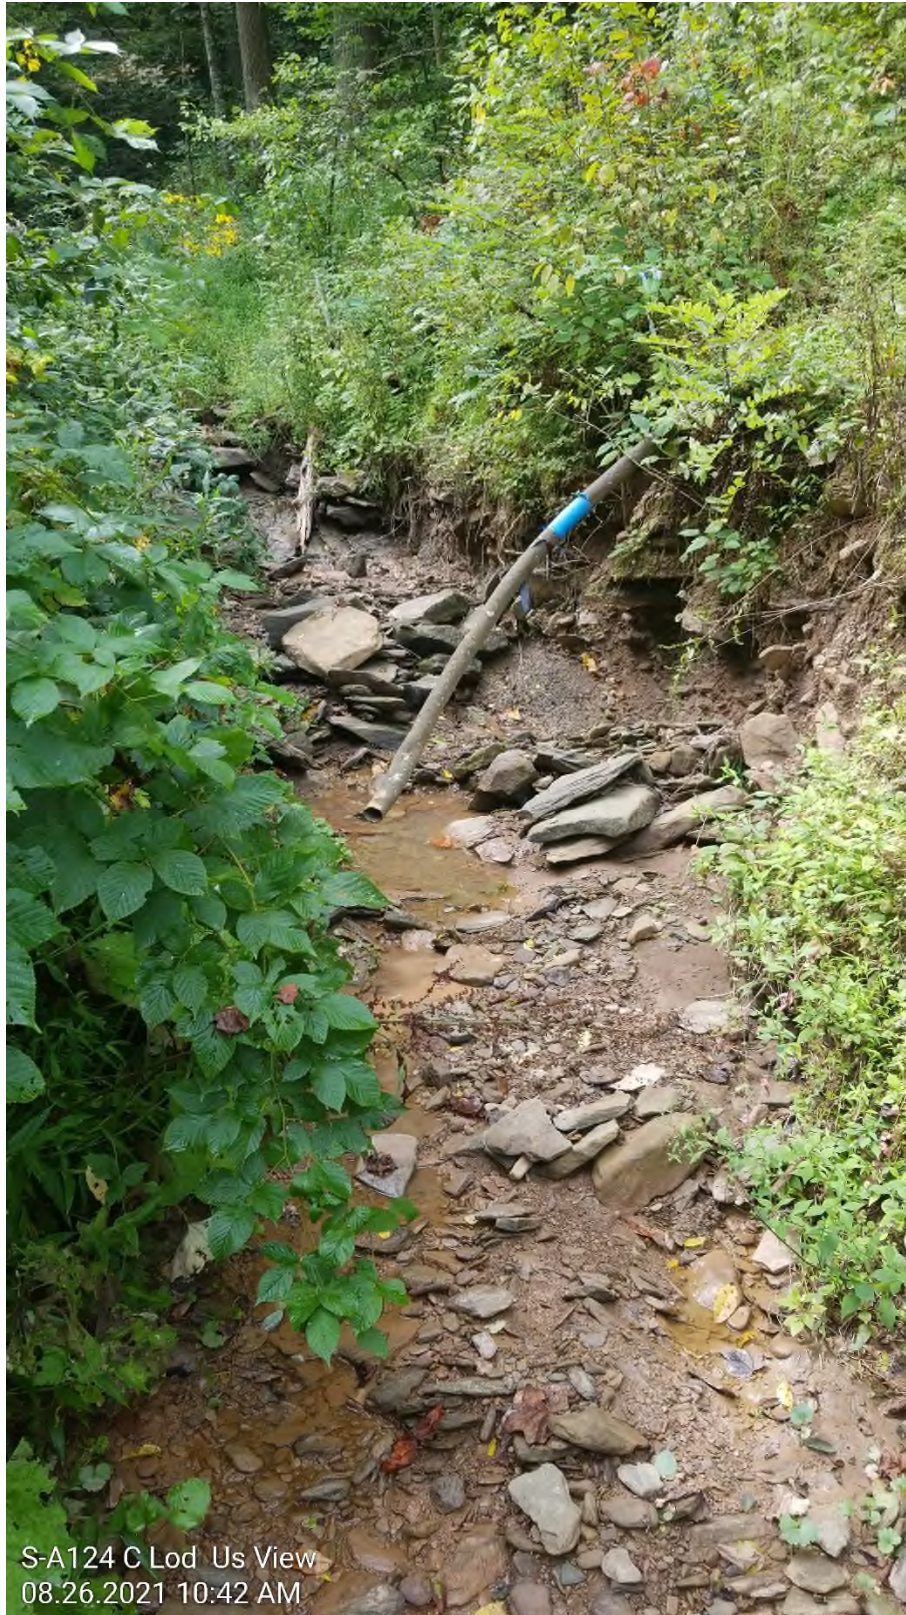
S-A124 C Lod Us View
08.26.2021 10:42 AM

Photo Type: US View at Center
Location, Orientation, Photographer Initials: Center ROW, Upstream View, MB/JR
Lat: 39.503288 Long: -80.53268

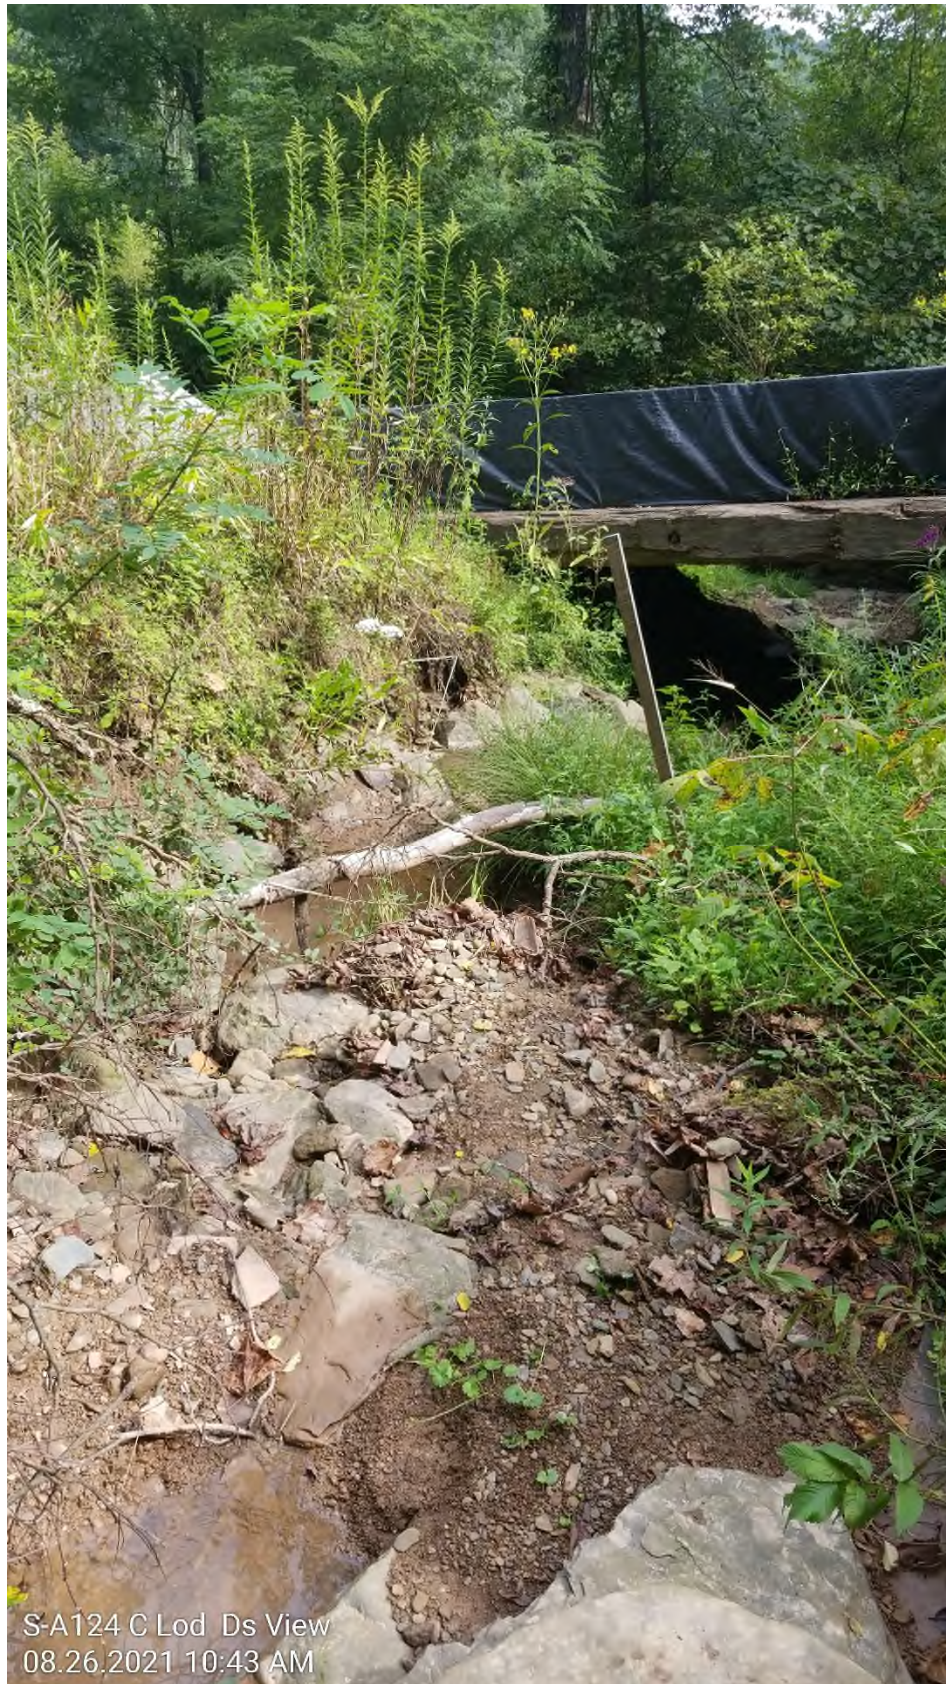
S-A124 C Lod Ds View
08.26.2021 10:43 AM

Photo Type: DS View at Center
Location, Orientation, Photographer Initials: ROW Center, Downstream View, MB/JR
Lat: 39.503288 Long: -80.53268

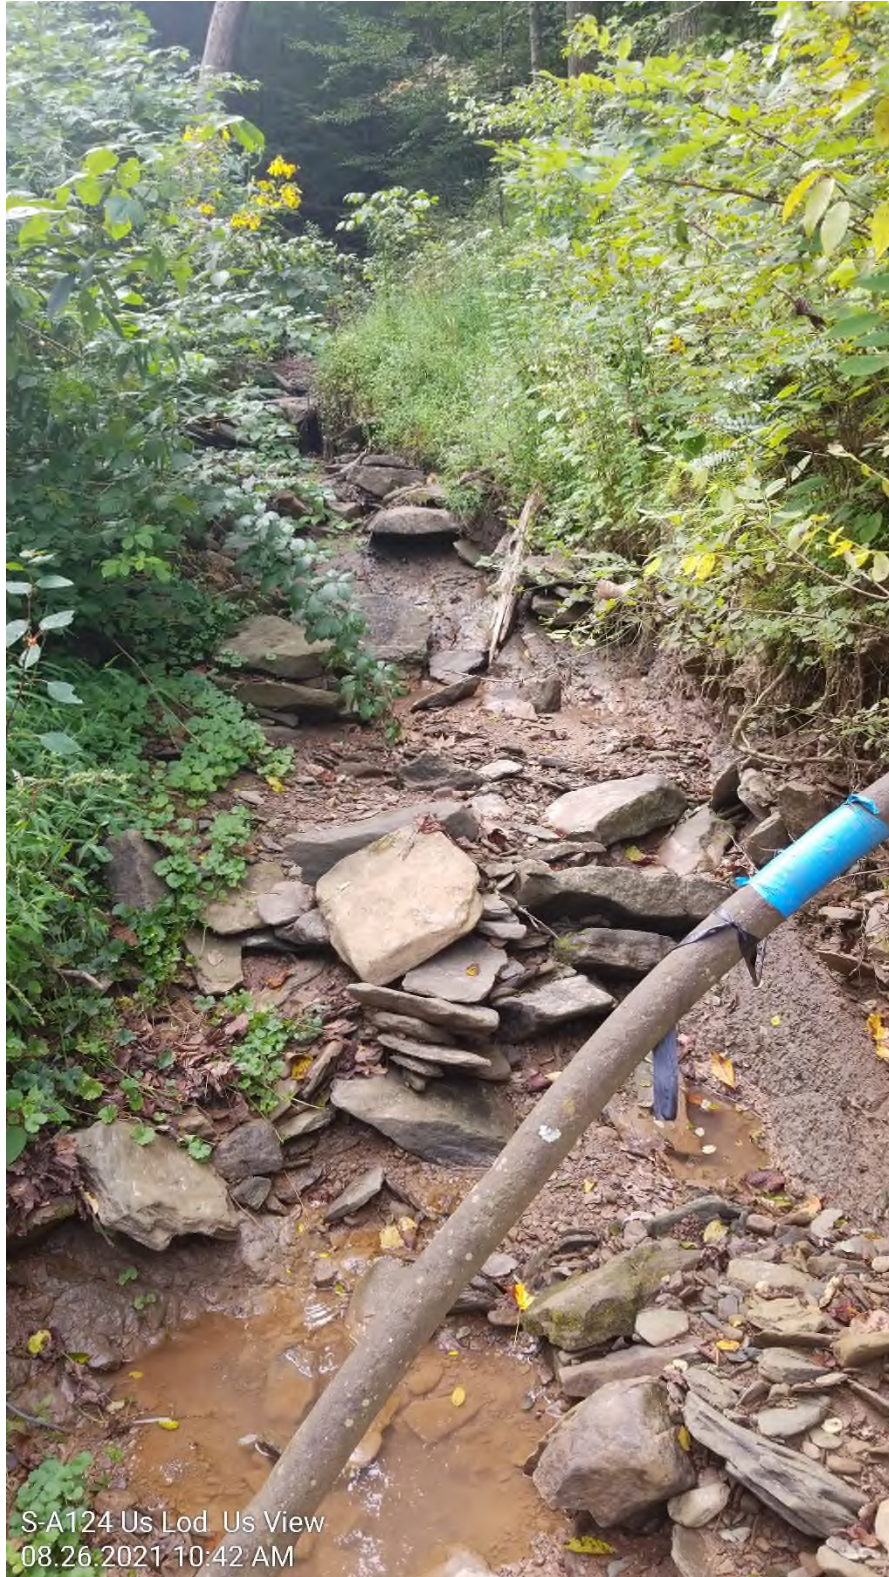
S-A124 Us Lod Us View
08.26.2021 10:42 AM

Photo Type: US, US View

Location, Orientation, Photographer Initials: Upstream Edge of ROW, Upstream View, MB/JR

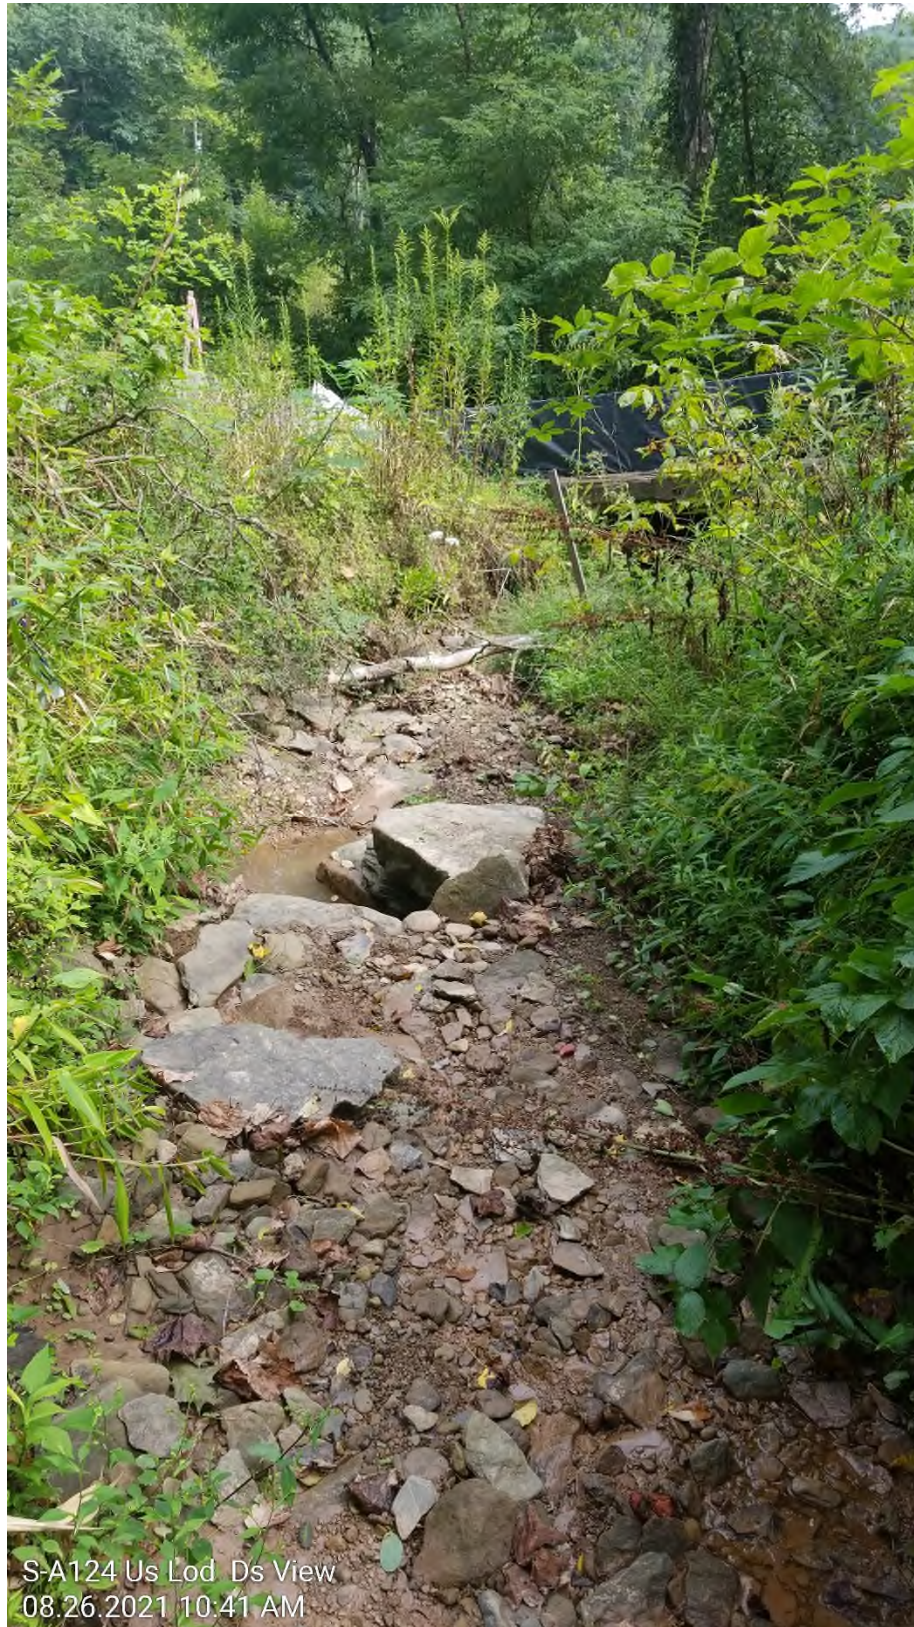
S-A124 Us Lod Ds View
08.26.2021 10:41 AM

Photo Type: US, DS View

Location, Orientation, Photographer Initials: Upstream Edge of ROW, Downstream View, MB/JR
Lat: 39.503288 Long: -80.53268

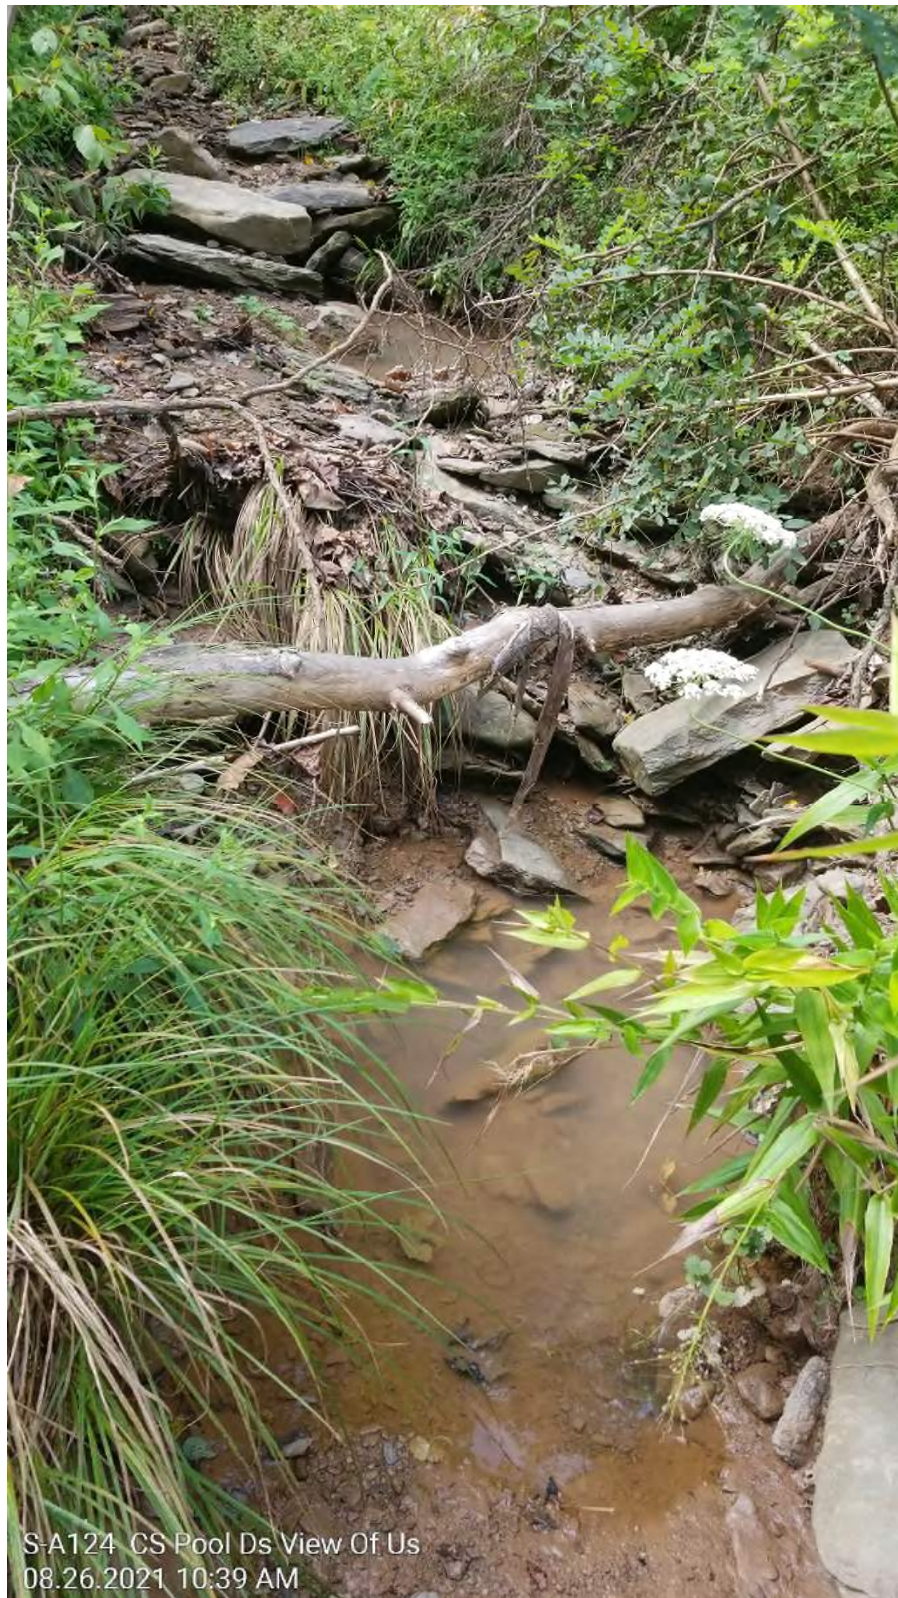
Photo Type: Pool, DS View
Location, Orientation, Photographer Initials: Upstream of Pool, Downstream View, MB/JR
Lat: 39.503288 Long: -80.53268

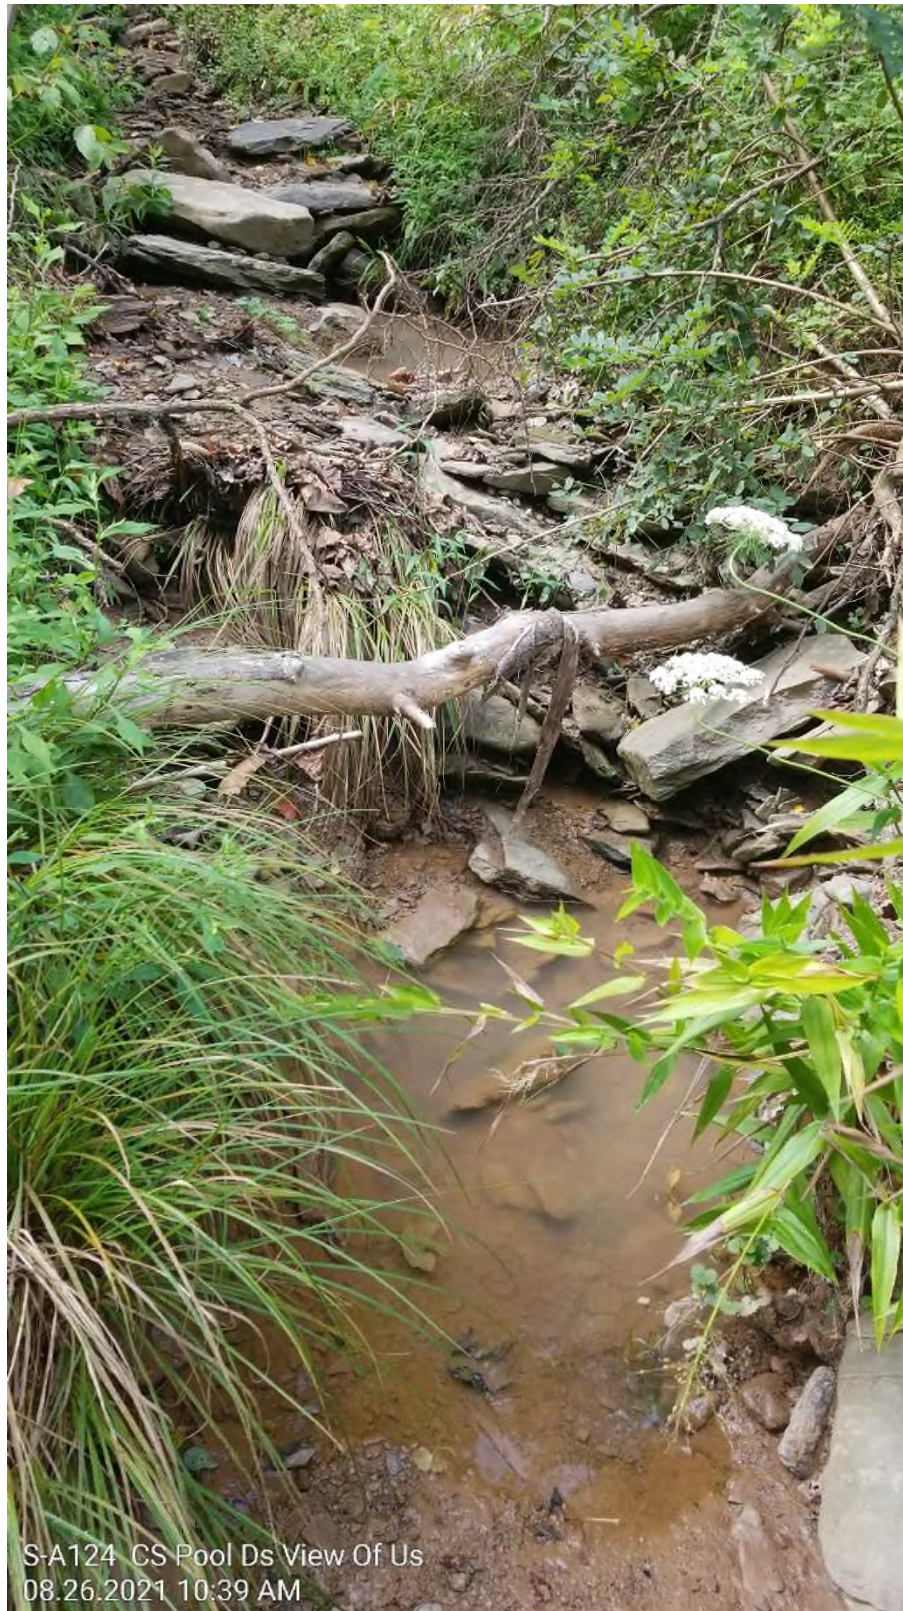
Photo Type: Pool, US View
Location, Orientation, Photographer Initials: Downstream of Pool, Upstream View, MB/JR
Lat: 39.503288 Long: -80.53268

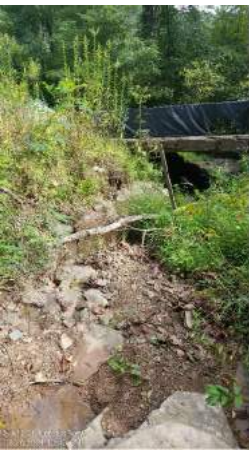
PHOTO TAKEN LOOKING DOWNSTREAM FROM UPSTREAM IMPACT LIMITS

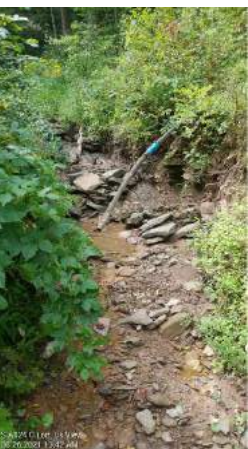
PHOTO TAKEN LOOKING UPSTREAM FROM DOWNSTREAM IMPACT LIMITS
