### **Baseline Assessment – Stream Attributes**

# Reach S-A3a (Pipeline ROW) Intermittent Spread A Wetzel County, West Virginia

**Project Name:** MVP Stream Assessment **Location:** Wetzel County; Spread A

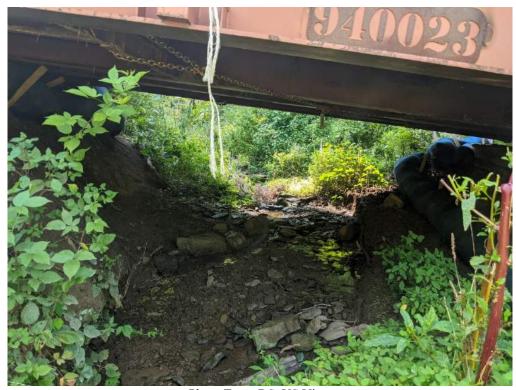
Photo Type: DS, US View
Location, Orientation, Photographer Initials: Downstream Edge of ROW, Upstream View, JR/MB
Lat: 39.551814 Long: -80.545633

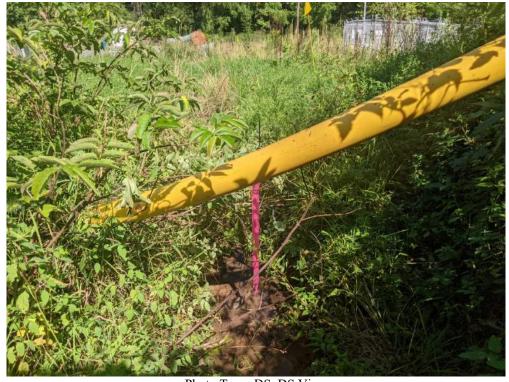
Photo Type: DS, DS View
Location, Orientation, Photographer Initials: Downstream Edge of ROW, Downstream View, JR/MB
Lat: 39.551814 Long: -80.545633

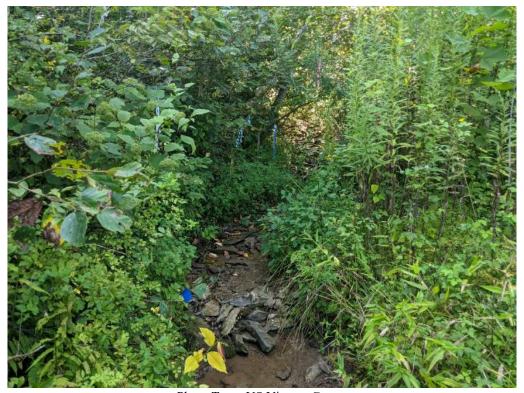
Photo Type: US View at Center Location, Orientation, Photographer Initials: Center ROW, Upstream View, JR/MB Lat: 39.551814 Long: -80.545633

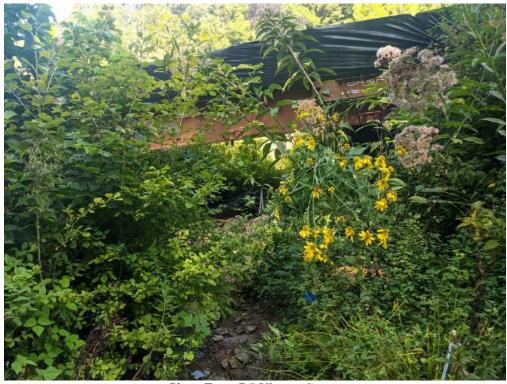
Photo Type: DS View at Center Location, Orientation, Photographer Initials: ROW Center, Downstream View, JR/MB Lat: 39.551814 Long: -80.545633

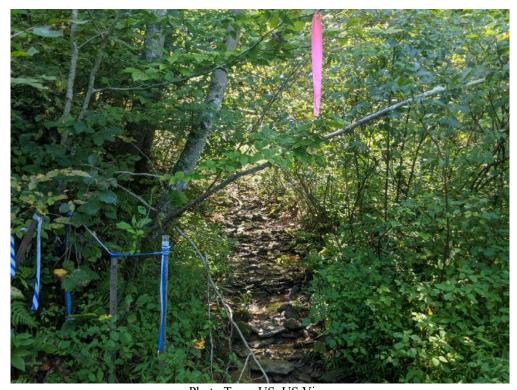
Photo Type: US, US View Location, Orientation, Photographer Initials: Upstream Edge of ROW, Upstream View, JR/MB Lat: 39.551814 Long: -80.545633

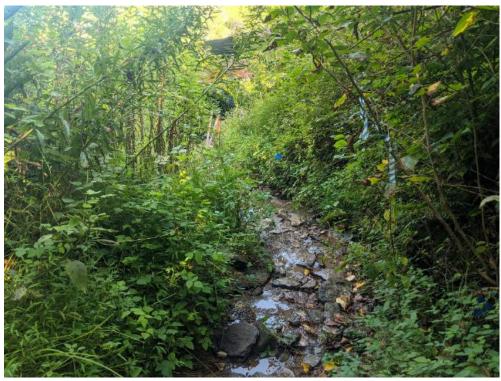
Photo Type: US, DS View Location, Orientation, Photographer Initials: Upstream Edge of ROW, Downstream View, JR/MB Lat: 39.551814 Long: -80.545633

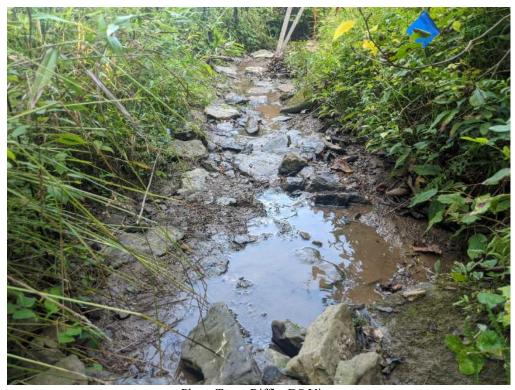
Photo Type: Riffle, DS View Location, Orientation, Photographer Initials: Upstream of Riffle, Downstream View, JR/MB Lat: 39.551814 Long: -80.545633

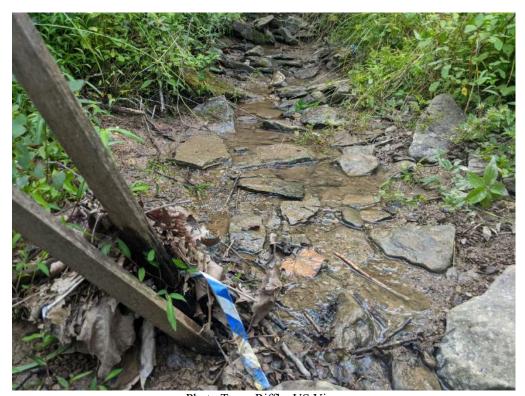
Photo Type: Riffle, US View Location, Orientation, Photographer Initials: Downstream of Riffle, Upstream View, JR/MB Lat: 39.551814 Long: -80.545633

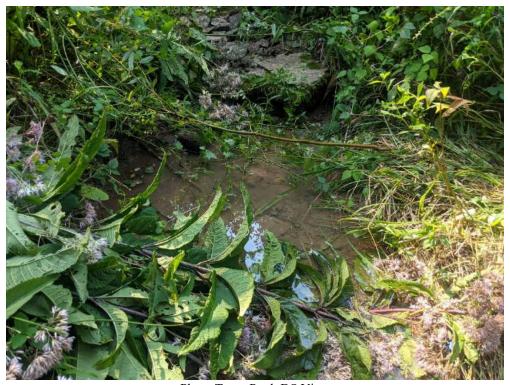
Photo Type: Pool, DS View
Location, Orientation, Photographer Initials: Upstream of Pool, Downstream View, JR/MB
Lat: 39.551814 Long: -80.545633

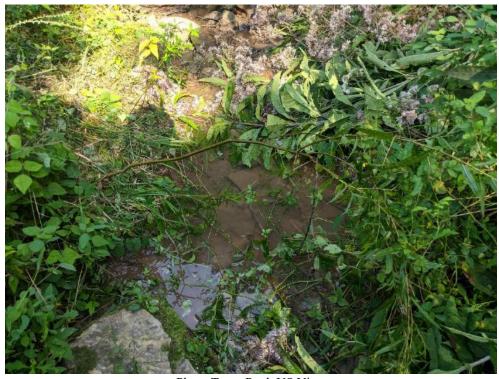
Photo Type: Pool, US View Location, Orientation, Photographer Initials: Downstream of Pool, Upstream View, JR/MB Lat: 39.551814 Long: -80.545633

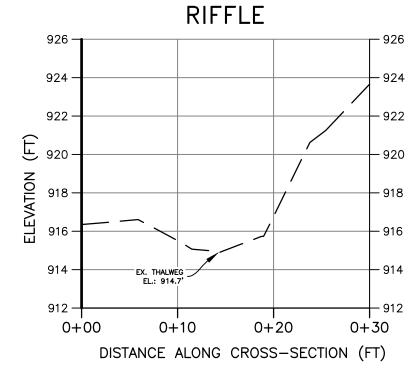
# S-A3A BASELINE CROSS-SECTION B

AS-BUILT	TABLE: S-A3A (	CROSS SECT	IÓN B	
	PI		AŞ-E	BUILT	
PT. LOC.	NORTHING	EASTING	ELEV	VERT. DIFF.	HORZ. DIFF.
TS-L	14363869.54	1768493.20	916.29		
BS-L	14363861.94	1768492.46	914.81		
THW	14363860.26	1768492.14	914.72		
BS-R	14363858.92	1768492.45	914.82		
TS-R	14363852.71	1768492.87	918.14

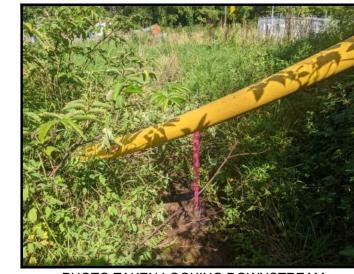
PHOTO TAKEN LOOKING DOWNSTREAM FROM UPSTREAM IMPACT LIMITS

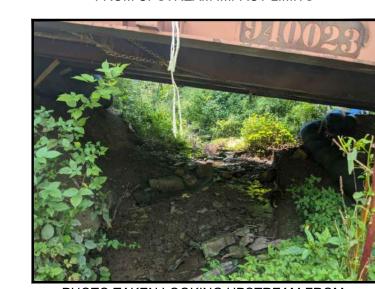
PHOTO TAKEN LOOKING UPSTREAM FROM

DOWNSTREAM IMPACT LIMITS POST-CROSSING PHOTOS
