## Baseline Assessment – Stream Attributes

### Reach S-A5a (Timber Mat Crossing) Intermittent Spread A Wetzel County, West Virginia

**Spread A   Stream S-A5a (Timber Mat Crossing)   Wetzel County**

Title  
PROFILE AND CROSS-SECTIONS  
BASELINE SURVEY  
CROSSING S-A5A - UNNAMED TRIB. TO  
FALLEN TIMBER RUN (MP 2.29)  
WETZEL COUNTY, WV

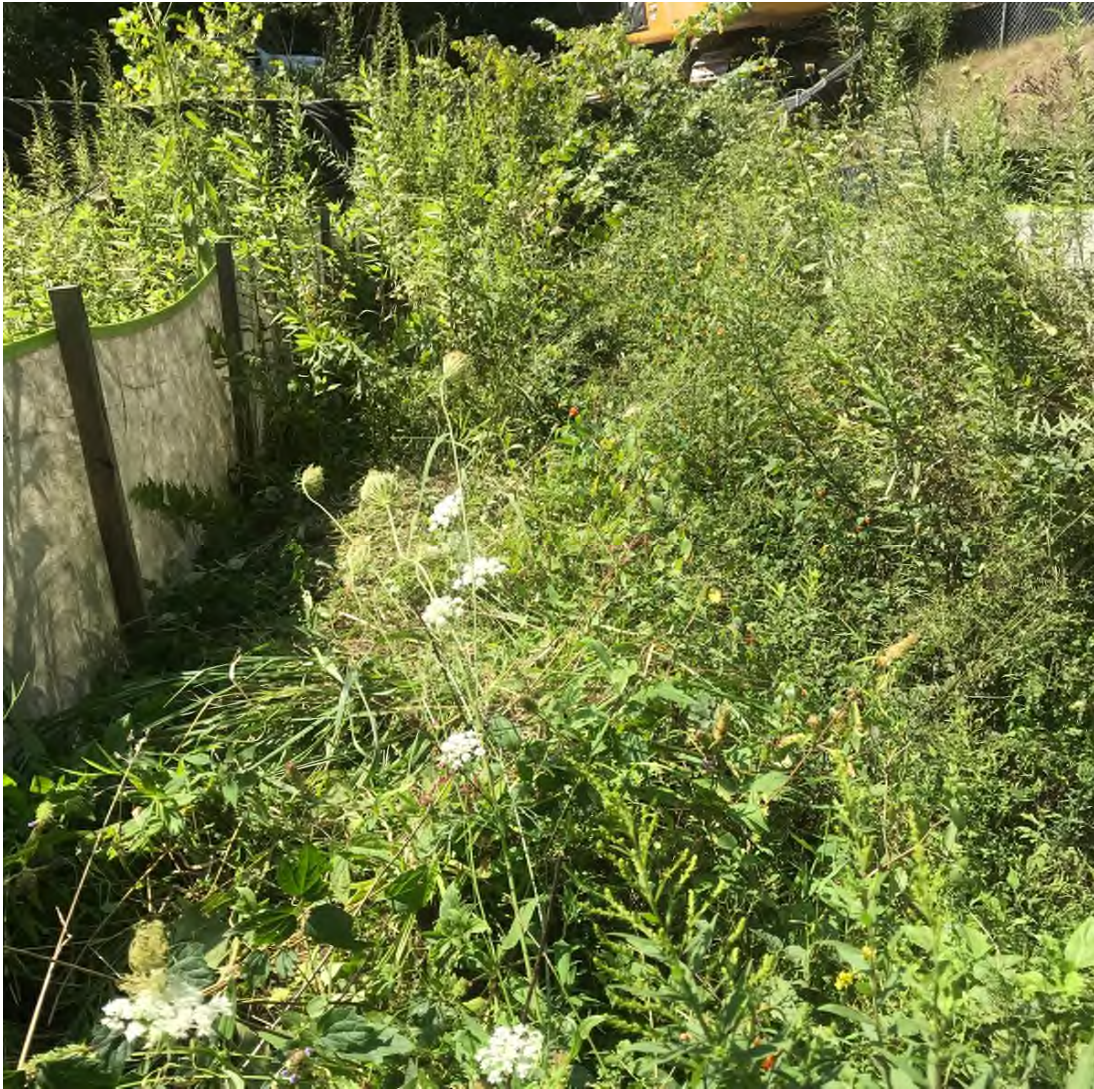
Photo Type: DS, US View

Location, Orientation, Photographer Initials: Downstream Edge of ROW, Upstream View, MB/JR  
Lat: 39.534241 Long: -80.540995

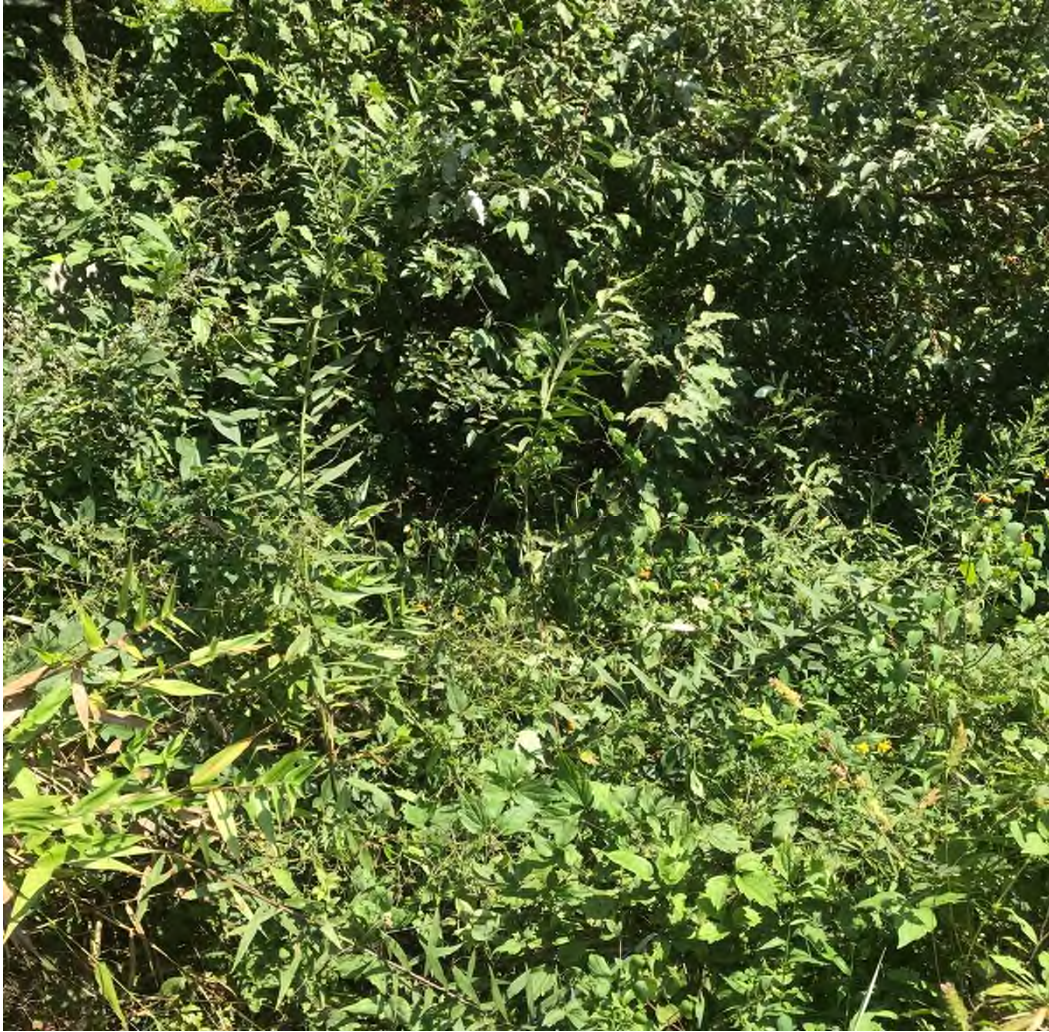
Photo Type: DS, DS View

Location, Orientation, Photographer Initials: Downstream Edge of ROW, Downstream View, MB/JR  
Lat: 39.534241 Long: -80.540995

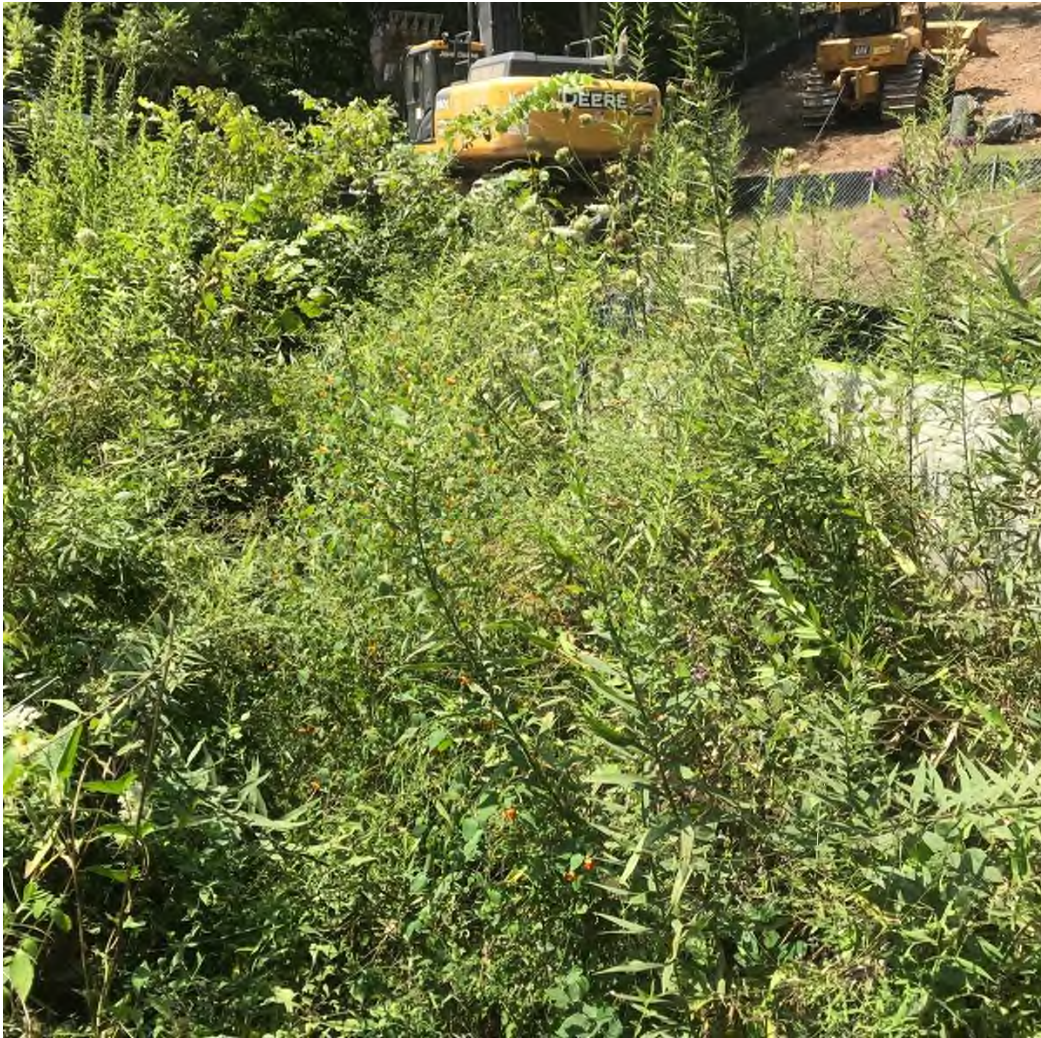
Photo Type: US View at Center  
Location, Orientation, Photographer Initials: Center ROW, Upstream View, MB/JR  
Lat: 39.534241 Long: -80.540995

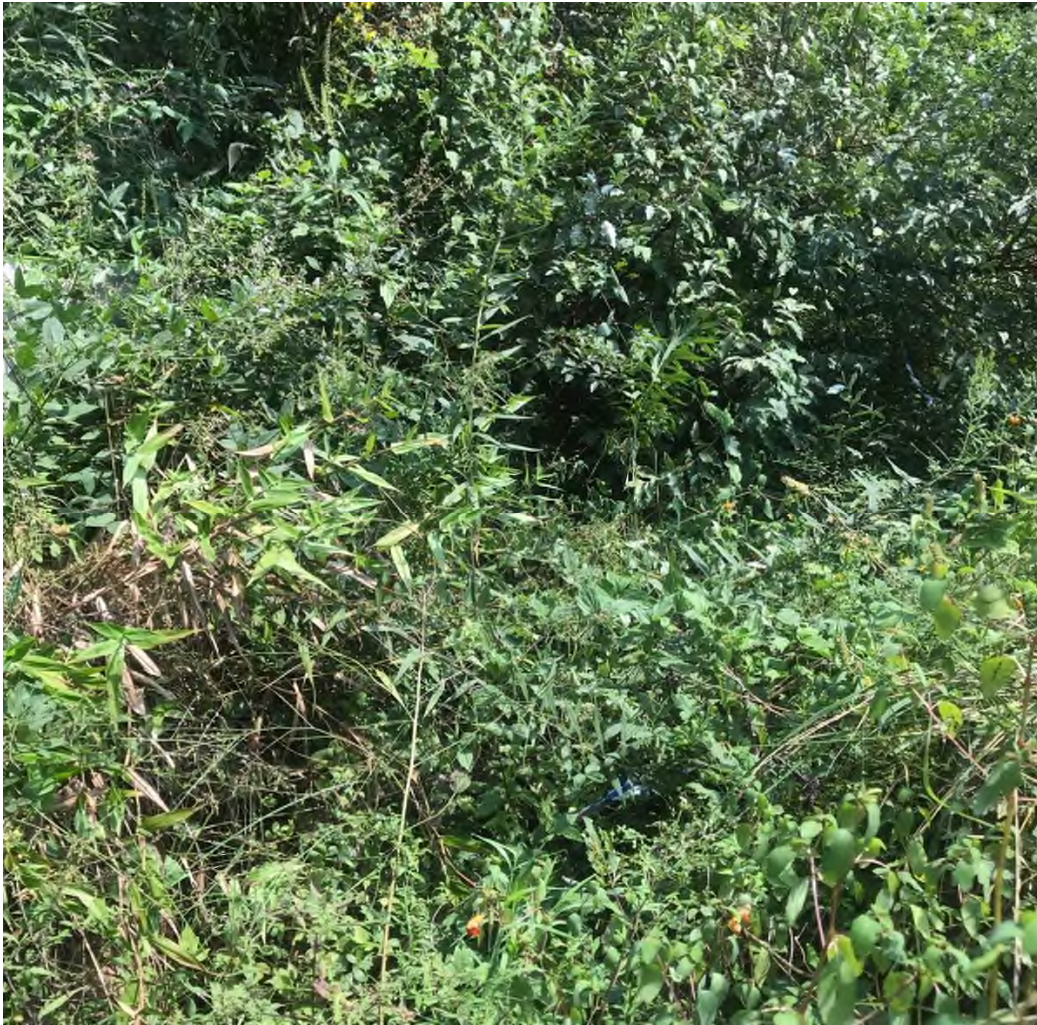
Photo Type: DS View at Center  
Location, Orientation, Photographer Initials: ROW Center, Downstream View, MB/JR  
Lat: 39.534241 Long: -80.540995

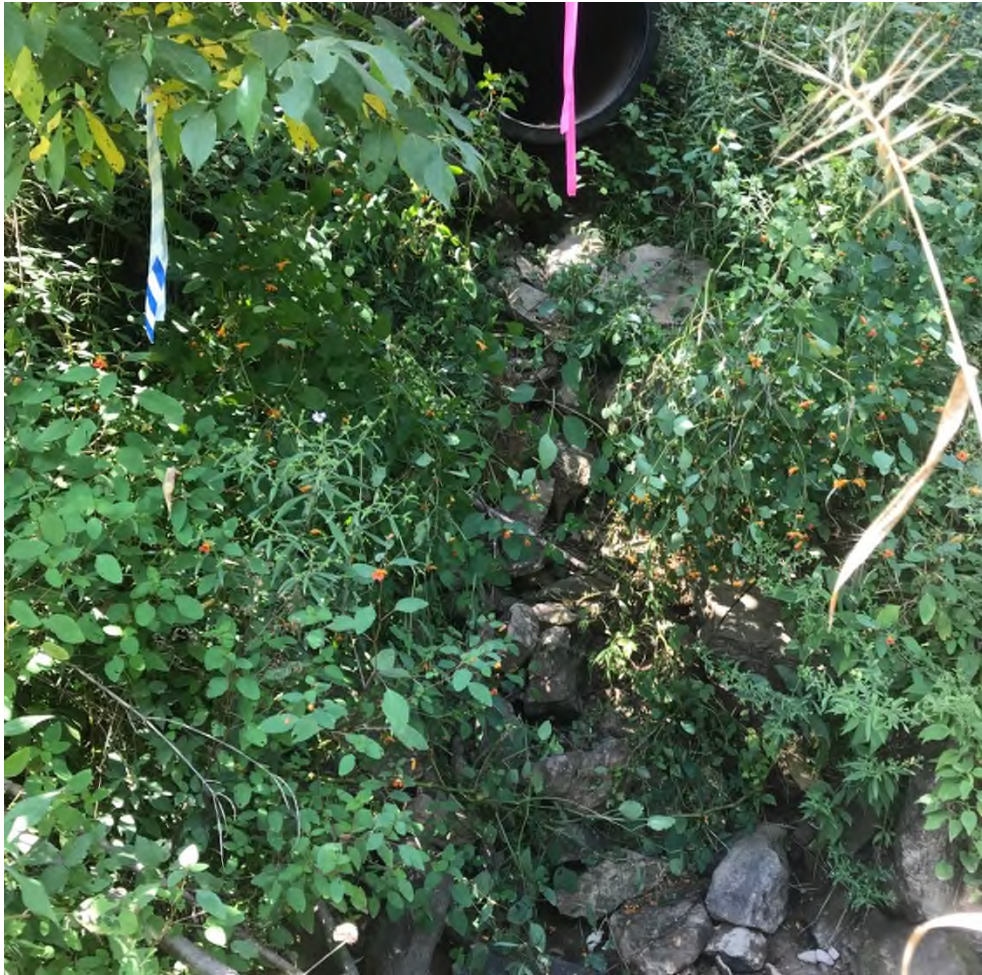
Photo Type: US, US View

Location, Orientation, Photographer Initials: Upstream Edge of ROW, Upstream View, MB/JR

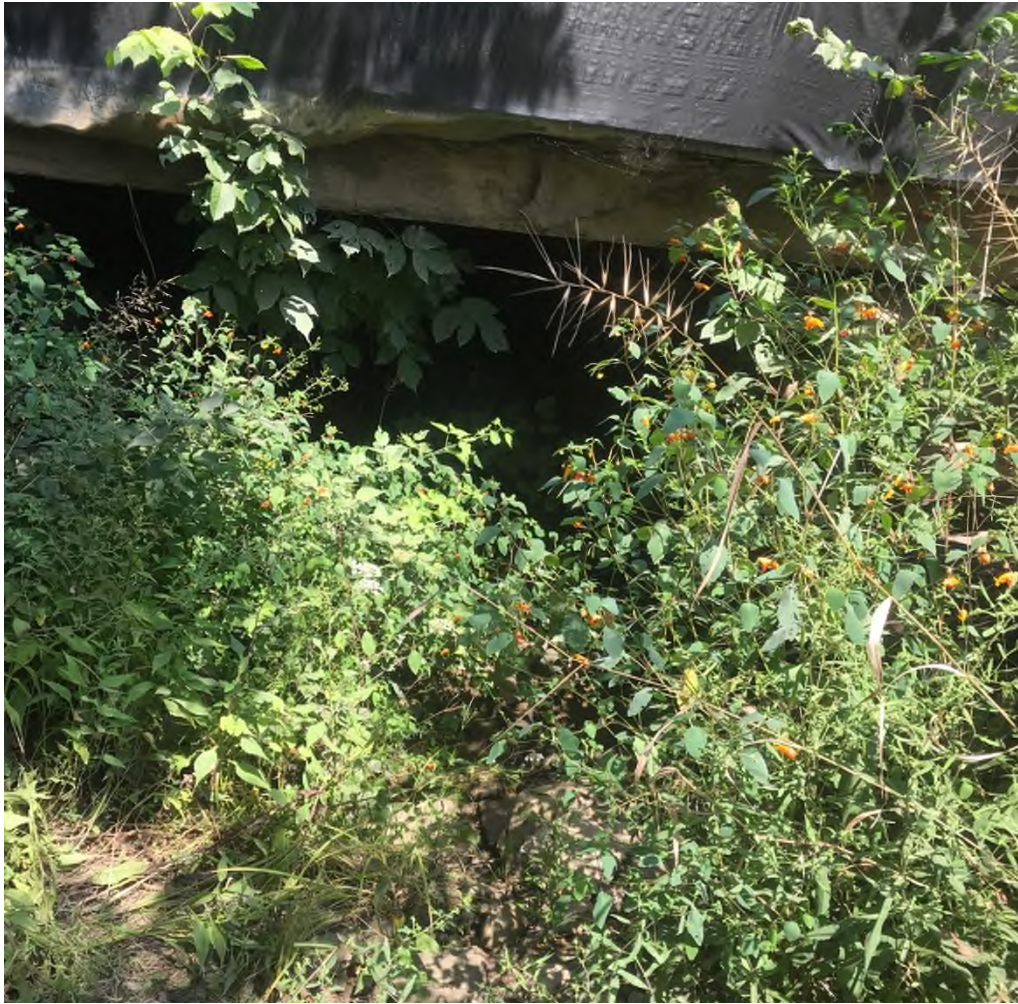
Photo Type: US, DS View

Location, Orientation, Photographer Initials: Upstream Edge of ROW, Downstream View, MB/JR

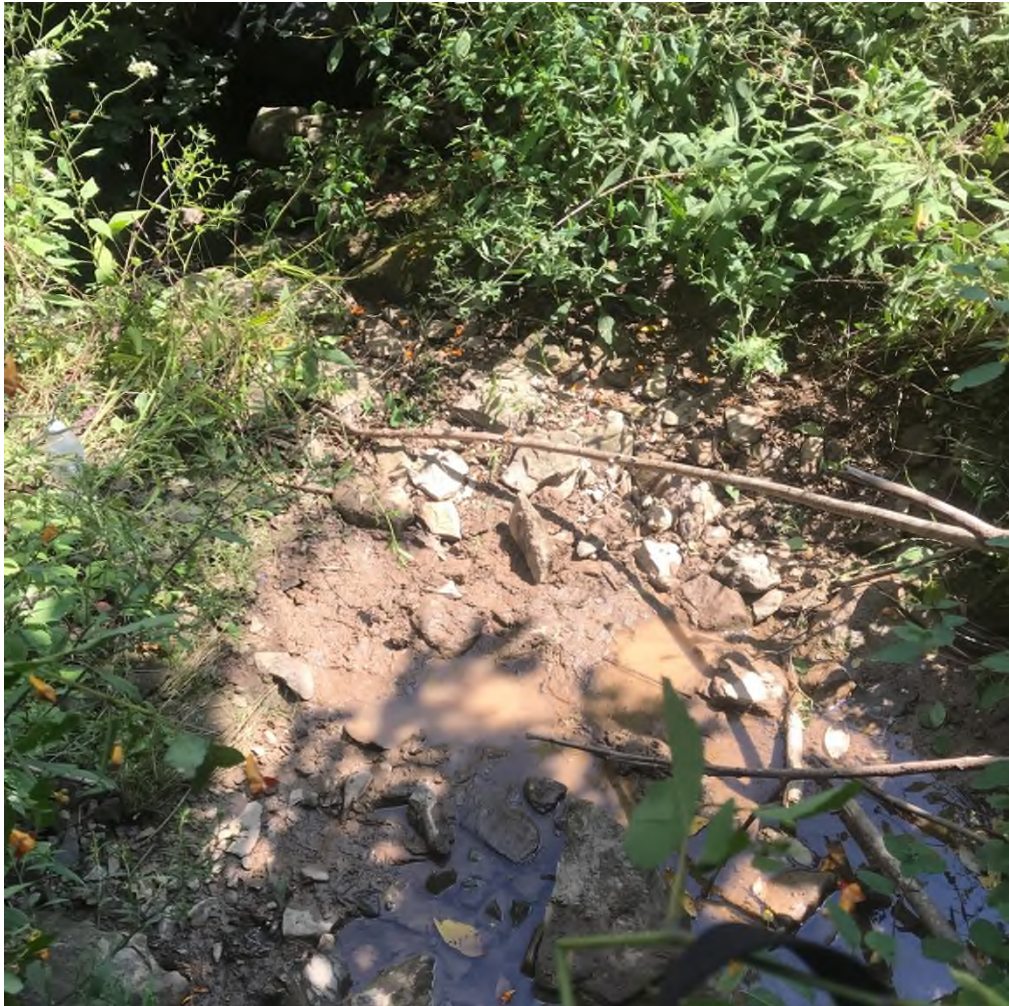
Photo Type: Pool, DS View  
Location, Orientation, Photographer Initials: Upstream of Pool, Downstream View, MB/JR  
Lat: 39.534241 Long: -80.540995

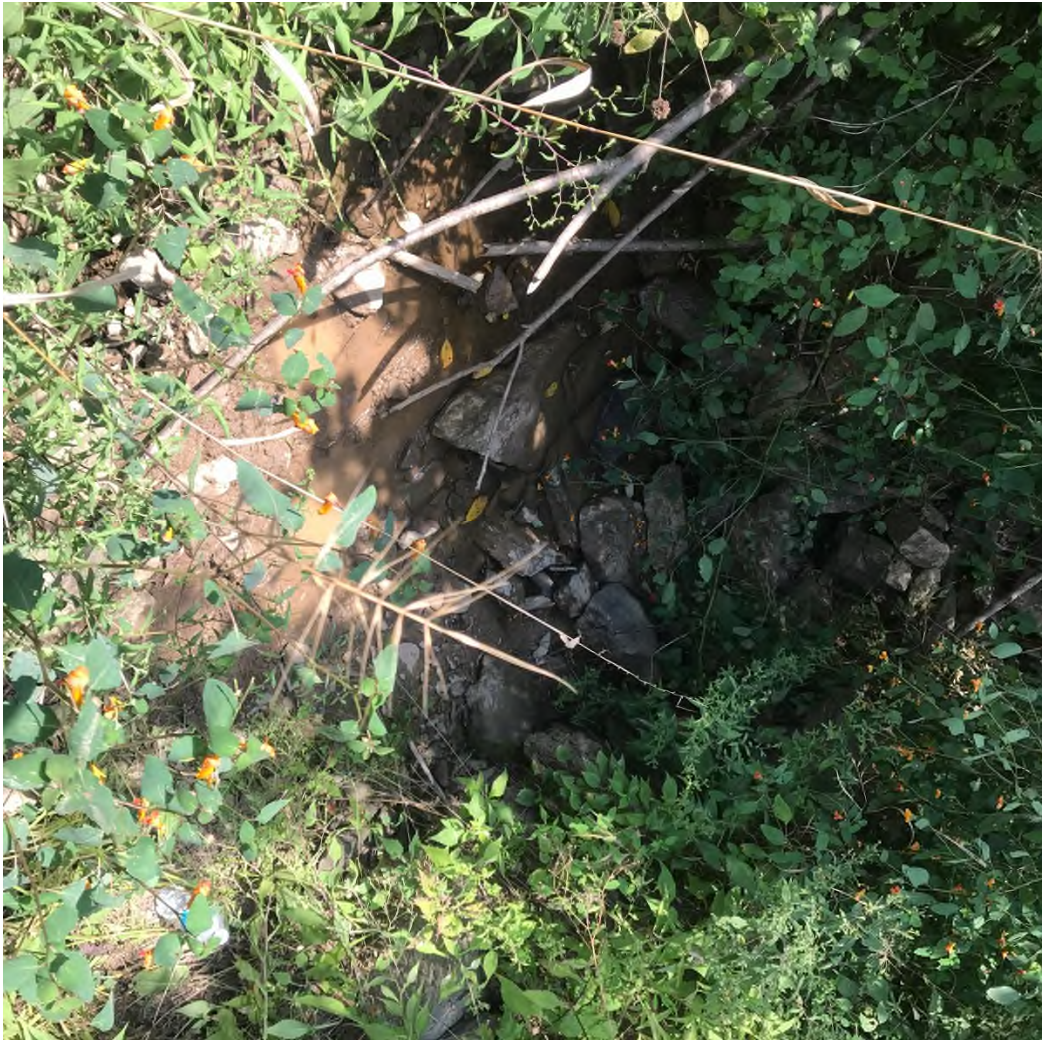
Photo Type: Pool, US View  
Location, Orientation, Photographer Initials: Downstream of Pool, Upstream View, MB/JR  
Lat: 39.534241 Long: -80.540995

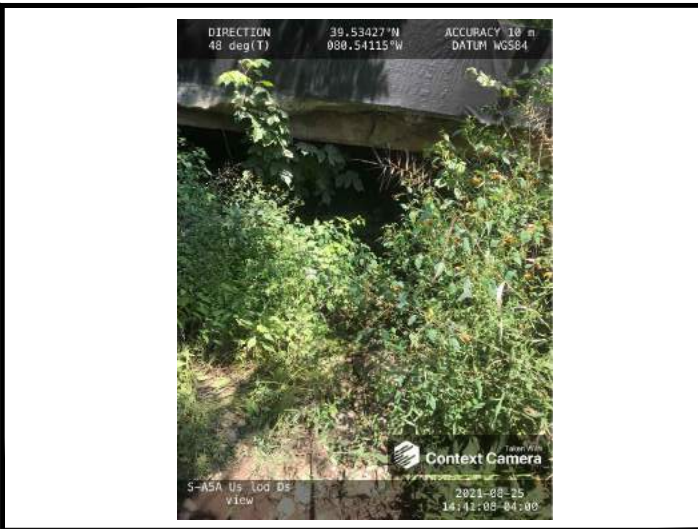
PHOTO TAKEN LOOKING DOWNSTREAM  
FROM UPSTREAM IMPACT LIMITS

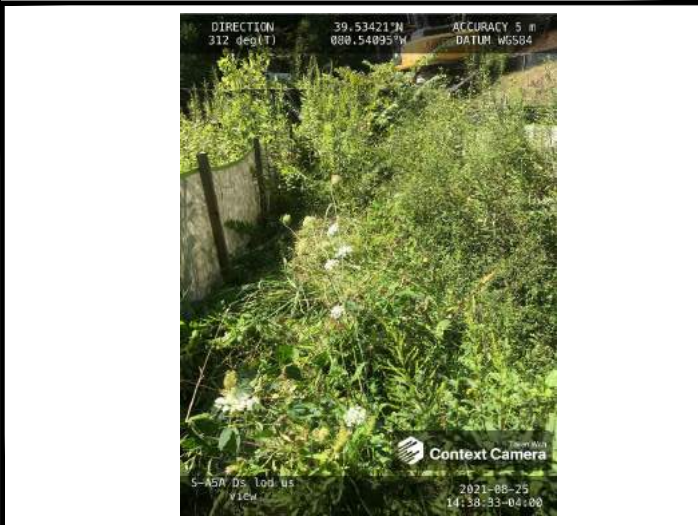
PHOTO TAKEN LOOKING UPSTREAM FROM  
DOWNSTREAM IMPACT LIMITS
