Baseline Assessment – Stream Attributes

Reach S-A72 (Timber Mat Crossing) Ephemeral Spread D Nicholas County, West Virginia

Spread D Stream S-A72 (Timber Mat Crossing) Nicholas County

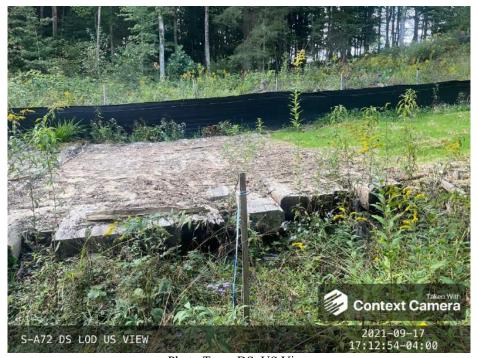
Photo Type: DS, US View
Location, Orientation, Photographer Initials: Downstream Edge of ROW, Upstream View, KY/ZS
Lat: 38.321687 Long: -80.670952

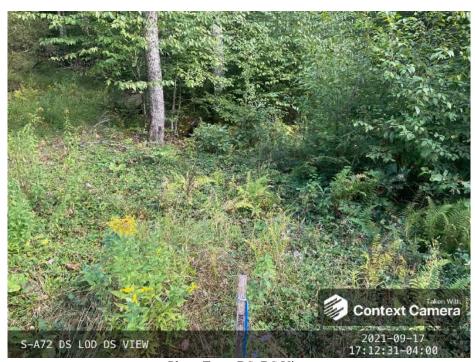
Photo Type: DS, DS View Location, Orientation, Photographer Initials: Downstream Edge of ROW, Downstream View, KY/ZS Lat: 38.321687 Long: -80.670952

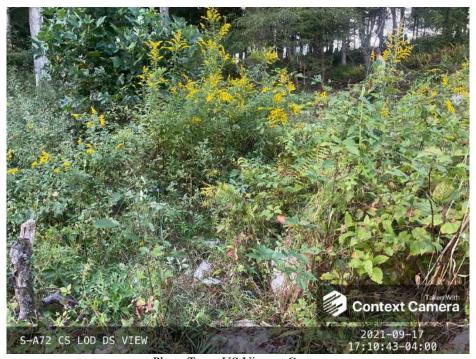
Photo Type: US View at Center Location, Orientation, Photographer Initials: Center ROW, Upstream View, KY/ZS Lat: 38.321687 Long: -80.670952

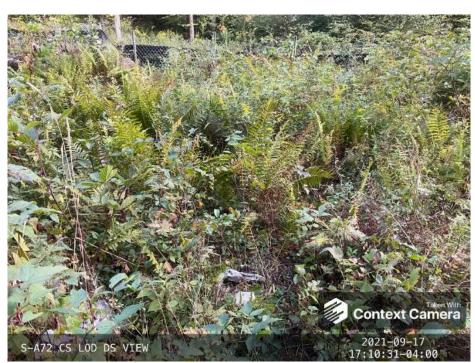
Photo Type: DS View at Center
Location, Orientation, Photographer Initials: ROW Center, Downstream View, KY/ZS
Lat: 38.321687 Long: -80.670952

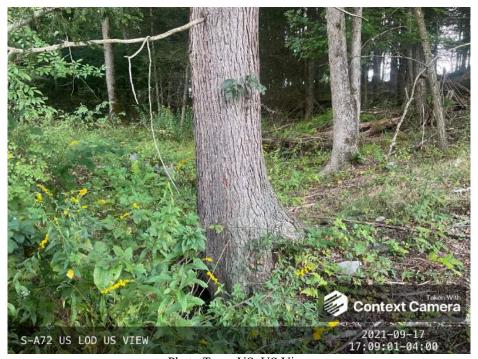
Photo Type: US, US View Location, Orientation, Photographer Initials: Upstream Edge of ROW, Upstream View, KY/ZS Lat: 38.321687 Long: -80.670952

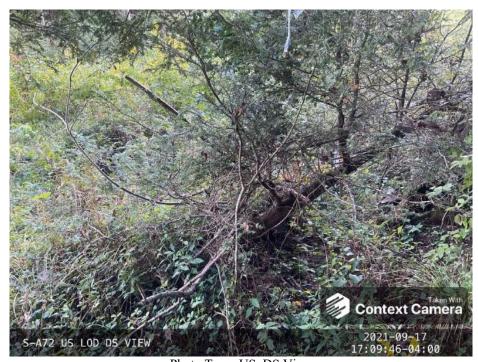
Photo Type: US, DS View
Location, Orientation, Photographer Initials: Upstream Edge of ROW, Downstream View, KY/ZS
Lat: 38.321687 Long: -80.670952

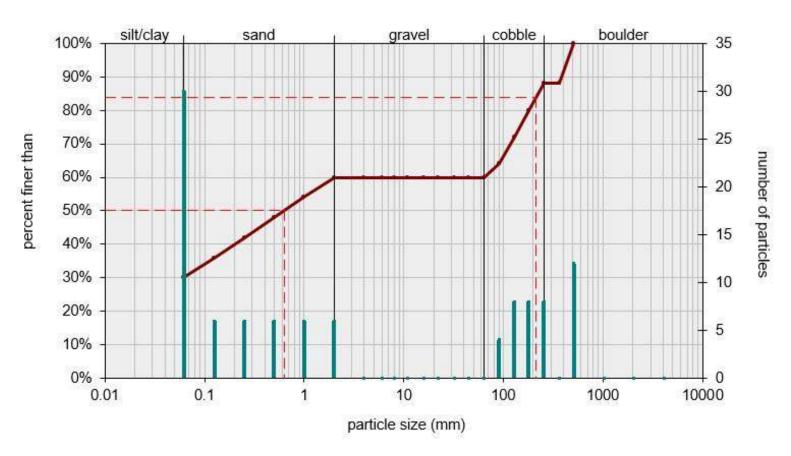
#### Bankfull Channel Pebble Count, S-A72, UNT to Big Beaver Creek

Size (ı	Size (mm)							
D16	0.062							
D35	0.11							
D50	0.63							
D65	94							
D84	210							
D95	440

Size Distr	ribution
mean	3.6
dispersion	171.7
skewness	0.40

e ***	Type								
silt/clay	30%								
sand	30%								
gravel	0%								
cobble	28%								
boulder	12%
