## Baseline Assessment – Stream Attributes

**Reach S-A83/A91 (Pipeline ROW)**

**Webster County, West Virginia**

Title	Client
PROFILE AND CROSS-SECTIONS BASELINE SURVEY CROSSING S-A83/S-A91 - UNNAMED TRIB. TO CAMP CREEK (MP 92.39) WEBSTER COUNTY, WV	MC 22

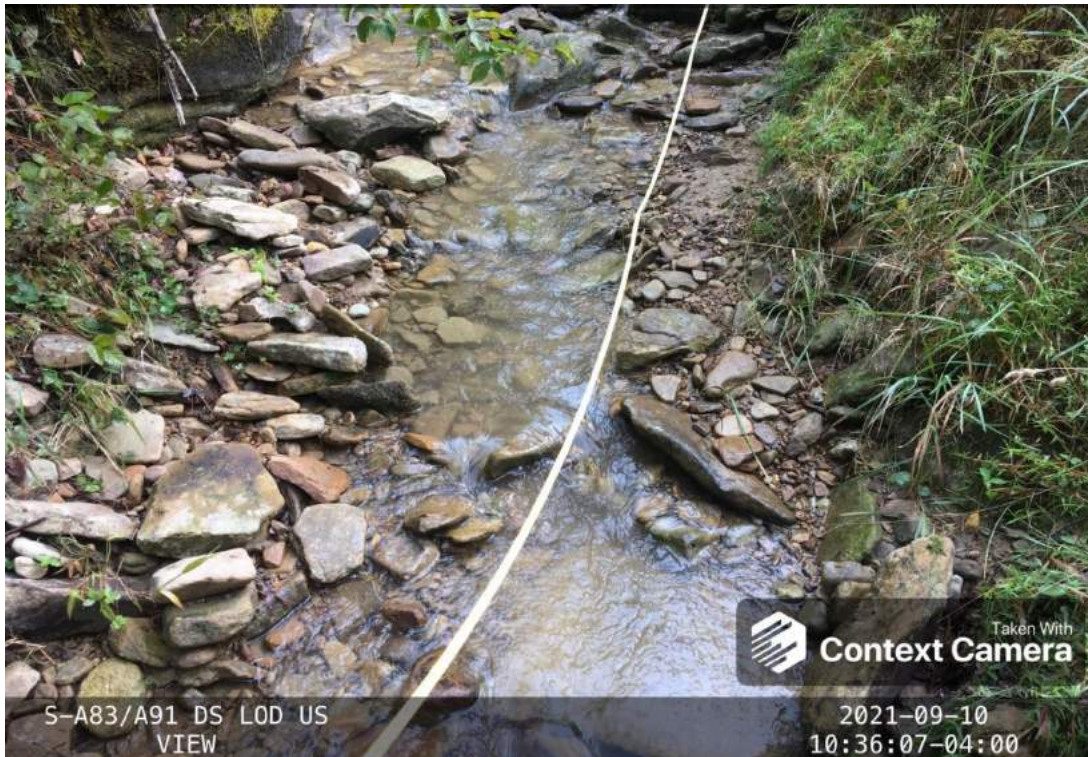
Photo Type: DS, US View

Location, Orientation, Photographer Initials: Downstream Edge of ROW, Upstream View, DPF/HK  
Lat: 38.557064 Long: -80.535592

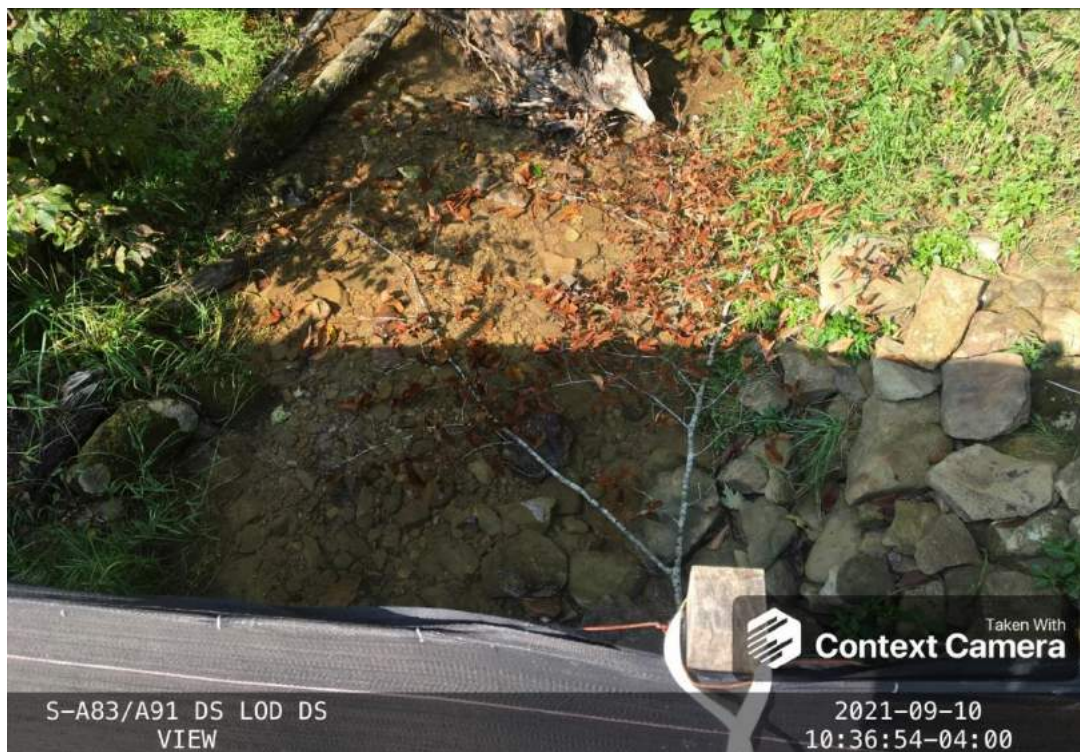
Photo Type: DS, DS View

Location, Orientation, Photographer Initials: Downstream Edge of ROW, Downstream View, DPF/HK  
Lat: 38.557064 Long: -80.535592

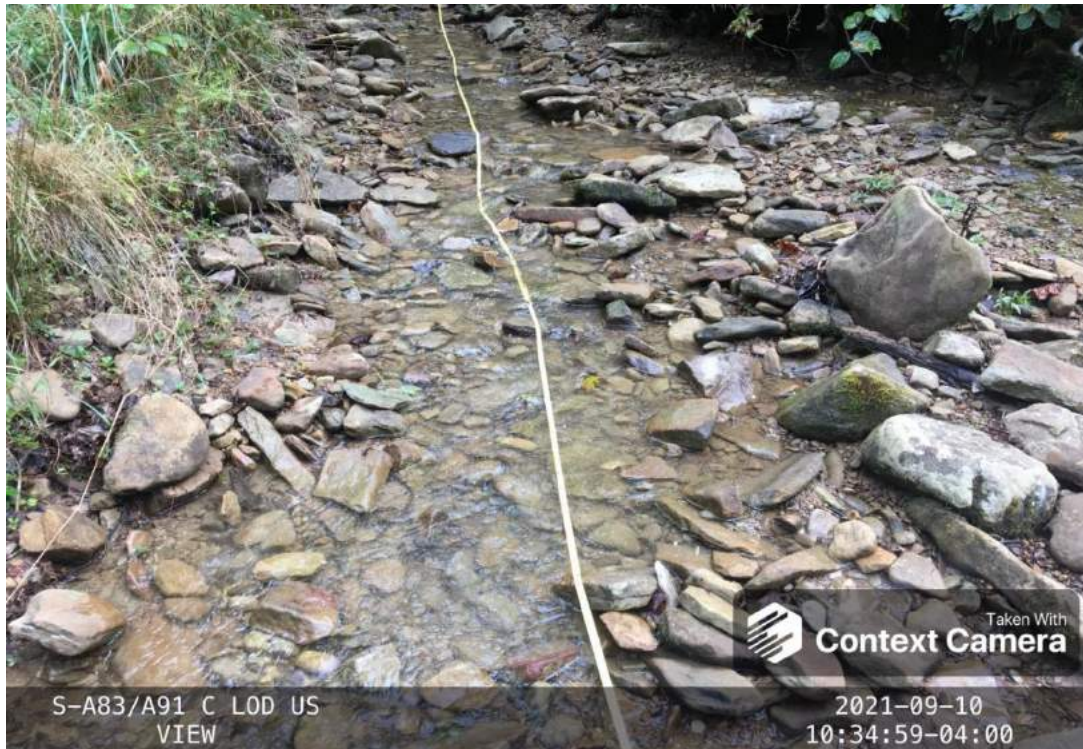
Photo Type: US View at Center  
Location, Orientation, Photographer Initials: Center ROW, Upstream View, DPF/HK  
Lat: 38.557064 Long: -80.535592

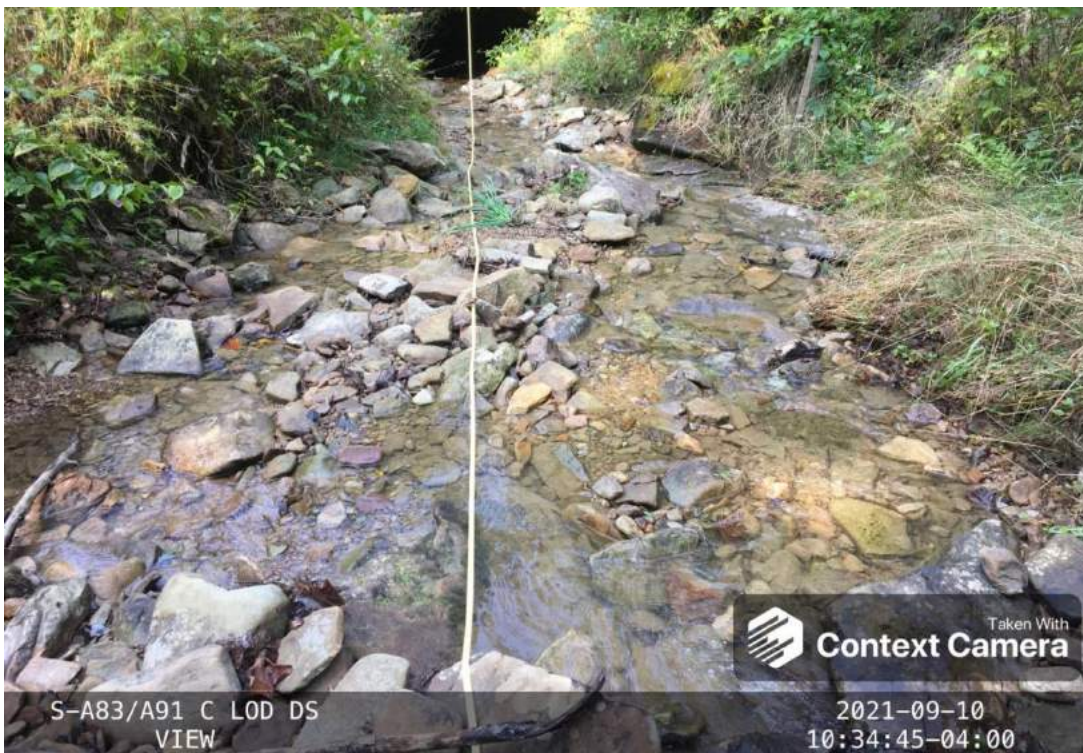
Photo Type: DS View at Center  
Location, Orientation, Photographer Initials: ROW Center, Downstream View, DPF/HK  
Lat: 38.557064 Long: -80.535592

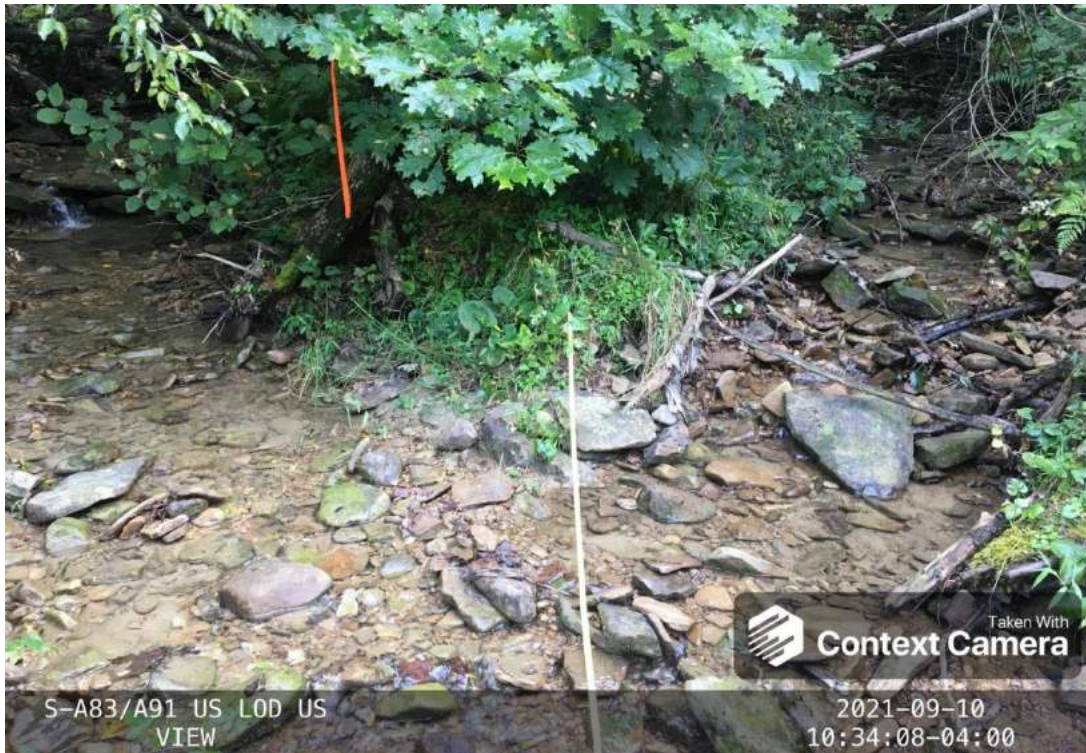
Photo Type: US, US View

Location, Orientation, Photographer Initials: Upstream Edge of ROW, Upstream View, DPF/HK  
Lat: 38.557064 Long: -80.535592

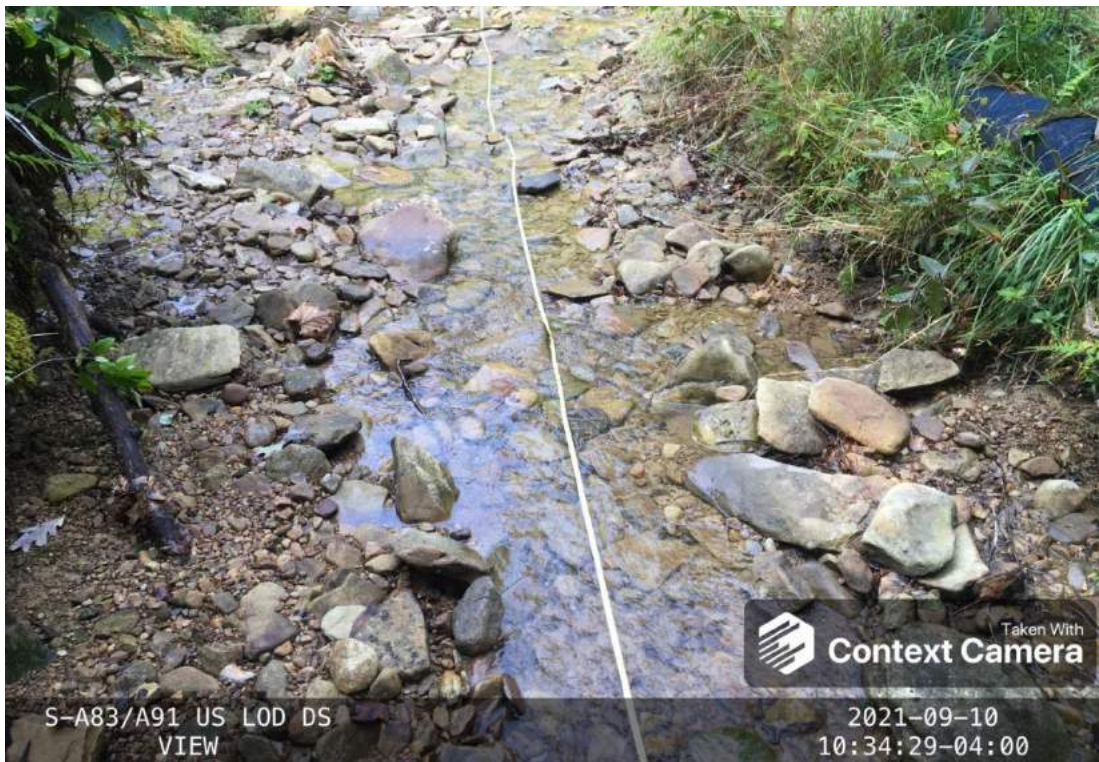
Photo Type: US, DS View

Location, Orientation, Photographer Initials: Upstream Edge of ROW, Downstream View, DPF/HK  
Lat: 38.557064 Long: -80.535592

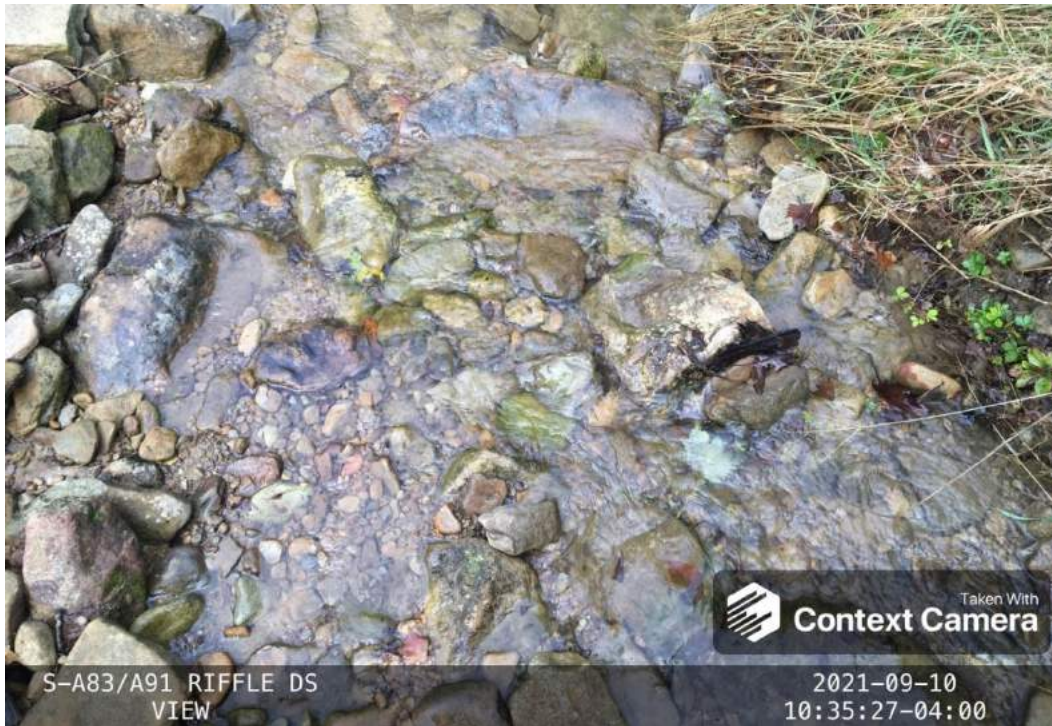
Photo Type: Riffle, DS View  
Location, Orientation, Photographer Initials: Upstream of Riffle, Downstream View, DPF/HK  
Lat: 38.557064 Long: -80.535592

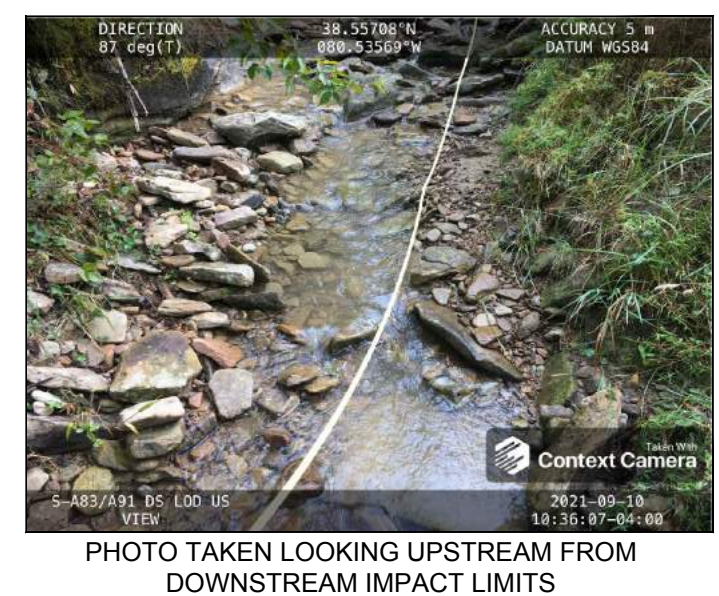
AS-BUILT TABLE: S-A83/S-A91 CROSS SECTION A					
		PRE-CROSSING		AS-BUILT	
PT. LOC.	NORTHING	EASTING	ELEV	VERT. DIFF.	HORZ. DIFF.
TS-L	14001697.30	1773157.35	1699.56		
BS-L	14001703.08	1773155.50	1695.96		
THW	14001705.67	1773155.67	1695.69		
BS-R	14001708.08	1773154.98	1696.56		
TS-R	14001712.48	1773154.16	1698.77
