**Reach S-A96/A103 (Pipeline ROW)**  
**Ephemeral**  
**Spread C**  
**Webster County, West Virginia**

## Spread C Stream S-A96/A103 (Pipeline ROW) Webster County

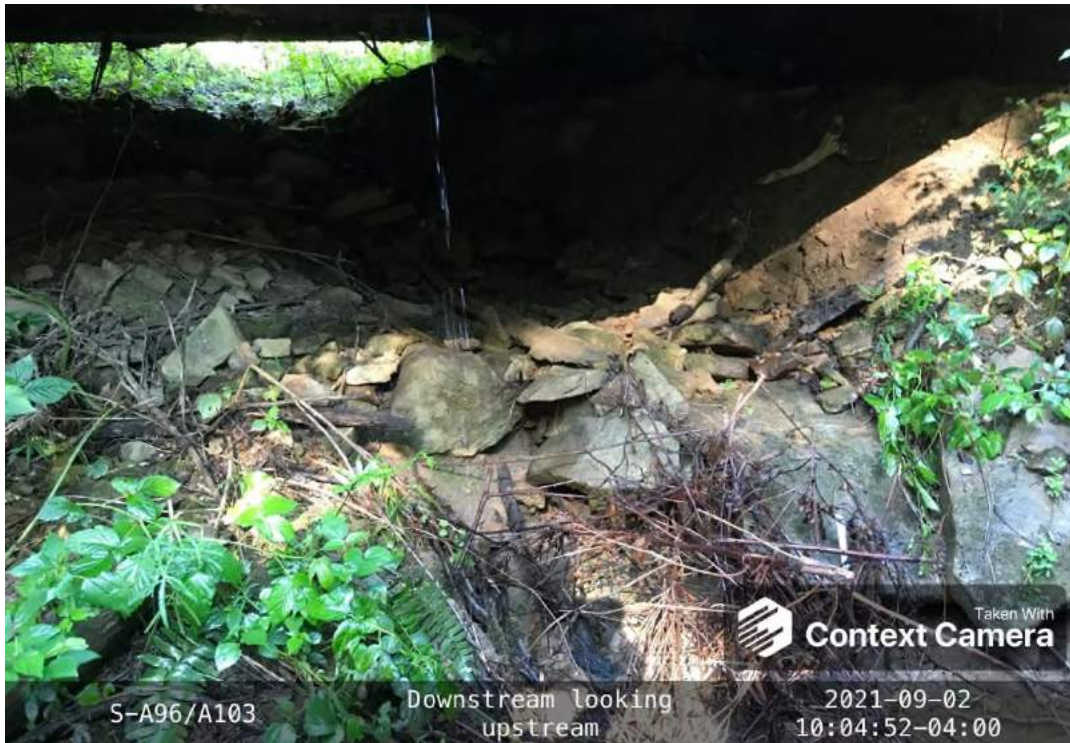
Photo Type: DS, US View

Location, Orientation, Photographer Initials: Downstream Edge of ROW, Upstream View, DD/LC  
Lat: 38.688706 Long: -80.47859

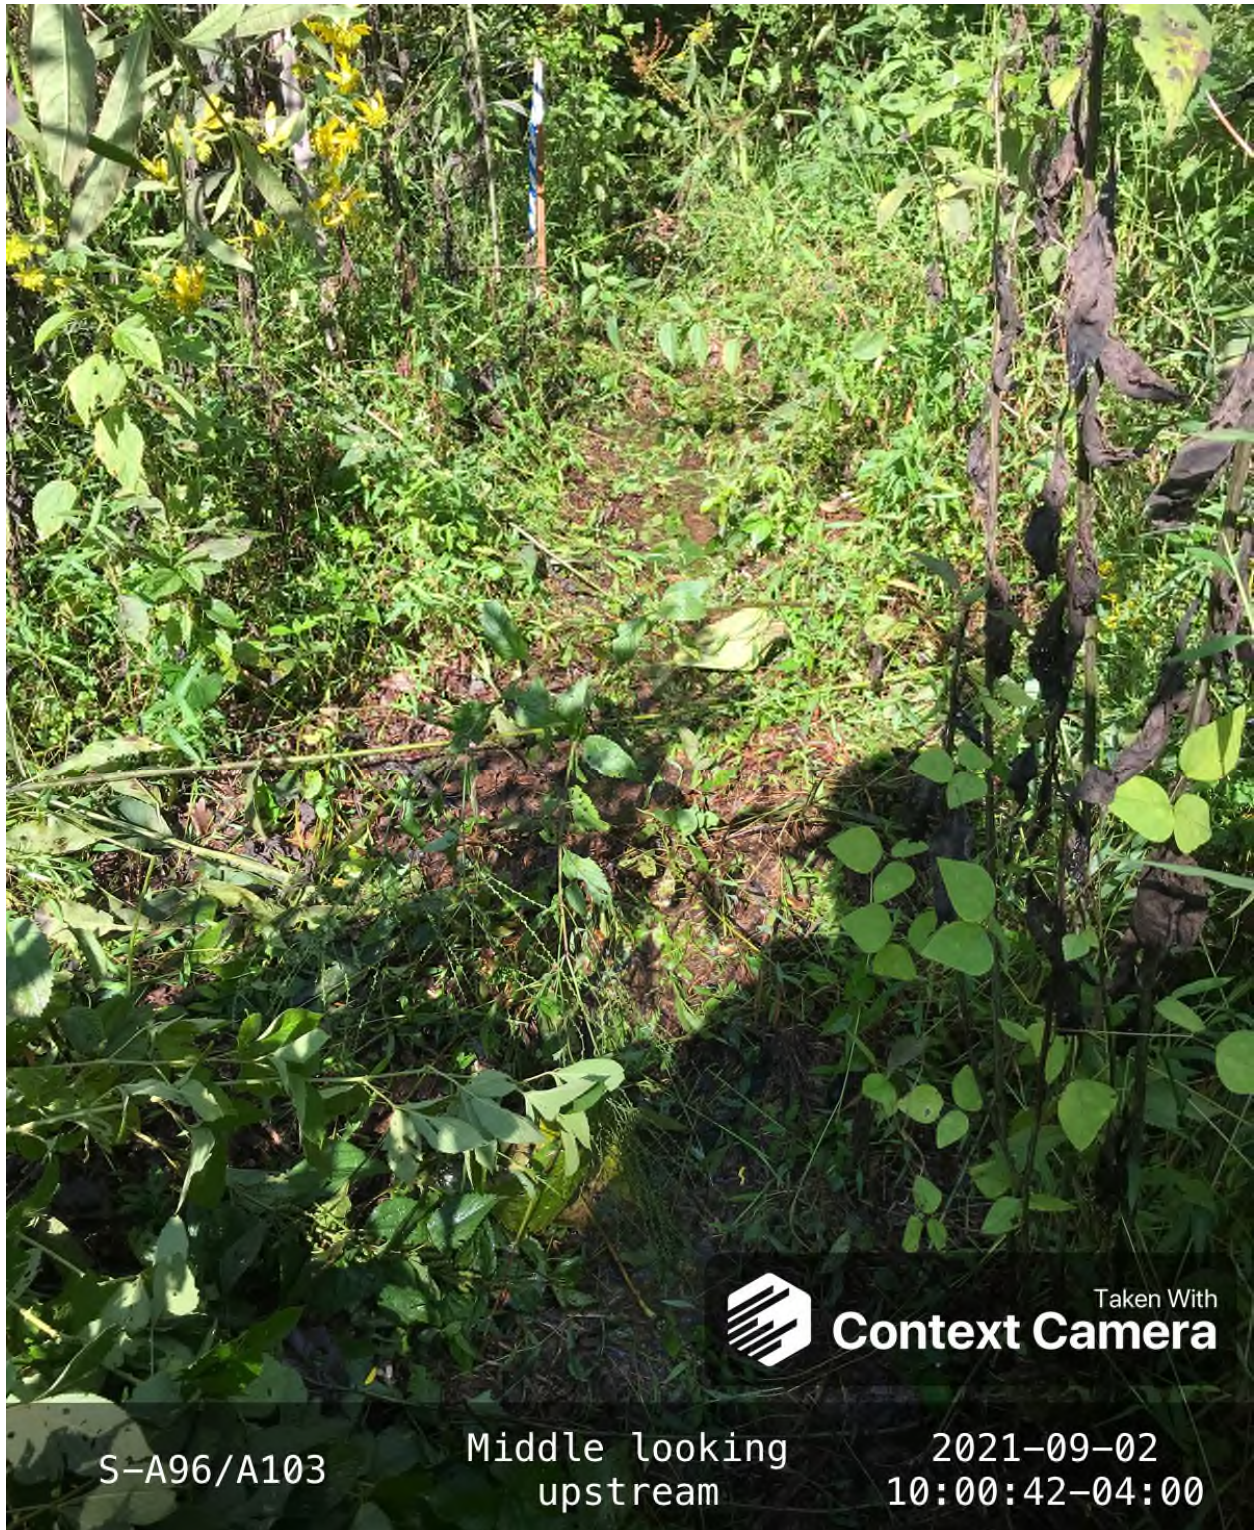
S-A96/A103

Middle looking  
upstream

Photo Type: US View at Center  
Location, Orientation, Photographer Initials: Center ROW, Upstream View, DD/LC  
Lat: 38.688706 Long: -80.47859

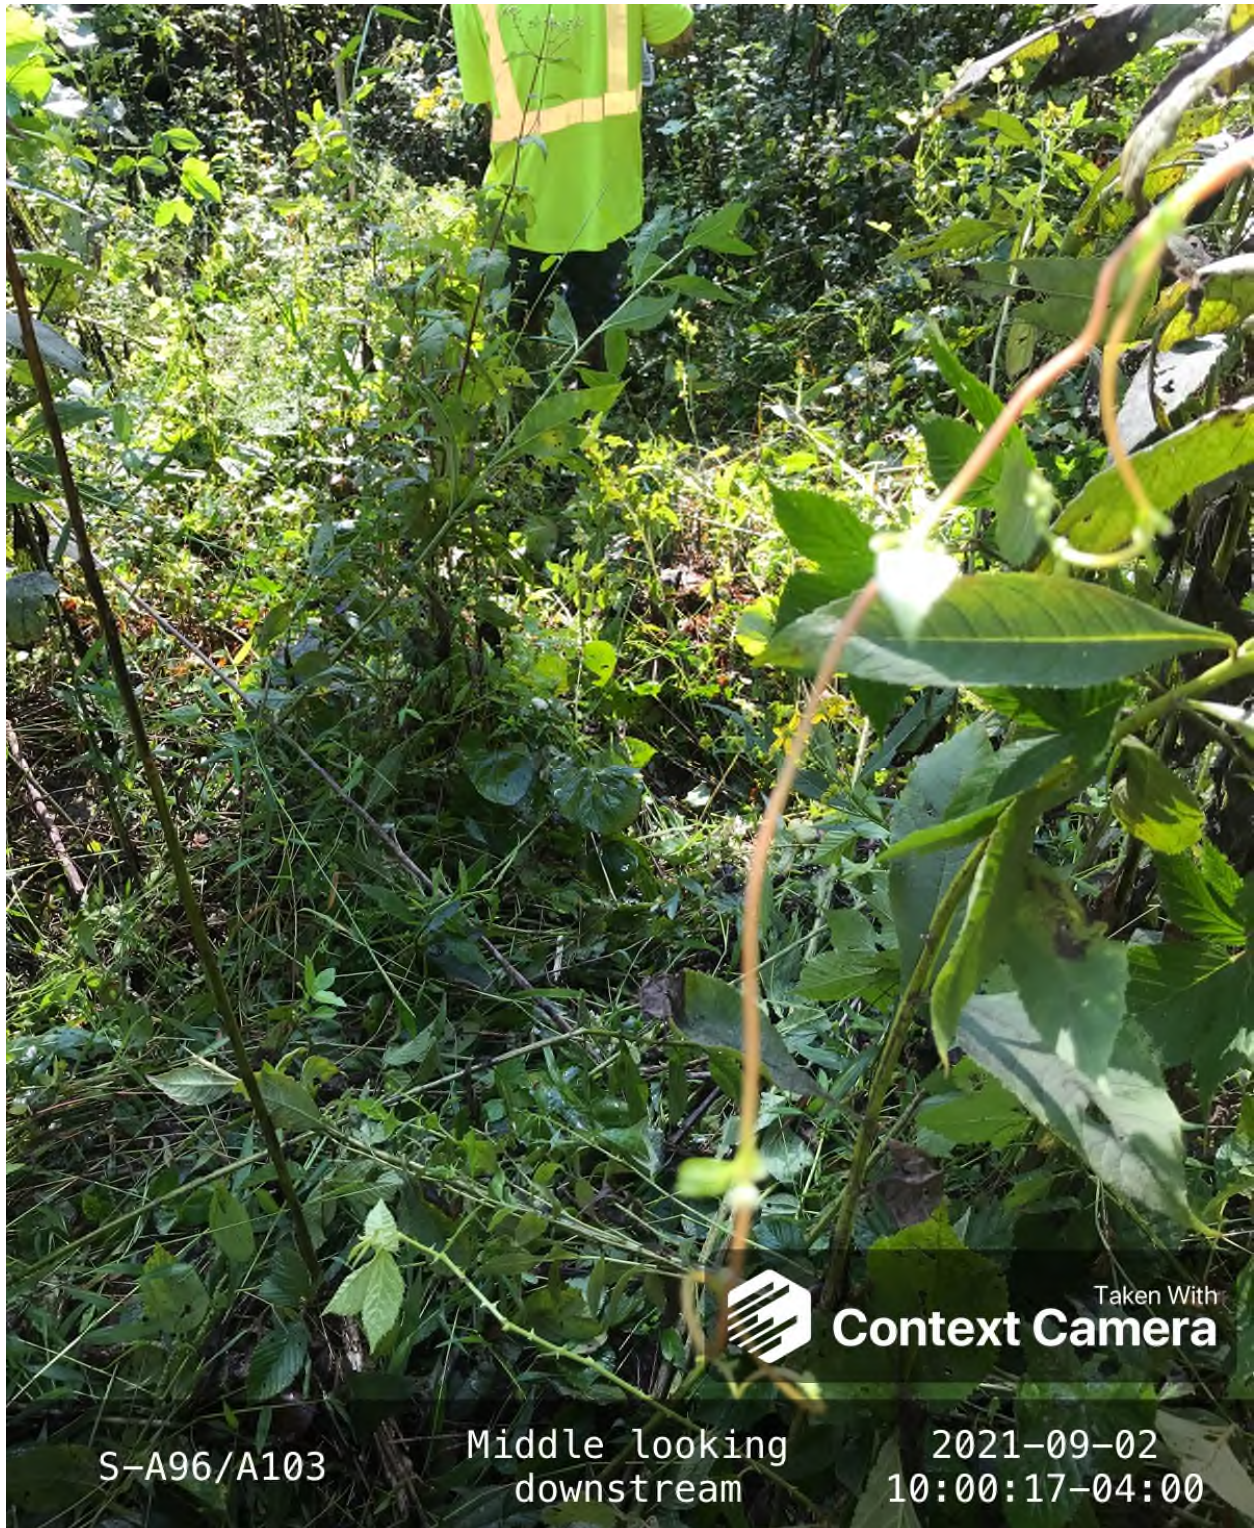
S-A96/A103

Middle looking  
downstream

Photo Type: DS View at Center  
Location, Orientation, Photographer Initials: ROW Center, Downstream View, DD/LC  
Lat: 38.688706 Long: -80.47859

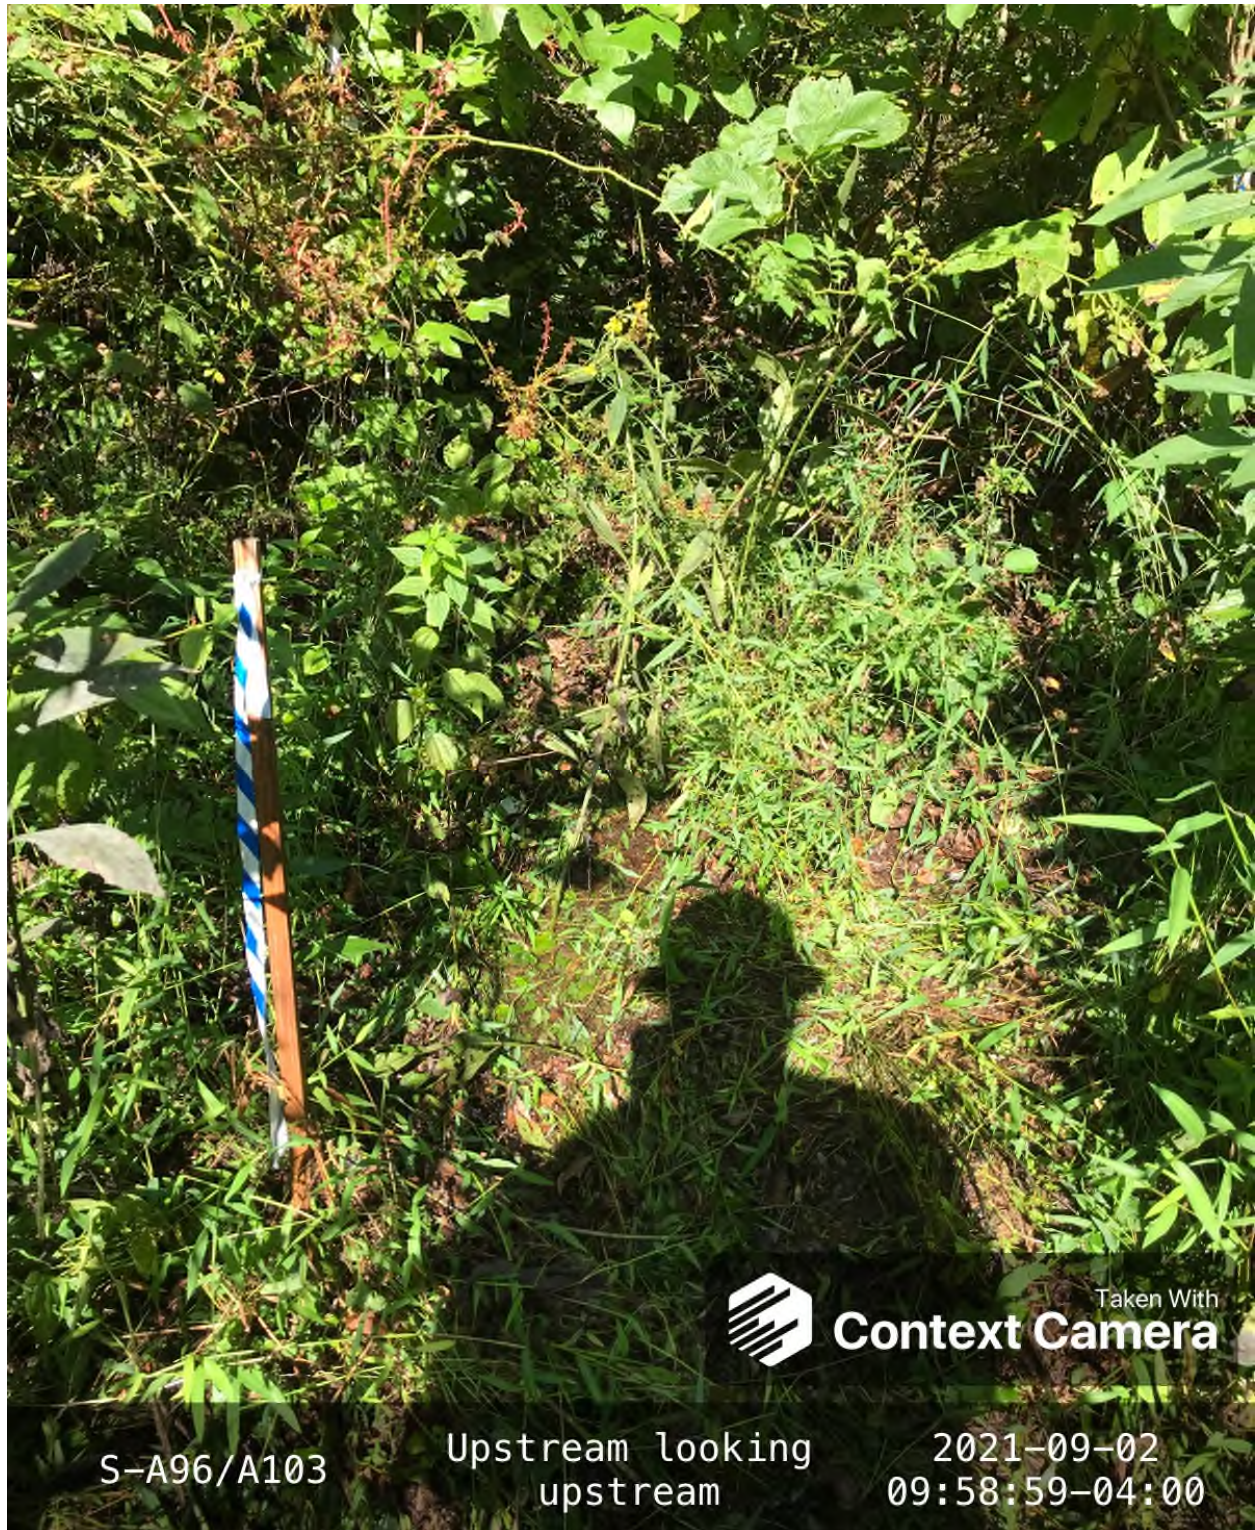
S-A96/A103

Upstream looking  
upstream

Photo Type: US, US View  
Location, Orientation, Photographer Initials: Upstream Edge of ROW, Upstream View, DD/LC  
Lat: 38.688706 Long: -80.47859

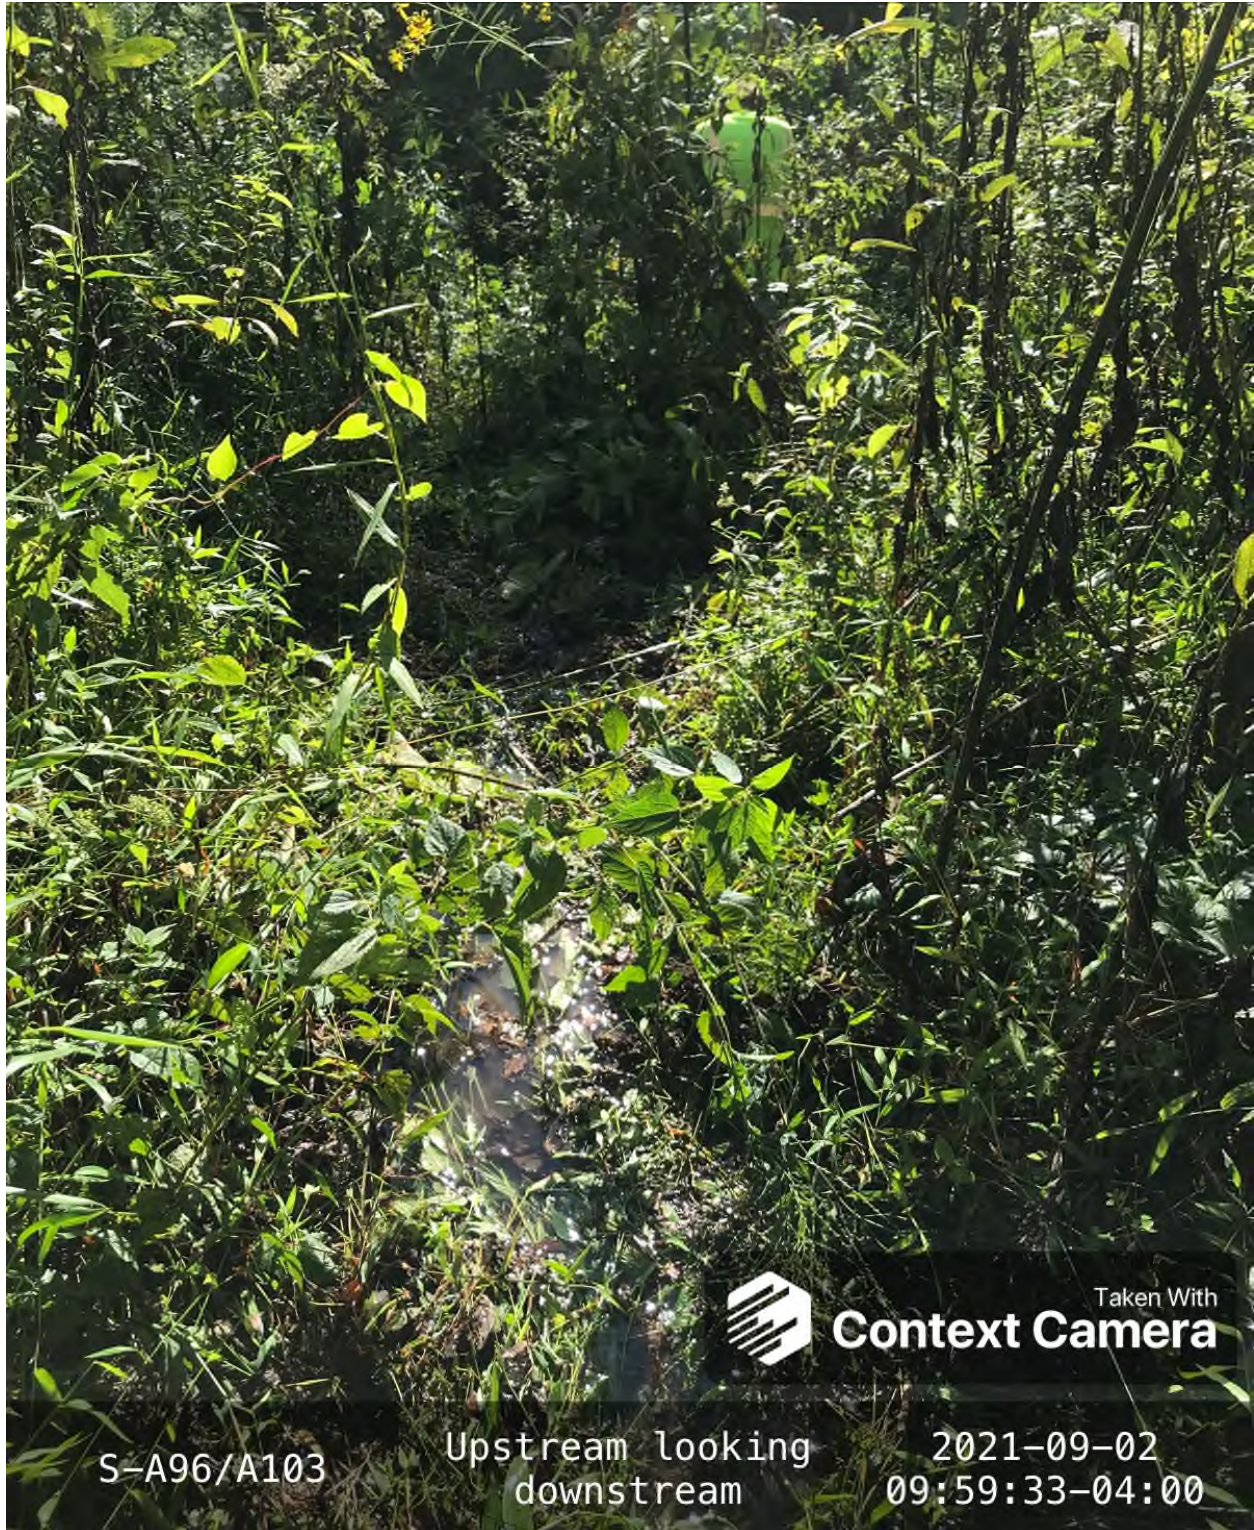
Photo Type: US, DS View  
Location, Orientation, Photographer Initials: Upstream Edge of ROW, Downstream View, DD/LC  
Lat: 38.688706 Long: -80.47859

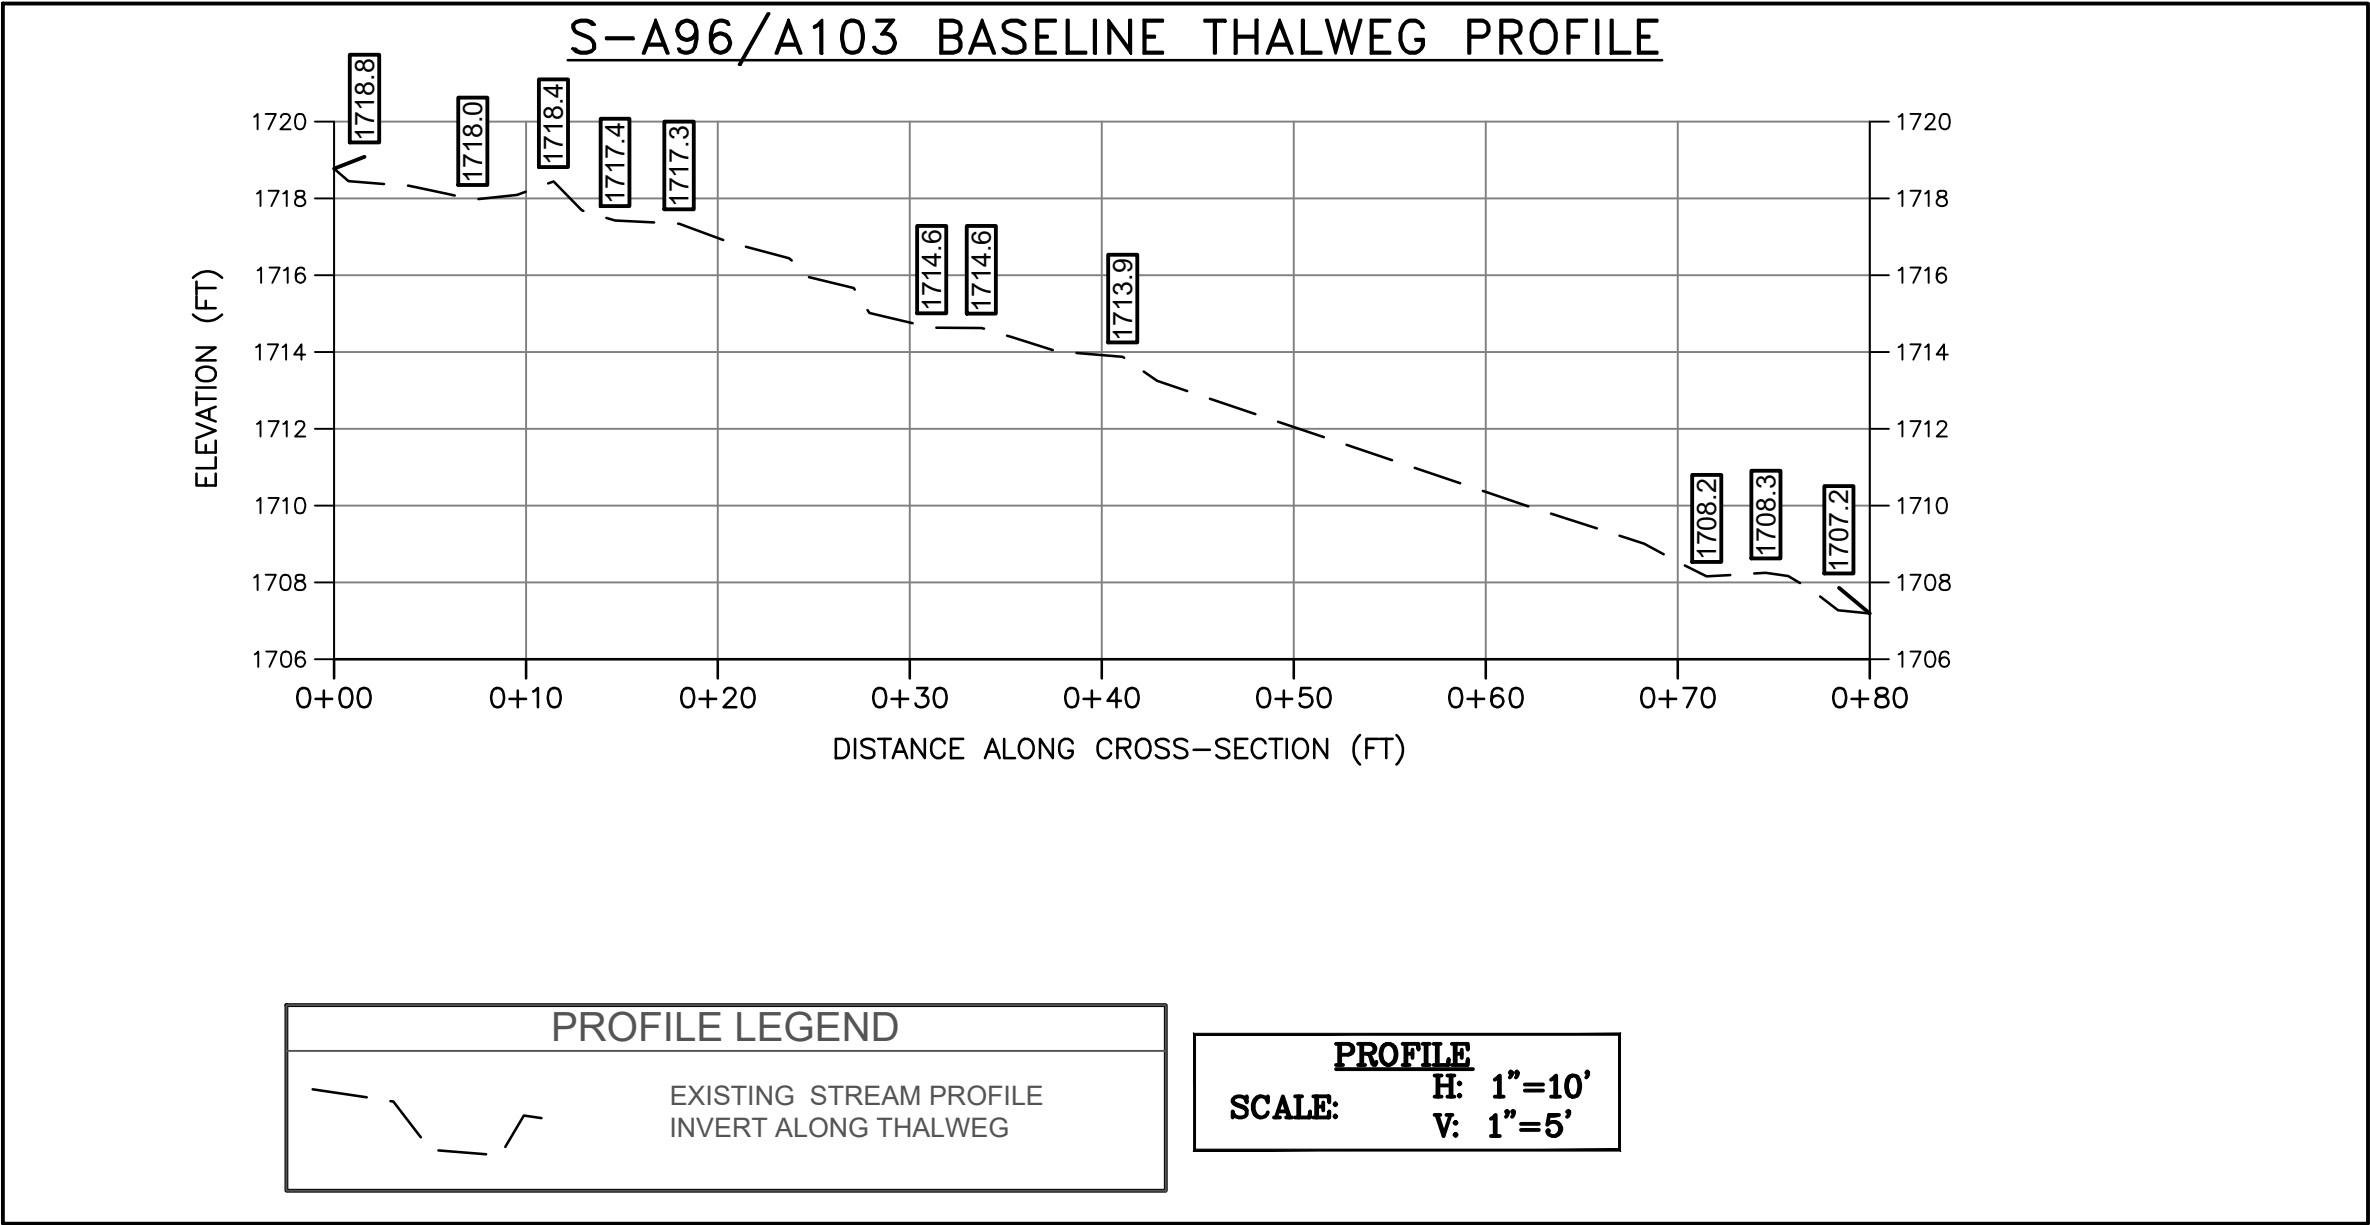
- THIS MAP HAS BEEN ORIENTED TO NAD 1983 UTM ZONE 17N, AND VERTICALLY TO THE NORTH AMERICAN VERTICAL DATUM OF 1988 (NAVD 88), USING REAL TIME DGPS. FIELD LOCATIONS WERE COMPLETED ON SEPTEMBER 4, 2021.

- ALL SECTION VIEWS SHOWN LEFT TO RIGHT FACING DOWNSTREAM.
- POST-CROSSING SURVEY INFORMATION SHOWN IN RED. DATA PENDING.
- POST-CROSSING SURVEY POINTS FOR CROSS SECTIONS AND THALWEG ARE PROJECTED ONTO PRE-CROSSING SECTION AND PROFILE VIEWS FOR COMPARISON.

AS-BUILT TABLE: S-A96/A103 CROSS SECTION A						
PT. LOC.	PRE-CROSSING			AS-BUILT		
	NORTHING	EASTING	ELEV.	VERT. DIFF.	HORZ. DIFF.	
TS-L	14049735.88	1789187.03	1725.85			
BS-L	14049712.80	1789193.49	1714.56			
THW	14049707.43	1789195.00	1714.28			
BS-R	14049704.47	1789195.83	1714.25			
TS-R	14049687.39	1789200.61	1720.25
