Baseline Assessment – Stream Attributes

Reach S-B30 (Anode Bed) Ephemeral Spread D Webster County, West Virginia

Title PROFILE AND CROSS-SECTIONS
BASELINE SURVEY
CROSSING S-B30 - UNNAMED TRIBUTARY
TO MEADOW FORK (MP 107.10)
WEBSTER COUNTY, WV

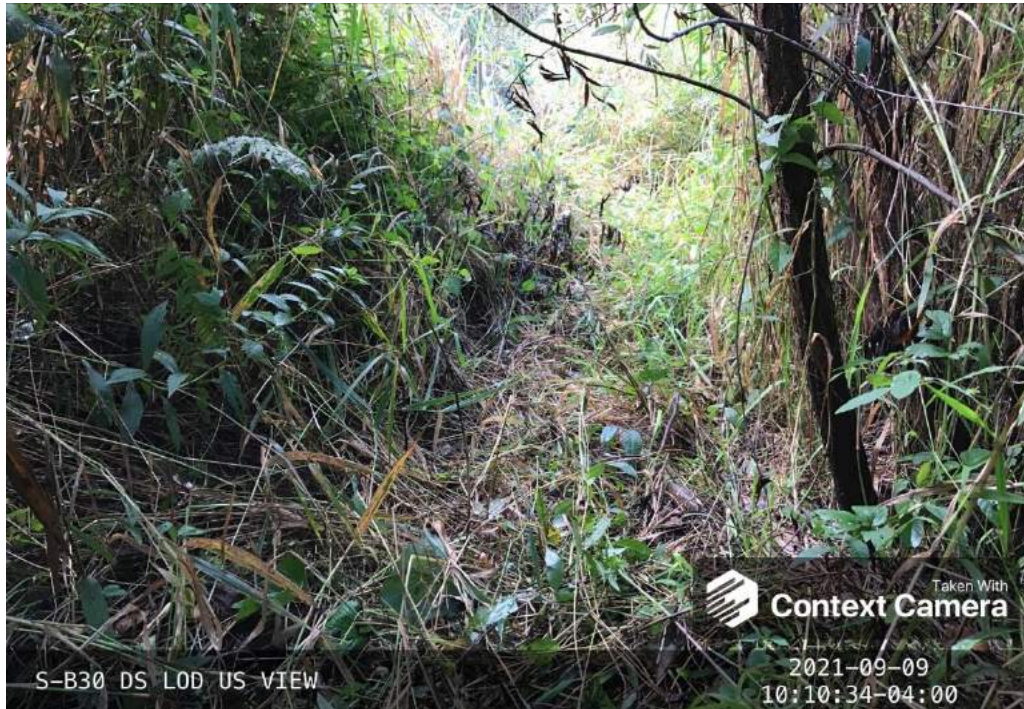
Photo Type: DS, US View

Location, Orientation, Photographer Initials: Downstream Edge of ROW, Upstream View, RH/AR

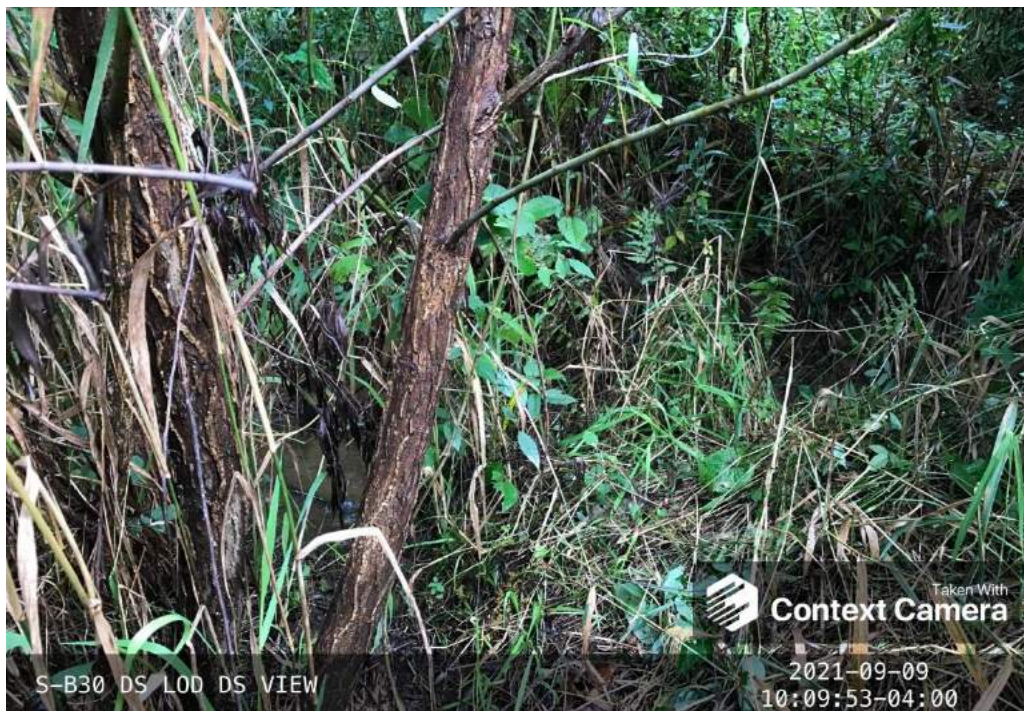
Photo Type: DS, DS View

Location, Orientation, Photographer Initials: Downstream Edge of ROW, Downstream View, RH/AR

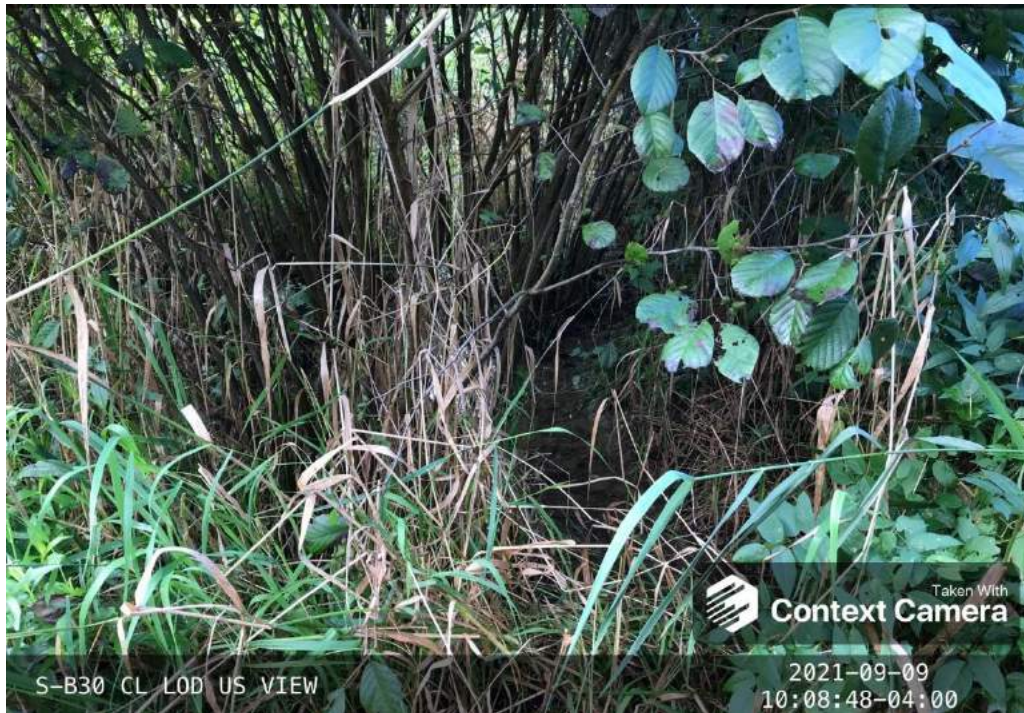
Photo Type: US View at Center
Location, Orientation, Photographer Initials: Center ROW, Upstream View, RH/AR
Lat: 38.399733 Long: -80.597536

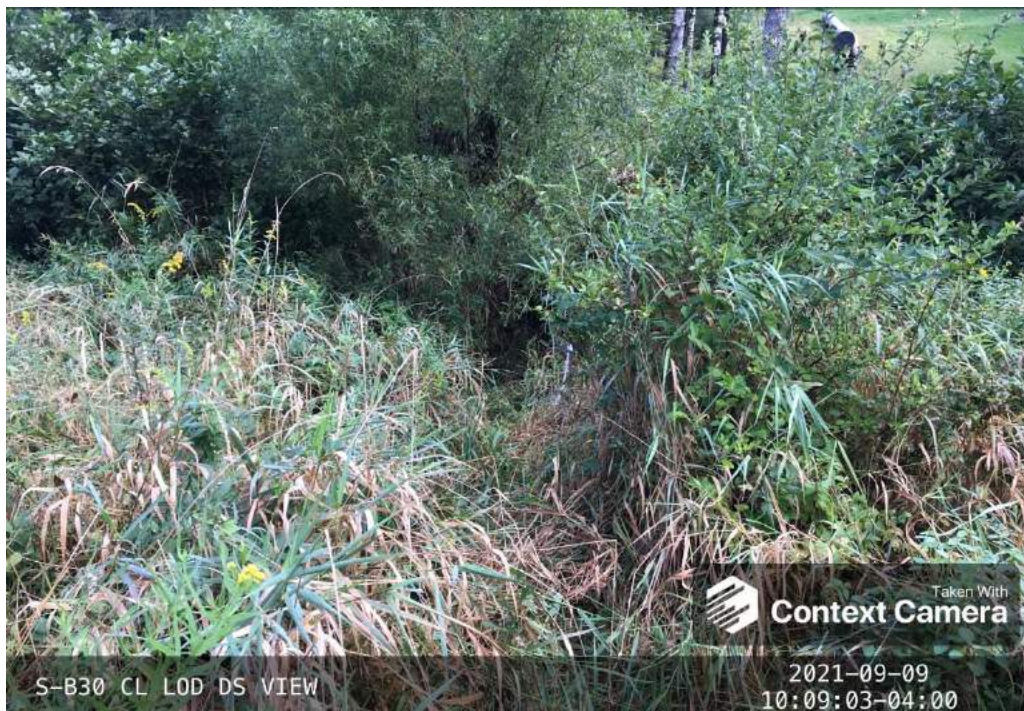
Photo Type: DS View at Center
Location, Orientation, Photographer Initials: ROW Center, Downstream View, RH/AR
Lat: 38.399733 Long: -80.597536

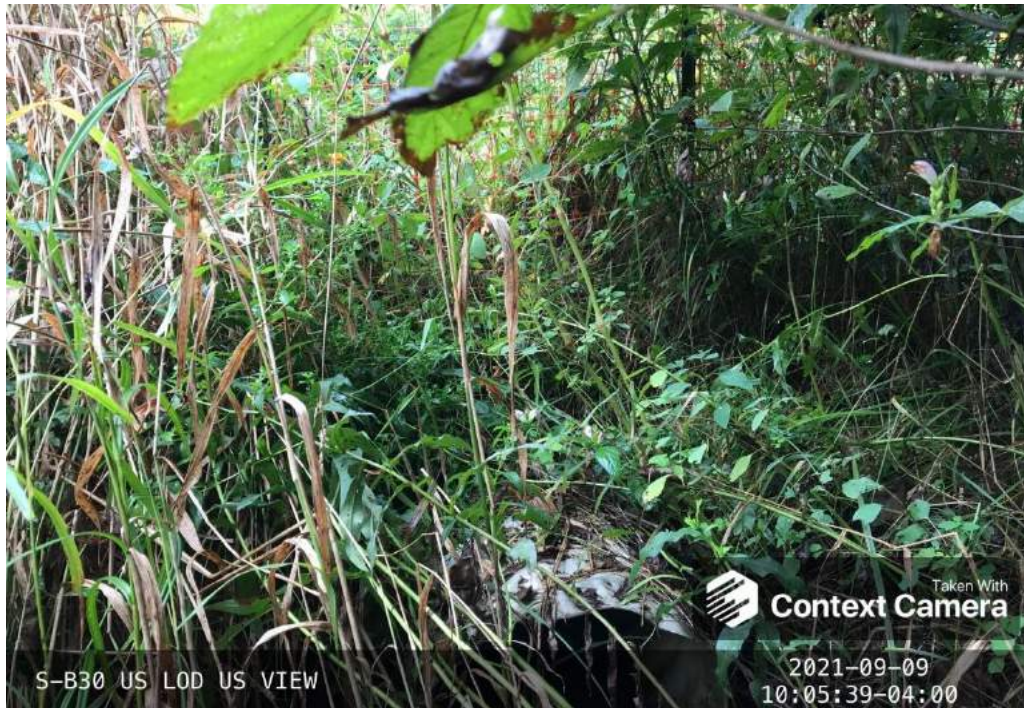
Photo Type: US, US View

Location, Orientation, Photographer Initials: Upstream Edge of ROW, Upstream View, RH/AR
Lat: 38.399733 Long: -80.597536

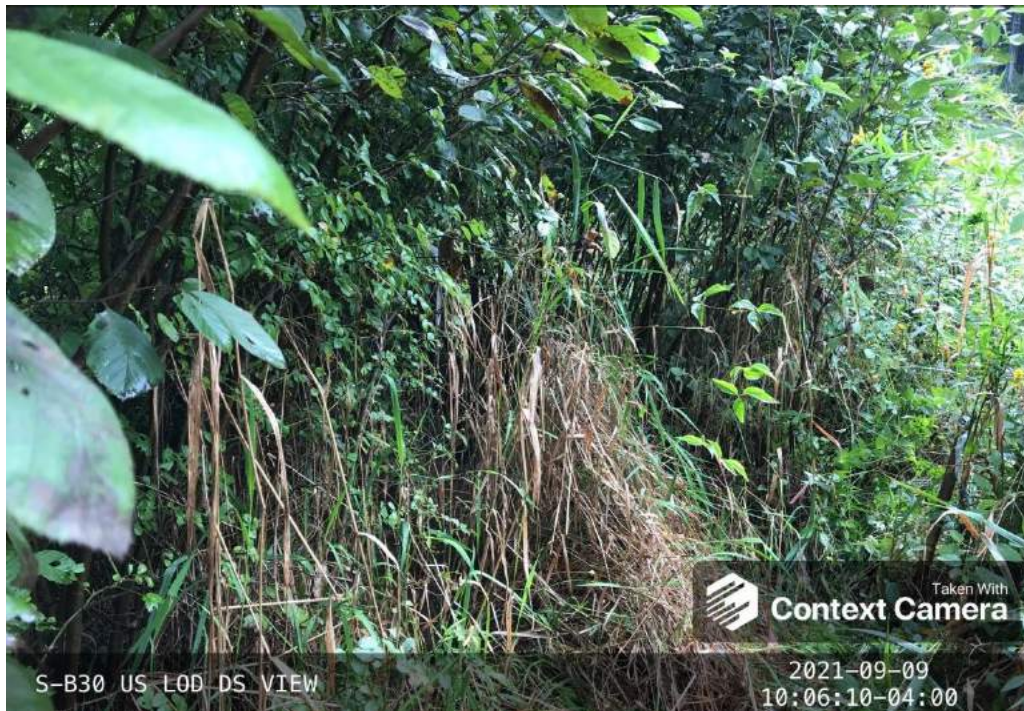
Photo Type: US, DS View

Location, Orientation, Photographer Initials: Upstream Edge of ROW, Downstream View, RH/AR
Lat: 38.399733 Long: -80.597536

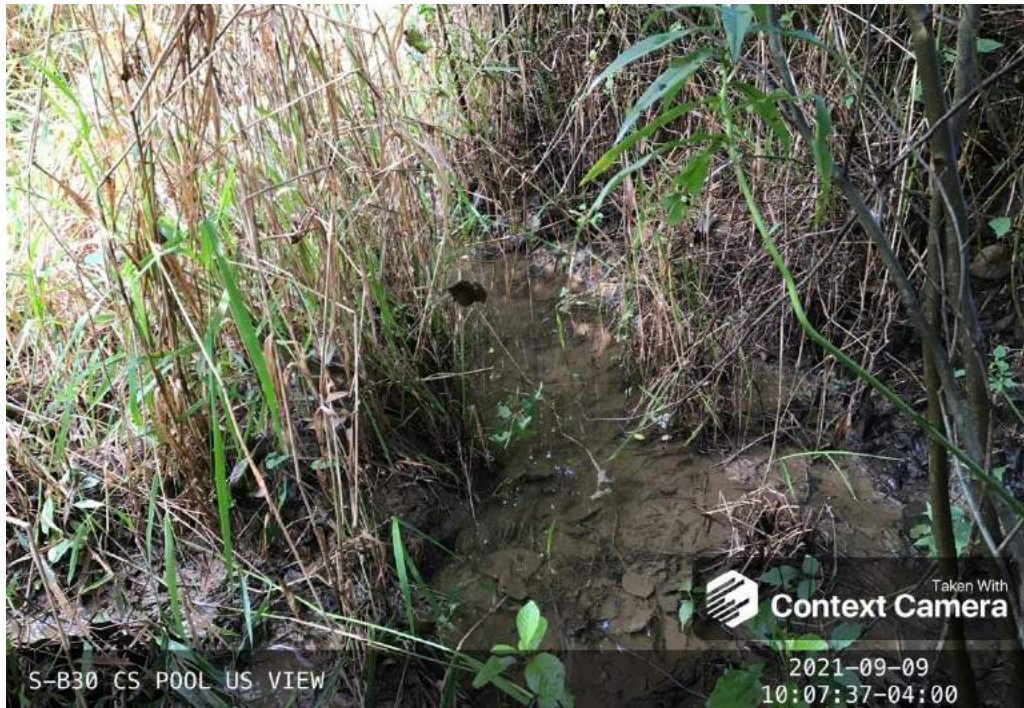
Photo Type: Pool, DS View

Location, Orientation, Photographer Initials: Upstream of Pool, Downstream View, RH/AR
Lat: 38.399733 Long: -80.597536

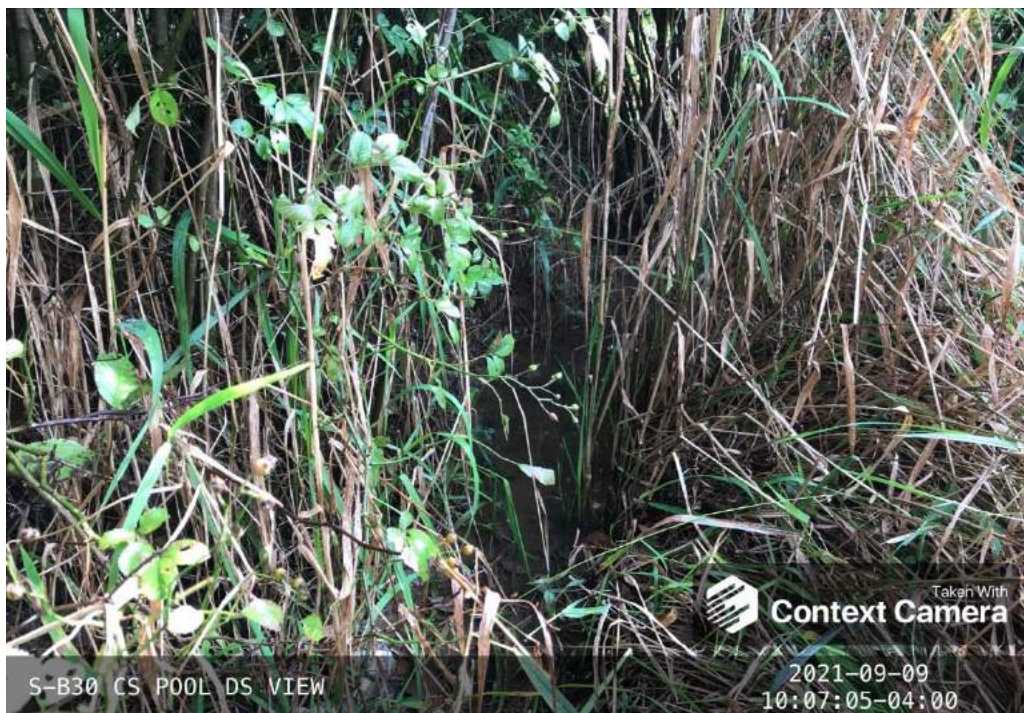
Photo Type: Pool, US View

Location, Orientation, Photographer Initials: Downstream of Pool, Upstream View, RH/AR
Lat: 38.399733 Long: -80.597536

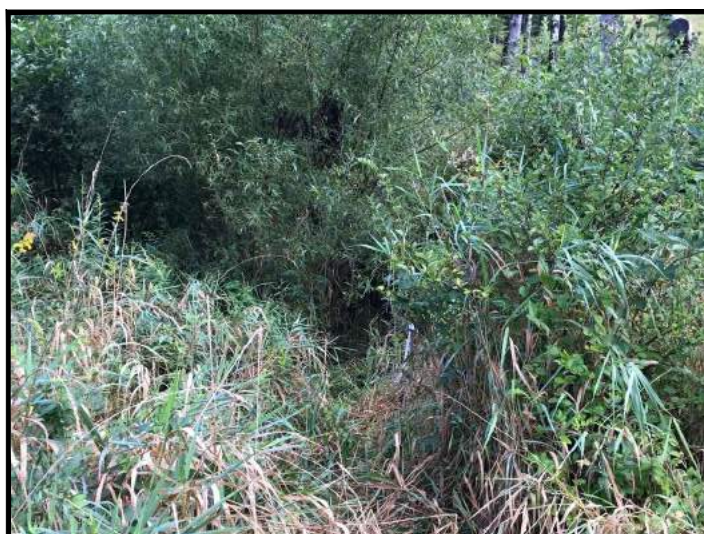
PHOTO TAKEN LOOKING UPSTREAM FROM
DOWNSTREAM IMPACT LIMITS
