## Baseline Assessment – Stream Attributes

### Reach S-B38 (Pipeline ROW) Ephemeral Spread C Webster County, West Virginia

CROSSING S-B38 - UNNAMED TRIB.  
AMOS RUN (MP 97.7)  
WEBSTER COUNTY, WV

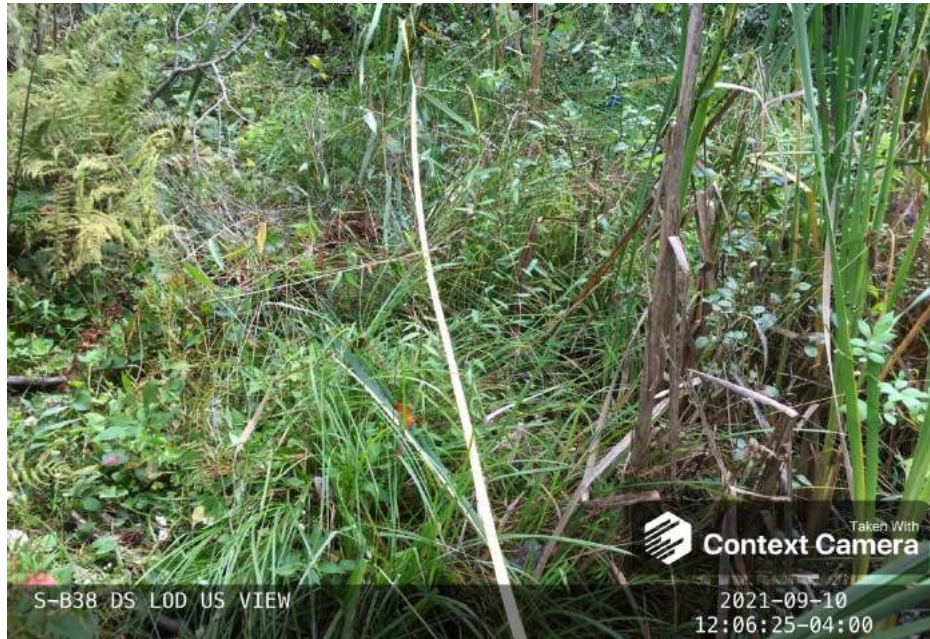
Photo Type: DS, US View

Location, Orientation, Photographer Initials: Downstream Edge of ROW, Upstream View, HC/VM  
Lat: 38.493723 Long: -80.560843

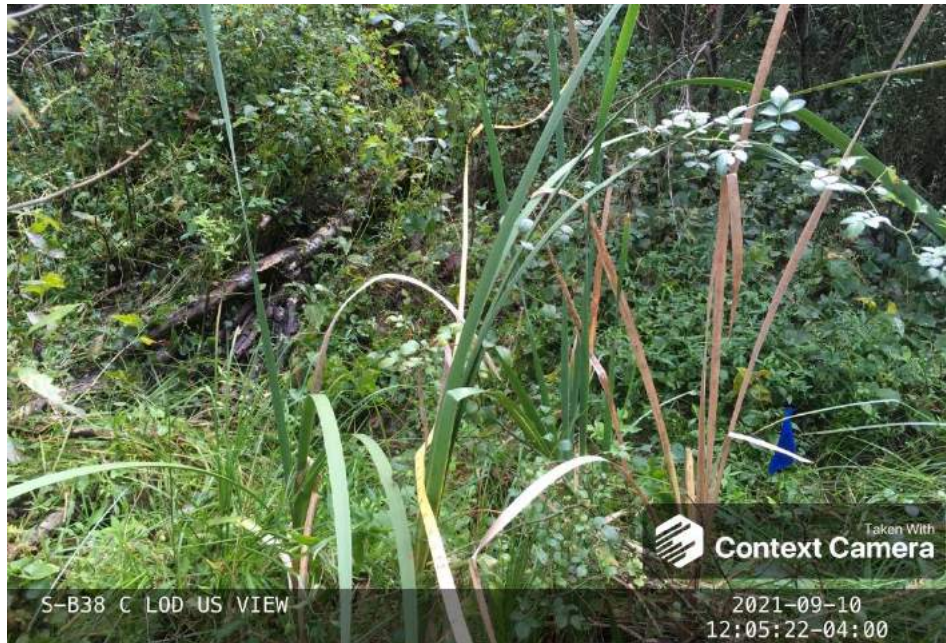
Photo Type: US View at Center  
Location, Orientation, Photographer Initials: Center ROW, Upstream View, HC/VM  
Lat: 38.493723 Long: -80.560843

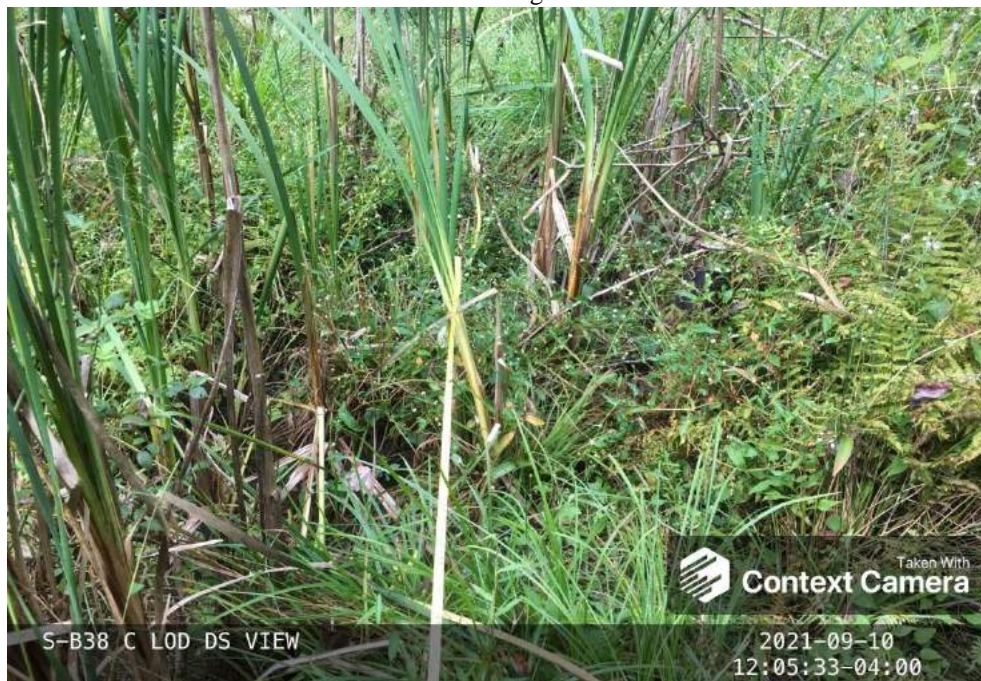
Photo Type: DS View at Center  
Location, Orientation, Photographer Initials: ROW Center, Downstream View, HC/VM  
Lat: 38.493723 Long: -80.560843

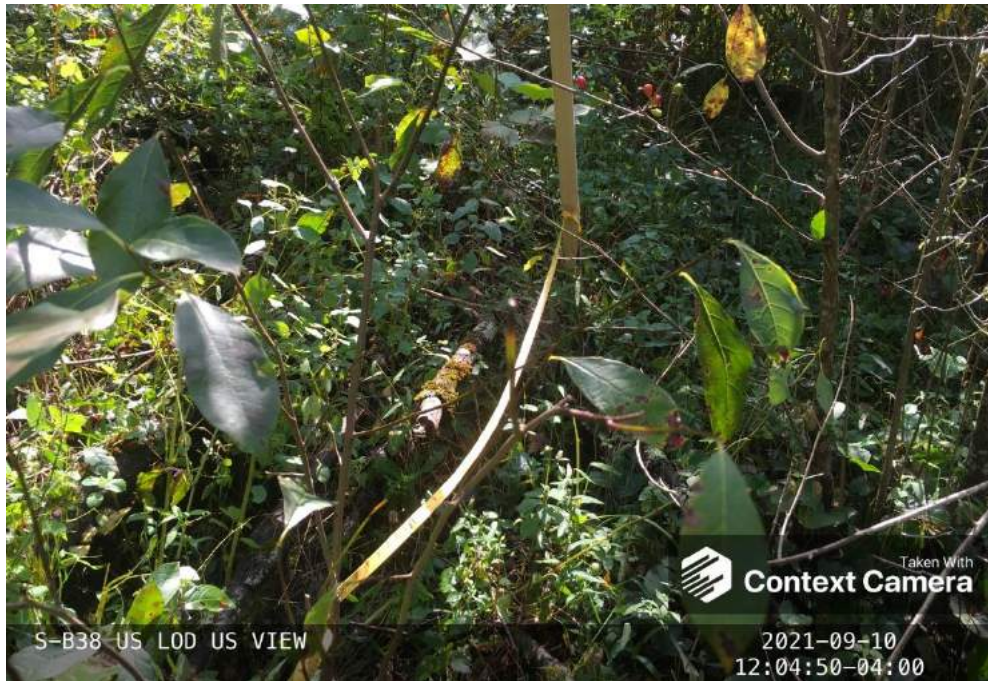
Photo Type: US, US View  
Location, Orientation, Photographer Initials: Upstream Edge of ROW, Upstream View, HC/VM  
Lat: 38.493723 Long: -80.560843

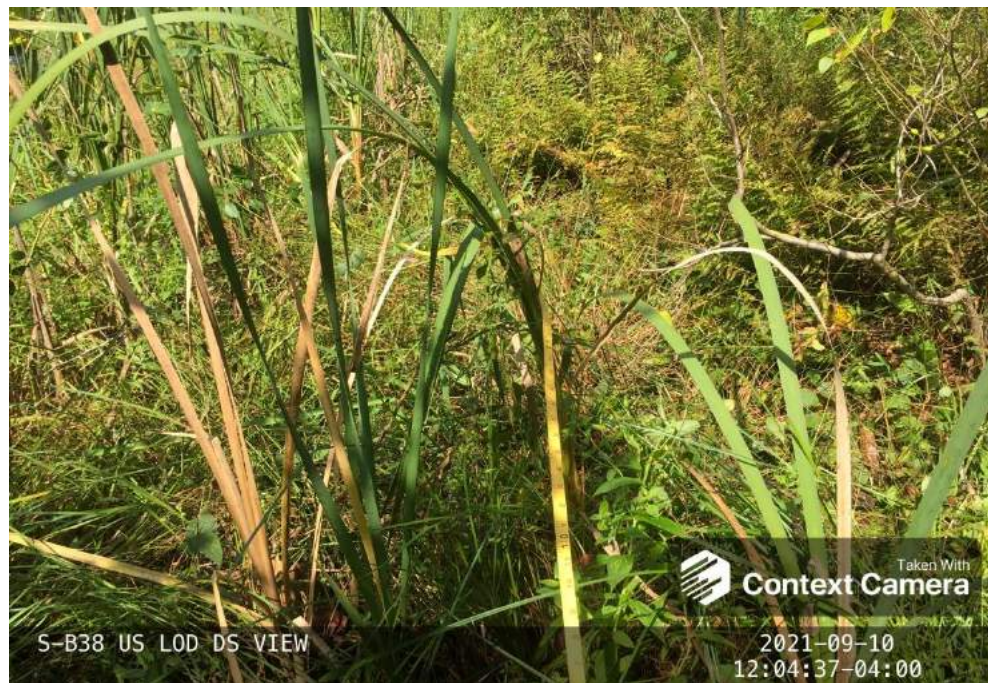
Photo Type: US, DS View  
Location, Orientation, Photographer Initials: Upstream Edge of ROW, Downstream View, HC/VM  
Lat: 38.493723 Long: -80.560843
