## Baseline Assessment – Stream Attributes

### Reach S-B39b (2) (Pipeline ROW) Ephemeral Spread C Webster County, West Virginia

**Project Name:** MVP Stream Assessment

TITLE  
PROFILE AND CROSS-SECTIONS  
BASELINE SURVEY  
CROSSING S-B39B (1) & S-B39B (2)-  
UNNAMED TRIB. TO AMOS RUN (MP 97.9)  
WEBSTER COUNTY, WV

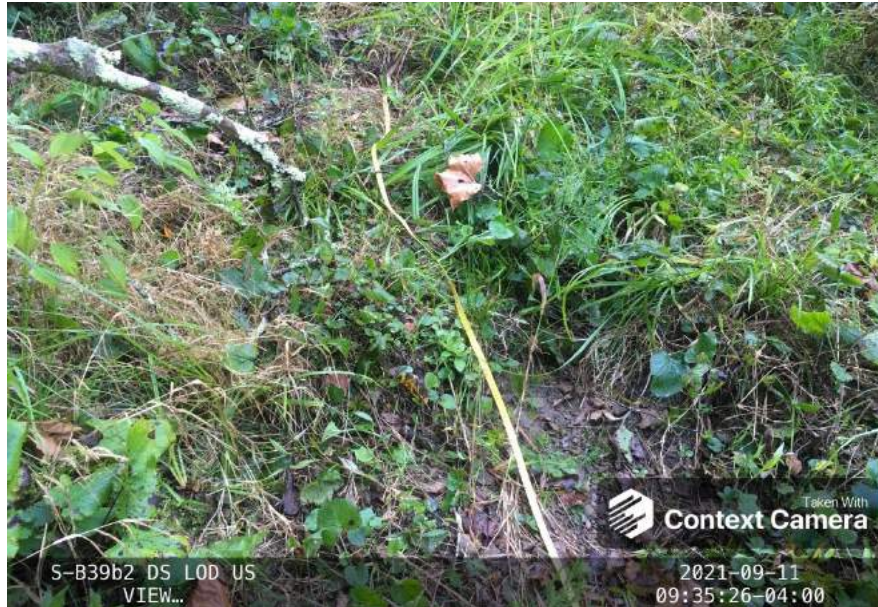
Photo Type: DS, US View

Location, Orientation, Photographer Initials: Downstream Edge of ROW, Upstream View, HC/VM  
Lat: 38.493352 Long: -80.560574

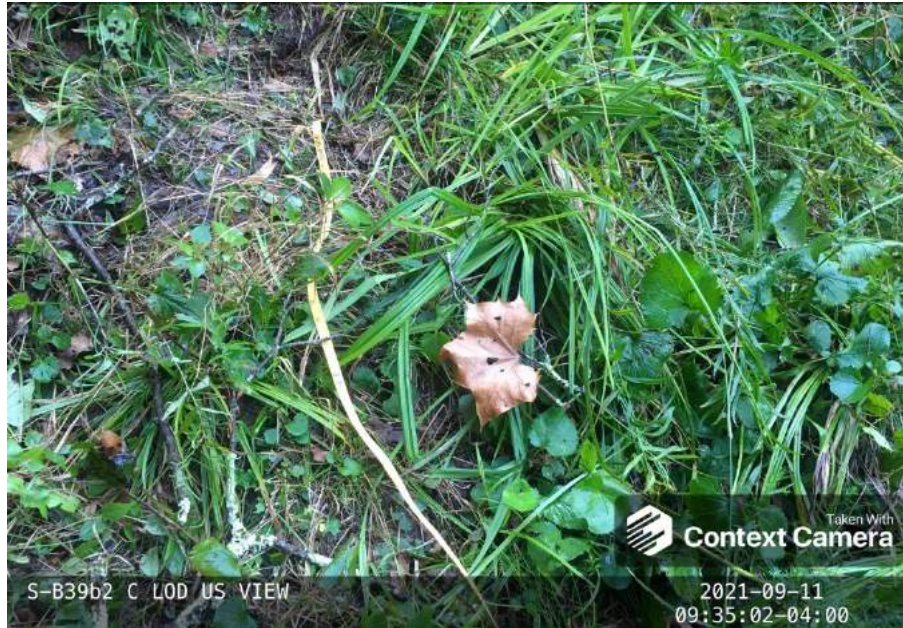
Photo Type: US View at Center  
Location, Orientation, Photographer Initials: Center ROW, Upstream View, HC/VM  
Lat: 38.493352 Long: -80.560574

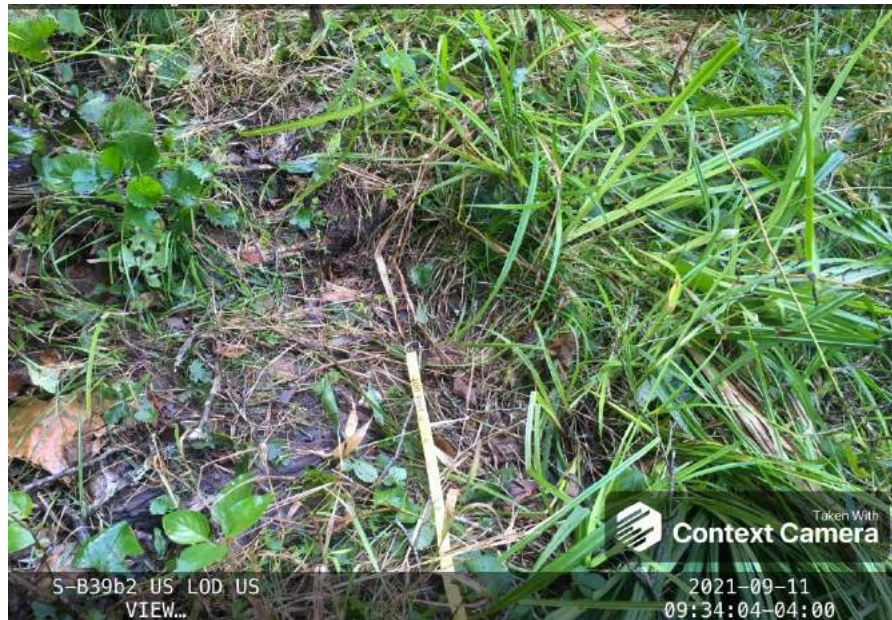
Photo Type: US, US View

Location, Orientation, Photographer Initials: Upstream Edge of ROW, Upstream View, HC/VM

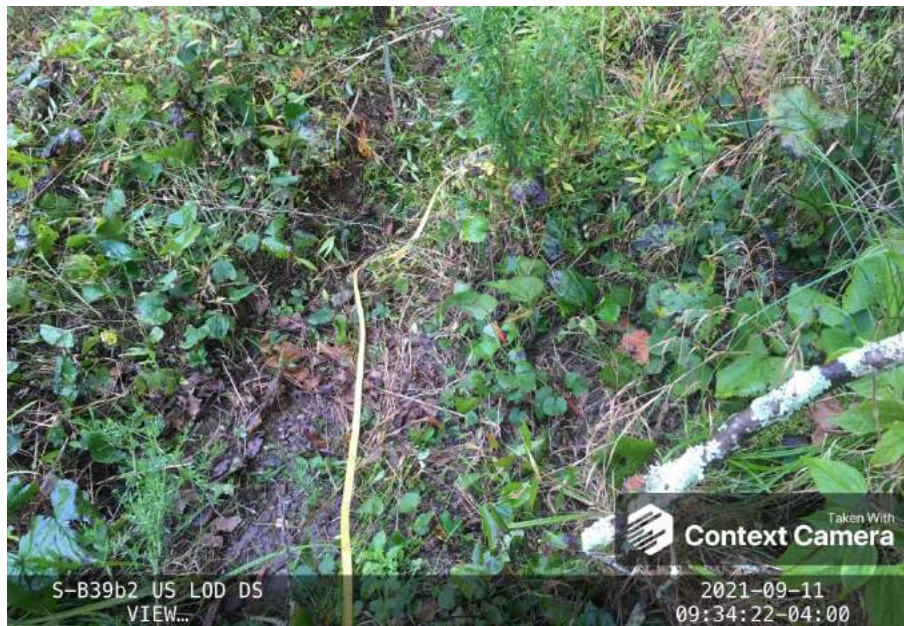
Photo Type: US, DS View

Location, Orientation, Photographer Initials: Upstream Edge of ROW, Downstream View, HC/VM

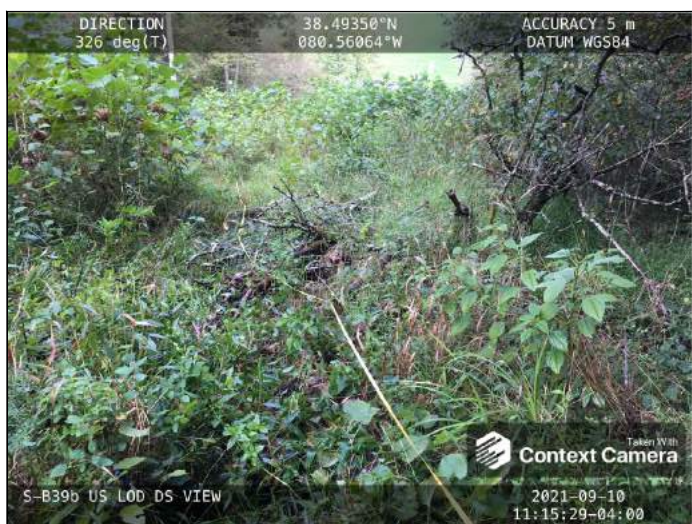
PHOTO TAKEN LOOKING DOWNSTREAM FROM UPSTREAM IMPACT LIMITS

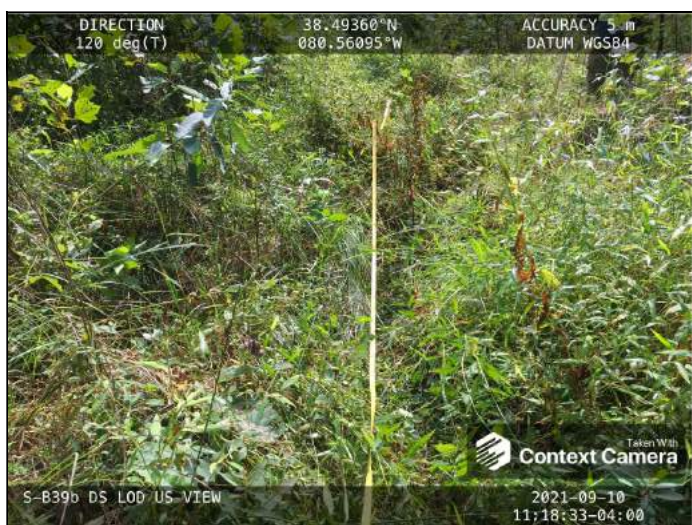
PHOTO TAKEN LOOKING UPSTREAM FROM DOWNSTREAM IMPACT LIMITS
