Baseline Assessment – Stream Attributes

Reach S-B79 TEMP AR (1) (Temporary Access Road) Ephemeral Spread A Harrison County, West Virginia

Spread A Stream S-B79 1 TEMP AR (Temporary Access Road) Harrison County

le PROFILE AND CROSS-SECTIONS
BASELINE SURVEY
CROSSING S-B79 TEMP AR (1) AND
UNNAMED TRIB. TO BIG ELK CREEK
17 70' HARRISON COUNTY, WY

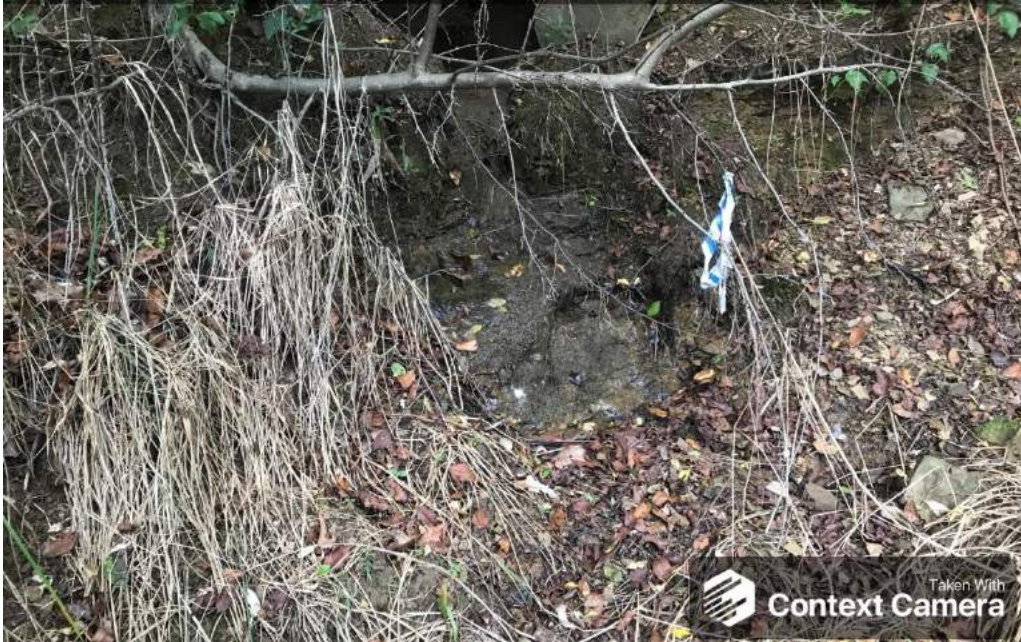
Photo Type: DS, US View

Location, Orientation, Photographer Initials: Downstream Edge of ROW, Upstream View, RFC/AJE

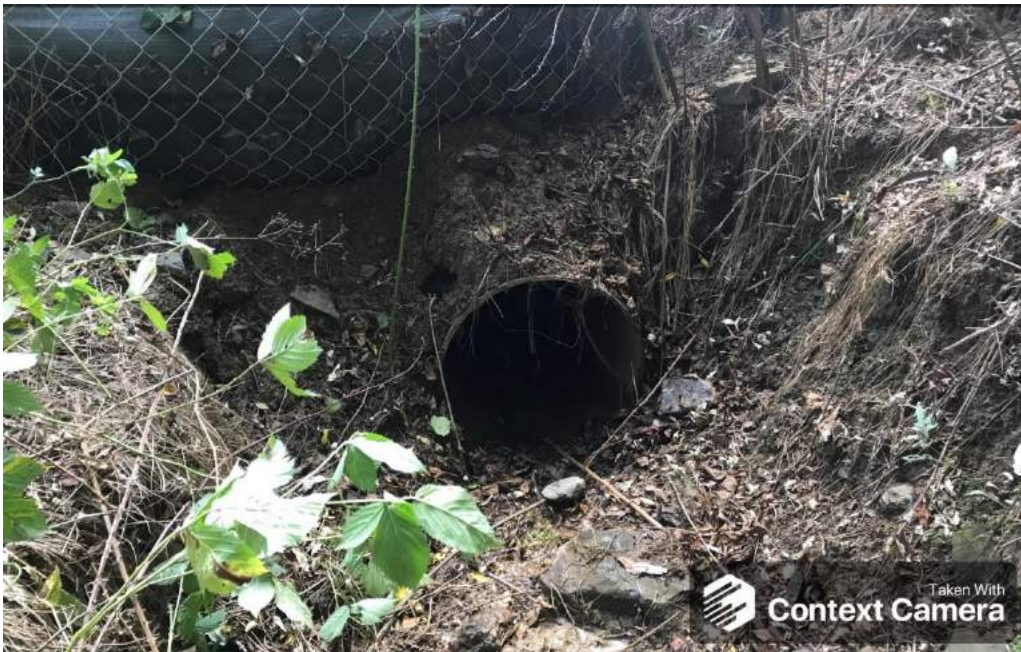
Photo Type: DS, DS View

Location, Orientation, Photographer Initials: Downstream Edge of ROW, Downstream View, RFC/AJE

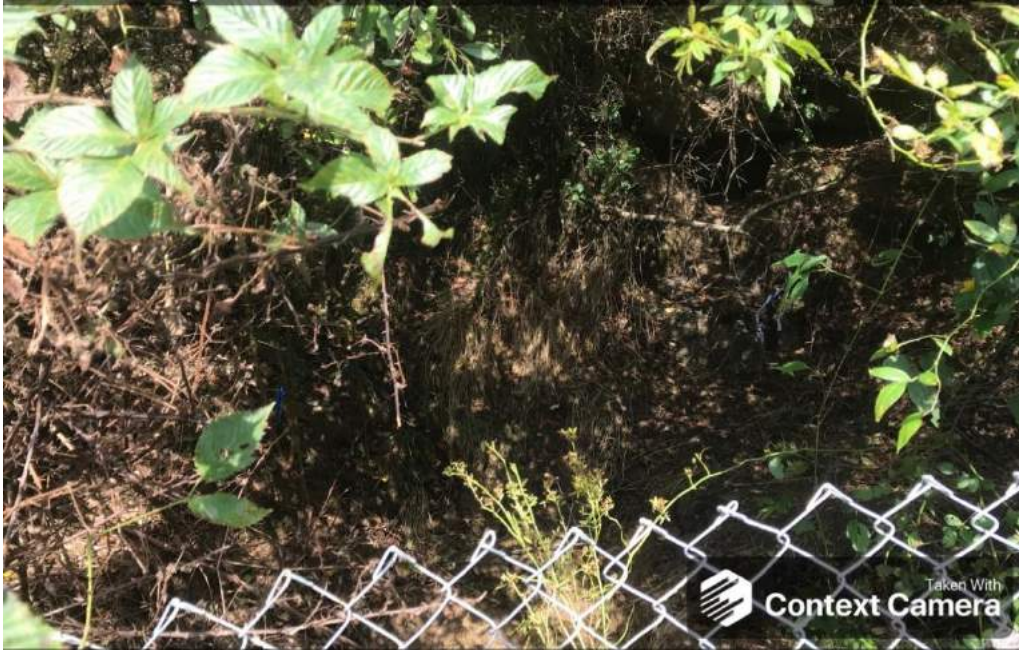
Photo Type: US View at Center
Location, Orientation, Photographer Initials: Center ROW, Upstream View, RFC/AJE
Lat: 39.423571 Long: -80.476278

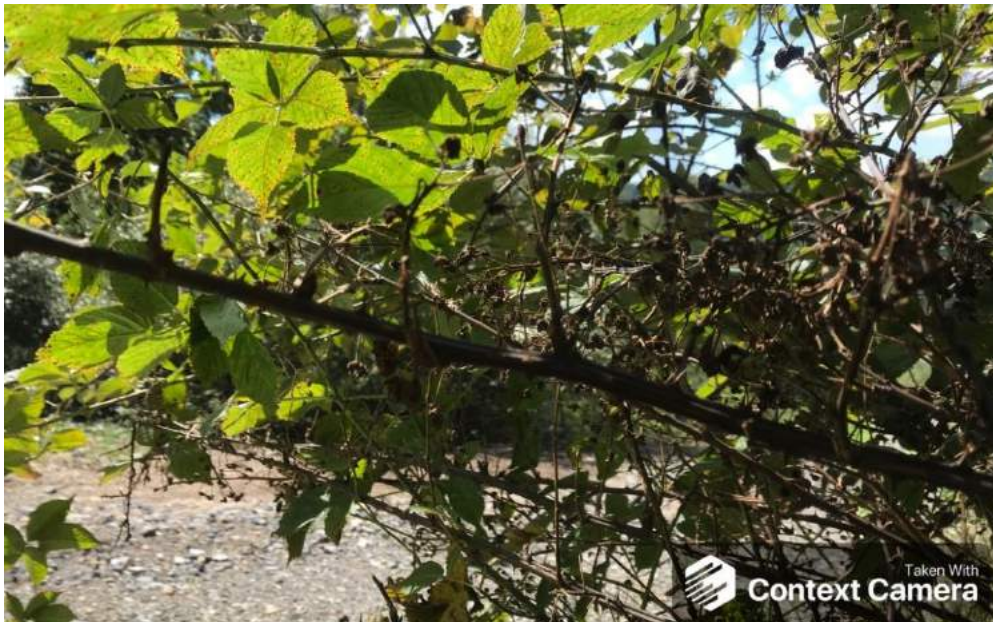
Photo Type: DS View at Center
Location, Orientation, Photographer Initials: Center ROW, Downstream View, RFC/AJE
Lat: 39.423571 Long: -80.476278

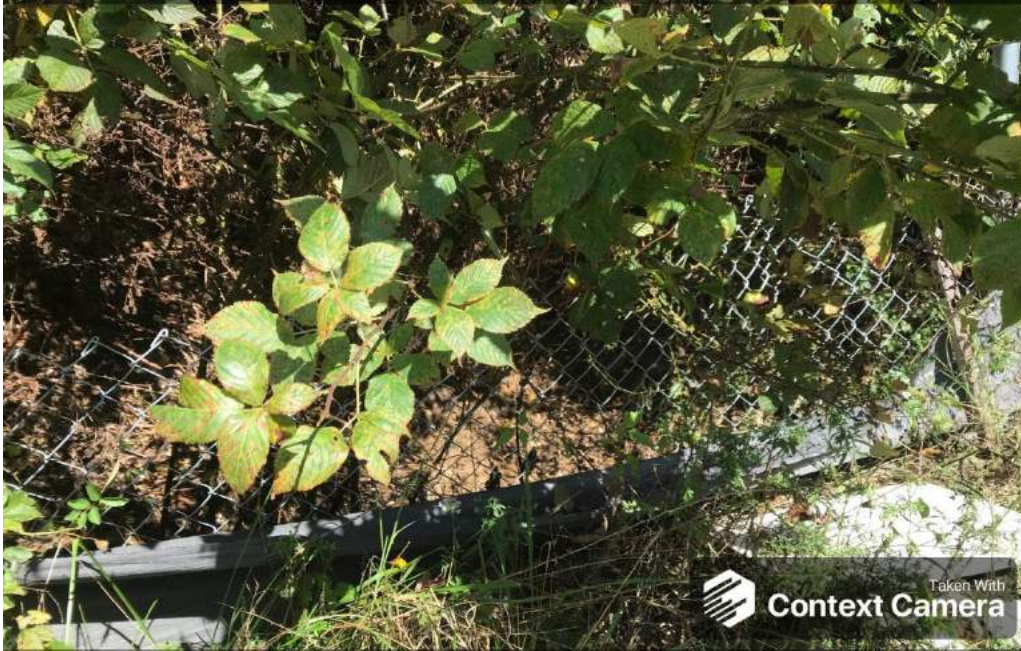
Photo Type: US, US View

Location, Orientation, Photographer Initials: Upstream Edge of ROW, Upstream View, RFC/AJE
Lat: 39.423571 Long: -80.476278

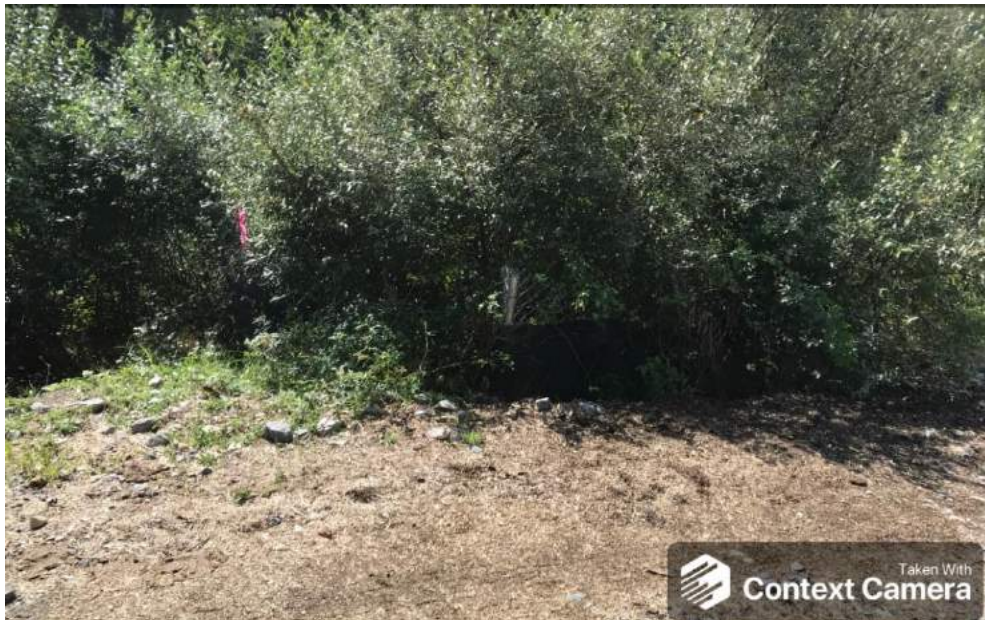
Photo Type: US, DS View

Location, Orientation, Photographer Initials: Upstream Edge of ROW, Downstream View, RFC/AJE
Lat: 39.423571 Long: -80.476278

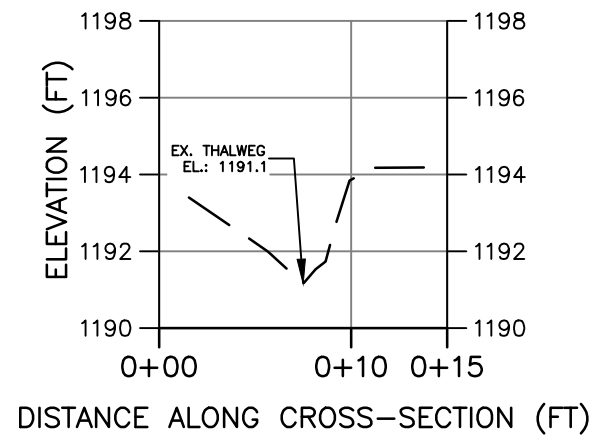
EXISTING STREAM PROFILE
INVERT ALONG THALWEG

TYPICAL 5-POINT CROSS-SECTION
(FACING DOWNSTREAM)

AS-BUILT TABLE: S-B79 TEMP AR (1) AND (2) CROSS SECTION B				
PRE-CROSSING			AS-BUILT	
PT. LOC.	NORTHING	EASTING	ELEV	VERT. DIFF.
TS-L	14317238.6730	1788300.5750	1192.002'	
BS-L	14317238.7230	1788301.0270	1191.379'	
THW	14317238.9920	1788303.7600	1190.902'	
BS-R	14317238.5670	1788304.9320	1191.496'	
TS-R	14317237.8360	1788305.6410	1192.981'

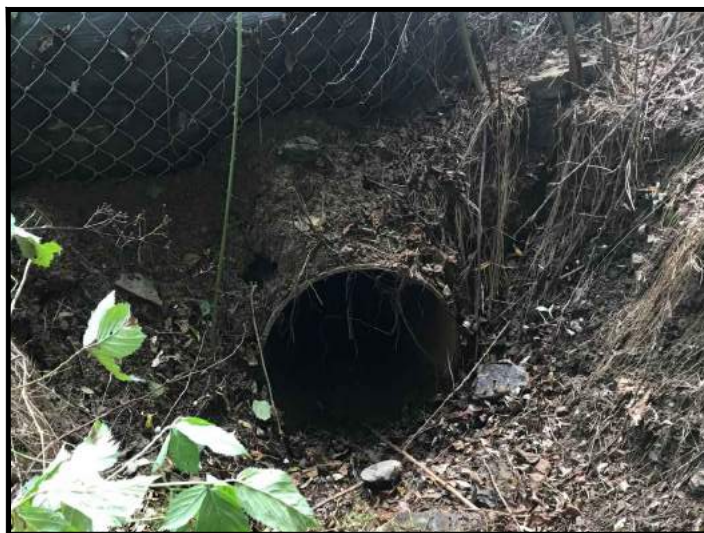
PHOTO TAKEN LOOKING DOWNSTREAM
FROM UPSTREAM IMPACT LIMITS

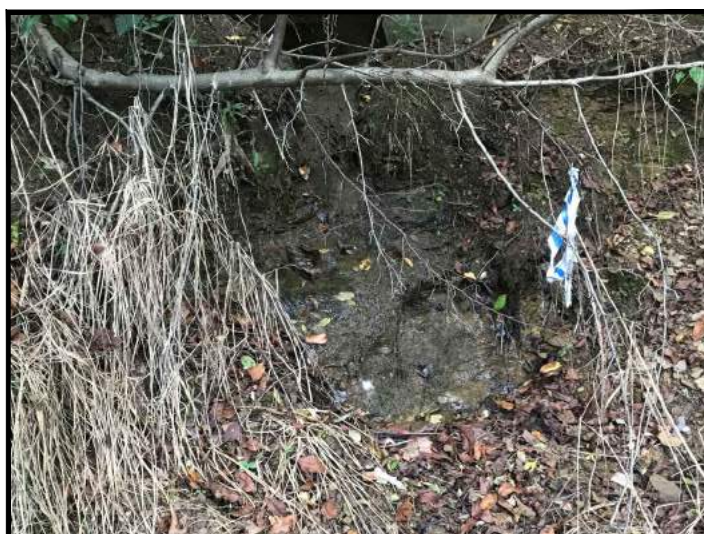
PHOTO TAKEN LOOKING UPSTREAM FROM
DOWNSTREAM IMPACT LIMITS
