## Reach S-E49 (Pipeline ROW) Ephemeral Spread D Nicholas County, West Virginia

### Spread D Stream S-E49 (Pipeline ROW) Nicholas County

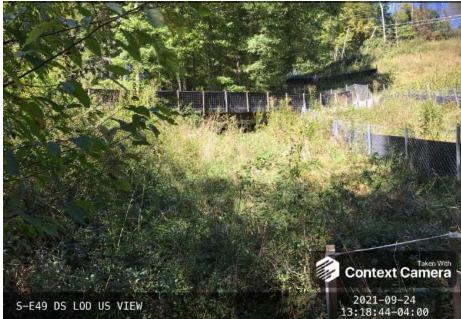
Photo Type: DS, US View Location, Orientation, Photographer Initials: Downstream Edge of ROW, Upstream View, RH/VM Lat: 38.365574 Long: -80.613141

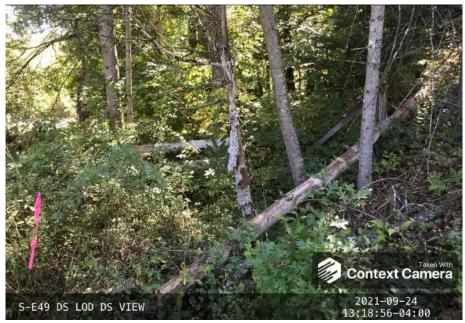
Photo Type: DS, DS View Location, Orientation, Photographer Initials: Downstream Edge of ROW, Downstream View, RH/VM Lat: 38.365574 Long: -80.613141

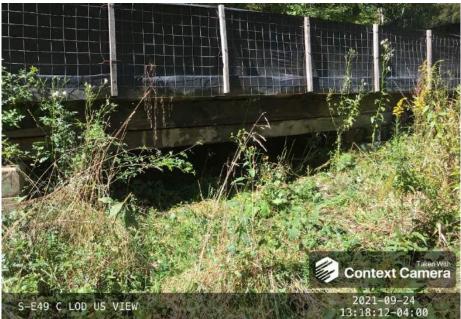
Photo Type: US View at Center Location, Orientation, Photographer Initials: Center ROW, Upstream View, RH/VM Lat: 38.365574 Long: -80.613141

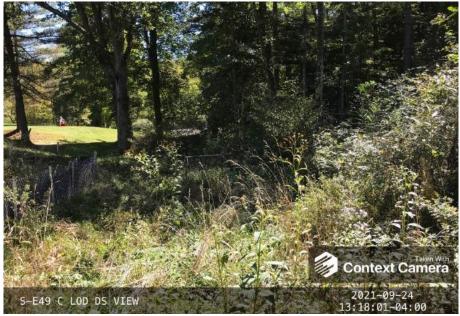
Photo Type: DS View at Center Location, Orientation, Photographer Initials: ROW Center, Downstream View, RH/VM Lat: 38.365574 Long: -80.613141

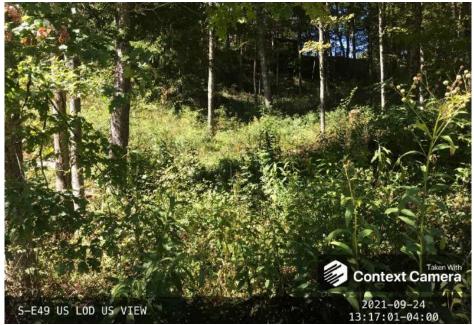
Photo Type: US, US View

Location, Orientation, Photographer Initials: Upstream Edge of ROW, Upstream View, RH/VM Lat: 38.365574 Long: -80.613141

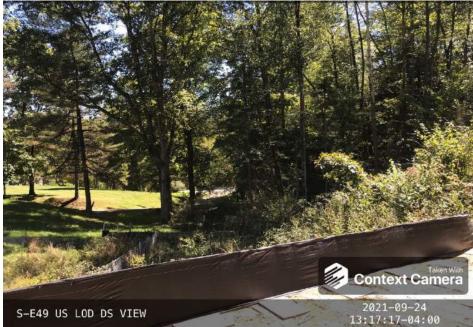
Photo Type: US, DS View Location, Orientation, Photographer Initials: Upstream Edge of ROW, Downstream View, RH/VM Lat: 38.365574 Long: -80.613141

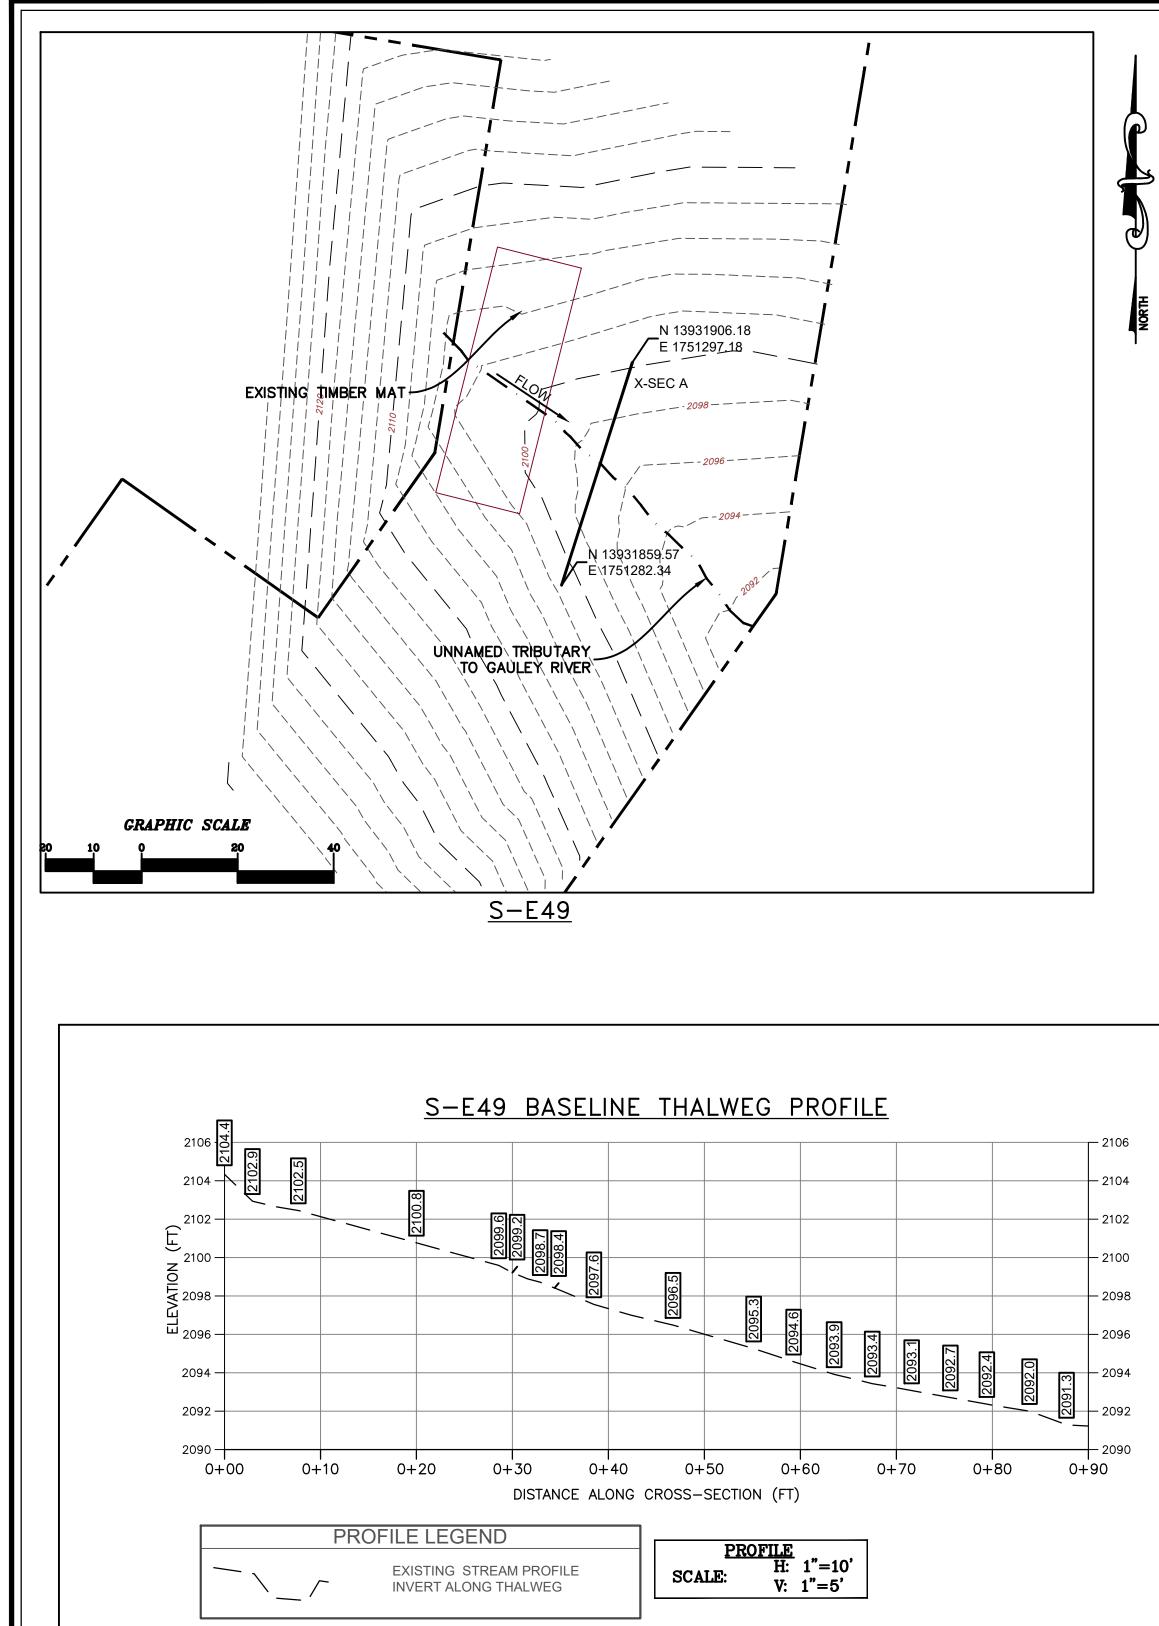
AS-BUILT TABLE: S-E49 CROSS SECTION A					
	PRE-CROSSING			AS-BUILT	
PT. LOC.	NORTHING	EASTING	ELEV	VERT. DIFF.	HORZ. DIFF.
TS-L	13931888.8576	1751294.2624'	4193.844'		
BS-L	13931884.2400	1751293.4835'	2096.531'		
THW	13931882.1400	1751293.0950'	2096.490'		
BS-R	13931874.5781	1751291.8537	2096.482'		
TS-R	13931870.1100	1751289.9540'	2096.905'

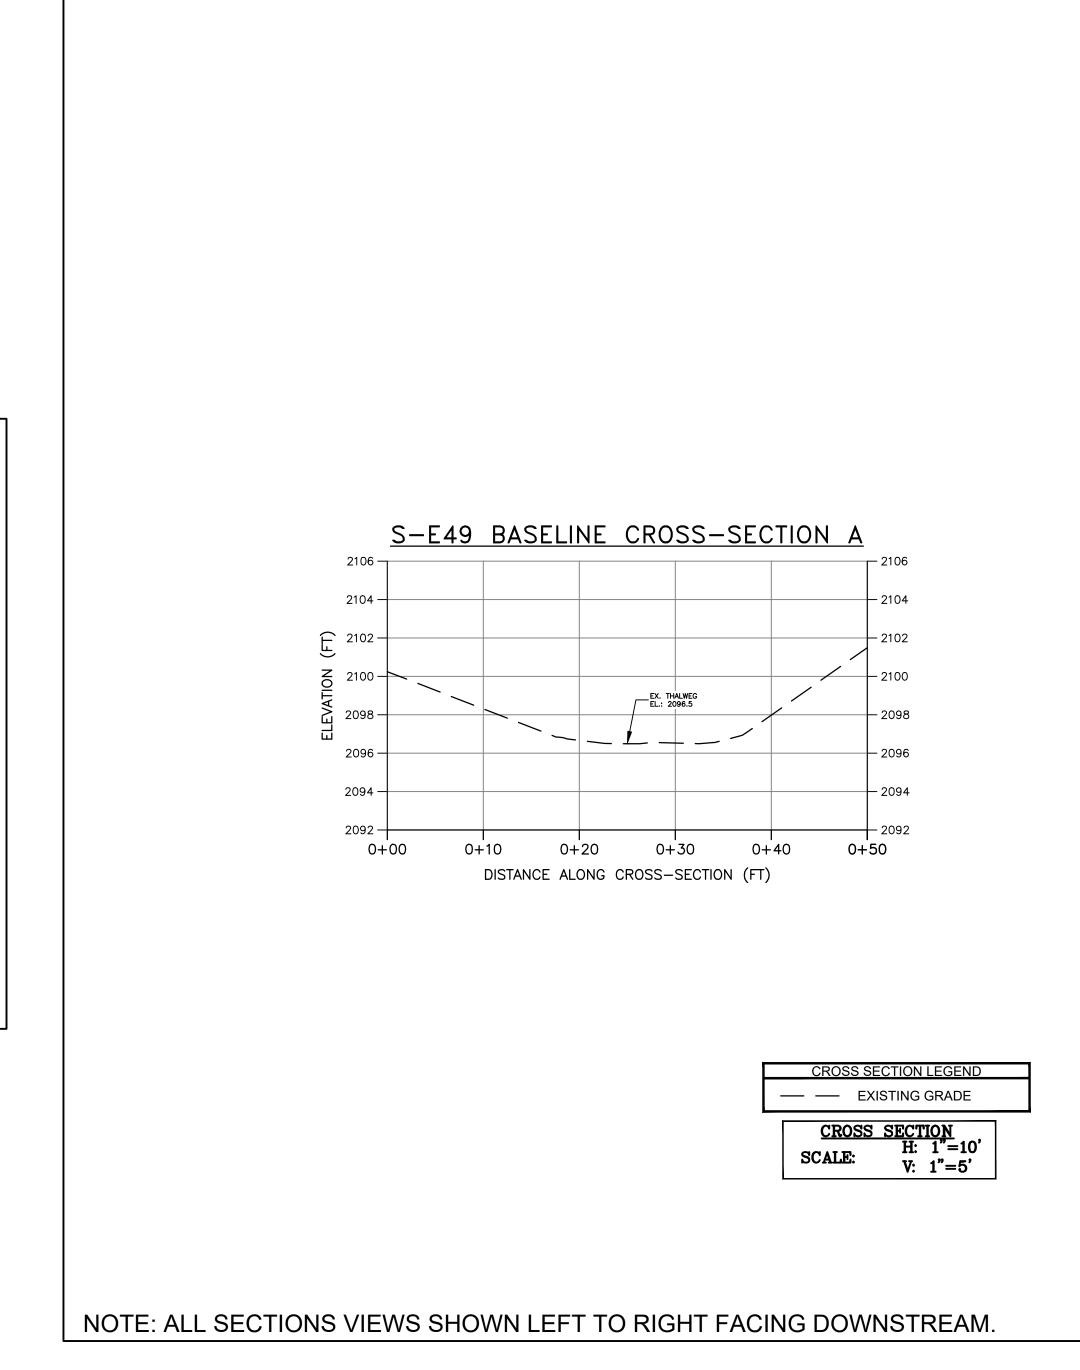
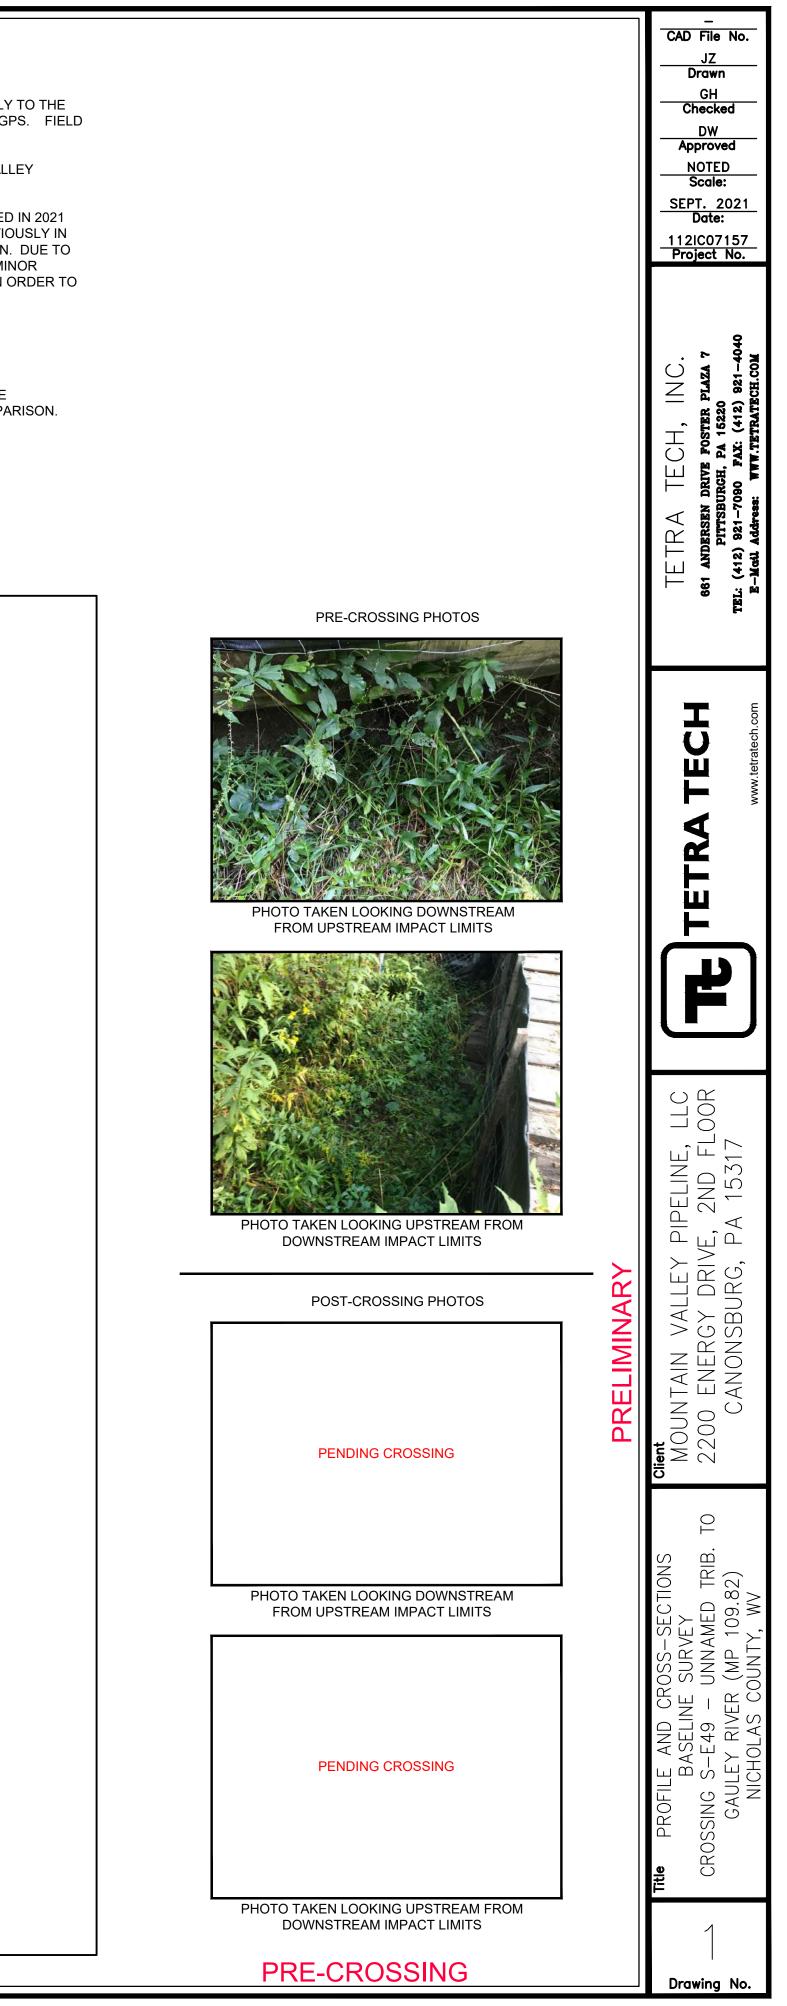
3. SURVEY POINTS FOR CROSS SECTIONS AND THALWEG PROFILES COLLECTED IN 2021 HAVE BEEN USED IN COMBINATION WITH SURVEY POINTS COLLECTED PREVIOUSLY IN 2020 IN ORDER TO GENERATE THE PRE-CROSSING SURFACE SHOWN IN PLAN. DUE TO NATURAL EROSIONAL STREAM PROCESSES THAT CAN OCCUR OVER TIME, MINOR ADJUSTMENTS TO THE PROFILE ALIGNMENTS MAY HAVE BEEN REQUIRED IN ORDER TO GENERATE A CLEAN PRE-CROSSING SURFACE.

- 4. ALL SECTION VIEWS SHOWN LEFT TO RIGHT FACING DOWNSTREAM.
- 5. POST-CROSSING SURVEY INFORMATION SHOWN IN RED. DATA PENDING.
- 6. POST-CROSSING SURVEY POINTS FOR CROSS SECTIONS AND THALWEG ARE PROJECTED ONTO PRE-CROSSING SECTION AND PROFILE VIEWS FOR COMPARISON.
