Baseline Assessment – Stream Attributes

Reach S-E55 (Timber Mat Crossing) Ephemeral Spread D Webster County, West Virginia

Spread C Stream S-E55 (Timber Mat Crossing) Webster County

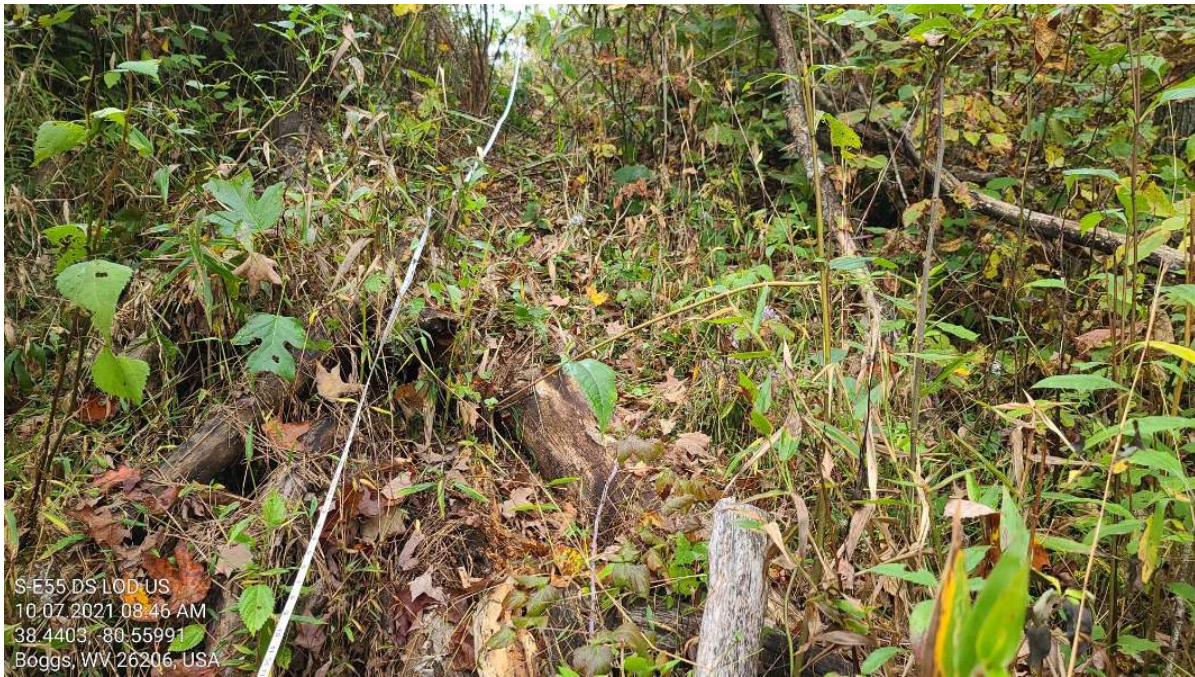
Photo Type: DS, US View

Location, Orientation, Photographer Initials: Downstream Edge of ROW, Upstream View, VM
Lat: 38.44027 Long: -80.559955

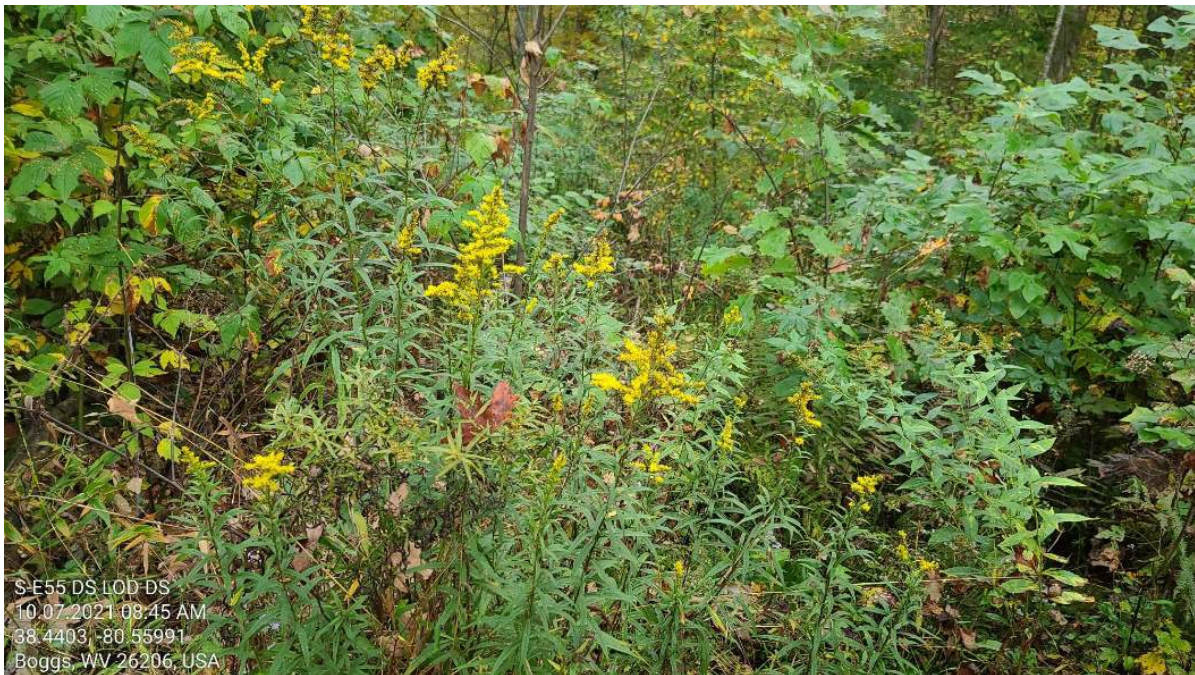
Photo Type: DS, DS View

Location, Orientation, Photographer Initials: Downstream Edge of ROW, Downstream View, VM
Lat: 38.44027 Long: -80.559955

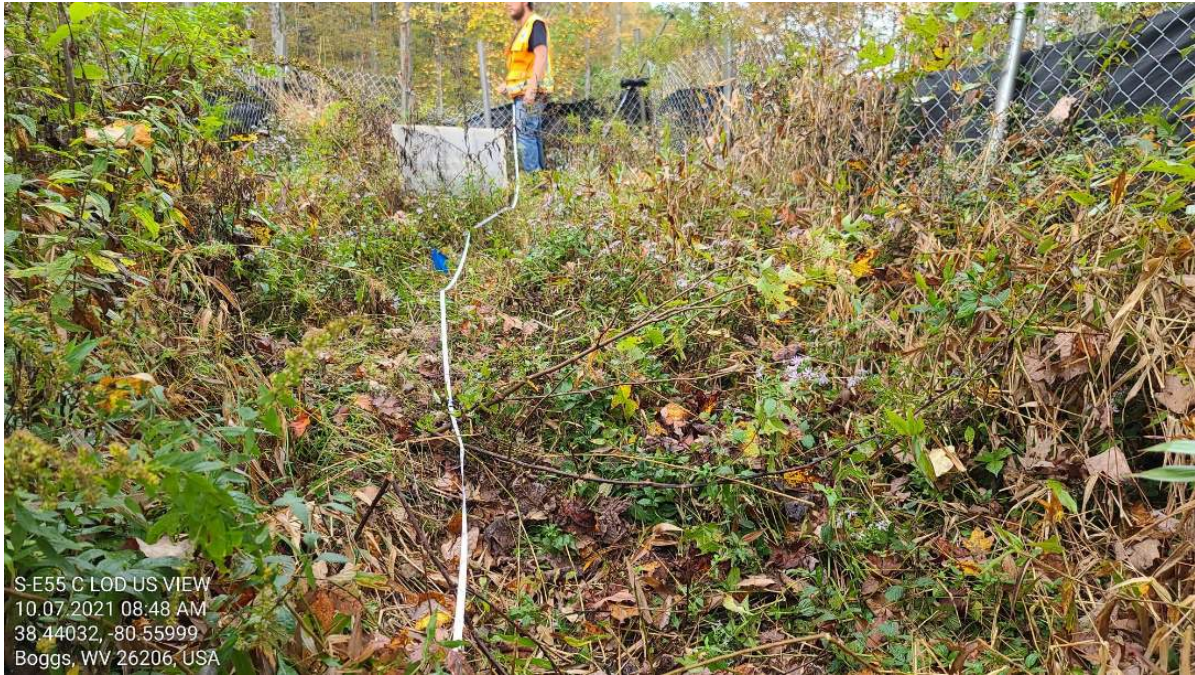
Photo Type: US View at Center
Location, Orientation, Photographer Initials: Center ROW, Upstream View, VM
Lat: 38.44027 Long: -80.559955

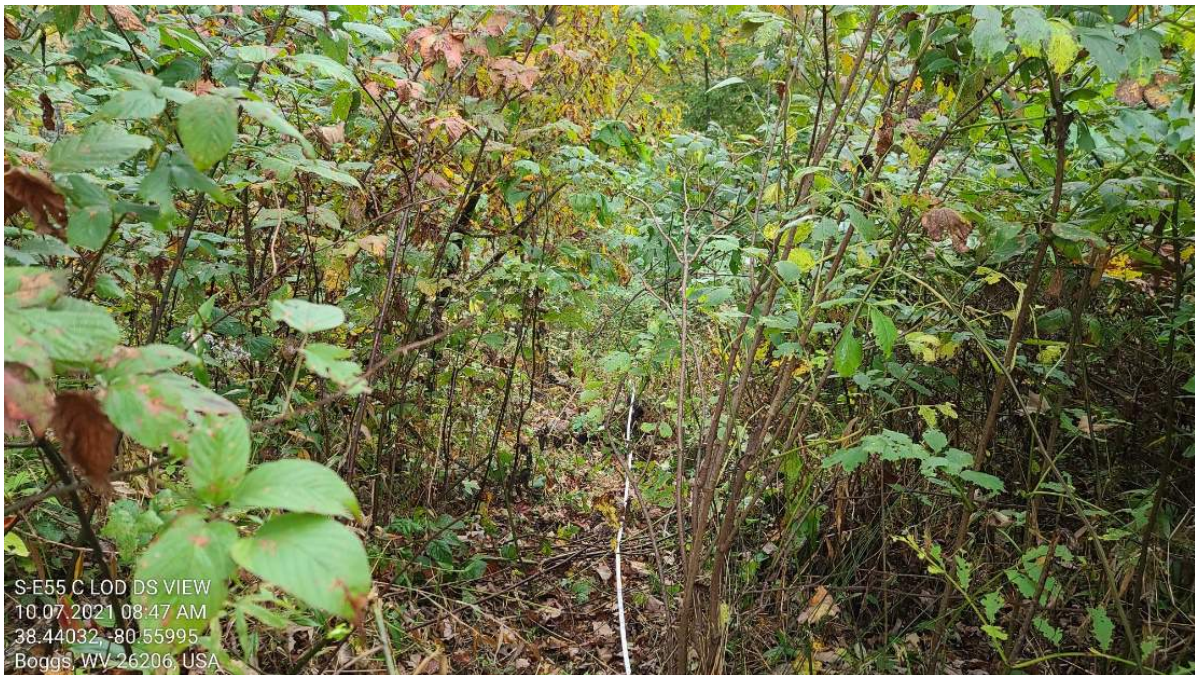
Photo Type: DS View at Center
Location, Orientation, Photographer Initials: ROW Center, Downstream View, VM
Lat: 38.44027 Long: -80.559955

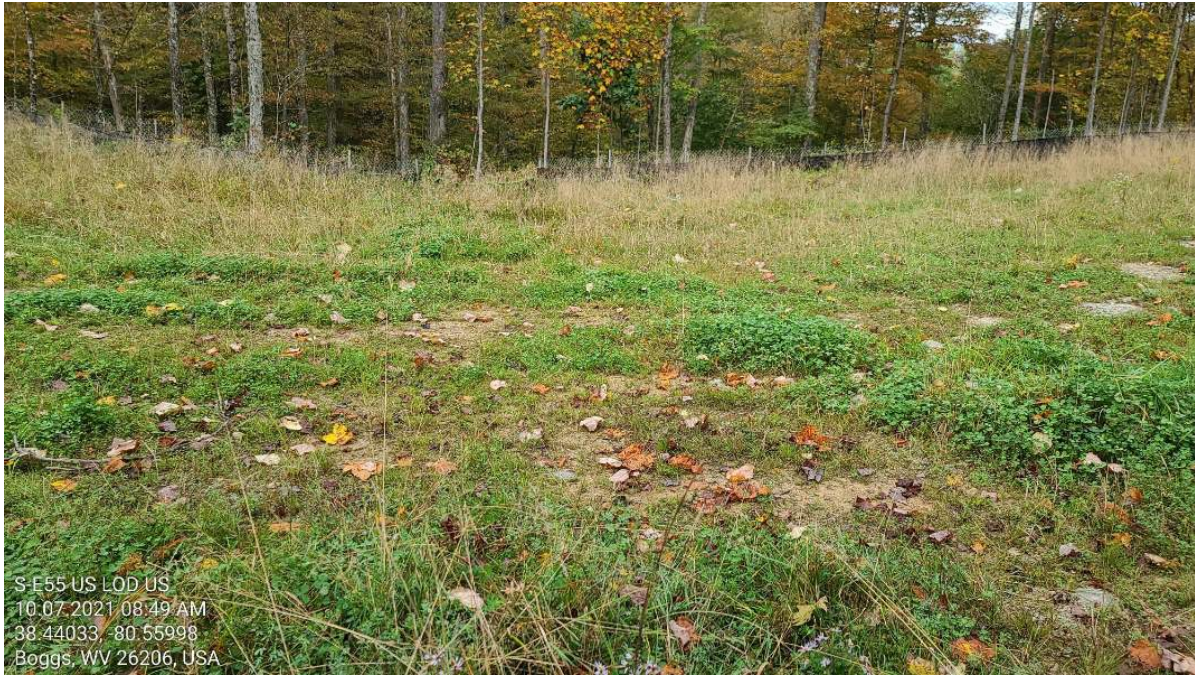
Photo Type: US, US View

Location, Orientation, Photographer Initials: Upstream Edge of ROW, Upstream View, VM
Lat: 38.44027 Long: -80.559955

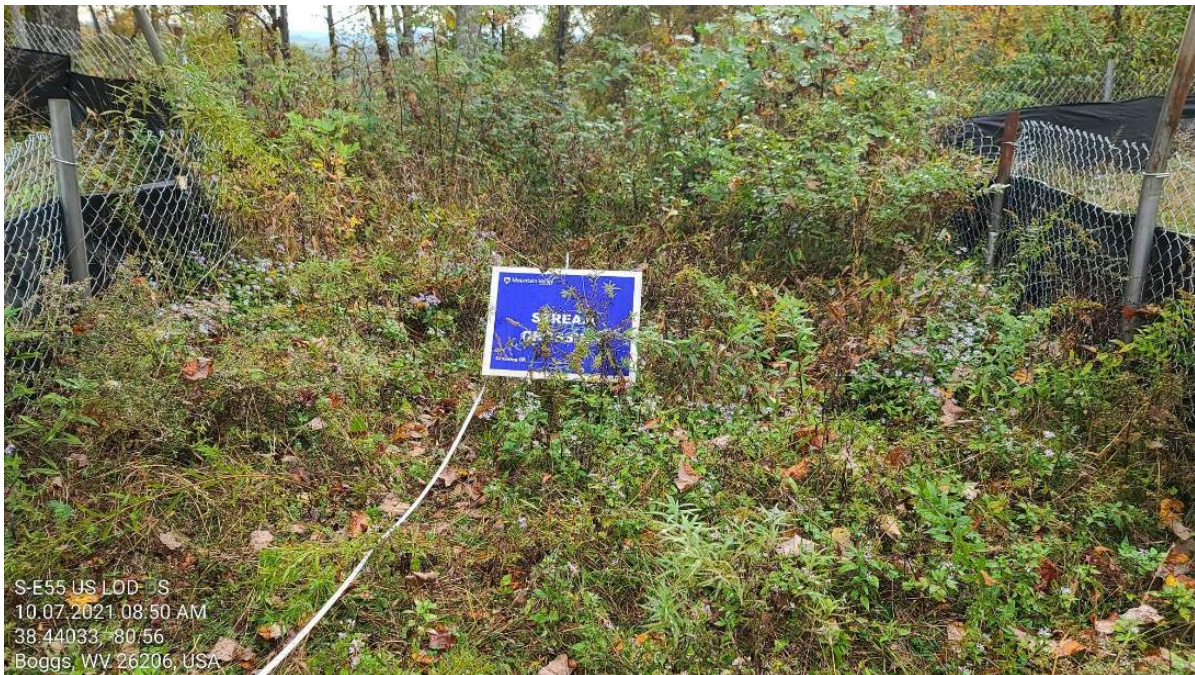
Photo Type: US, DS View

Location, Orientation, Photographer Initials: Upstream Edge of ROW, Downstream View, VM
Lat: 38.44027 Long: -80.559955
