Baseline Assessment – Stream Attributes

Reach S-EF40 (Anode Bed) Intermittent Spread D Webster County, West Virginia

Title	PROFILE AND CROSS-SECTIONS BASELINE SURVEY CROSSING S-EF40 - UNNAMED TRIB. TO MEADOW FORK (MP 107.00) WEBSTER COUNTY, WV	Client	MC 222
--------------	--	---------------	-----------

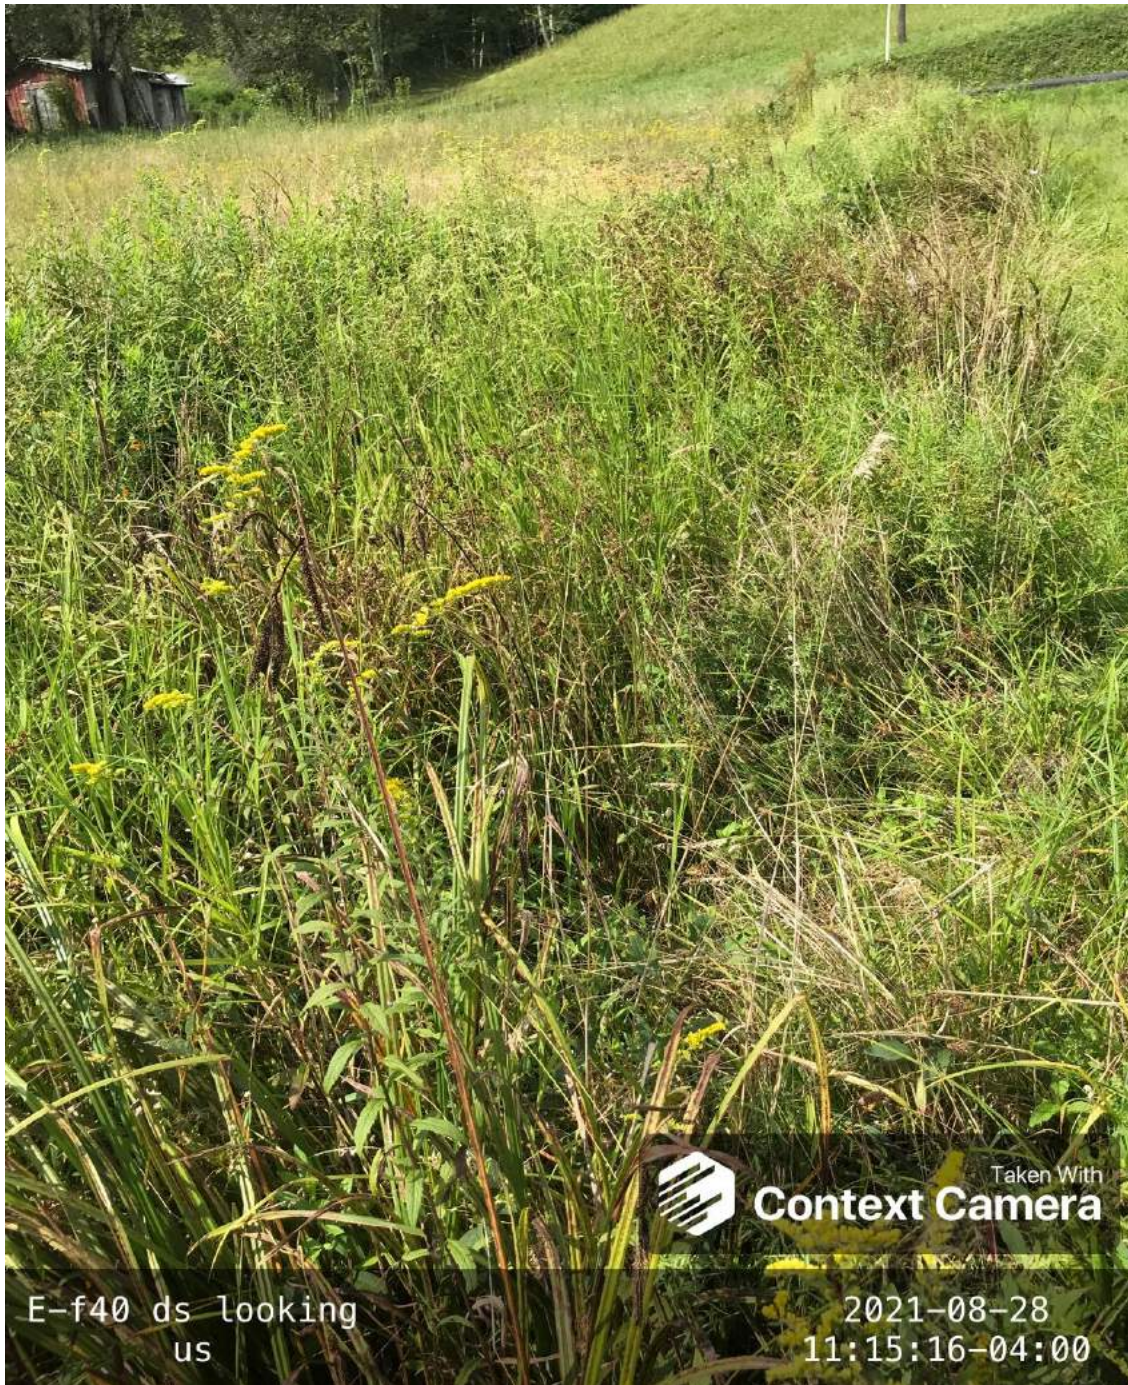
Photo Type: DS, US View
Location, Orientation, Photographer Initials: Downstream Edge of ROW, Upstream View, DD/LC/KP
Lat: 38.400883 Long: -80.597787

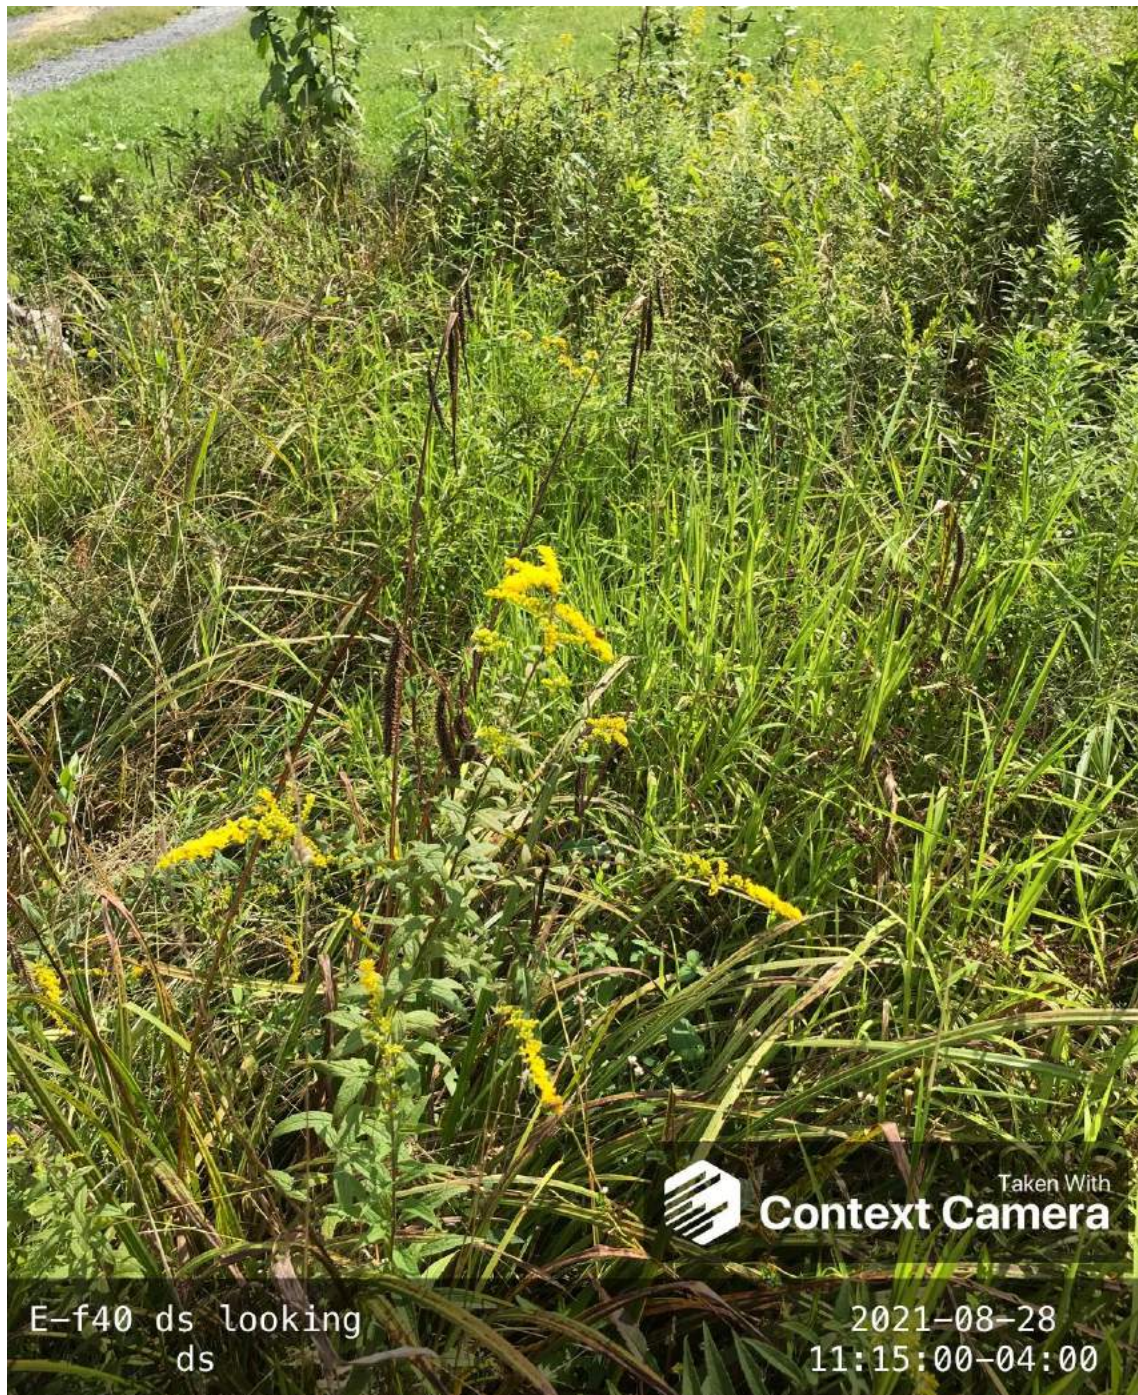
Photo Type: DS, DS View
Location, Orientation, Photographer Initials: Downstream Edge of ROW, Downstream View, DD/LC/KP
Lat: 38.400883 Long: -80.597787

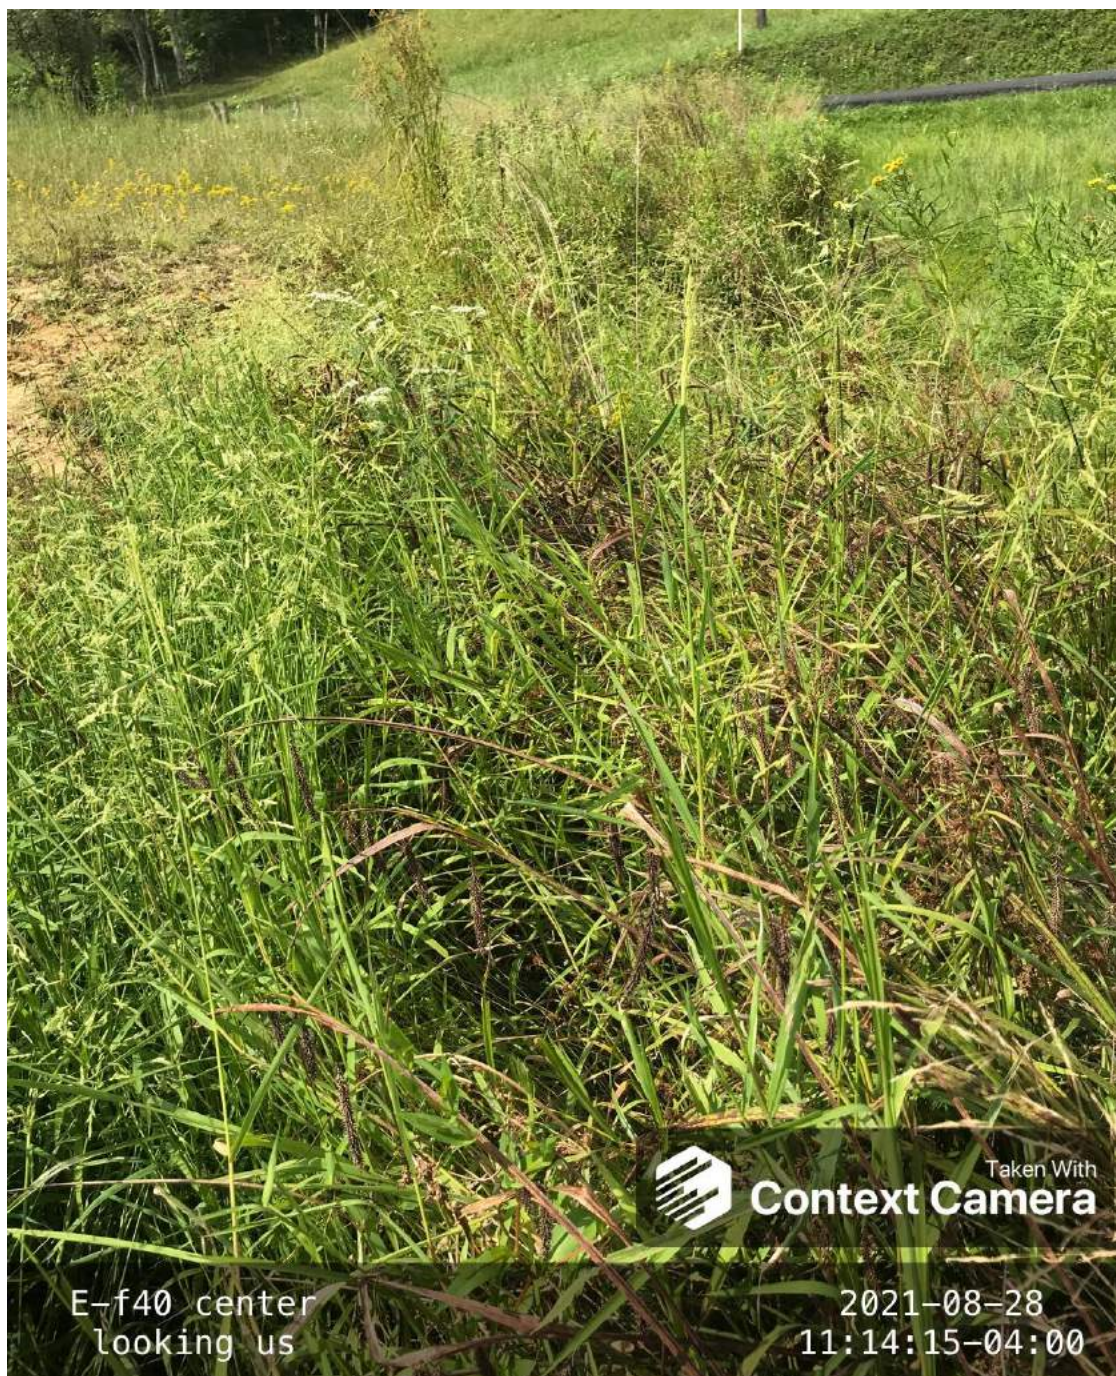
Photo Type: US View at Center
Location, Orientation, Photographer Initials: ROW Center, Upstream View, DD/LC/KP
Lat: 38.400883 Long: -80.597787

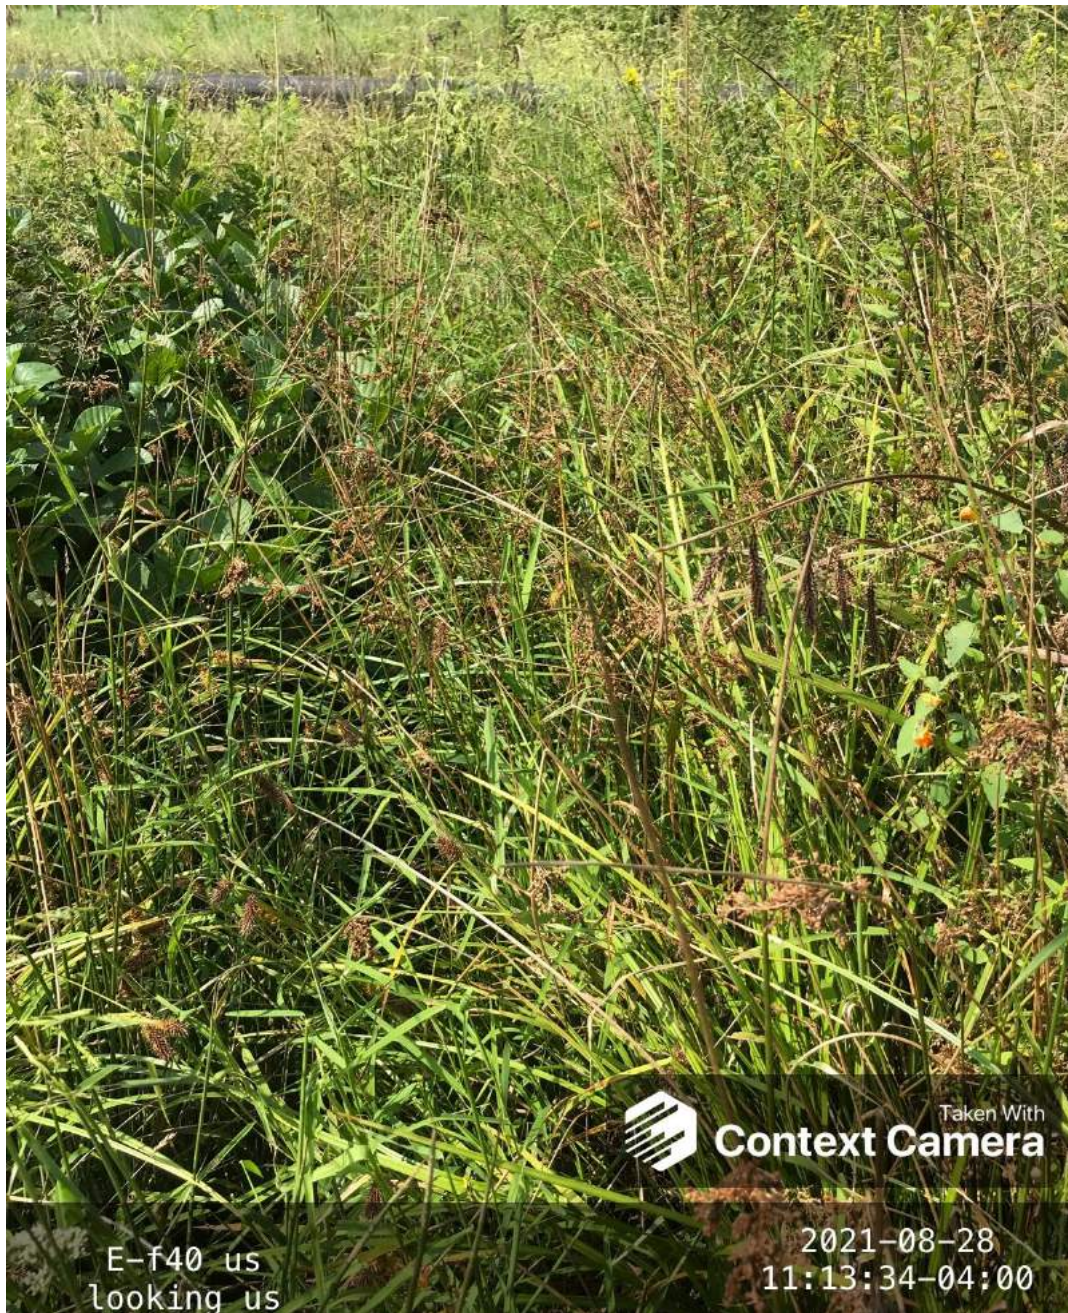
Photo Type: US, US View
Location, Orientation, Photographer Initials: Upstream Edge of ROW, Upstream View, DD/LC/KP
Lat: 38.400883 Long: -80.597787

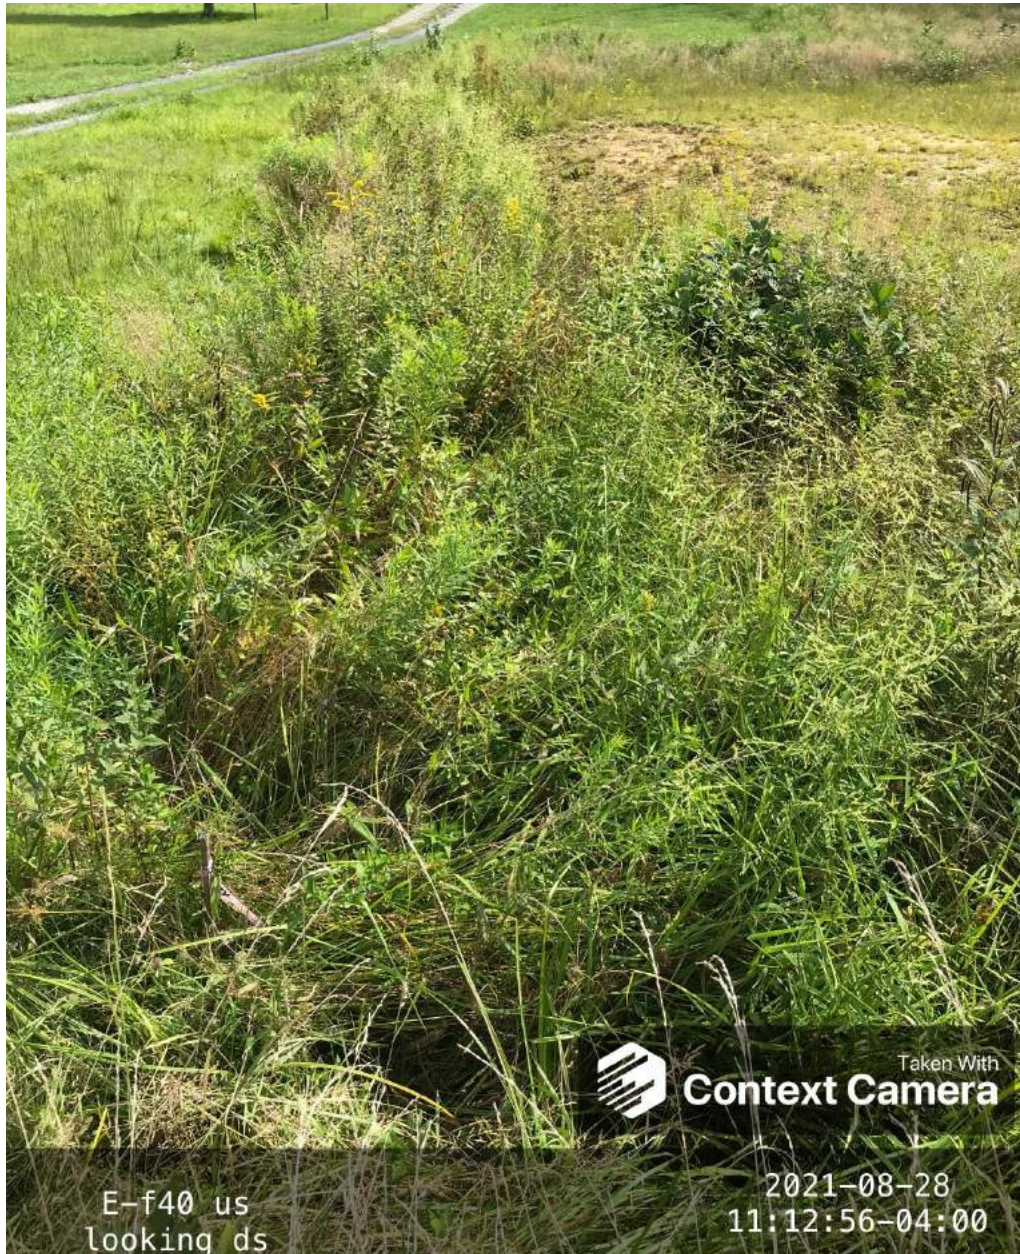
Photo Type: US, DS View
Location, Orientation, Photographer Initials: Upstream Edge of ROW, Downstream View, DD/LC/KP
Lat: 38.400883 Long: -80.597787

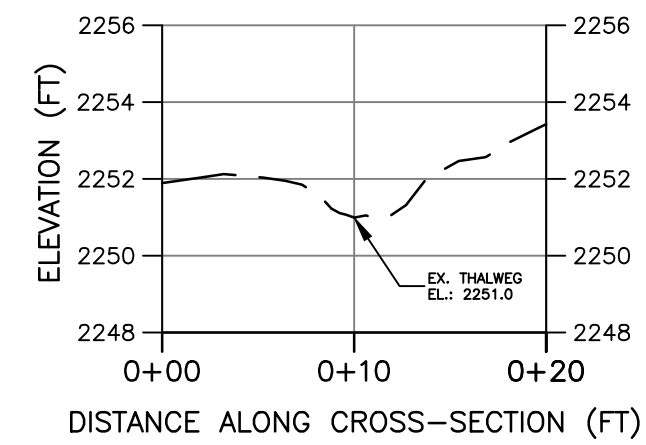
TYPICAL 5-POINT CROSS-SECTION
(FACING DOWNSTREAM)

The graph displays a cross-section profile with ELEVATION (FT) on the vertical axis (ranging from 2248 to 2256) and DISTANCE ALONG CROSS-SECTION (FT) on the horizontal axis (ranging from 0+00 to 0+20). The profile line starts at approximately 2251.5 ft at 0+00, dips to a minimum of about 2250.2 ft at a distance of 8 ft, and then rises to about 2252.5 ft at 0+20. A label 'EX. THALWASS EL.: 2250.2' points to the minimum of the profile.

A5-BUILT TABLE: S-EF40 CROSS SECTION B					
PRE-CROSSING			A5-BUILT		
PT. LOC.	NORTHING	EASTING	ELEV	VERT. DIFF.	HORZ. DIFF.
TS-L	13944764.73	1755663.25	2250.55		
BS-L	13944763.79	1755663.60	2250.28		
THW	13944763.18	1755663.79	2250.18		
BS-R	13944762.34	1755664.07	2250.24		
TS-R	13944758.35	1755665.44	2251.84
