Baseline Assessment – Stream Attributes

Reach S-H110 (Timber Mat Crossing) Ephemeral Spread C Webster County, West Virginia

Spread C Stream S-H110 (Timber Mat Crossing) Webster County

PROFILE AND CROSS-SECTIONS

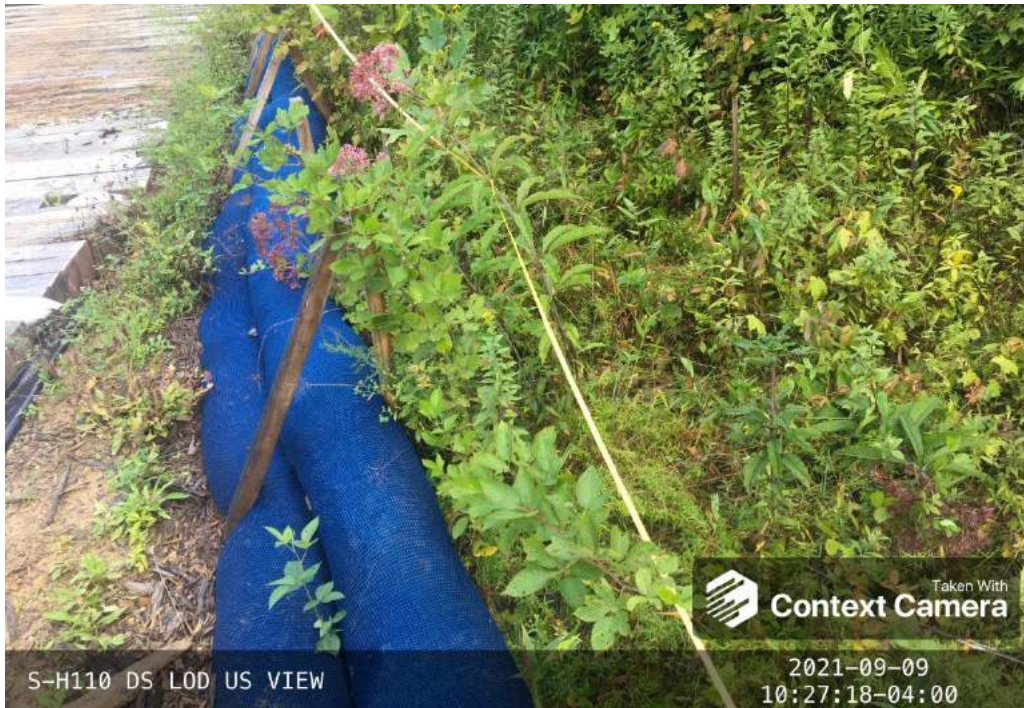
Photo Type: DS, US View

Location, Orientation, Photographer Initials: Downstream Edge of ROW, Upstream View, HK
Lat: 38.5872, Long: -80.509634

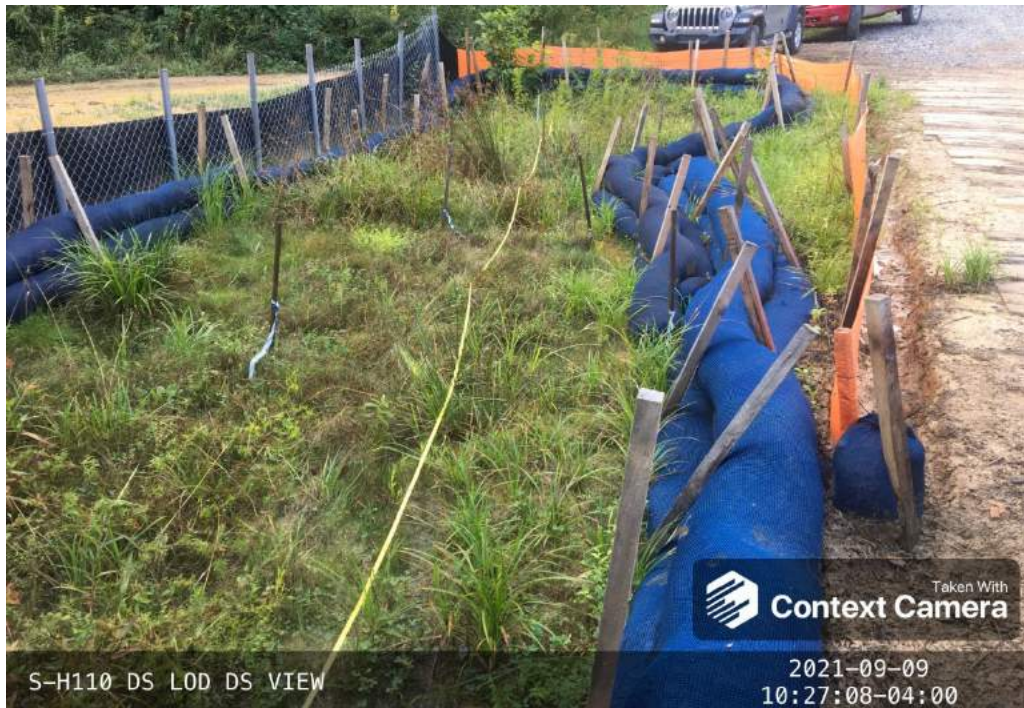
Photo Type: DS, DS View

Location, Orientation, Photographer Initials: Downstream Edge of ROW, Downstream View, HK
Lat: 38.5872, Long: -80.509634

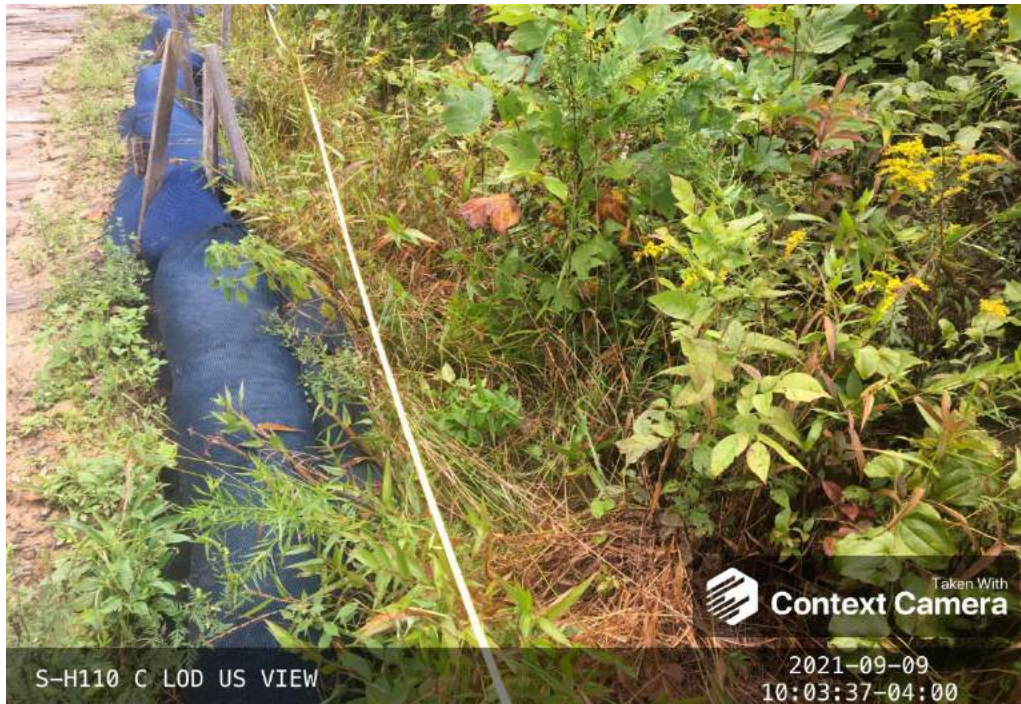
Photo Type: US View at Center
Location, Orientation, Photographer Initials: Center ROW, Upstream View, HK
Lat: 38.5872, Long: -80.509634

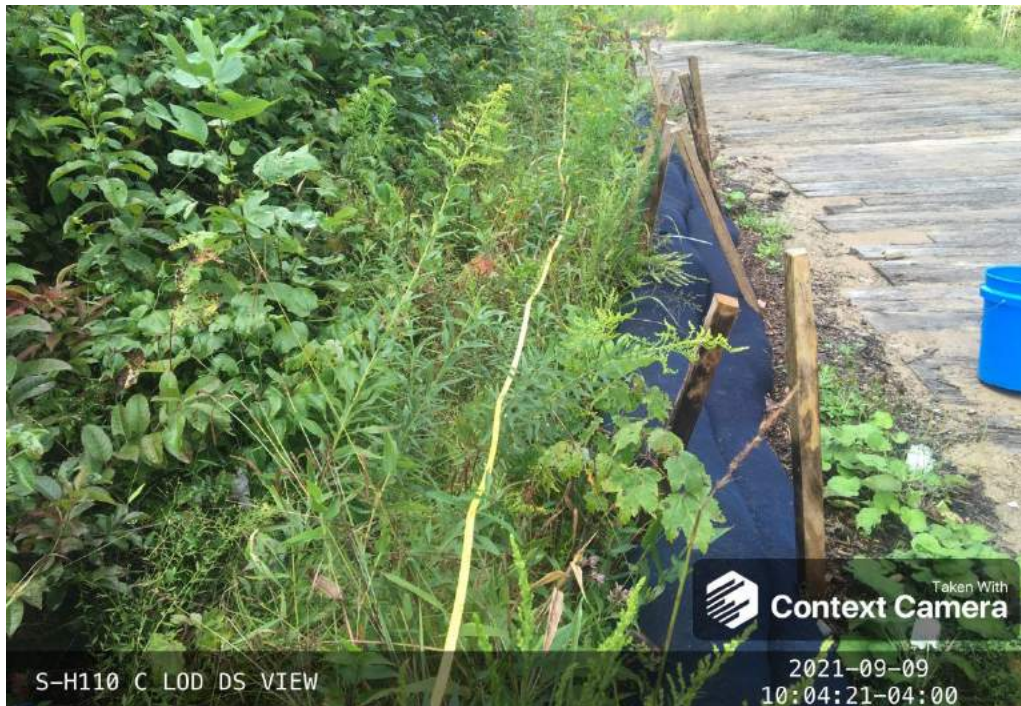
Photo Type: DS View at Center
Location, Orientation, Photographer Initials: ROW Center, Downstream View, HK
Lat: 38.5872, Long: -80.509634

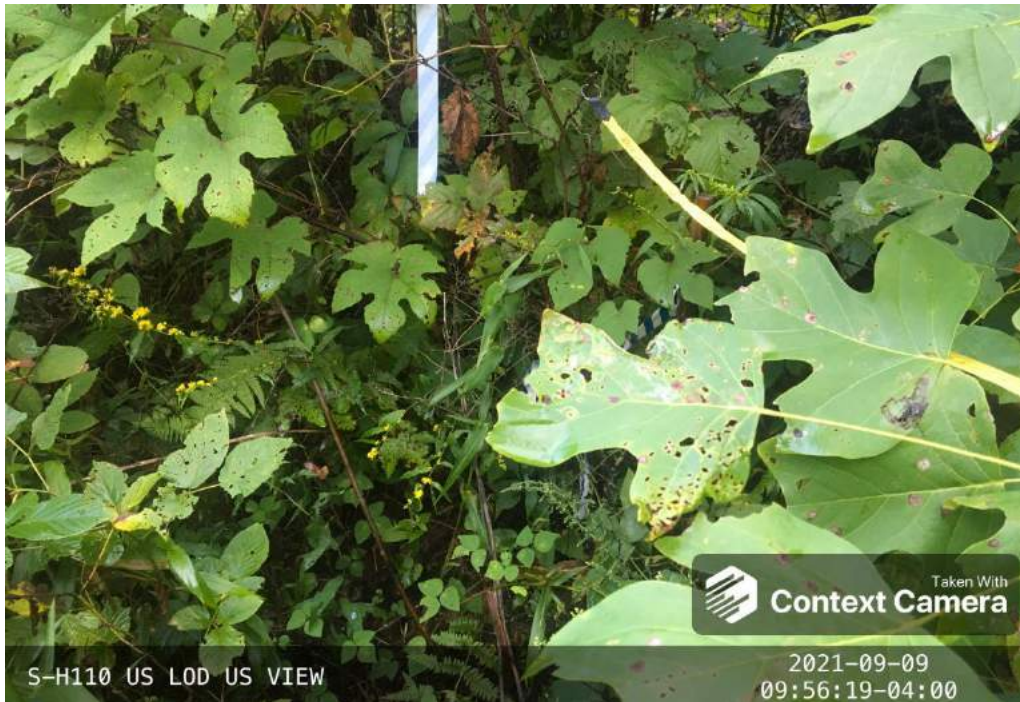
Photo Type: US, US View
Location, Orientation, Photographer Initials: Upstream Edge of ROW, Upstream View, HK
Lat: 38.5872, Long: -80.509634

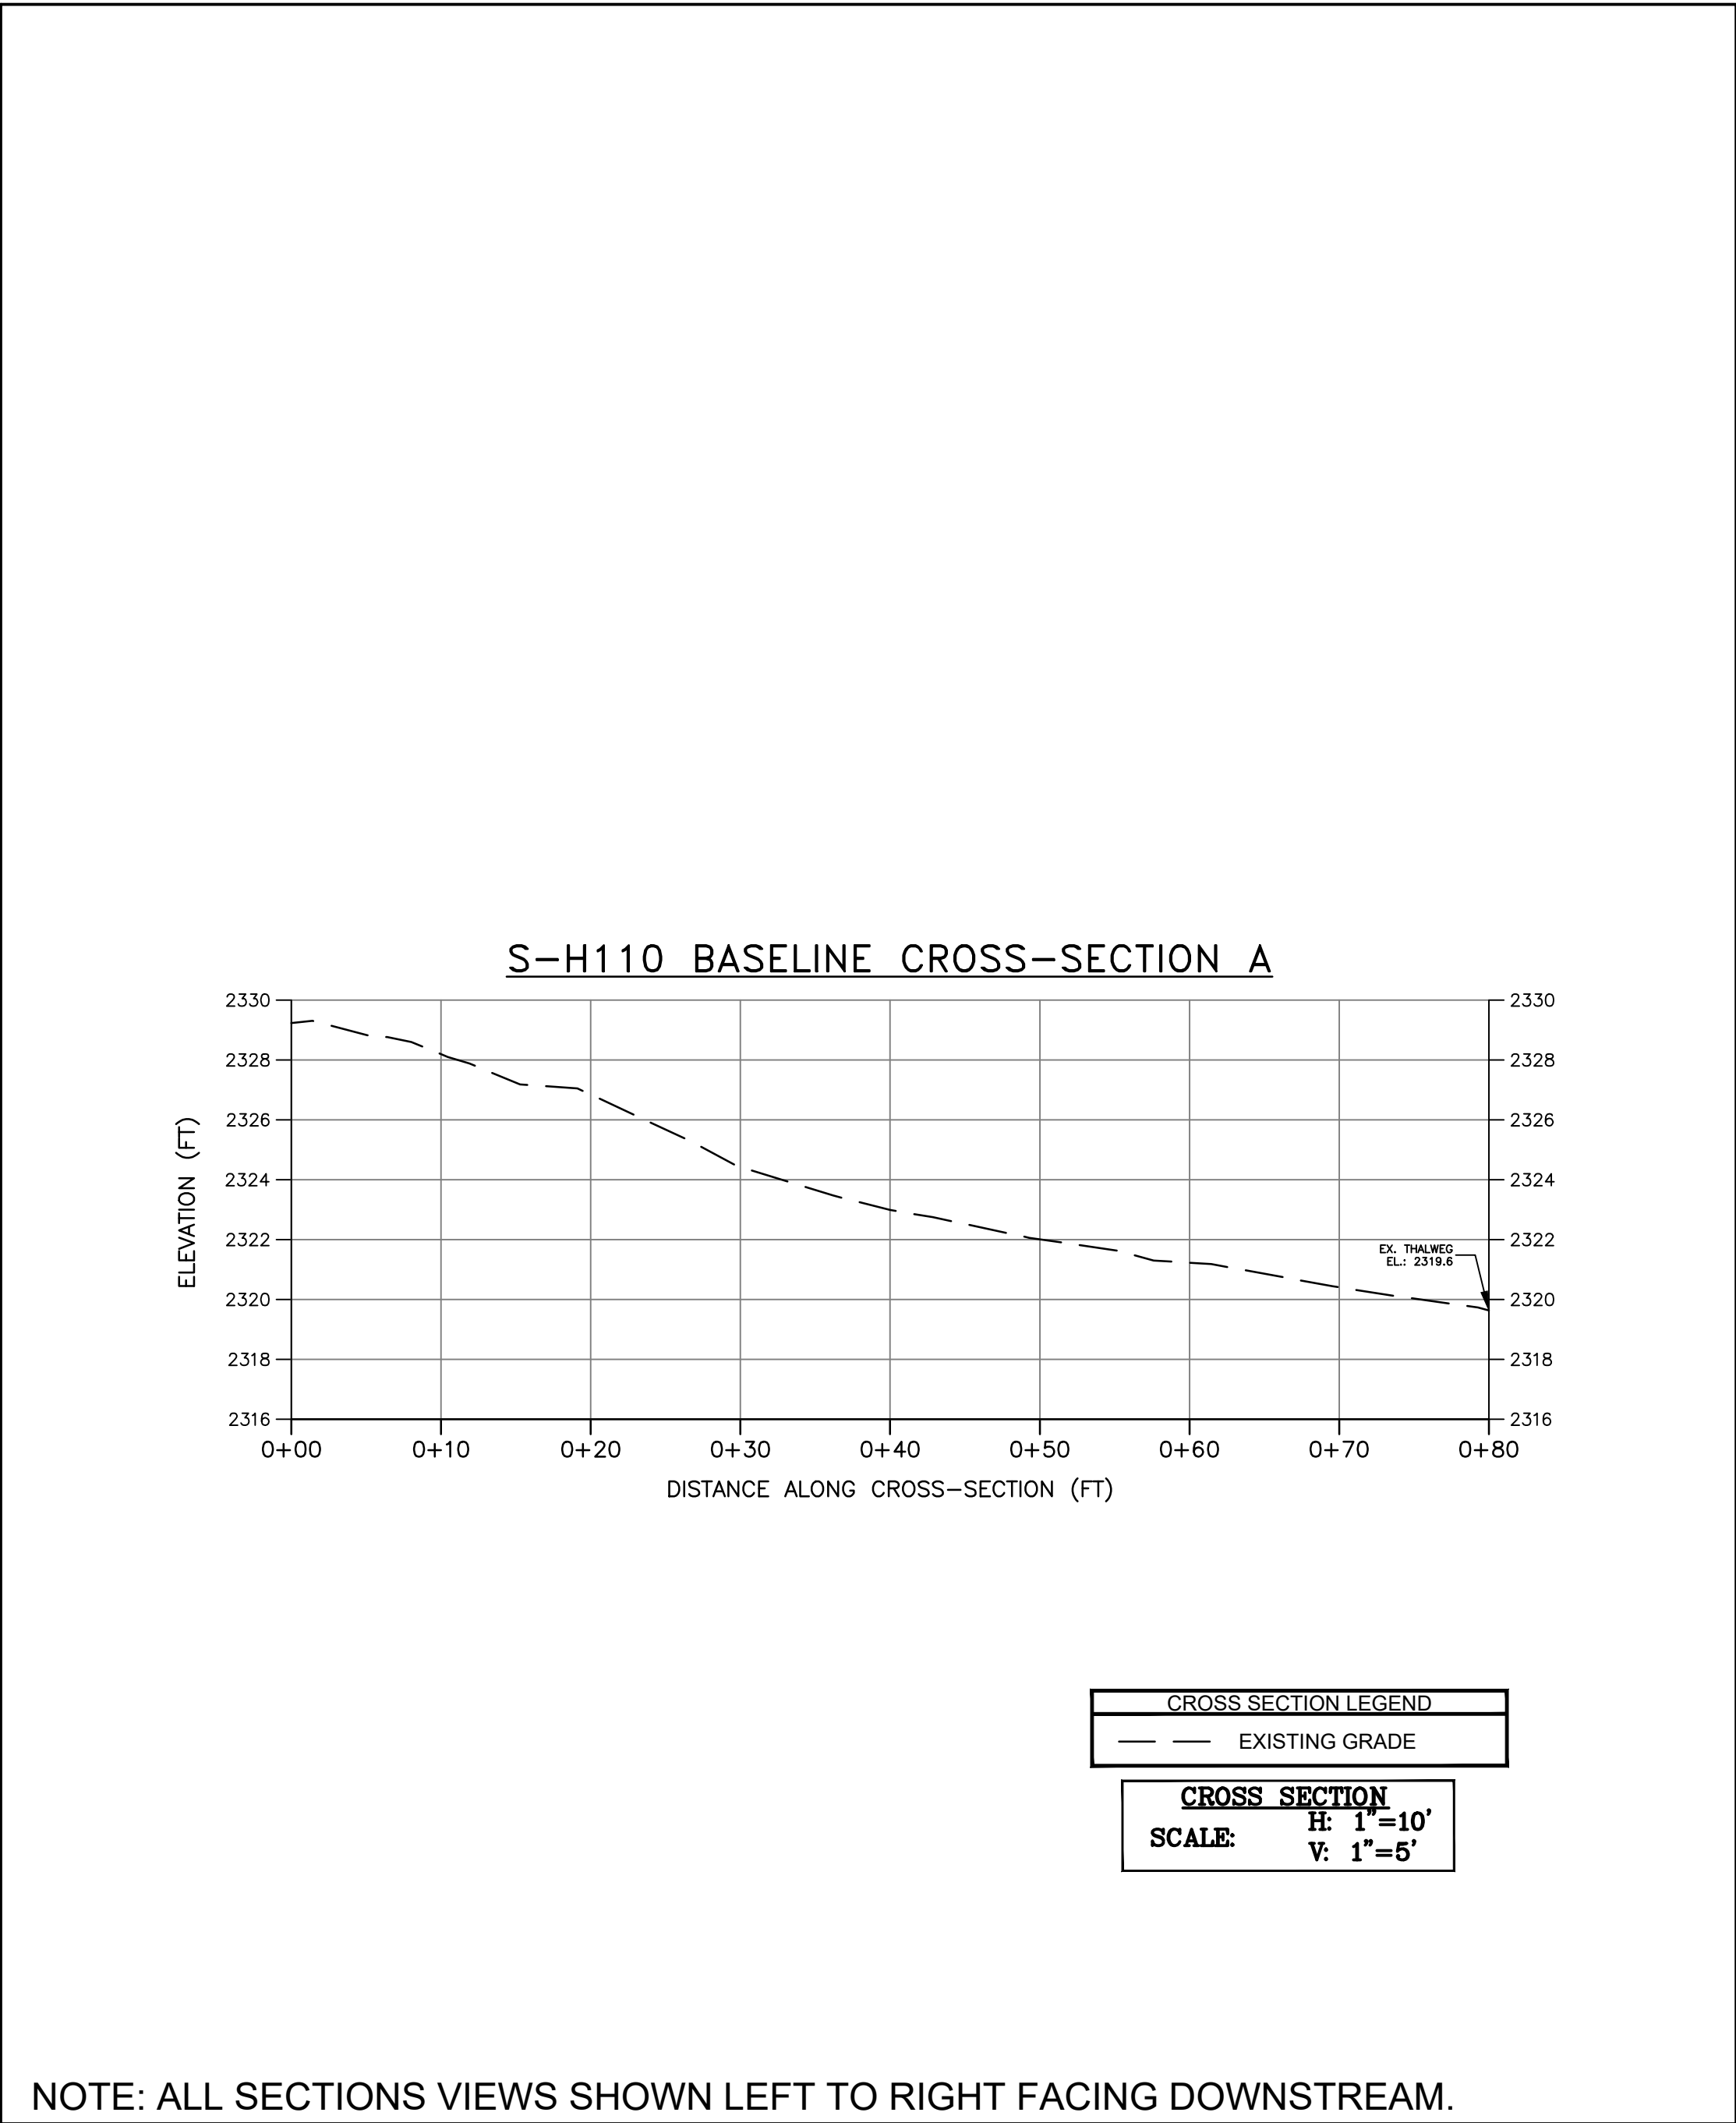
NOTE: ALL SECTIONS VIEWS SHOWN LEFT TO RIGHT FACING DOWNSTREAM.
