Baseline Assessment – Stream Attributes

Reach S-H111 (2) (Timber Mat Crossing) Intermittent Spread C Webster County, West Virginia

Spread C Stream S-H111 (2) (Timber Mat Crossing) Webster County

Client: MOUNTAIN VALLEY PIPELINE, LLC
2200 ENERGY DRIVE, 2ND FLOOR
CANONSBURG, PA 15317
Title: PROFILE AND CROSS-SECTIONS
BASELINE SURVEY
CROSSING S-H111 (2) - UNNAMED
TRIBUTARY TO ELK RIVER (MP 87.49)
WEBSTER COUNTY, WV

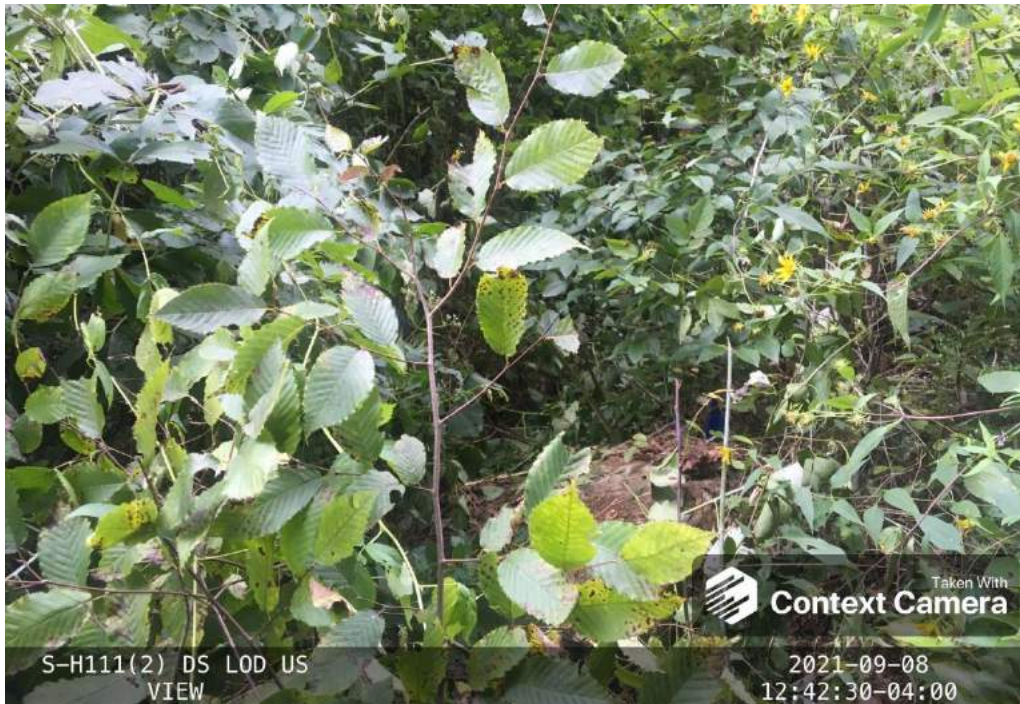
Photo Type: DS, US View

Location, Orientation, Photographer Initials: Downstream Edge of ROW, Upstream View, VM
Lat: 38.613341 Long: -80.50462

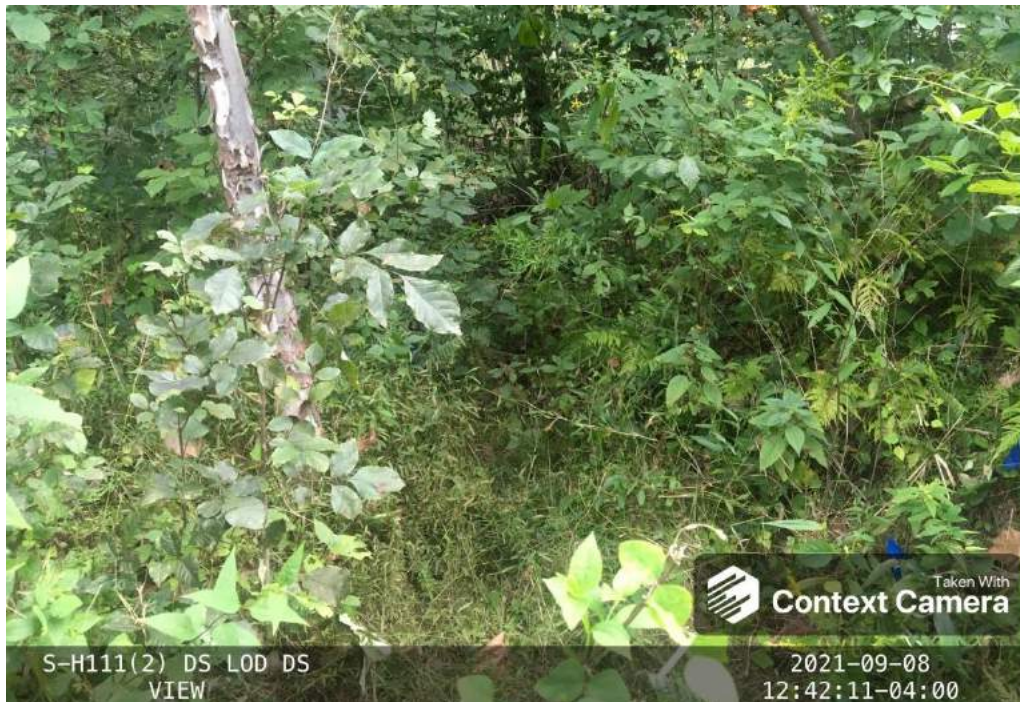
Photo Type: DS, DS View

Location, Orientation, Photographer Initials: Downstream Edge of ROW, Downstream View, VM
Lat: 38.613341 Long: -80.50462

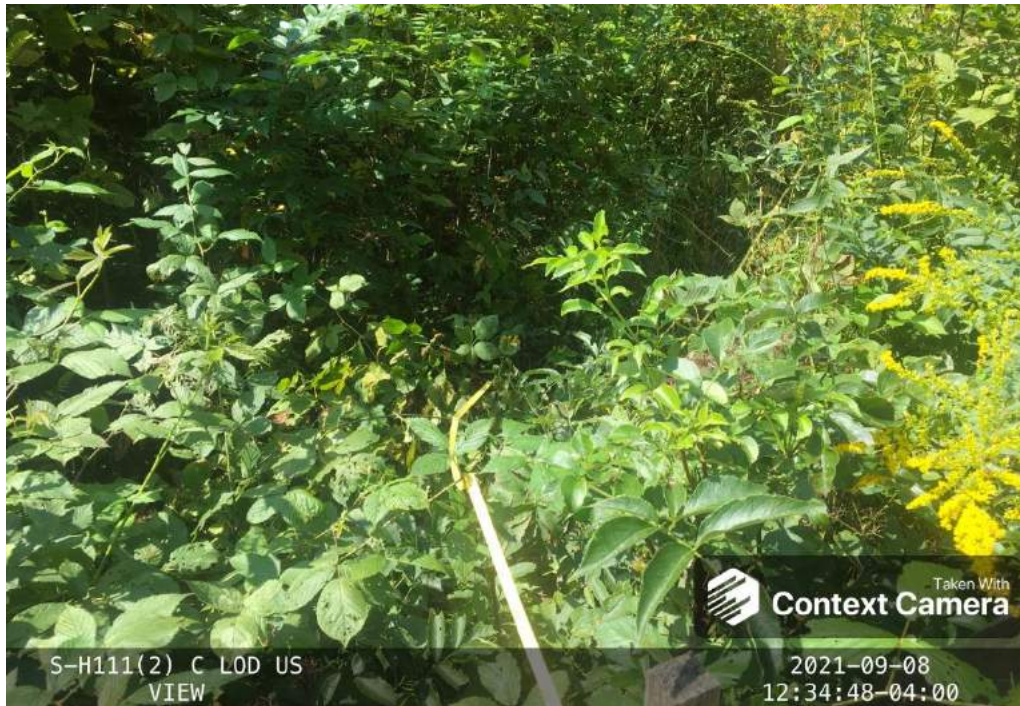
S-H111(2) C LOD US
VIEW

Photo Type: US View at Center
Location, Orientation, Photographer Initials: Center ROW, Upstream View, VM
Lat: 38.613341 Long: -80.50462

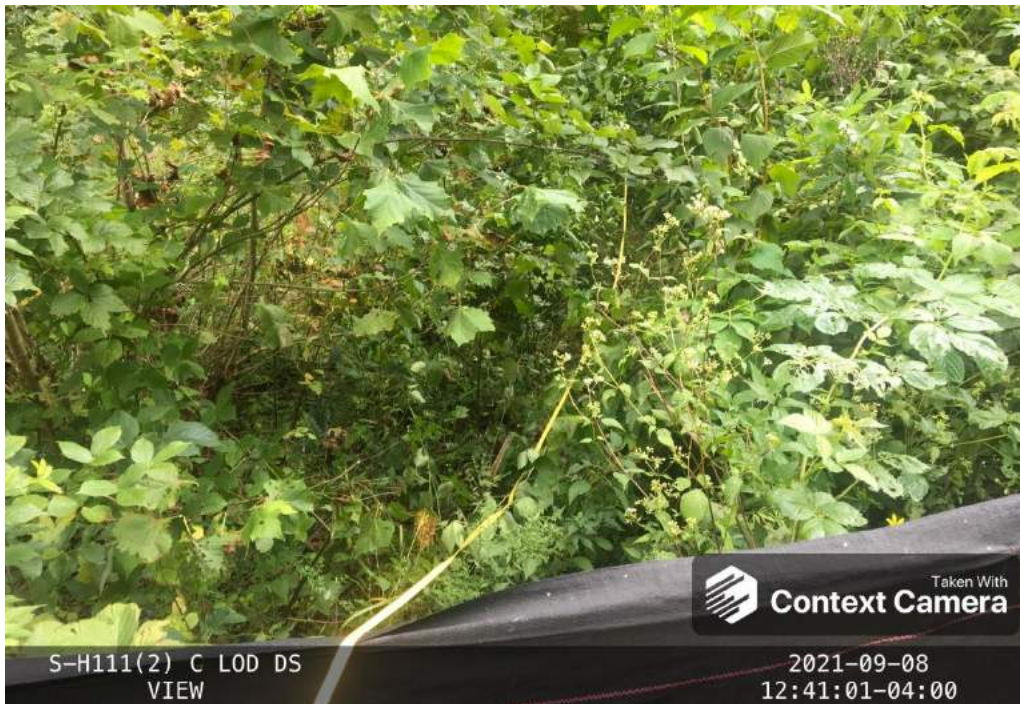
S-H111(2) C LOD DS
VIEW

Photo Type: DS View at Center
Location, Orientation, Photographer Initials: ROW Center, Downstream View, VM
Lat: 38.613341 Long: -80.50462

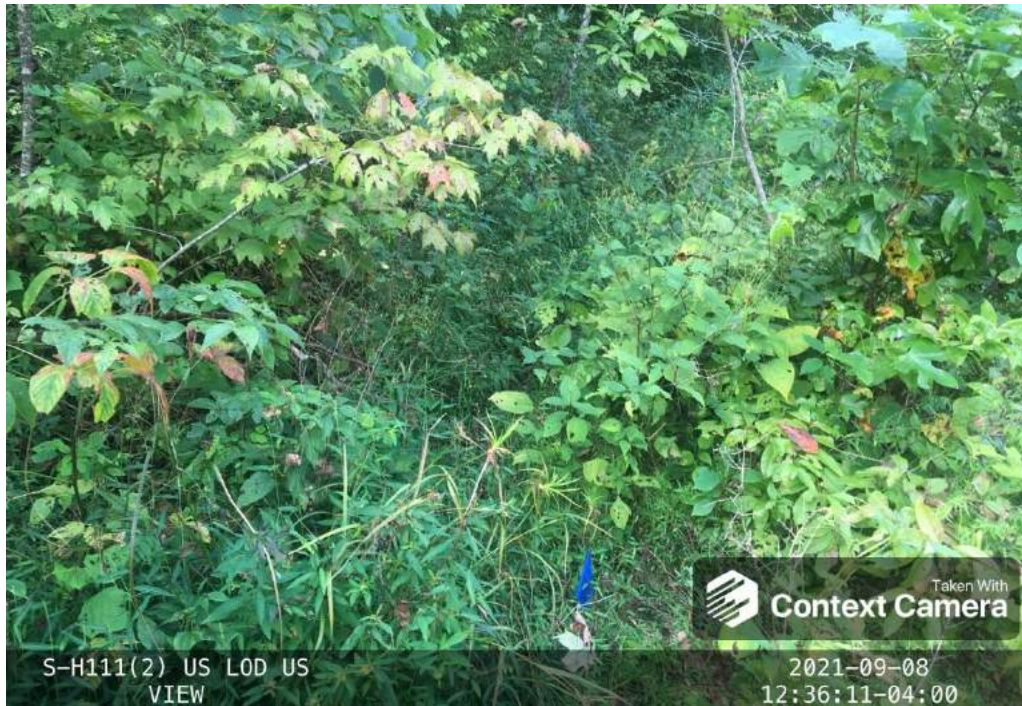
Photo Type: US, US View

Location, Orientation, Photographer Initials: Upstream Edge of ROW, Upstream View, HK
Lat: 38.613341 Long: -80.50462

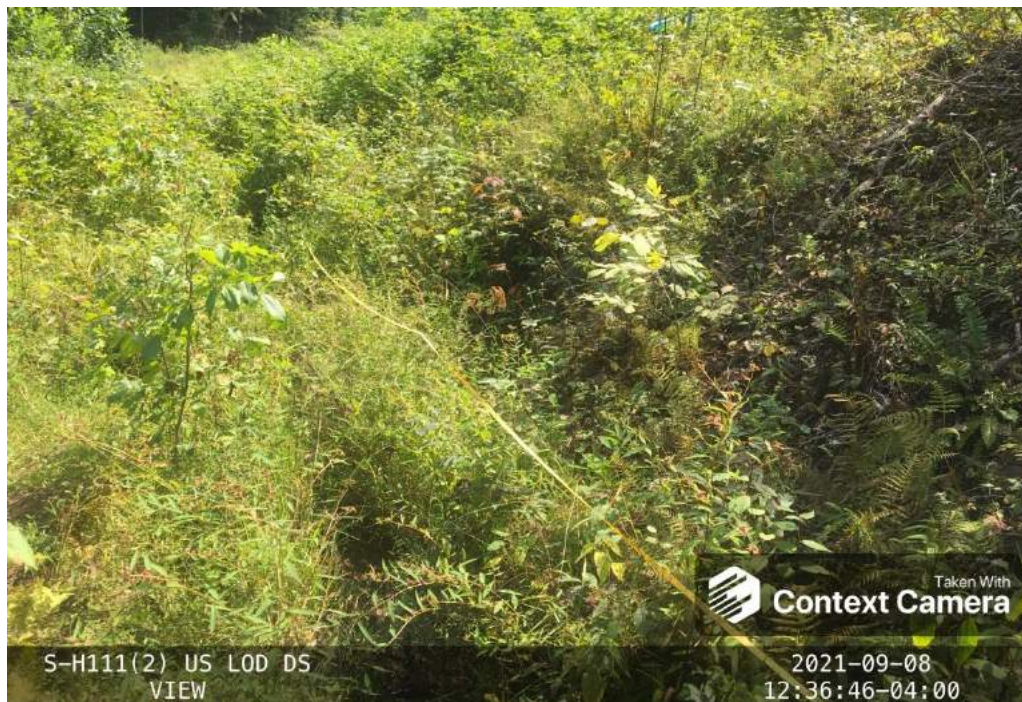
Photo Type: US, DS View

Location, Orientation, Photographer Initials: Upstream Edge of ROW, Downstream View, HK
Lat: 38.613341 Long: -80.50462

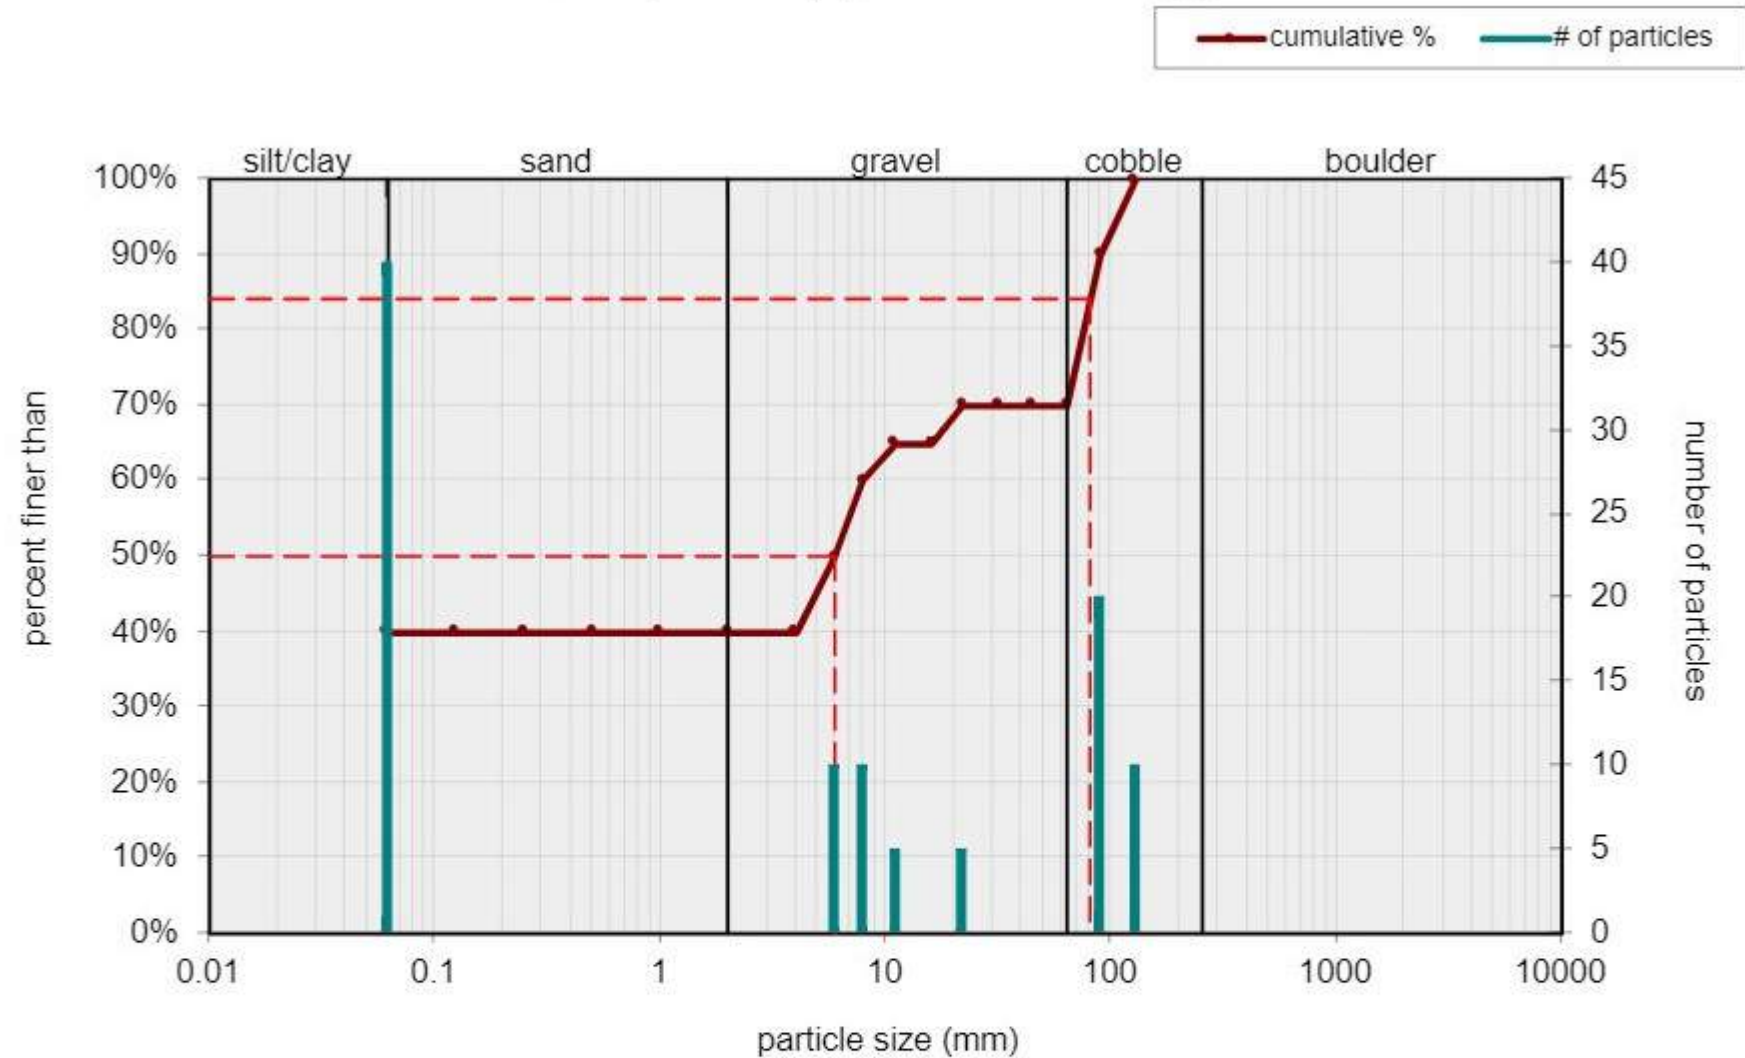
Bankfull Channel Pebble Count, S-H111 (2), UNT to Elk River (2)

Size (mm)		Size Distribution		Type	
D16	0.062	mean	2.2	silt/clay	40%
D35	0.062	dispersion	55.1	sand	0%
D50	6	skewness	-0.24	gravel	30%
D65	11			cobble	30%
D84	81			boulder	0%
D95	110

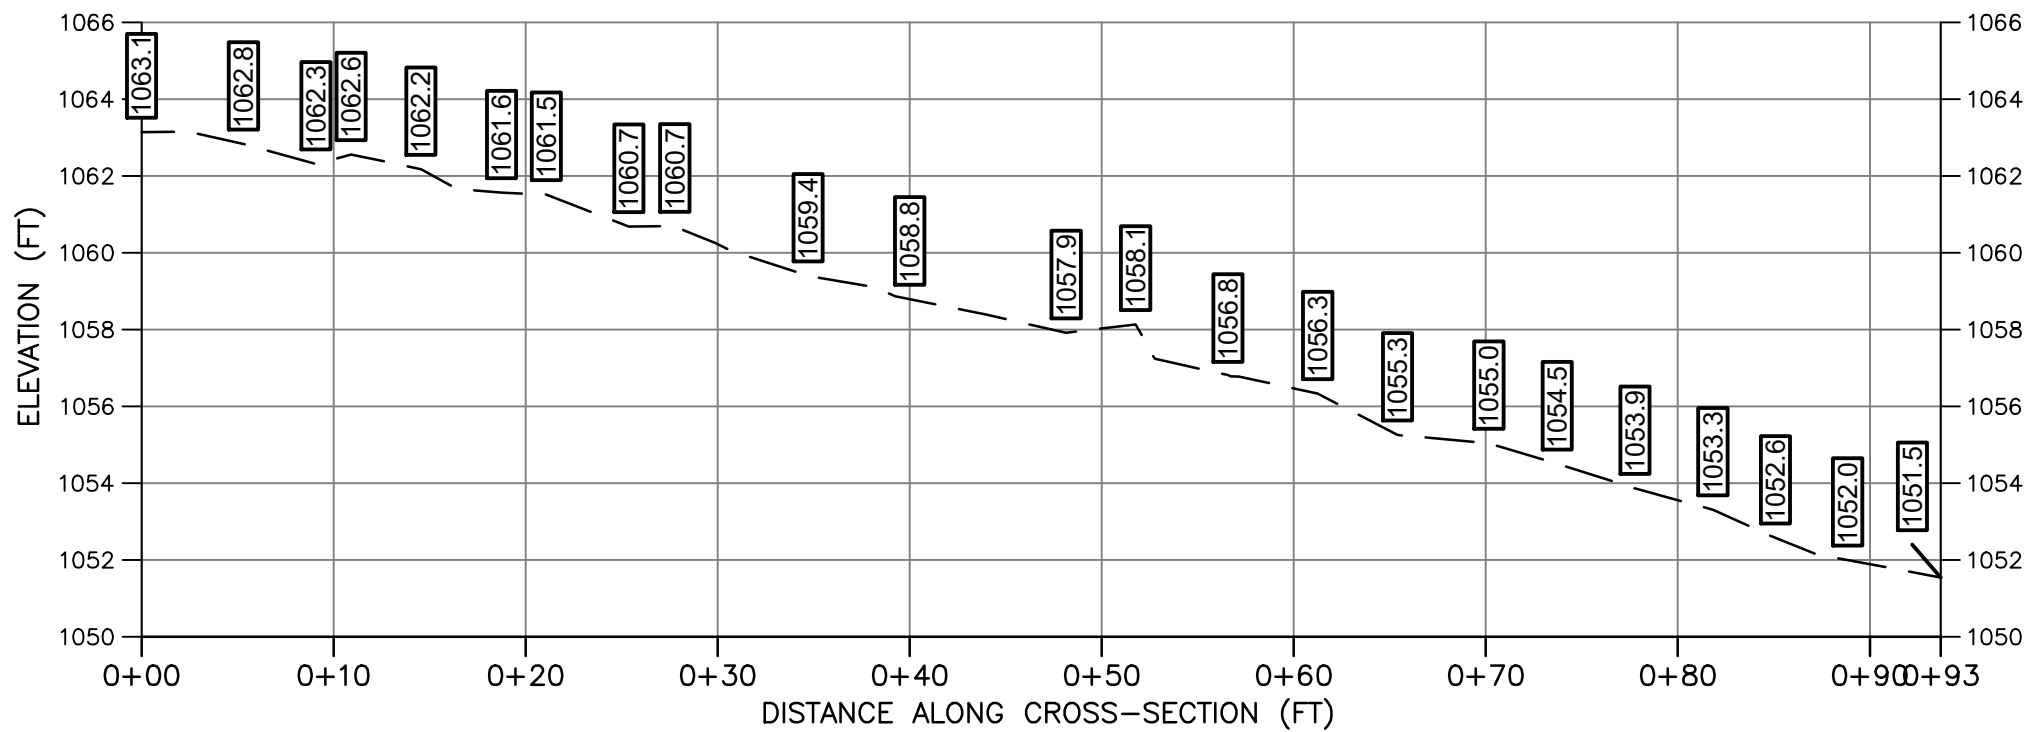
S-H111 (2) BASELINE THALWEG PROFILE

EXISTING STREAM PROFILE
INVERT ALONG THALWEG

SCALE: H: 1"=10'
V: 1"=5'
