Baseline Assessment – Stream Attributes

Reach S-H129 (Timber Mat Crossing) Intermittent Spread C Braxton County, West Virginia

Spread C Stream S-H129 (Timber Mat Crossing) Braxton County

Title PROFILE AND CROSS-SECTIONS
BASELINE SURVEY
CROSSING S-H129 - UNNAMED TRIB. TO
LITTLE KANAWHA RIVER (MP 74.98)
BRAYTON COUNTY, WV

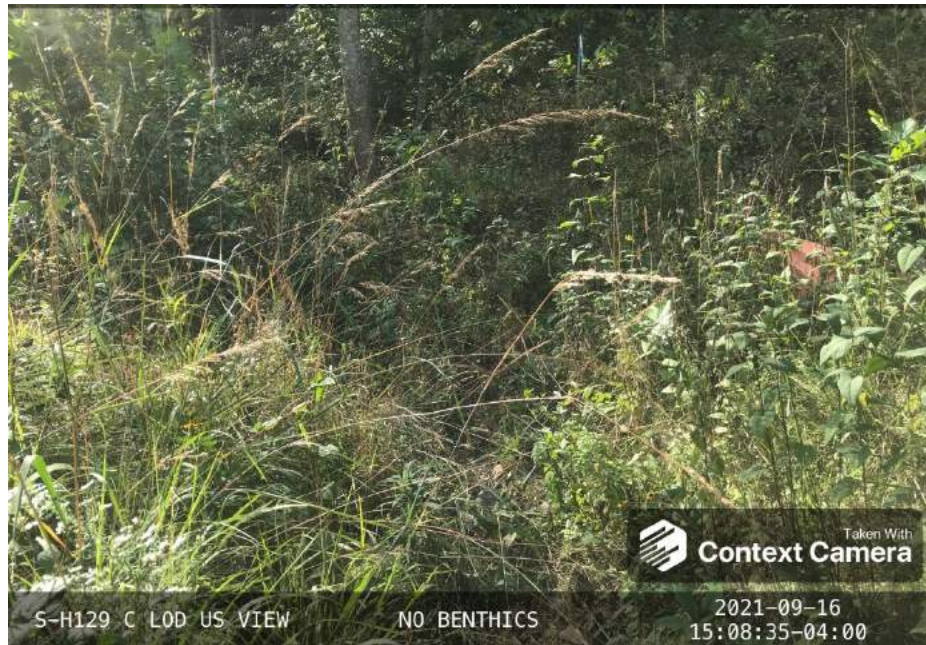
Photo Type: US View at Center
Location, Orientation, Photographer Initials: Center ROW, Upstream View, RH/HK
Lat: 38.749321 Long: -80.514337

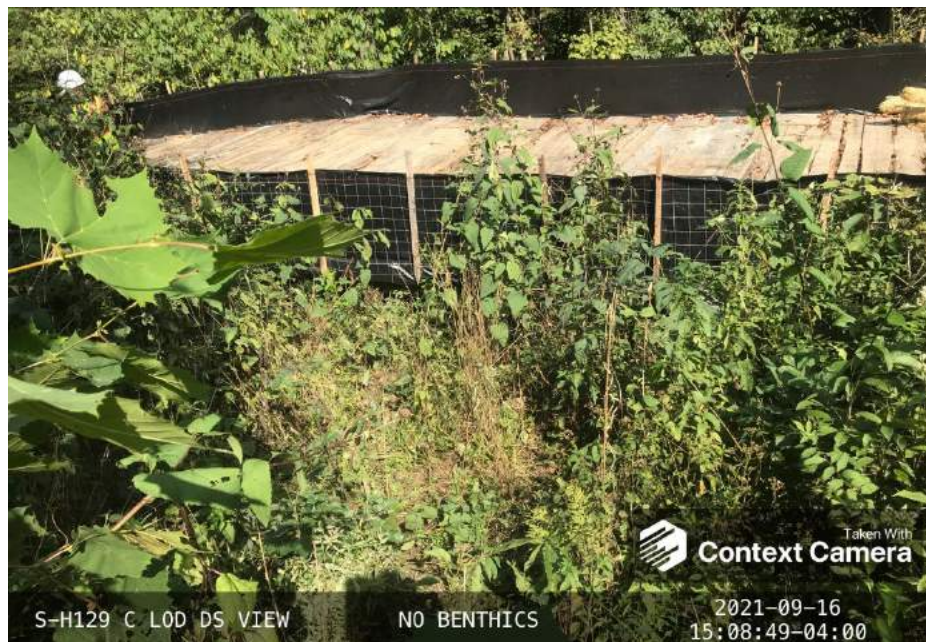
Photo Type: DS View at Center
Location, Orientation, Photographer Initials: ROW Center, Downstream View, RH/HK
Lat: 38.749321 Long: -80.514337

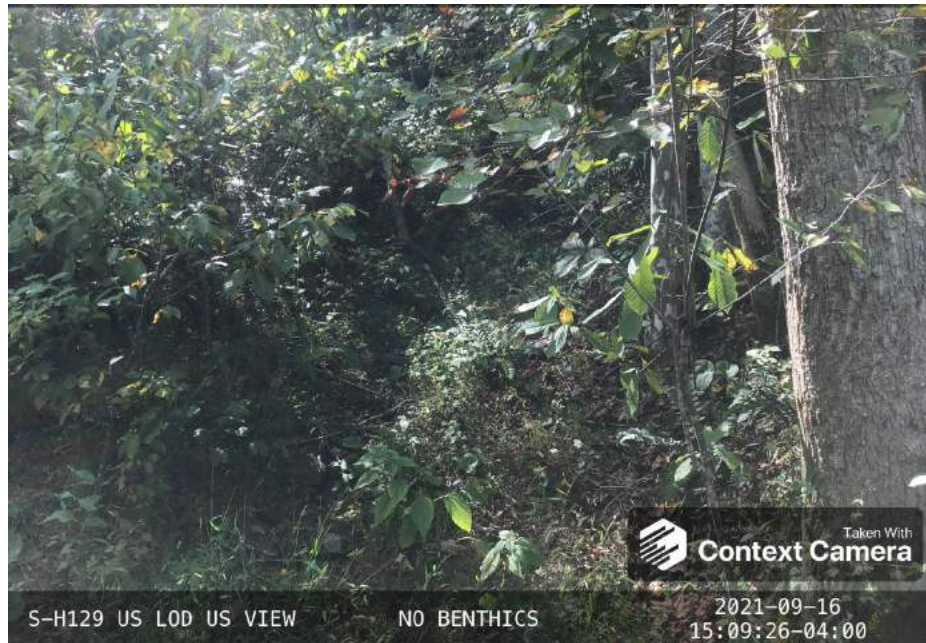
S-H129 US LOD US VIEW

NO BENTHICS

Photo Type: US, US View

Location, Orientation, Photographer Initials: Upstream Edge of ROW, Upstream View, RH/HK

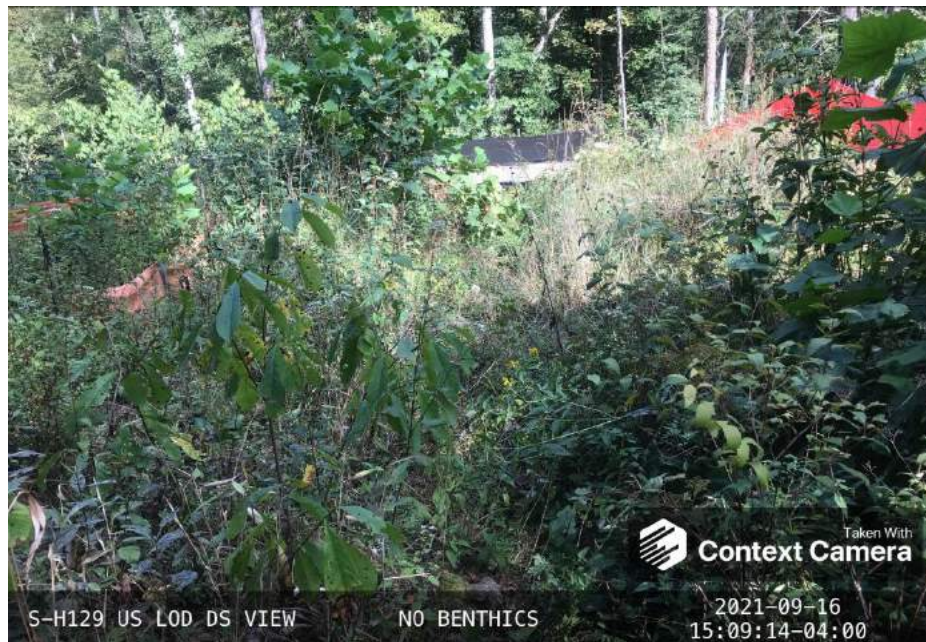
S-H129 US LOD DS VIEW

NO BENTHICS

Photo Type: US, DS View

Location, Orientation, Photographer Initials: Upstream Edge of ROW, Downstream View, RH/HK
