Baseline Assessment – Stream Attributes

Reach S-H131 (Timber Mat Crossing) Ephemeral Spread C Braxton County, West Virginia

Little Profile and Cross-Sections
Baseline Survey
Crossing S-H131 - Unnamed Tributary
Little Kanawha River (MP 74.90)
Braxton County, WV

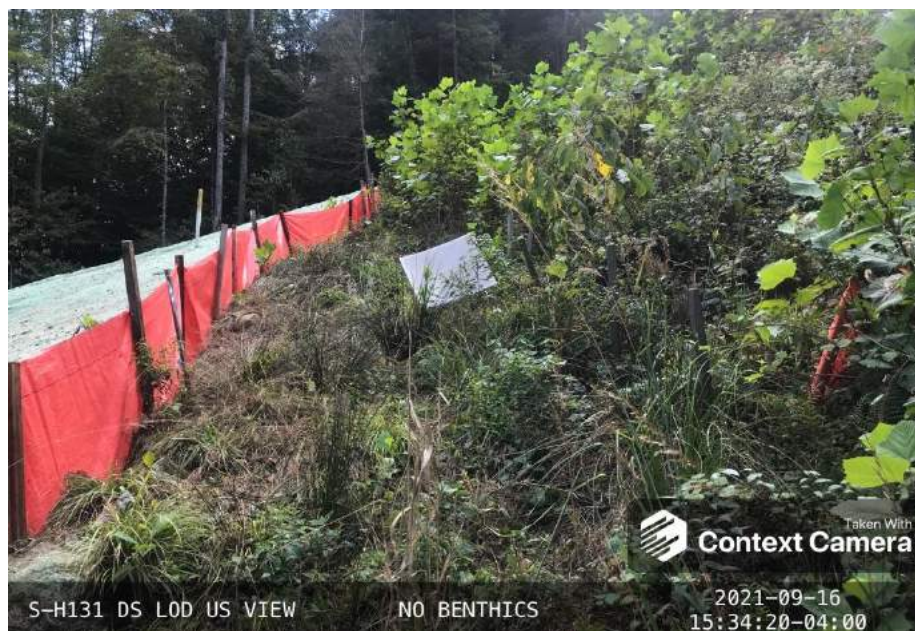
S-H131 DS LOD US VIEW

NO BENTHICS

Photo Type: DS, US View

Location, Orientation, Photographer Initials: Downstream Edge of ROW, Upstream View, RH/HK
Lat: 38.749215 Long: -80.51437

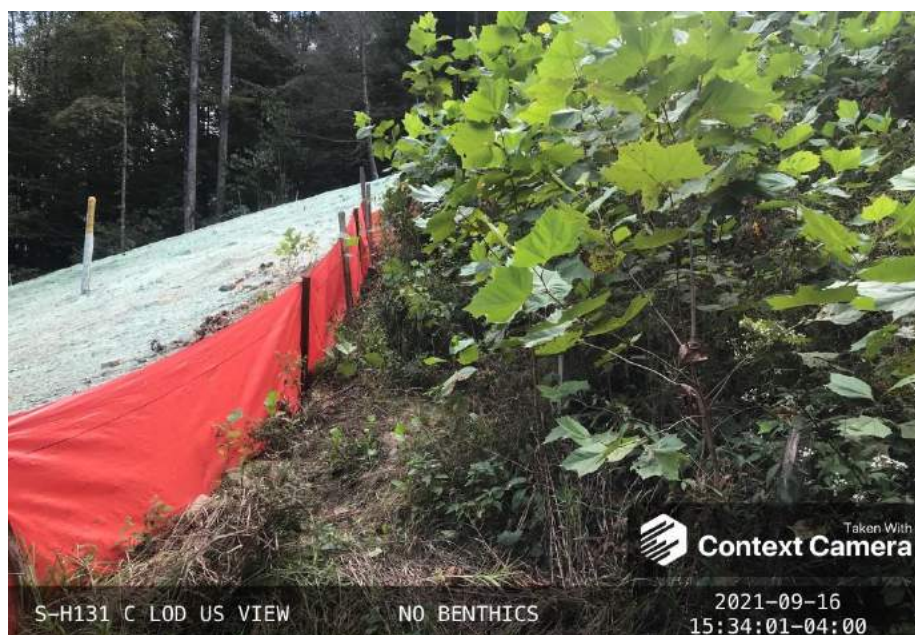
Photo Type: US View at Center
Location, Orientation, Photographer Initials: Center ROW, Upstream View, RH/HK
Lat: 38.749215 Long: -80.51437

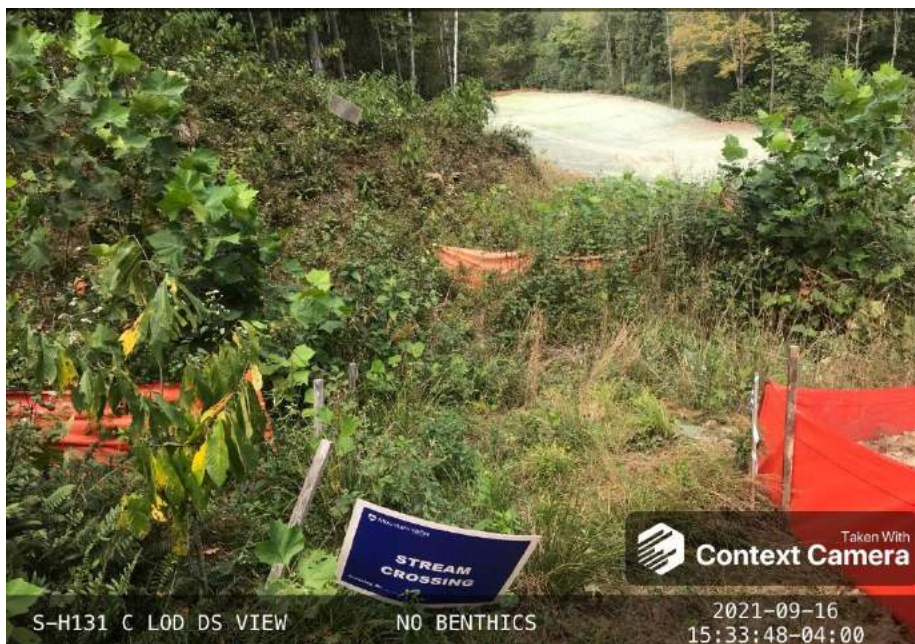
Photo Type: DS View at Center
Location, Orientation, Photographer Initials: ROW Center, Downstream View, RH/HK
Lat: 38.749215 Long: -80.51437

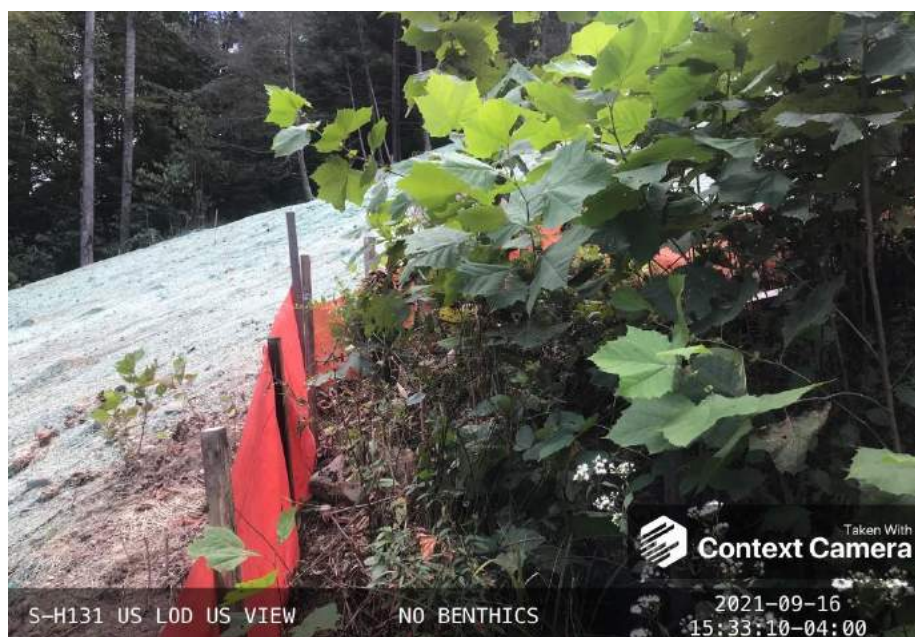
Photo Type: US, US View

Location, Orientation, Photographer Initials: Upstream Edge of ROW, Upstream View, RH/HK
Lat: 38.749215 Long: -80.51437

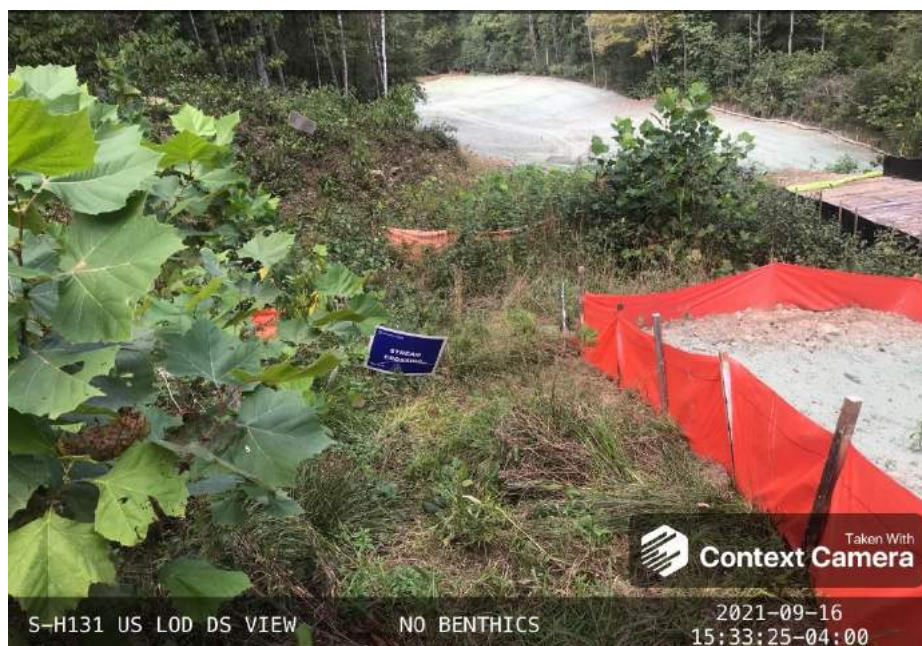
Photo Type: US, DS View

Location, Orientation, Photographer Initials: Upstream Edge of ROW, Downstream View, RH/HK
Lat: 38.749215 Long: -80.51437

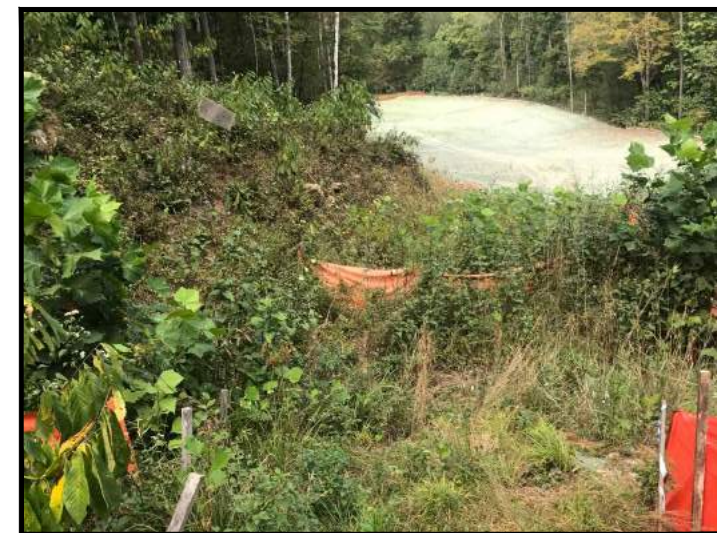
PHOTO TAKEN LOOKING DOWNSTREAM
FROM UPSTREAM IMPACT LIMITS

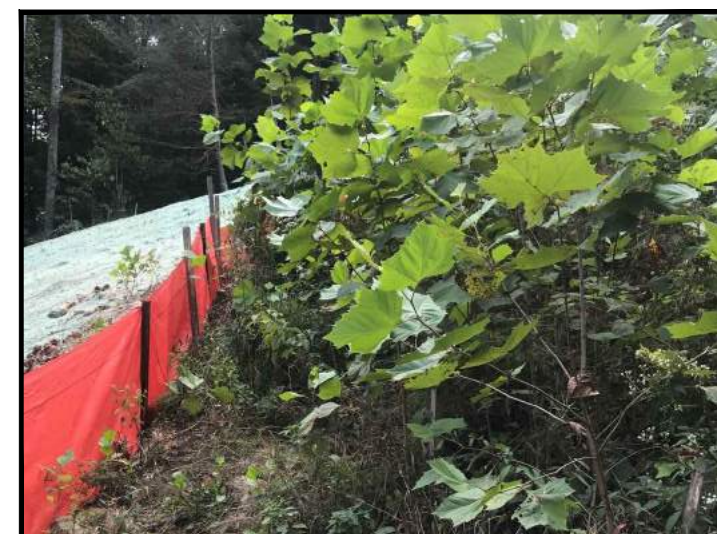
PHOTO TAKEN LOOKING UPSTREAM FROM
DOWNSTREAM IMPACT LIMITS
